# An Archaeological Watching Brief on Land at Rainford Tennis Club, Rainford, Merseyside Site Code 150 Assessment Report

*Prepared for Rainford Tennis Club*

**June 2013**

**National Museums Liverpool Field Archaeology Unit,  
Dock Traffic Office,  
Albert Dock,  
Liverpool  
L3 4AX**

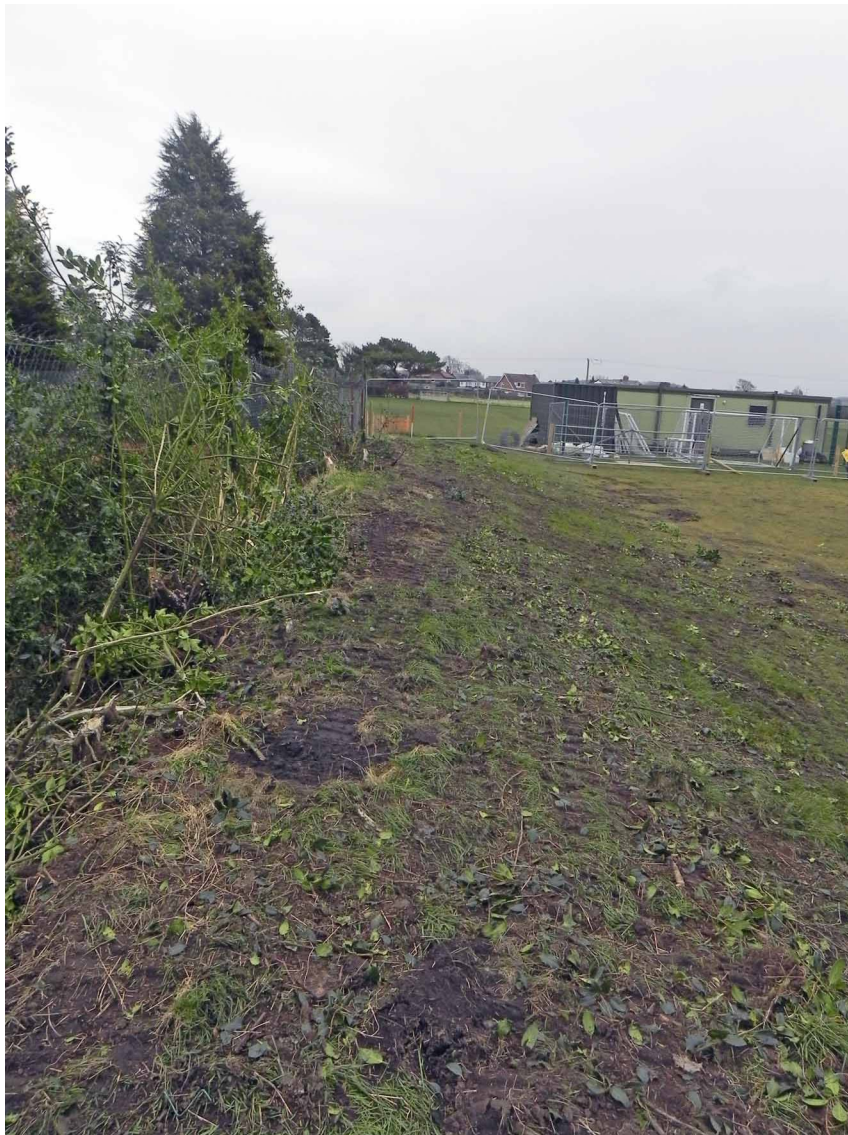
Plate 1. View looking south along the bank to the old tennis courts.

The bank (Context 8) which formed the western boundary to the original tennis courts (Fig. 4) was c. 2 m wide and 1 m high above ground level (Plates 1 and 2). It was excavated by machine during the topsoil strip for the new courts. Although sherds of early post-medieval pottery were noted within this material it was generally present in much lower quantities and as smaller (< 100 mm) sherds than were present in the stratified deposits to the west. Given that the material in the bank was relatively sparse and effectively unstratified, resources were concentrated on excavating the deposits described below.

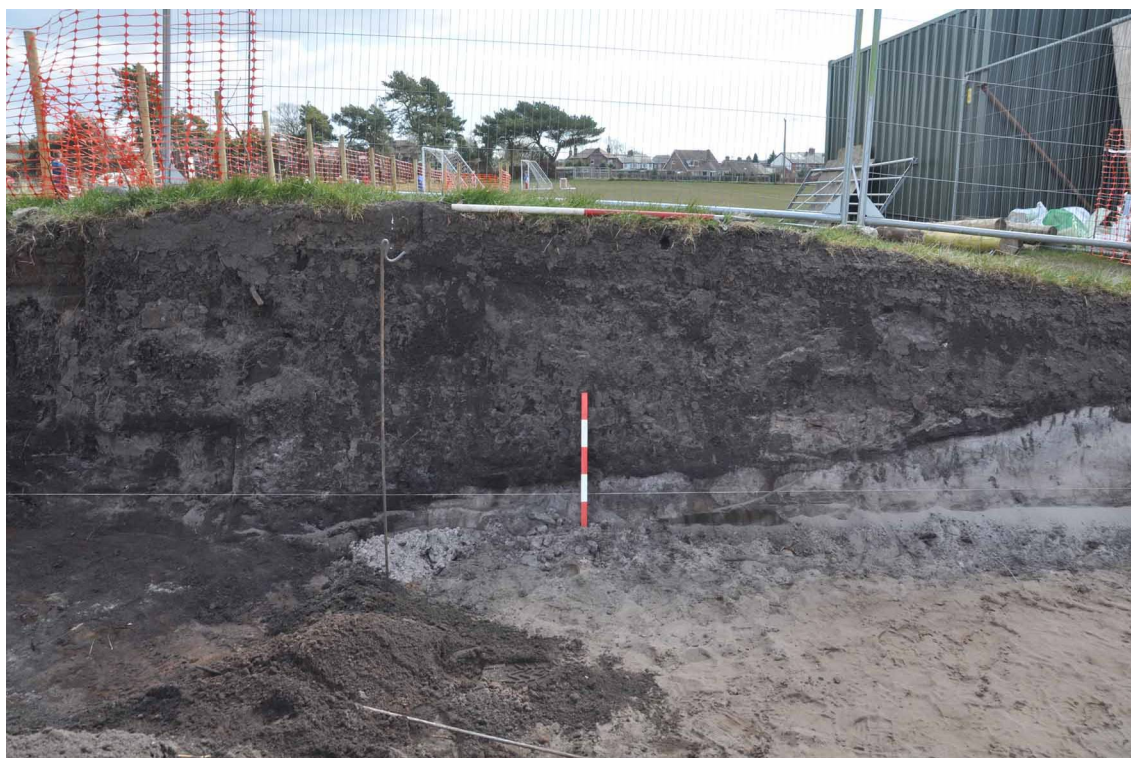
Plate 2. Section across the southern end of the bank to the old tennis courts looking south.

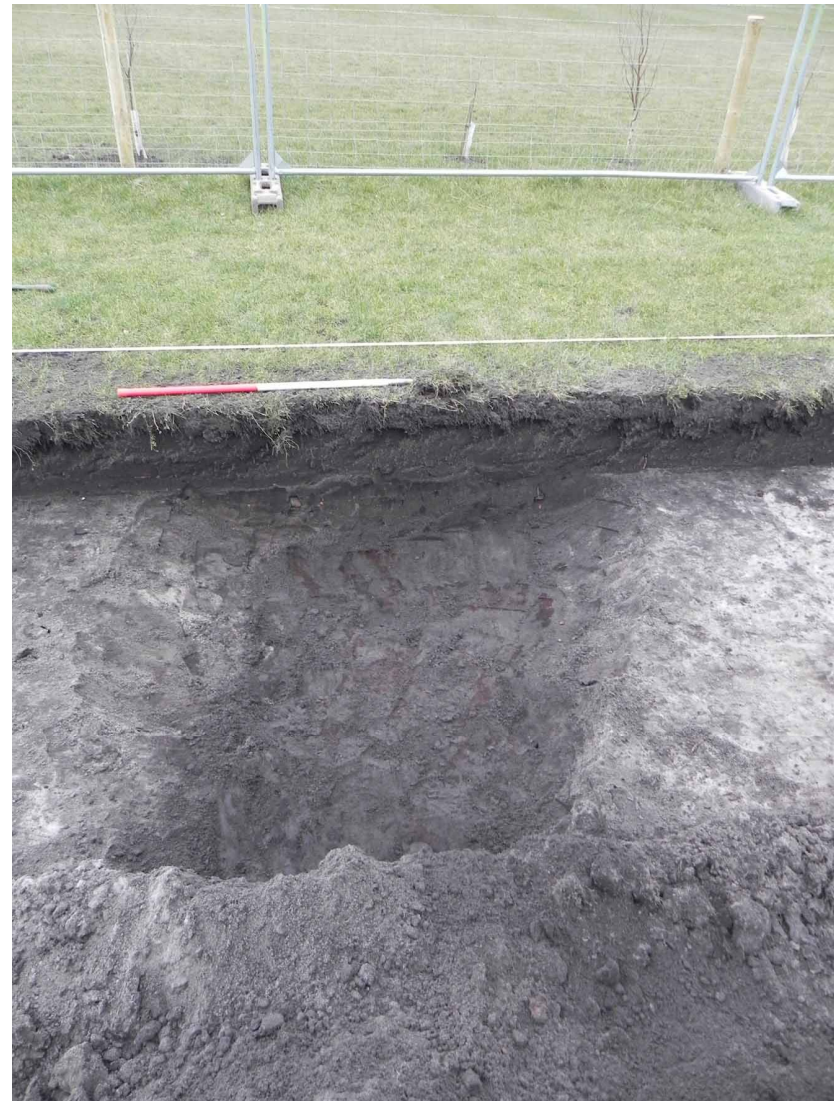
Plate 4. Section excavated across context 3. View looking west.

Context 3 was the fill of a possible east-west aligned ditch (Context 82) on the western edge of the new courts. The fill was a dark grey humic silty sand and the cut was 1.9 to 2.10 m wide and 0.20 m deep (Plate 4). However, the edges of the cut were very poorly defined and it was only traced for a length of c. 2 m, it was not observed in the area to the east. It is possible that this feature was in fact a shallow water course or area of slightly boggy ground. No features are shown in this area on the 1850 or 1893 OS maps (Figs 7 & 17) and it is perhaps more likely that it was a sands extraction pit similar to Context 17. Context 4 was situated c. 2 m to the south of context 3 but appeared to be of natural origin.

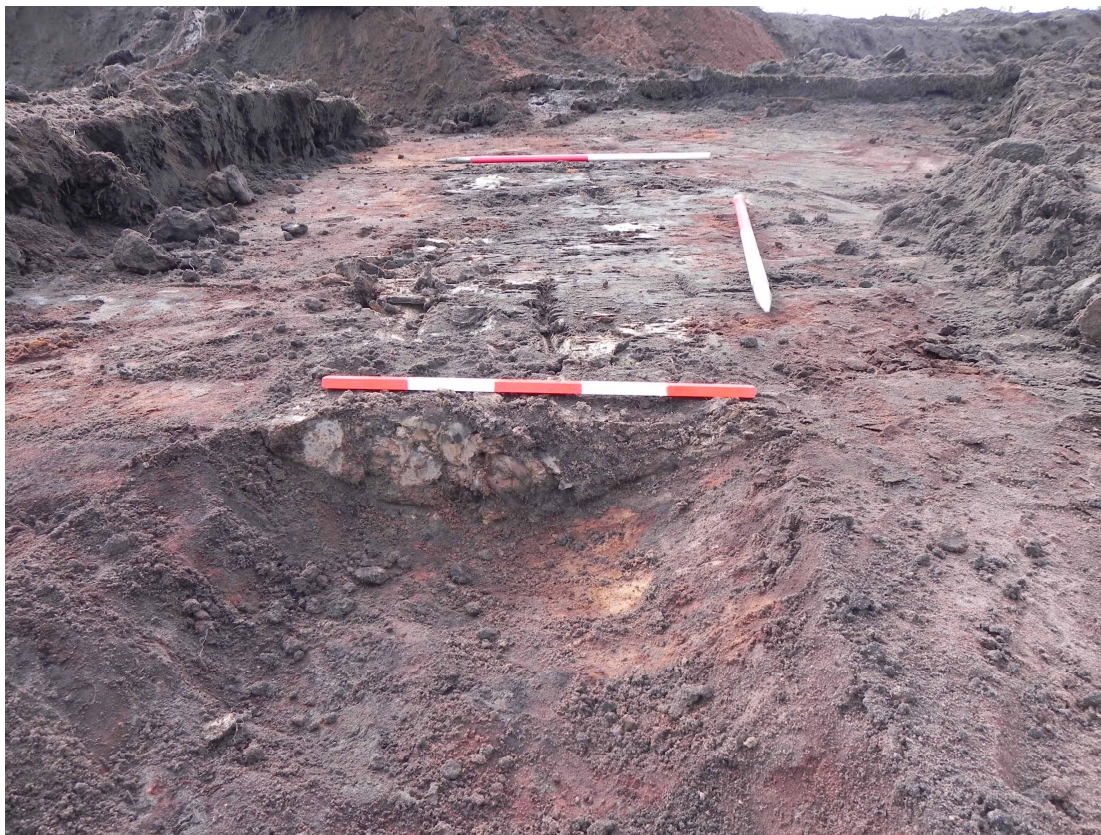
Plate 6. South-west facing section across context 9.

Context 9 was the fill of a shallow north-west to south-east aligned gully (Context 76) with a shallow U-shaped profile situated close to the centre of the excavation (Fig. 5, Plates 5 and

6). The cut was 0.55 m wide, 0.20 m deep and 4.80 m long. It terminated in a squarish end to the north-west but had probably continued for an uncertain distance to the south-east but had not been observed during machine excavation which suggests that it either terminated c. 1-2 m south-east of the point it was first observed at or that the fill had not been sufficiently distinctive to be distinguished. The fill (Context 9) exhibited some variation, consisted of a mass of redeposited clay blocks and lumps set within a matrix of black humic silty sands. In places up to 75% of fill of gully was dumped clay, further to the south the clay was perhaps 40% of the fill. The clay was laminated and contained large quantities of pottery, many large portions of pottery vessels, some full profiles and probably originally complete or nearly so. Many were damaged in rapid removal from the encasing clay in rapid excavation circumstances, and in one case a clay block broke open to reveal what strongly resembled an unfired earthenware dish.

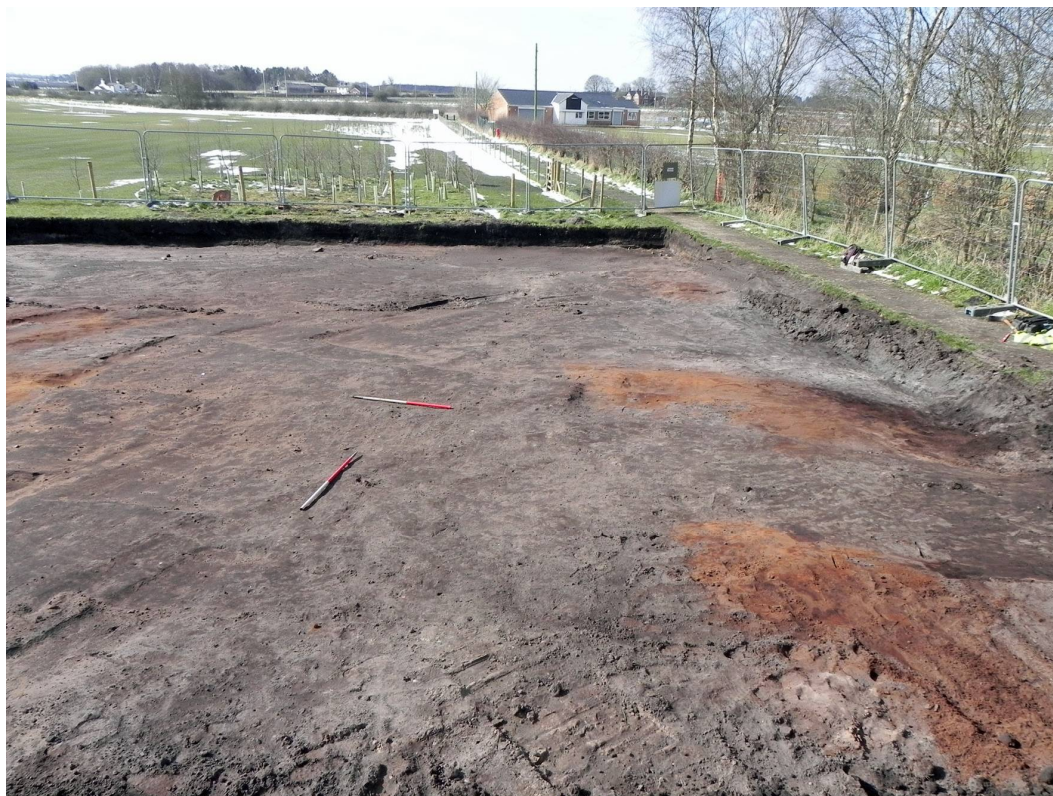
Plate 7. The north-west corner of the new courts following top-soil stripping. View looking west. The scales are on context 18, context 17 to the left, context 5 in the rear ground.

Two of the pits were originally seen as a linear area of material (context 17, Figs 11 and 12, Plates 7 and 16) running north from the northern edge of ditch context 18. As excavation progressed it became clear that this was in fact the upper fill of two discrete pits. Context 17 filled context 59 and contained at least two near complete faceted tygs and several other very large fragments of vessels in the infill. Many smaller fragments were also present including a spiral handle and an impressed yellow pad of clay with cross stamp.

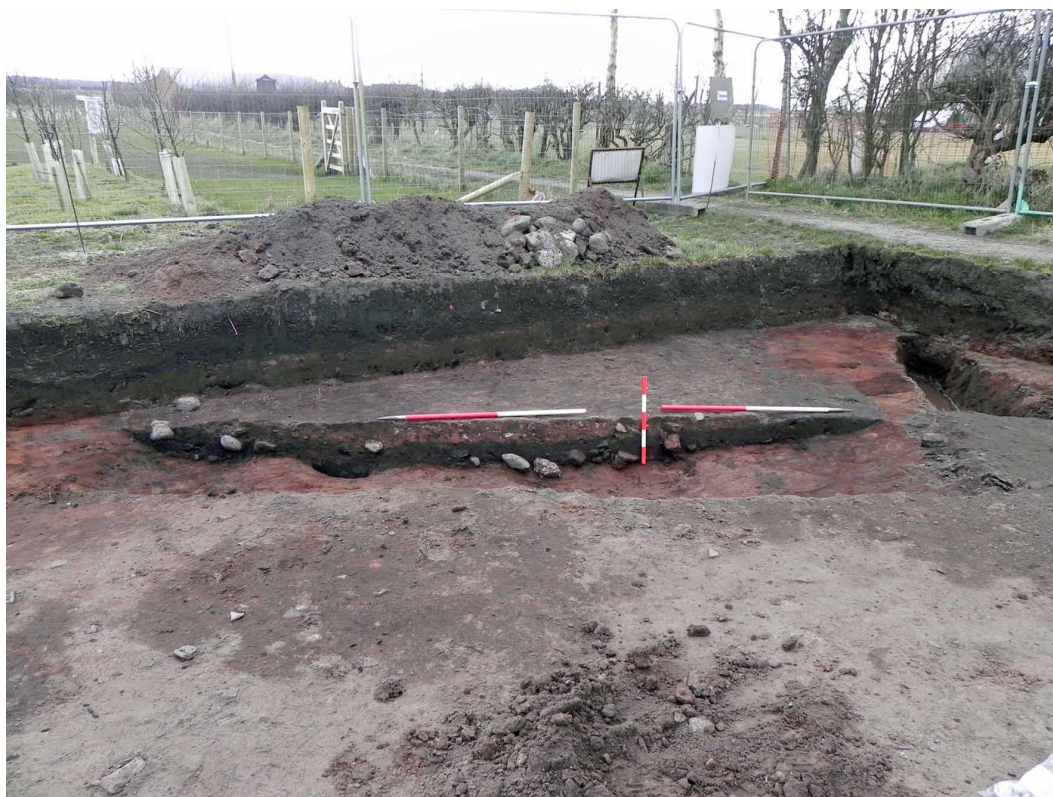
Plate 8. Section across the western end of the east-west aligned trackway. View looking north-west.

The lowest fill of this trackway (Context 45, not visible on Fig. 8, Plate 8) consisted of a soft, coarse yellowish brown sand of sand occurring as localised patches in the base of the cut. This deposit was very similar to the geological deposits on this part of the site but contained fragments of pottery and was probably material eroded from the sides of the cut during its use.

Context 39 was the fill of the western branch of the trackway represented by context 40 in Phase 1 (Fig. 8, Plate 8). In general it was very similar to the fills to the east but there were also several large glacial cobbles and fragments of red sandstone at the base of the cut which appeared to have been deliberately deposited in an attempt to consolidate the underlying sands. This deposit was sealed by the clay layer (context 10) in Phase 5.

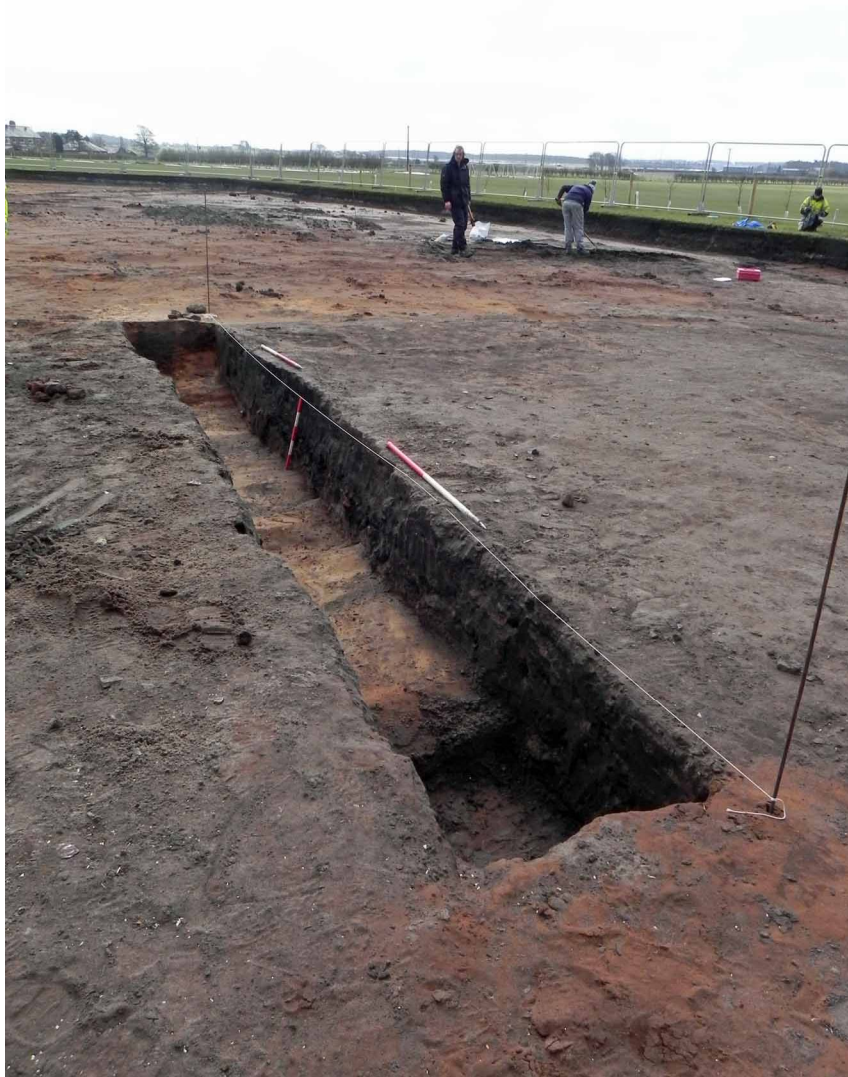
Plate 9. Section across the eastern end of the trackway. View looking south-west.

Context 27 continued on the same alignment as context 40 and in the excavated section was 6.8 m wide and up to 0.6 m deep with a steep sided, flat bottomed profile (Fig. 9, Plate 9). Slight irregularities in its base may have represented wheel ruts. This feature appeared to become gradually shallower to the east because it became increasingly difficult to locate.

Similar deposits were present in the east-west aligned trackway (context 27 in Phase 1) where Context 18 was the fill of the eastern branch (Fig. 9, Plate 9). It was seen as a broad c. 5 m wide band of darker, humic silty sand with occasional lenses of sand contrasting sharply with the dark reddish brown naturally deposited sands in this part of the site. In contrast with the fills of context 40 to the west context 18 appeared to be uniform throughout, though most of the pottery was concentrated in the lower 200 mm and may represent an attempt at stabilisation similar to Context 28. Context 16 was material collected from this area during cleaning following machine excavation and is probably derived from context 18 with some contamination from context 5.

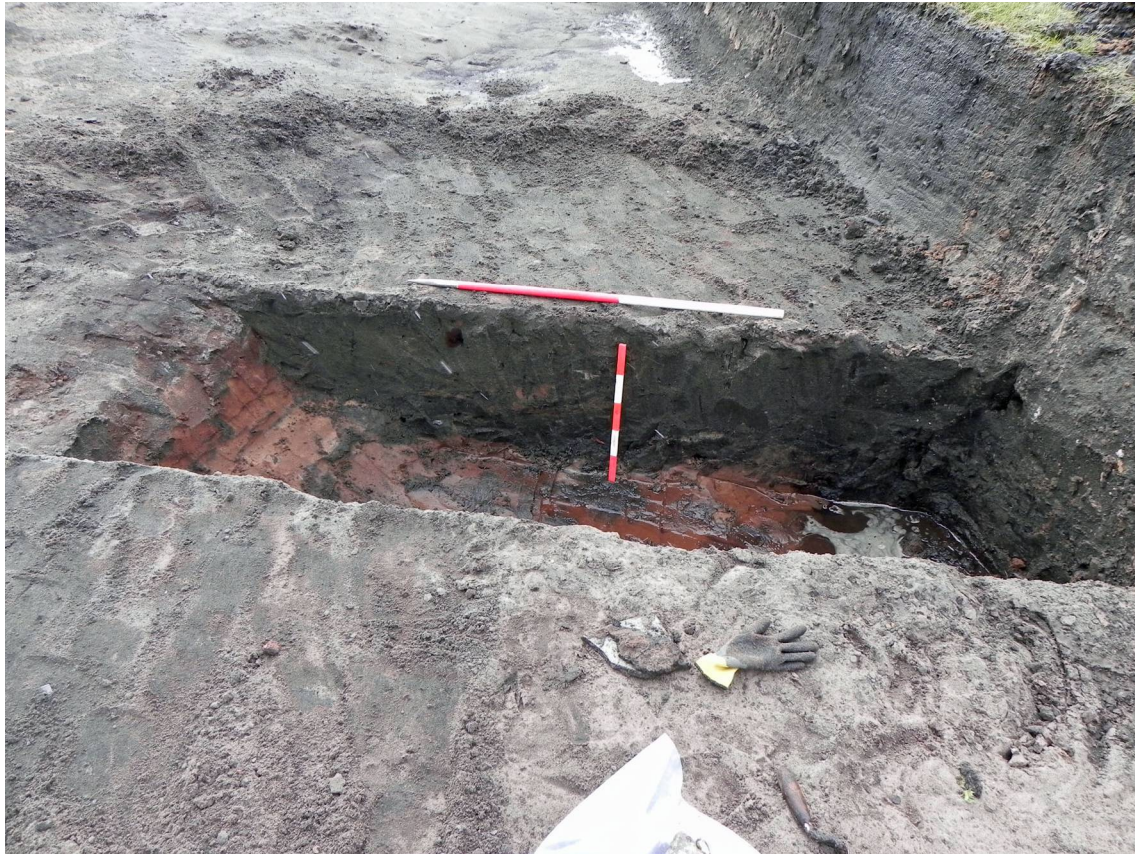
Plate 10. Section across the southern end of the boundary. View looking south.

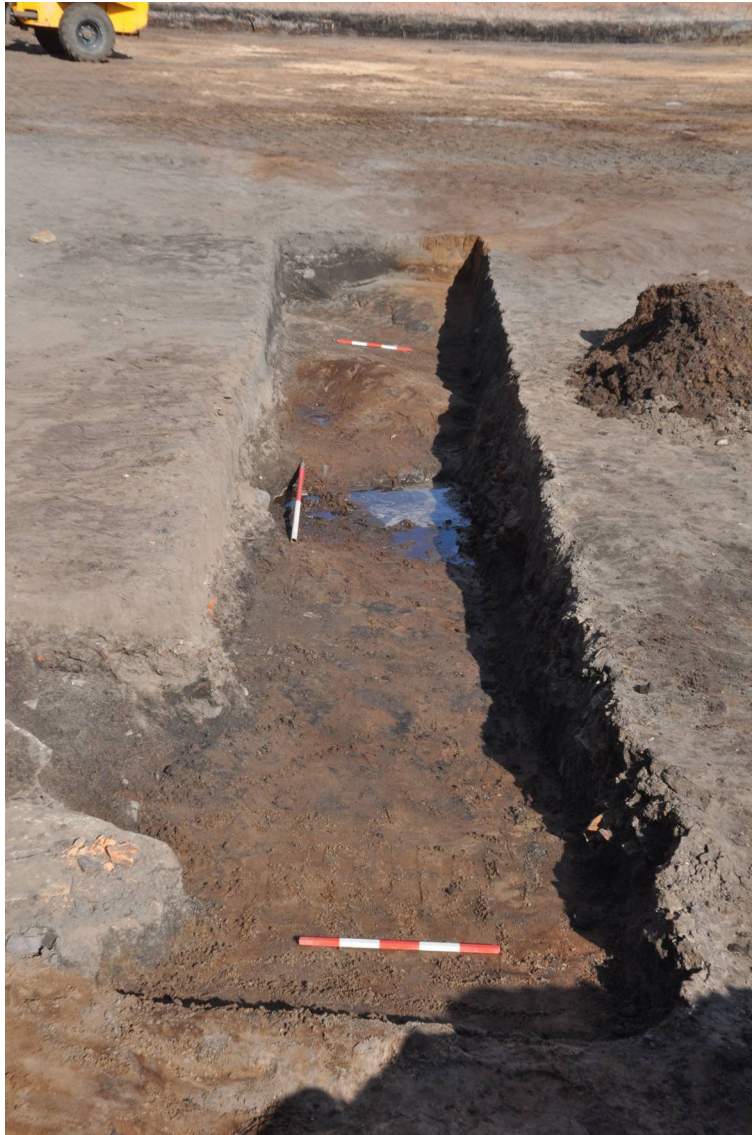
Plate 11. Section across central section of boundary. View looking east.

A section excavated across the central section of this feature (Fig. 5, Plates 11 and 12) found that Context 5 was shallower here at c. 200 mm thick and sealed context 36 which was slightly darker in colour but also up to 200 mm thick (Fig. 10). This deposit in turn sealed context 28 (Phase 2).

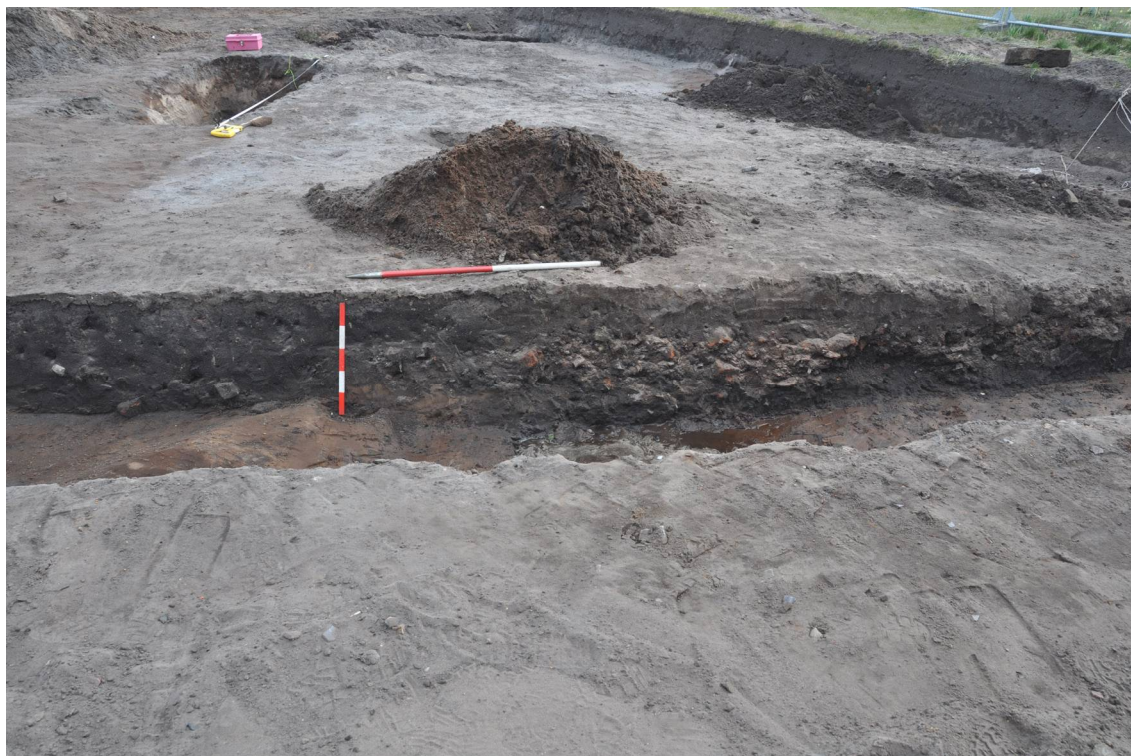
Plate 12. Detail of central section across the north-south aligned boundary. Context 28 is in the centre of the frame. View looking south.

Deposits relating to this phase were only noted in the central section excavated across the north-south aligned field boundary (context 72) and in a section excavated across the eastern arm of the trackway (Figs 5, 8 & 10; Plates 12 and 14).

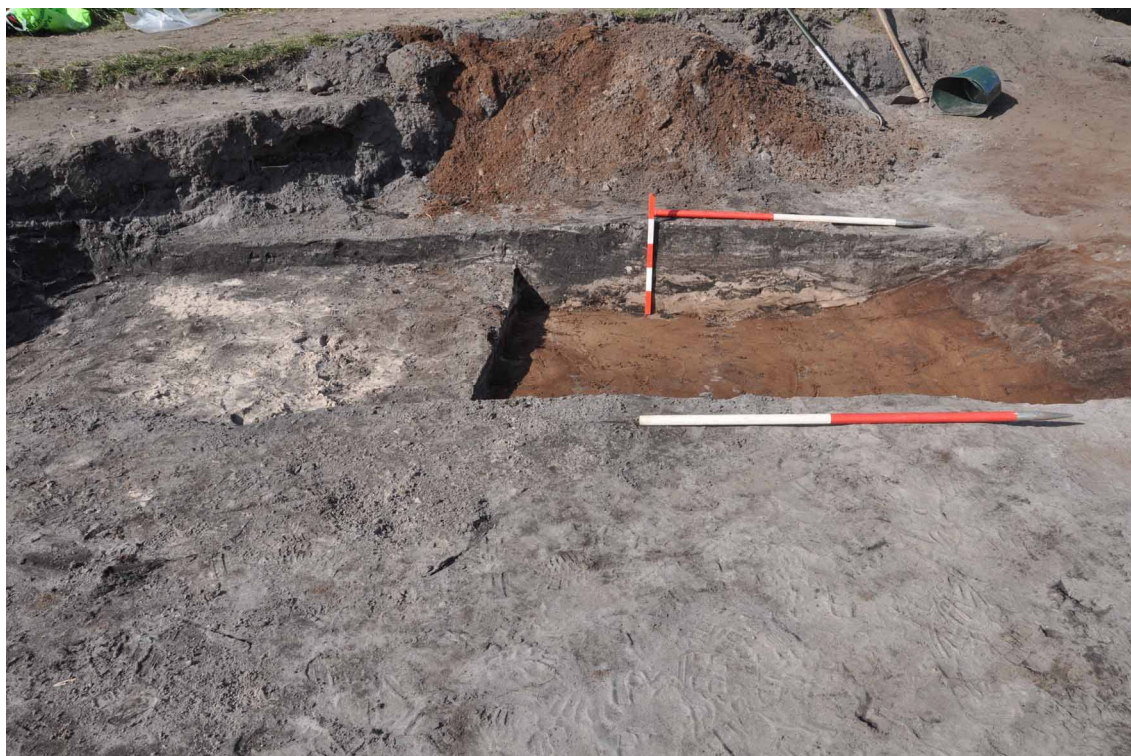
Plate 13. Section across the northern end of the north-south boundary. View looking north.

At the northern end the lower fill consisted of context 55, a deposit of lenses of fine off-white, beige and silvery sand lensed with dark grey silt c. 0.3 m thick which had probably accumulated as a result of erosion of the sides. This was sealed by context 54 which was identical to context 5 but only c. 100 mm thick (Plate 13).

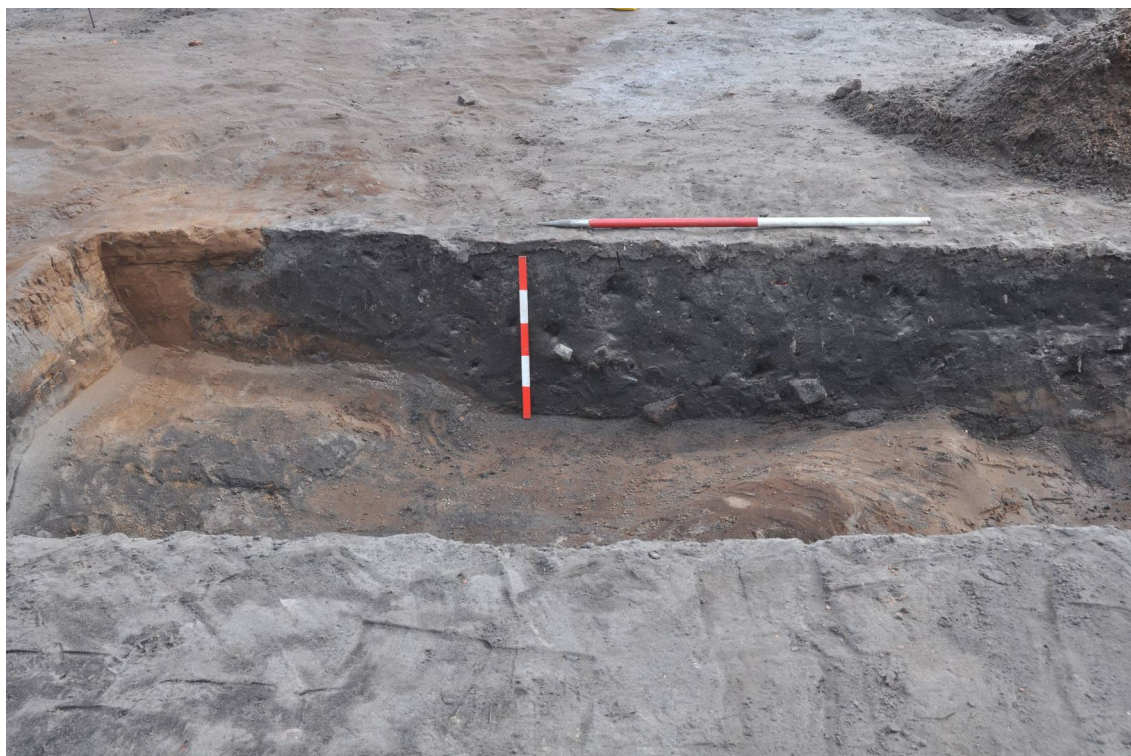
Plate 15. Western end of the central section across the north-south aligned boundary showing the recut ditch. View looking South.

At the eastern end of the central section across Context 5 was a discrete cut (Context 42) filled by contexts 36 and 38 (Fig. 10, Plate 15). The cut was 2.7m wide and 0.57 m deep with a shallow, dish-shaped profile. Context 36 was very similar to context 5 and the relationship between these deposits was only observed in section. It is therefore likely that context 5 was contaminated with finds from 36 during excavation. Context 38 was slightly darker, browner and sandier than context 36 and contained less pottery.

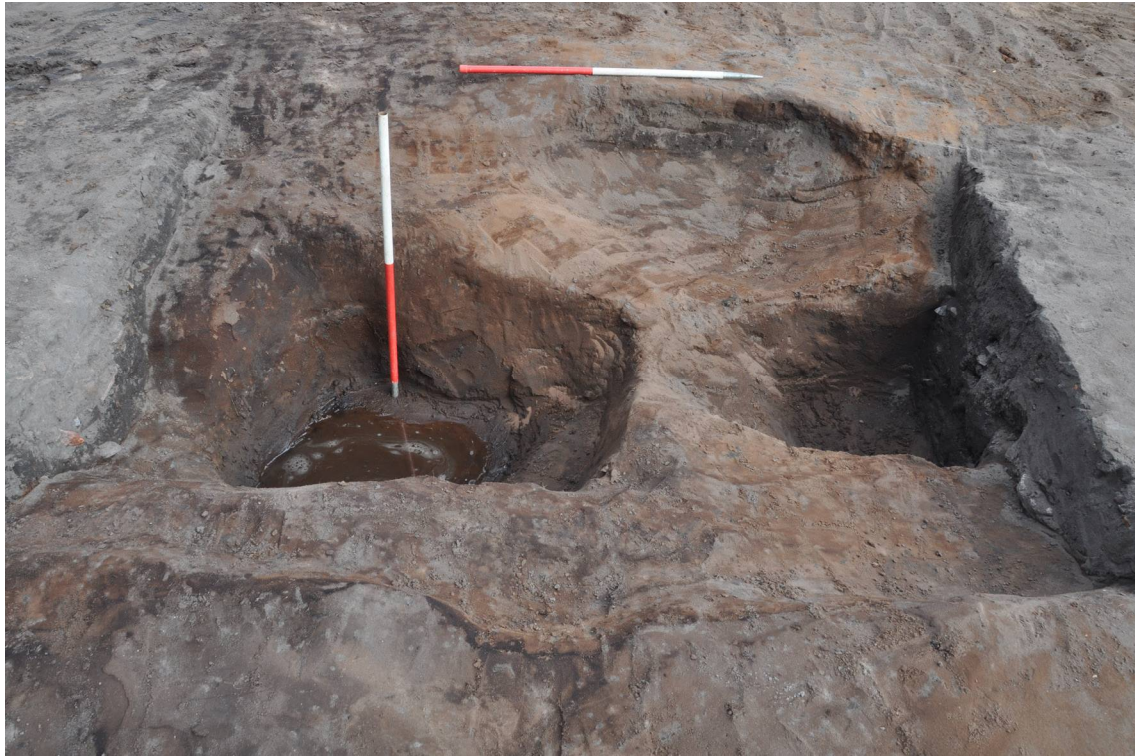
Plate 16. Post-excavation view of cuts filled by context 17, view looking east.

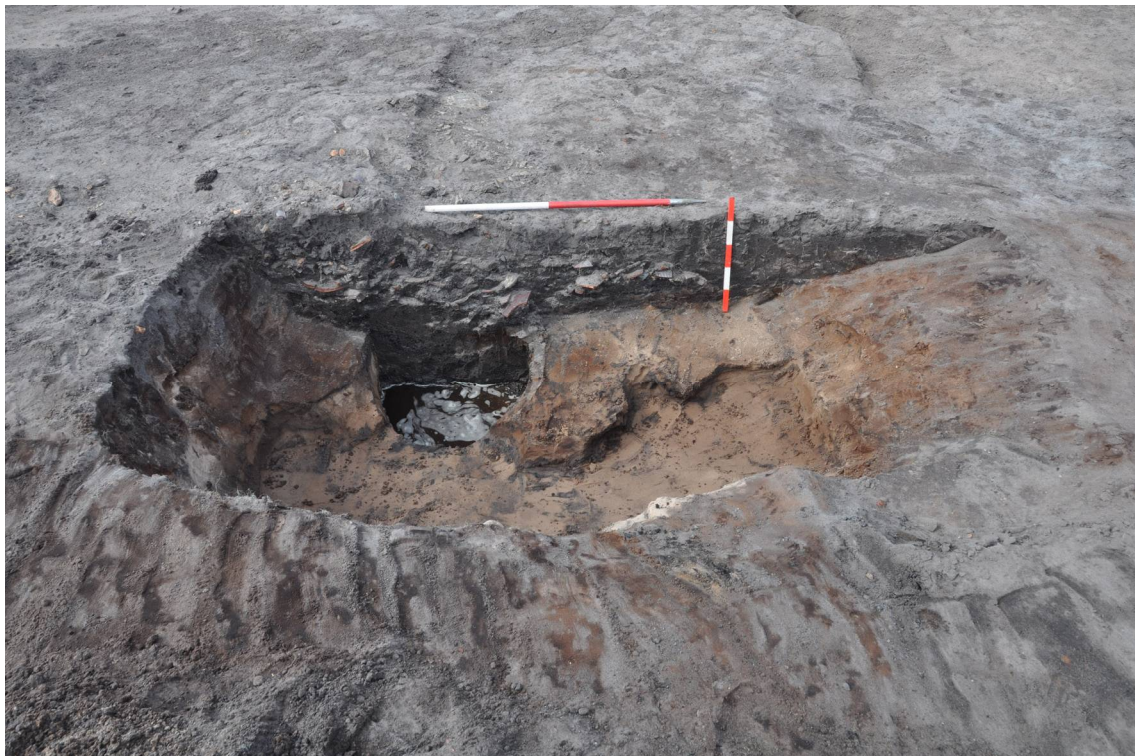
Plate 17. East facing section across pit context 65. View looking West.

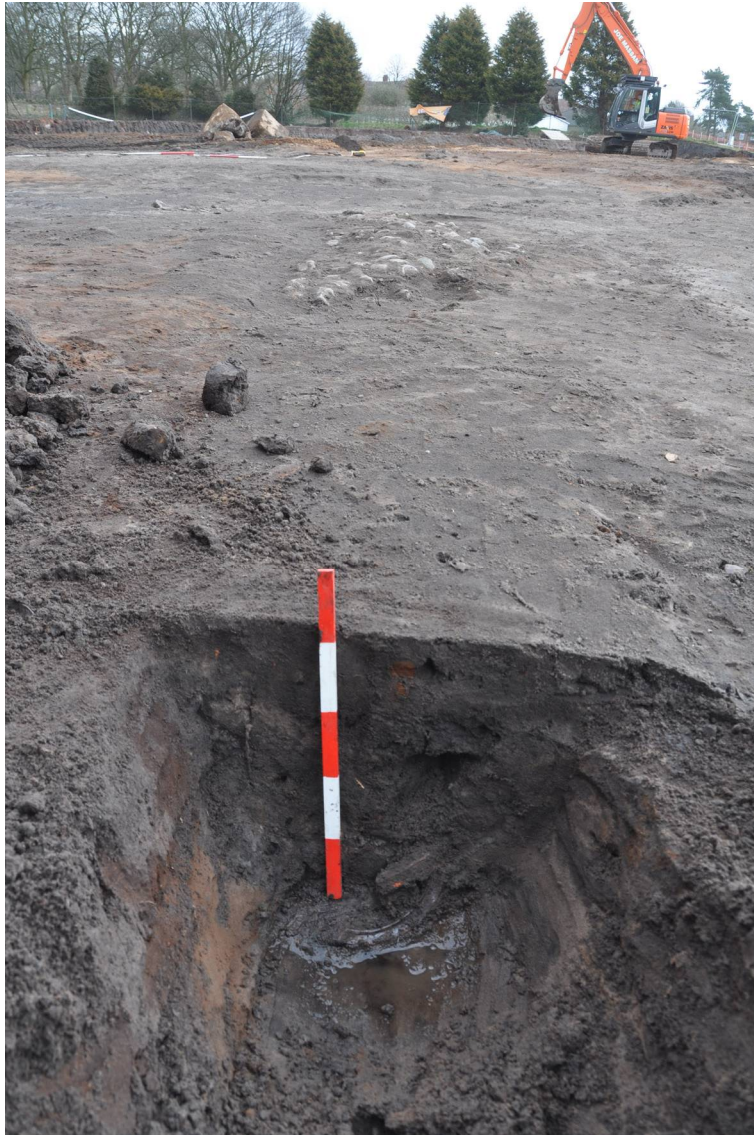
Plate 18. West facing section across context 24. View looking East.

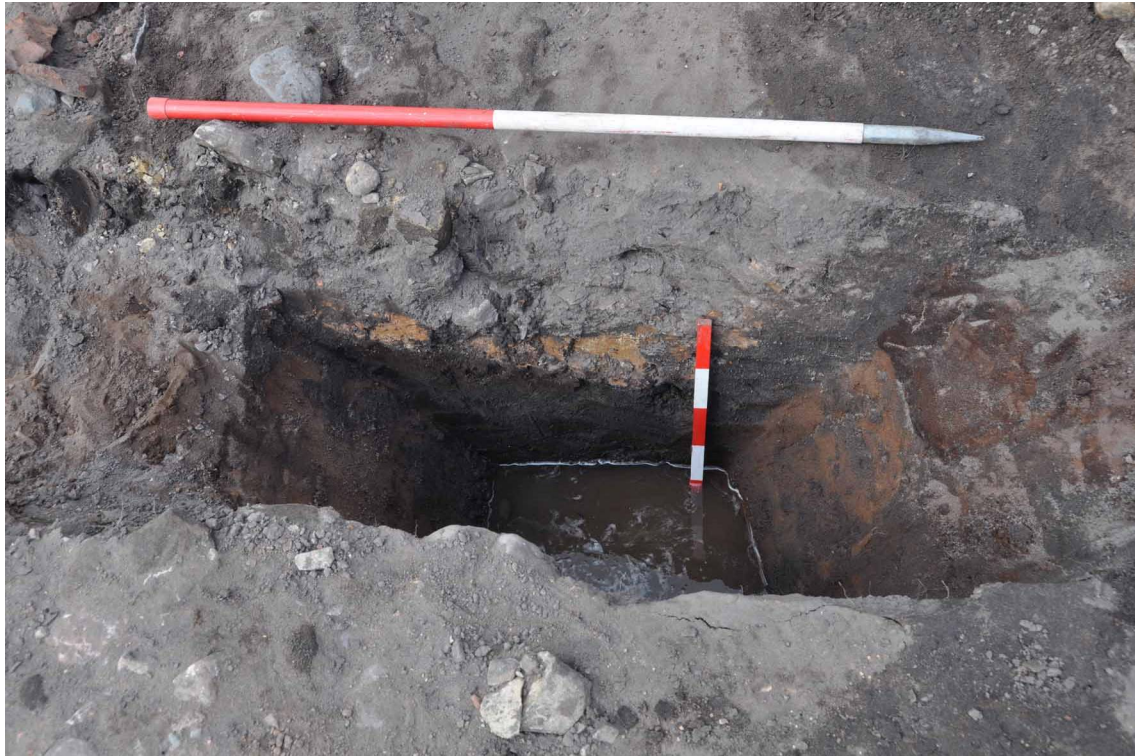
Plate 19. East facing section across context 24. View looking West.

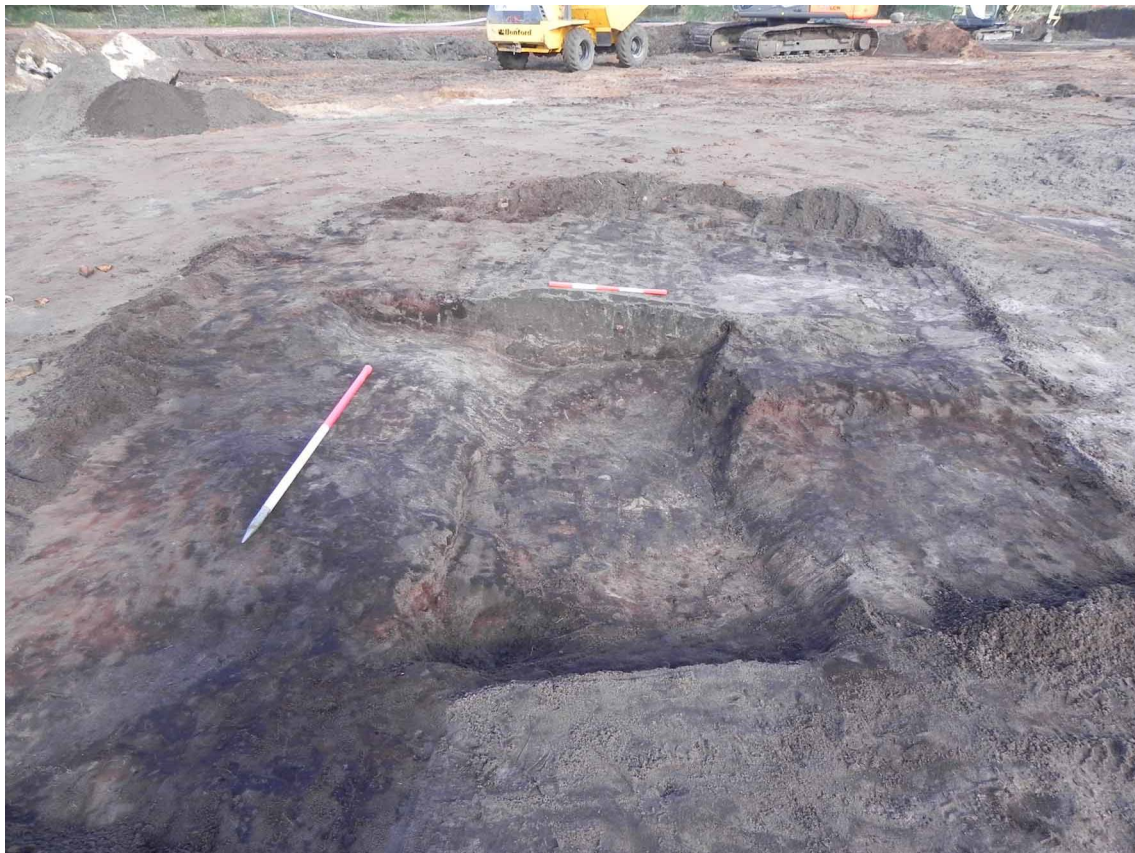
Plate 20. West facing section across context 29. View looking South-East.

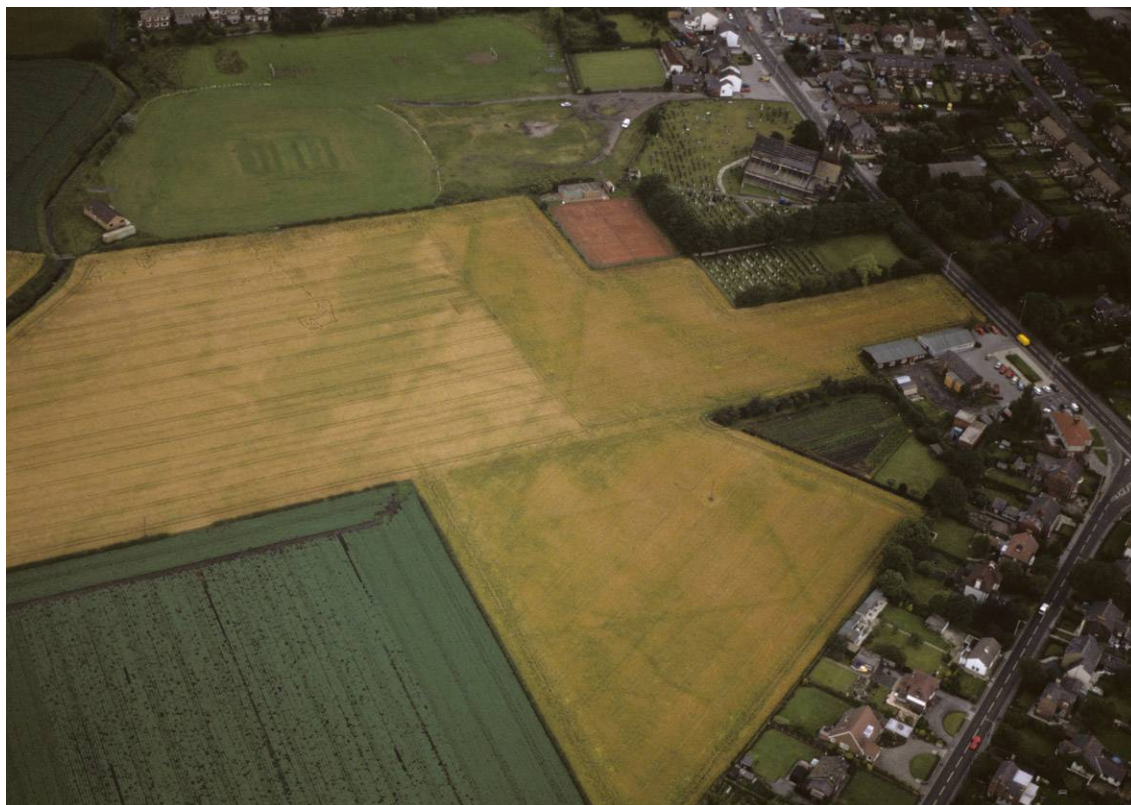
Plate 21. Aerial photograph taken in 1994 showing some of the excavated features as developed cropmarks. View looking north (R. Philpott Aerial Photography Collection, Liverpool Museum LM90.311).
