**An Archaeological Excavation at
Crow Lane, Newton-le-Willows,
St. Helens, Merseyside
(Site Code 103)
NGR SJ 579 957
Final Report**

Produced for Pinetree Developments

April 2008

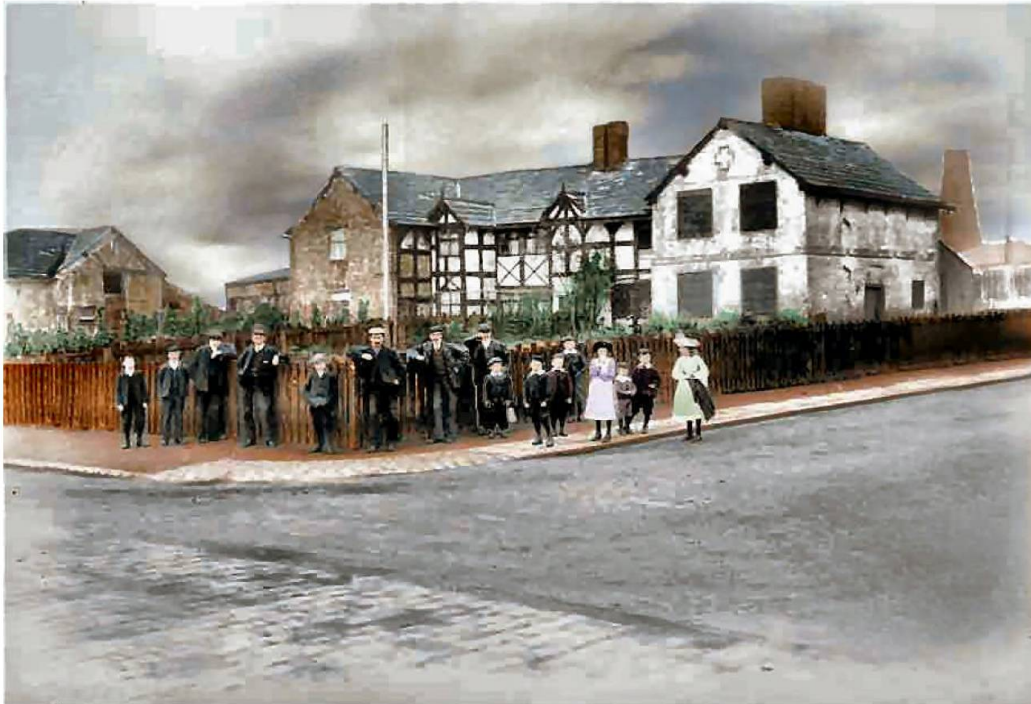
Plate 1. Late 19th or early 20th century photograph of Crow Hall taken from the south-east by A. Frost (Tinted version courtesy Steven Dowd).

possibly caused by the partially overlying walls of the east wing. For safety reasons the backfill of the well could only be excavated to a depth of 0.50 m therefore a date for its construction could not be obtained. The well appears to have continued in use after the construction of the hall as the water pump, the base of which was evident during excavation, can be clearly seen in the Frost photograph (Plate 1).

In conclusion, there was little evidence for any occupation pre-dating the first direct mention of the site in 1534 and it appears likely that much of the structure visible in Plate 1 need date to no earlier than the mid to late 17th century and was probably built in a single phase. Interestingly this date coincides neatly with the sale of the Hall by William Blackburne to John Stirrup in 1673 (Farrer and Brownbill 1911, 134), raising the possibility that Stirrup had the house rebuilt following his purchase. Some sections of the building were rebuilt in the 19th century and the replacement of internal floors destroyed much of the evidence for the original internal layout of the building.

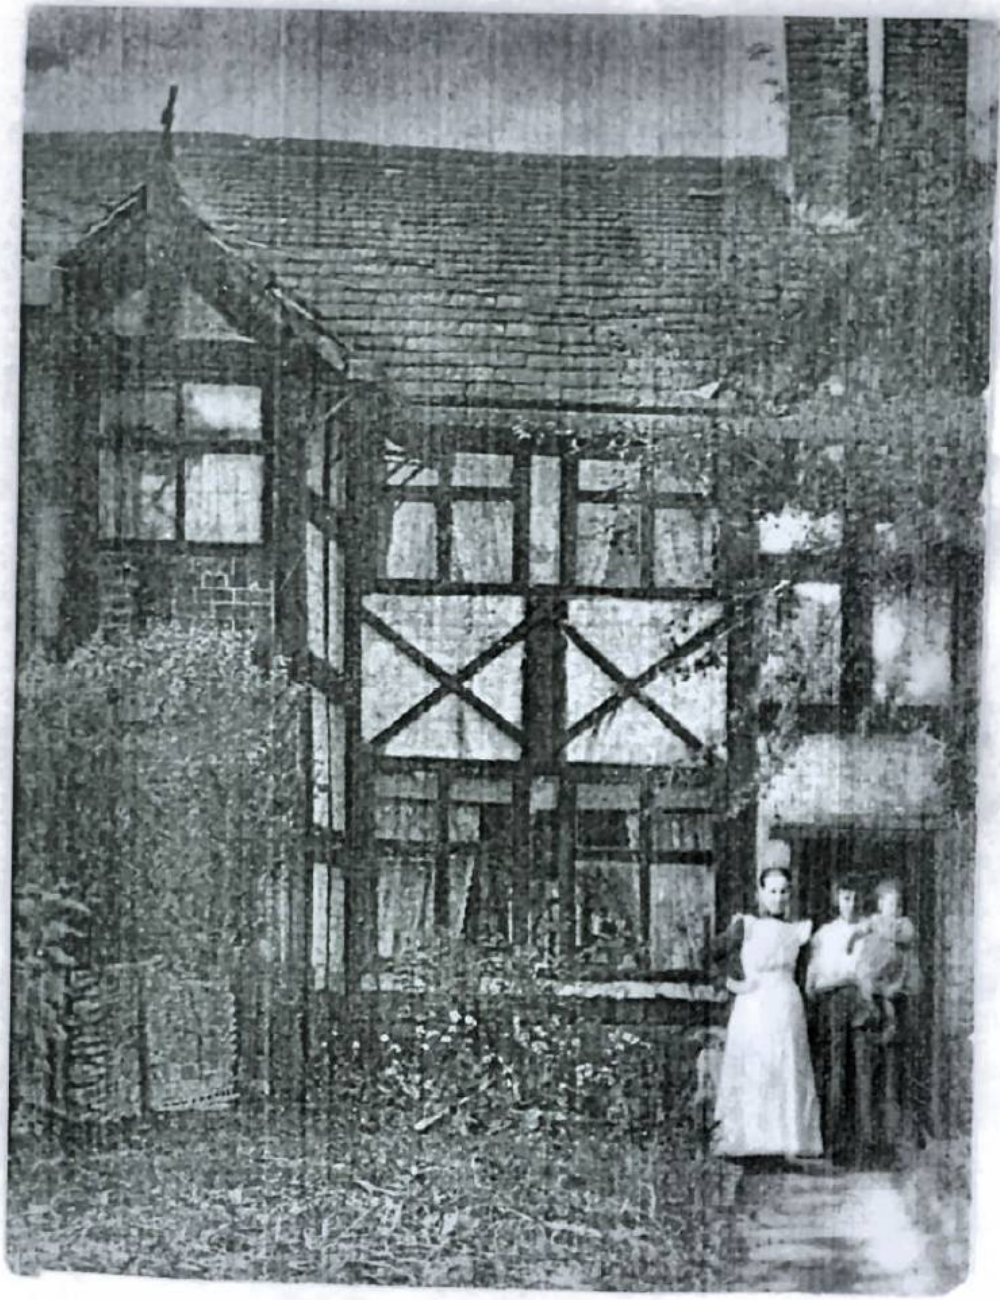
The Smith Family outside Crow Hall – date unknown

Plate 2. Late 19th or early 20th century photograph of Crow Hall showing the central range from the south (Courtesy Steven Dowd).

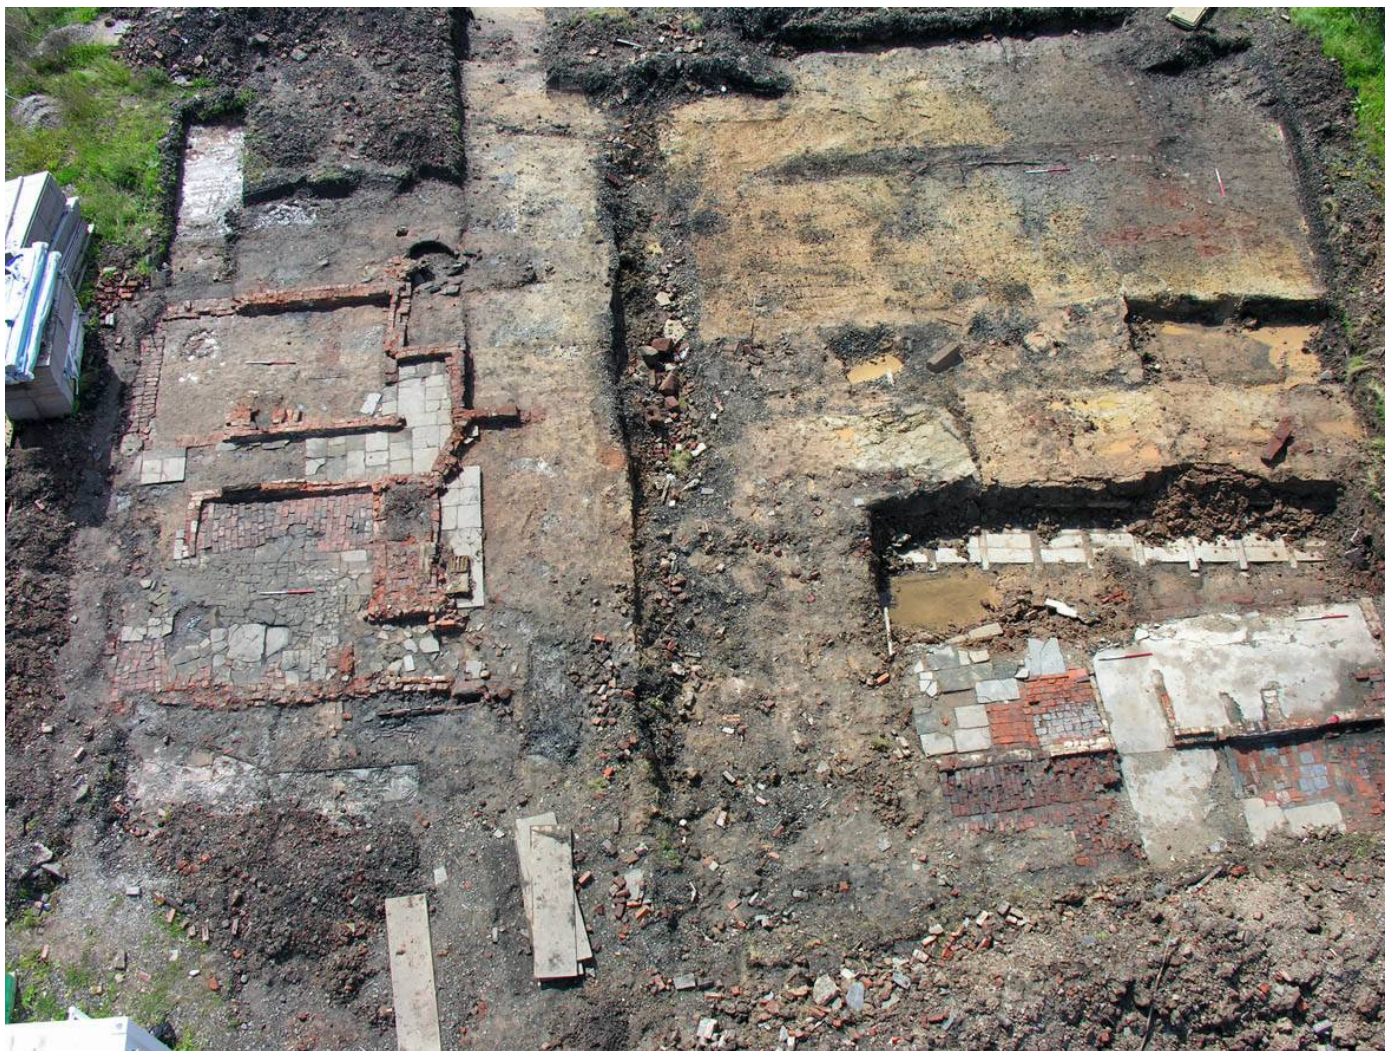
Plate 3. Aerial view of the excavated area looking south and showing the remaining elements of Crow Hall. The disturbed north-south aligned area in the centre of the view relates to the offices demolished in 2006.

The excavation found remains relating to the eastern and western wings of Crow Hall consisting of cut features, the foundations of brick and sandstone walls and some *in situ* floor surfaces (Fig. 7, Plate 3). These were excavated in stratigraphic sequence and are described below, where possible, in stratigraphic order beginning with the oldest. Because of the limited range of directly datable material present, dating usually relied upon stratigraphic evidence and constructional details. However, although the two side wings were relatively well preserved there was little evidence for the central range.

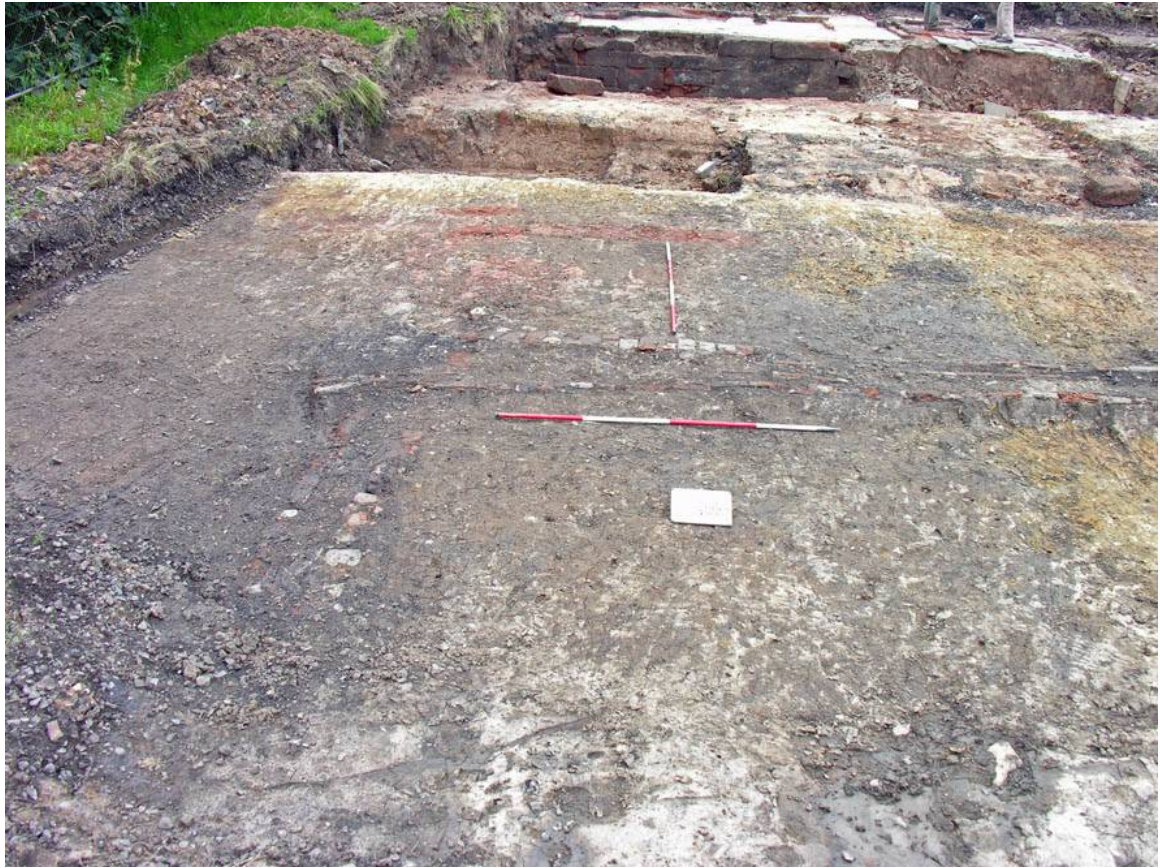
Plate 4. South-west corner of the trench showing layer 74. This context is also visible in the top right of Plate 3.

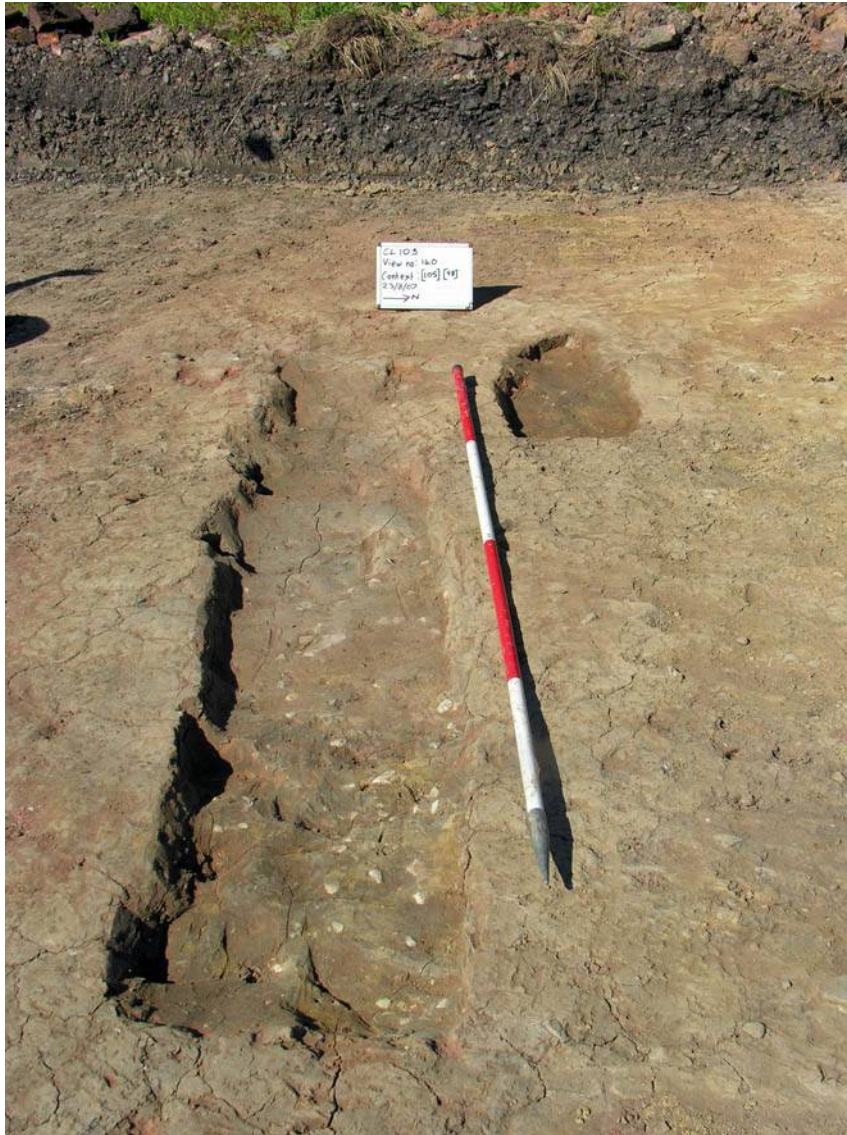
Plate 5. Post-excavation view of cuts **98** and **105**. View looking west.

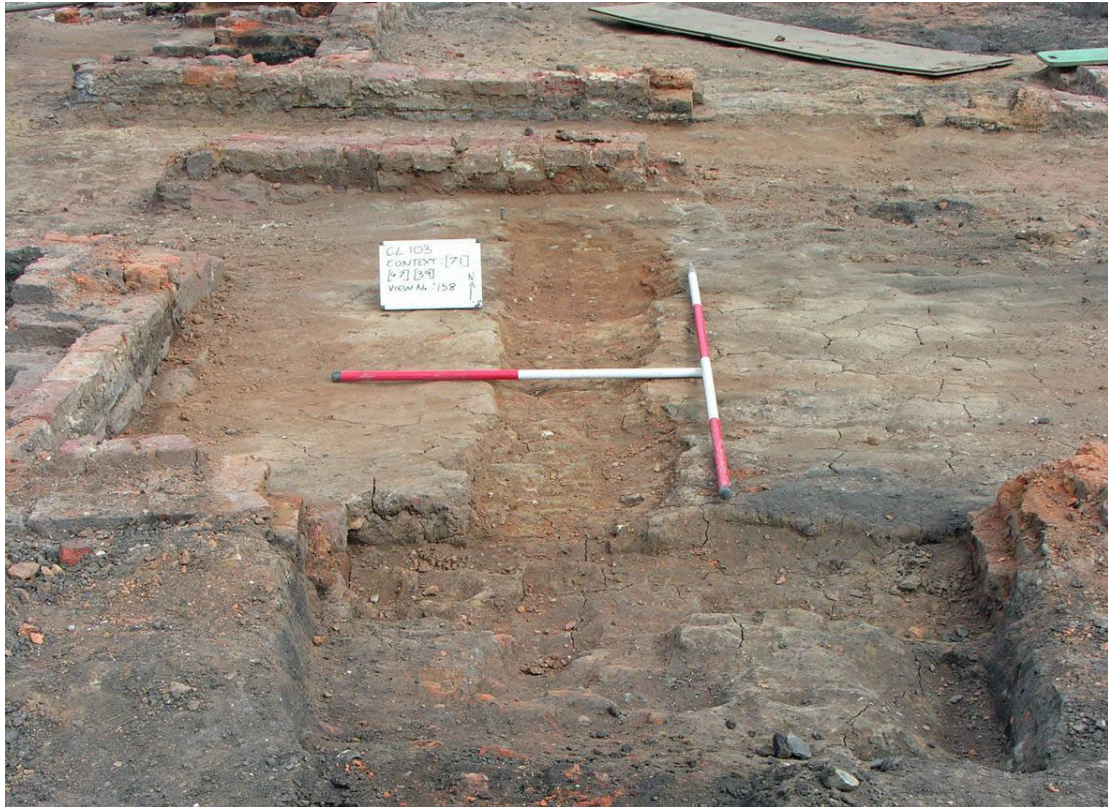
Plate 6. Cut **180** viewed from the south.

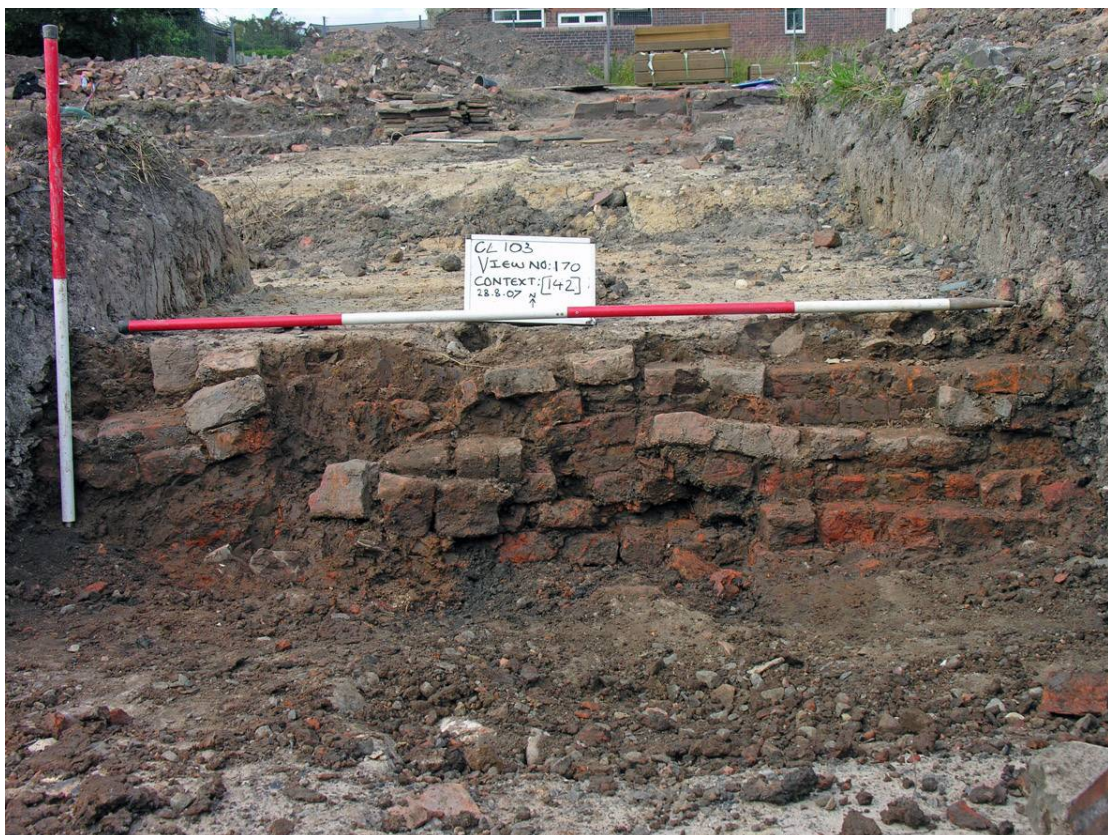
Plate 7. Garden wall 142, view looking north.

Context **142** (Fig. 7, Plate 8) was an east-west aligned wall constructed in hand-made brick set c. 7.5 m south of the east wing. Its function was not clear, though it appeared to be a revetment to a bank or garden feature external to the hall.

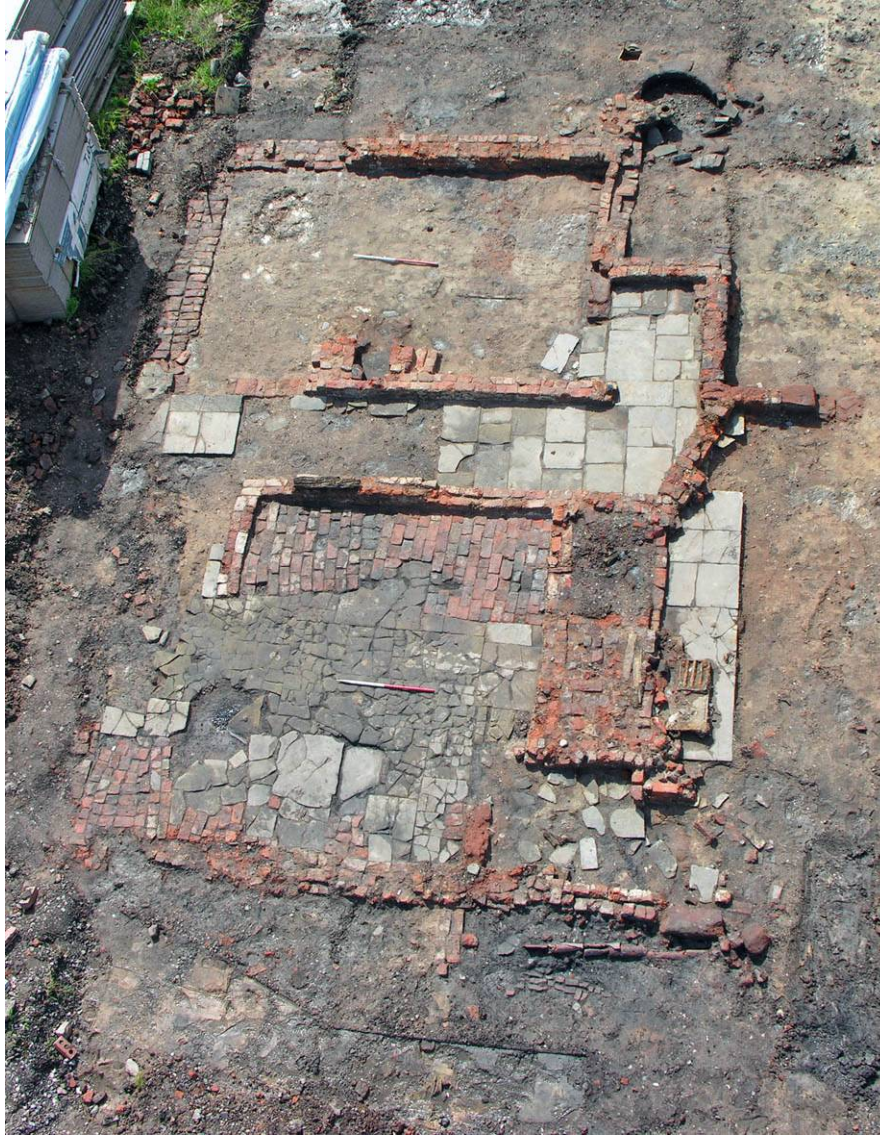
Plate 8. Plan view of the East wing with floor surfaces *in situ*. South is at the top of the frame.

The east wing was the best preserved section of the hall and was defined by exterior walls **38, 39, 40, 41, 42** and **50**, though the eastern wall **38** had been partially destroyed at its northern end by modern disturbance (Fig. 9, Plate 8). In addition the upper courses of some walls (e.g. **50**) had been severely damaged by frost action, possibly compounded by compaction during construction of the offices in the 1960s, making it difficult or impossible to distinguish individual bricks. The wing covered approximately 10.0 x 6.4 m and was sub-divided into two large rooms separated by a central corridor running between them.

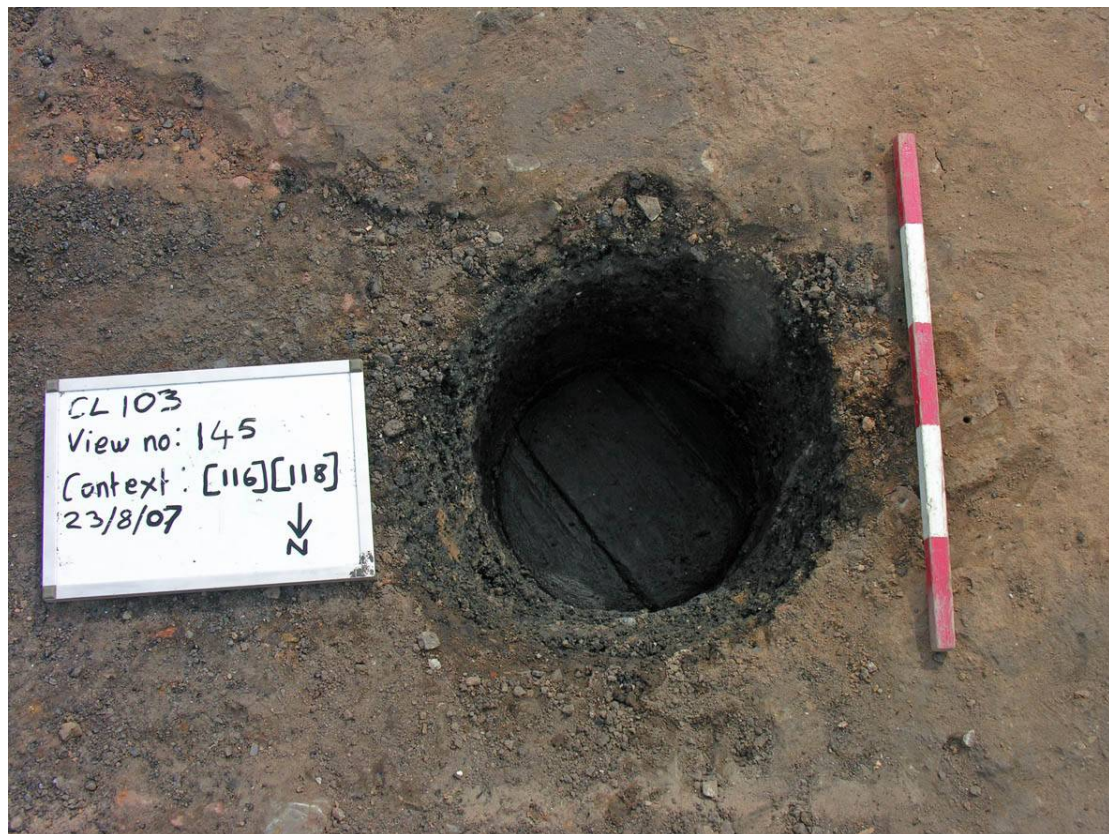
Plate 9. Wooden bucket under excavation.

Finds evidence from the make-up levels for the floors in this area (context **100**) suggests that the original floors were totally replaced in the late 18th or early 19th century (i.e. Phase 4). However, a small group of cut features with the northern half of the room all clearly predated the flooring and may belong to this phase. Two of these had a stratigraphic relationship but are considered together for simplicity. The earliest, **149**, was a square cut feature approximately 0.50 m across and 0.15 m in depth, the other, was **116**, which near-circular in plan with a diameter of 0.40 m and 0.30 m in depth. Both features appeared to have been deliberately backfilled with deposits containing a high volume of charcoal and ferrous material. A spread of similarly charcoal-rich material was evident within the north-eastern corner of the room. The well preserved remains of a bucket (Context **118**) were recovered from the base of **116** (Plate 9). The bucket had been deliberately placed as a lining within the pit, though the reason for this was not clear. A clay tobacco pipe bowl (SF 184) contained within the fill dates its disuse to the late 18th or early 19th century. Some of the clay tobacco pipe stems found in the fill were heavily sooted and one was slagged, suggesting an association with high temperatures, though this is more likely to relate to the material deposited in the bucket than the bucket itself.

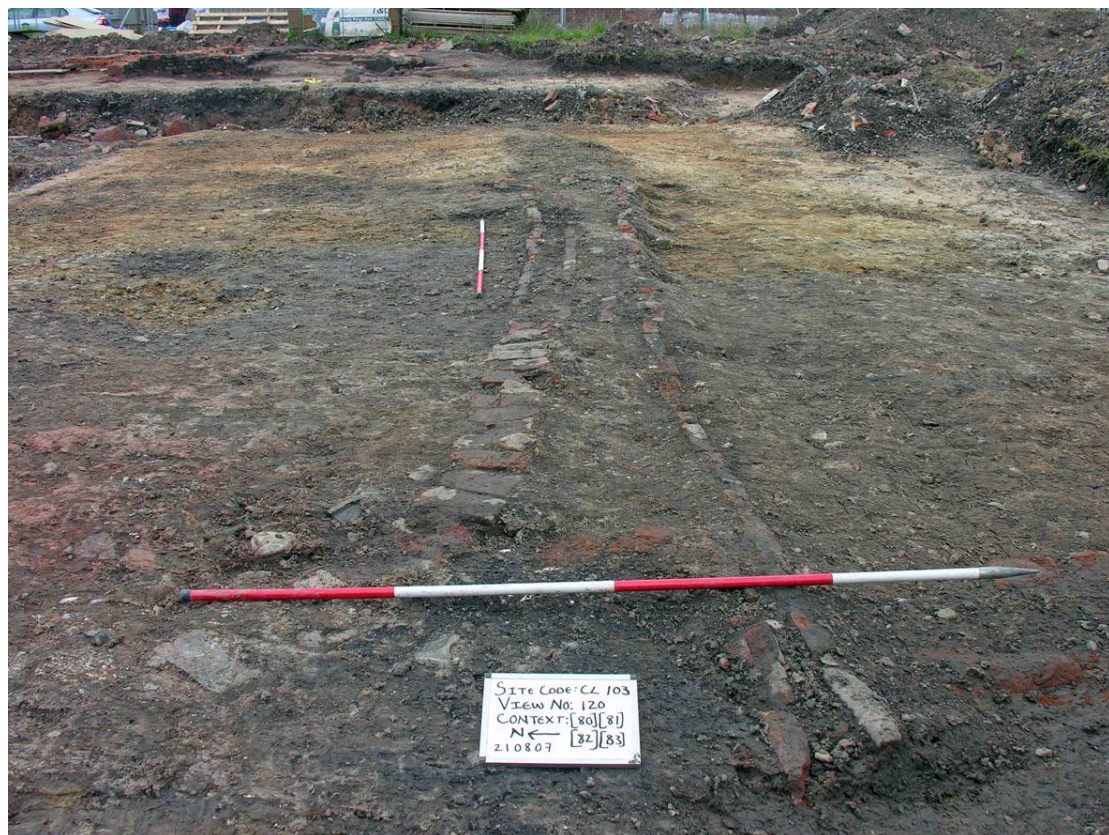
Plate 10. Drains 81 and 82. View looking east.

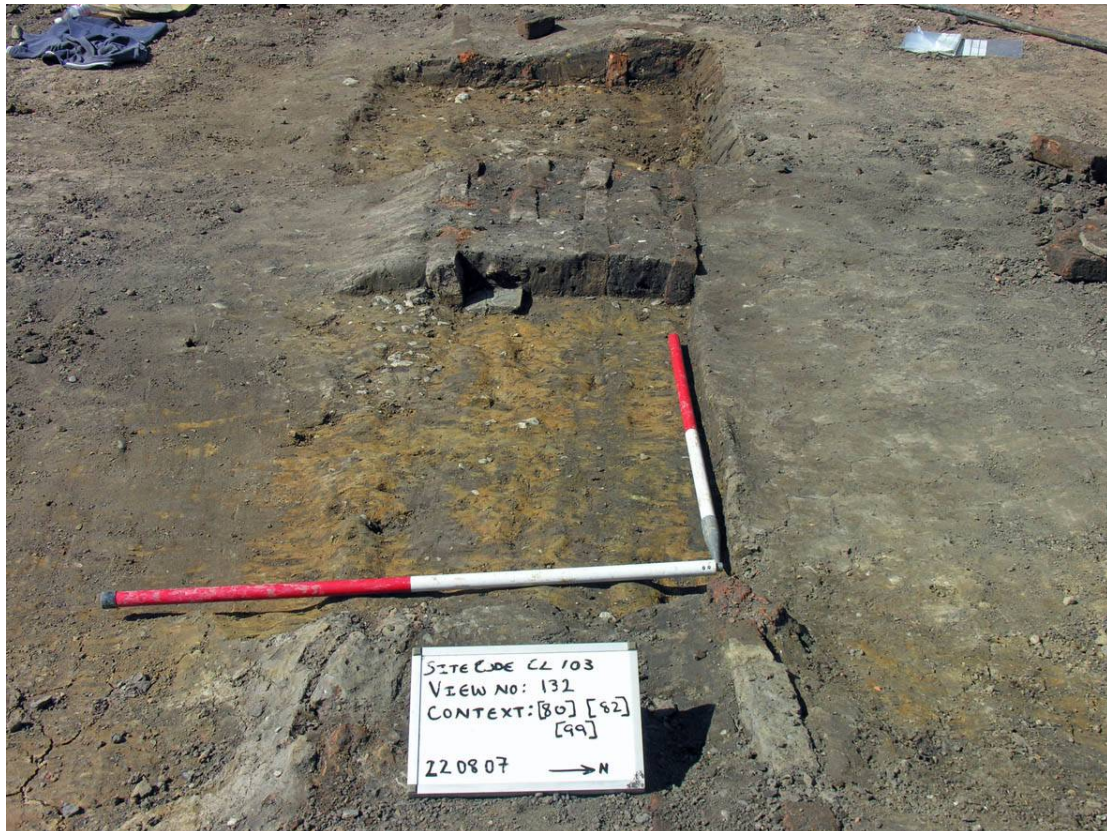
Plate 11. West facing sections through drains

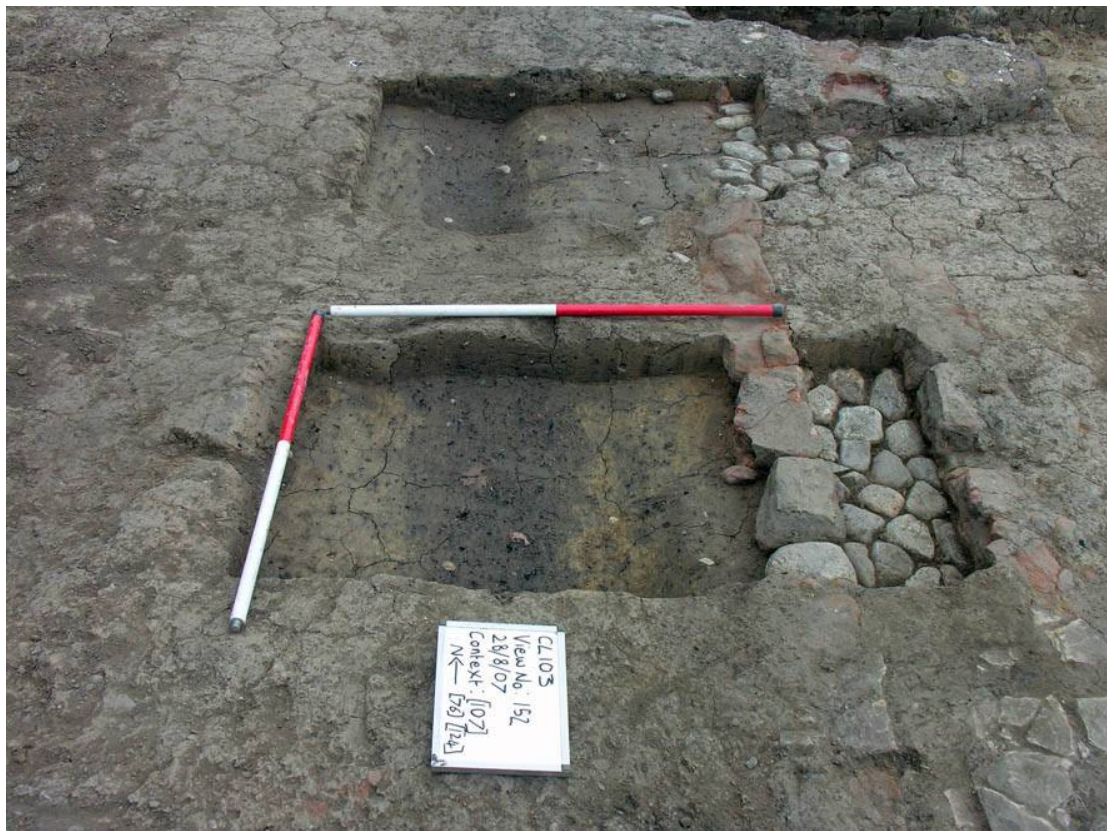
Plate 12. Drains at south-west of site.

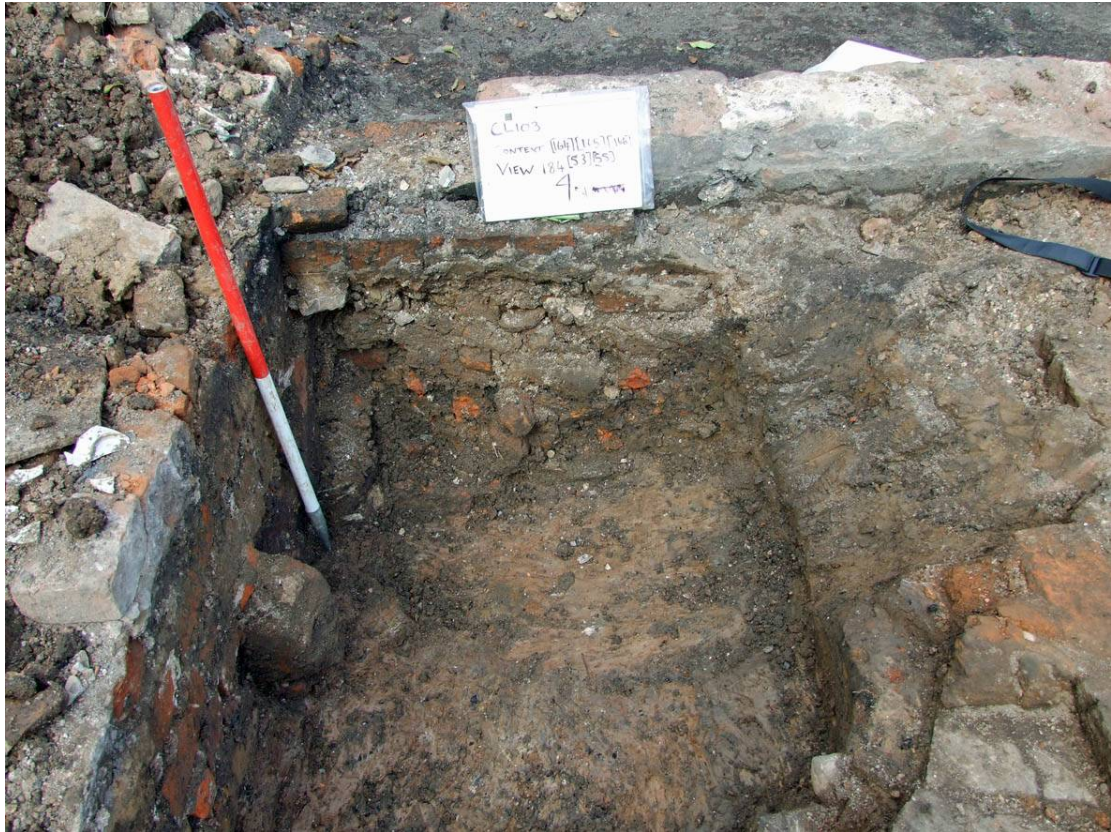
Plate 13. South facing section through pit **165** showing its relationship with wall **72**.

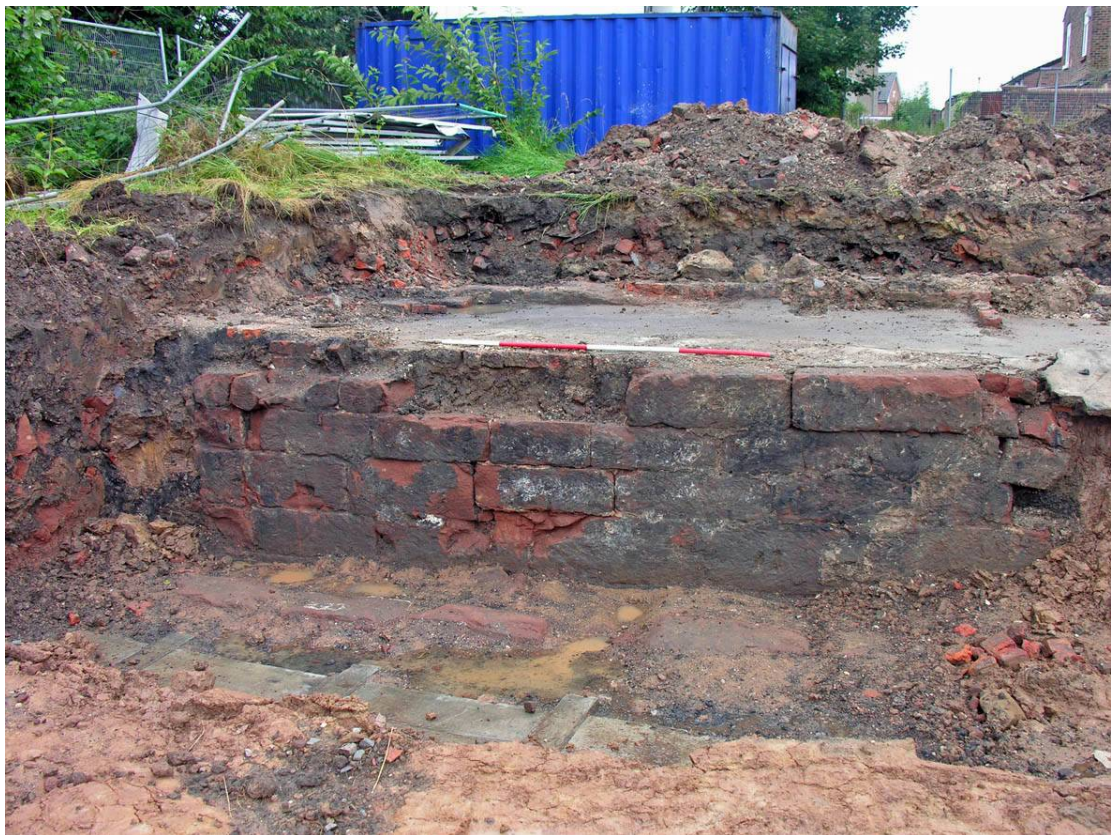
Plate 14. North wall **168** of cellar in west wing. View looking north.

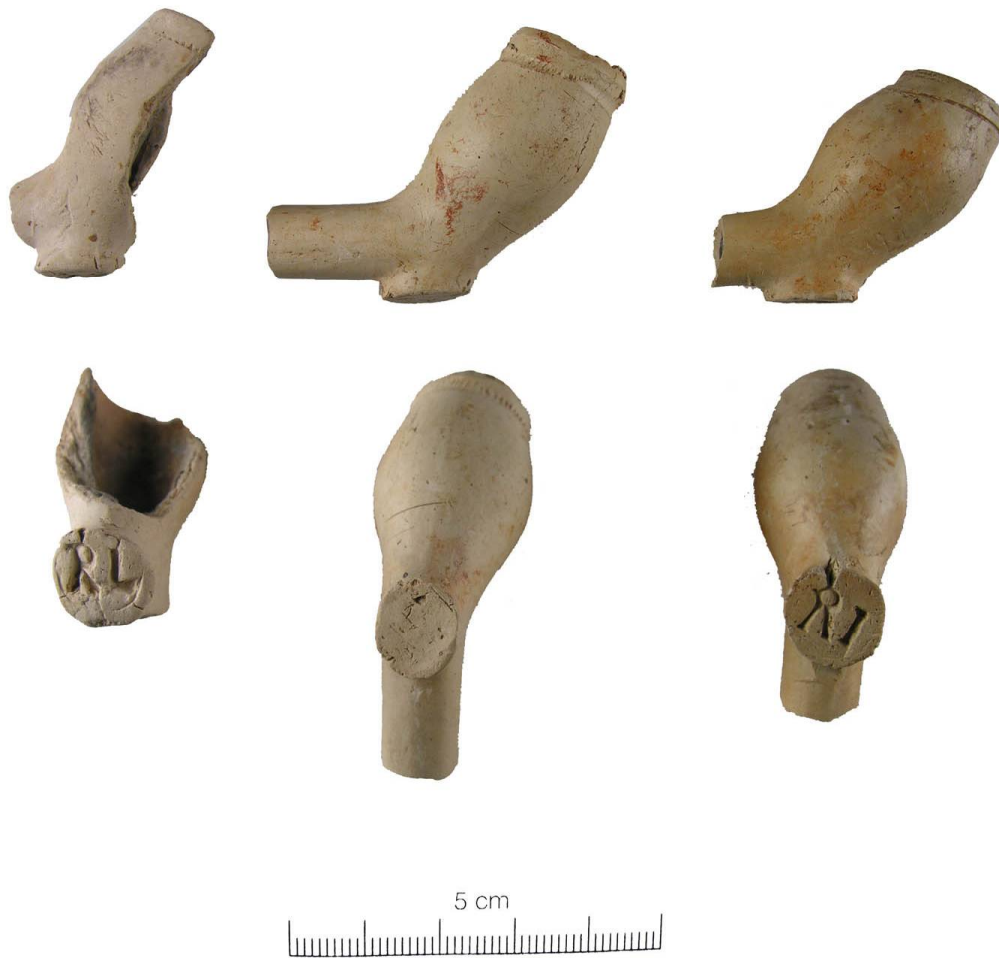
Plate 15 SF 29, Context 153. Tobacco pipe bowls bowls, form and size suggest mid-17th century.

Context	SF No	Description	Provisional Date
153	28	Stems	1600-1700
153	29	Four bowls, one stamped 'RL' with rouletted decoration to rim, one stamped 'RI' incised decoration to rim. Form and size suggest mid-17th century. Found in association with modern pottery (SF 24) in make-up for 19th century floor.	1600-1700
110	31	One bowl, no stamp, with rouletted decoration to rim. Form and size suggest mid-17th century. Very similar to SF43 and unstamped form in SF29. However, 19th century stems (SF 30) found in same context. Found in association with 19th century pipe stem in pit below floor in north room, east wing.	1600-1700
167	43	One bowl, no stamp, with rouletted decoration to rim. Form and size suggest mid-17th century and unstamped form in SF29. Very similar to SF31. Found with 19th century material in construction cut for west wing cellar, Phase 4.	1600-1700
171	57	Two stems with wider bore. Found in drain to rear of west wing. Occurred in 17th century assemblage dated stratigraphically to 19th century.	1600-1750

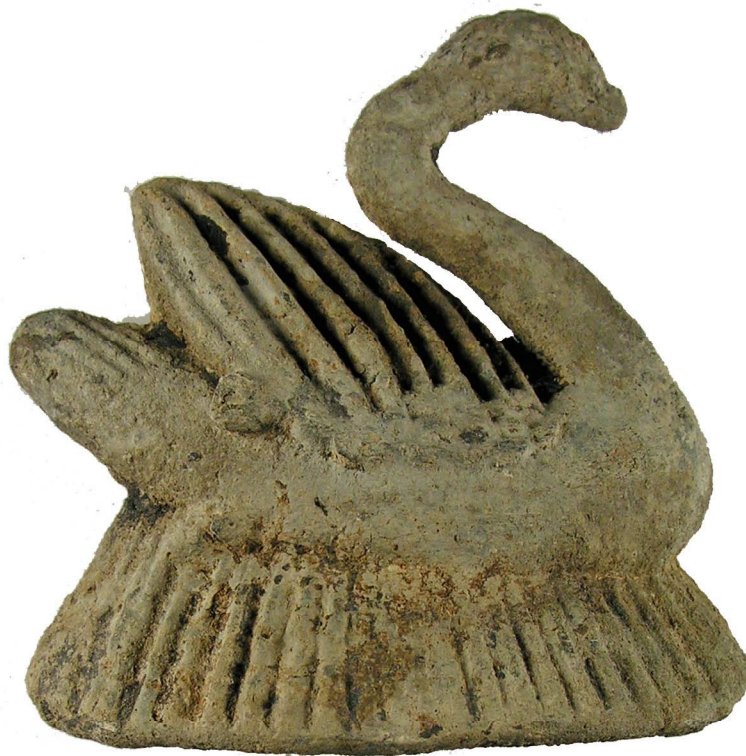
Plate 21. Plaque in the form of a swan. SF 19, context 4.

The majority of the lead items were found in the demolition debris and consisted of sheet and pipe from the roof and plumbing system. A plaque in the form of a swan (SF19, Context 4) is of uncertain function (Plate 21).
