# An Archaeological Excavation at Firwood, Alexandra Road, Formby, Merseyside Final Report Site Code 125

*Prepared for Sefton Coast Landscape Partnership*

August 2012

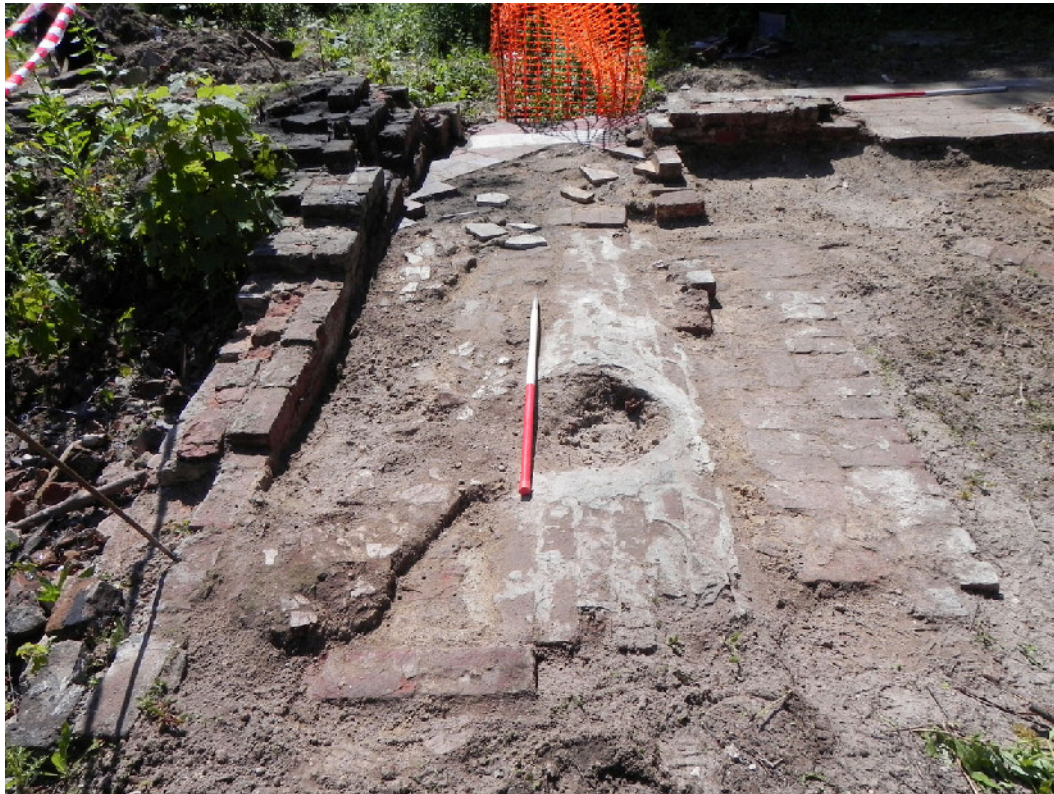
Plate 1. Rainwater cistern, Trench IV. View looking west.

This phase was identified from a brick vaulted water cistern (context 34) situated to the south of the kitchen, below the floor of a passageway leading to a rear door to the house (Figs 4 and 5. Plates 1 and 2). It measured 2.74 x 1.80m in plan and had a barrel vaulted roof constructed in hand-made brick. Its interior could not be investigated in detail because the only access was via a circular opening, c. 0.5 m in diameter, in its upper surface. It had been filled with deposits of sand though it was not clear whether this had been deposited when the cistern went out of use or whether it was in-wash following demolition of the house.

It is likely that this was originally an external feature, the circular opening in its upper surface was probably for access for cleaning and could have been accommodated within the passageway. However, water was probably extracted using a hand pump which is unlikely to have been in use when the passageway floor above was *in-situ* and in use. In addition similar cisterns observed on excavations on Merseyside have always been situated outside any buildings on the site (e.g. Adams 2012) and although little has been published on post-medieval water cisterns of this type, most appear to have been intended to collect 'grey water', usually collected from gutters fed from the roof. This therefore strongly suggests that the passageway and kitchen were later additions to the house.

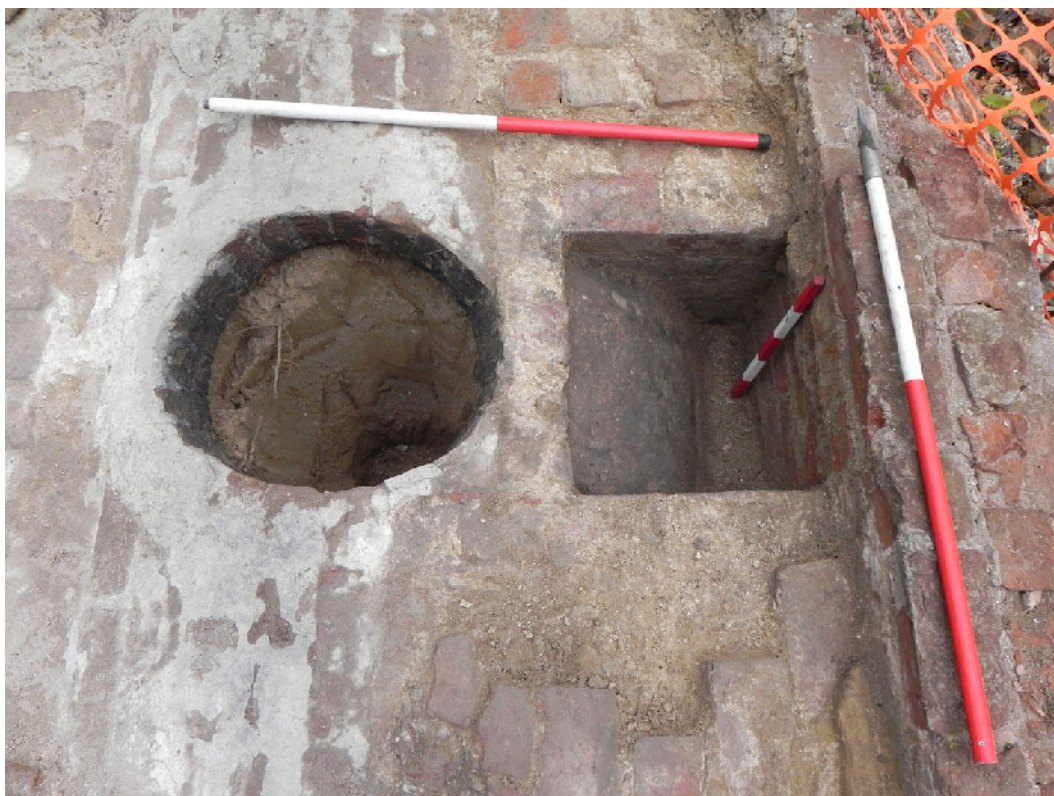
Plate 2 . Opening in upper surface of rainwater cistern and connection to cellar.

There was some stratigraphic evidence that the cistern was broadly contemporary with the cellar to its south, a 'niche' of uncertain function connected to a blocked opening in the northern cellar wall (Plate 2) and appeared to relate to the cistern, though its function was uncertain. However it was not possible to examine the direct stratigraphic relationship with the cellar and it remains possible that it in fact related to a structure to its north.

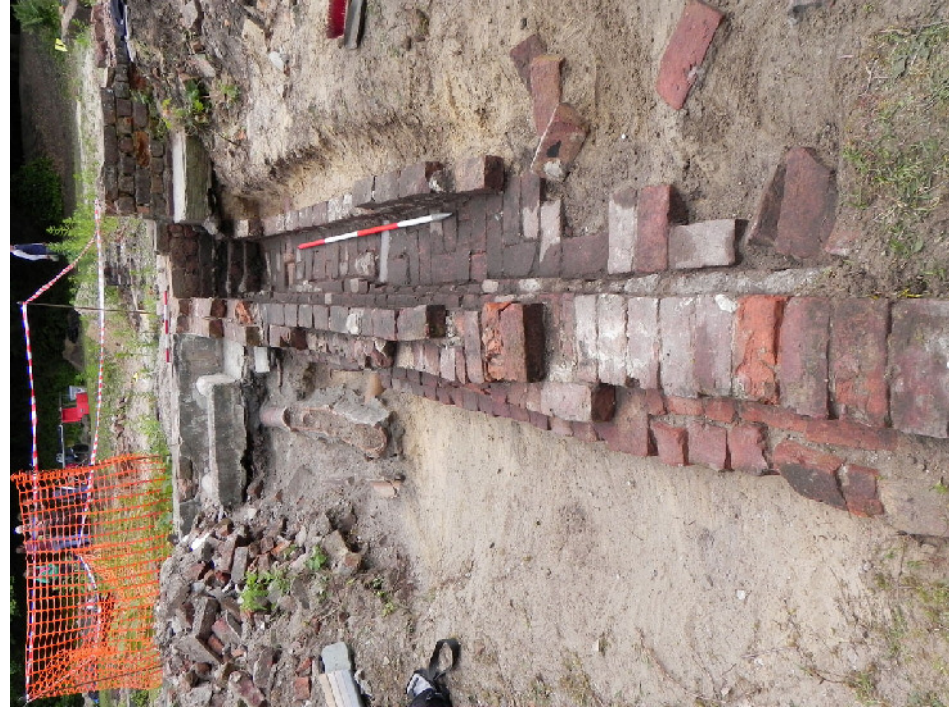
Plate 3. North wall of conservatory. View looking east.

The northern and eastern walls to the conservatory featured shallow gullies constructed in 2-3 courses of brick (Plates 3 and 4). Their function is unclear but being internal is unlikely to relate to drainage. It is likely that they carried pipes, perhaps hot water to heat the conservatory.

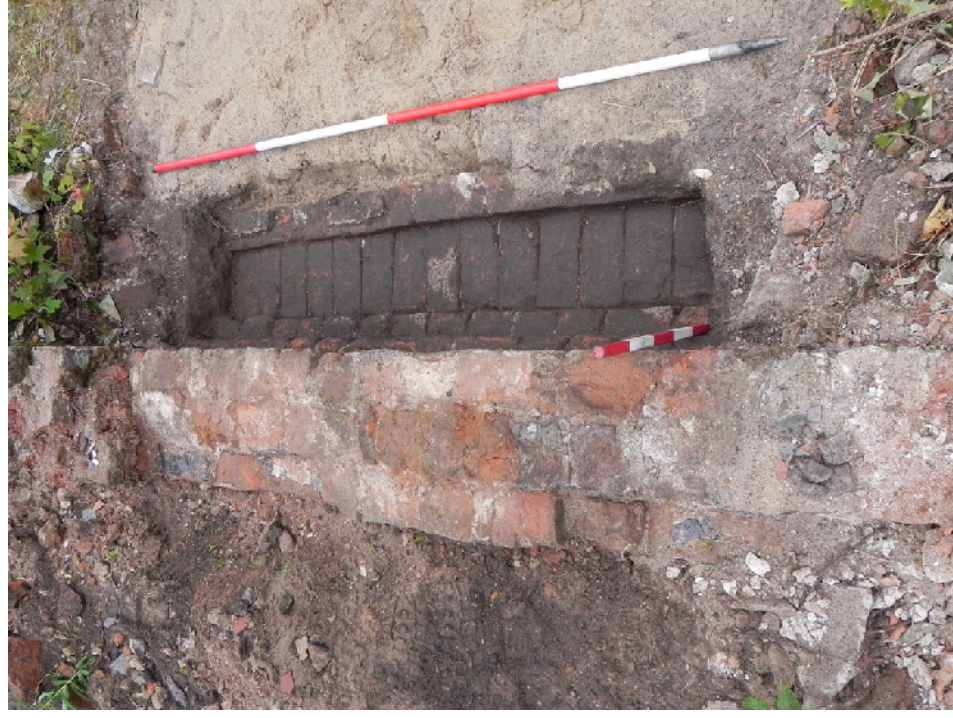
Plate 4. East wall to conservatory Trench VII. View looking south.

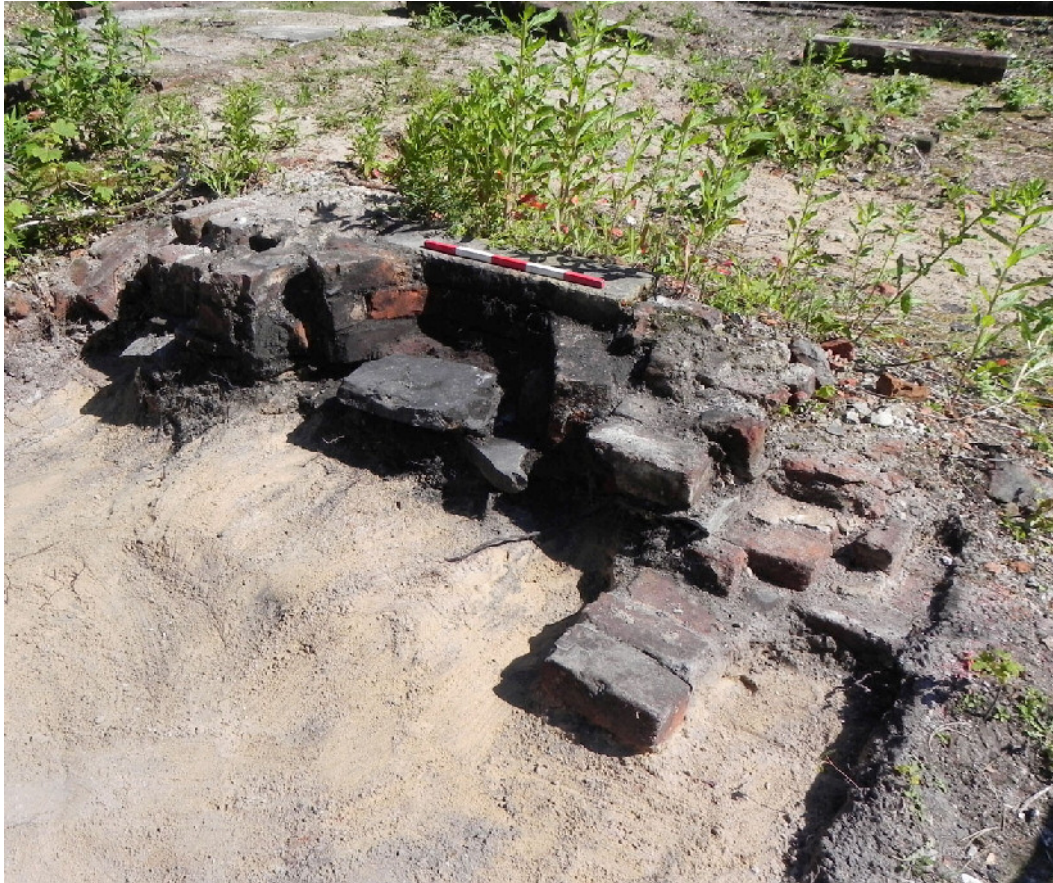
Plate 5. Kitchen fireplace and quarry tile flooring. View looking north.

Internally little survived of the floor surfaces apart from small areas of quarry tile flooring in the kitchen (Plate 5). Otherwise few structural features survived other than the foundations to chimney breasts. The hearth to a fireplace was located in Trench VI (Plate 6) and its position suggests that the floor surfaces were c. 0.5 m above current ground levels. Although there was little other structural evidence this suggests the use of timber floors in all rooms other than the kitchen.

The best survival was in the kitchen where the fireplace base and small areas of flooring were excavated. The fireplace included a cast iron boiler with a copper water pipe (Plate 6).

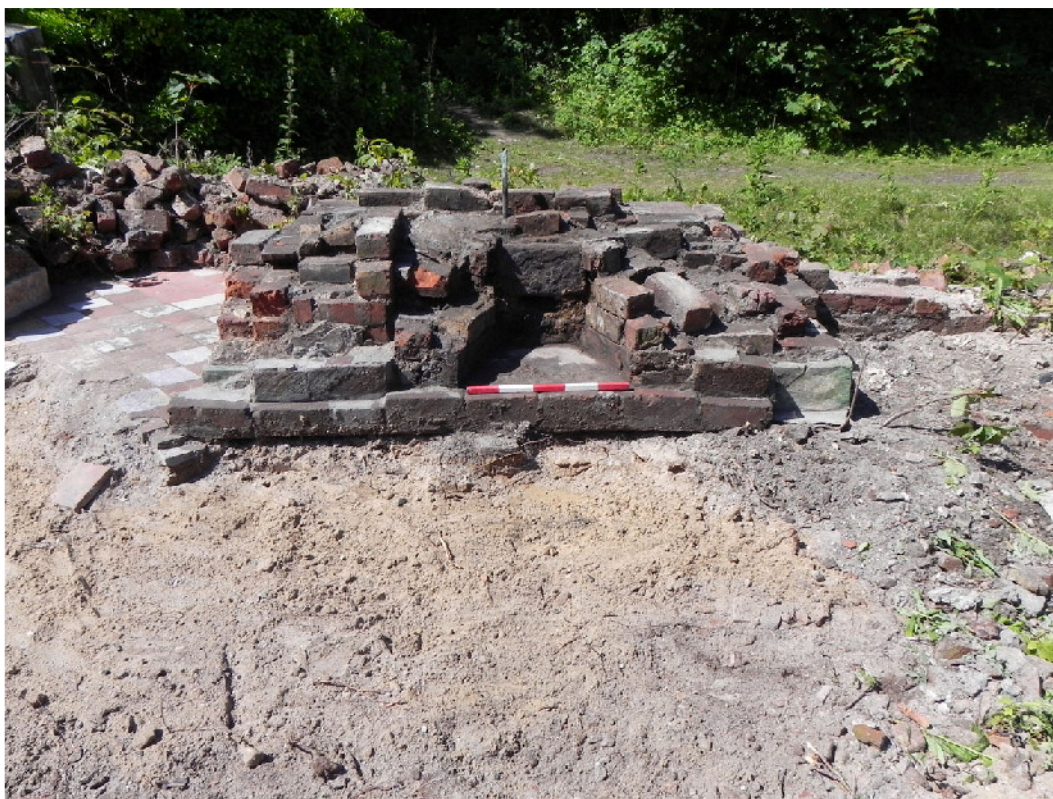
Plate 6. Remains of hearth, Trench VI

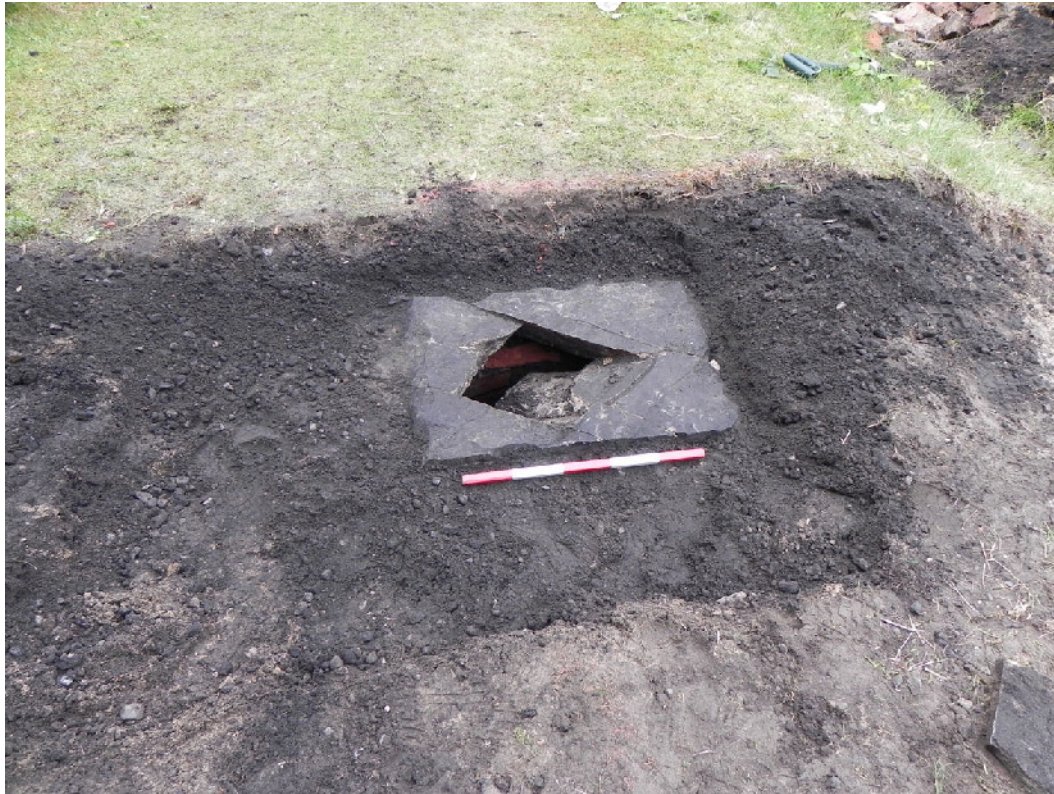
Plate 7. Flagstone capping soakaway in Trench VIII.

The depression along the northern and eastern sides of the house was investigated with three trenches to establish its function. None of these found evidence of revetting to support its interpretation as a garden feature. In Trench VIII a drain feeding a brick lined soakaway at least 1m deep (Plates 7 & 8) had been truncated by this feature suggesting that it related to the demolition of the house.

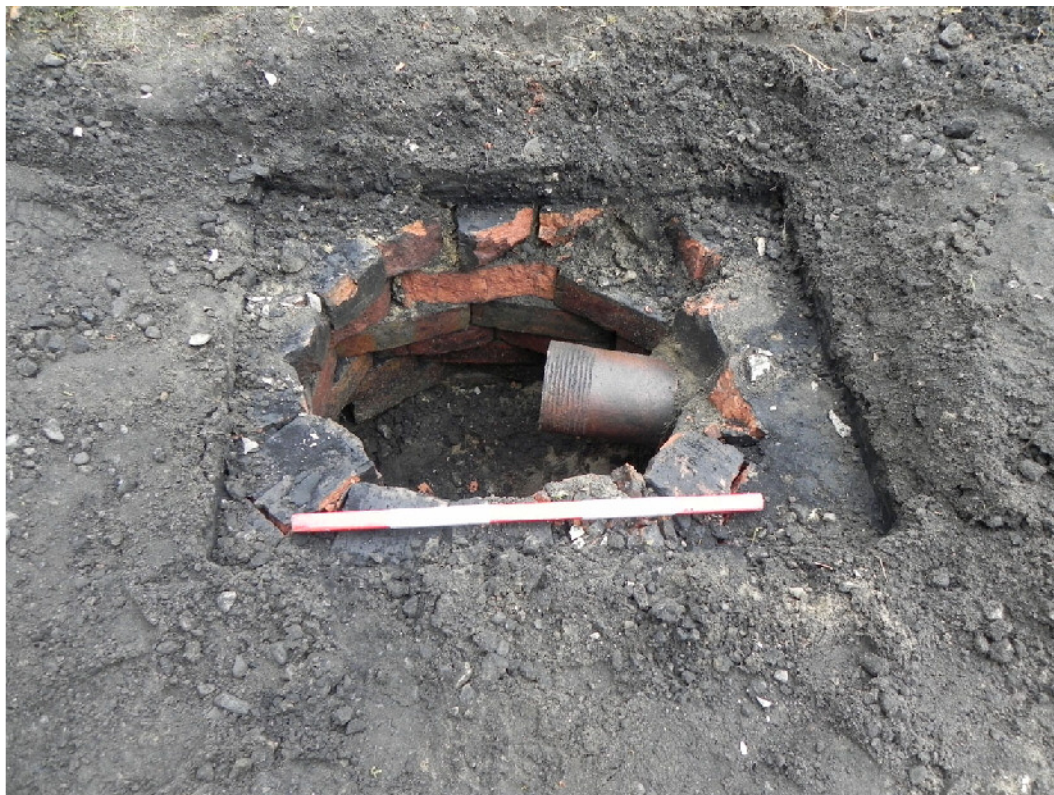
Plate 8. Brick lined soakaway in Trench VIII

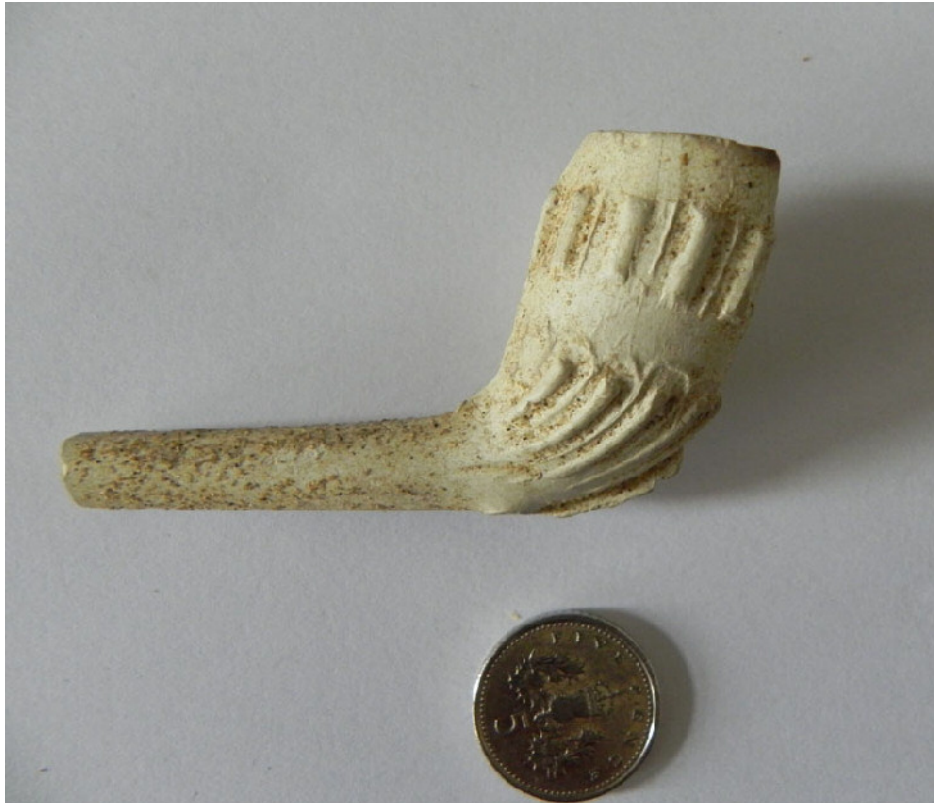
Plate 9. Clay tobacco pipe bowl.

The only significant find was a clay tobacco pipe bowl found in Trench II (Plate 9). It's precise context is uncertain (it was found after the trench was given over to school groups) but is likely to be from below the foundations of the east wall to the main house.

The pipe was assessed by David Higgins and is of a type certainly in use by c. 1860-65 since there are a couple of similar examples in a dump of that date from Big Lea Green (Towel & Philpott in prep) and there is an example from the Williamson Tunnels, which were being filled between 1840 and 1870. Given that the style was certainly current by the early 1860s (there are at least two different mould types represented at Lea Green). This style of pipe was still being illustrated in Davidson's catalogue of c. 1880 (Glasgow) and it is likely to have continued in production until around 1900. So, a date of c1850-1900 for the use of this style is probable. Unfortunately this date range does not assist with dating the construction of that part of the house.
