**An Archaeological Watching Brief on Land at  
Princes Half-Tide Dock, Liverpool.  
Site Investigation Works.**

Prepared for City Lofts

June 2006

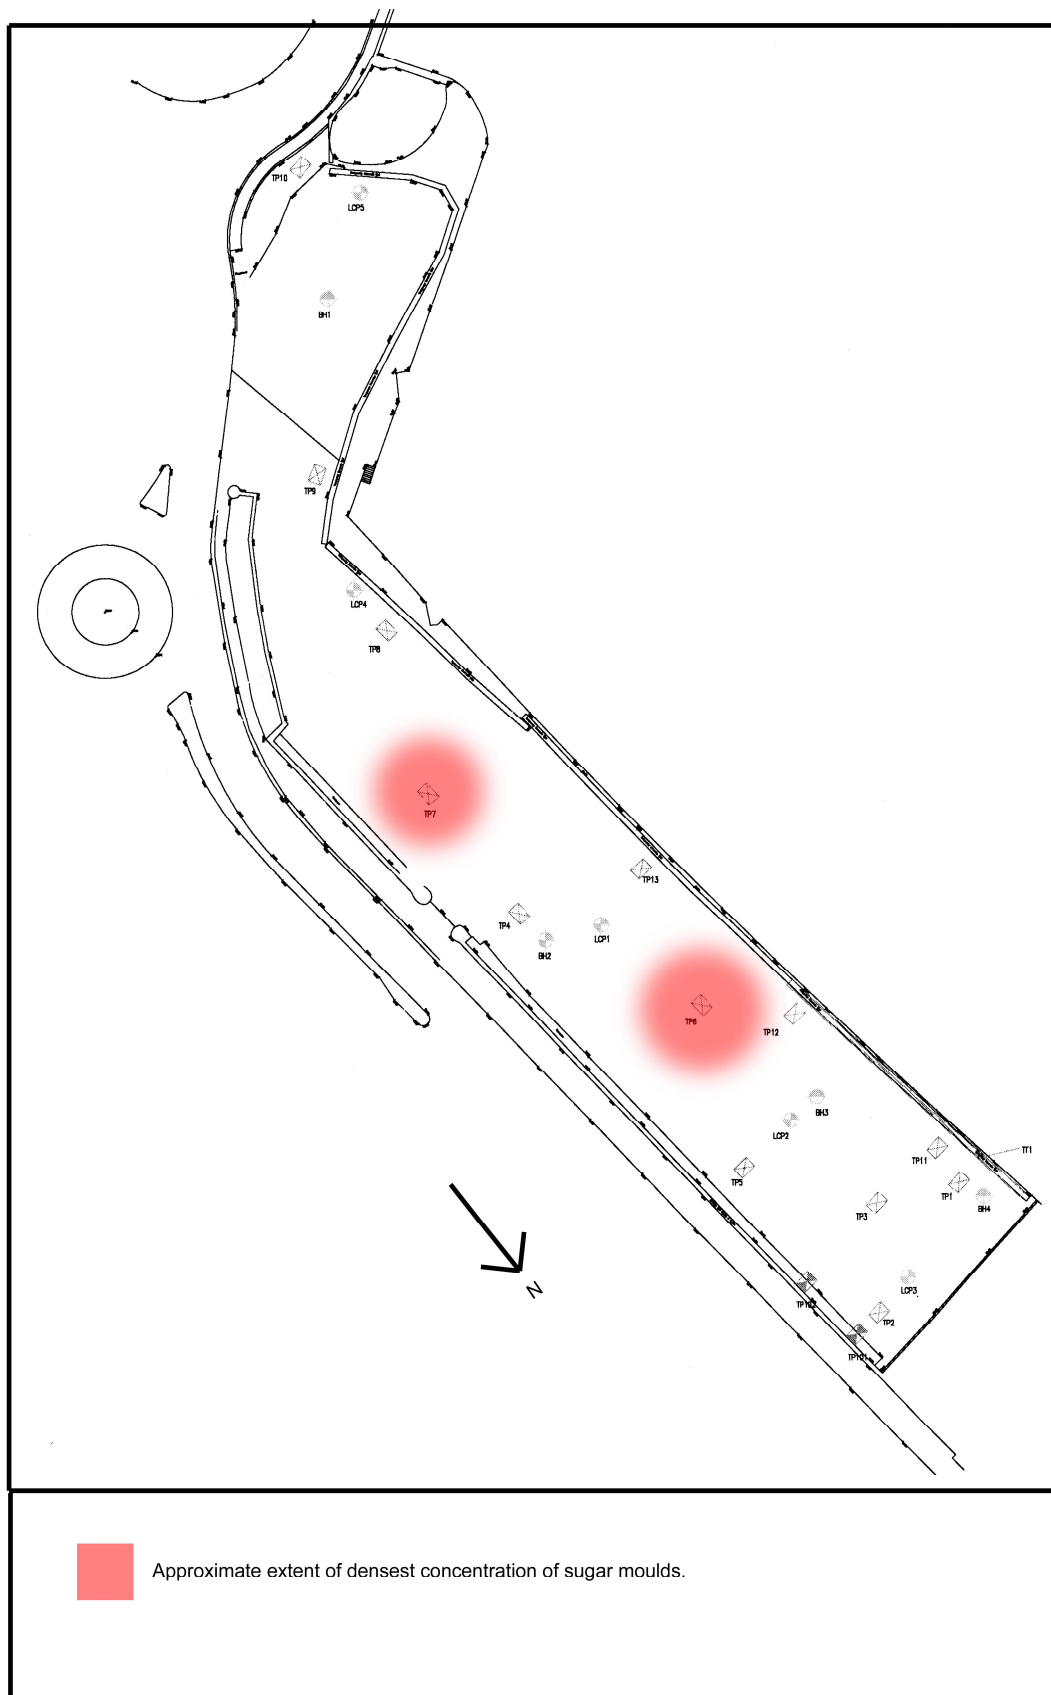
Figure 2. Test pit locations and projected extent of deposits containing sugar moulds. Not to scale.

Test pits (TP) are described and numbered in the order in which they were excavated. Locations are given in Figure 2. All depths were measured from the present ground surface.

Fragments of sugar mould were also found in TP 4, 5, 8, 10 and 13 but the largest and most abundant fragments were from TP 6 and 7 suggesting that although deposits containing this material extend across most of the site, the two densest concentrations occur across the centre of the plot (Figure 2). Most of this material consists of fragments of body sherd, though sections of rim are also present. One of the fragments of rim from TP 7 features part of a stamp with three remaining letters visible from the end of a word, "OTT". This was compared with photographs of an example from Eccleston Hall, which had an identical stamp of the word "PRESCOTT" (J. Speakman, pers. comm.). The significance of this is unclear, there are no known late 18<sup>th</sup> century sugar factories of that name in Liverpool, the only known example being from mid-18<sup>th</sup> century London. One possible interpretation is that it indicates manufacture in Prescott for which there is excavated evidence for manufacture of this material (R. Philpott, pers. comm.). However, the spelling of the placename had settled to a single T by the late 18<sup>th</sup> century (c.f. Yates' 'Map of Lancashire' 1786) and it is more likely that it is a personal, rather than placename. Prescott may be the name of the manufacturer of the mould rather than the sugar refiner for whom it was made, though this too would appear unlikely, as does the possibility that it is a London mould reimported from the West Indies. Some of the fragments had very coarse fabric with a black glaze on the inside, possibly for the boiling of sugar. These sugar moulds were deposited in the construction make-up for the dock and so could not be any later in date than 1820. Further dating evidence is provided by the association with a tobacco pipe dated 1787-1805. This is very important evidence for the development of Liverpool as a port and of the significance of the trade in sugar and slaves from the West Indies.

However, excavation for basement pits across the centre of the plot to a depth of 2.5 m below present ground surface crosses areas which potentially contain significant quantities of sugar mould (Figure 10). Whilst these deposits do not merit detailed recording, this section of the excavation should be monitored as a Watching Brief to allow for the retrieval of a further sample of this material.

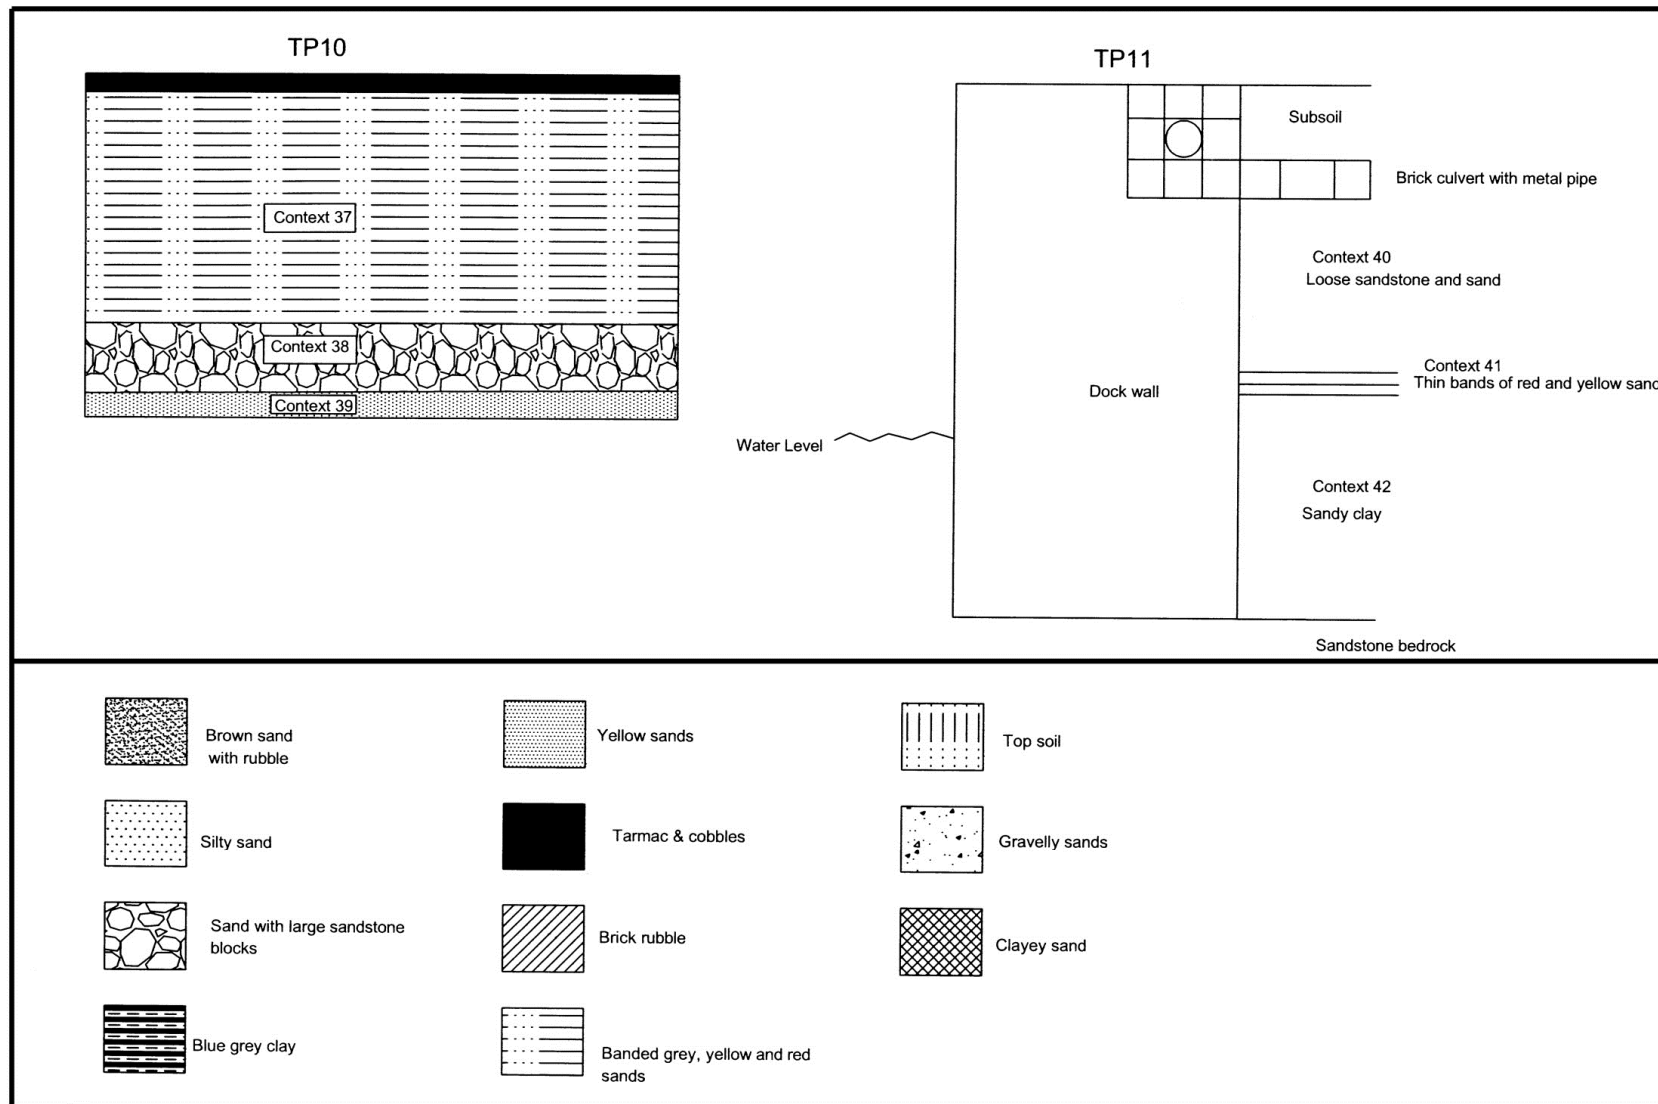
Figure 7. Sketch sections across Test-pits TP10 & TP11. Scale 1:50.

This was the furthest South of the test pits and was located next to the junction of Princes Parade. It measured 5m by 2m and was 2.9m deep (Figure 7). The deposits were composed of layers of sandstone and red sand (Context 37) below the concrete and layers of dark grey and yellow sandstone (Context 38) at 2.1 m. Below this there was a layer of mixed grey brown sand (Context 39). There were very few finds from this test pit.

TP 11 was located to the South-West of TP1 next to the back of the dock wall. The rear dock wall is constructed of squared red and yellow sandstone blocks, most measuring c. 1.5 m across by 1 m high but others were smaller, only 0.30 m by 0.20 m (Figure 7). A brick culvert for a water pipe was laid into a step on the dock wall, 0.95 from the back of the wall and 0.95 m below current ground surface. The bricks extend 1.10m out from the dock wall. The dock wall itself was 2.4m wide at this point and the dock water level within the basin was 3 m from the top of the dock wall. TP 11 was excavated to a depth of 4.5m down to sandstone bedrock. The fill below the brick culvert was a loose yellowish brown sand with sandstone fragments (Context

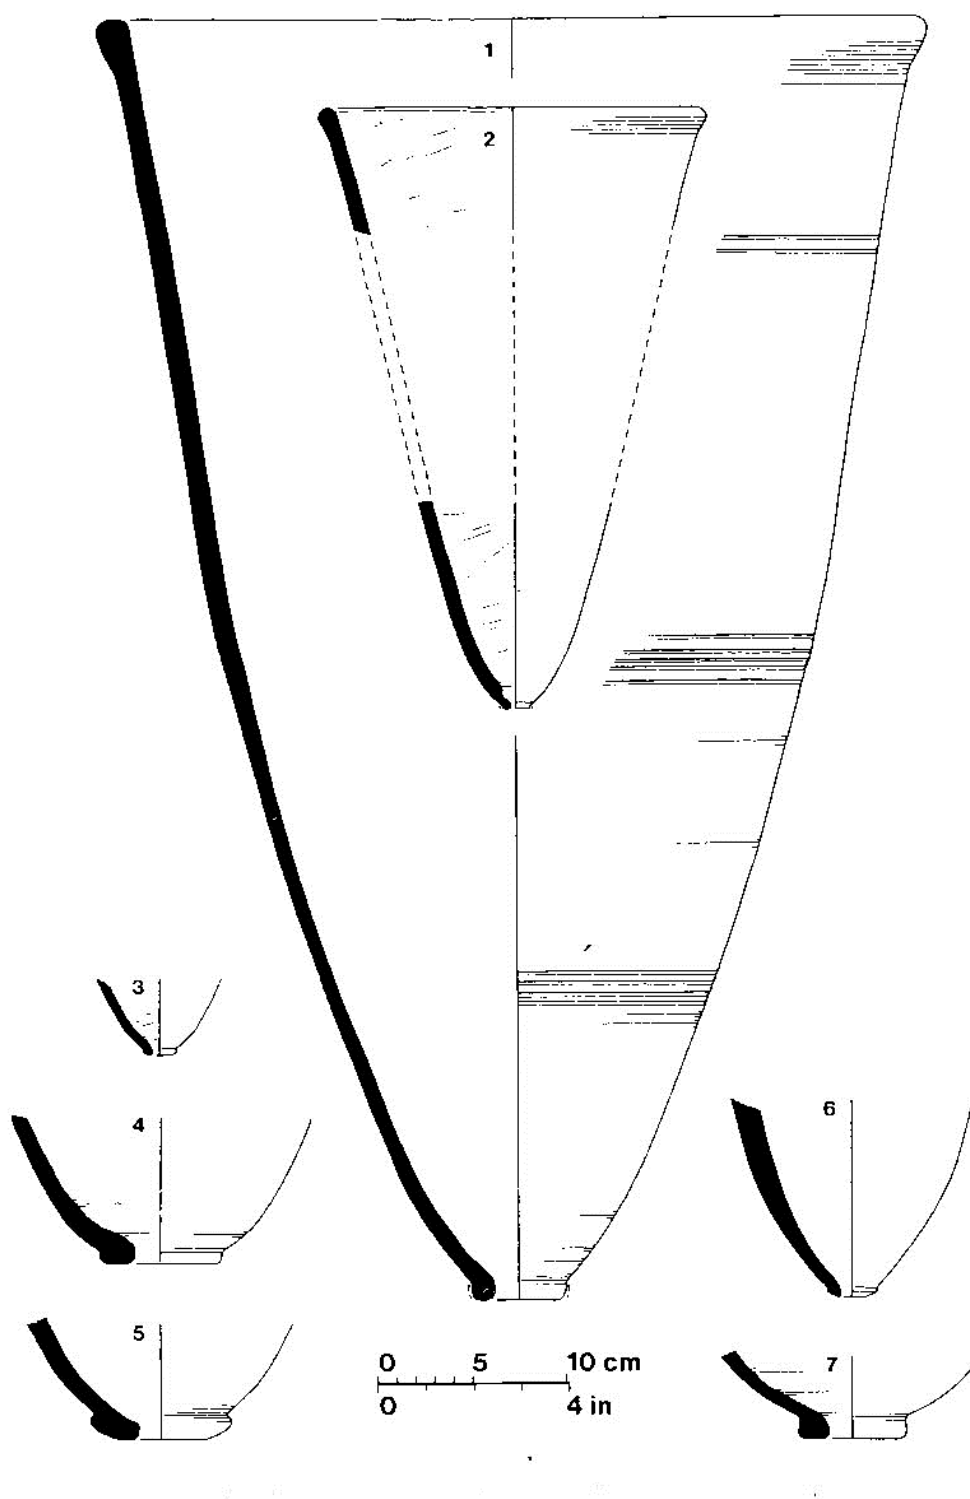
Sugar moulds were unglazed conical vessels with thickened rims, straight sides and a hole in the pointed base (Figure 9) and were used with part glazed earthenware jars in which the waste syrup was collected (see below). Fragments of both types of vessel are present within the assemblage which represents a significant collection of this type of material from a securely dated context (i.e. pre-1820).

Figure 9. Examples of sugar mould from York and Bristol (From Brooks 1983)

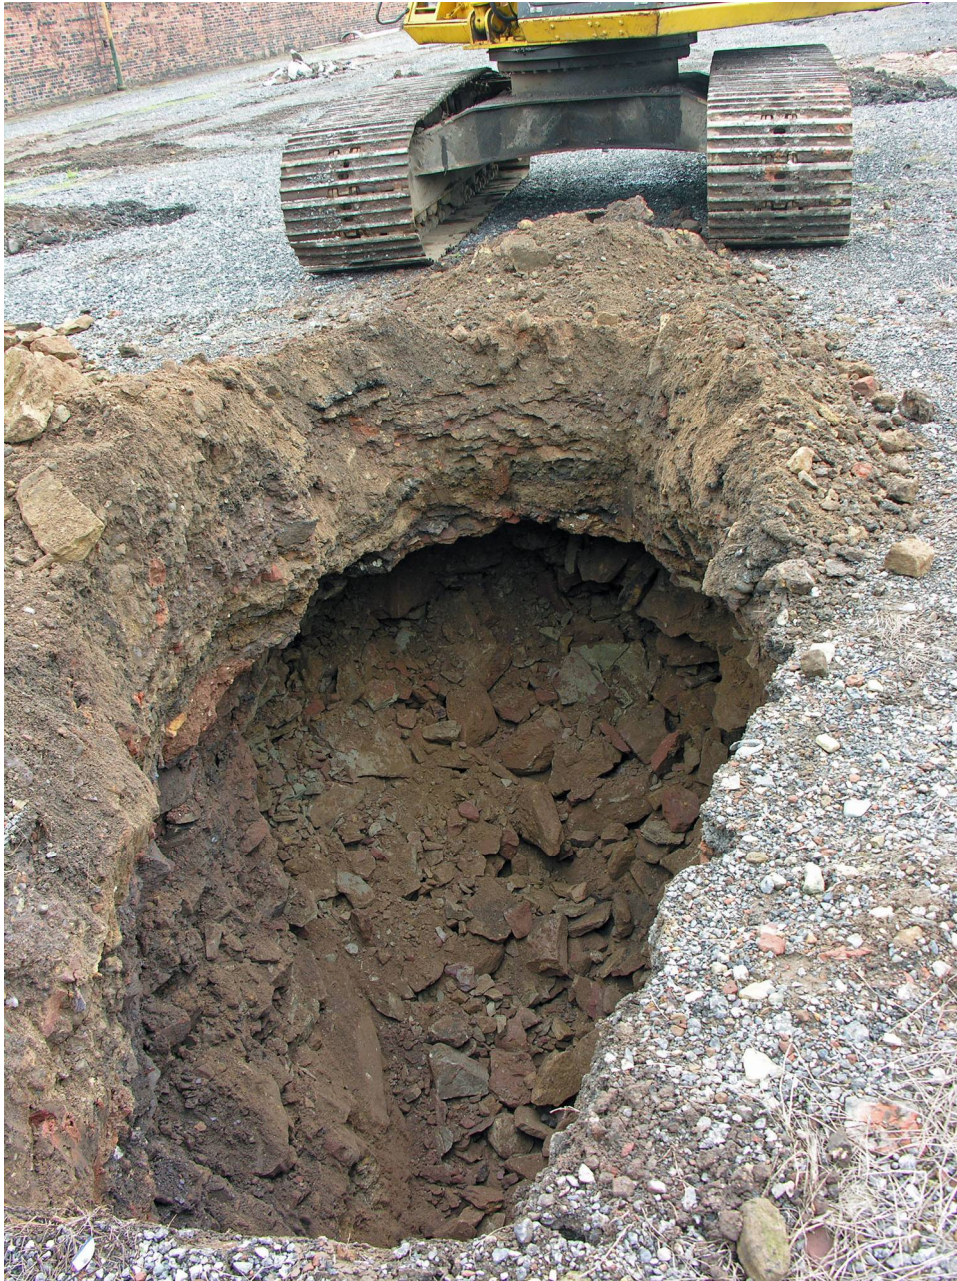
TP 1 was situated in the far North West corner of the site. Due to the friable nature of the deposits, the sides of this test pit had a tendency to collapse frequently and it was therefore difficult to record the measurements accurately (Plate 1). A mid-brown sandy deposit (Context 1) lay immediately below the concrete, which included fragments of brick, angular stones and slate (Figure 3). This was mixed with pockets of light brown-yellow silty sand (Context 2) that contained fewer inclusions. Below this was a thick layer of very loose light brown sand (Context 3) mixed with large sandstone blocks and slabs measuring up to approximately 0.5 m by 0.3 m by 0.2 m. A layer of dark blue grey clay (Context 4) was revealed at 3.8 m below the surface. This contained few inclusions apart from one fragment of china and was approximately 0.20 m thick. A fine yellow sand (Context 20) was found below the dark clay at 4 m. Excavation was terminated at this point.

Plate 1. Test-pit 1 under excavation showing collapse of sides.

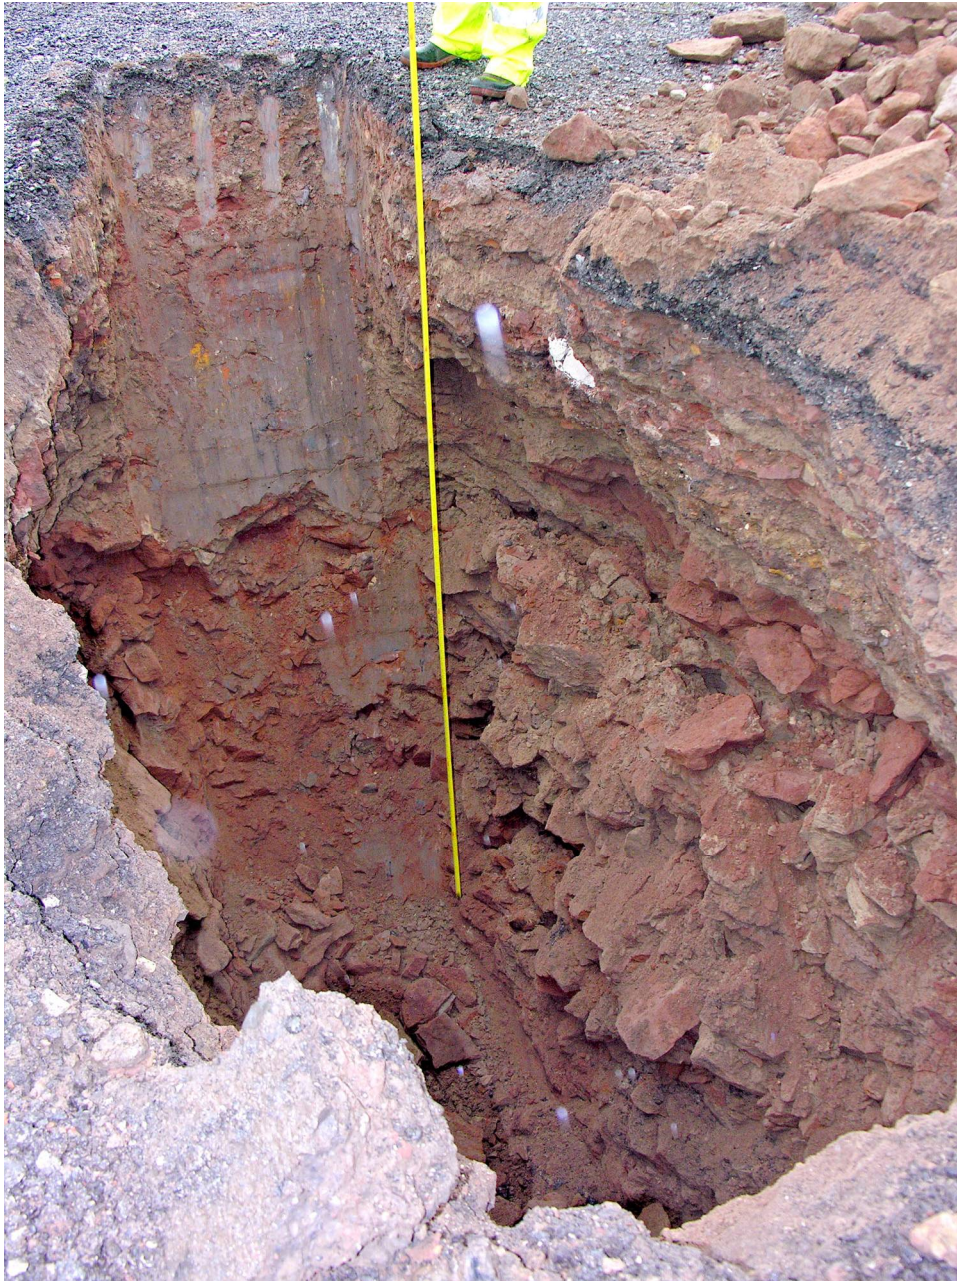
TP 3 was located to the south of TP 1 and 2. It measured approximately 2 m by 5 m and was 3.3 m deep. Below the tarmac there was a thick section of banded layers of alternate grey, yellow and red stony sand (Figure 4), approximately 1 m thick (Context 25). The main fill below this was a mixed red brown sand (Context 6) with large sandstone blocks and slabs measuring up to approximately 0.5 m by 0.3 m by 0.2 m (Plate 2). Small fragments of white china and orange ceramic were recovered, as well as half an oyster shell from the base of the pit. This pit was excavated to sandstone bedrock at 3.3m.

Plate 2. Test pit 3, context 6.

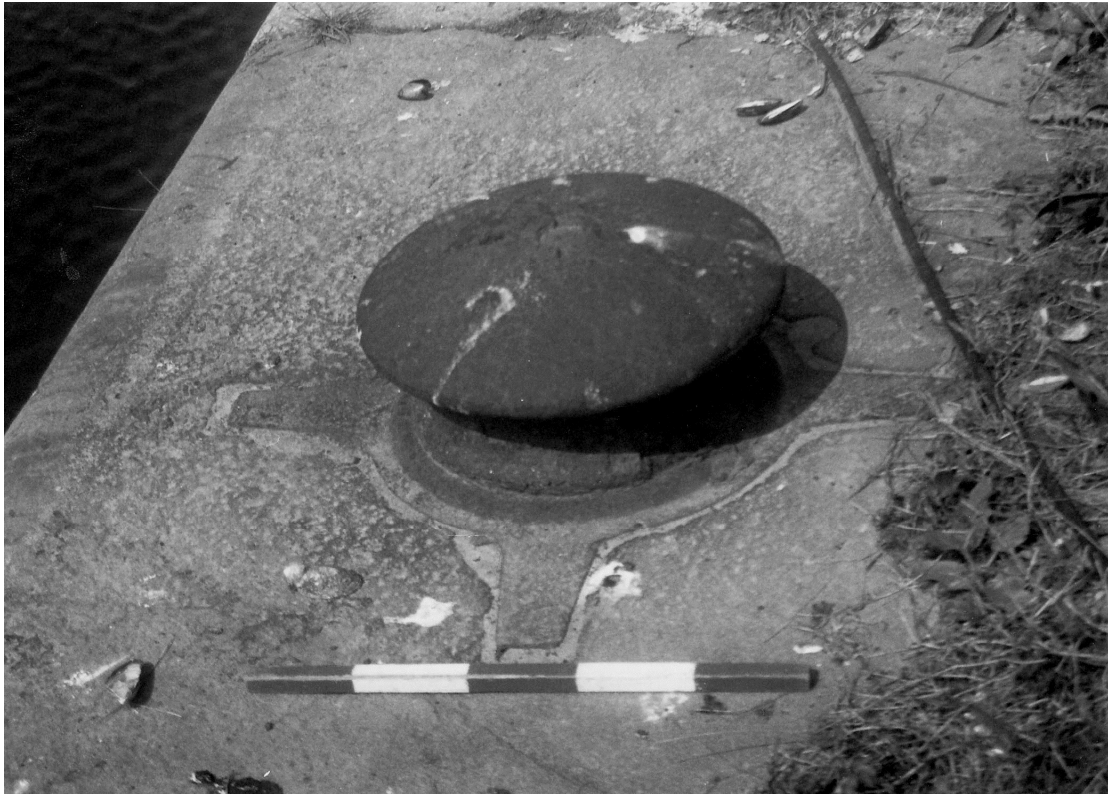
Idler Wheel: Cast iron on a cruciform cast iron base set into granite (Plate 3). This is identical in form to NWSIAH (1981-2) Type T1. These were used to re-direct the rope from a ship to a capstan when warping it through a passage and this form is common through out the central docks area.

Plate 3. Idler Wheel: Cast iron on a cruciform cast iron base set into granite.  
NWSIAH (1981-2) Type T1

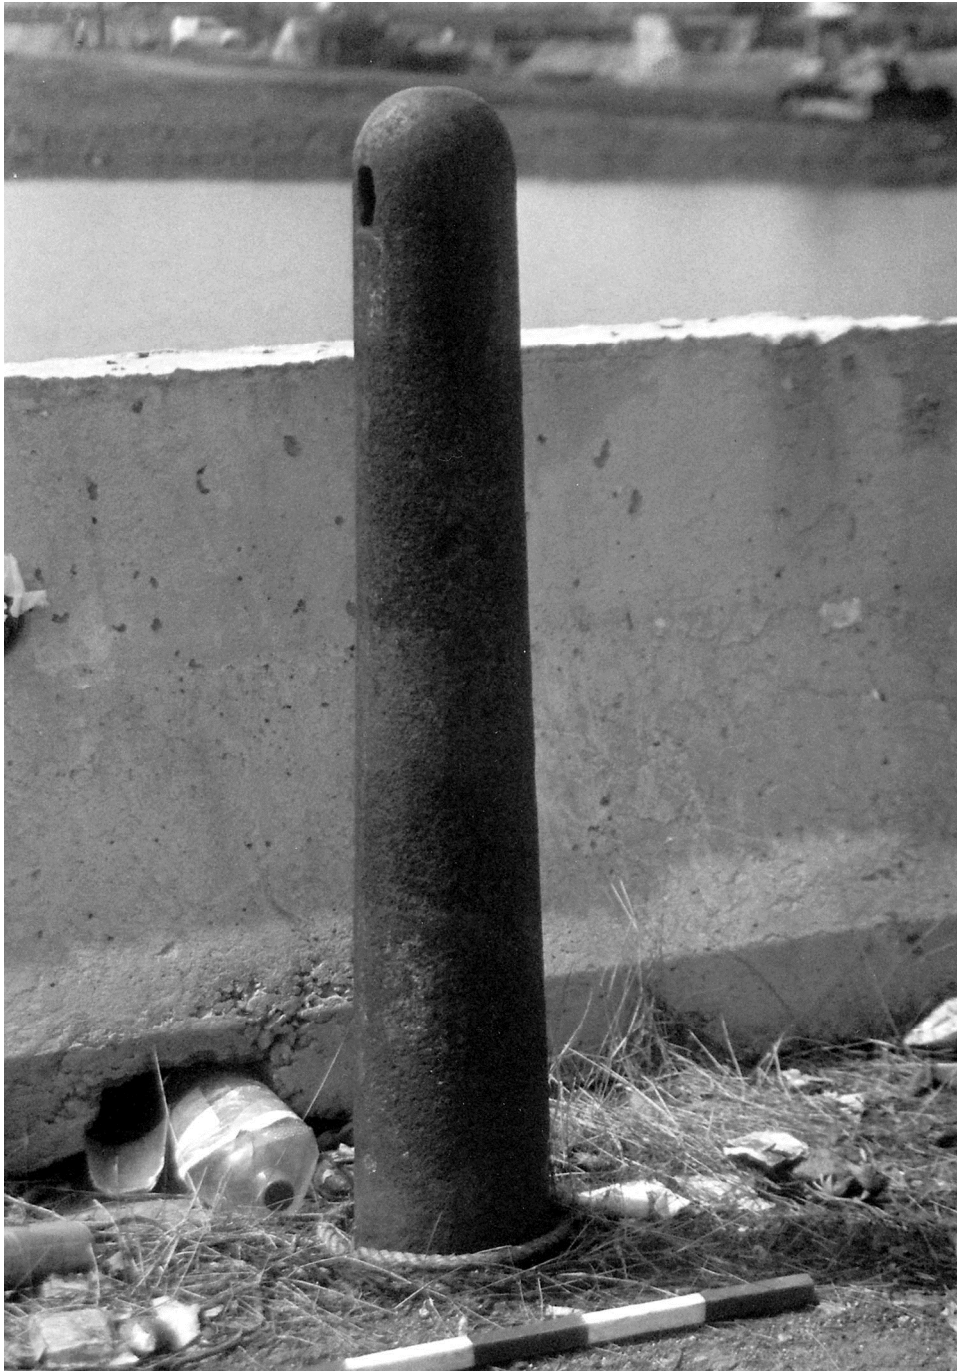
Handrail Stanchions: These are all of NWSIAH (1981-2) Type H, a standard pattern found throughout the Central Docks (Plate 4). They are tapered cast iron cylinders with a slot at the top through which the chain passed. They are only present at the southern end of the site and the chains have been removed.

Plate 4. Handrail Stanchions, NWSIAH (1981-2) Type H.

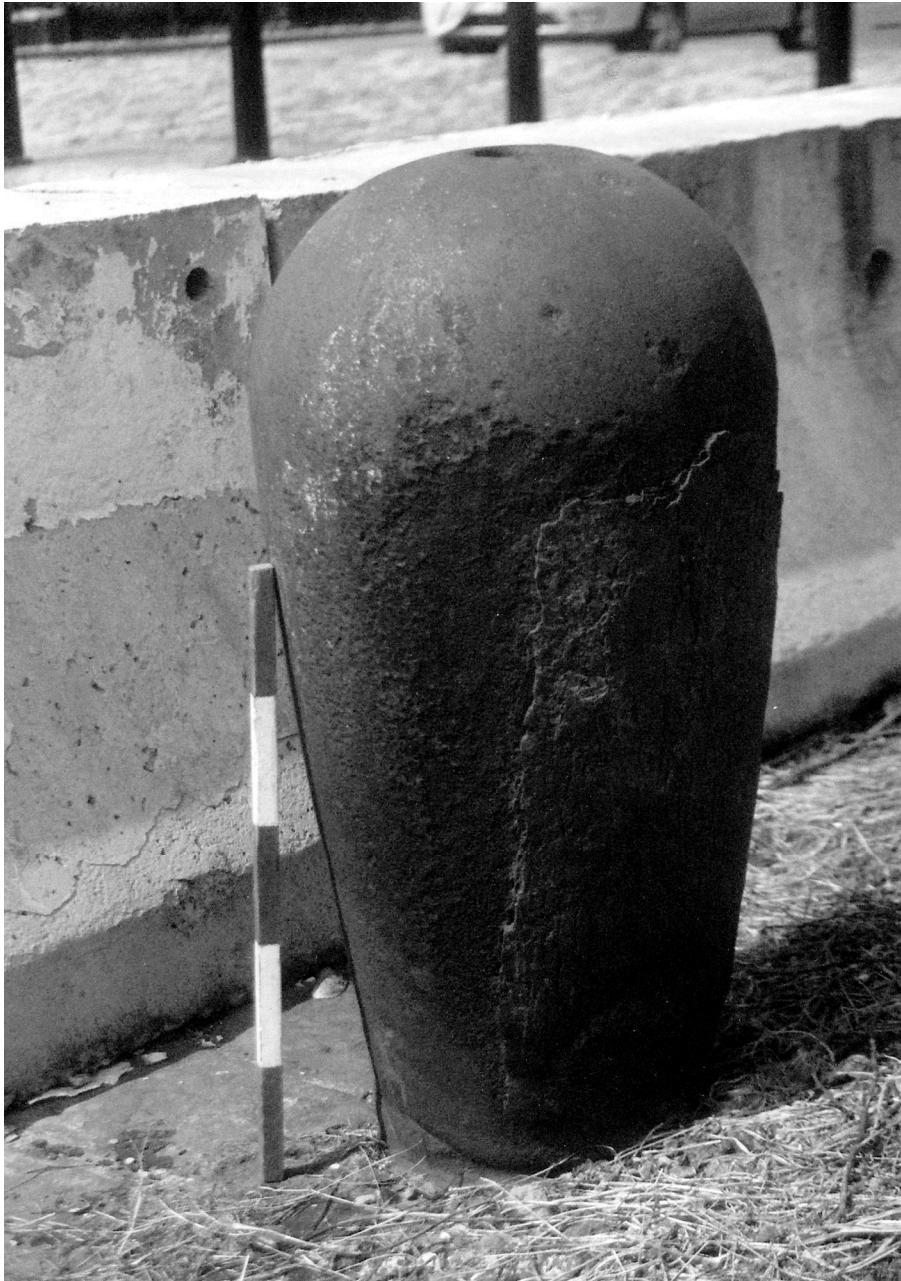
Bollards: Two types of bollard are present. The commonest are NWSIAH (1981-2) Type B1 in cast iron. It has been suggested (ibid) that these are to a design by Jesse Hartley (Plate 5). Some have had wrought iron brackets welded to their heads (Plate

Plate 5. Bollard, NWSIAH (1981-2) Type B1 in cast iron.

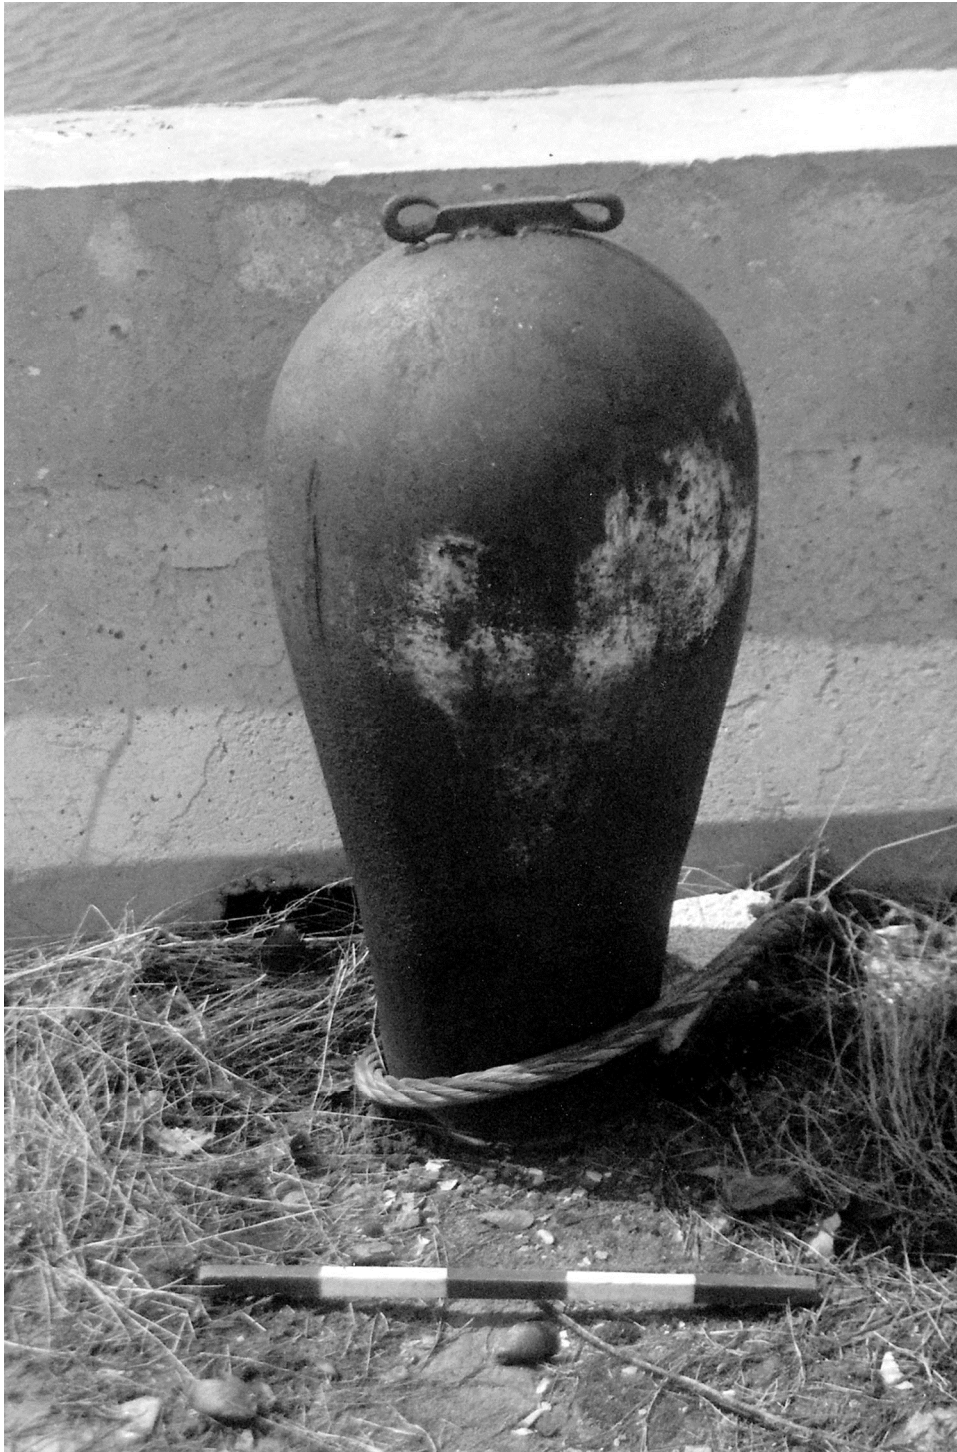
6) and it appears that these are later additions. The second type is a further modification to a Type B1 which has had an iron(?) 'collar fitted to the widest point (Plate 7) and not noted on the NWSIAH survey. The function of the collar is unclear but is presumably associated with securing the rope.

Plate 6. Bollard, NWSIAH (1981-2) modified Type B1 in cast iron with wrought iron bracket welded to the head.

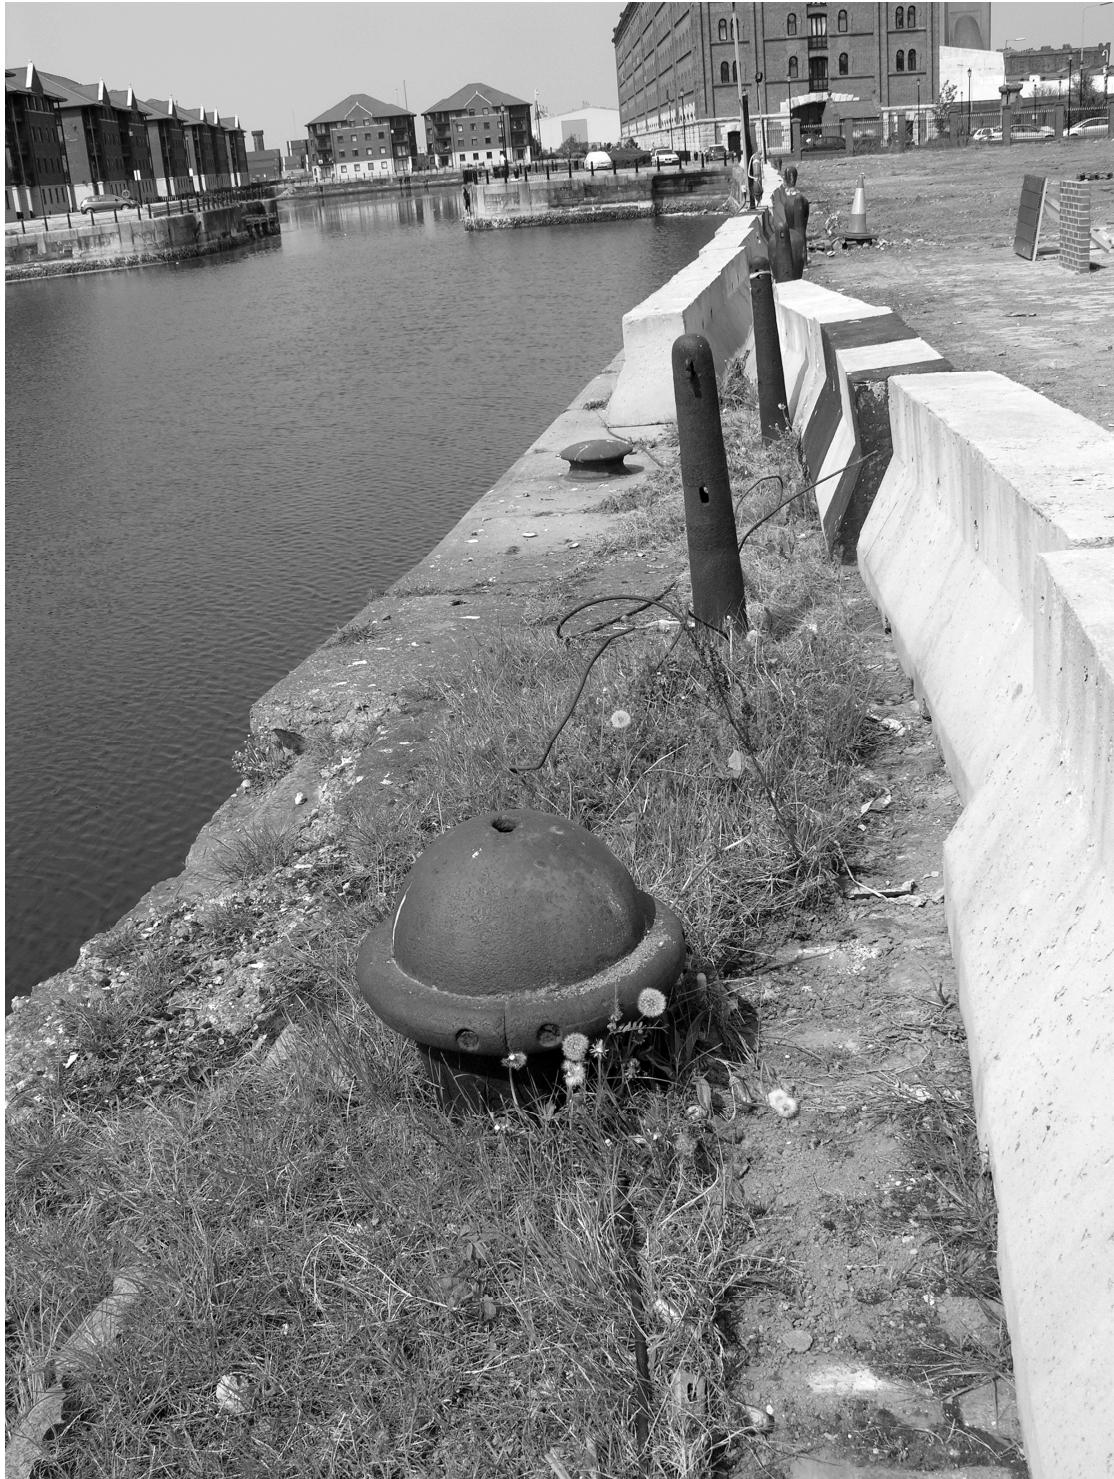
Plate 7. Bollard, NWSIAH (1981-2) modified Type B1 in cast iron with iron(?) 'collar fitted to the widest point.

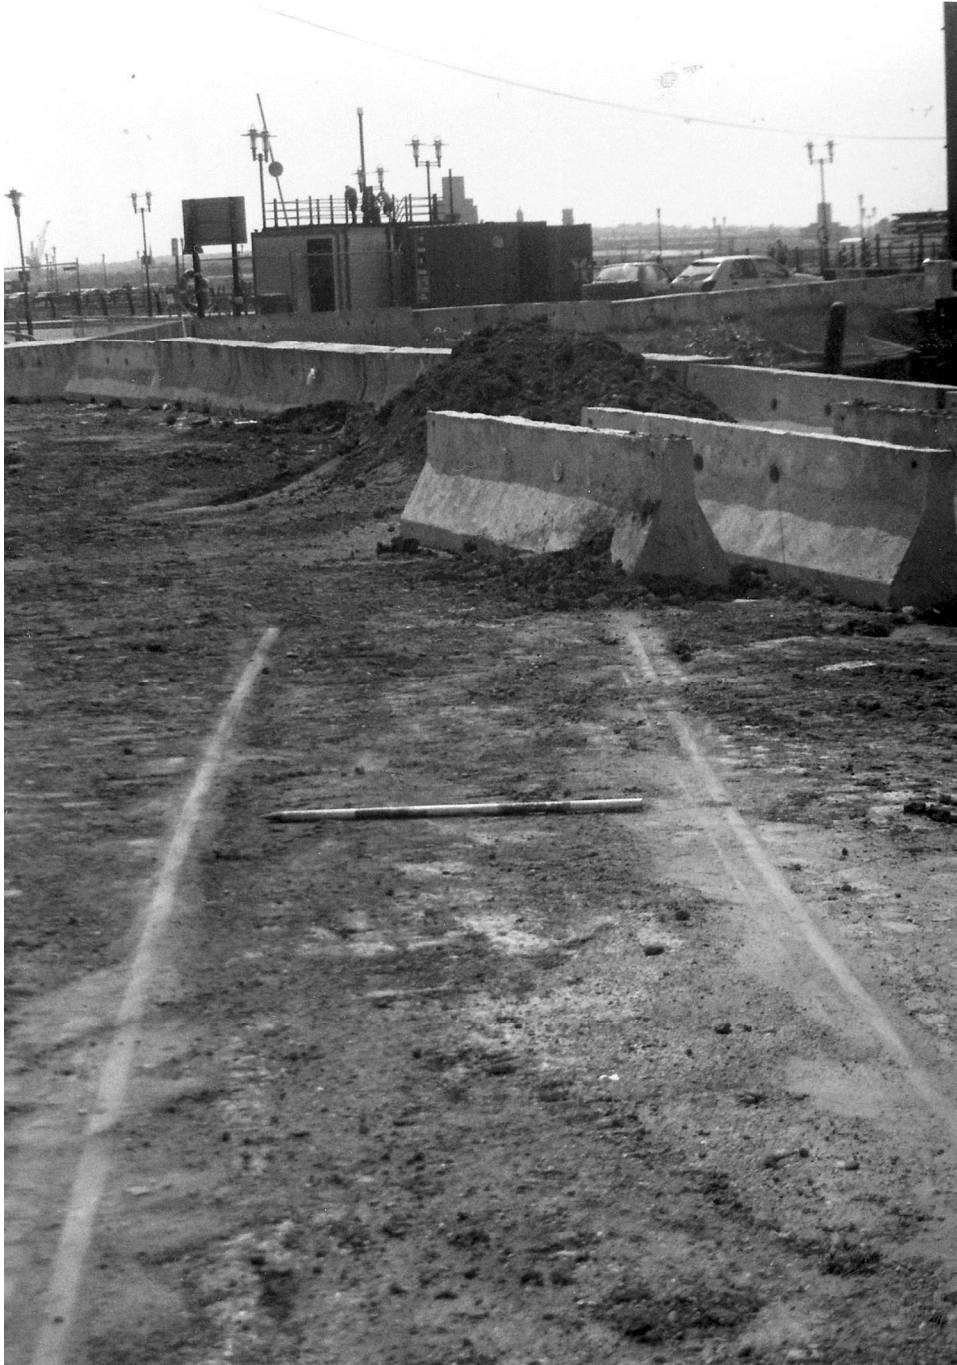
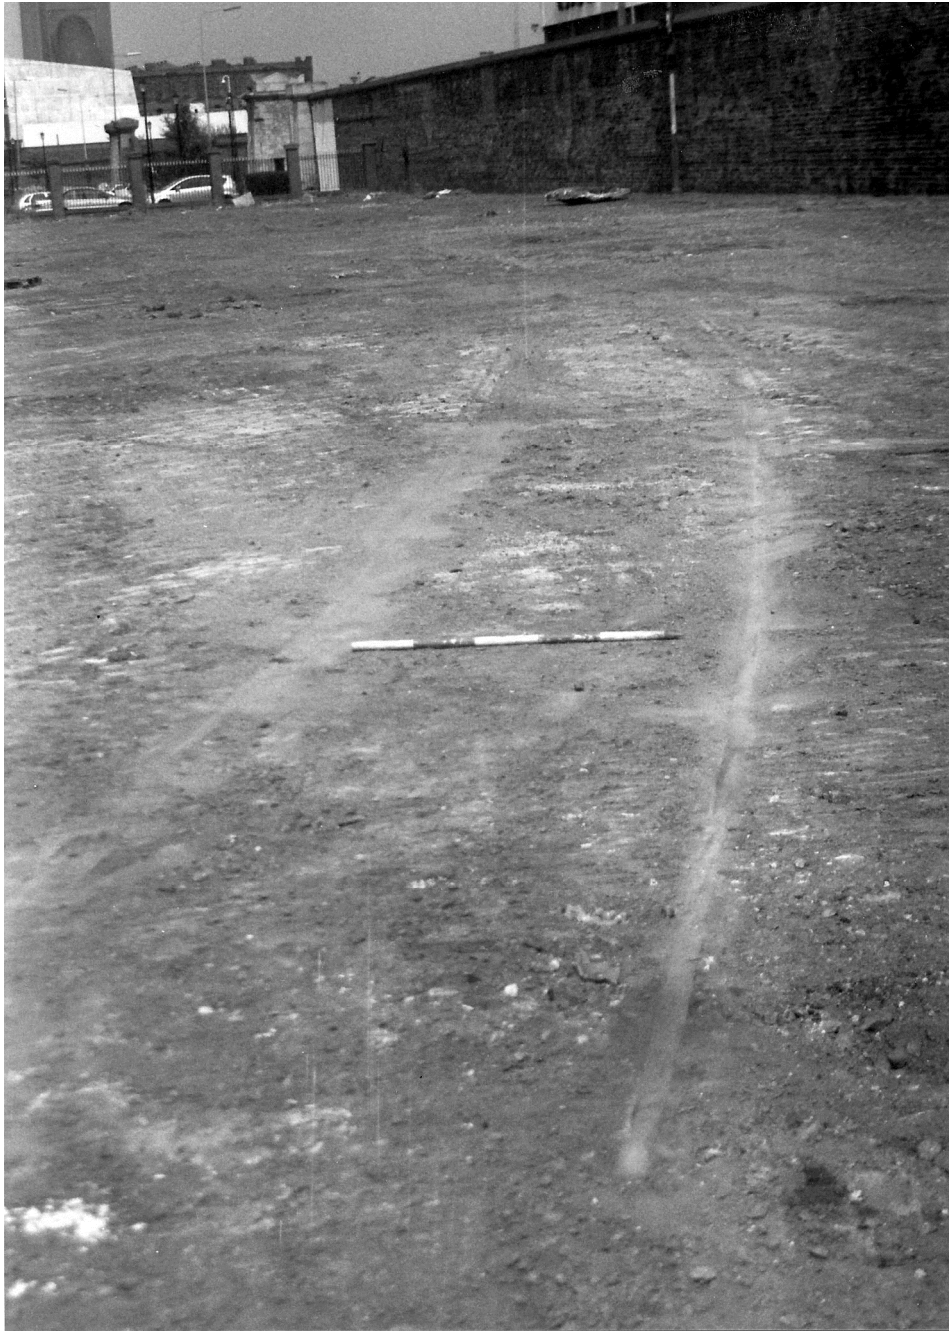
Rail Tracks: Cast iron rails set within granite sets (Plates 8 & 9), these are the railway sidings for the East Sheds, first shown on the 1891 OS sheet (Adams 2005).

Plate 8. Rail Tracks, view looking south.

Plate 9. Rail Tracks, view looking north.

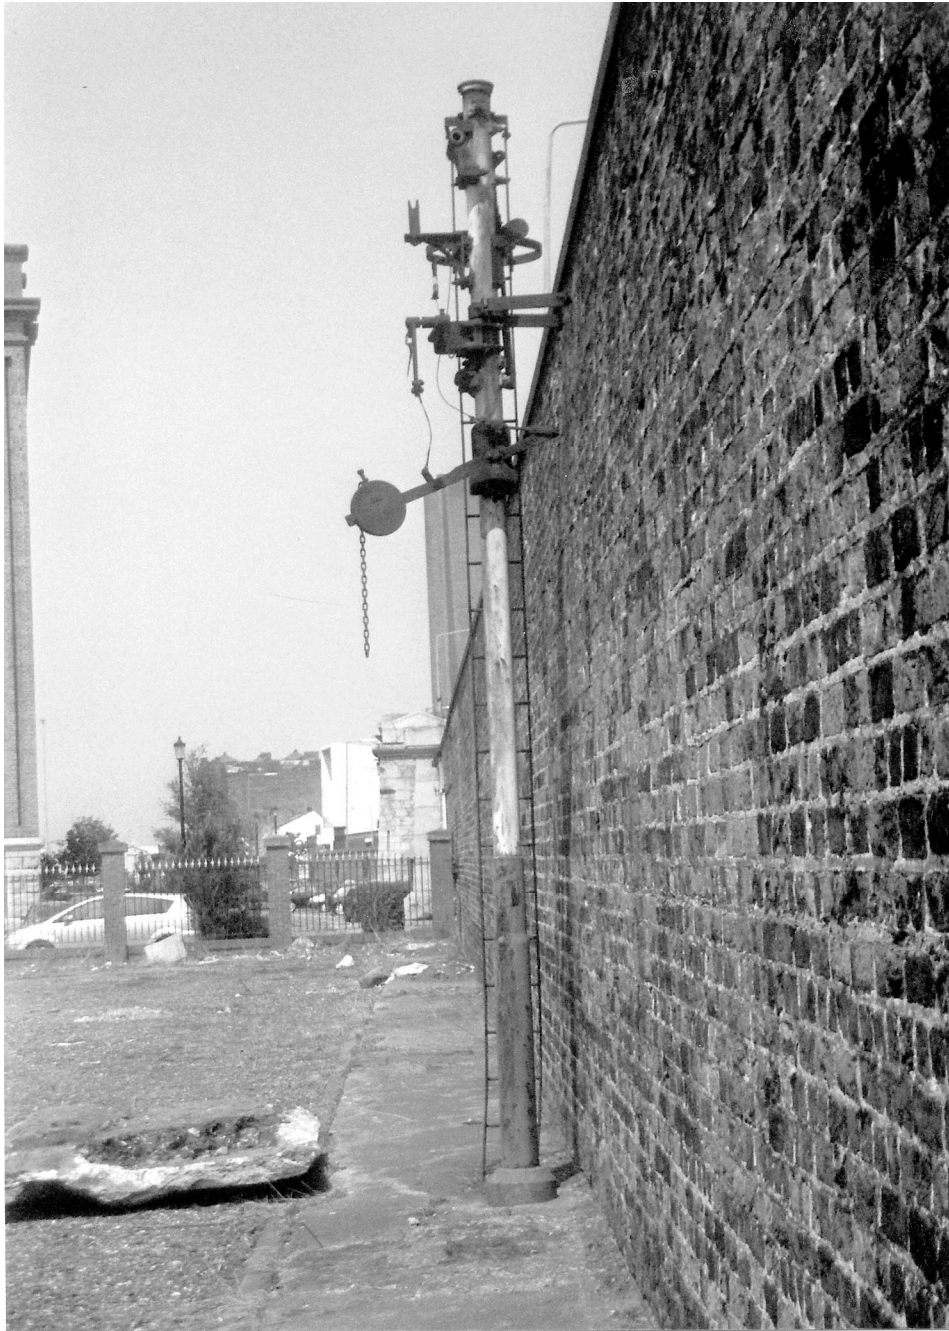
Railway signals: A single set survives against the eastern site boundary (Plate 10). The cast and wrought iron mechanism is supported upon a cylindrical cast iron post which also carries an access ladder in wrought iron. The signal board is missing.

Plate 10. Signalling equipment.
