An Archaeological Watching Brief During Ground Investigation Works at Princes Reach, Princes Dock, Liverpool.

Site Code 174

Final Report

Prepared for Ridge & Partners LLP & Moda Living

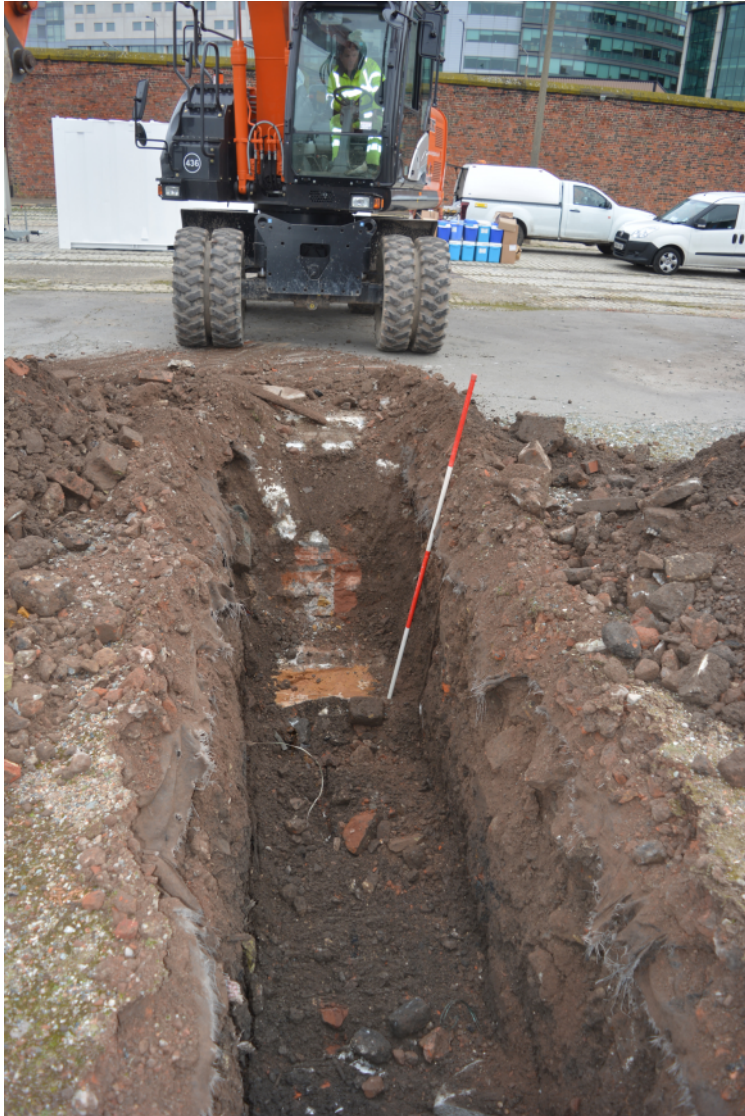
Plate 1. TT301/305. Retaining wall to Princes Dock as first exposed. View looking east. Scale = 2 m.

The only archaeologically significant feature was the sandstone retaining wall to Princes Dock (Context 3 Fig. 3, Plates 1 & 2). This was situated at the predicted location and was exposed to a depth of c. 3 m below current ground surface. The top of the wall was c. 0.7 m BGL (c. 6.8 m AOD) but was partly obscured the bitumen and concrete floor to the 1920s transit sheds (Contexts 1 & 2) and by debris which fell into the trench and could not be cleared making accurate measurement difficult. The setts seen in TT302/3 were not observed but may have been covered by debris. A cut c. 1 m wide and 1.20 m deep had been made into the top of the wall, removing the coping stone and showing the wall to be constructed in a mix of red and yellow sandstone with portland(?) cement as a bonding material. A patch of concrete measuring c. 0.2 x 0.2 m in the cut face may relate to the concrete staging constructed in 1929 but could not be directly inspected.

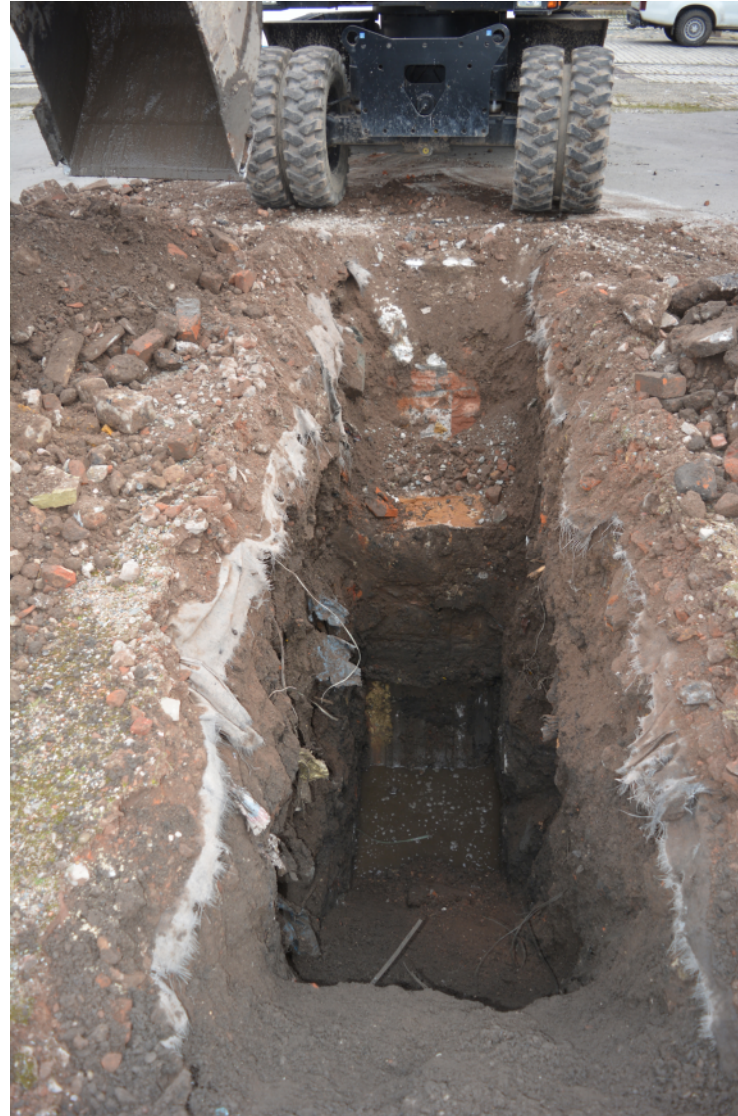
Plate 2. TT301/305. Retaining wall to Princes Dock after further excavation. View looking east. A scale could not be inserted.

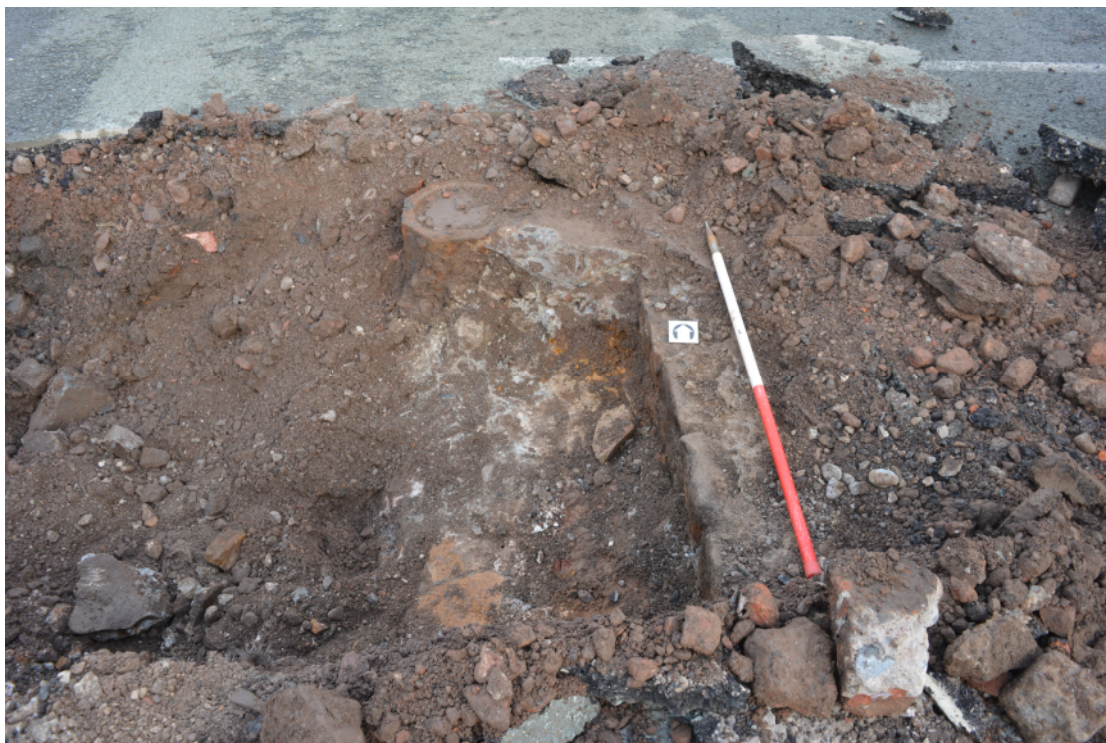
Plate 3. TT302/303. Upper surface of Princes Dock retaining wall as first exposed. View looking north. Scale = 1m.

The only archaeologically significant feature was the sandstone retaining wall to Princes Dock (Context 7 Fig. 3, Plates 3 & 4). This was situated at the predicted location and was exposed to a depth of c. 1.30 m below current ground surface. A similar cut to that seen to the north, c. 1.2 m wide and 0.9 m deep, had been made

into the top of the wall, removing the coping stones. The top of the wall was c. 0.35 m BGL (c. 6.95 m AOD).

The upper surface of the wall was obscured by a layer of granite setts c. 0.2 m thick (Context 5) and these were in turn sealed by a layer of concrete c. 50 mm thick (Context 4). A hexagonal cast iron setting (Context 6) 0.34 m across had been placed with its upper, slightly dished surface level with the concrete. Its function and date is uncertain, the position suggests that it relates to the sheds constructed in 1929 though images of the interior of the sheds (e.g. Jarvis 1991, 61) do not show any columns for which it could have served as a base. It may relate to the earlier sheds, Jarvis (1991, 31) shows column bases projecting above floor level in a broadly contemporary (i.e. mid-19th century) shed, though this remains unproven.

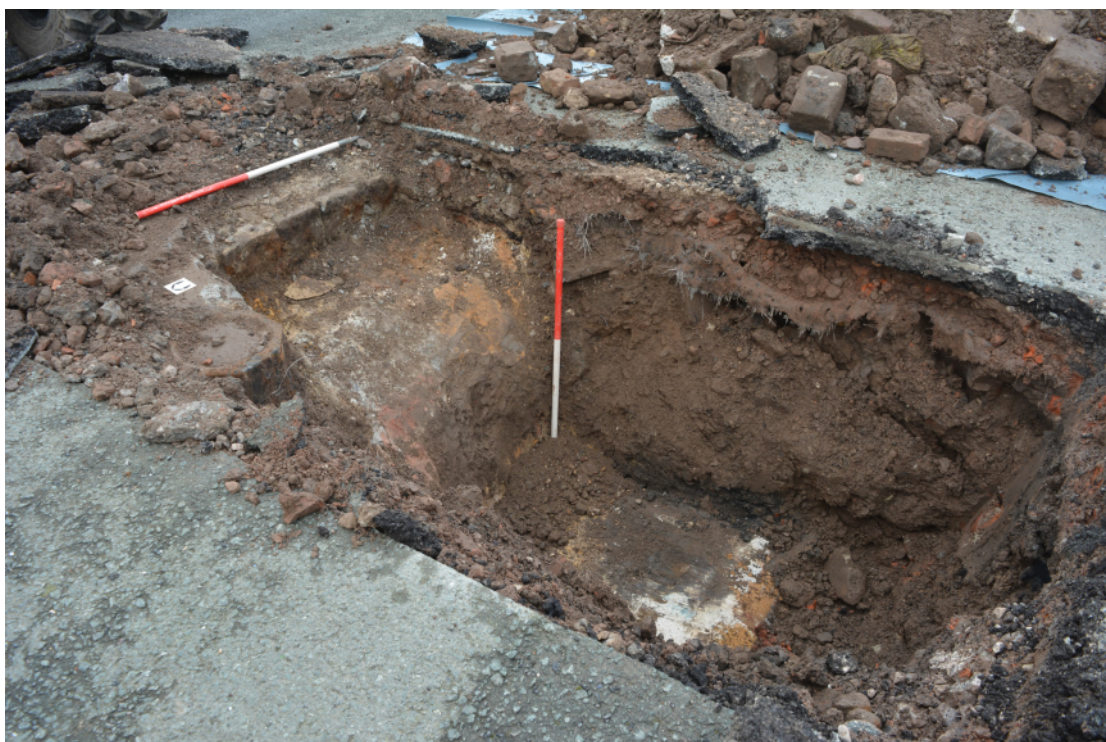
Plate 4. TT302/303. Step cut into upper surface of Princes Dock retaining wall. View looking south-east. Scales = 1m.

TT301/305 and TT302/303 successfully located the upper courses of the retaining wall to Princes Dock though this appears to have been badly disturbed to a depth of c. 1.2-0.90 m for most or all of its length by the cutting of a step c. 1-1.2 m wide and 0.9 to 1.2 m deep. This was possibly made to accommodate the concrete staging constructed in 1929, though it will also, at least in part, have been created during the replacement of Foster's original sandstone copings with granite in the 1860s (Jarvis 1991, 38). In consequence none of the dock copings survive and the upper levels the wall retain little of its original form. The wall is constructed in a mix of red and yellow sandstone using a Portland cement or similar. Whilst the facing of the wall has been located it was not possible to determine its thickness, though a minimum upper thickness of c. 1.5 m should be assumed. Photographic evidence shows that the wall had a pronounced batter on the dock face and it is likely to be considerably thicker at its base. Fig. 2 shows the line of this feature projected from the excavated evidence

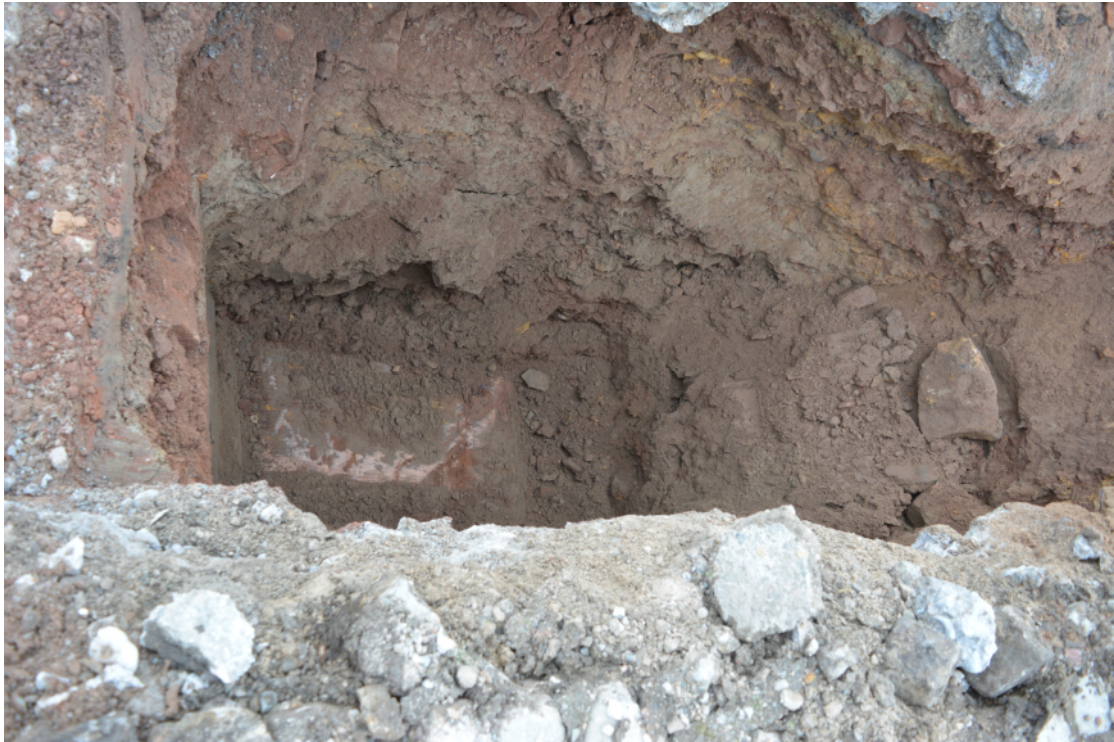
Plate 5. TT304. Large red sandstone block exposed at base of trench. View looking west. See Plate 6 for scale.

In the central section a large squared red sandstone block (Context 12) was observed at a depth of c. 3.5 m BGL (c. 3.6 m AOD), (Plates 5, 6 & 7) it was

impossible to obtain direct measurements because of the unstable nature of the deposits, but it probably measured c. 0.5 x 1 m in plan. The block appeared to be securely fixed in place and is likely to be part of a substantial wall.

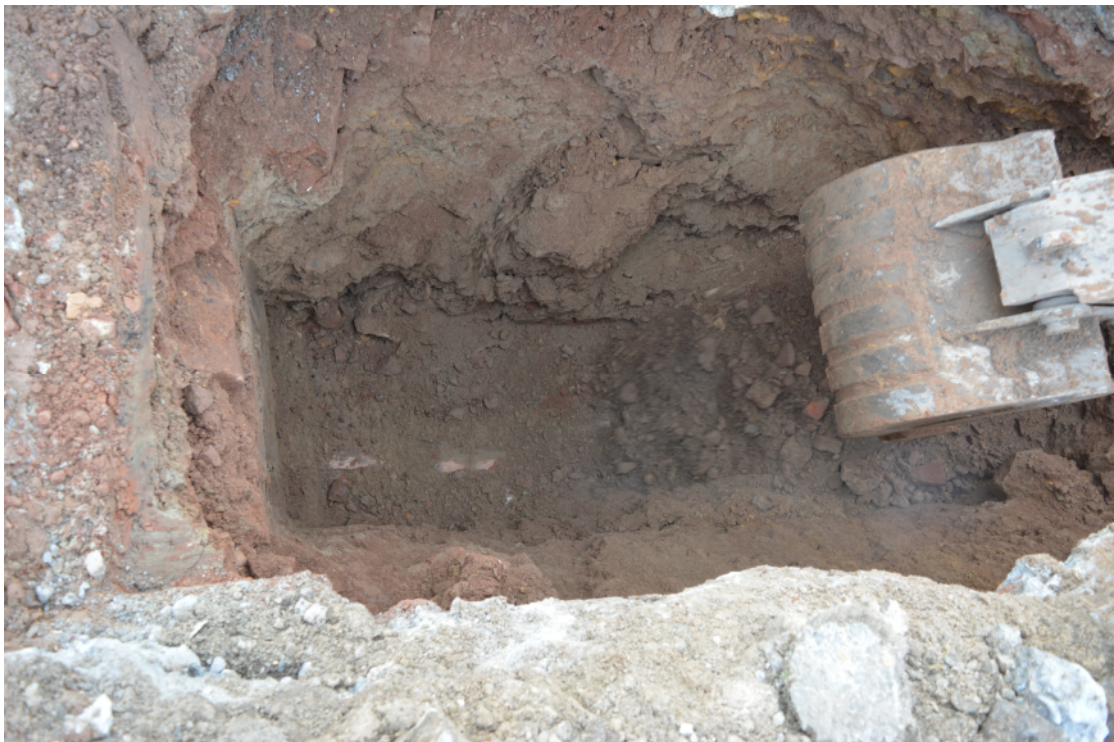
Plate 6. TT304. Same view as Plate 5 with excavator bucket included for scale.

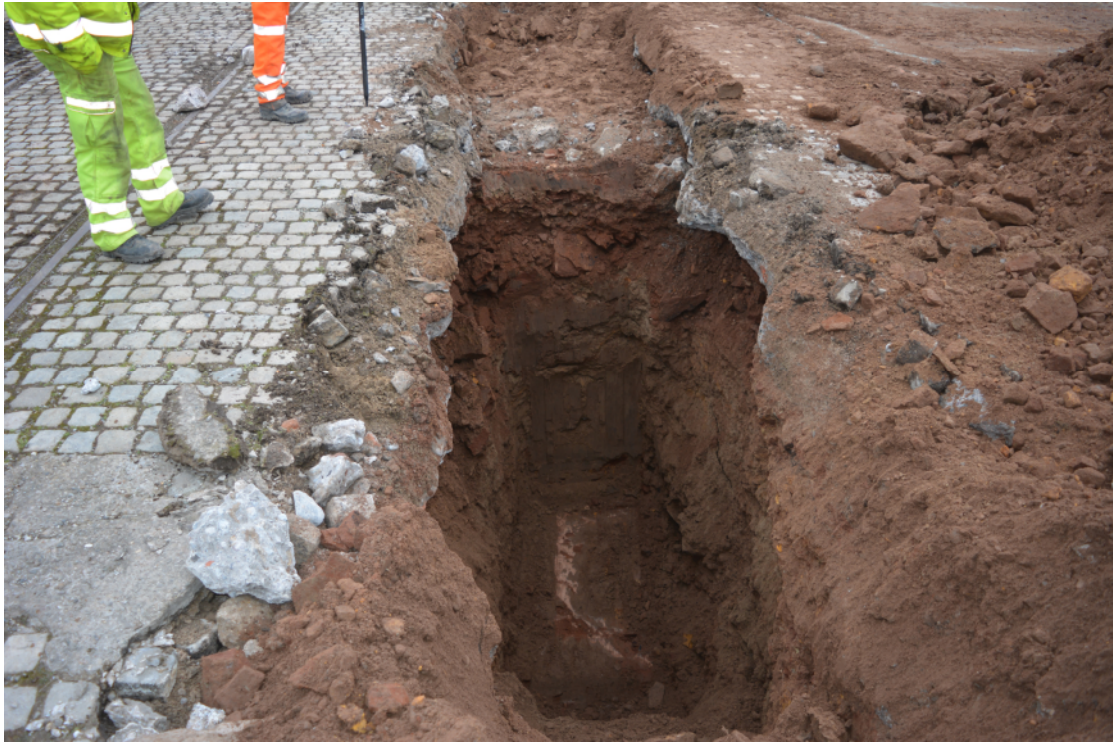
Plate 7. TT304. Large red sandstone block exposed at base of trench. View looking south.

The sandstone in TT304 was less completely observed though there appeared to be a vertical edge on its eastern side which suggests that it is part of a wall, though no jointing could be seen and it is possible that it is in fact the upper surface of bedrock though borehole data suggests that this is unlikely because rock head is probably located at a depth of c. 5.6 m below BGL in the general area of the TT304 and 306 (Arup desk-study). This also suggests that if the sandstone features located in TT304 and 306 are the 1803 sea wall it survives to a height of c. 1.5-2 m.

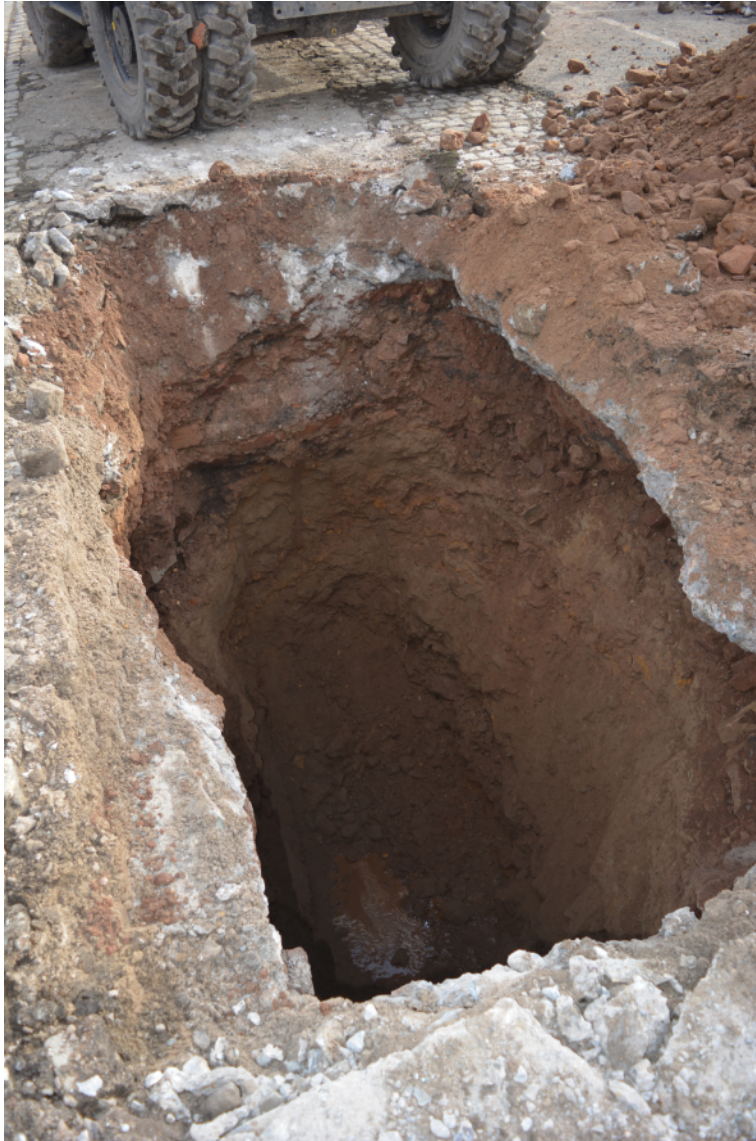
Plate 8. TT304. Brick lined culvert exposed in southern edge of trench. View looking south-west.

The only other feature observed was a brick lined culvert in the southern edge of the excavation (Plate 8). It was impossible to gain direct access for recording but it was set c. 0.5 m below ground surface (c. 6.7 m AOD) and was c. 0.4 m in diameter.

The brick culverts observed in the upper levels of this deposit are of uncertain function but are likely to relate to drainage of the site. They are undated but must be in the range 1820-1929.

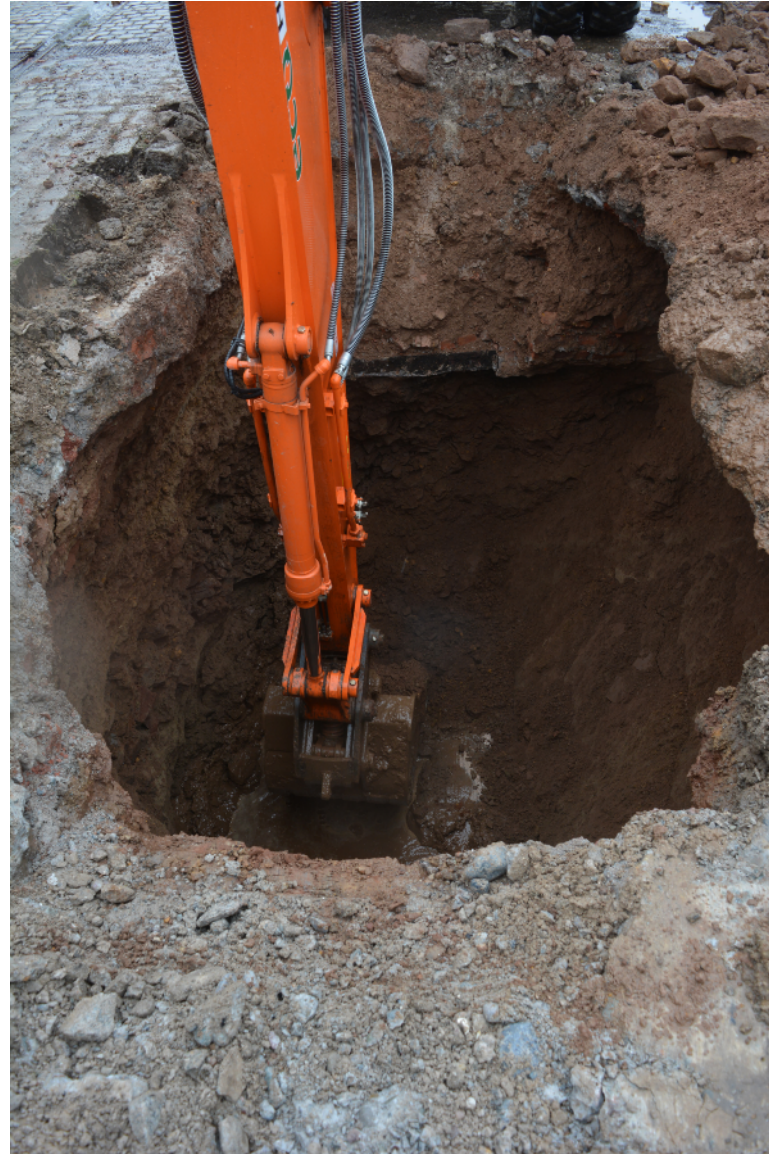
Plate 9. TT306. Red sandstone obstruction in base of trench. The block is set to the immediate right of the excavator bucket. View looking south.

The deposits in this trench (Contexts 13, 14, 15 and 16) were identical to those in TT304. A large sandstone obstruction (context 17) was encountered at a depth of c. 4 m BGL (c. 3.2 m AOD). This was less clearly identifiable as worked masonry than that in TT304 but appeared to have a flat upper surface and a vertical edge on its eastern side (Plate 9). Grey streaking on its upper surface may represent traces of mortar.

The sandstone features identified at the bottom of TT304 and 306 (contexts 12 and 17) probably represent the sea wall shown on Horwood's Map of Liverpool of 1803 though it is difficult to be certain of this. The squared block at the base of TT306 was firmly set in place and appeared to be level and *in situ*. Unfortunately it was not possible to prove the presence of any adjacent blocks which means that it is impossible to show whether this was part of an east-west or north-south aligned wall (See Fig. 2) and there therefore remains a degree of uncertainty as to its precise location and alignment within the site. The absence of any similar blocks to the north and south could be an indication that it is aligned east-west but could equally be because the blocks along that section of a north-south aligned wall are absent at this point.

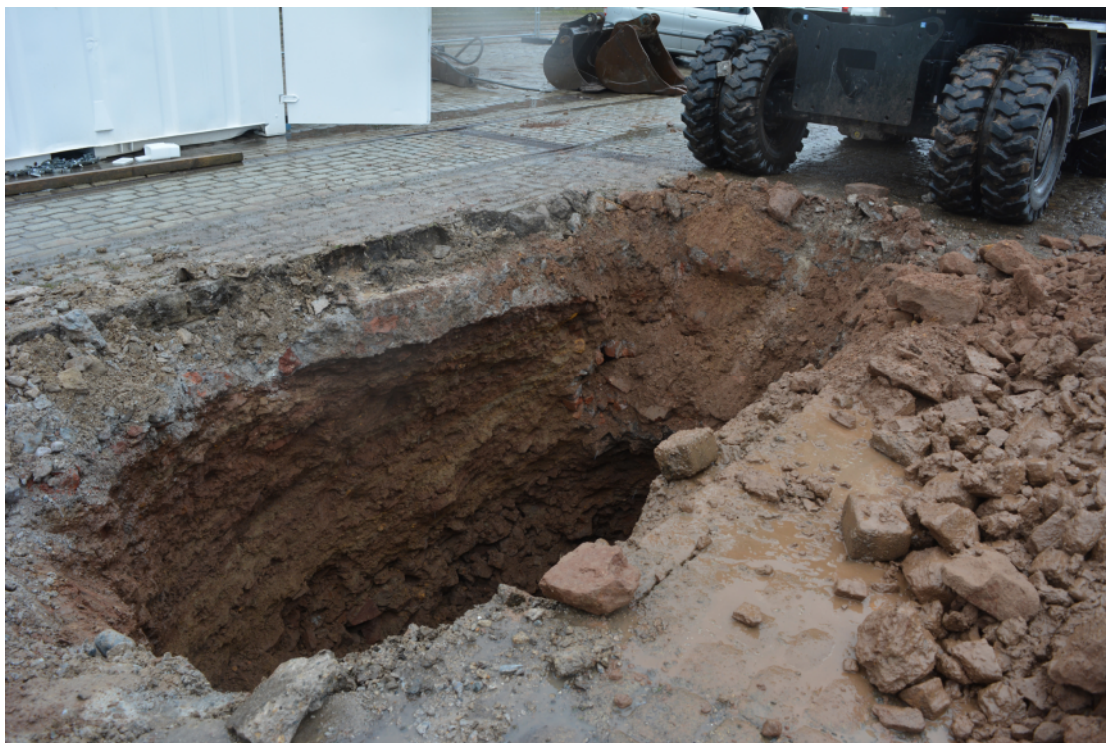
Plate 10. TT306. Brick lined culvert exposed in southern edge of trench. View looking south-east.

The only other feature observed was a brick lined culvert in the southern edge of the excavation identical to that seen in TT304 (Plates 10 & 11). It was impossible to gain direct access for recording but it was set 0.4-0.5 m below ground surface (c. 6.7 m AOD) and was c. 0.4 m in diameter.

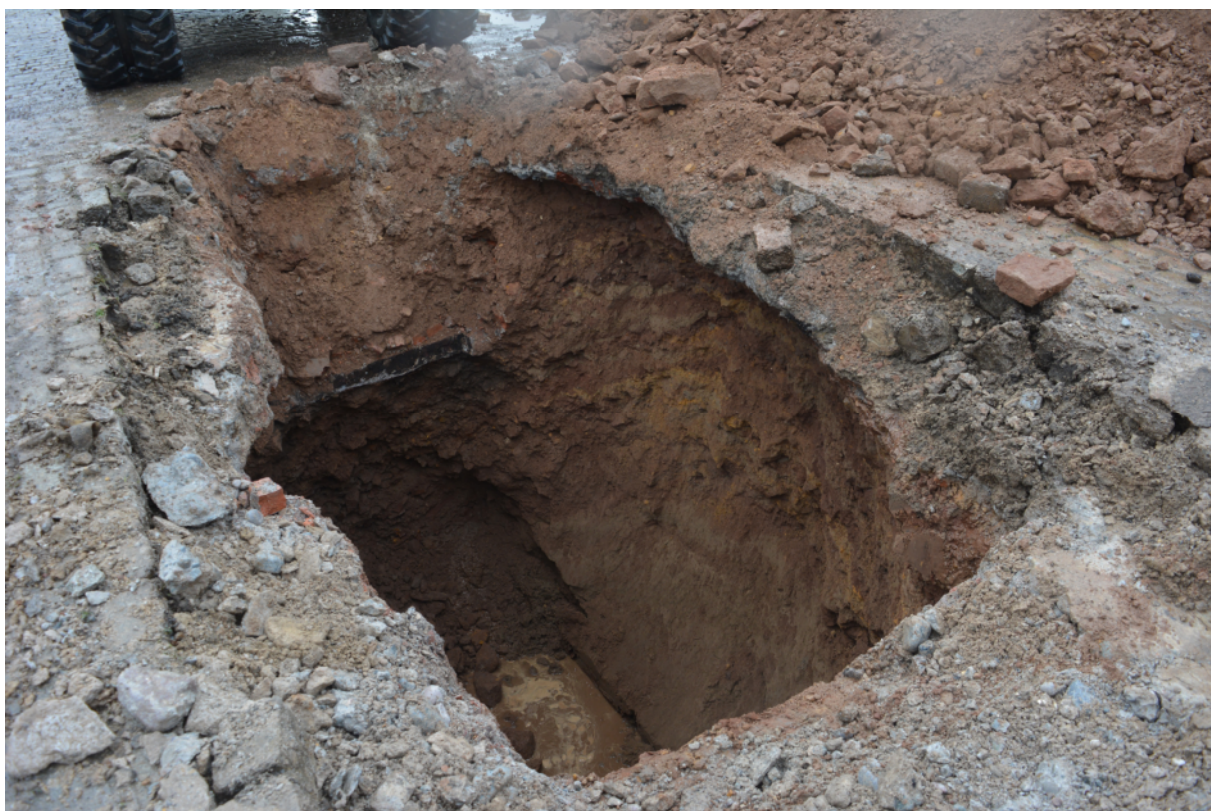
Plate 11. TT306. Brick lined culvert exposed in southern edge of trench. View looking south-west.
