ART. X.—*Excavation of the fortified manor-house at Burgh-by-Sands.* By ROBERT HOGG, B.Sc., A.M.A.

Communicated at Penrith, September 14th, 1954.

MANOR-HOUSE, BURGH-BY-SANDS, 1950.

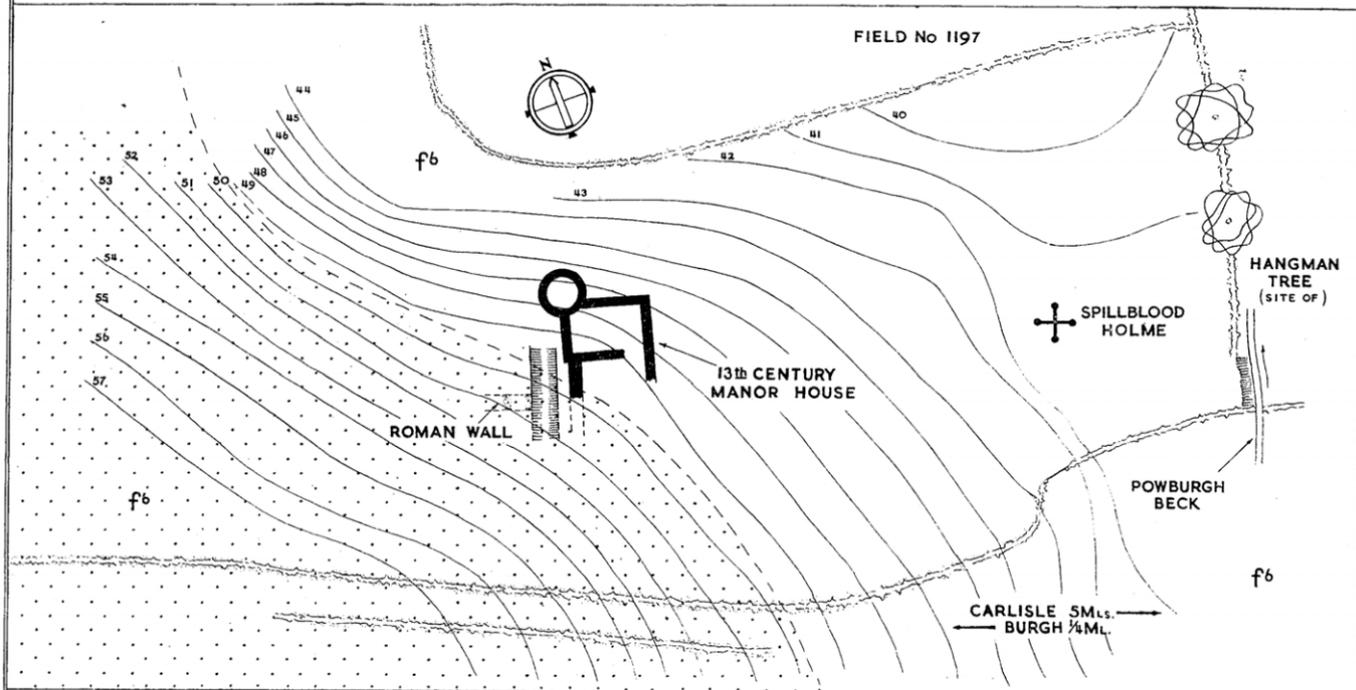
TOPOGRAPHICAL SETTING

GEOLOGICAL SIGNS

- BOULDER CLAY
- FLOOD PLAIN ALLUVIUM
- f6 STANWIX SHALES

The castle site (fig. 1) lies on the lower eastern slopes of a ridge of boulder clay and is skirted on its northern and eastern sides by the comparatively broad alluvial tracts of the Powburgh Beck. To the east of the Powburgh Beck the ground rises, for about a mile, to the crest of a boulder clay ridge upon which stands the village of Beaumont. Beaumont is the site of the motte of the le Brun, or de la Ferté, family. Here also the Roman Wall makes an almost right-angle turn away from the River Eden, and after crossing the ridge its line is plainly discernible descending its western slope on its way to Burgh fort. To reach the fort the line of the Wall traverses the site of the medieval castle, although its precise course at this point is lost, and a conjectural line is given on O.S. maps, obtained by the continuation of the observed line immediately east of Powburgh Beck. The road from Carlisle to Bowness, which is no doubt a communication route of the greatest antiquity, passes the site on its immediate south side.

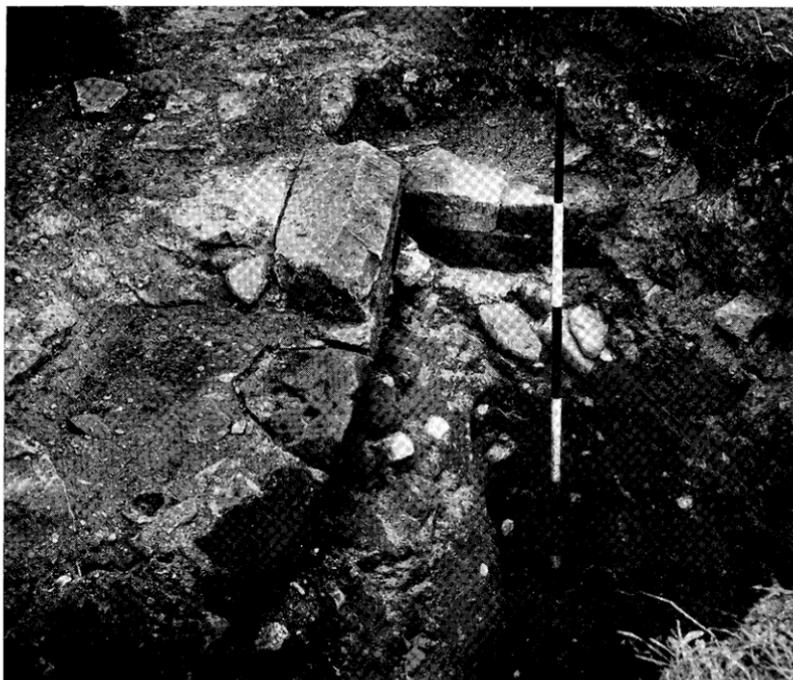
PL. I, 1.—S.W. arc of tower foundation from the W., showing point of juncture with W. wall of hall.

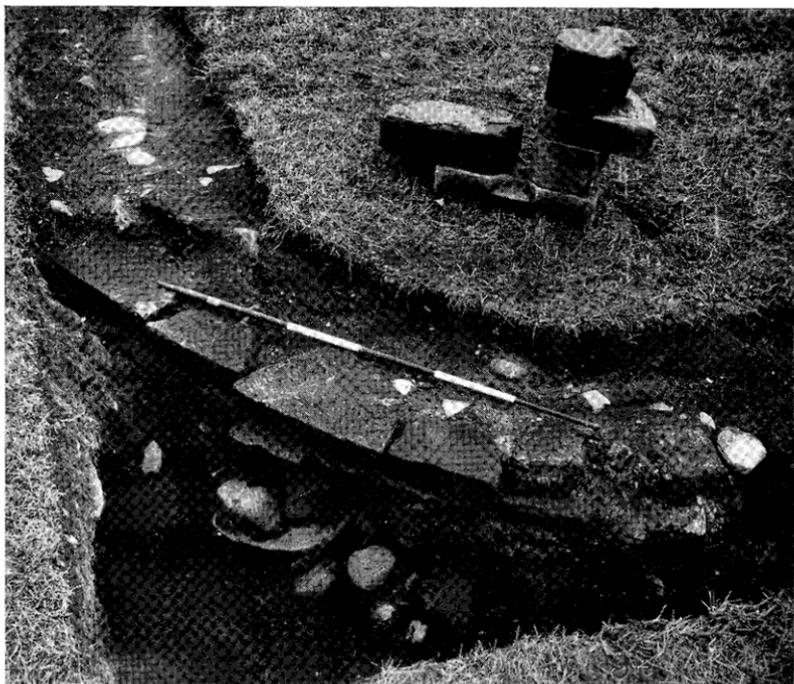
PL. I, 2.—N.E. arc of tower foundation; below, boulder packing of Wall ditch.
facing p. 112.

that even the core mass of the walls had been removed. The only surviving structures here were one or two large granitic boulders and some stone pitching, which had been used for the consolidation of the ditch of the Roman Wall, which lies beneath the north wall of the castle. The lay-out of these foundation structures clearly indicated the rectilinear character of the north-eastern corner of the wall, and therefore the absence of a second tower.

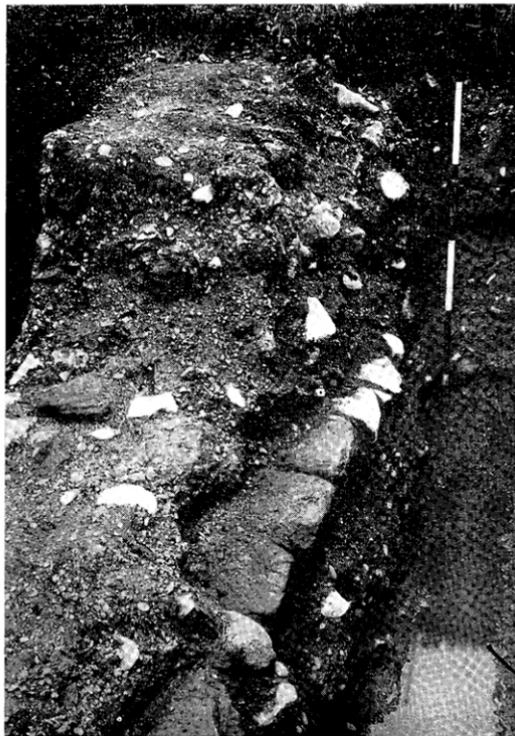
PL. II, 1.—W. wall from the N., showing mass of rotted core on flagged foundation.

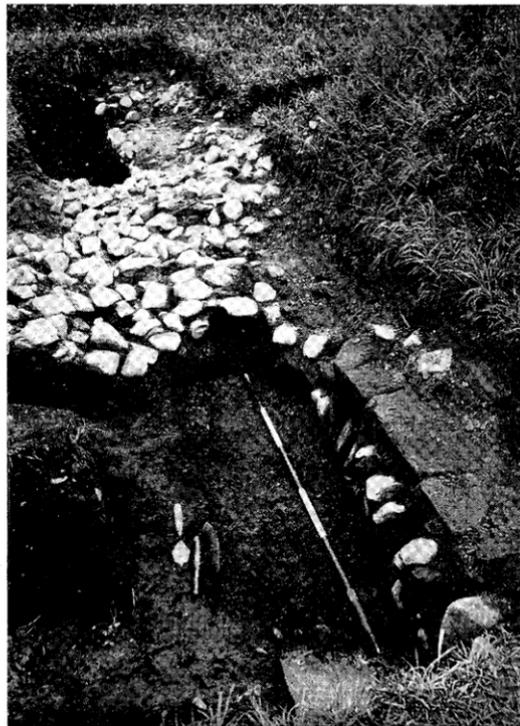
PL. II, 2.—E. edge of E. wall from the N., showing spread of cobble pitching outside the wall.

At one point on the outer face of the west wall, and at two others on the outer face of the east (fig. 2), there were small areas of cobble pitching associated with the foundations. These structures may have been the foundations of buttresses, but no masonry of such survived.
