A medieval piscina from the grounds of St. Nicholas Church, Whitehaven, Cumbria.

This report deals with the find of a medieval piscina in the gardens of the church of St. Nicholas in Lowther Street, Whitehaven, Cumbria in 2003. The circumstances of the find along with its conservation, identification and exhibition are outlined below.

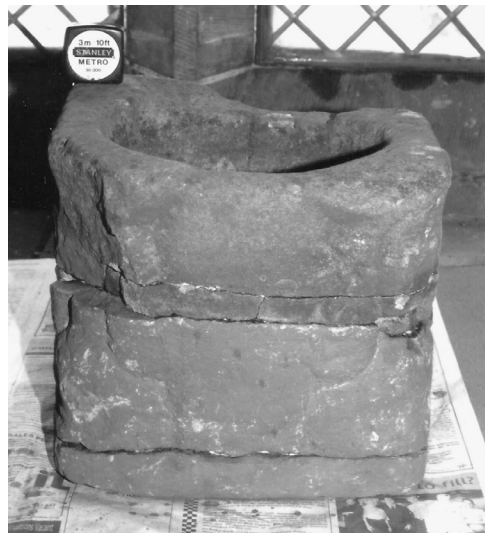
FIG. 1. Whitehaven. Piscina. Front view showing female figure on right.

Viewing the piscina from the front, a central plain panel is seen. This panel is bounded on either side by moulding that highlights the rounded nature of the front edges. This moulding is hourglass in shape. The rim on the front edge forms bulbous protrusions that overhang the corner mouldings rather in the manner of lugs. Closer inspection of the right moulding reveals the carving of a female bust incorporated into it; the eyes face outline and hair being the most obvious features. The remaining features are

weathered and difficult to make out, although the upper torso and arms along with clasped hands are hinted at. The left moulding is badly damaged making the original form impossible to make out. The right elevation is plain. However, incised into the lower central area of this side is a series of faint hatched lines making up a lattice type decoration with a lozenge clearly visible at the bottom. The left side likewise is plain, except that is for a Gothic style upper case W made up of two overlapping Vs 3.5cms high x 5cms wide overall. Next to this is a feint diagonal / line that presumably formed part of a second letter, whilst just above this is what appears to be a small cross. Like the right elevation, these marks are incised into the stone.

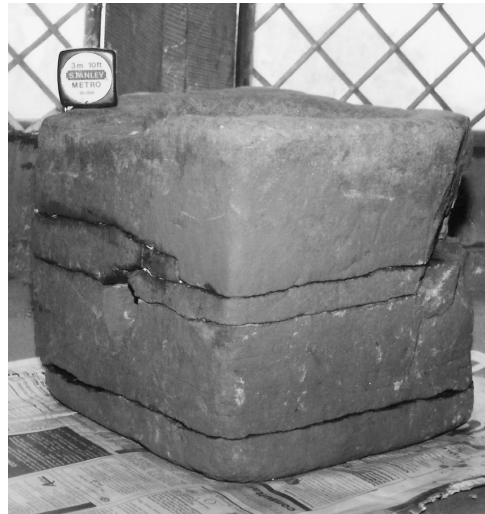
The piece shows considerable weathering indicating that it has stood out in the open for some time, or was exposed to the elements. Of particular interest is the amount of wear on the rear rim where little or none should be. When used in its normal setting, "a piscina is usually set within a fenestella (a canopied niche) in the south wall of the PRESBYTERY" (S. Friar, 1996). The wear and later graffiti would suggest the piece has seen a secondary use in which it was subject to physical abuse prior to being set into the flowerbed in the church grounds, perhaps in a smithy used in quenching small objects and horseshoes?

fracture line emanating from this point. The rim exhibits a lot of wear, particularly on the rear elevation. All exposed surfaces are a pale dirty grey colour, the upper half bearing a slight greenish tinge due to algae. Four major cracks are evident, with others connecting the various fragments. The surfaces all over are smooth, including the underside of the base and the interior of the basin.

FIG. 3. Whitehaven. Piscina. Rear drain hole & wear on rim.

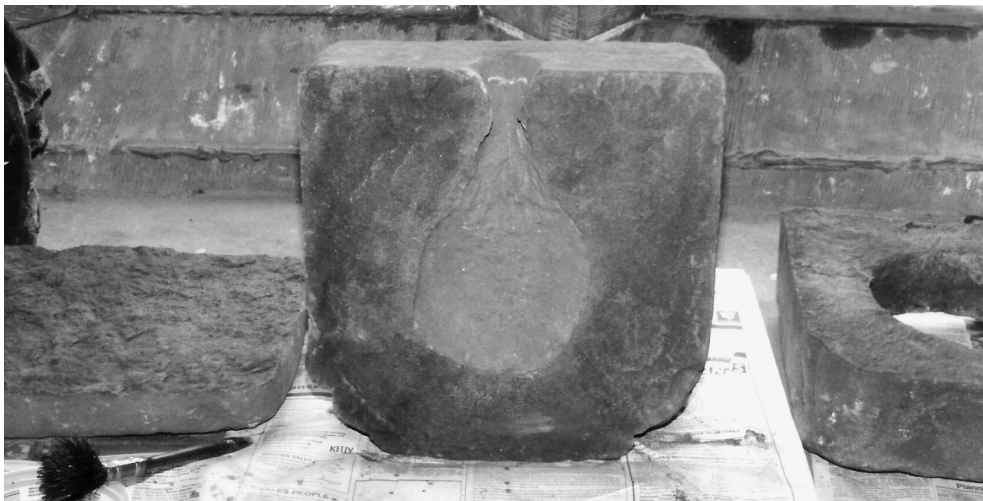
The stone from which the piece is made had become water saturated from lying in the flowerbed. This in turn had led to mechanical agencies upon the stone effectively splitting it apart, (freeze thaw action from winter ice and wet cold/hot cycles from sun, wind and rain). The stone had separated into ten pieces, mainly along the original bedding planes. The surfaces thus exposed were very friable. The stone was allowed some seven weeks to air-dry, this meant that the pieces were given time to acclimatise to their new location and equilibrium to be achieved slowly. The aim now was to consolidate the broken surfaces, prior to reassembling the pieces, so as to enable the artefact to be handled and moved as required. No attempt was made to restore the stone completely, any missing fragments and the resultant cavities being left void.

FIG. 4. Whitehaven. Piscina during consolidation.
