Report Number: 1617-27

**GEOARCHAEOLOGICAL
INVESTIGATION OF
DEPOSITS AT LAND AT
SOUTH CERNEY CASTLE,
GLOUCESTERSHIRE**

Prepared for Rubicon
Heritage Services Ltd

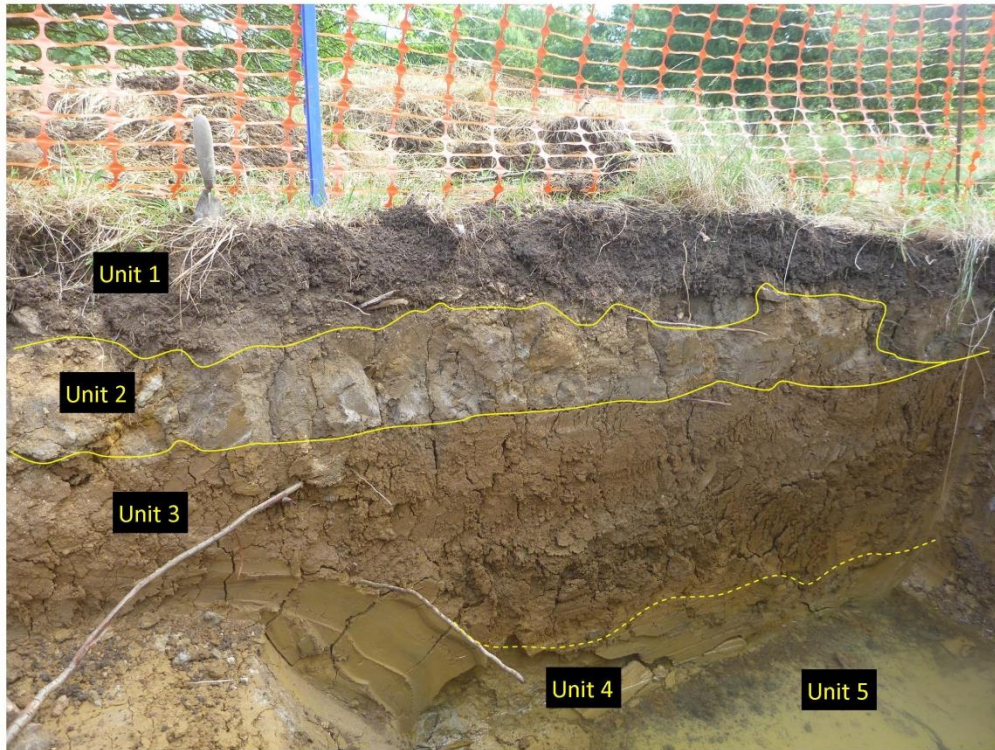
- 4.1 **Test Pit 3** is located next to an old brick well and on the south bank of the drain. Five units are exposed in section (see Figure 1). The lowest (5) is below the water table and is a stiff grey silt/clay. It represents the weathered top of the Kellaways Clay Member. It is conformably overlain by oxidised silt/clay (Unit 4) that is also part of the top of the Kellaways Clay Member which has been subject to fluctuating water levels that result in the deposition of manganese oxide (black) and iron oxide (orange brown), which have mottled the grey silt/clays. The succeeding deposit (Unit 3) is redeposited silt/clays derived from repeated maintenance of the drain that forms a low levee or bank. This deposit is dark yellowish brown, clast-free and oxidised

(Munsell: 10 YR 4/4). A sharp boundary marks the following stratum (Unit 2) composed of cobble-sized angular clasts/lenses of grey silt/clay (Munsell:2.5 Y 5/1) interdigitated with yellowish brown pebble-sized silt/clay clast/lenses. Rare limestone granules are also present. This well-defined deposit is the most recent episode of drain clearance. A dark brown (Munsell: 10 YR 2/2) clast-free topsoil (Unit 1) has developed in the top of this clearance deposit.

Figure 1. Test pit 3 north section.

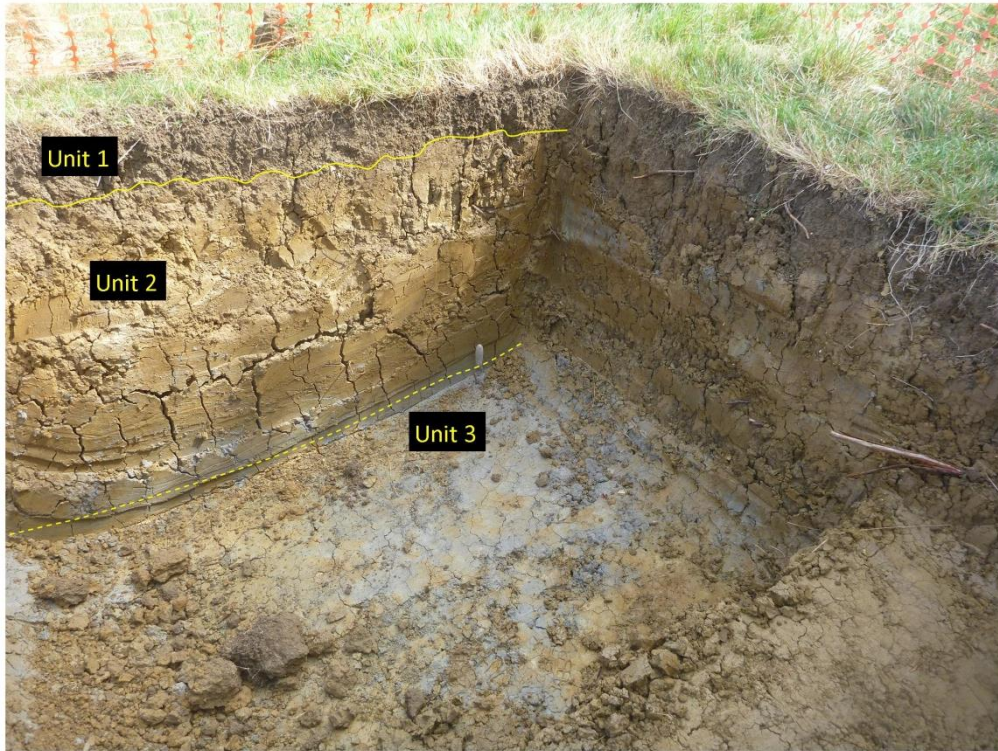
- 4.2 **Test Pit 1** is located c. 20m to the north east of TP3 on the north side of the drain. The stratigraphy is the same as in TP3 except that Unit 2 in TP3 is absent (see Figure 2). The TP has in all probability cut through or into the levee, although at this location the levee is low and poorly defined, and the oxidised top of the bedrock cannot be distinguished from the redeposited silt/clays.

Figure 2. Test pit 1 south section.

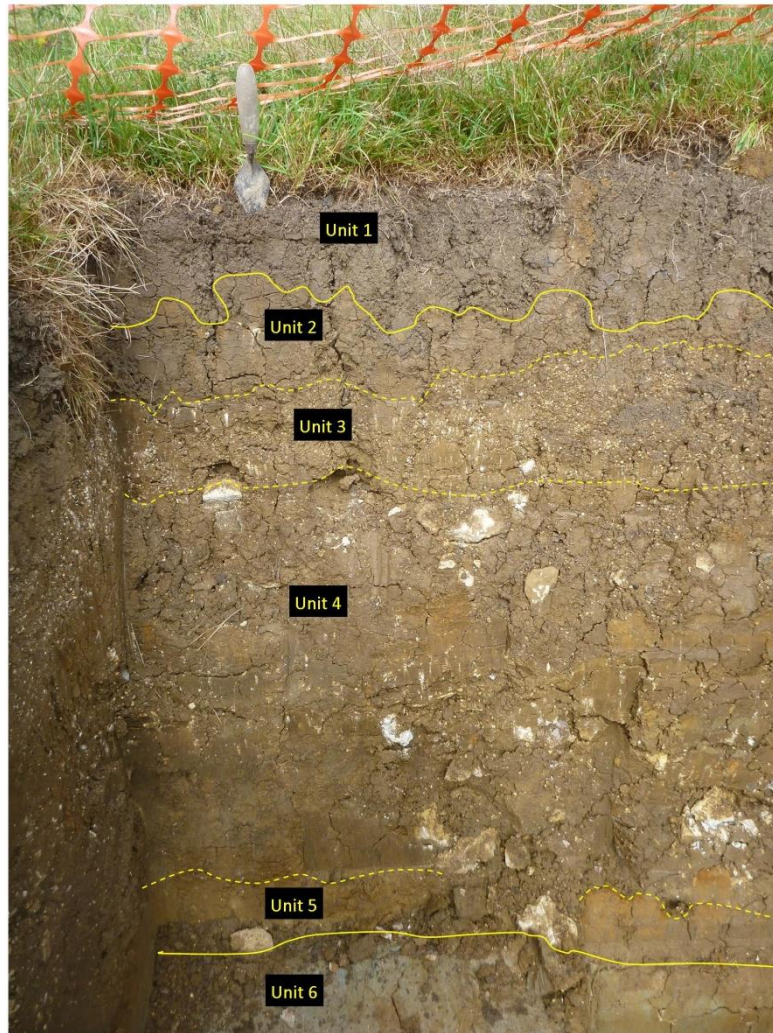
- 4.3 **South end of Transect 1.** This location is a test pit c. 20m further down slope from TP1. The lowermost deposit (Unit 5/6) is the Kellaways Clay Formation with a thin and irregular and possibly truncated, oxidised top (see Figure 3). It is overlain by an heterogeneous deposit (Unit 4) c. 0.8m thick that is composed of very dark greyish brown (Munsell: 10 YR3/2) silt/clay with frequent yellowish brown (Munsell: 10 YR 4/4) coarse pebble to cobble-sized lenses of homogenous silt/clay and frequent fine to coarse clastics. The fine clasts are composed of occasional charcoal grains and frequent granules of heavily eroded, rounded granules of fossiliferous, whitish yellow limestone. The limestone granules are distributed irregularly throughout the unit except at the top where they form a pea grit horizon (Unit 3). The coarse clasts are frequent medium pebble to cobble-sized, eroded, sub angular to sub-rounded, fossiliferous limestone with rare reddish, sub-rounded quartzites and rare white patinated flints. These clasts are distributed throughout the unit including some set into the top of the underlying bedrock. A clast-free topsoil and B horizon (Unit 1 and 2) cap the stratigraphy.

Figure 3. South end of Transect 1 west section.

- 4.4 The sequence described above (Section 4.3) is believed to represent an anthropogenic deposit laid down on a truncated bedrock as a result of excavation from elsewhere on the site. The coarse limestone clasts are probably building rubble derived ultimately from the local Cornbrash Formation. The fine limestone granules are the product of on-site erosion of the limestone via human action and natural processes. Their accumulation as a pea grit horizon is the result of earthworms moving the particles down the profile of the topsoil and is evidence that the site at this location has not been ploughed. Rare quartzites and flints are probably derived from one or other of the Pleistocene deposits. The action of gravity would account for their derivation from the Hanborough Gravel Member on the top of the spur whereas human action would be needed to move them up from the Northmoor Sand and Gravel Member below the site. A soil profile has developed in the top of the deposit. Medieval pottery sherds were recovered from the spoil of the test pit.

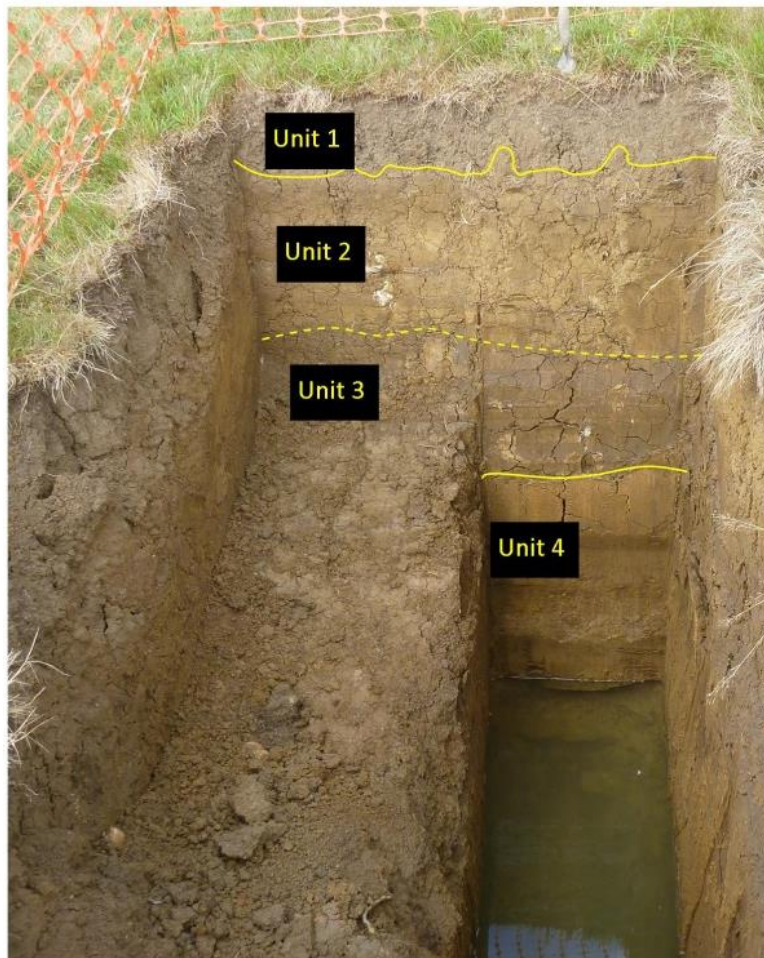
- 4.5 **Test Pit 4** is located c. 20m east and downslope of South end of ?Transect 1. Five units are present in the west section (see Figure 4). The lowermost unit is the bedrock (Unit 5 is below the water level) that is overlain by an oxidised top (Unit 4). The succeeding unit (3) is very dark greyish brown (Munsell: 10YR 3/2) compact silt/clay with very rare coarse pebble-sized limestone clast. This unit is overlain with a sharp boundary by a dark yellowish brown, compact silt/clay (Munsell: 10 YR 4/4) that is clast-free (Unit 2) and appears to be redeposited sediment that forms a very low hummock. It is overlain by a clast-free topsoil. It is significant that there is an almost complete dearth of limestone clasts, both fine and coarse, which probably indicates an area of the site unaffected by stone buildings.

Figure 4. Test pit 4 west section.

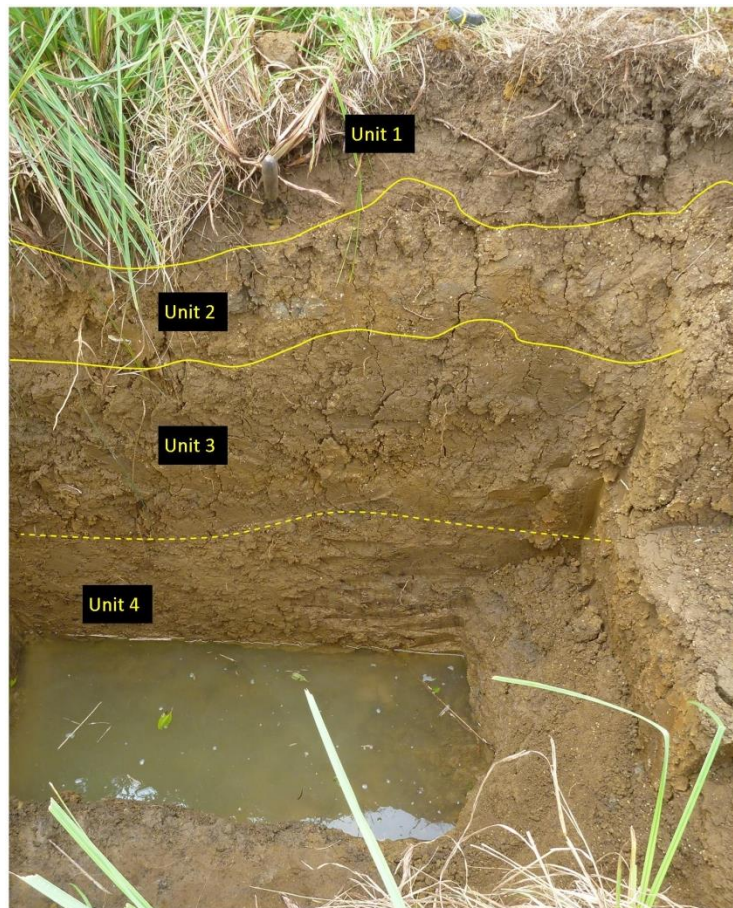
- 4.6 **Test pit 5** is located c. 25m downslope of south east of TP 4 on the west side of a pond. The lowermost unit (5) below the water level is the bedrock that has a ubiquitous oxidised top (Unit 4) as discussed above. Manganese oxide grains (streaked black

from the digger bucket) and orange iron oxide mottling is very prevalent in the section and reflects the fluctuating water table. The overlying unit (3) is a brown (Munsell: 7.5 YR 4/4) silt/clay and represents redeposited material probably excavated from the pond. The succeeding unit (2) has distinct cobble-sized lenses of grey silt/clay within a yellowish brown silt/clay. Limestone granules are frequent. This unit appears to be the same as Unit 2 in TP 3 and is redeposited sediment from maintenance of the pond. A clast-free topsoil caps the sequence. Deeply rooted *Juncus* sp. bioturbates the entire sequence (c. 1.9m).

Figure 5. Test pit 5 south section.
