October 2015

Report Number: 1516-9

**GEOARCHAEOLOGICAL
INVESTIGATION OF
DEPOSITS AT
GLOUCESTER
CATHEDRAL**

Prepared for Border
Archaeology

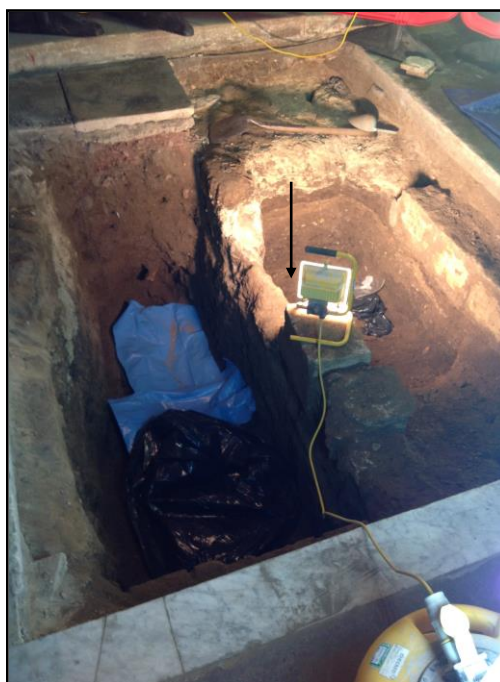
Figure 1. Excavation of the graves. Location of the auger hole is marked by the arrow.

- 2.1 Of the two 18th century graves in the excavation, the north grave contained a partially uncovered lead coffin at c.1.5m below ground level (BGL) which was taken to be the top of the paving stones of the North Transept floor. There was too little space in the corners of the grave to allow for the drilling of an auger hole. A location was therefore chosen within the southern grave at its east end, c.1m BGL (Figure 1).
- 2.2 The position of the auger hole was as close to the east section and central baulk between the graves as was possible to avoid striking buried human remains while still allowing free manipulation of the auger handle. An Edelman soil auger with extension rods was employed and the sediment recovered described according to standard geological criteria (Jones *et al* 1999; Tucker 2011).

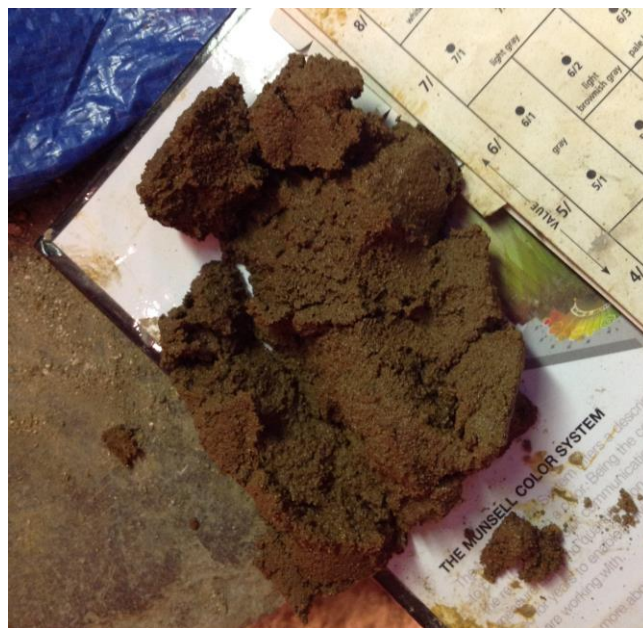
Figure 2. Sand recovered from Unit 8.

- 3.5 Units 7 and 8 represent superficial geological deposits underlying the grave deposits. The top c.0.2m (Unit 7) was a dark grey sandy silt/clay with iron oxide mottles, no archaeological material culture remains were recorded. From c.3.15m to 4.76m BGL (Unit 8) approximately 1.6m of brown

fine to medium sand was recorded with a minor silt/clay fraction and very rare rounded, medium pebble-sized vein quartz and rock fragments (Figure 2). The deposit was wet and very malleable. With depth the auger hole walls collapsed and suction prevented deeper penetration. The auger hole was terminated at 4.76m BGL.
