ARCHAEOLOGICAL EVALUATION REPORT:

TRIAL TRENCHING OF LAND AT PARK VILLA, 173 DONCASTER ROAD, THRYBERGH, SOUTH YORKSHIRE

Planning Reference No: RB2012/0715

Report prepared for Mr Stephen Webb  
By Elmet Archaeological Services Ltd  
Report Number 2013001

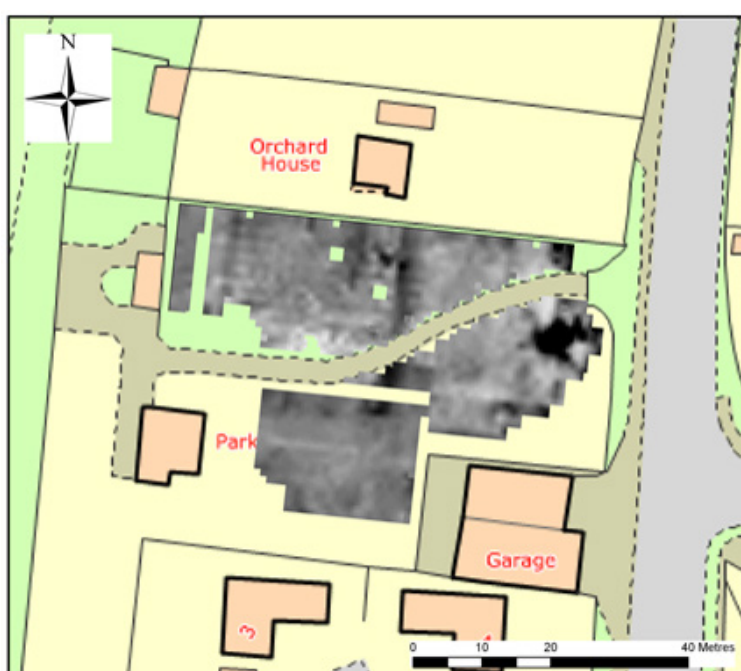
Figure 1: Site with geophysical results

Elmet Archaeological Services (hereafter 'Elmet') were commissioned by Mr Stephen Webb ('the Client') to undertake an archaeological evaluation in advance of a housing development at Park Villa, Thrybergh ('the Site' **Figure 1**). Park Villa is located on Doncaster Road and has previously undergone geophysical survey (Elmet 2012a), which revealed anomalies that could relate to the previous formal gardens that occupied the Site.

The evaluation revealed no significant archaeological remains and showed only evidence for modern intrusive made ground and tree boles. The geophysical anomalies were thought to have been variations in the made ground due to deposition and the natural geology.

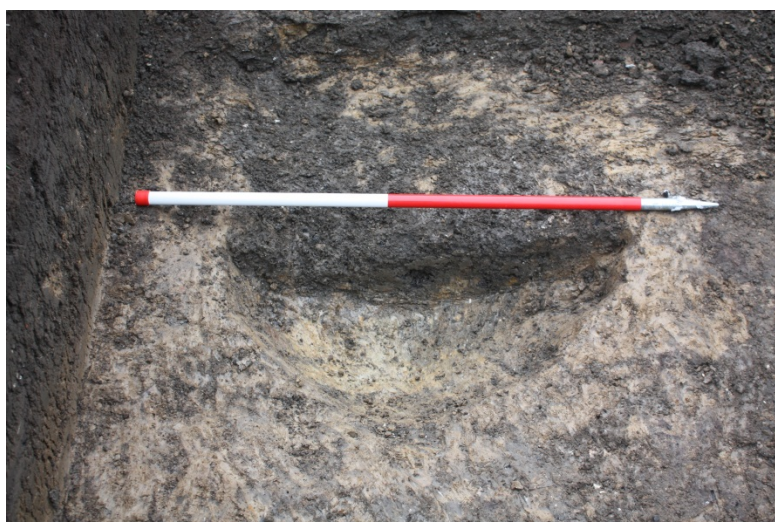
Figure 2 Excavated tree bole trench 4

6.4 Tree boles were noted in **Trenches 2** and **4**. These were both excavated in section to demonstrate that they were natural features.

<b>Trench 4</b>	<b>Length: 6m, Width: 2m, Depth: 0.60m</b>	
<b>Context</b>	<b>Description</b>	<b>Depth</b>
4001	Topsoil: Dark greyish brown humic silty clay with frequent roots and turf	0.22m
4002	Pebble spread, length 2.20m	0.06m
4003	Subsoil: Mid greyish brown mottled silty clay with frequent charcoal and coke flecks	0.38m
4004	Natural: Mid greyish yellow clay	-

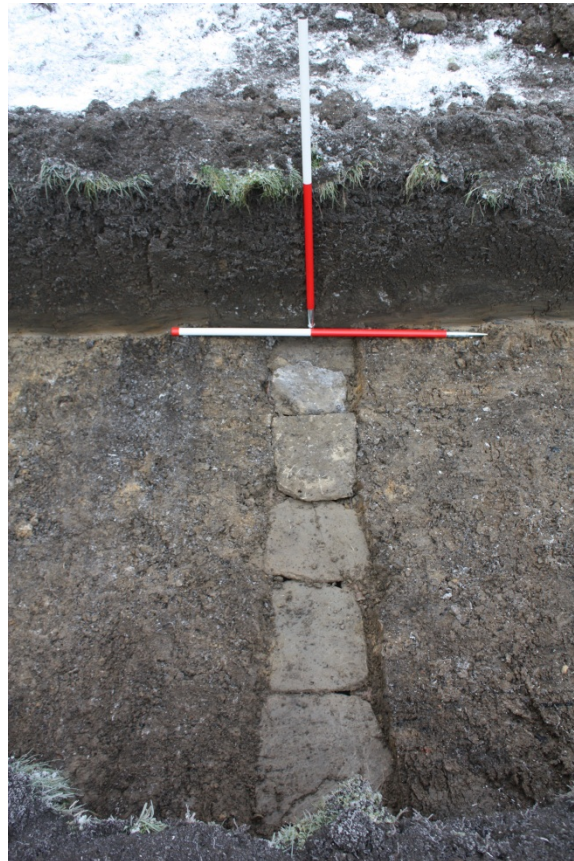
Figure 3: Sandstone capped drain trench 5

6.7 A sandstone capped drain was also noted in **Trench 5**; it was constructed with handmade bricks and reused sandstone roof tiles and dated to the modern period by the recovery of modern pottery. This lay in an area of disturbance which was probably a result of the construction of the drain.

5002	Subsoil: Mid greyish brown mottled silty clay with frequent charcoal and coke flecks	0.42m
5003	Sandstone capped, brick lined drain	0.11m
5004	Spread of disturbed ground cut by 5003	0.10m
5005	Natural: Mid greyish yellow clay	-
