ARCHAEOLOGICAL EXCAVATION REPORT:

Silverwood Scout Camp, Silkstone, Barnsley, South Yorkshire

Report Prepared By: Elmet Archaeological Services Ltd

Elmet Report Reference: SIL14

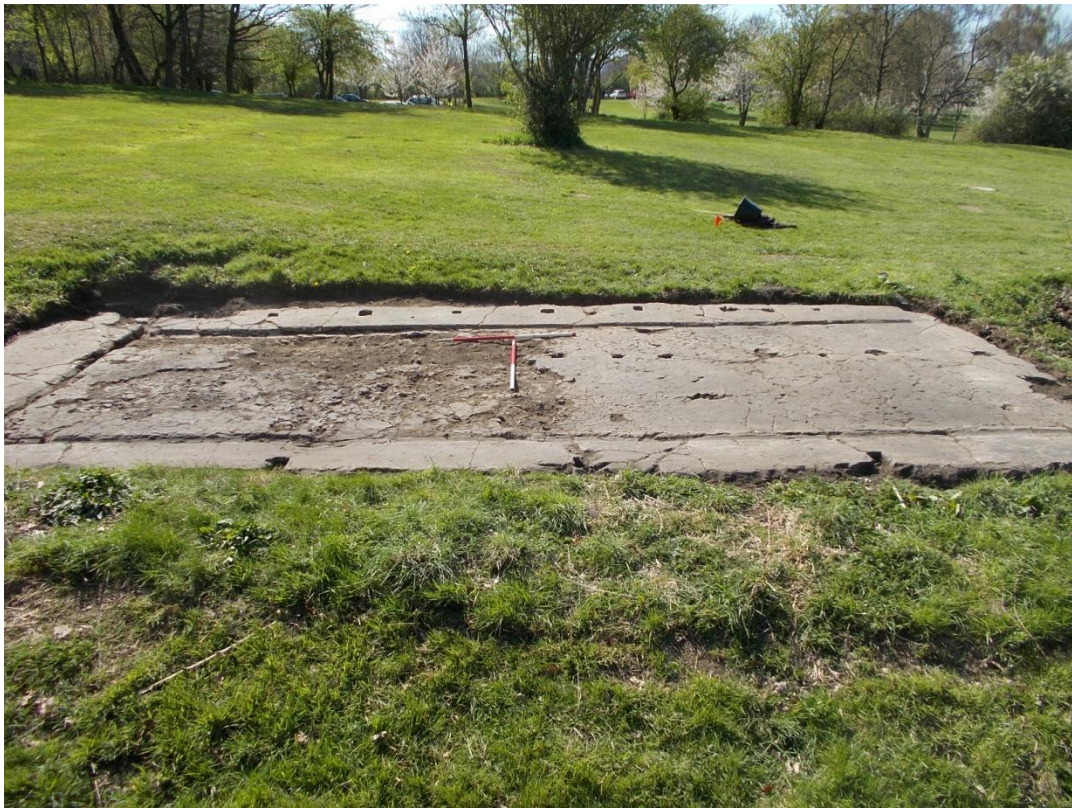
Plate 1: Base 1, post ex, facing south-west. Scales 2 x 1m.

5.2.1 **Base 1** was identified as a latrine block (**Figure 3 & Plate 1**), as evidenced from the features that were extent in the concrete. The bedding layer of **Base 1** was **1003** which was mixed stone and red brick rubble. This layer was only exposed in patches through the broken concrete **1002**, the largest being 3.10m long and 2.20m wide. It was not excavated below the exposed surface.

- 5.2.2 The layer **1003** underlay the concrete base **1002**, which was rectangular in shape measuring 7.94m (26') long, 3.50m (11' 5") wide and 0.05m in depth. The base was constructed of well mixed concrete with very few inclusions of pebbles and the remaining undamaged surfaces were relatively level, with only a 0.06m difference across the entire surface. The central area was cracked and fragmentary, due to high heating from camp fires after the structure had gone out of use in the training camp. This was more apparent in the central area which was bound by three gullies.

- 5.2.3 The three gullies formed a 'U' shape around the interior edge of the base, the two which ran in a north-west to south-east direction measured approximately 6.80m long (approximately 22'). The shorter north-east to south-west gully had a length of approximately 2.90m (9' 6"). The gullies all had a width of 0.12m (approximately 4"). The two longer gullies joined the shorter gully which in turn emptied over the edge of the base on the southern corner. A slope within the long gullies was identifiable through the levels of these features. The north-eastern gully had a drop off of approximately 0.02m from 142.15mOD at the north-western end to 142.13mOD at the south-eastern end. The opposite north-western gully had a steeper slope of 0.06m, starting at 142.19mOD on its north-western end, culminating at 142.13mOD at the south-eastern end. The shorter gully had a depth of 142.10mOD to allow the water to run away from the base in a south-westerly direction. These gullies would have been utilised to facilitate the cleaning of the latrines, by allowing water to collect and run over the edge of the base into a possible soak-away which wasn't investigated.

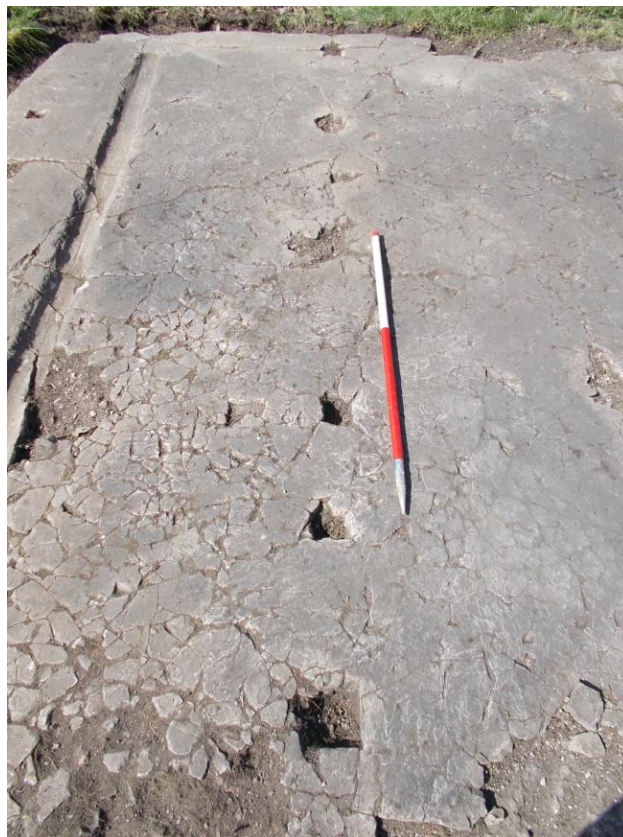
Plate 2: Base 1, post-ex detail of interior frame work post holes, facing north-west. Scale 1 x 1m.

- 5.2.4 Several post holes were also identified within the fabric of the concrete base. The edge of the base was bounded by no less than fourteen post holes. The north-west edge displayed evidence for two rectangular posts measuring approximately 0.12m x 0.08m (5" x 3"), the north-eastern edge retained four further rectangular post holes, measuring 0.12m x 0.09m (5" x 3.5") and the south-western edge retained a line of no less than eight of these features. This last alignment of posts consisted of alternate rectangular and square posts of four square and four rectangular features. The measurements of the square post holes were 0.08m x 0.08m (3" x 3") and the rectangular posts measured 0.12m x 0.08m (5" x 3"), which demonstrated regularity to the size of the wooden posts used in the construction of the structure.

- 5.2.5 The alignment of posts on the south-western edge was mirrored by a row of similar posts running along the near centre of the structure, approximately 1.50m (5") from the south-west edge of the concrete. These two rows of posts formed the individual stalls within the latrine block (**Plate 3**). The centre of each post was approximately 0.81m (32") from its neighbour giving an idea of the width of each individual stall.

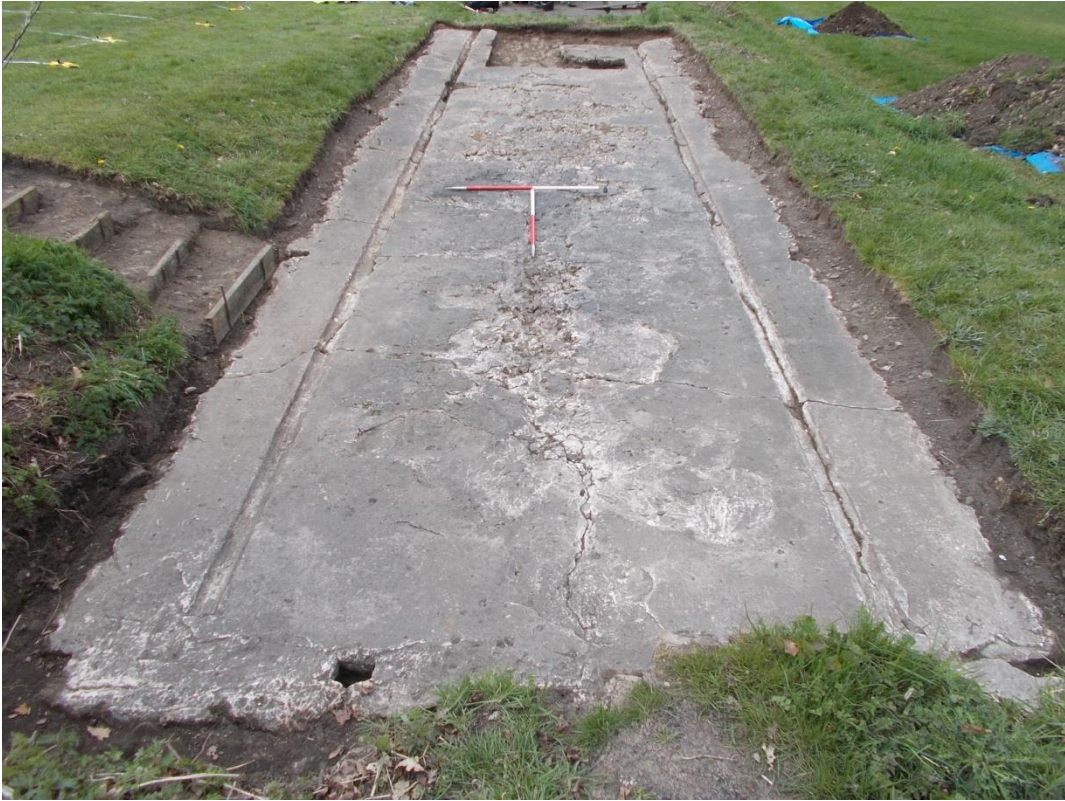
Plate 3: Base 2, Post-ex, facing north-west. Scales 2 x 1m.

- 5.3.1 The concrete of **Base 2** (**Figure 4** & **Plate 3**) in the centre of the structure was very fragmentary and a large section of bedding material **1005** was visible in this area. The largest patch of this material was 1.80m long with a width of 1.10m and consisted of broken brick fragments and small stones mixed to make a bedding layer for the concrete **1004**. This layer was not excavated below the exposed upper surface.

- 5.3.3 The remains of the **Base 2, 1004**, were constructed with well mixed concrete with very little aggregate inclusions. In a similar construction method as **Base 1** and **Base 3**, the concrete appears to have been smoothed but not tamped in the same style that modern concrete would be. The shape of the base was rectangular, with a length of 11.67m (38' 3"), a width of 3.36m (11') and a depth of 0.05m. However, the full length of the structure was not evident as a section of the north-west end had been broken off at some point since going out of use. **Base 2** was much longer than both **Base 1** and **Base 3**, indicating that it was for a different purpose than the latrines and was in fact an ablution block.

- 5.3.4 The base was bound on the long sides by two drainage gullies, both of which ran almost the entire length of the concrete. The longest measured 11.20m (36' 9") long with a width of 0.12m (4") and an average depth of 0.07m (2 ¾"). There was no evidence that these drains joined at any point or where the run-off would have been located, but it is probable that it was located towards the north-west end of the structure. This was evidenced by the level of the drains having a difference in height of 0.16m from south-east to north-west on the south-west drain and 0.13m difference in height from the south-east to north-west on the north-east drain.

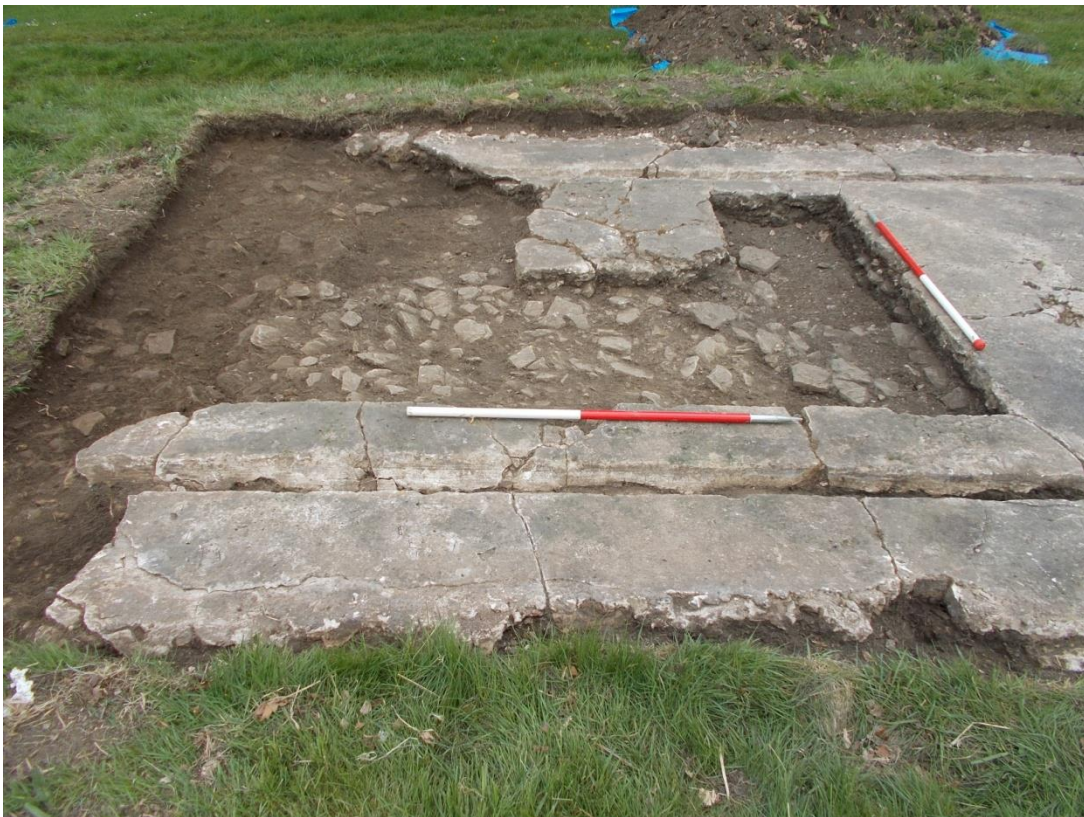
Plate 4: Base 2, detail of north-west end, showing void in concrete, facing north-east. Scales 2 x 1m.

- 5.3.6 At the north-west end of the concrete **1004** was unexplained L shaped feature, measuring 1.70m (6' 6") along its widest edge and 2.40m (7' 10") long (**Plate 4**). The reason for the cut was unknown but it was postulated that it may have been a placement for a water tank or a similar feature. However, this feature is not present on the Winchester plans (**Plate 8** & see below) so it may have been a local variation. Also a small metal pipe was visible situated 4.10m from the north-west end of the base, located on the north-east edge of the fractured concrete. The pipe was assumed to have been used as a water flow system for the ablutions block.

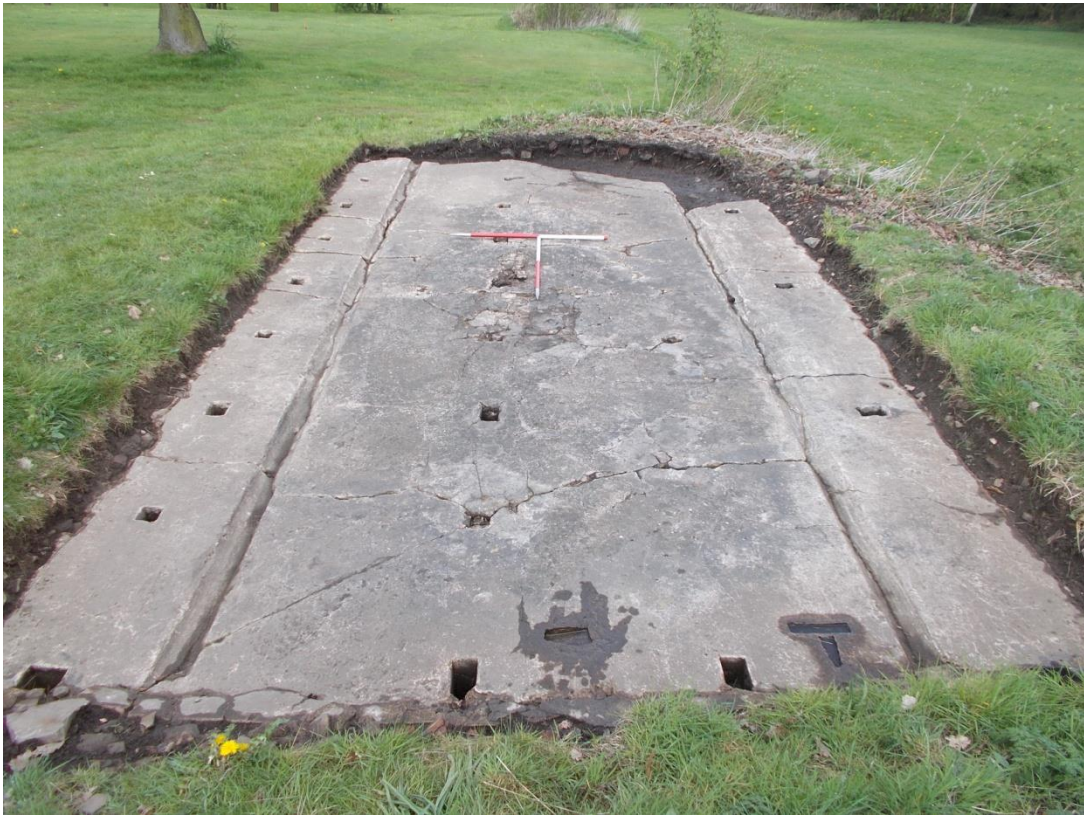
Plate 5: Base 3, Post-ex, facing north-west. Scales 2 x 1m.

- 5.4.1 Only a small amount of bedding material for **Base 3 (Figure 5 & Plate 5)** was noted as **1007**, which was similar to **1003**, mixed brick fragment and stone rubble. The bedding was only noticeable on the north-west of the concrete base **1006**, where a large section of the concrete

- 5.4.2 Comparable to the other two bases, the concrete of **Base 3** was more complete except on the edges which had cracked and were fragmentary. The remains of the base measured 6.98m long by 3.65m wide with a maximum depth of 0.23m. The concrete **1006** was well mixed concrete with few inclusions of pebble and had not been stamped, similar to the other bases. Along the south-east edge of the base a line of cracked concrete was visible, which had possibly been displaced or was the result of the construction, it was difficult to ascertain.

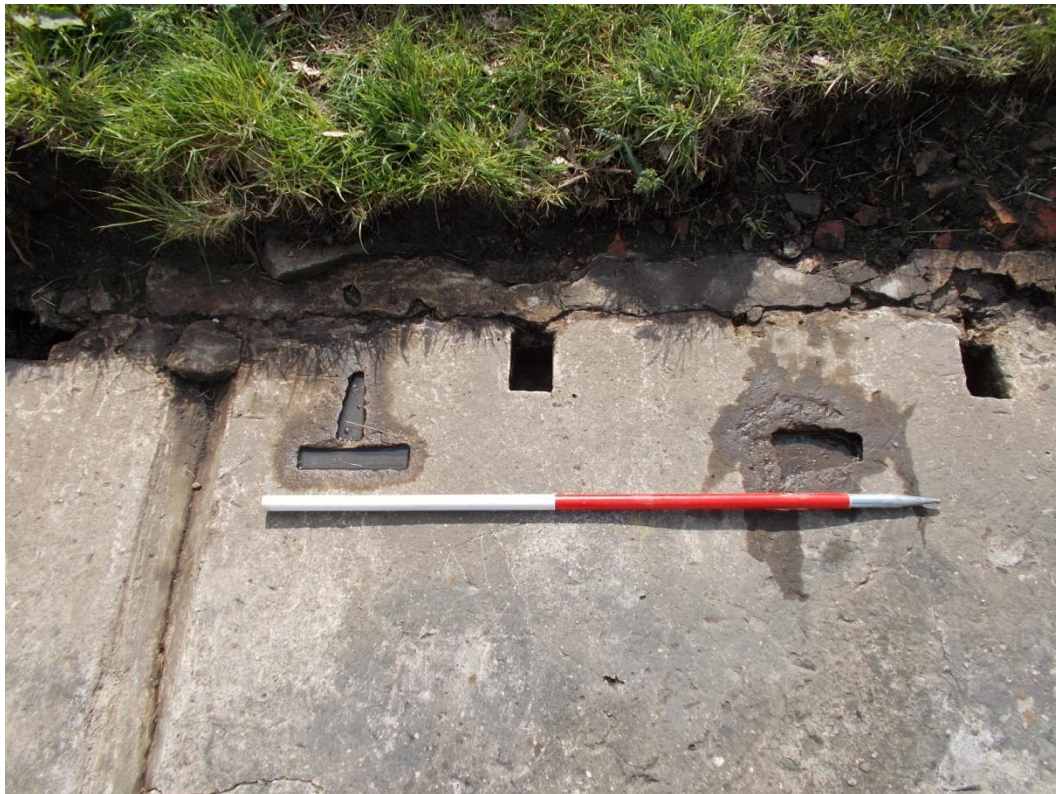
Plate 6: Base 3, detail of north-west end, showing remains of possible steps. Scale 1 x 1m.

- 5.4.4 Other internal fittings were apparent which were not noted in **Base 1**. Three rectangular post holes appeared to be pressed into the concrete surface at the south-east end of the base (**Plate 6**). Two of these post-holes were laid in a T shape, with the longest one measuring 0.20m (8") long by 0.04m (1½") wide and had a depth of 0.02m (1") whilst the shorter feature was 0.13m (5") long, by 0.05m (2") wide and 0.02m (1") deep. These two post holes were on the south-west corner of the base and quite close to the outer row of four post holes on the south-eastern edge. Another single post hole was found to be 0.14m (5½") in length, 0.08m (3¼") wide and 0.03m (1¼") in depth. None of these post holes penetrated through the skin of the concrete and it appeared that they had been created after the concrete had been laid and was still in a wet state. It was also impossible to ascertain what the purpose of these of these post holes may have had, but it was surmised that they could have formed the legs of a set of wooden stairs leading into the structure from the higher level of the ablutions block, **Base 2**.
