## Small gate modifications and kerb removal

RAF Lakenheath, Suffolk

Archaeological Monitoring Report v0.2  
SACIC Report No. 2015/029  
Author: Rob Brooks  
© SACIC

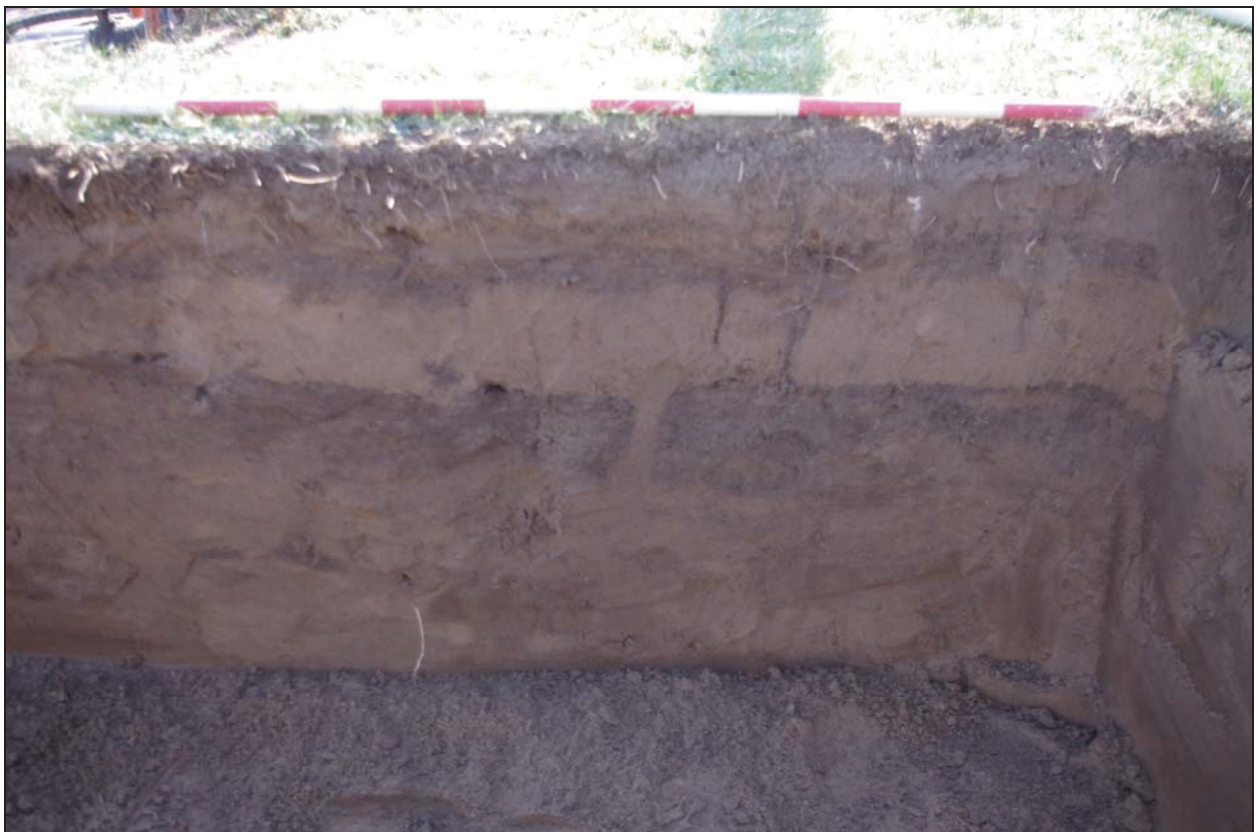
Plate 1. Gate 4, northern bollard strip (1m scale, facing south-west)

In this area the natural geological layers were not reached. Much of the soil profile appeared to be made up of redeposited layers that had been used to build up the ground, with the levels sloping away noticeably (by c.0.5m-1m) immediately west of the airbase boundary fence. In places the original topsoil horizon appeared to survive.

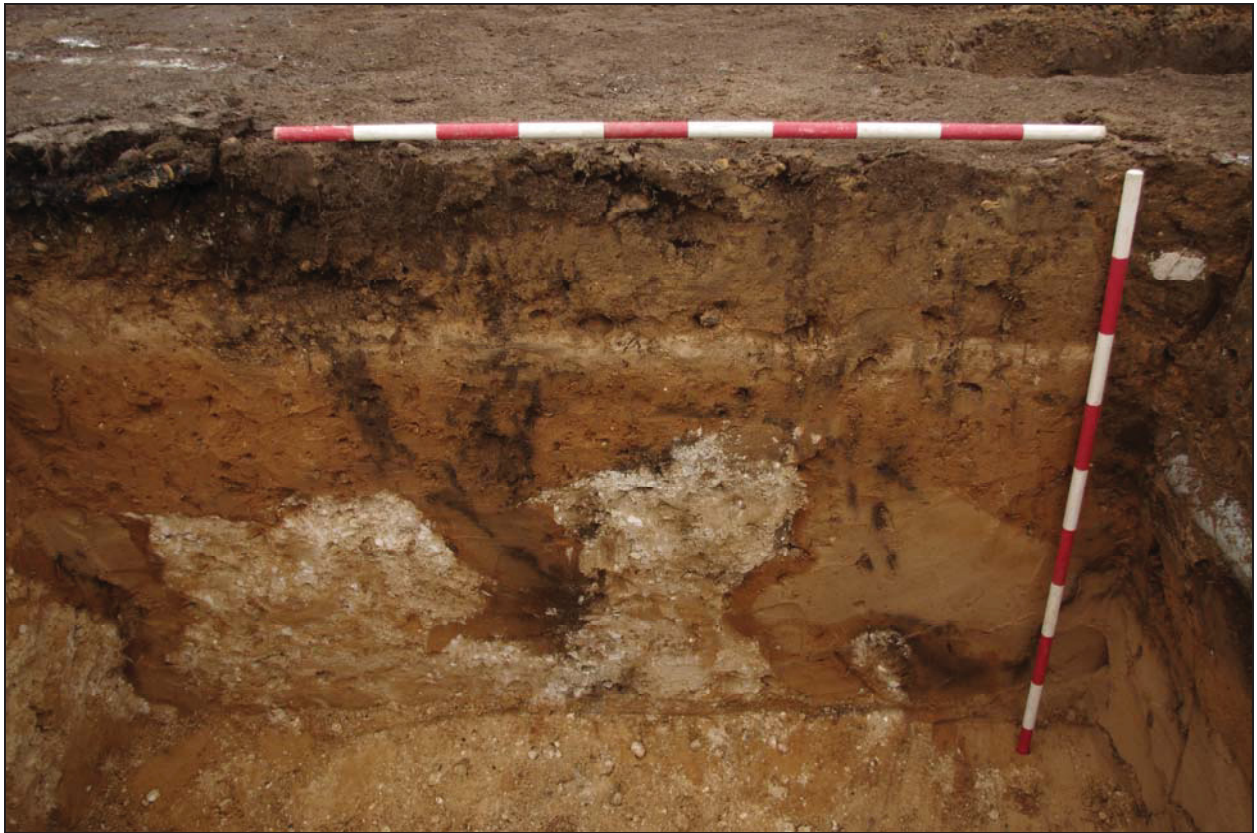
Plate 2. Gate 5, northern gate post pit (2 x 1m scale, facing east)

A shallow depth of imported topsoil/turf and in places tarmac (associated with the existing gate) overlaid redeposited horizons of chalk and sand over much of this area. Underlying this, a layer of what appeared to be levelled natural sand was recorded. In

the northern bollard strip the original topsoil-heathland soil interface may have survived, buried under the redeposited levelling layers.

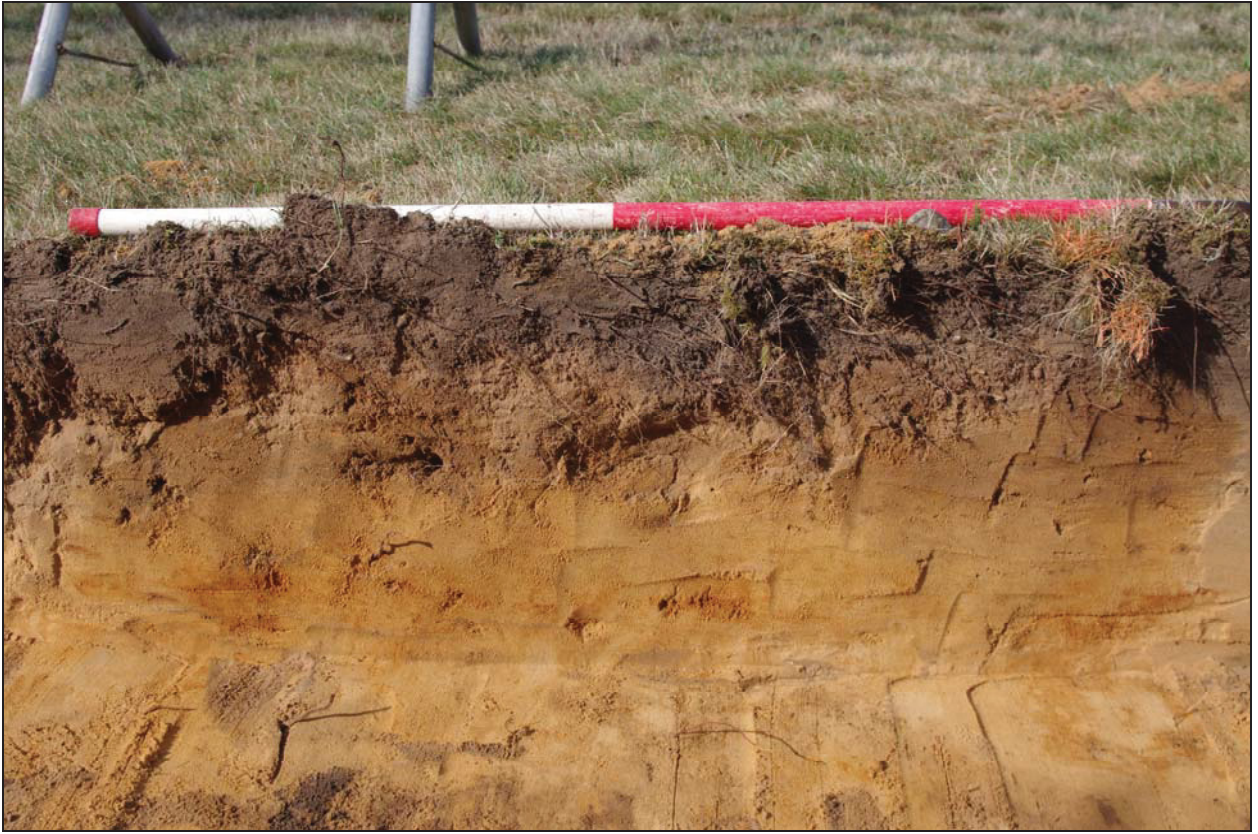
Plate 3. Gate 7, southern bollard strip (1m scale, facing south-west)

In the southern bollard strip for this gate, topsoil/turf overlaid remnants of an eluviated horizon, before revealing the natural, whilst in the northern strip very little of the eluviated layer survived. The topsoil/turf deposit across the area was very flat with a sharp horizon, suggesting that the area had been levelled and the upper deposit imported.
