ARCHAEOLOGICAL MONITORING REPORT

SACIC REPORT No. 2015/074	<i>Parish:</i> Blythburgh
MATRON'S HOUSE, BLYTHBURGH	<i>Planning Application No.:</i> C/06/1062 original
	Event No.: ESF 23201
	<i>OASIS ref:</i> suffolka1-217208
Address: Matron's House, Blyth View, Blythburgh Suffolk	<i>Grid Reference:</i> TM 4402 7633
	<i>Number of site visits:</i> 2
	<i>Date of visits:</i> 10th & 24th August 2015
<i>Nature of the work:</i> Clearance of slab for new concrete raft and excavation of service trench for drain.	
<i>Reason for condition:</i> Proximity to Blythburgh Hospital burial ground (BLB 033/052)	
<i>% of total seen:</i> 30% of slab removed and all of drainage trenches.	
Location Map:

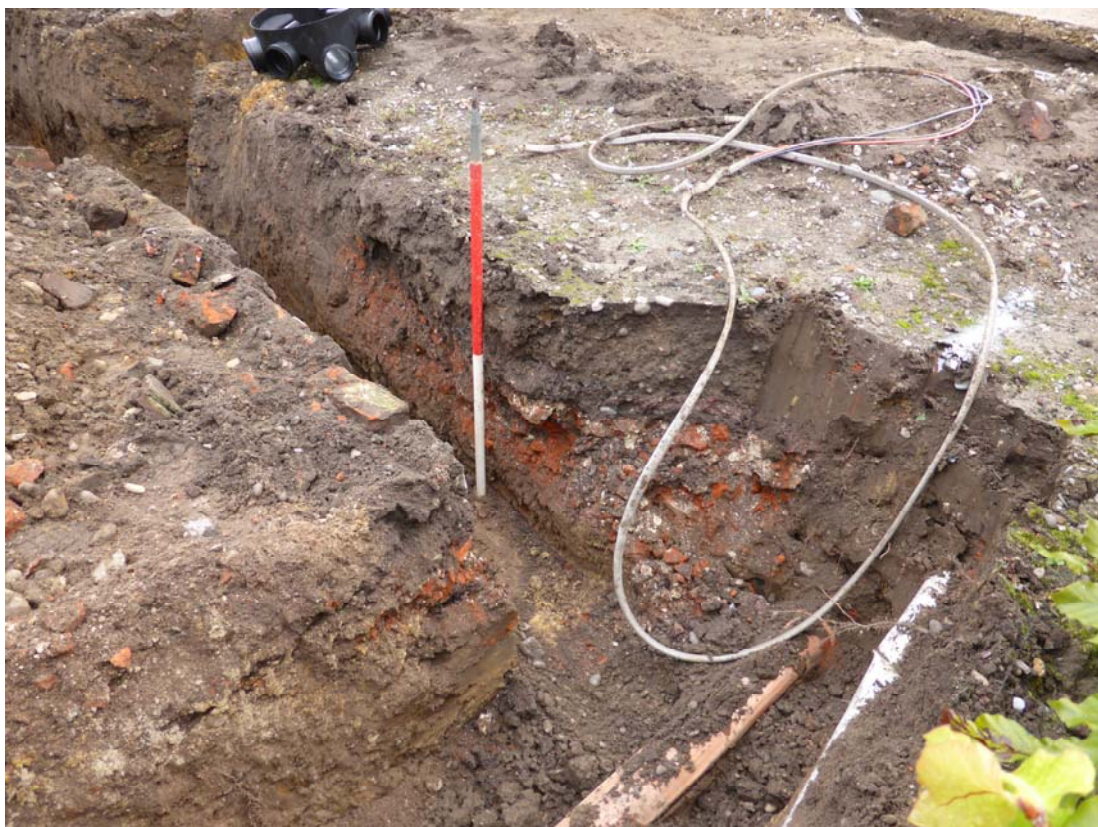
The drainage trench observed was of c.0.7m depth with the disturbed topsoil horizon continuing to approximately 0.4m depth, under which was a further spread of building rubble and hard-core. At the base of the trench occasional patches of sandy natural were seen. Approximately half of the drain run was within a previously dug service trench.

Plate 1. View of the drain run showing thickness of disturbed topsoil over brick rubble and hard-core (behind 1m ranging rod). Some sand natural apparent in base of trench to right of ranging rod. The drain to the right of the frame is within an existing service trench.
