## A&B Ramps

RAF Lakenheath, Suffolk

Archaeological Monitoring Report v0.1  
SACIC Report No. 2015/080  
Author: Rob Brooks  
© SACIC

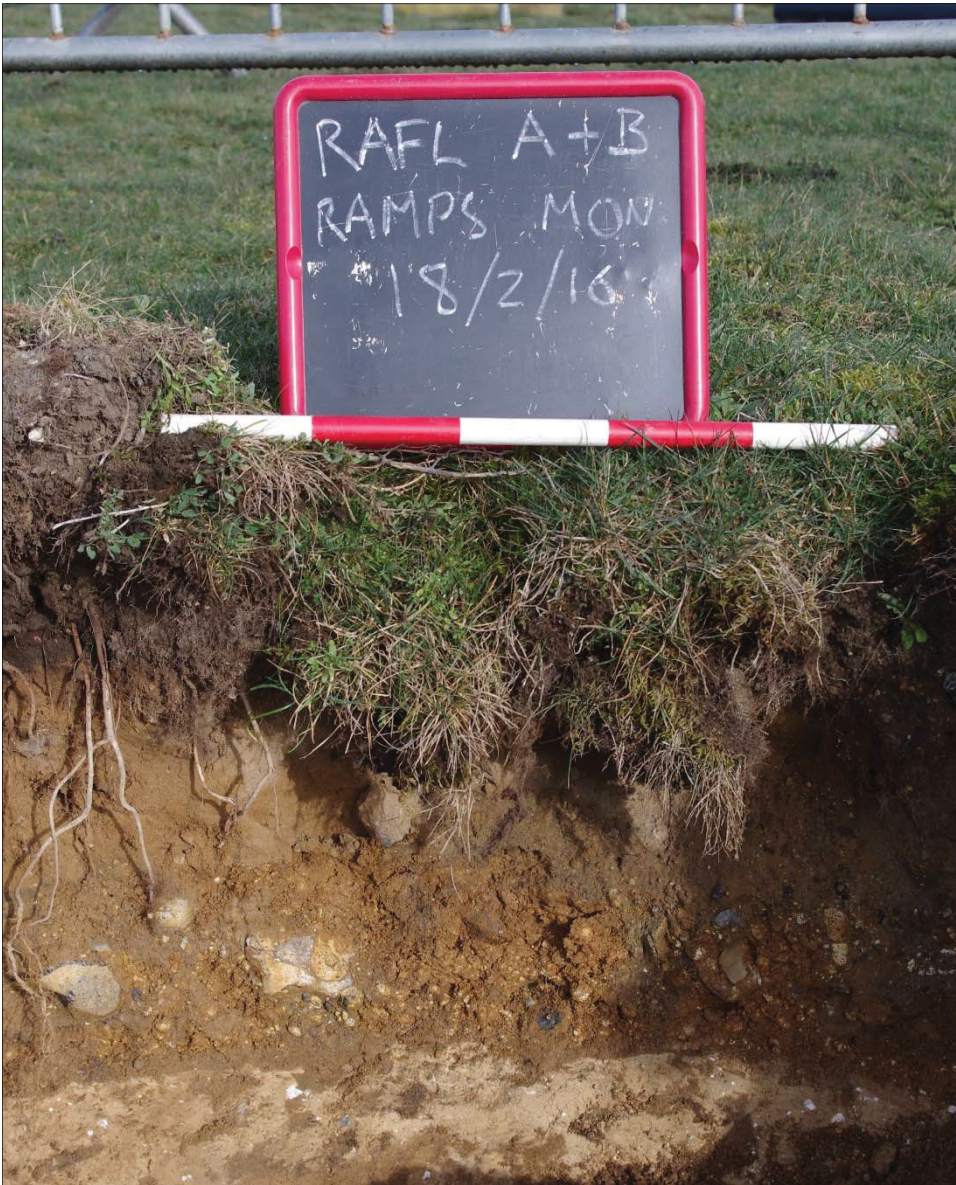
Plate 3. Profile 3 (0.5m scale, facing north-north-west)
