**Almoner's Barns, Cullum Road,
Bury St Edmunds, Suffolk
BSE 496**

Archaeological Evaluation Report

SACIC Report No. 2016/023

**Almoner's Barns,
Bury St Edmunds,
Suffolk
BSE 495**

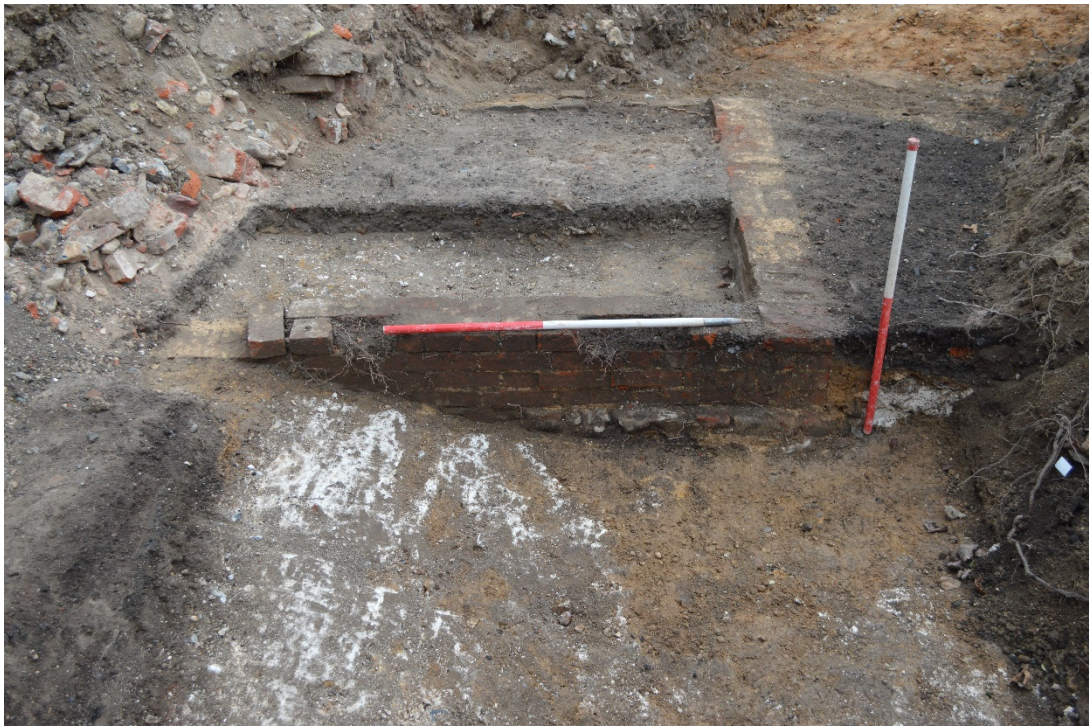
Plate 1. Wall 0006, facing south-east

The wall, which was constructed of mid red bricks in random coursing and bonded with a smooth, yellow grey lime mortar, measured 0.26m wide and 0.35m deep and survived from a depth of c. 0.40m below existing ground level. The lower course of the wall contained some flint nodules and stone fragments and cut into the natural geology (1004). The interior of the structure was infilled by 1007, a compacted light grey sandy silt, with frequent rubbish of 19th century date.

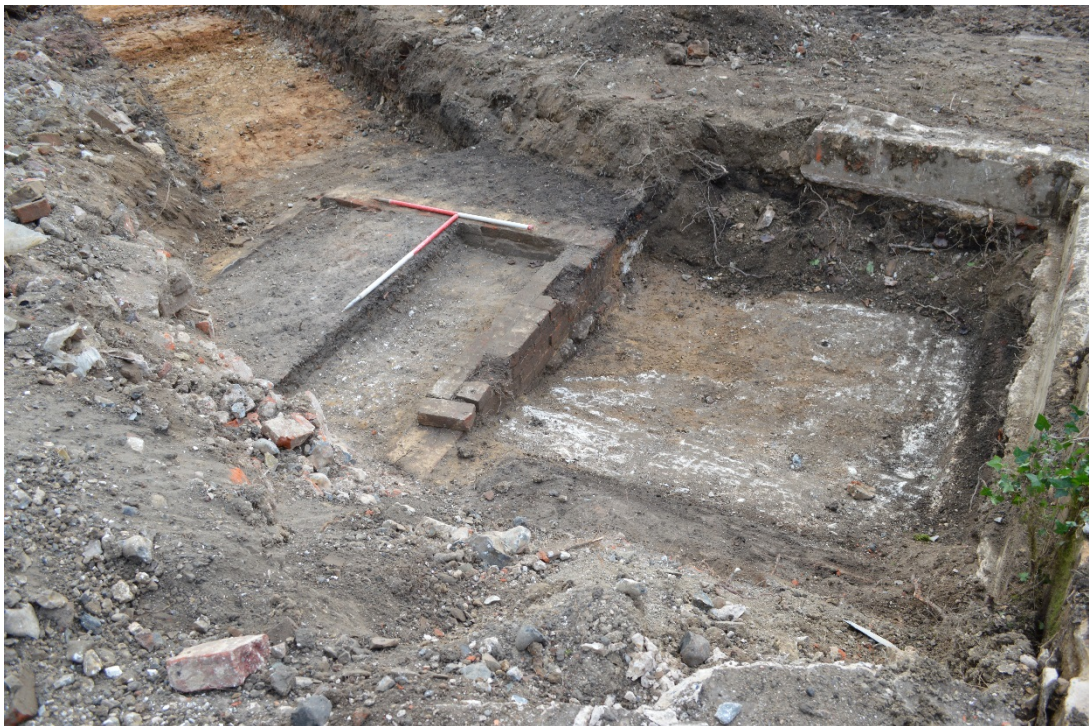
Plate 2. Walls 0006 and 0008, facing west

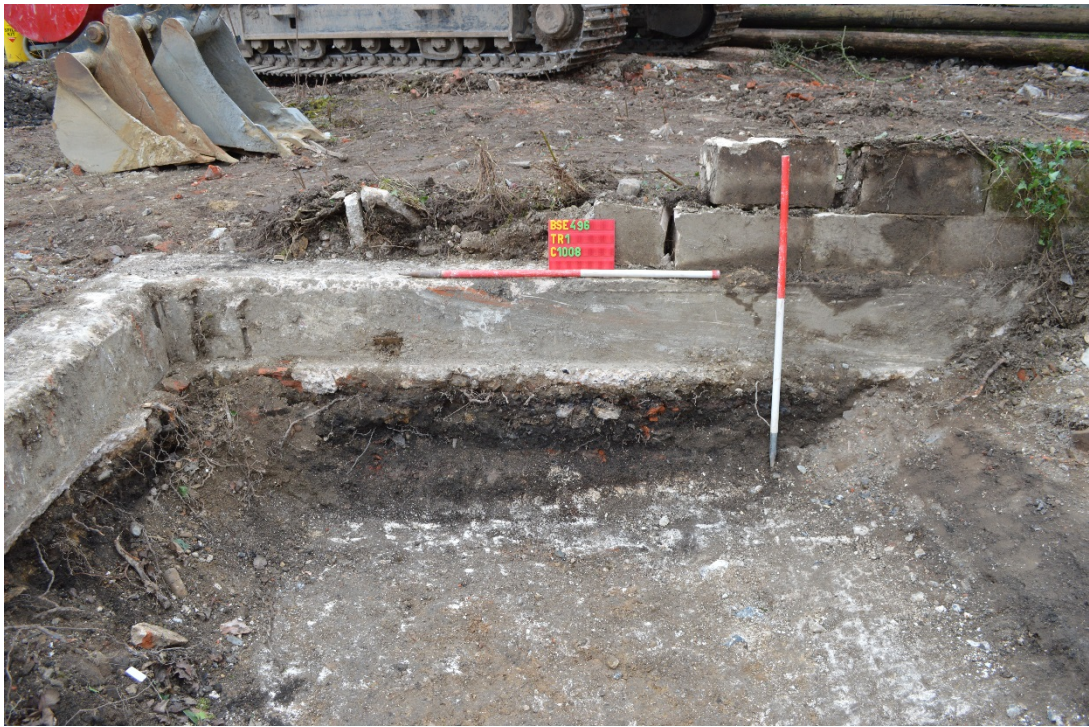
Plate 3. Trench 1, wall 0008, facing north

Wall 1008 was present along the northern end of Trench 1. It was a concrete foundation for a recently demolished building, constructed of breeze block bonded with smooth, grey mortar. The wall was laid on a thin layer of concrete, which in turn sat upon the layer of modern destruction debris, 1009, that sealed the natural geology. There was no indication of a construction cut for the foundation.

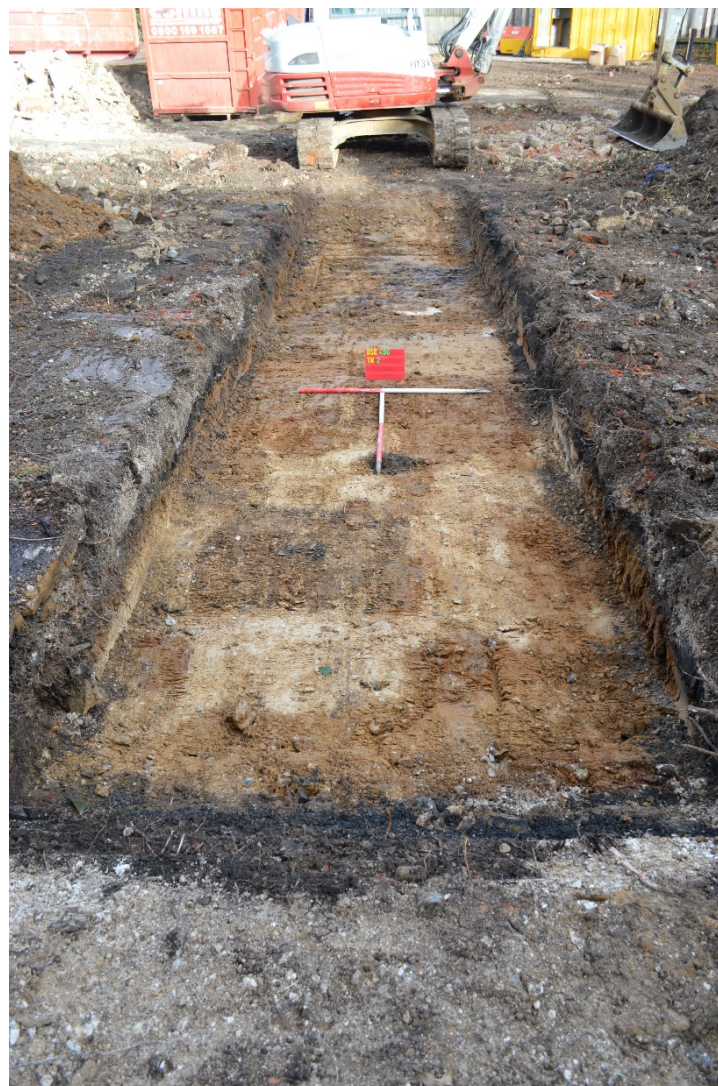
No archaeological features of pre-modern date were noted within the trench.

Plate 4. Trench 2, facing north with visible modern disturbance in trench base

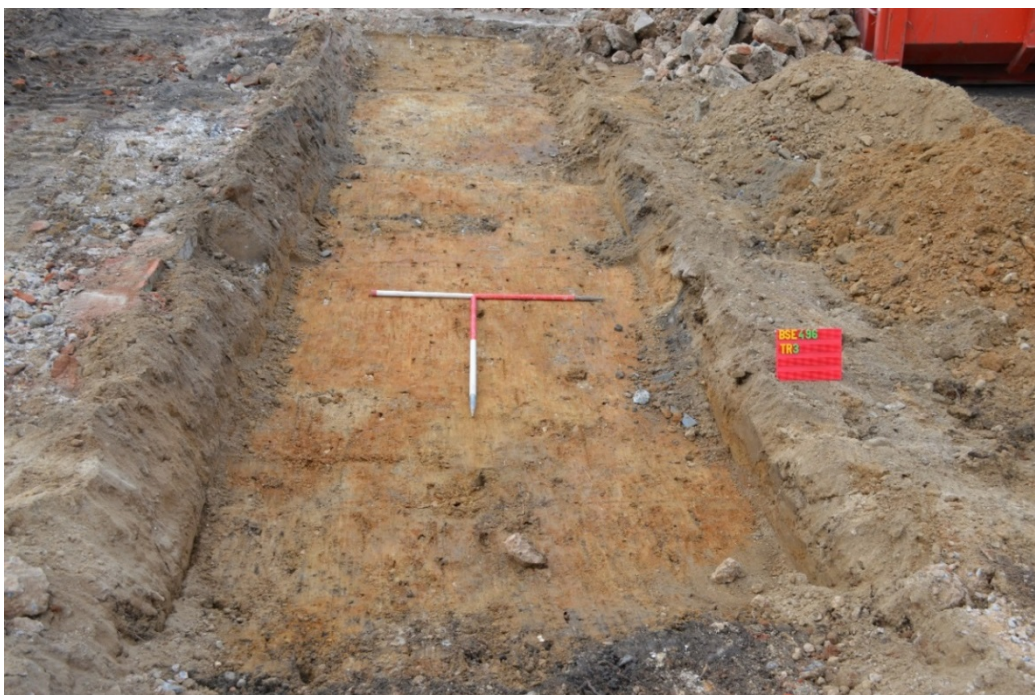
Plate 5. Trench 3, facing west

Archaeological features

No archaeological features were noted within the trench.

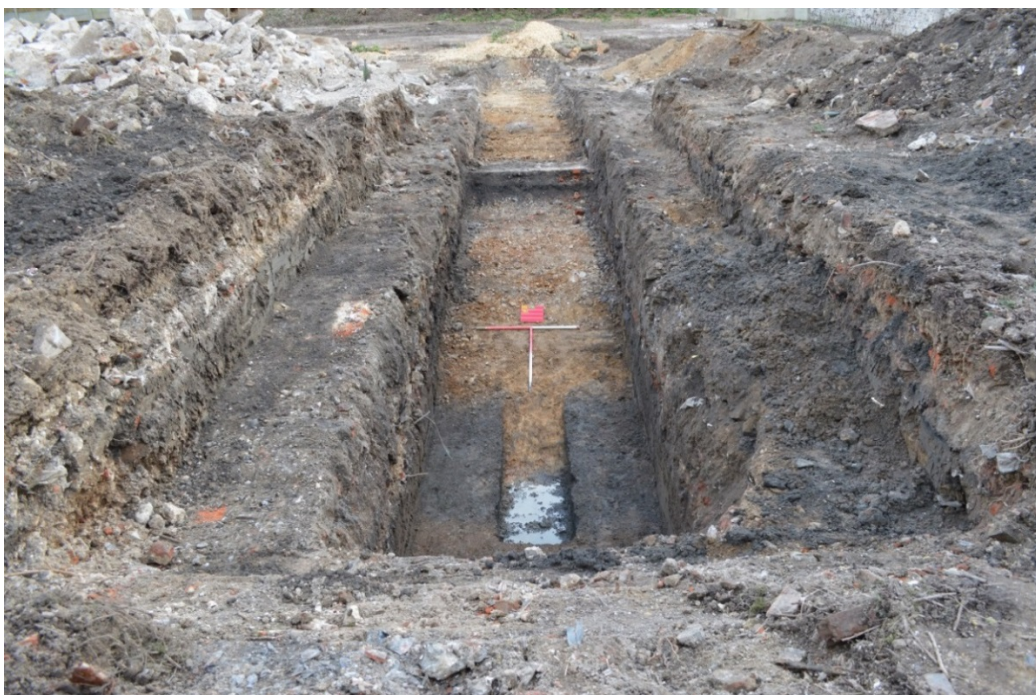
A modern wall foundation crossing the centre of the trench was not recorded. 1020 was a wide ditch at the northern end of the trench. Orientated east-west it measured at least 2.2m wide and 0.40m deep and had moderately steep sides. It cut geological stratum 1004 and was sealed by made ground deposits 1017, 1016 and 1015. Its upper fill, 1018, was a firm, mid brown silty sand which contained a moderate amount of small stone. Its basal fill, 1019, was a compact dark grey silty sand which contained four sherds of post-medieval (19th-20th century) pottery.

Plate 6. Trench 4, facing south, ditch 1020 in foreground

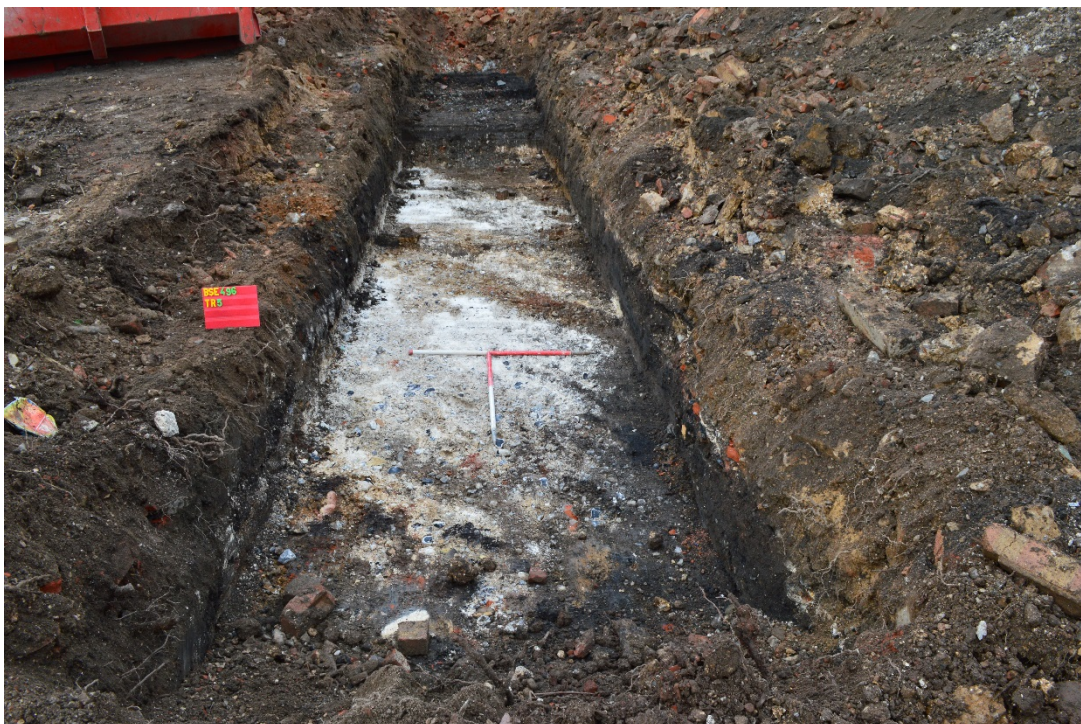
Plate 7. Trench 5, facing north-west

Archaeological features

No archaeological features were noted within the trench.

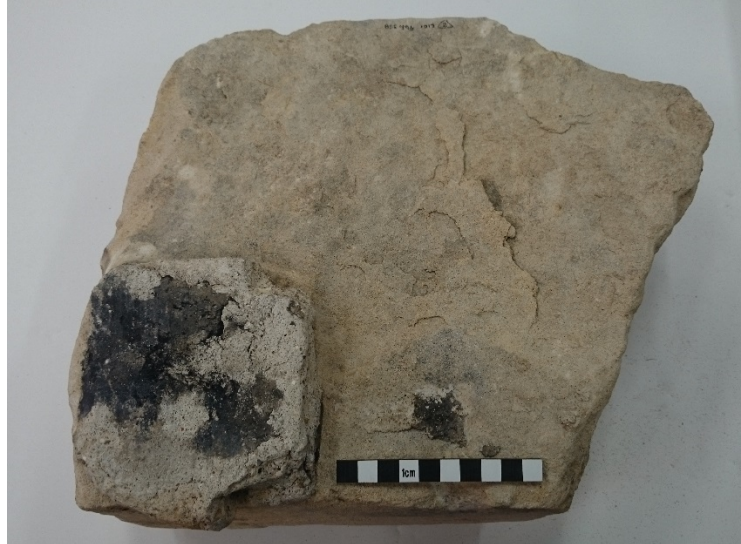
Plate 8. SF0003

Three fragments of moulded stone were recovered. A pentagonal-shaped fragment of limestone (SF0003), heavily coated in mortar, was deposited in wall stub (1021). It is probably a fragment of a voussoir around an arch, perhaps for a window.

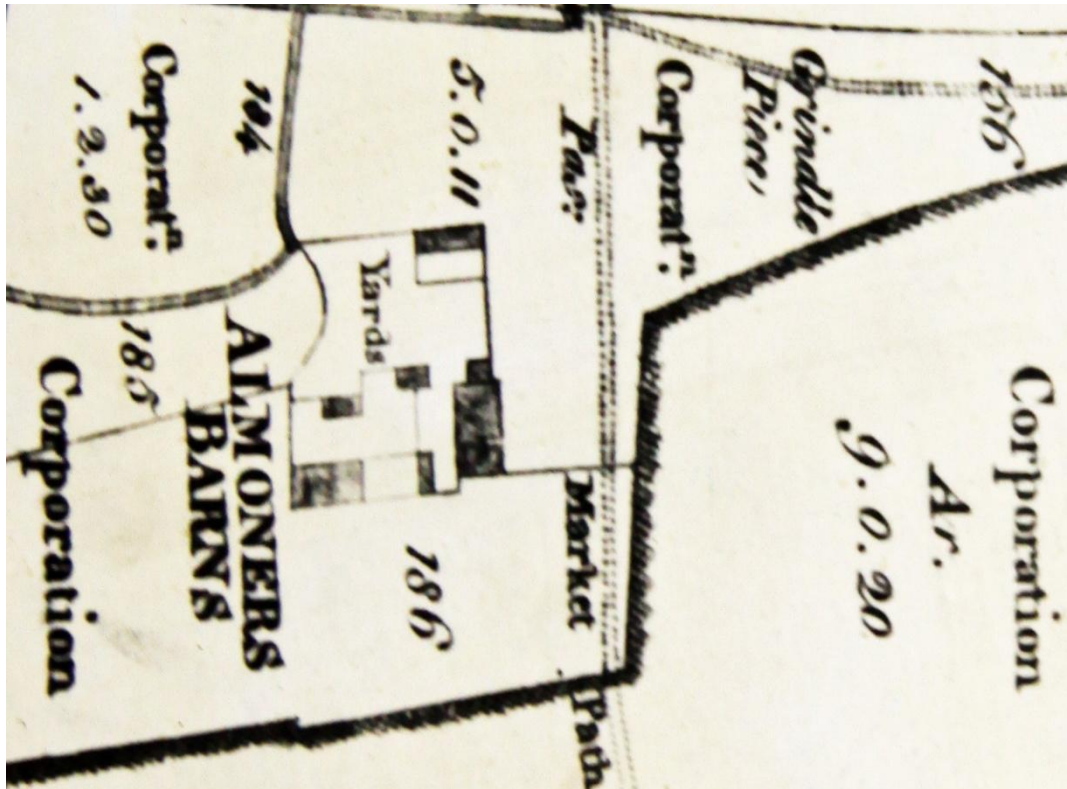
Figure 1a. The 1791 revision of Warren's map, showing the Barns in more detail. The adjoining land formed a block in the ownership of the town Corporation, which the farm buildings presumably served.

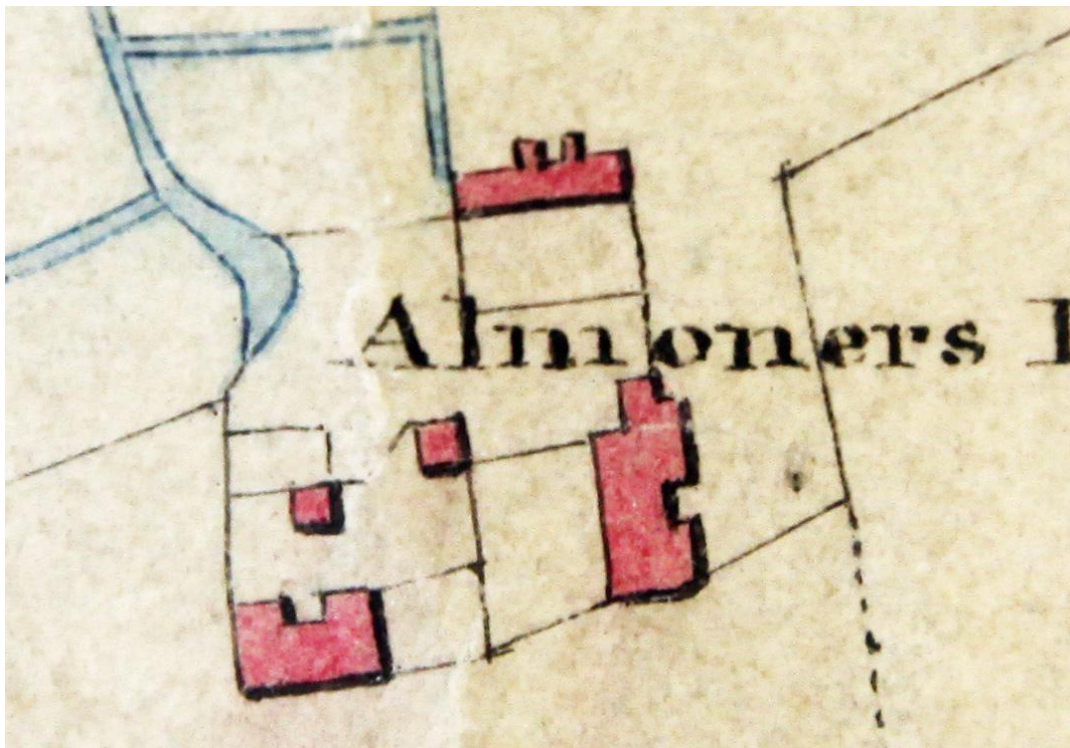
Figure 2. The Bury St Edmunds tithe map of 1845 (Suffolk Record Office T 77, 1/2). The buildings had altered little since 1791. The angled boundary which extends eastwards from the southern gable of the south-eastern building reflects the adjoining 'Grindle' and is occupied today by a stub-wall of re-used dressed stone (4 in figure 10).

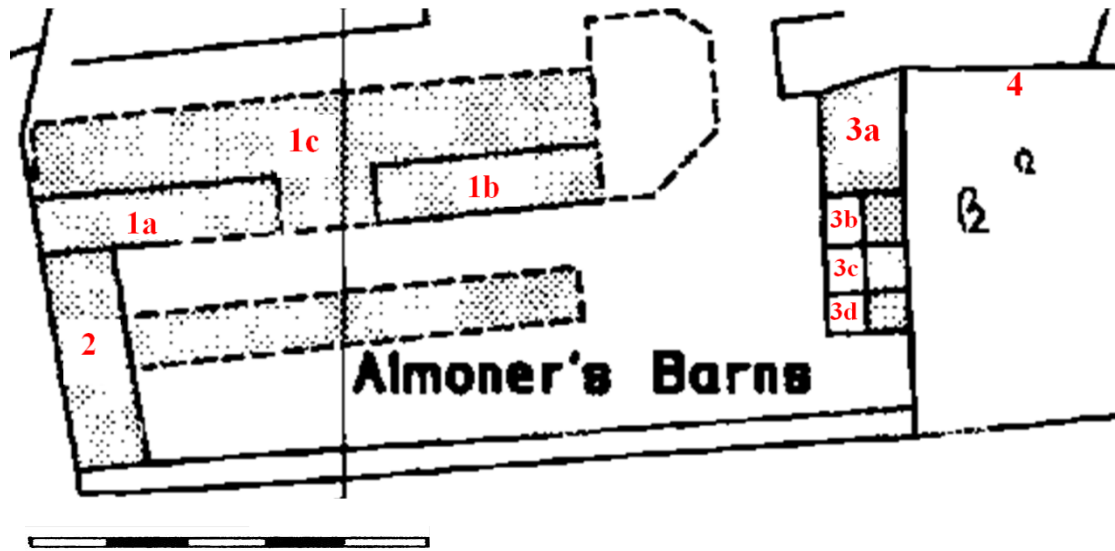
Figure 10

A ground plan based on the Ordnance Survey identifying each structure with a number for ease of reference in the text and photographic record.
25 m scale in blocks of 5 metres.

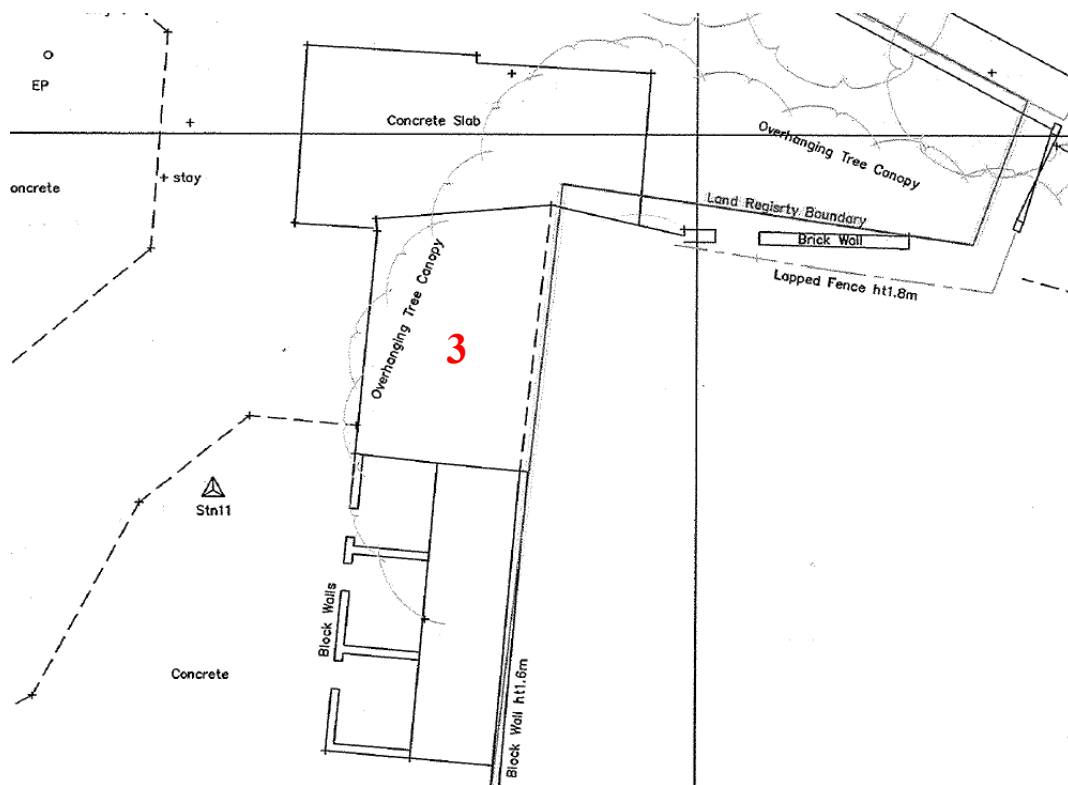
Figure 11

A detail of a 2015 survey by A&B Surveys showing the 'brick wall' (4) consisting of re-used dressed stone to the east of building 3.

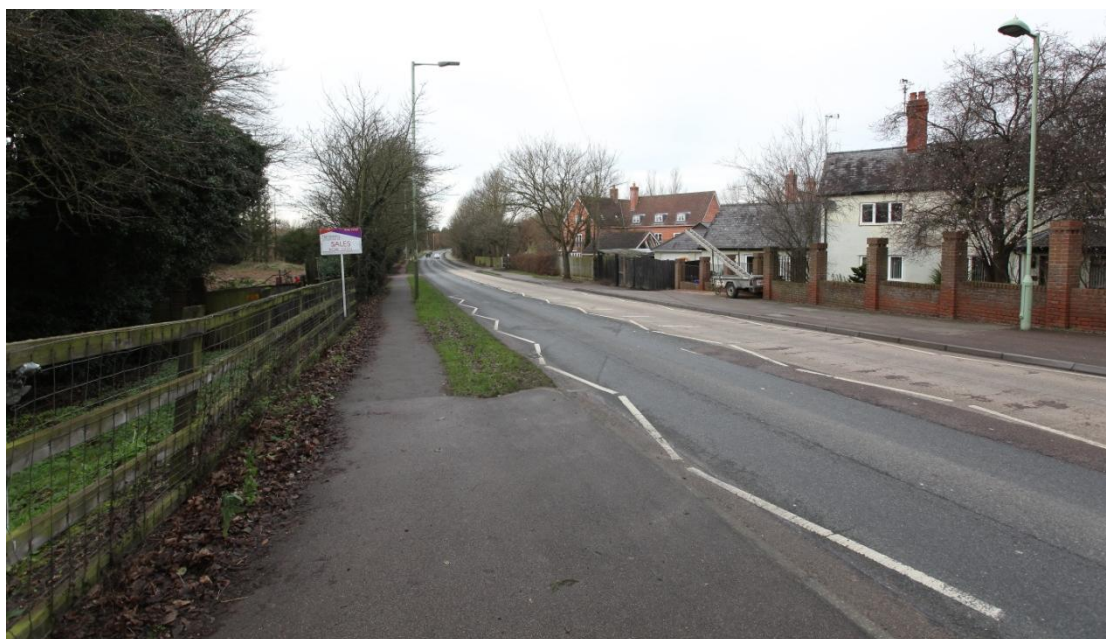
Illus. 1. A general view of the site from the east showing Cullum Road which since the 1970s has divided the mid-19th century slate-roofed farmhouse known as Almoners Cottage on the right from the rest of the farmstead on the left. The 18th century farmhouse lay on the approximate site of the modern garage to the left (west) of Almoners Cottage (compare figures 2 and 3 above).

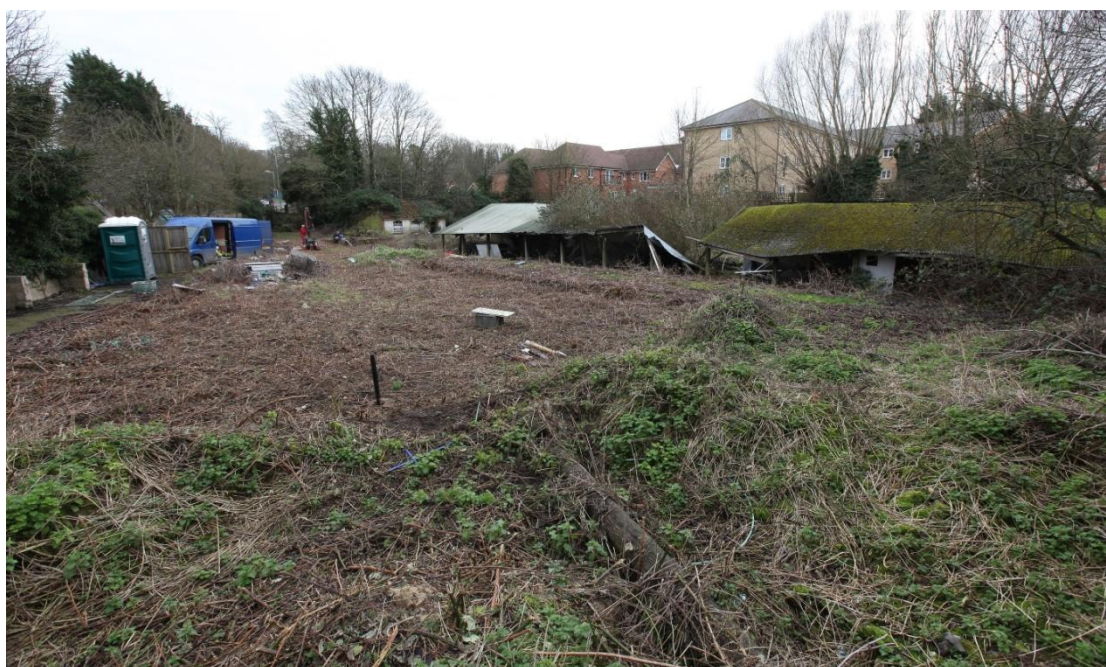
Illus. 2. A general view of the site from the overgrown rubble heap to the west showing the much altered linear range of open-sided mid-19th century sheds (1) to the right and the cement-rendered shed of *circa* 1900 in the rear (3a). Cullum Road lies beyond the hedge to the left. The linear sheds mark the southern boundary of the 18th century farmstead. The level of the ground in the centre of this image has been raised in height by approximately 1m and is retained on the south by a wall of cement blocks (see illus. A1. 43).

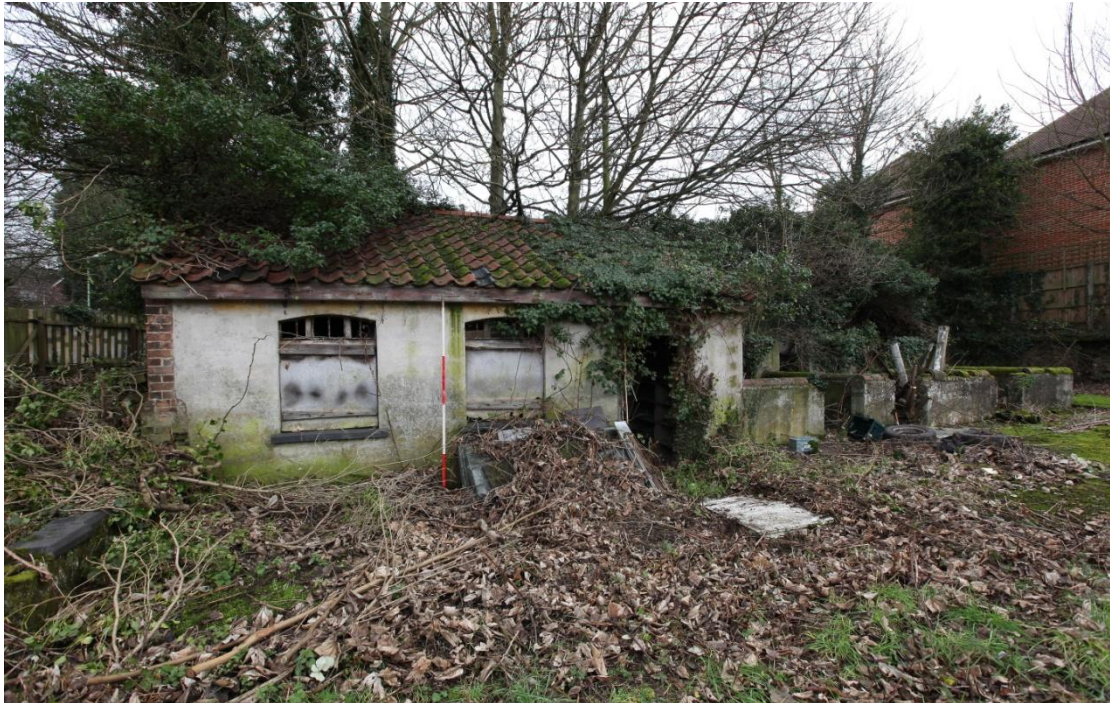
Illus. 3. The western facade of the cement-rendered pantiled shed of *circa* 1900 to the east of the site (3a) with the three adjoining pig sties (3b-3d) on the right. The left-hand (northern) gable of Fletton brick is not at right-angles to the walls, and reflects the southern boundary of the site in 1845 and before. The 18th century ‘eastern barn’ lay to the left of this building and apparently survived until the mid-20th century.

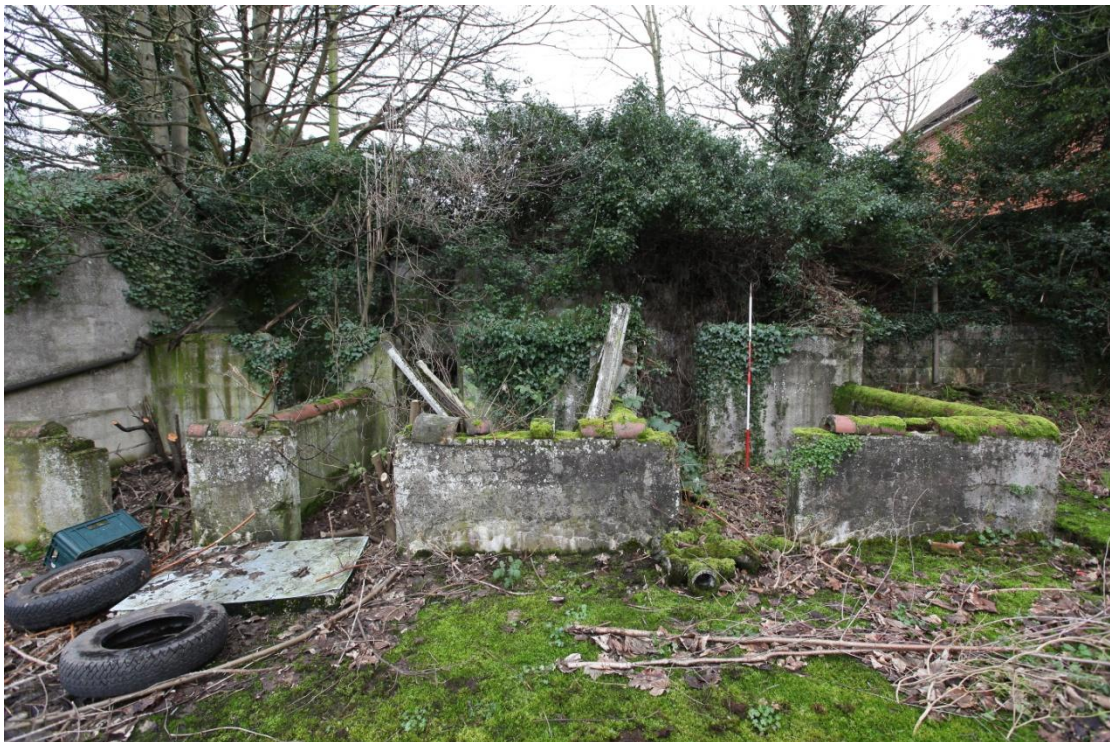
Illus. 4. The three pig sties (3b-3d) seen from the west, with the enclosed shed (3a) on the left. Each sty consisted of an open pen in the foreground with an enclosed shed beneath a collapsed pantiled roof in the rear. These sties were first built in *circa* 1900 but their present configuration differs from those depicted in 1903 and 1924 (figures 5 & 6) and they were evidently rebuilt or remodelled in the mid-20th century.

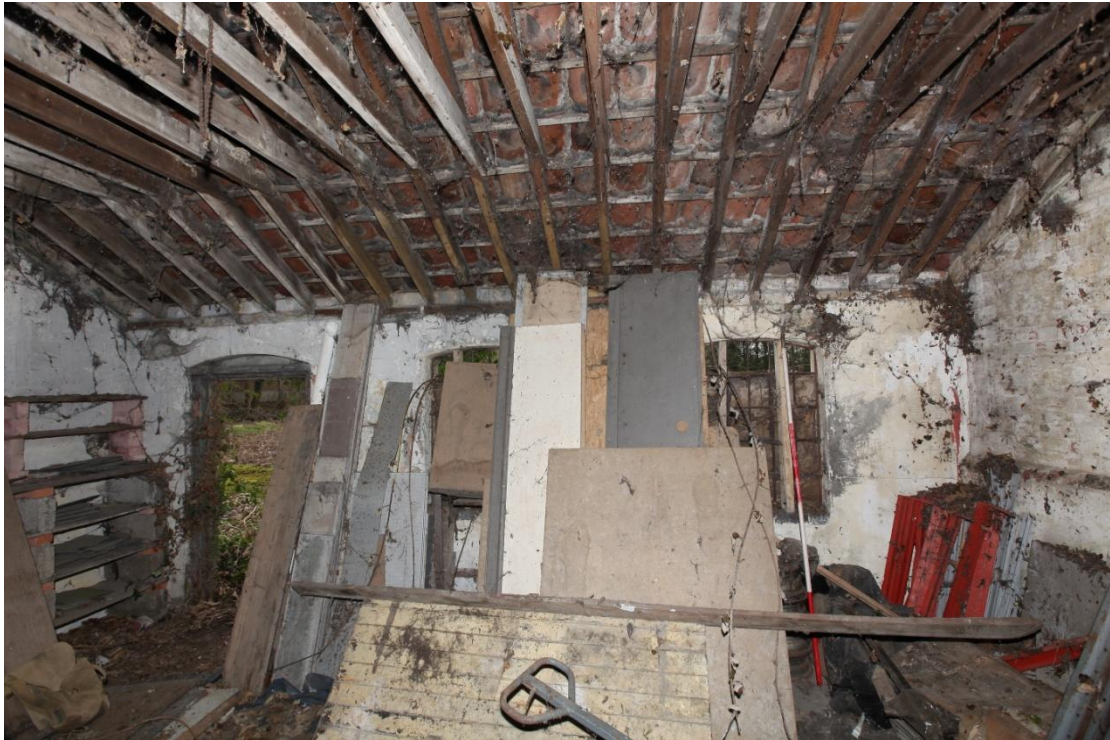
Illus. 5. The rendered and colourwashed interior of the pantiled shed’s western facade (3a) showing its original windows with iron glazing bars. The roof structure of machine-sawn softwood with nailed collars also appears to be original to the walls.

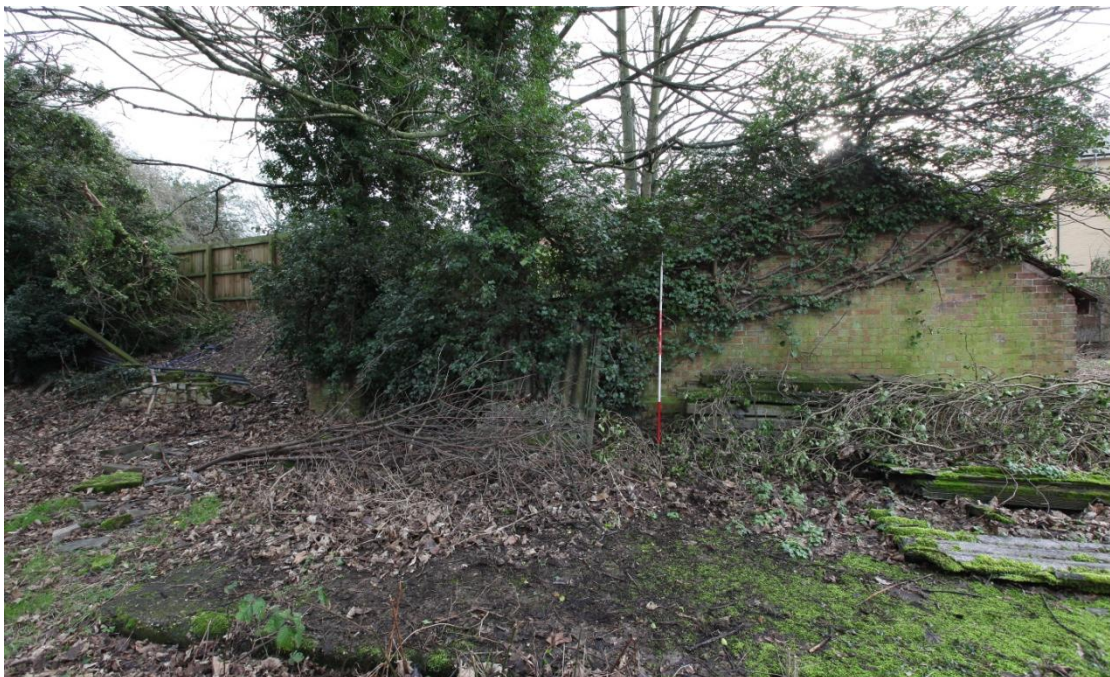
Illus. 6. The Fletton-brick northern gable of the *circa* 1900 pantiled shed (3a, right) with the low stub wall (4) adjoining its north-eastern corner on the left. This stub wall or plinth consists of two sections on slightly different alignments: a predominantly brick section abutting the shed, largely hidden by vegetation, and a section of re-used dressed stone to the left of a narrow gap that presumably served as a doorway. The right-hand pier of this doorway consists of early- to mid-19th century brickwork incorporating further re-used stone. These walls ostensibly survive from the ‘eastern barn’ depicted in 1845 (figure 2) and its mid-19th century eastern extension (figures 3 and 4).

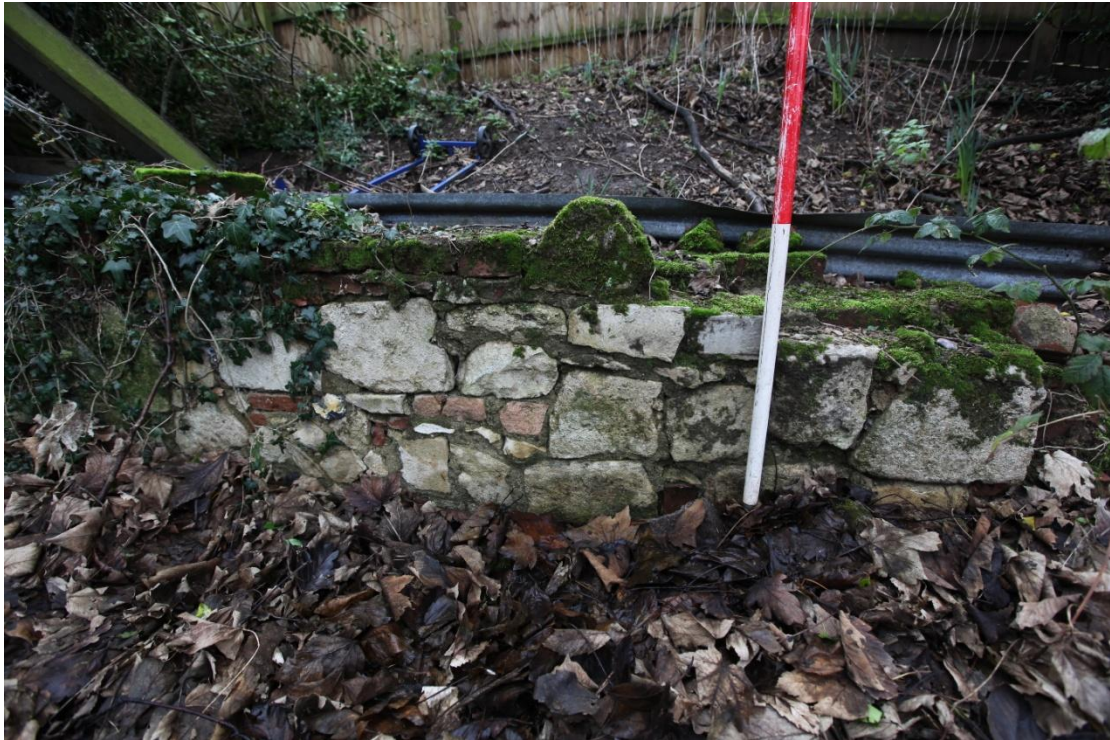
Illus. 7. The northern face of the eastern section of the stub wall or plinth (4) in the north-eastern corner of the site. The dressed limestone blocks are typical of those salvaged from Bury's monastic buildings but they are set in a hard mortar together with broken 19th and 20th century bricks and their present context is difficult to date with confidence.

The primary feature of note observed during the project as a whole is the extant fragment of wall on the eastern side of the site which incorporates re-used dressed stone and may be the last surviving remnant of the mid-19th century farm complex. Apparently partly or wholly rebuilt later in the 19th century it is thought to represent the southern end of the potentially medieval eastern barn.

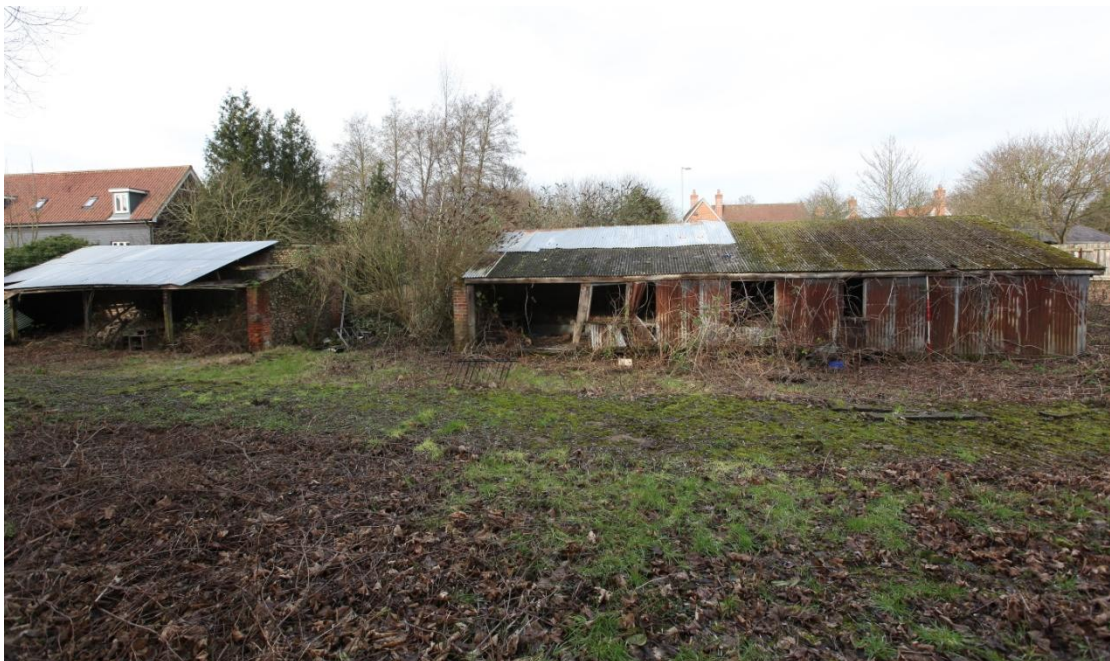
Illus. 8. The linear open-sided sheds from the south, showing the original gap between the western shed (1a) on the left and the eastern shed (1b) on the right. The latter was extended to the right in the mid-20th century, as indicated by the change in roof covering from corrugated iron to corrugated asbestos.

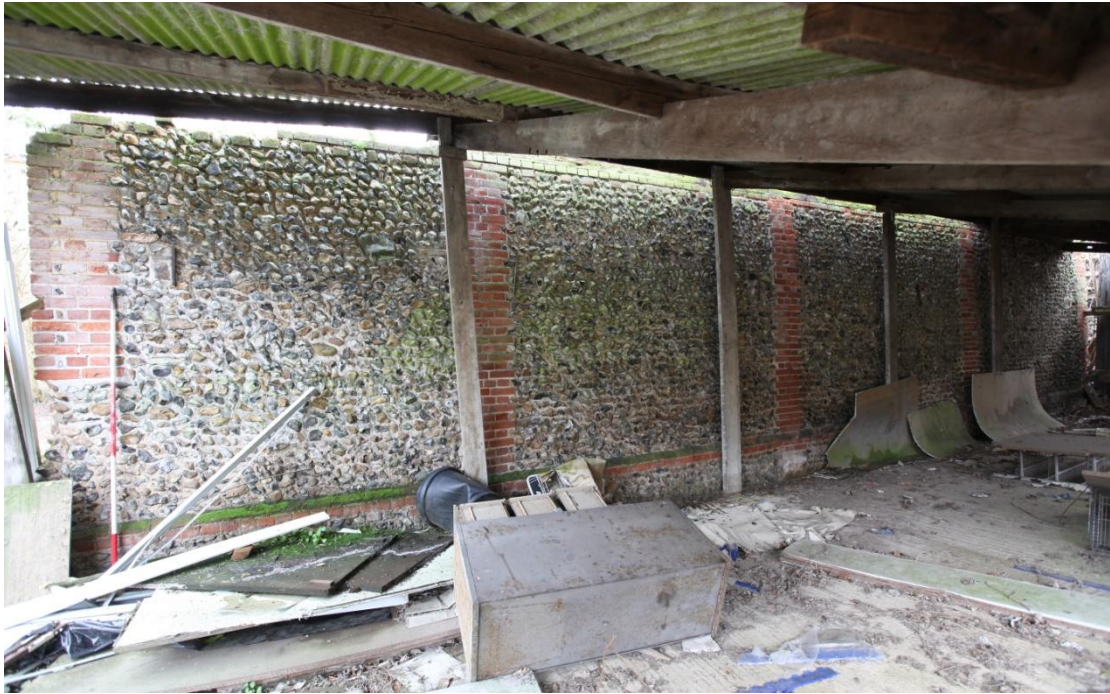
Illus. 9. The spine wall of flint rubble with red-brick dressing that marks the southern boundary of the 18th century farmstead but dates from its southward extension in the mid-19th century. Seen here from the north-east, it was initially built as the rear wall of the south-facing western shed (1a) but now also serves as the southern wall of the open-sided lean-to shed in the foreground (1c). First added between 1883 and 1903 this appears to have rebuilt and re-roofed in the mid-20th century.

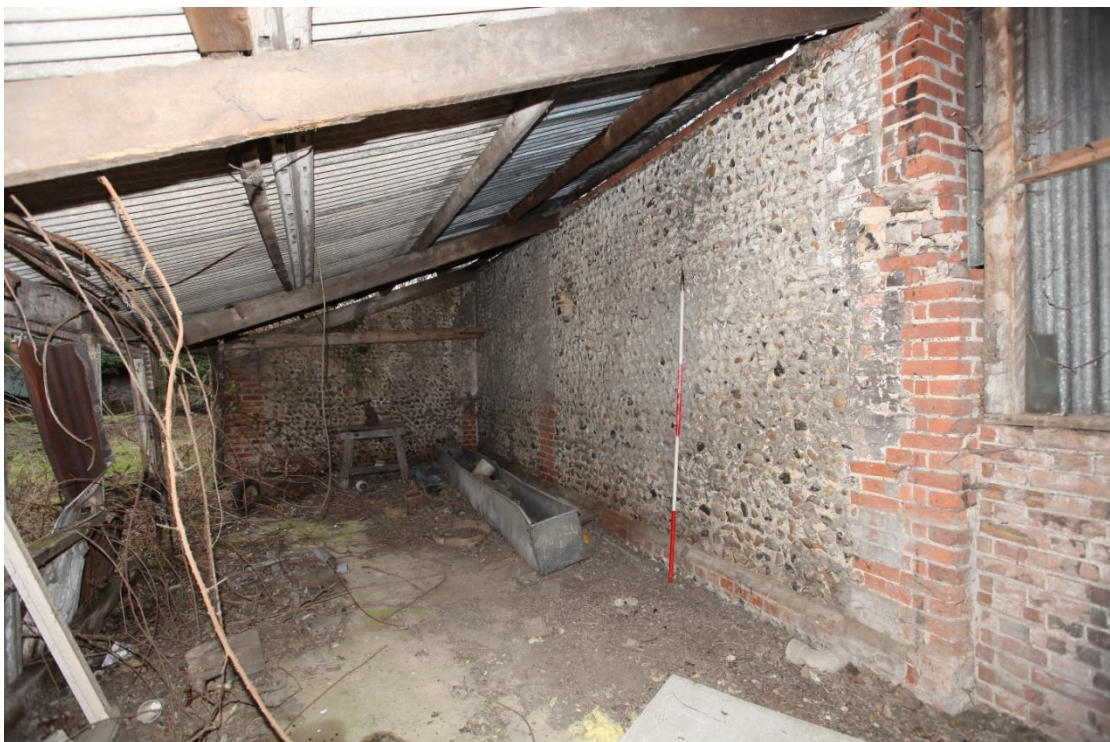
Illus. 10. The interior of the mid-19th century eastern shed (1b), seen from the east. The flint-rubble northern wall terminated at the red-brick dressing on the right, which abutted a timber-framed shed shown in figure 3, but was extended in brick in the mid-20th century. The softwood rafters are 20th century replacements.

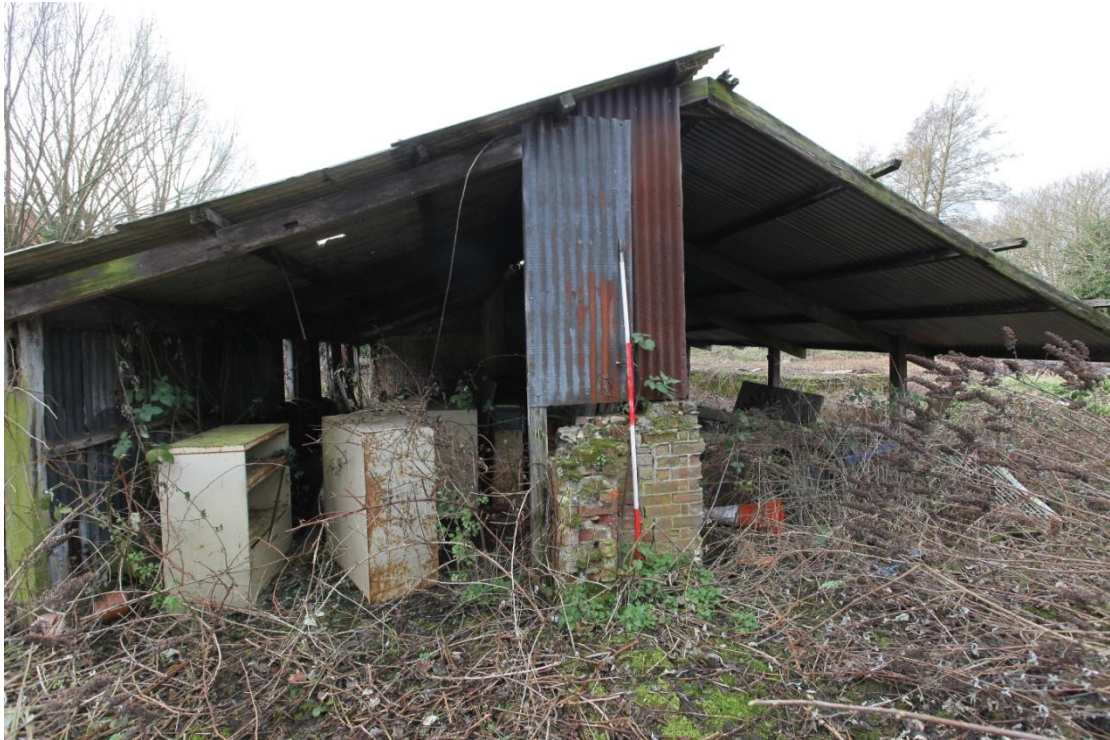
Illus. 11. The eastern gable of the linear sheds showing the 20th century brick extension to the original flint-rubble wall which divides the contemporary extension to the mid-19th century eastern shed (1b) on the left from the mid-20th century open-sided shed (1c) on the right.

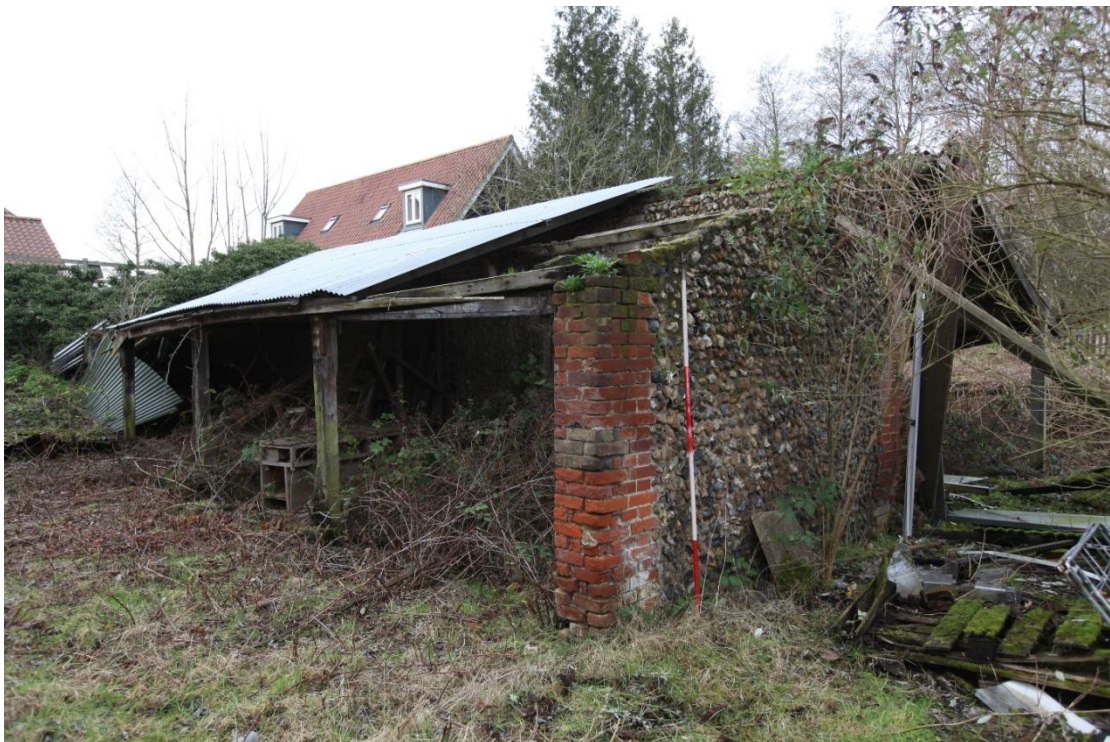
Illus. 12. The western open-sided shed (1a) from the south-east. This is the earliest building on the site, dating from its mid-19th century extension and refurbishment. A low yard wall formerly linked its north-eastern corner on the right to its smaller counterpart on the east (1b).

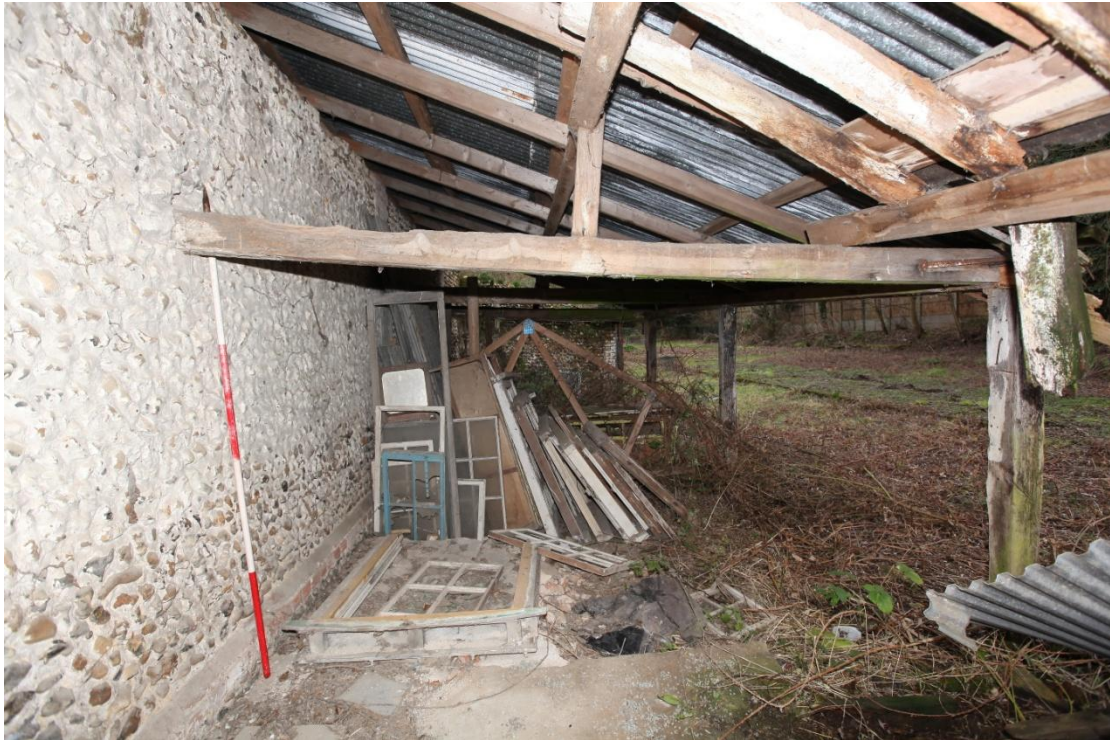
Illus. 13. The interior of the western open-sided shed (1a) seen from the west. An original tie-beam is embedded in the whitewashed flint-rubble wall to the left, with a small number of original rafters (top right). The majority of the present roof is a 20th century replacement of machine-sawn softwood.

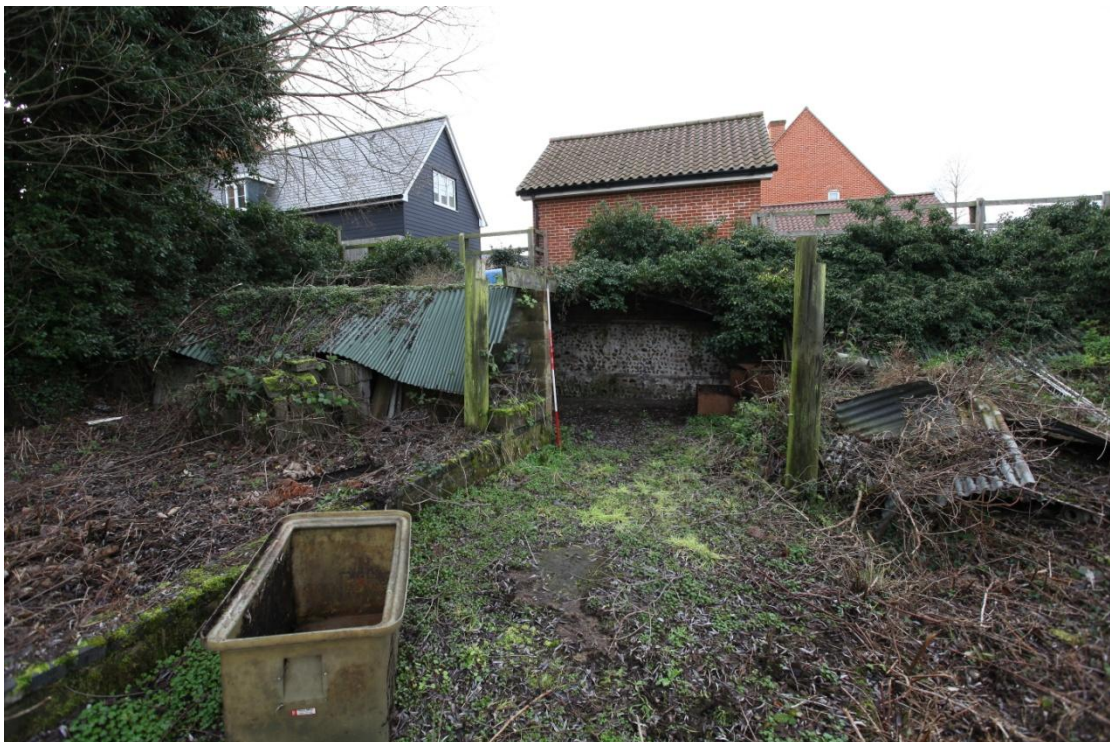
Illus. 14. The exterior of the roofless mid-20th century cement-block shed in the southwestern corner of the site (2), seen from the east. The original mid-19th century yard wall of flint-rubble survives in the southern and western walls of this shed, but has largely collapsed elsewhere.
