Guildhall Feoffment Primary School

Bury St Edmunds, Suffolk

Archaeological Assessment Report v0.4

SACIC Report No. 2016/020

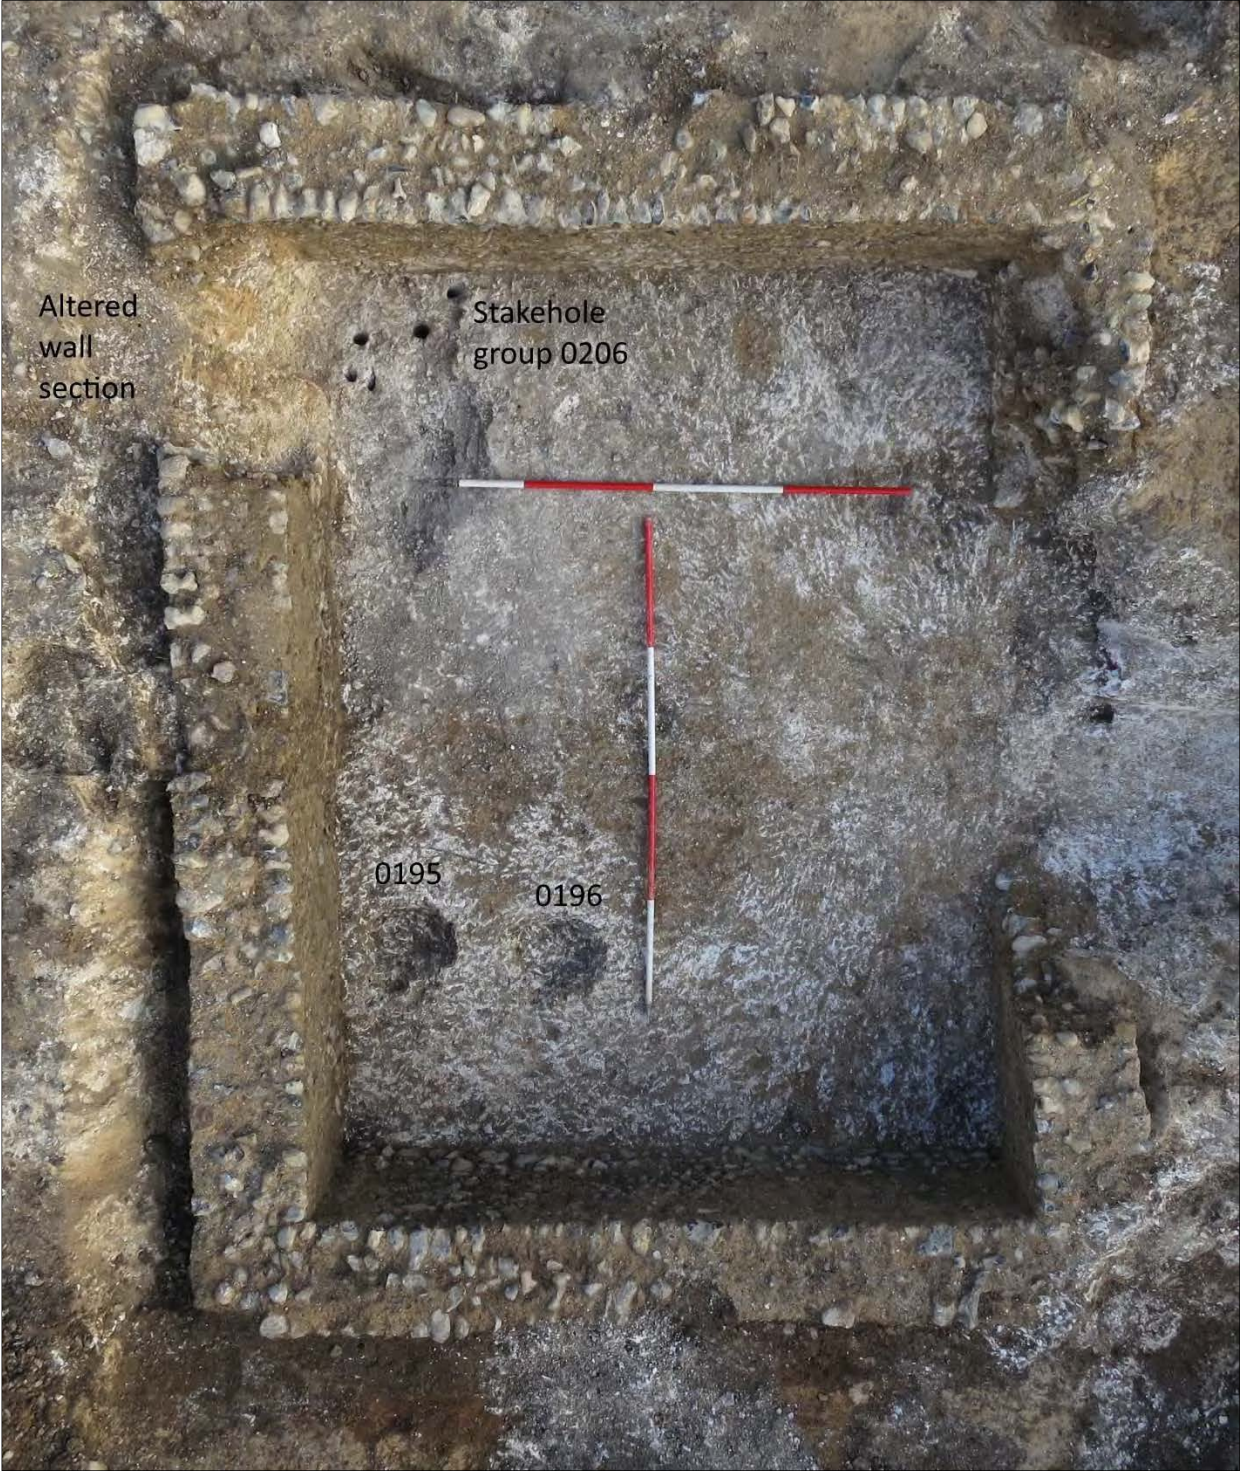
Plate 1. Building 0078 (north to top of photo, 2m scales)

The building was a small oblong structure, made up entirely of flint and soft pale orange sandy mortar, which was of a type often seen in medieval contexts in this part of the country (Pls. 1-2). It had been built within a 1m deep steep edged pit that had been dug to house the foundations. Internally the structure measured c.2.52m east to west x c.3.44m north to south and had c.0.4m thick walls. The west side of the wall by the northern corner had been somewhat altered, with an apparently original gap appearing to have been filled in (see 0208 and 0209) with a noticeably poorer quality repair that included some medieval roof tile fragments (Phase 1.4). It had also been truncated significantly on the eastern side by a later cut that seemed to be associated with the main phase of demolition and was possibly targeting the wall for building materials. The distance of the structure from the road (c.25m) suggested it was not part of an

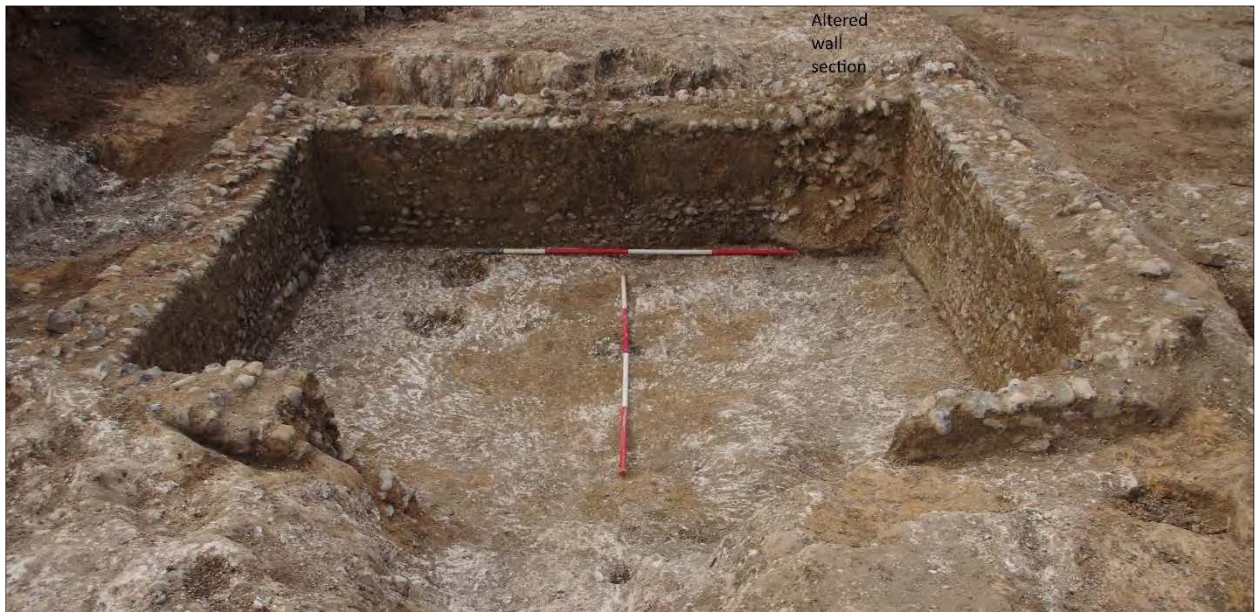
Plate 2. Building 0078 (showing repair 0208/0209, in the right side of the furthest wall. Facing west, 2m scales)

A gap, approximately 0.75m wide, in the northern end of the western wall of the building had obviously either been repaired, or more probably infilled, with deposits of loose chalk and mortar (0208) and loose flint and mortar (0209), as well as fragments of tile (Fig. 6 and Pl. 2). The quality of the construction here was markedly lower than that in the rest of the building and the position of the gap was adjacent to stakehole group 0206, suggesting that either the original void, or its repair may have been associated in some way with the five stakeholes.

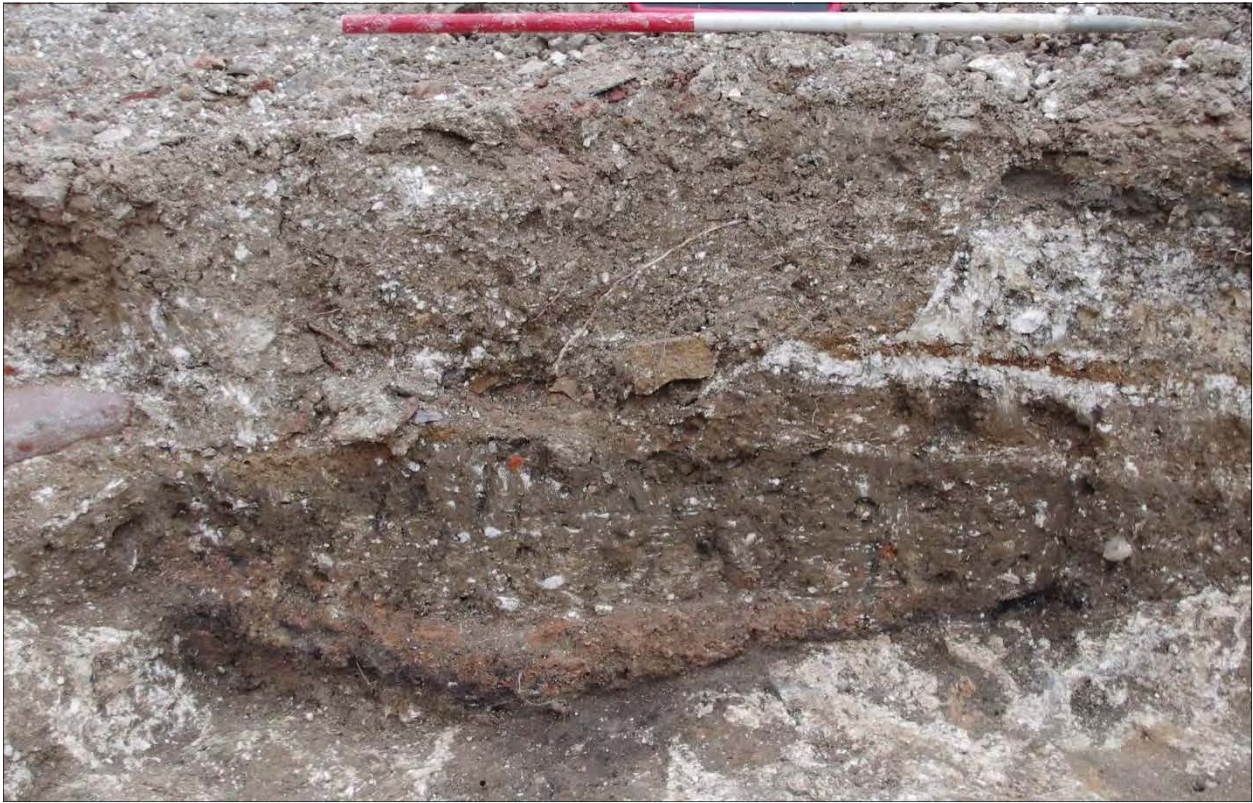
Plate 3. Hearth base 0112 (Facing north, 1m scale)

A shallow hearth (or possibly an oven, kiln or furnace) base, 0112, was excavated by the northern limit of excavation, although relatively little of it survived (Fig. 5 and Pl. 3). Pottery of 12th-13th century date was recovered from fill 0119, as well as a small, intrusive post-medieval sherd.

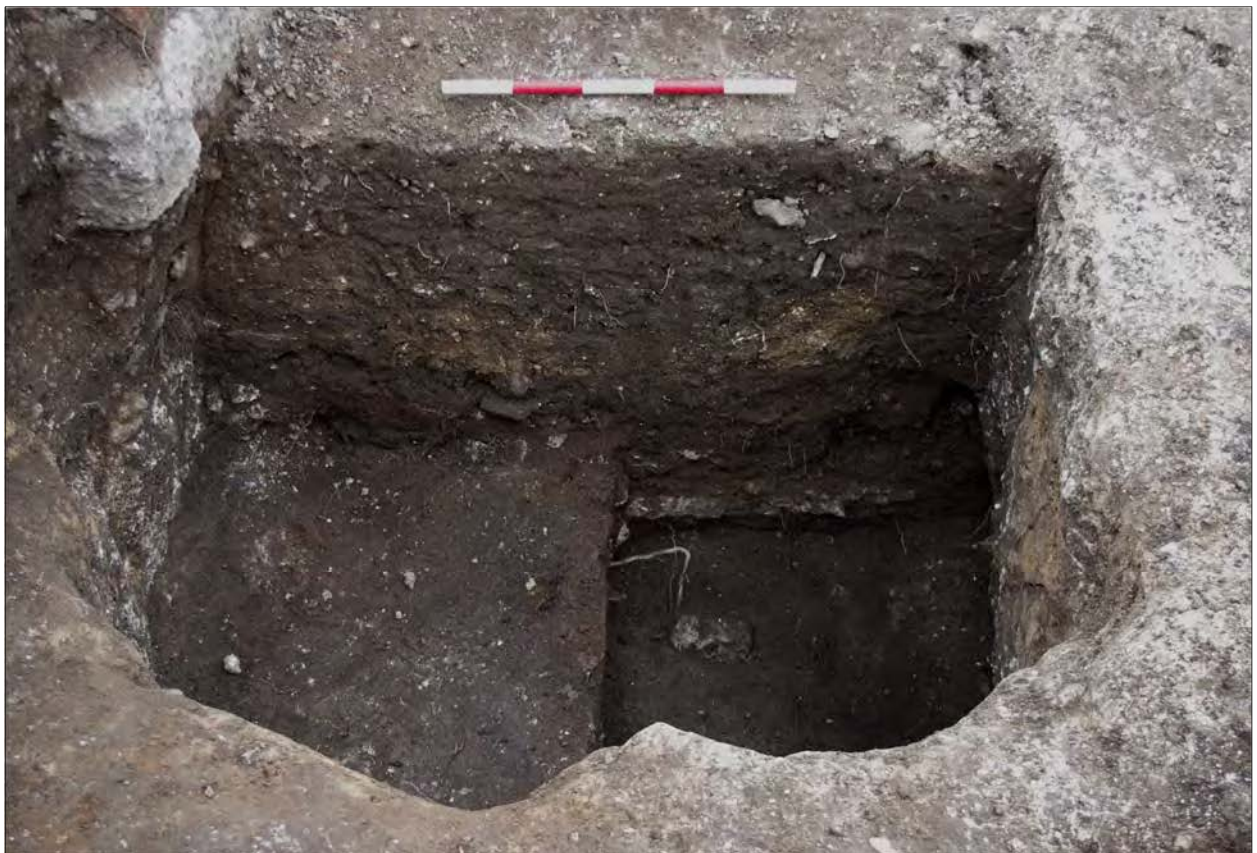
Plate 4. Pit 0106 (0.5m scale, facing east)

A number of smaller or more irregular pits were also included in this phase. These include shallow feature 0153 (which produced 13th century pottery, but cut pit 0106), as well as linear pit(s) 0145 (the two fills of which produced 13th century pottery, but were similar to those of 0106).

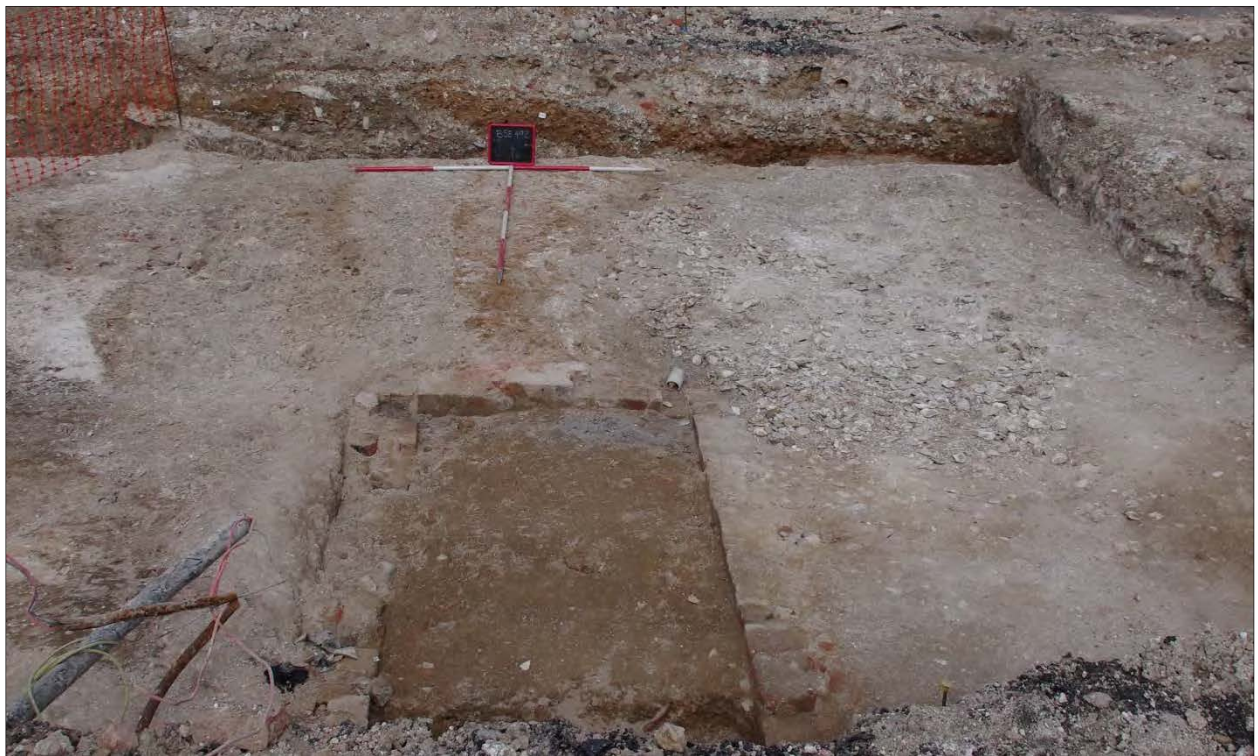
Plate 5. Eastern limit of site, showing upper fills of pit group 0063 and structure 0203 (facing north, 2m scales)

A brick structure (0203, Pl. 5) of late post-medieval date was recorded emerging from the southern limit of excavation and cut the backfill deposits in pit group 0063, fills from which produced 19th century pottery.
