Hitcham Garage, The Causeway Hitcham, Suffolk

Client:
M & S Contractors (EA) Ltd.

HTC 097
Archaeological Evaluation Report
SACIC Report No. 2017/088
Author: M. Sommers
© SACIC

Archaeological Evaluation Report

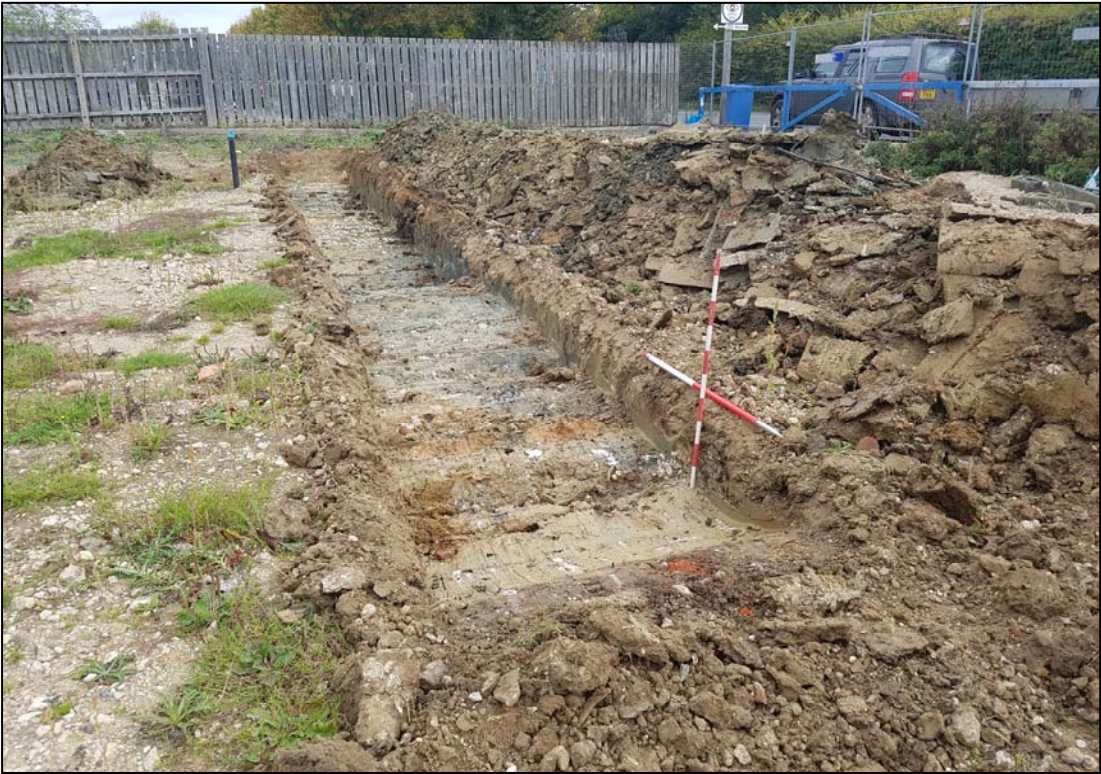
Plate 1. General view of Trench 1 (camera facing northeast)

A northeast-southwest aligned trench measuring just over 15m in length (Plate 1). At the southwest end of the trench the natural subsoil consisted of a stiff grey clay with occasional small chalk nodules and was located at a depth of c.0.25m beneath an overburden of clayey topsoil and crushed concrete with brick rubble (Plate 2). At the northeast end of the trench the natural subsoil had dipped to a depth of c.0.5m. The overburden comprised of c.0.35m of brown clayey loam below c.0.15m of topsoil (Plate 3). Other than a single small pit, containing modern debris that was clearly related to the site's use as a garage, no features of any period were present.

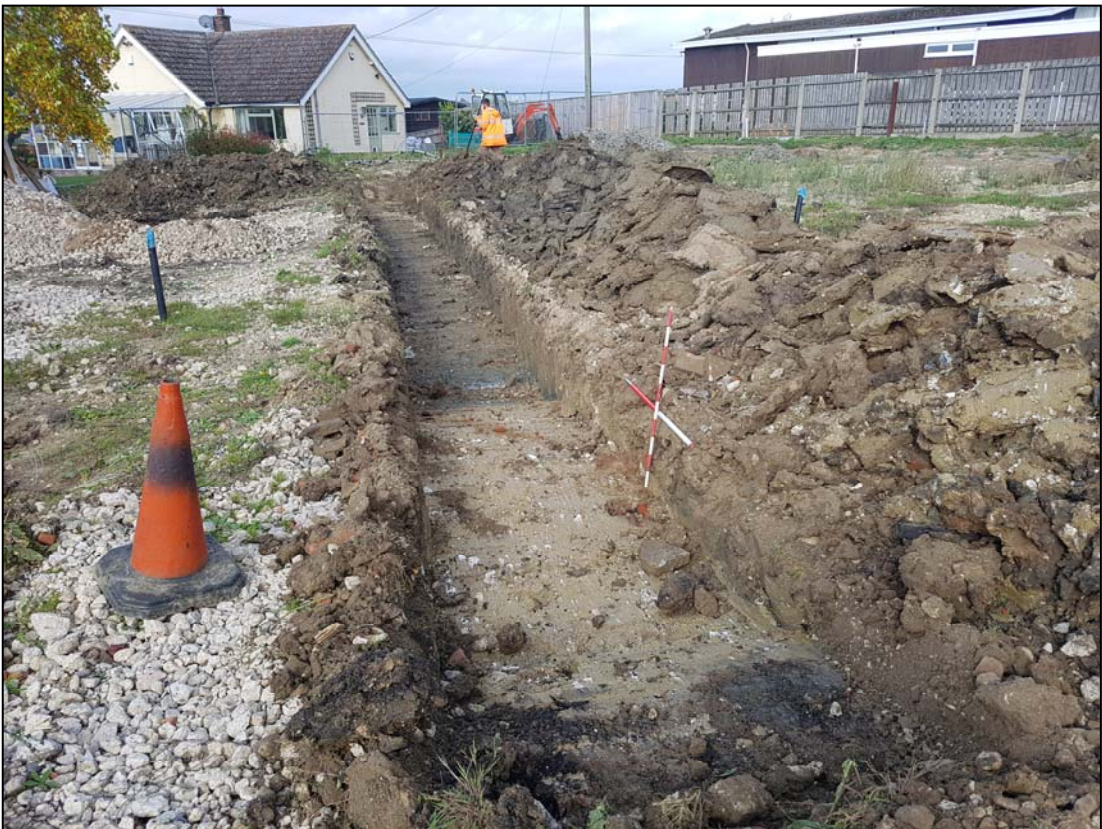
Plate 4. General view of Trench 2 (camera facing northwest)

A roughly northwest-southeast aligned trench measuring 21m in length (Plate 4). At the southeast end the natural subsoil comprised a stiff grey clay with occasional small chalk nodules and was located at a depth of c.0.25m beneath an overburden of clayey topsoil and crushed concrete with brick rubble, as seen in Trench 1 (Plate 5). At the northwest end of the trench the natural subsoil comprised a pale yellow clay with chalk that lay below c.0.35m of brown clayey topsoil (Plate 6).

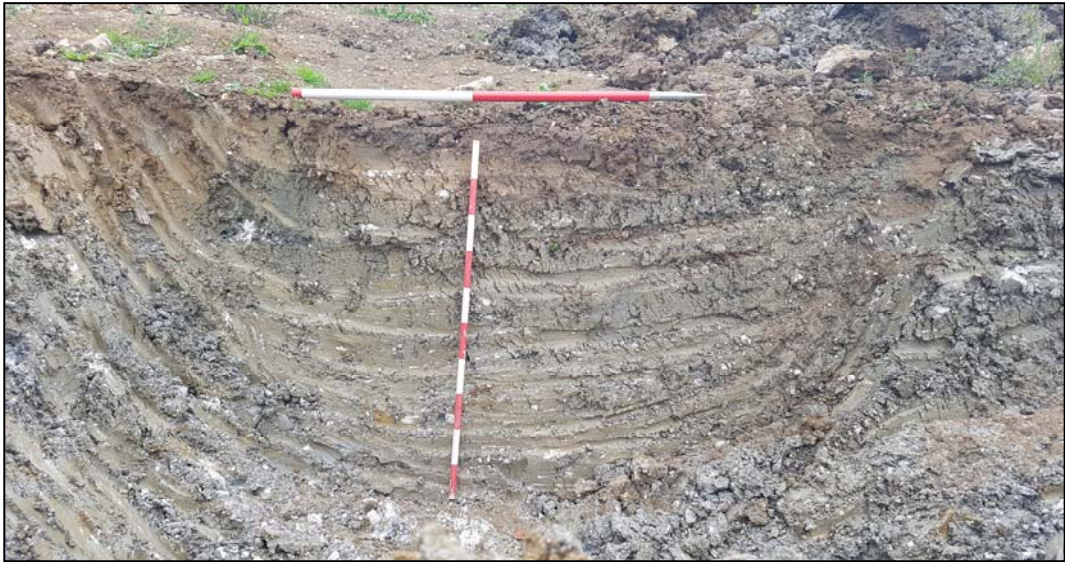
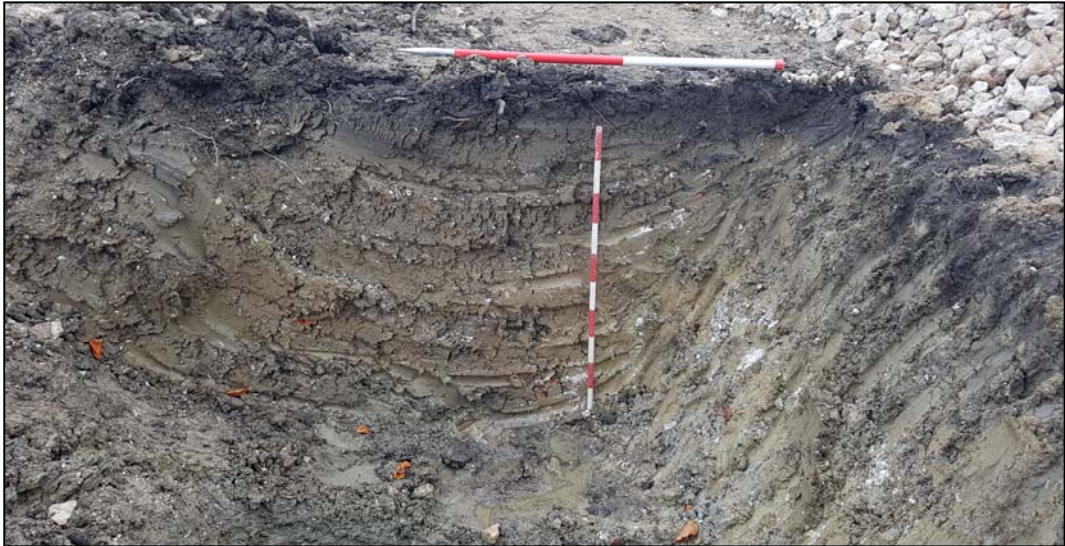
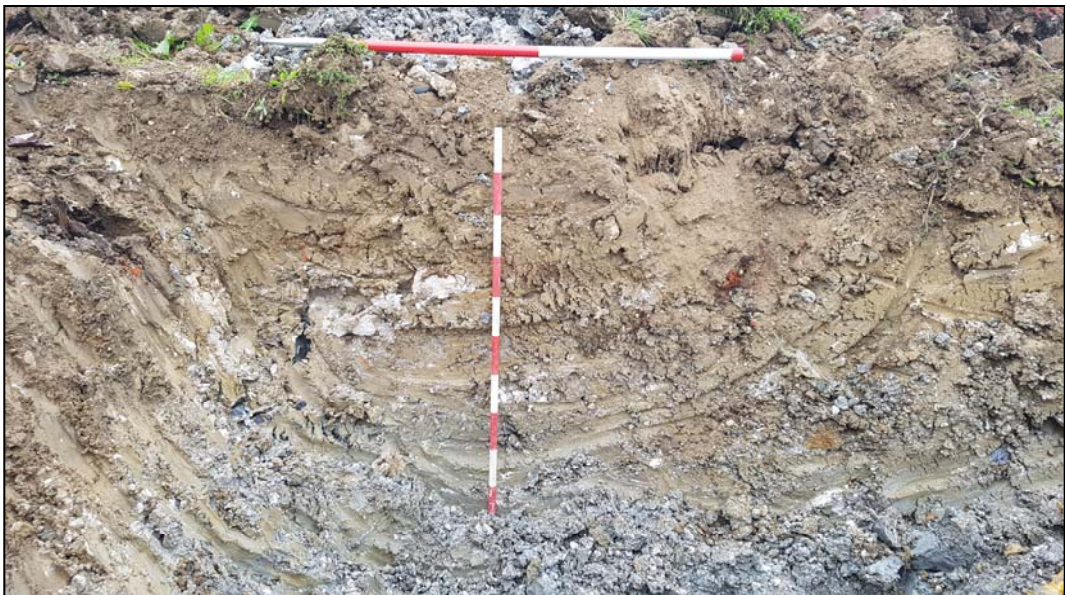
Other than the large feature present in Trench 2 and seen in TP 2, no other archaeological features were identified in the soakaway test pits. Each revealed a thin topsoil directly over a natural subsoil of grey clay with chalk (Plates 7, 8 and 9).

Plate 7. Soil profile, TP1 (camera facing southeast)

Plate 8. Soil profile, TP2 (camera facing southeast)

Plate 9. Soil profile, TP3 (camera facing southwest)
