ARCHAEOLOGICAL MONITORING REPORT

MEMORIAL TREE, ABBEY GARDENS, BURY ST EDMUNDS: SACIC Report no. 2016/093

SMC REF:	S00143355	SUFFOLK HER Nos.	ESF24883	BSE 510
SAM NO:	SM35556 HA 1021450	OASIS ref:	suffolka1-265672	
DATE OF FIELD WORK	19/10/2016	GRID REF:	TL 994 792

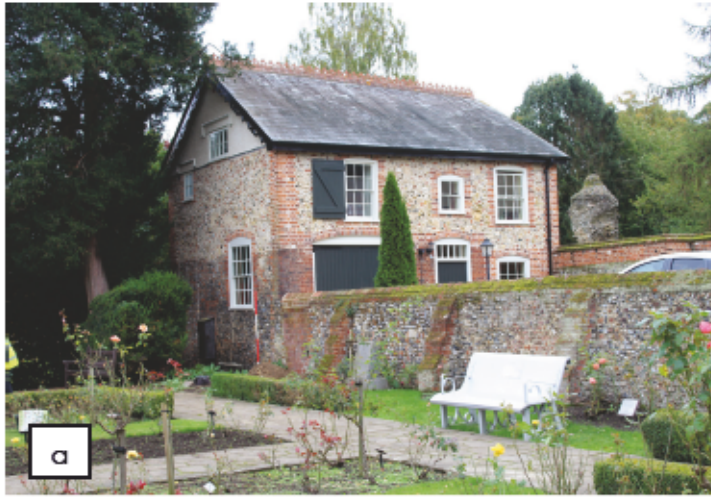
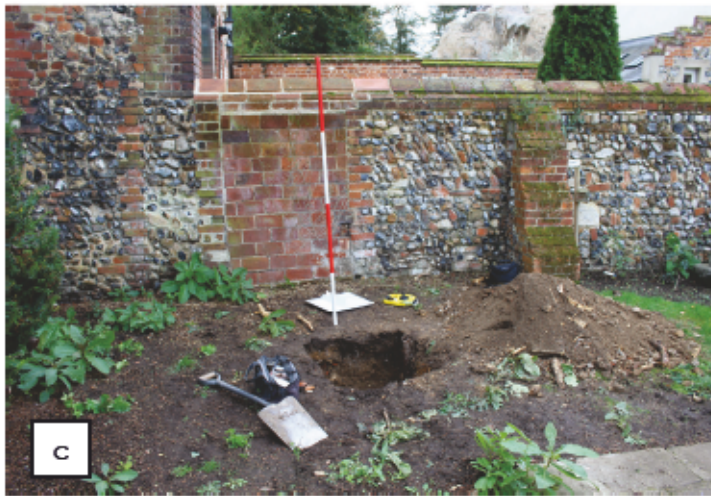
Plate 1. Showing the location of the excavated hole. The boundary wall and cart lodge (a and b) date to the C19th; they are not shown on the Tithe Map of Bury surveyed in 1845, but are included in the first edition of the Ordnance Survey (1884)

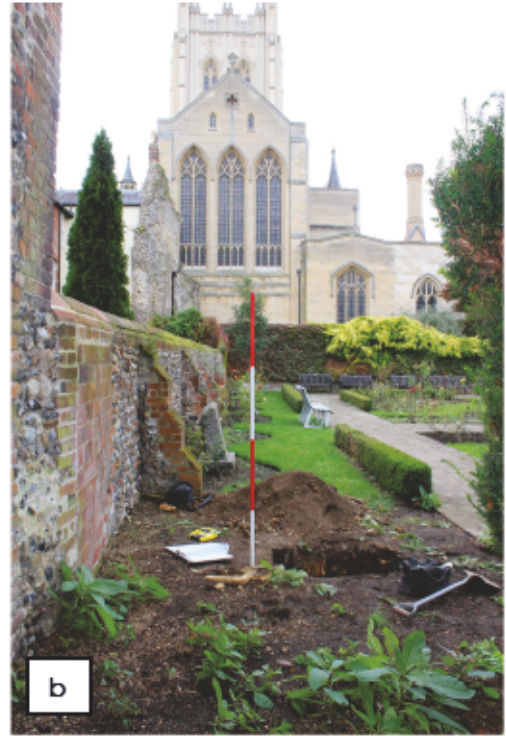
The ground levels have been built-up and the excavated section (Fig. 2) showed a soil profile made up of a muddy post-medieval rubble (0002) beneath a layer of clean, orange gravel (0001) and topsoil. The rubble (0002) at the base of the excavation was composed of a dense mix of

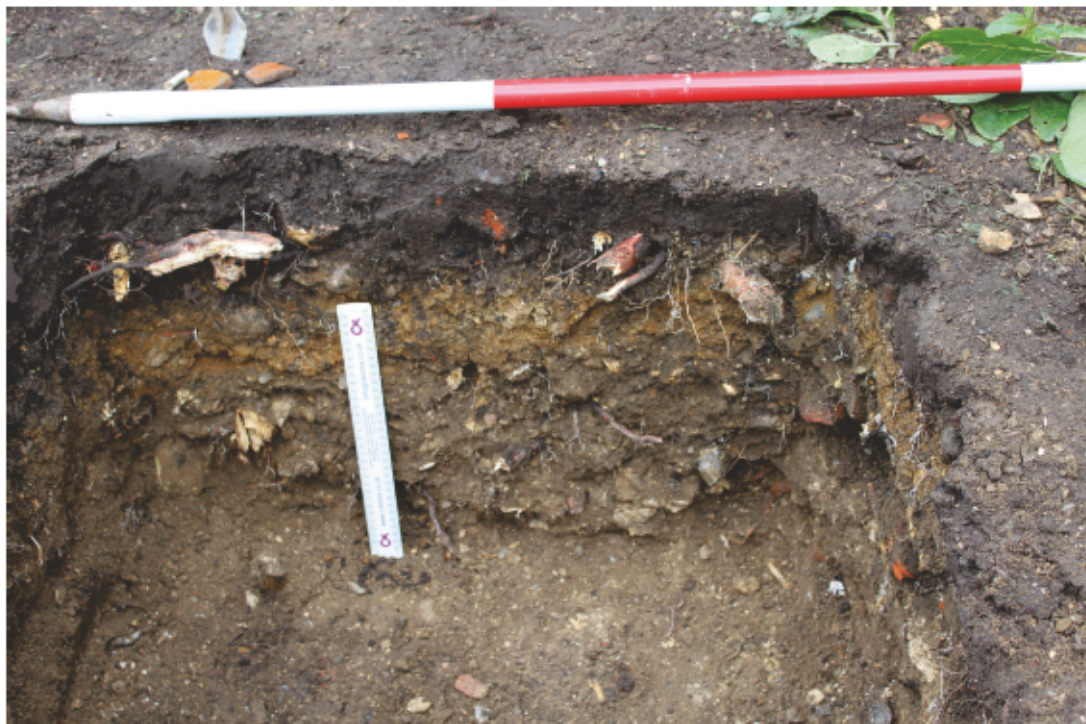
powdered, lime mortar with frequently occurring building-flint and small fragments of limestone; some of which was burnt.

Whilst the limestone and flint could have derived from the destruction of the Abbey's buildings the deposit was dated by post-medieval roof-tiles and bricks which included examples of 'white-bricks', similar to those that make up the frontage of the Georgian buildings on Angel Hill. The layer also included roofing-slate and clay pipe stems; the presence of orange-glazed earthenware pottery demonstrated that the rubble had been deposited no earlier than the 19th century.

Plate 2. Section looking east. The rubble at the lowest limit of the excavation was composed of lime-mortar, building flint and limestone and was deposited or re-worked in the 19th century. The short scale is 30cms long.
