**Former Police Station,  
Grundisburgh Road,  
Woodbridge, Suffolk  
WBG 117  
ESF 25611**

**Historic Building Record**

# **Former Police Station, Grundisburgh Road, Woodbridge, Suffolk**

## **Historic Building Record**

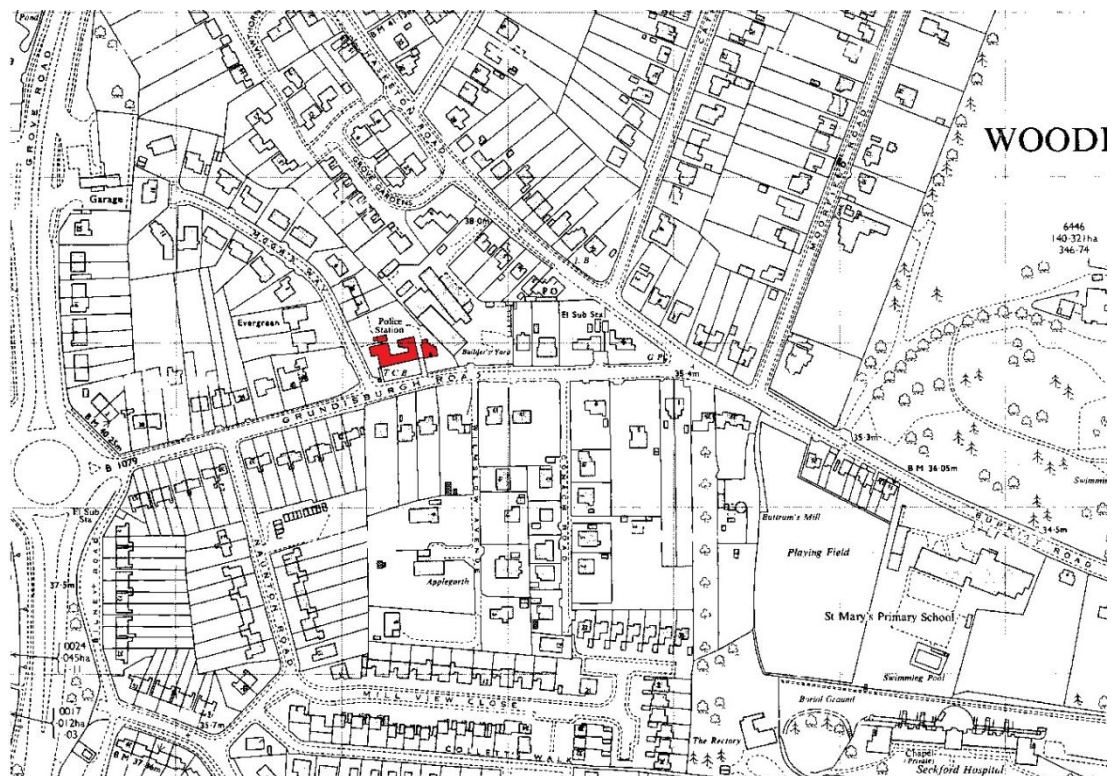
**Figure 1. Site plan based on the Ordnance Survey of 1976 highlighting the police station in red to the north of Grundisburgh Road with the A12 to the east.**

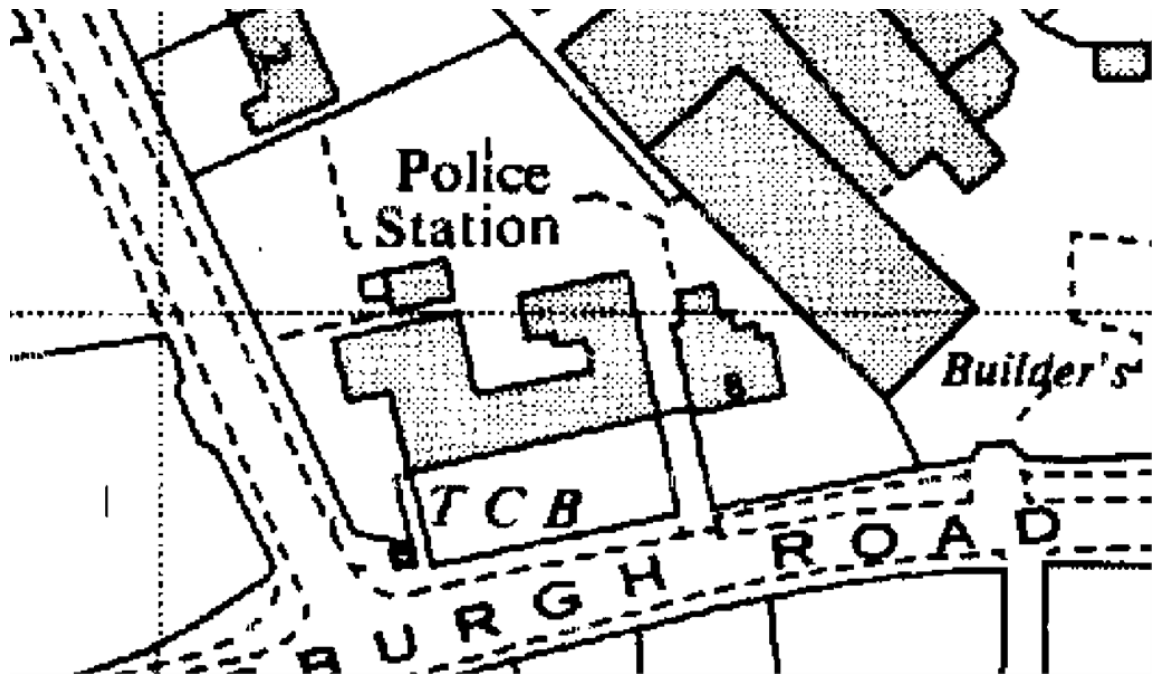
Figure 4. The 25 inch Ordnance Survey of 1976, showing the station with its present outline, albeit without the detached boiler house (B in figure 8), and the Police House to the east. TCB indicates a telephone call box on the corner of Moor's Way. The 19<sup>th</sup> century sheds on the east are part of a builder's yard, as they remain today.

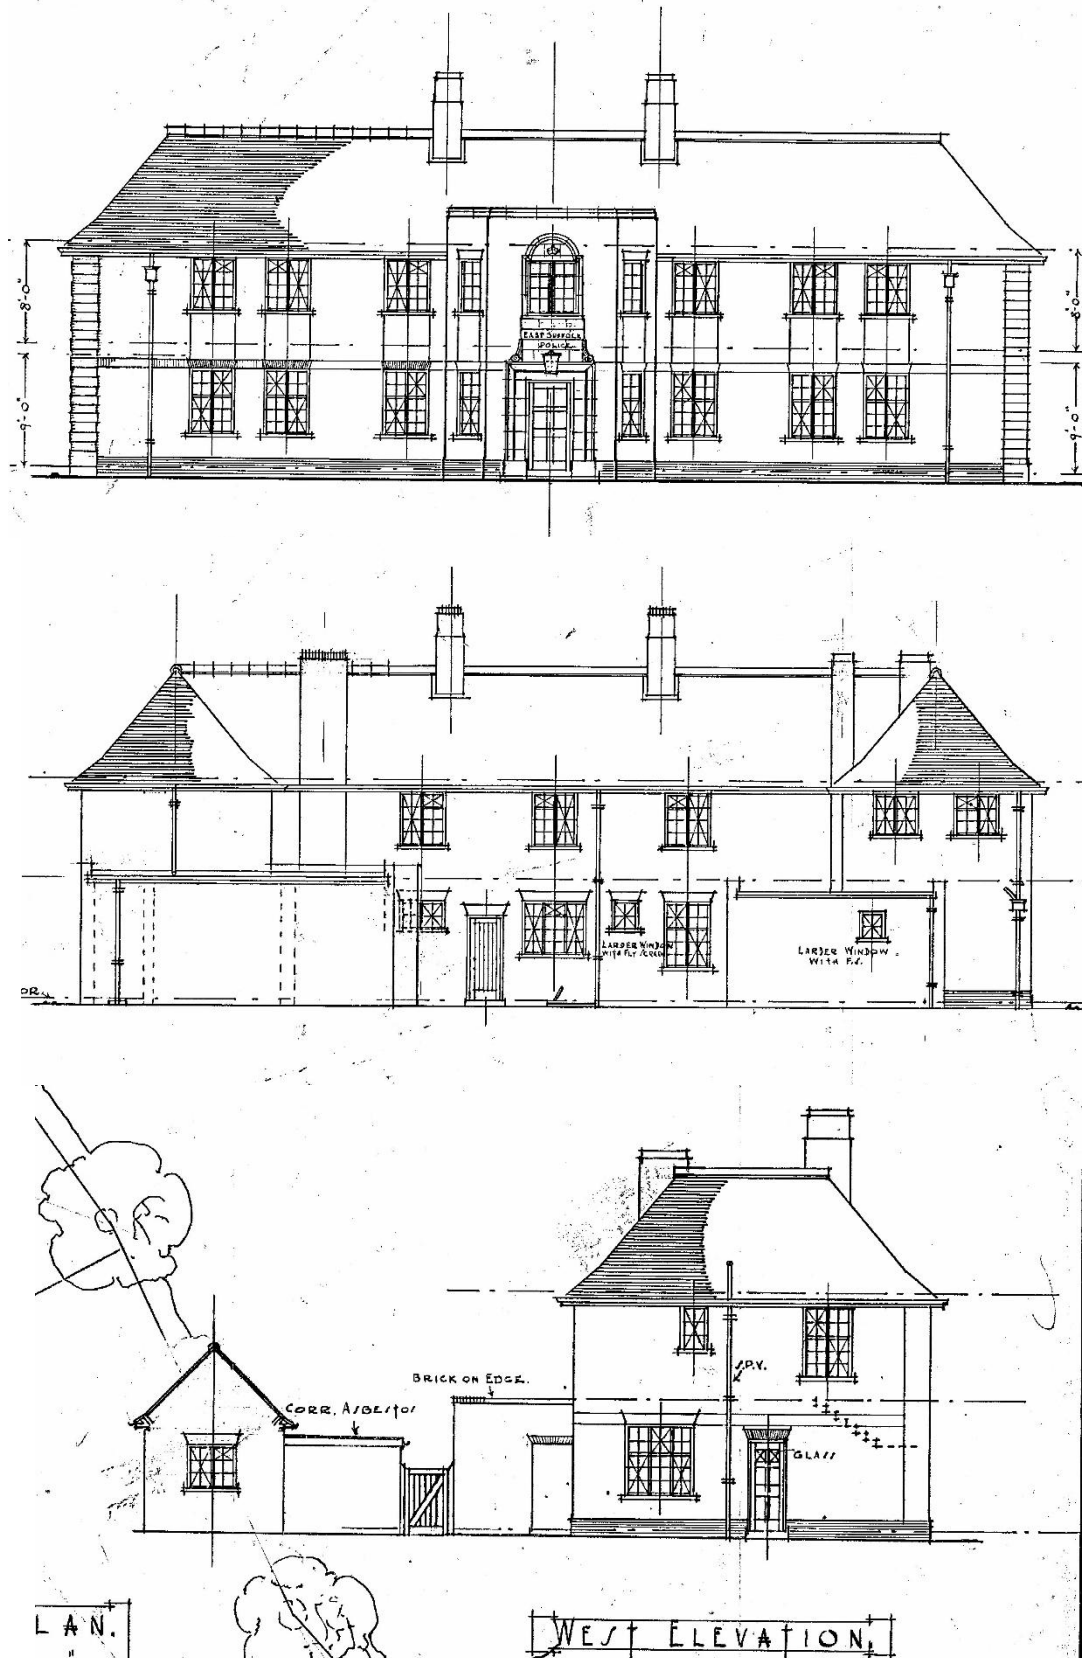
Figure 5b. The original elevations showing the southern façade (top) almost exactly as it remains today. The rear wings were less substantial, particularly on the upper storey, but their hipped rear gables are still visible.

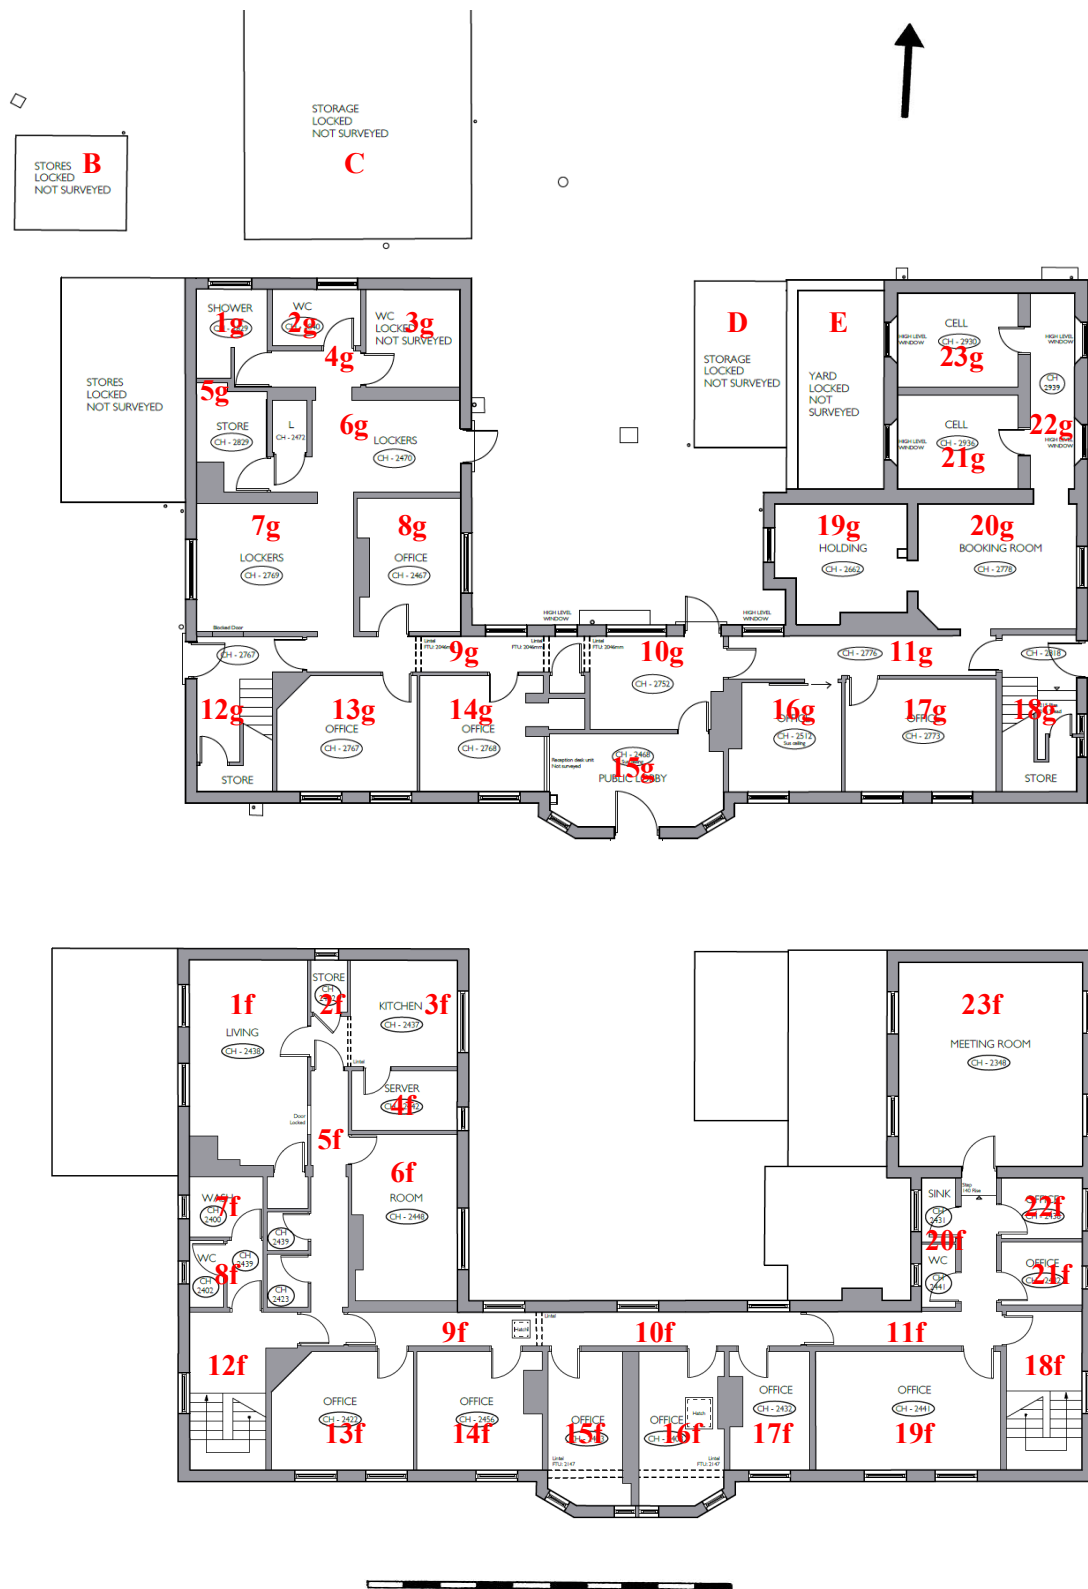
**Figure 8**  
**Ground (top) and first-floor plans of the main Police Station identifying each compartment for ease of reference in the text and photographic record. Adapted from a survey by Robert Hutson Architects. Scale in metres.**

Figures 5-8 illustrate the changing layout of the building. It originally consisted chiefly of residential accommodation for police officers and cadets, with the latter housed in 'cubicles' divided by screens on the first floor. The police force evolved in the 19<sup>th</sup> century as a military-style organisation staffed largely by single men living in communal 'barracks', and this persisted until real wages were increased during the third quarter of the 20<sup>th</sup> century. The charge room and two cells in the eastern rear wing of the U-shaped structure have remained largely unaltered (20-23g in figure 8), but the rest of the building was almost unrecognisable at the time of inspection, consisting of a series of identical offices stripped of fittings but with white-boards mounted on the walls and evidence of computer stations. Both rear wings were shorter initially, with hipped rear gables and single-storied projections to the north, but were later provided with upper stories to increase accommodation (in 1952 to the east and 1966 to

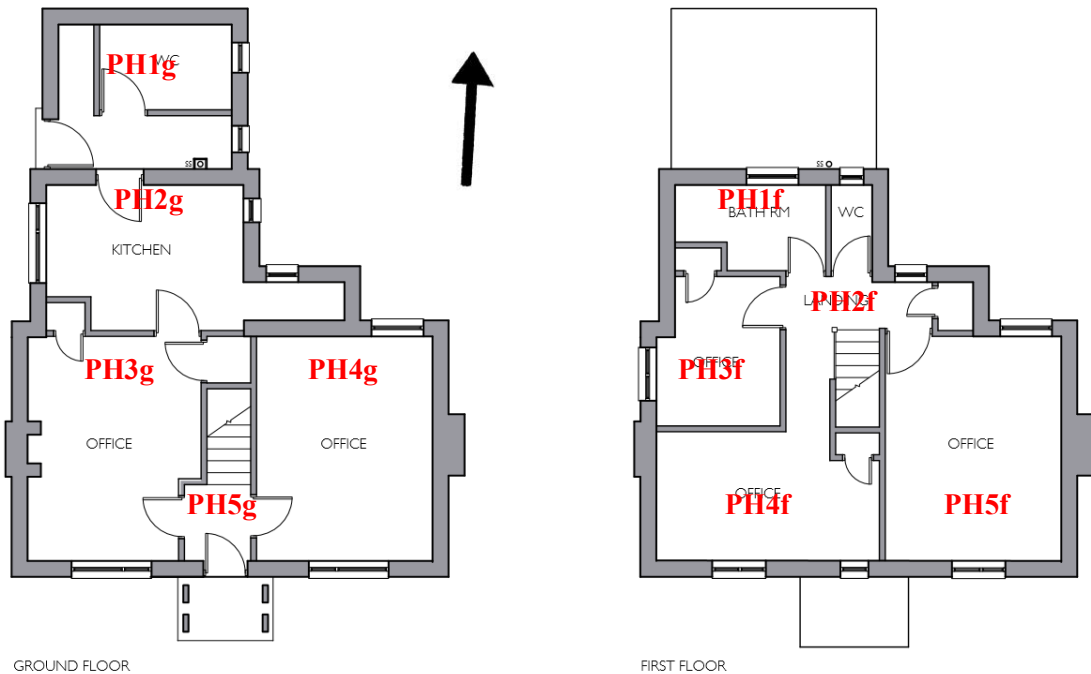
**Figure 9**  
**Ground and first-floor plans of the Police House to the east of the Police Station, identifying each compartment for ease of reference in the text and photographic record. Adapted from a survey by Robert Hutson Architects.**

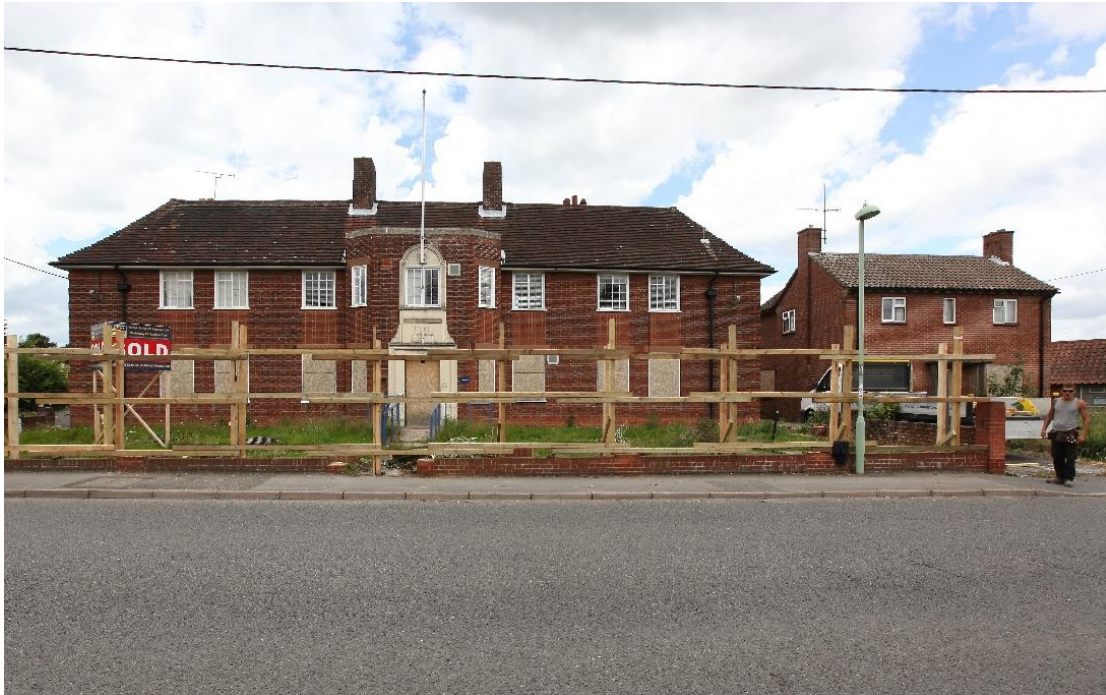
**Illus. 1. The distinctive facade of the 1930s Police Station seen from Grundisburgh Road to the south with the 1960s Police House to the right. (The perimeter fence is a modern addition in course of construction at the time of inspection.)**

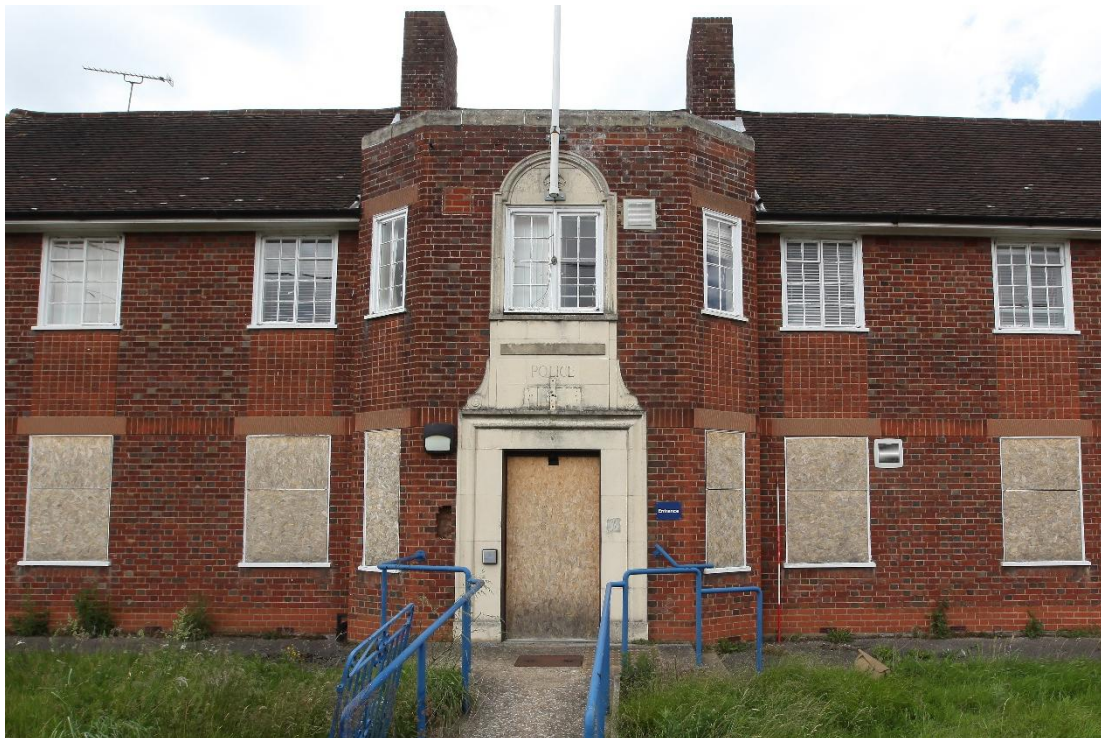
**Illus. 2. The symmetrical southern facade showing the stone detailing of the entrance porch with a crown behind the flagpole and the incised word 'POLICE' above the door. A blue lamp bearing the same word is shown in earlier photographs but has been removed. Note the original Crittall windows and the tiled panels between the ground and first-floor windows.**

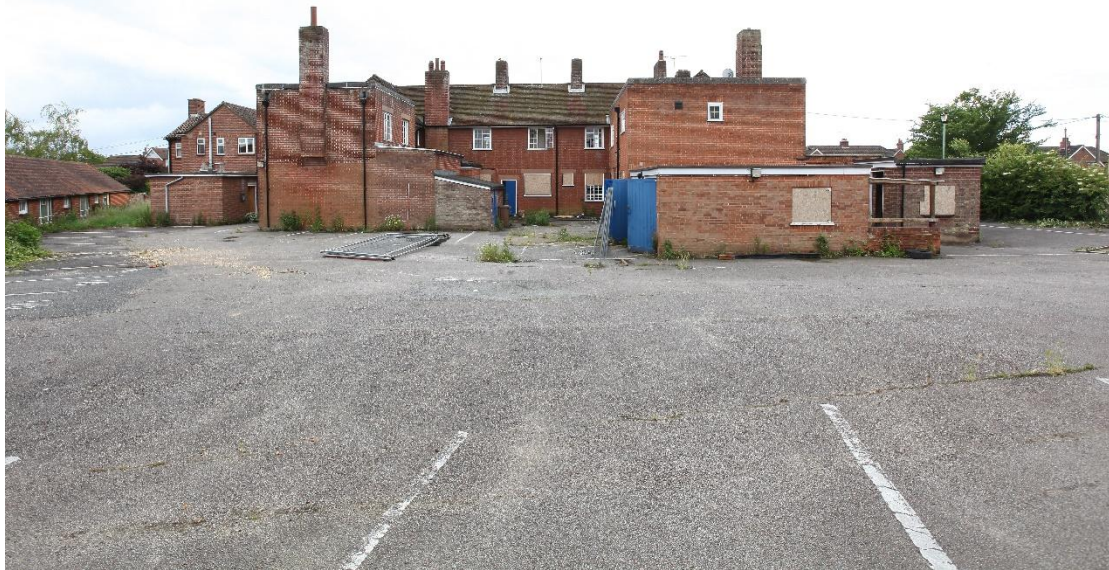
**Illus. 3. The site from the car park to the north showing the two projecting rear wings with the Police House and single-storied 19<sup>th</sup> century sheds on the left. In their present forms both square-ended gables are later additions and contrast with the elegant hips of their predecessors.**

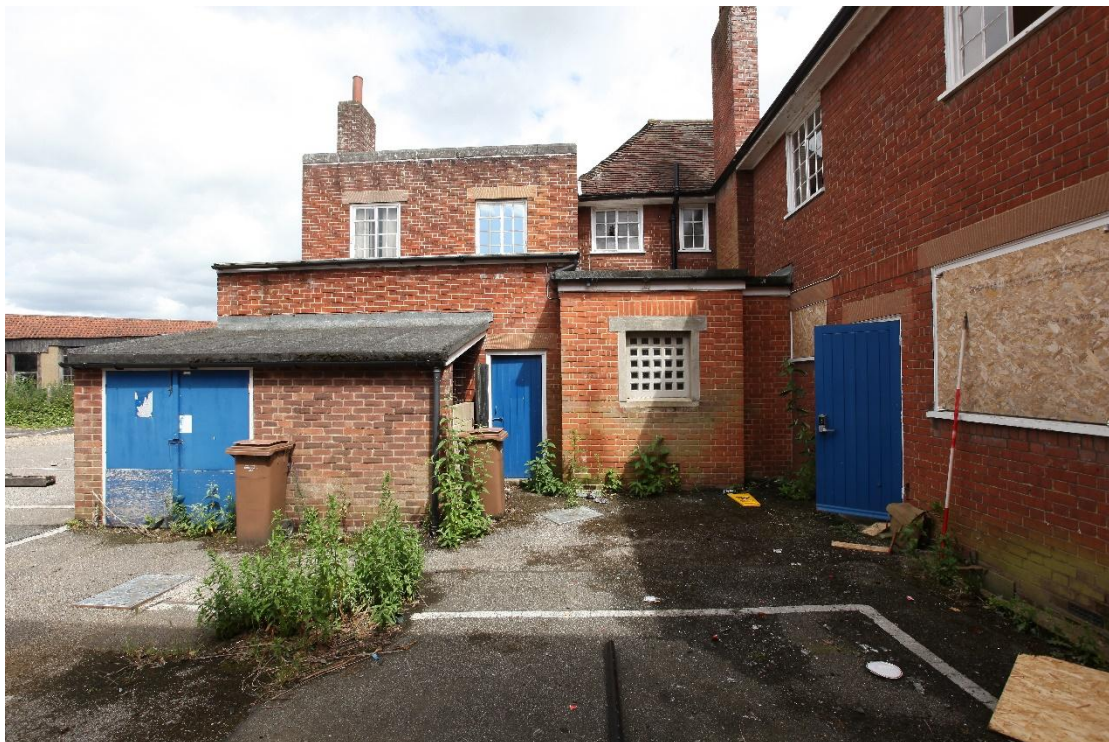
**Illus. 4. The eastern rear wing from the yard to the west showing the window of the juvenile detention cell (19g) in the centre and the enclosed exercise yard (E) to the left. The upper storey originally ended at the hipped gable above the juvenile cell and was extended in 1952.**

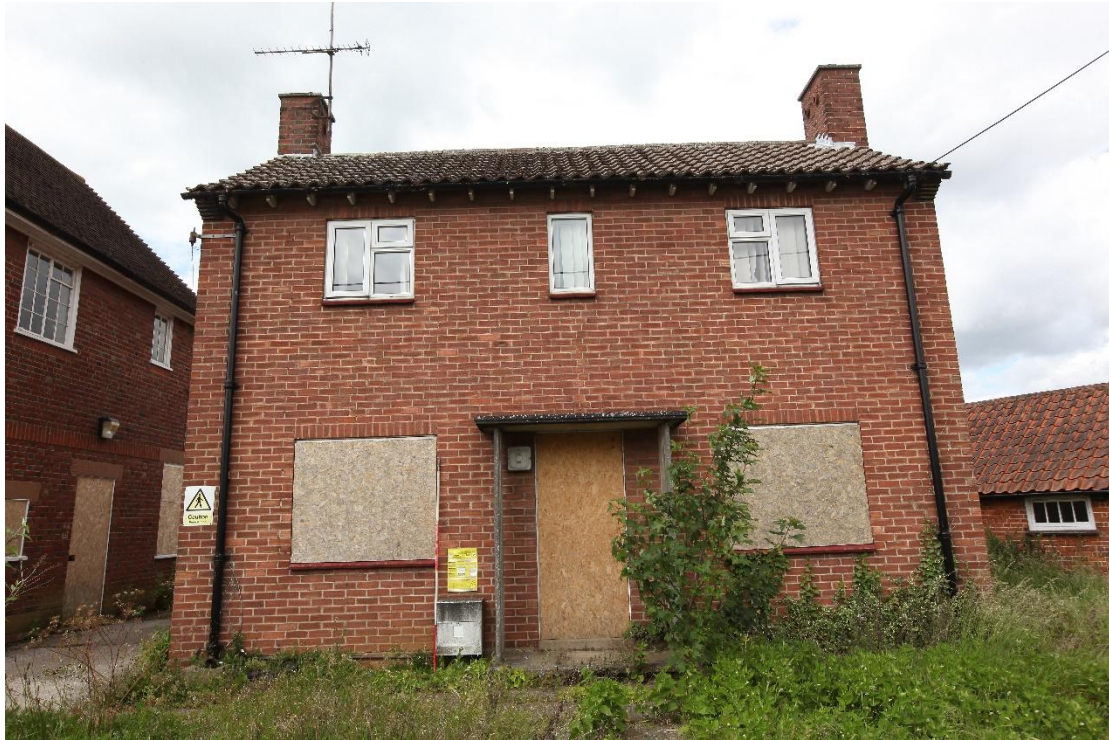
**Illus. 5. The southern facade of the 1960s Police House showing its later PVC windows with the main station to the left and the 19<sup>th</sup> century brick sheds to the right. The house operated most recently as additional office accommodation.**

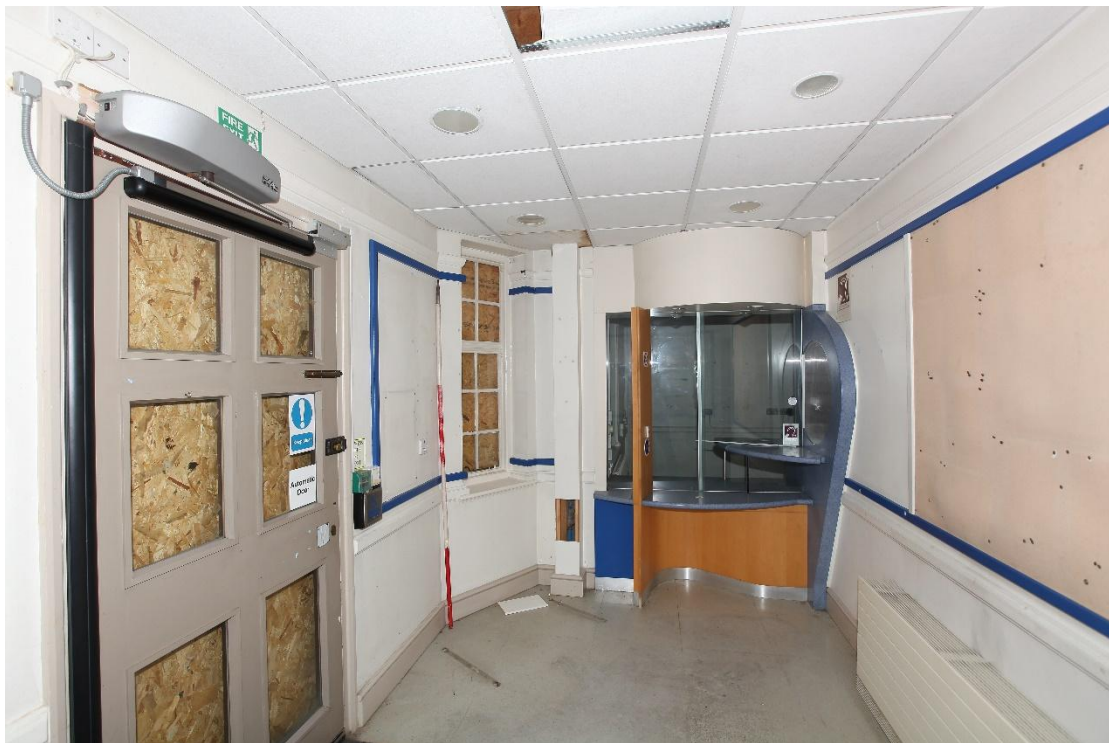
**Illus. 6. The interior from the east of the public lobby (15g) showing the reception desk with the central main entrance on the left and a notice board on the right.**

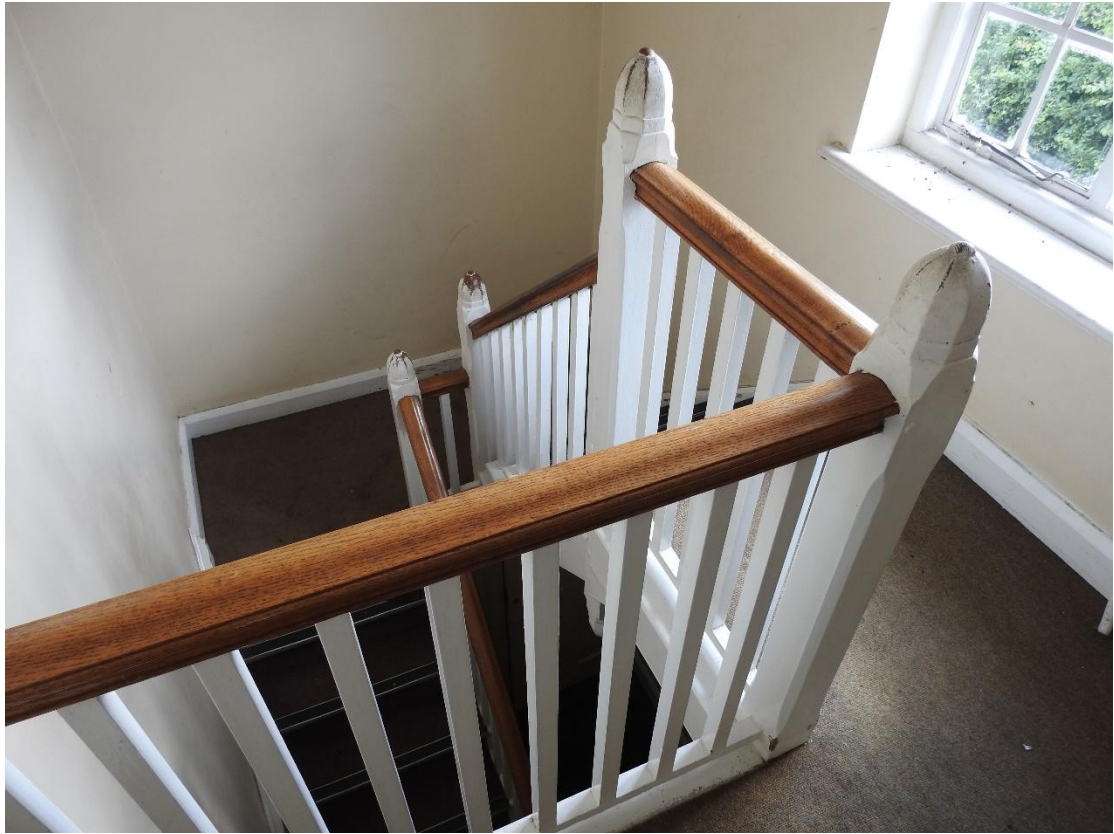
**Illus. 7.** The original main staircase at the western end of the building as seen from the first-floor landing (12f) to the north. The finials of the newel posts bear a striking and surely deliberate resemblance to contemporary police helmets.

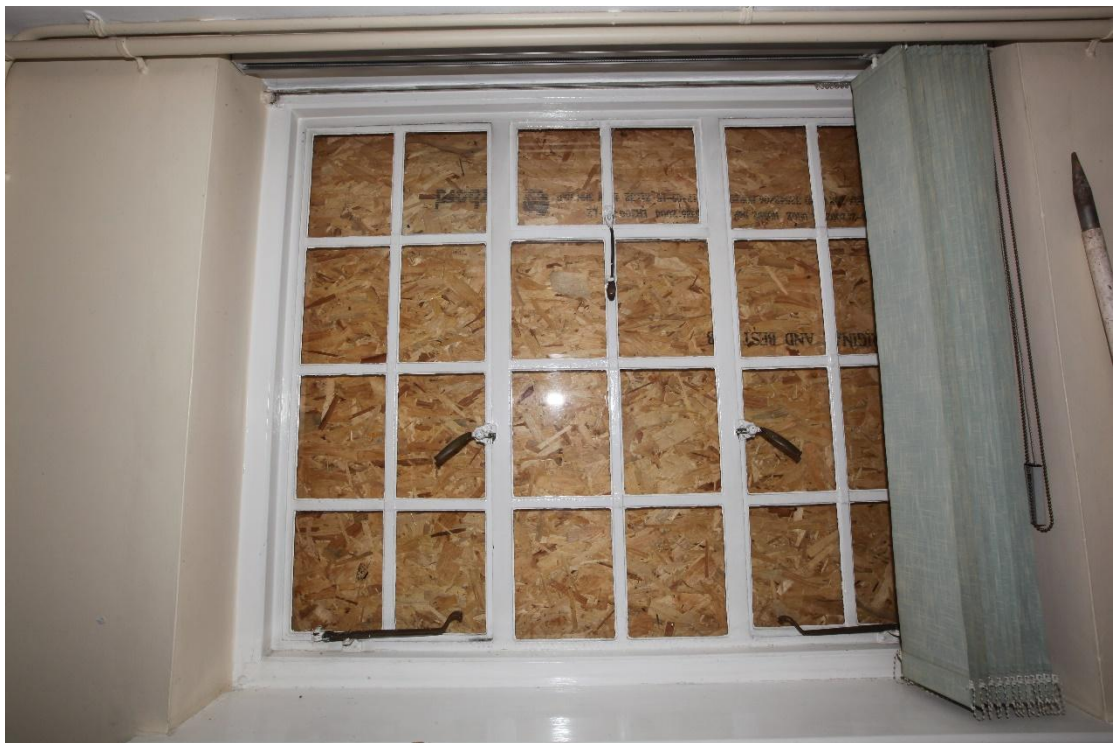
**Illus. 8.** An original metal-framed Crittall window, typical of those found throughout the building, with bronze handles, latches and catches. This example is in the eastern internal wall of the former constables' room, which was originally a kitchen (8g).

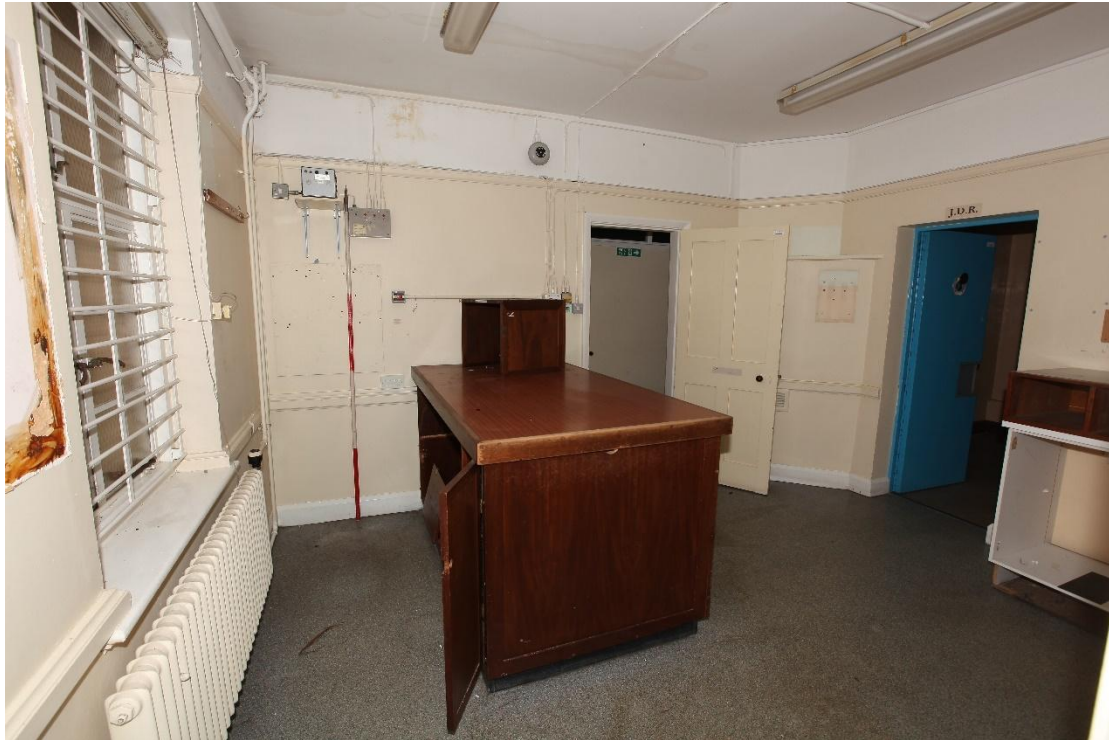
**Illus. 9. The charge room (20g) seen from the north, with the charge desk in the centre (facing right), the entrance from the main corridor (11g) in the rear and the blue-painted steel door of the juvenile detention cell (19g) on the right.**

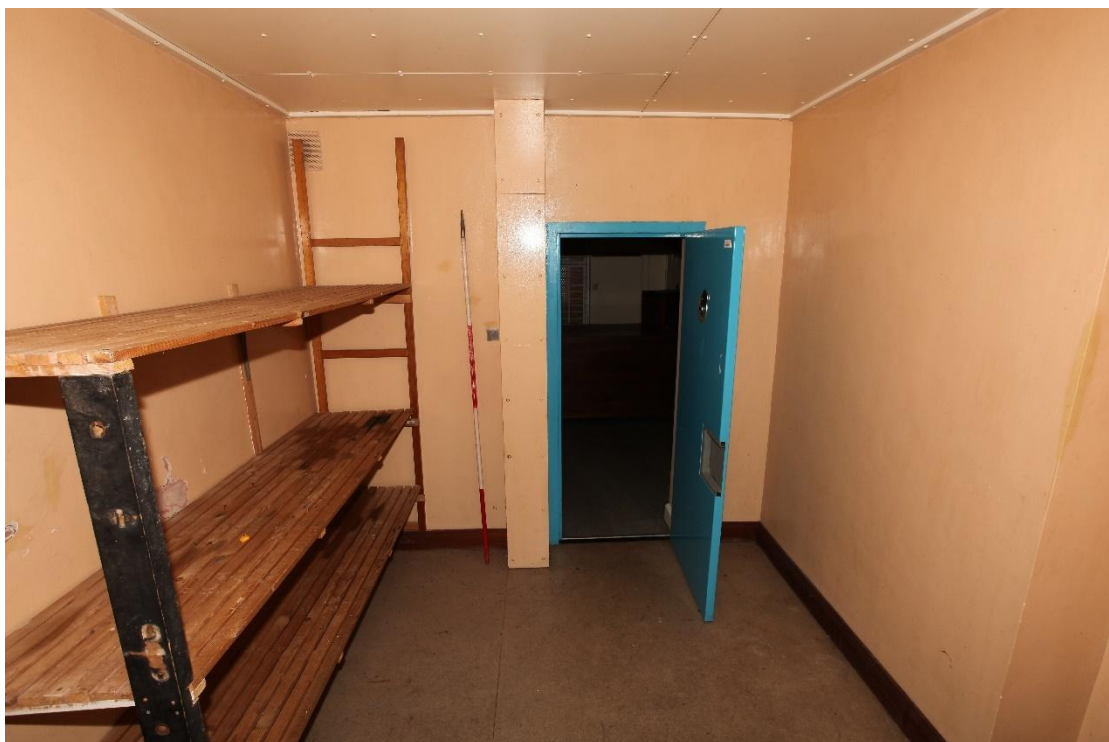
**Illus. 10. The juvenile detention cell (19g) from the west showing the steel door opening onto the charge room (20g). This cell is an addition of 1966 but was evidently converted into a storage shed in recent years as the shelving on the left is a modern insertion.**

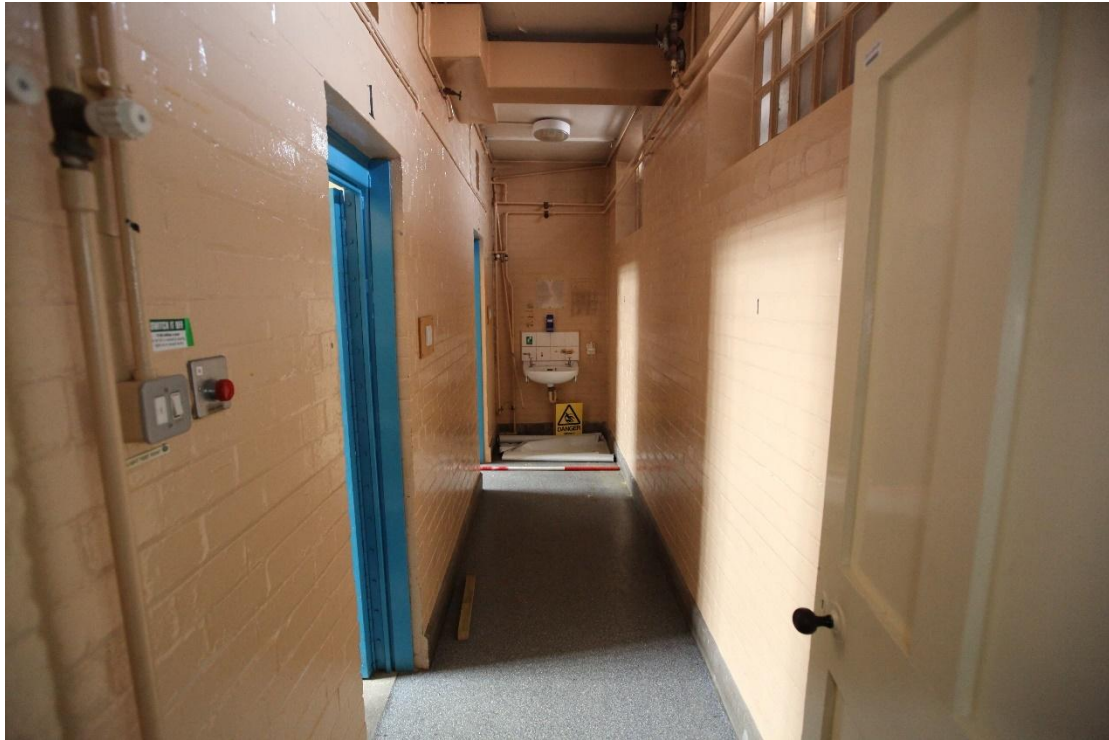
**Illus. 11.** The original cell passage of the 1930s (22g) seen from the south with the doors to cells 1 and 2 on the left. The number of each cell is painted above its door and on the opposite wall. The high windows of this passage are said on the original plans to have been re-used from Ipswich.

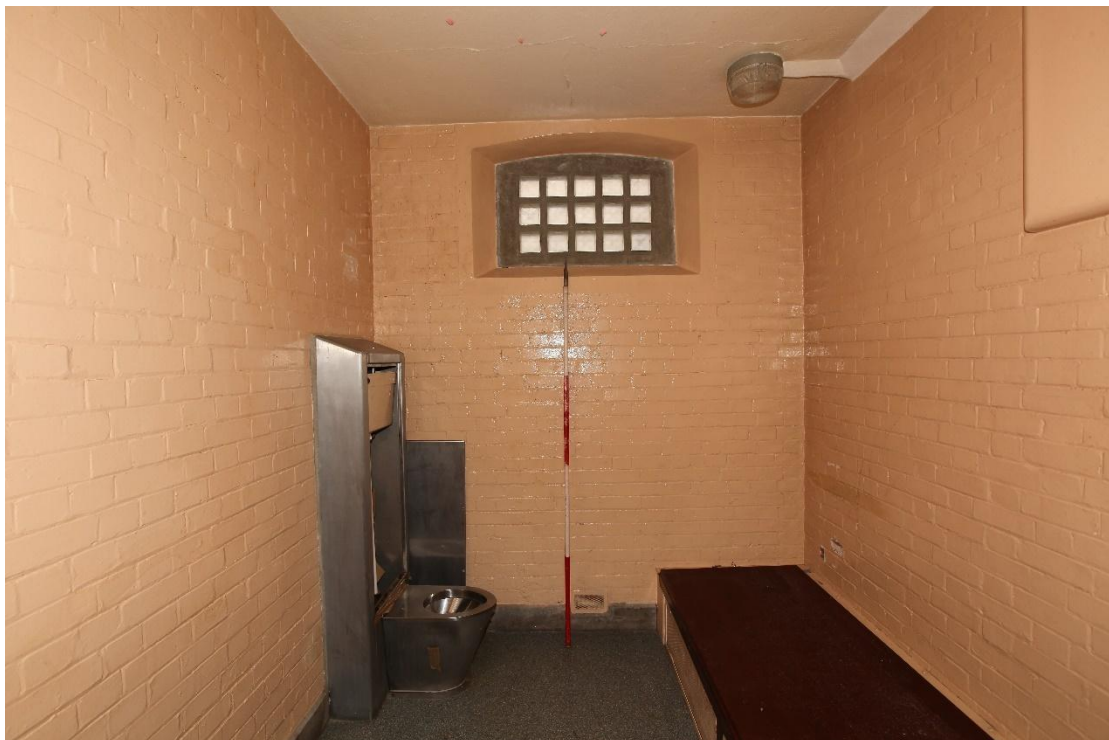
**Illus. 12.** The interior from its eastern entrance of cell 2 (23g) adjoining the northern gable on the right (identical to cell 1). The wooden bed-base on the right appears to pre-date the stainless-steel WC, which is a late-20th century insertion.

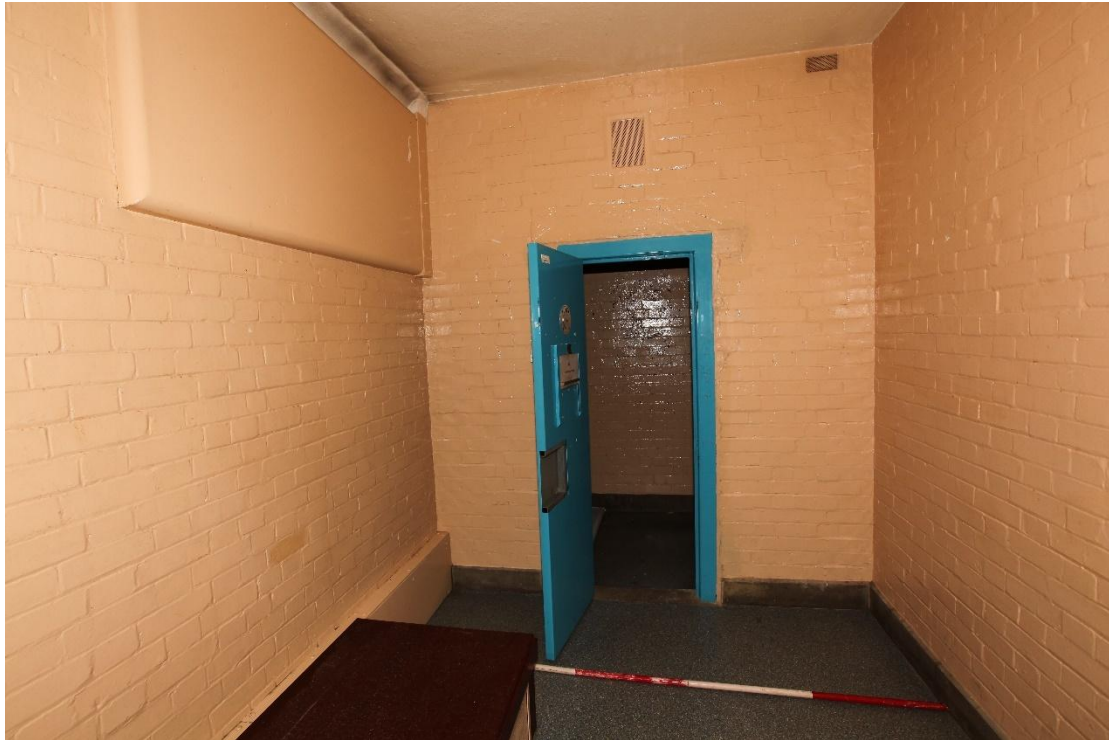
**Illus. 13. The interior of cell 2 seen from the west, showing its steel door, covered in incised graffiti, and wooden bed-base.**

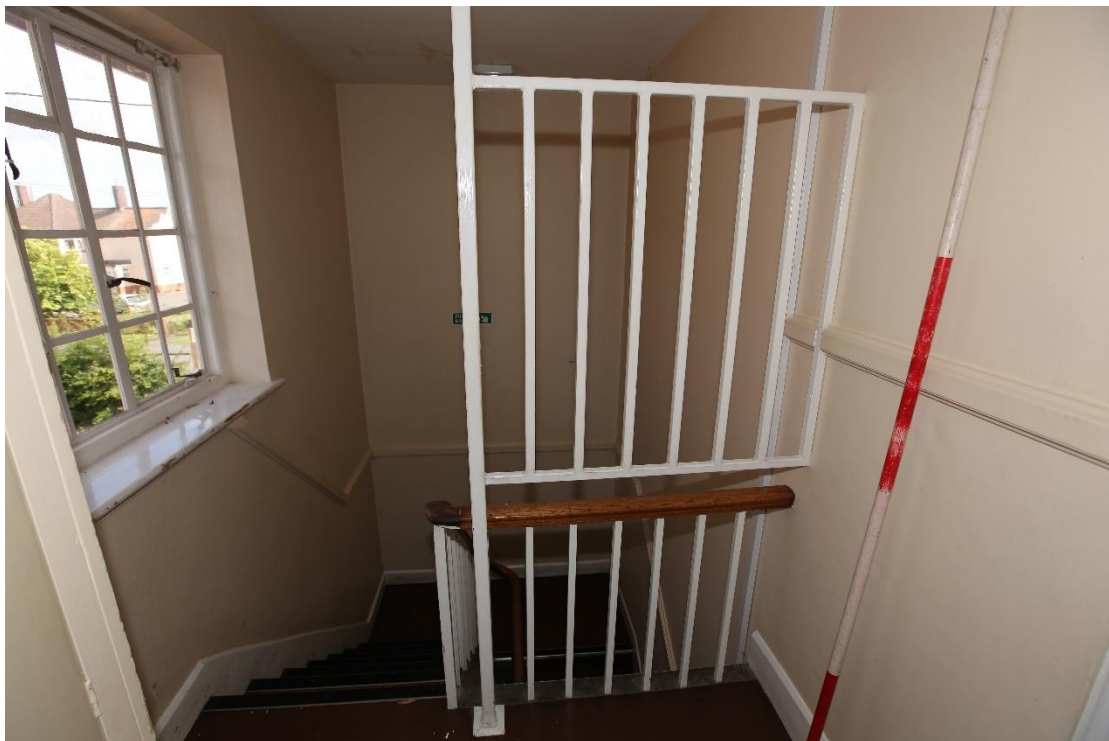
**Illus. 14. The first-floor landing of the relatively plain staircase (18f) at the eastern end of the main building, viewed from the rear (north). The steel bars are later insertions presumably designed to deter jumping. This stair initially linked the communal ground-floor mess and kitchen to the first-floor cadets' cubicles and constables' bedrooms.**

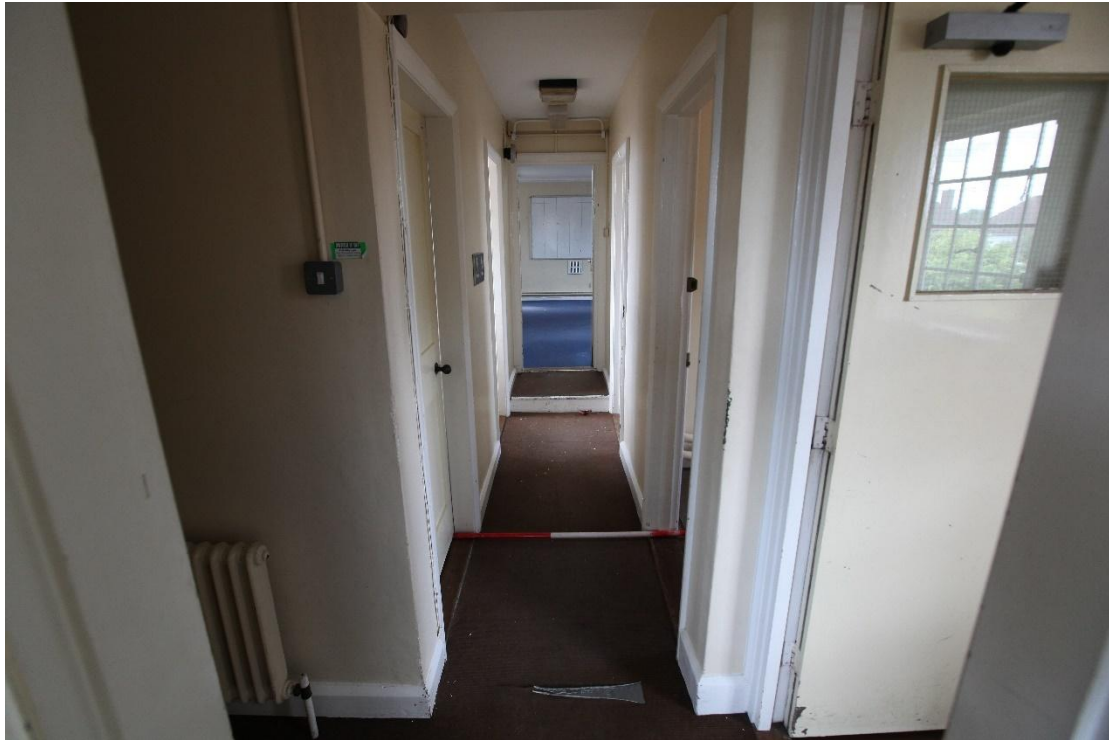
**Illus. 15.** The axial central first-floor corridor of the eastern wing (20f), seen from south, with the incident room (23g) in the rear and the door to the eastern staircase (18f) on the right. The appearance of this corridor is typical of those elsewhere in the building.

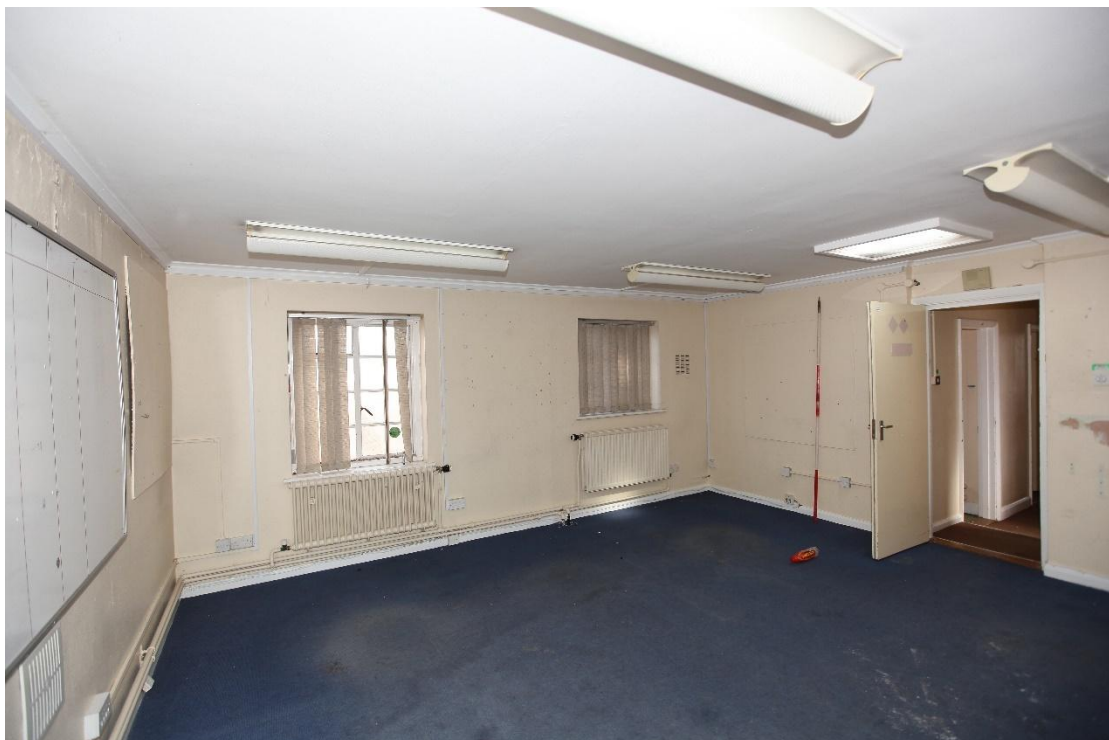
**Illus. 16.** The incident room at the northern end of the eastern wing (23f), as seen from west, with the central corridor (20f) on the right. Note the whiteboard on the northern gable to the left. Both the upper and lower storeys are characterised by almost identical offices of varying size, as is the interior of the former Police House. This room was added in 1952 as a ‘single men’s sitting room’.
