Lound to Gorleston Pipeline Archaeological Monitoring Off Hall Road, Lound, Suffolk

LUD 085

Archaeological Monitoring Report

SACIC Report No. 2018/006

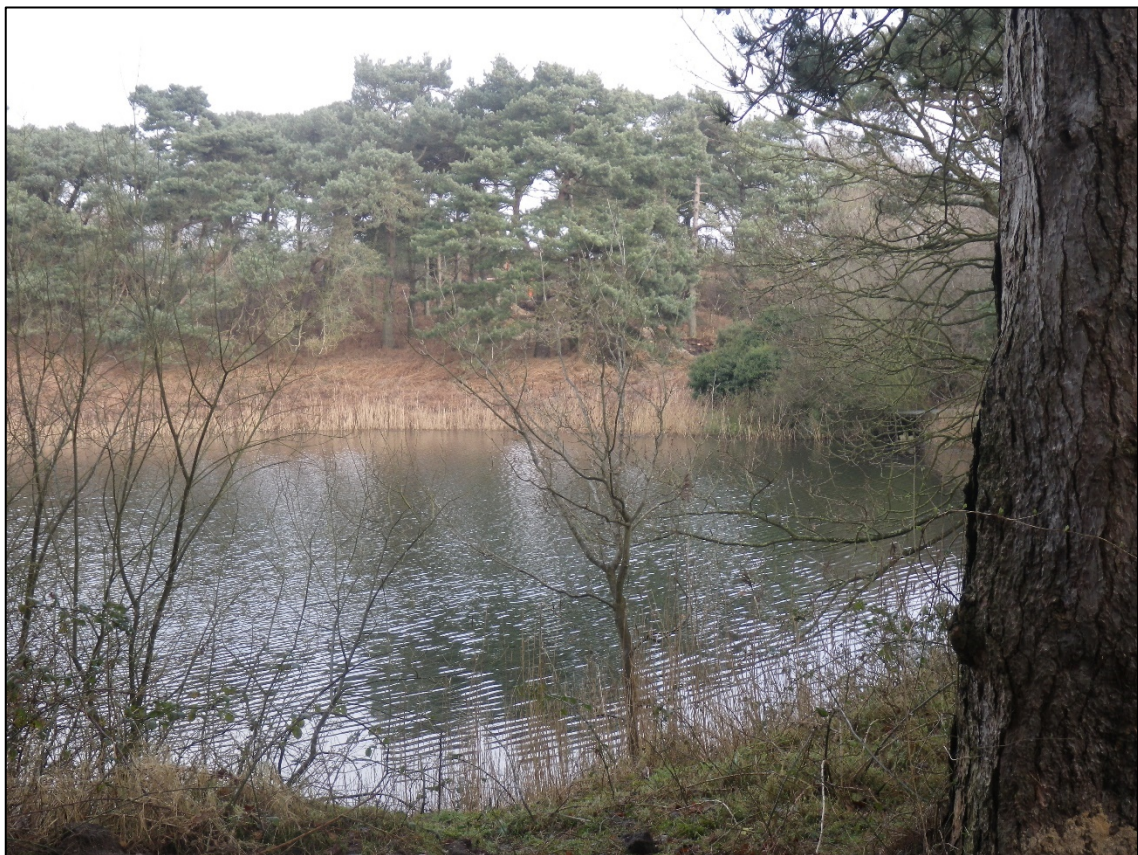
Plate 4. Location of monitored area shown in the distance, on the bank beyond the reservoir (facing northeast)

The reservoirs are first shown on the 1906 county series OS map. Prior to this, the water treatment works is shown on the 1884 Ordnance Survey map, with small buildings on the location of the current site and the words 'liable to floods' on the area that is now a reservoir. There was a Methodist chapel opposite the current site, on the east of Hall Road. It is possible that some of the spoil (redeposited sand) from the excavation of the reservoirs around 1900 was deposited on the current site, as the trees growing on the site are relatively young. The ground disturbance is likely to be from modern activities related to the water treatment works.
