## Dunwich Heath, Cable Duct Installation

### Dunwich, Suffolk

Archaeological Monitoring Report

SACIC Report No. 2018/015

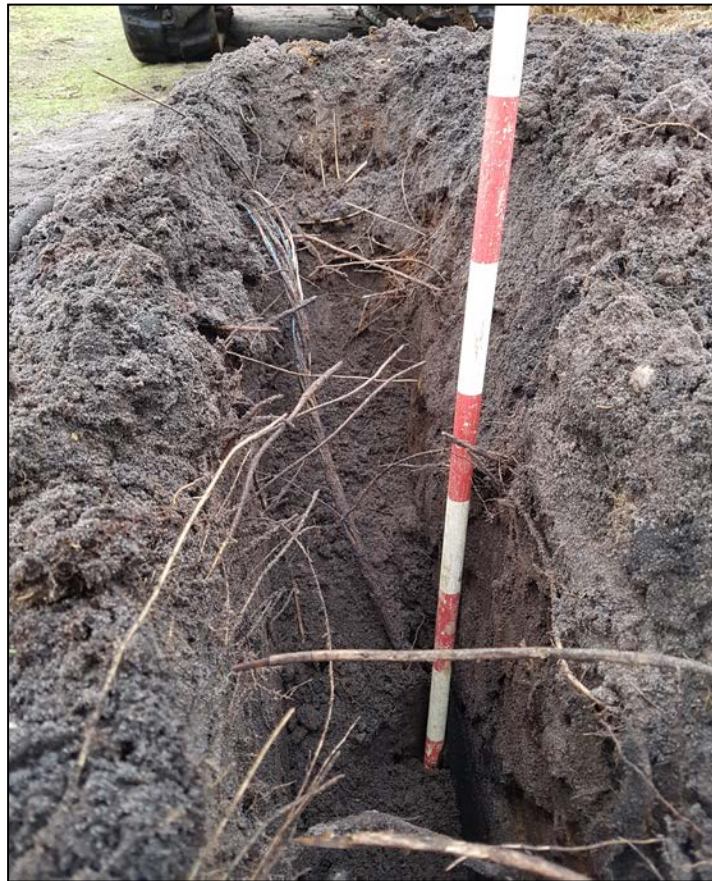
Plate 1. Item A: probable communications cable (camera facing S)

They lay to the west of the excavated duct trench and were not disturbed by these works although an electrical cable crossed the trench at a depth of c.0.4m (Plate 1) and on an alignment that would take it between the central two concrete pads. This cable

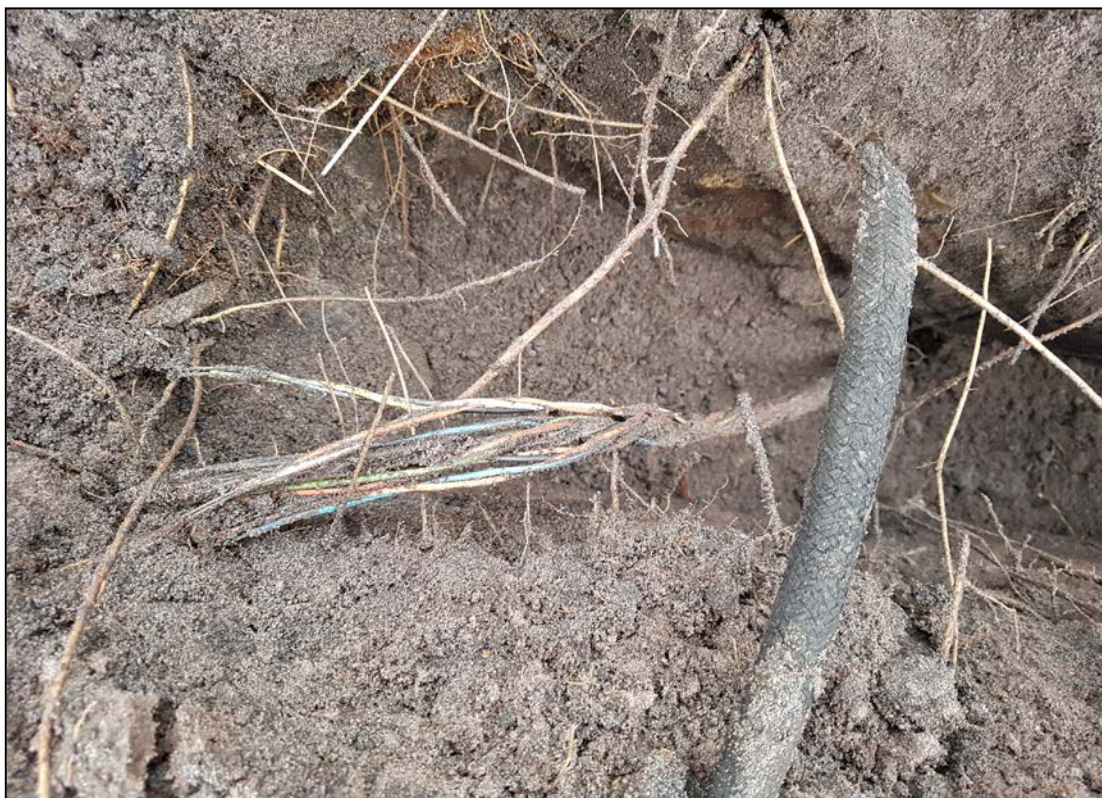
Plate 2. Item A: probable communications cable, the insulation, which was removed during excavation, is to the right (camera facing N)

was sheathed in an insulating material and contained multiple, individually insulated, wires (Plate 2) suggesting it was a communications cable rather than a power supply.

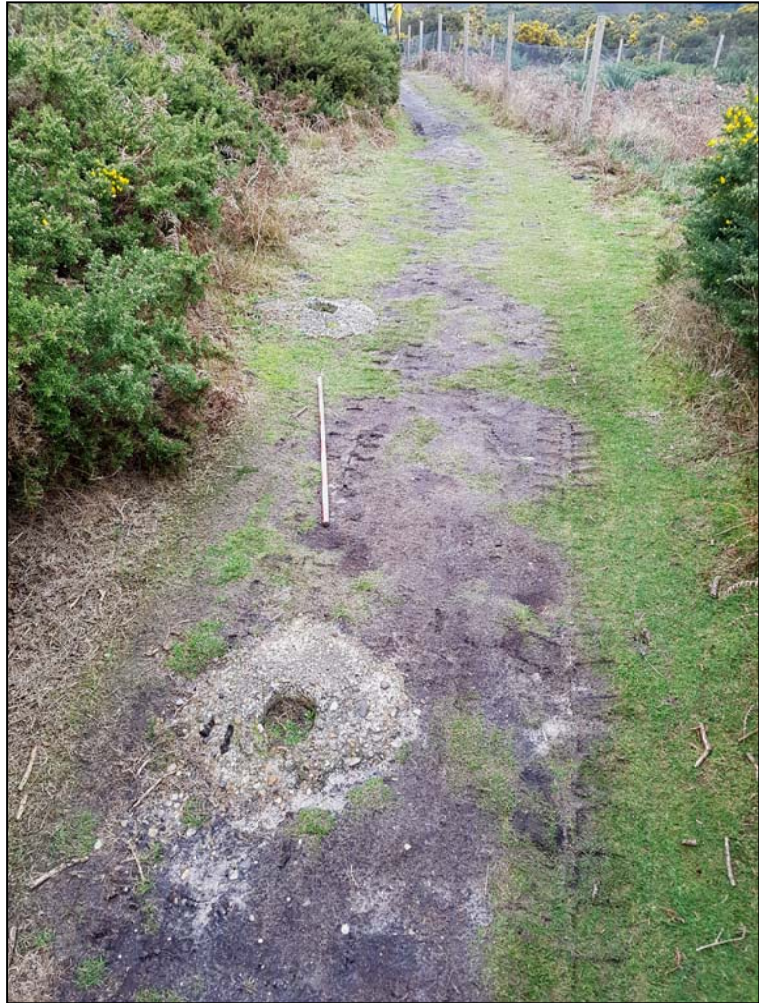
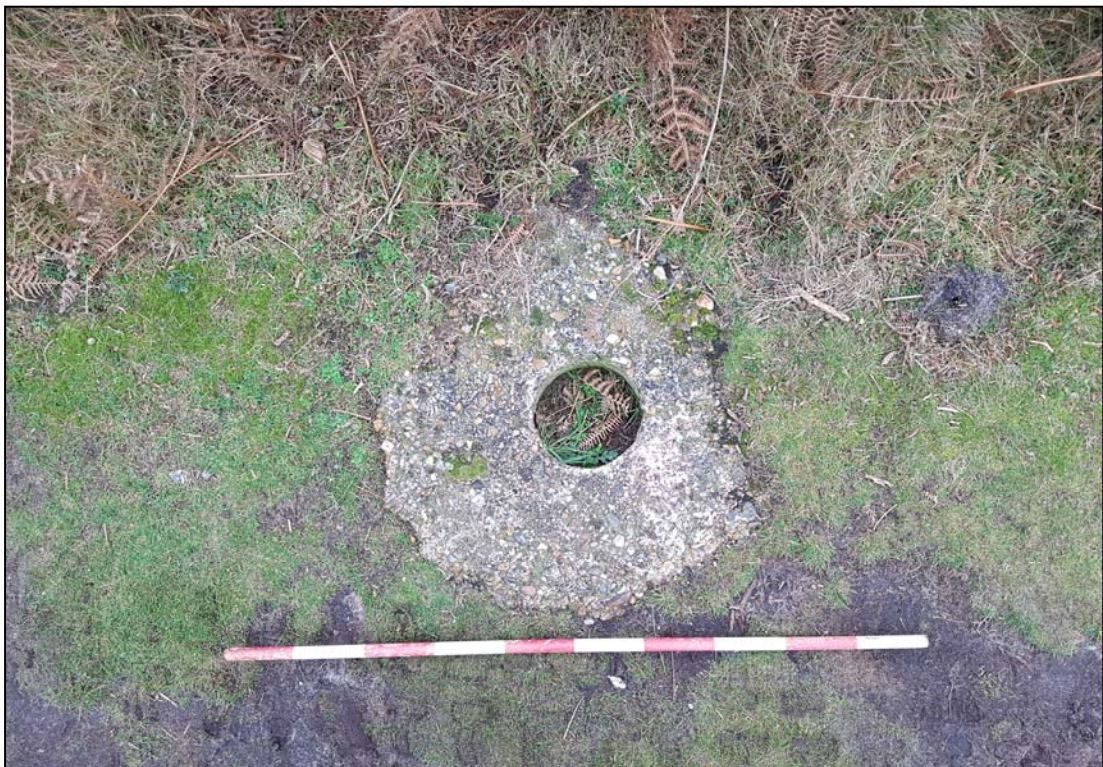
**Item B:** A further group of four concrete probable 'post settings' of similar dimensions, spacing and alignment as those described above. Presumably a continuation of the same line (Plates 3 and 4). Again all were to the west of the excavated trench and were not disturbed. A fifth setting, the upper surface of which was located just below ground level, was discovered to the south, but off-set slightly to the east which placed it in the direct line of the trench and necessitated its removal. It was placed in the adjacent undergrowth, immediately to the west of its original location.

Plate 3. Item B, four concrete 'post settings' (camera facing N)

Plate 4. Item B, plan view of a 'post setting'

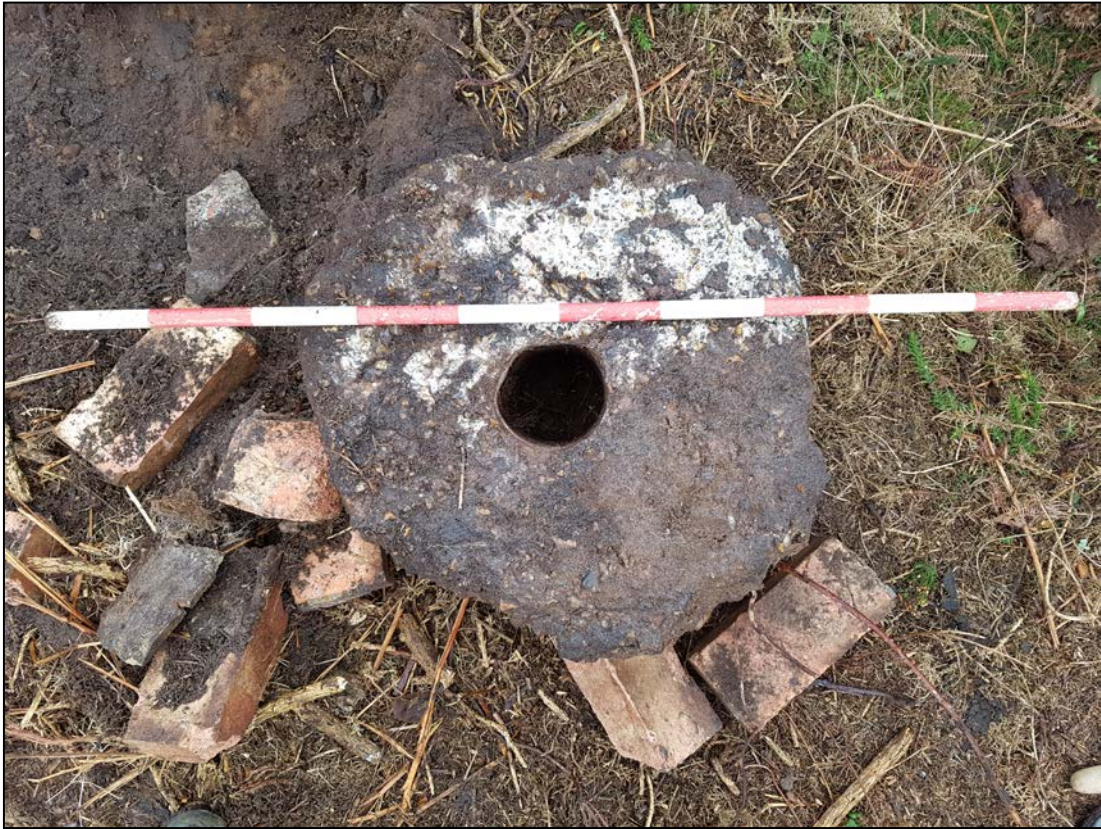
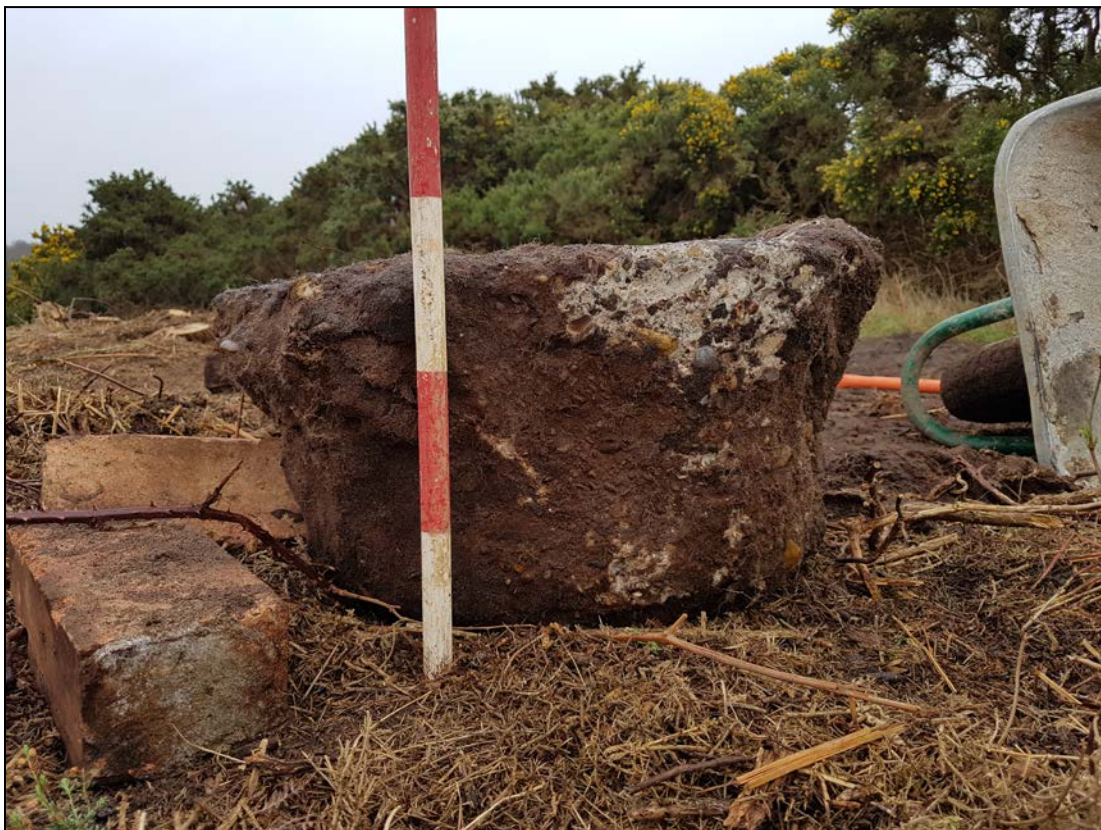
**Item C:** A single 'post setting', isolated with no obvious associated settings. Similar to those described above. The upper surface was situated just below ground level and consequently it was only discovered during excavation of the trench which necessitated its removal. Placed to the west side of the path. Measurements revealed it to be 0.5m in diameter and 0.28m thick, with a 0.12m diameter central hole (Plates 5 and 6). It could be seen that the concrete flared out slightly towards the top and that it was clearly formed by pouring concrete into a ready cut pit, which was roughly octagonal in shape, with the post presumably held *in situ*.

Plate 5. Item single C: single concrete 'post setting', after removal, plan view

Plate 6. Item C: concrete 'post setting', after removal, side view

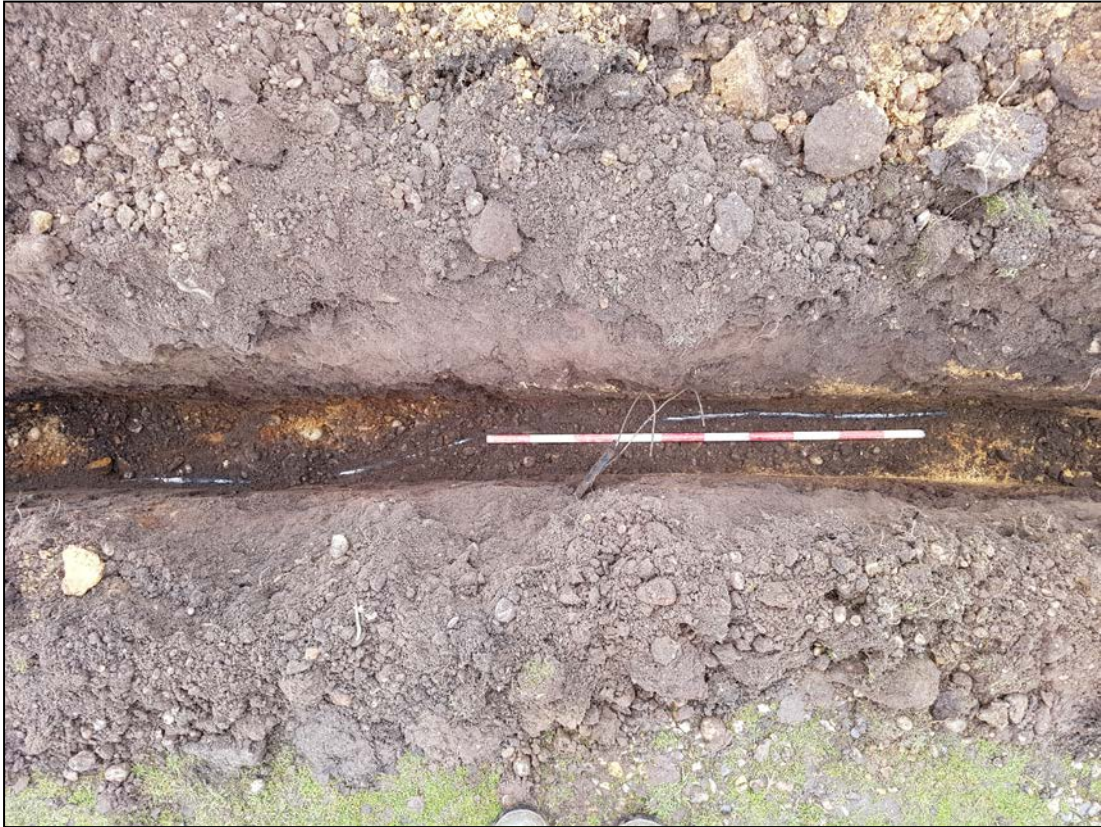
Plate 7. Item D: 'armoured' electrical cable with smaller cable crossing at higher level

**Item D:** A length of 'armoured' cable, probably part of an electrical supply running along the base of the trench at a depth of c.0.55m (Plate 7). In the same area a smaller electrical cable, consisting of two twisted wire cables within an insulating cover, crossed the trench on a perpendicular alignment at a depth of c.0.2m. Both these cables were located in the vicinity of a concrete slab (Plates 8) thought to be the base of the former 'guard room' as marked in Fig. 2.

The cables noted in the trench are likely to be parts of the telephone communications system and the site's internal power supply.

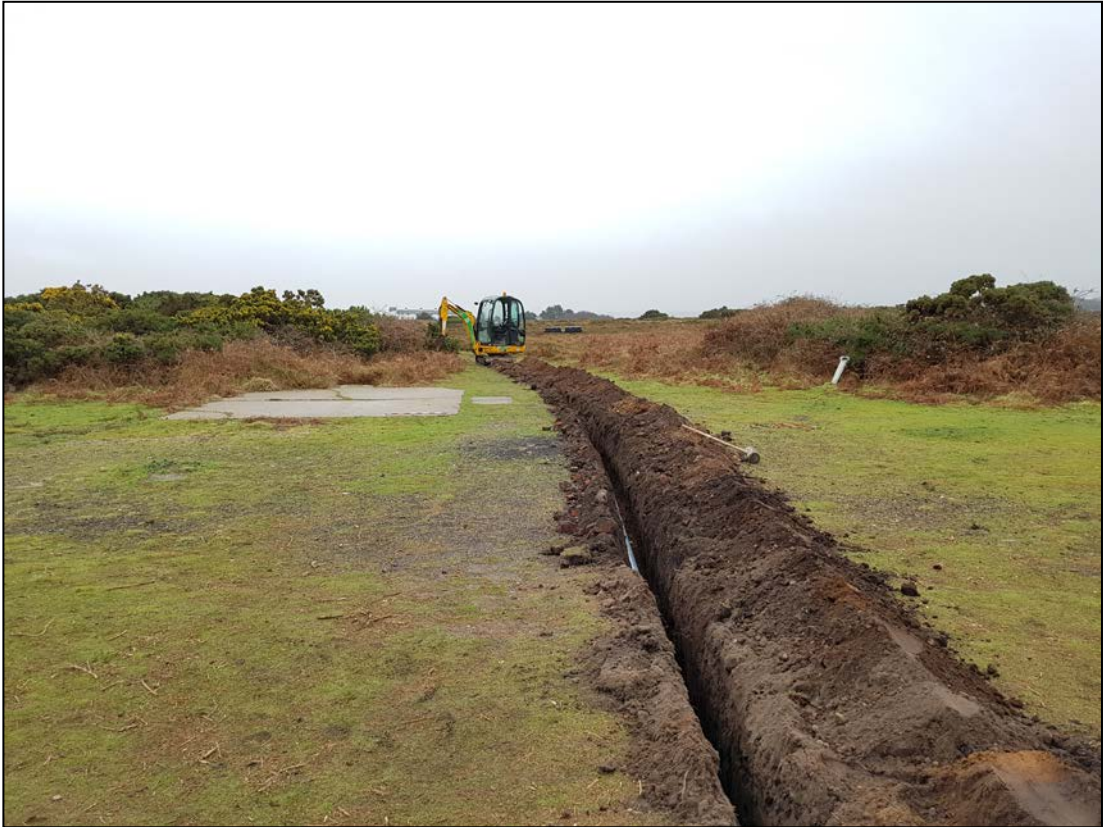
Plate 9. Base of guard room with trench running to the west (camera facing NE)

In the area to the northwest of the guard room frequent fragments of hardcore are visible on the surface (Plate 9) and brick rubble was evident in the topsoil in the vicinity of the excavated trench (Plate 10). The bricks primarily consisted of soft, unfrosted red bricks, many with mortar attached suggesting they had been used previously. The site plan (Fig. 2), shows a gap in the line of anti-tank cubes to the north of the guard room. This is likely to represent an entrance to the site, presumably via a trackway that ran to the west from Minsmere Road.

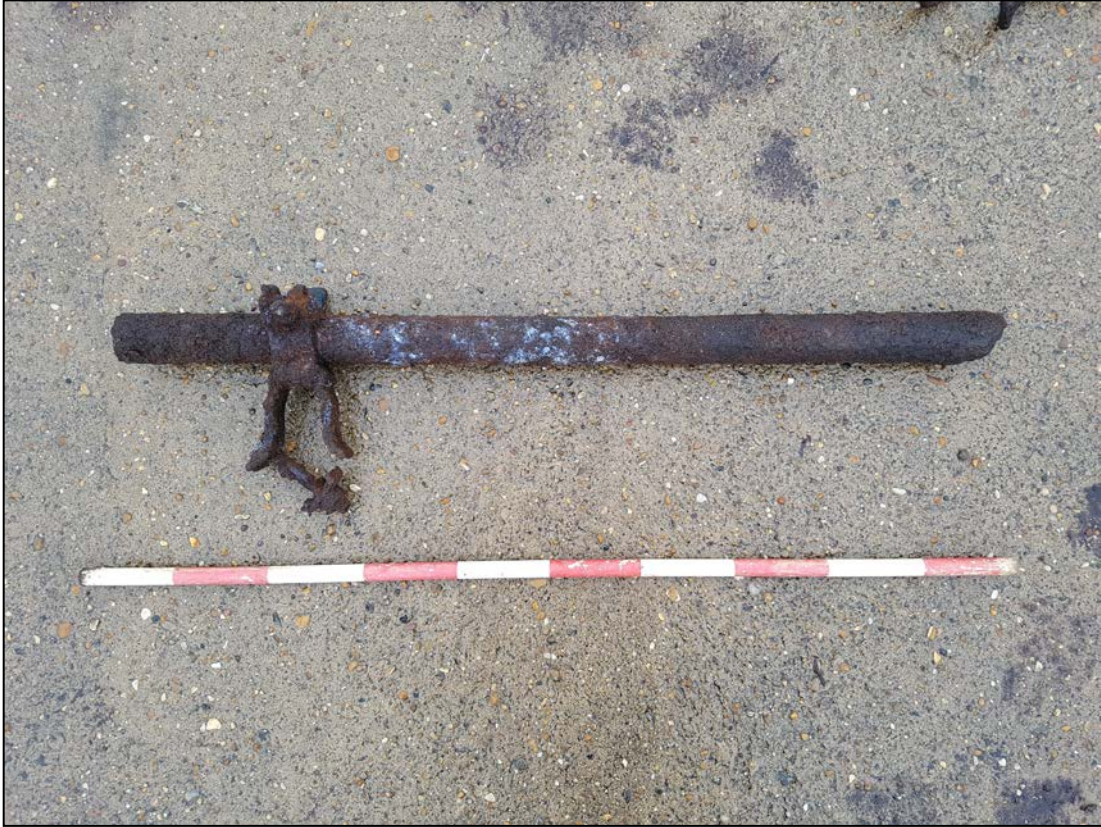
A handful of artefacts were also recovered in this area. They comprised; a length of scaffold pole with clamp (Plate 11), a short length of a 'pig-tail' type of fence post, either an end of line tether or possibly to hold a low trip wire, and various short lengths of barbed wire (Plate 12). These were returned to the trench upon its backfilling.

Plate 11. Length of scaffold pole with attached clip

Plate 12. Tether or possible trip wire support and fragments of barbed wire

The two scaffold poles found in the trenches are possibly related to construction work within the site although could potentially be remnants of the beach scaffolding defence that was positioned to prevent an attack by landing craft.

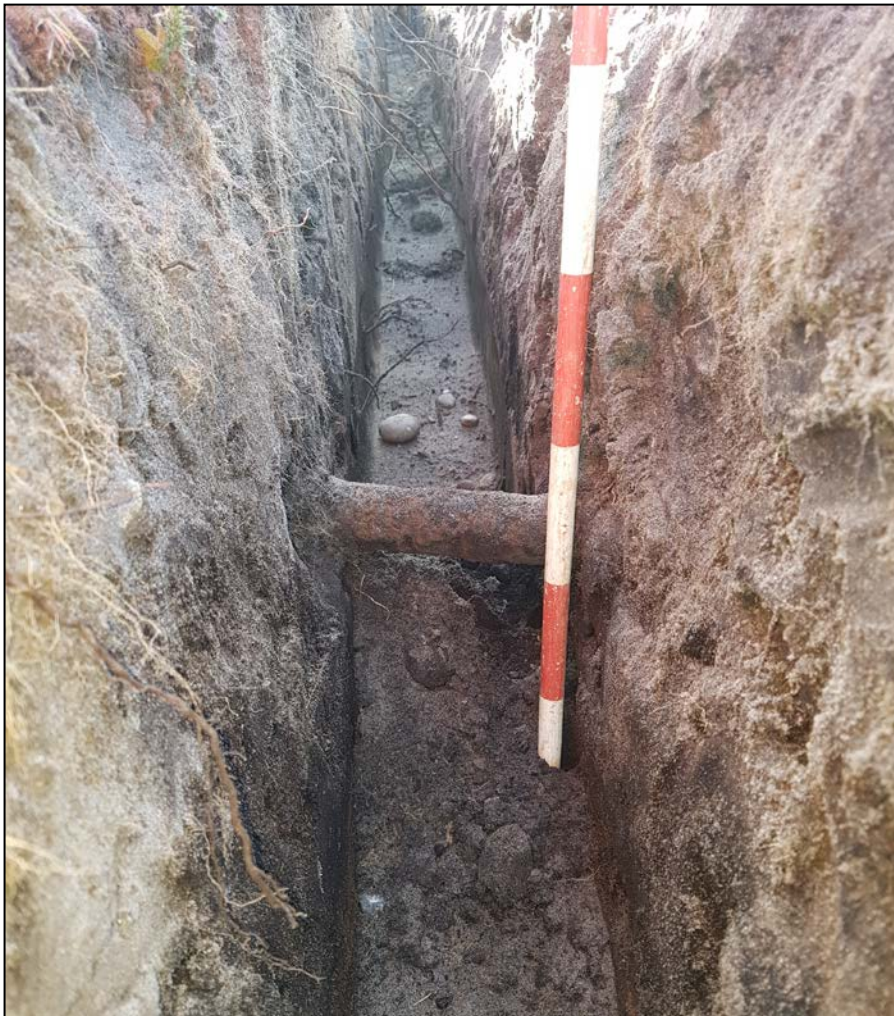
Plate 16. Item G: possible pipe of probable scaffold pole

**Item G:** A length of scaffold pole or possibly a water pipe running roughly perpendicular across the trench (Plate 16).

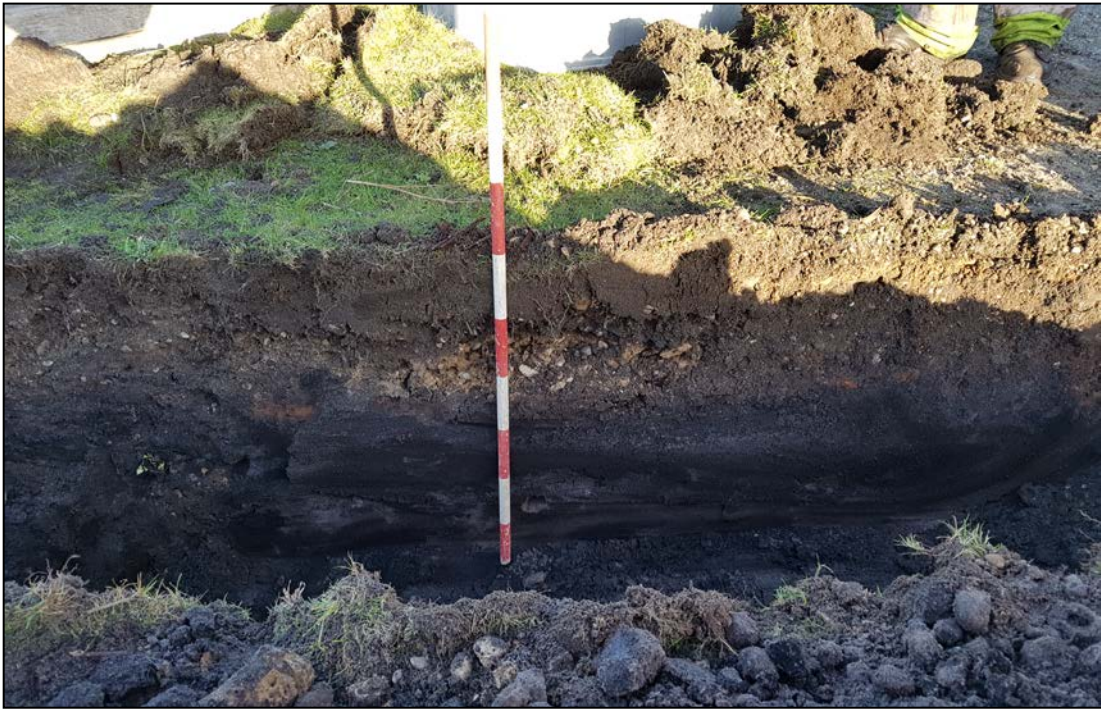
Plate 17. Item H: concrete surface (camera facing NE)

**Item H** Concrete surface/hardstanding located at the edge of Minsmere Road at the site of the junction with a track, of probable WW2 vintage, running to the west. It measured approximately 0.15m thick (Plate 17).

The concrete footings (Item F) are undoubtedly related to the buildings marked on the WW2 site plan to the west of Minsmere Road. The concrete surface (Item H) and the former road surface (Item I) are parts of the internal road system which was presumably enhanced during the military occupation to facilitate vehicle movements.

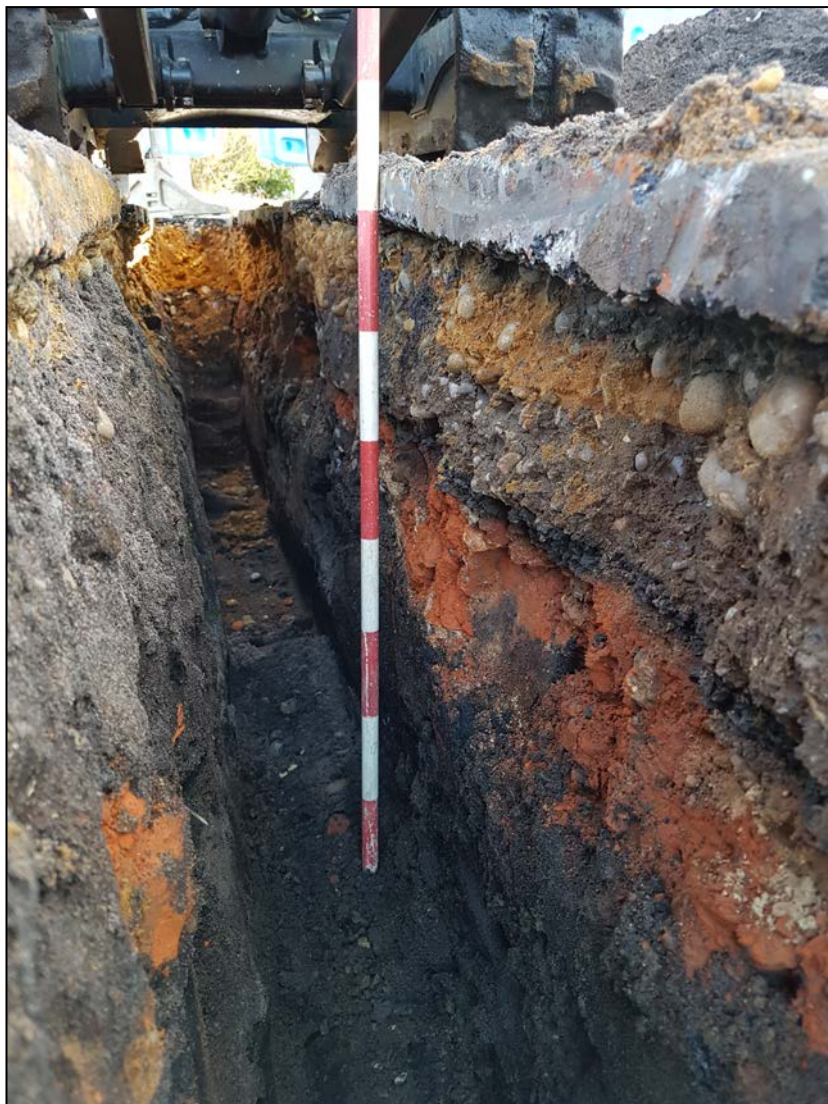
Plate 18. Item I cross-section through present road (camera facing SE)

**Item I:** The duct trench passed across Minsmere Road which revealed its make-up (Plate 18). The existing road surface comprised c.0.04m of tarmac over a c.0.15m thick base made of two layers of sand and gravel/shingle. This was laid over the top of an early surface that comprised a thin spread of tarmac over a c.0.15m thick layer of crushed red brick rubble which lay directly on the natural subsoil.
