## ARCHAEOLOGICAL MONITORING REPORT

SACIC REPORT No.: 2018/022	Parish: Ickworth
<b>Ickworth House Test Pits</b>  <b>IKW 030</b>	Planning Application No.: N/A
	OASIS No.: suffolka1 – 311366
Address: Ickworth House, Ickworth, Bury St. Edmunds, IP29 5QE	Grid Reference: TL 81521 61380
	Number of Site visits: One
	Date of visit: 8-3-2018

Four small test pits were opened to the rear of the west wing of Ickworth House on the west wing terrace, to examine ground composition and structural details of the vaults and suspected drainage system. Modern made ground deposits were identified laying directly over the vault structures.

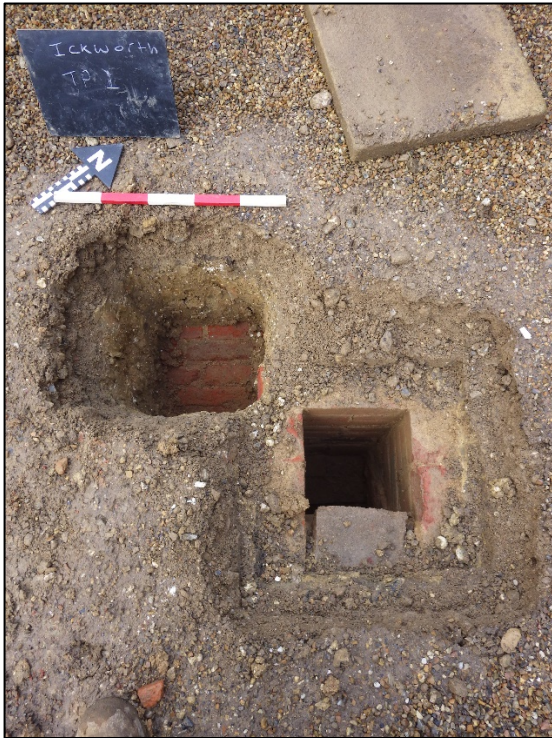
Plate 1: Test pit 1, looking west, 0.5m scale

Test pit 1 comprised two small adjoining square excavations. The northern excavation measured 0.6m x 0.6m and 0.15m deep. Three modern stone slabs were removed revealing a vertical brick built shaft, 0005, of which the central void was 0.25m wide and approx. 2m deep. The brick shaft was constructed of handmade 9" soft red bricks bonded by lime mortar. The southern excavation was excavated to reveal the brickwork of the vault ceiling and to investigate the relationship between the brick shaft and the vault structure. The excavation measured 0.35m x 0.35m and 0.7m deep and comprised the modern made ground deposits of gravel, 0001, overlying a yellow grey clay with frequent chalk nodules and large flints, 0003, that in turn overlay the vault structure 0004. The vault structure and the brick shaft were bonded together and are therefore contemporary.

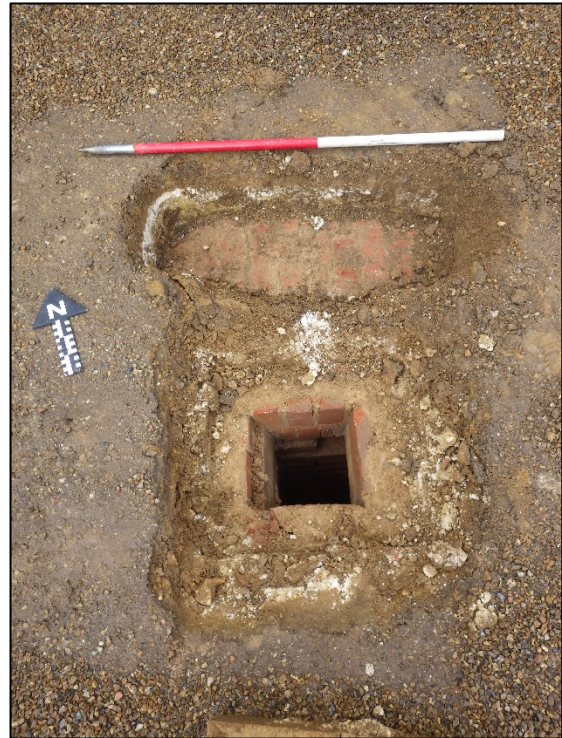
Plate 2: Test pit 2, looking north, 1m scale

Test pit 2 comprised two small adjoining excavations. The northern excavation measured 0.24m x 0.9m and 0.13m deep and comprised modern made ground deposits 0001, a chalk deposit (0002) and 0003. The apex of the brick vault ceiling, 0007, was revealed directly beneath deposit 0003. The southern excavation measured 0.45m x 0.55m and 0.15m deep. A modern stone slab was removed revealing a vertical brick built shaft, 0007, constructed of handmade 9" soft red bricks bonded by lime mortar of which the central void was 0.24m wide and approx. 2.5m deep.

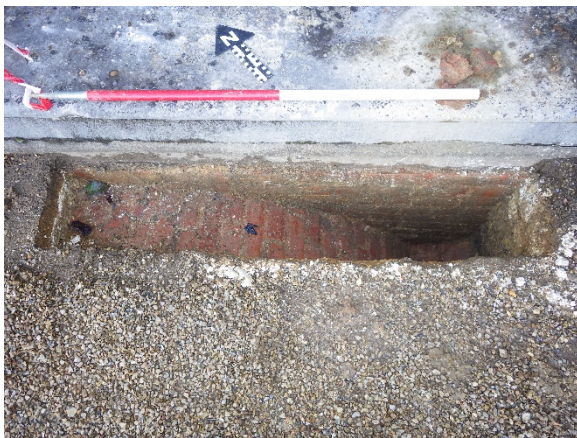
Plate 3: Test pit 3, looking north, 1m scale

Test pit 3 was excavated to identify the relationship between the brick vault structure, 0008, and a brick foundation wall, 0009, supporting the stone steps to

the south of the west wing. Test pit 3 measured 0.3m x 1.5m and 0.64m deep and comprised made ground deposits 0001, 0002 and 0003 that in turn overlay the brick vault structure. Both the wall, 0009, and vault, 0008, were constructed of the same materials however it was difficult to ascertain whether the brick vault structure and the brick foundation wall were bonded or abutting one another.

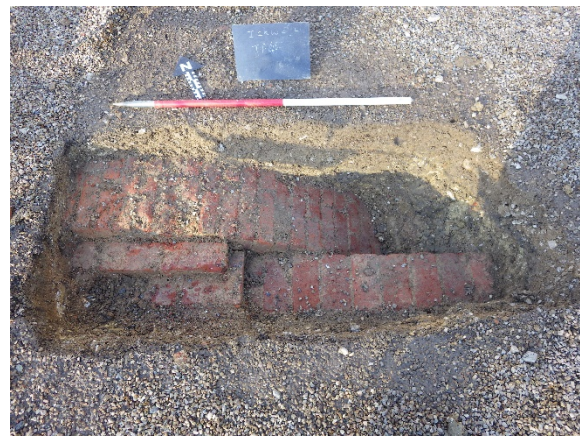
Plate 4: Test pit 4, looking north, 1m scale

Test pit 4 was excavated to note the relationship between the brick vaults and the southern end wall of the vault. Test pit 4 measured 0.75m x 1.69m and 0.6m deep and comprised made ground deposits 0001 and 0003 that in turn overlay the brick vault structure, 0011. Three courses of brick work were exposed of the southern end wall, 0010, comprising handmade 9" soft red bricks bonded by lime mortar. The upper course was laid length ways to block the void at the apex of the vault whilst the second course was laid end on but only extended the width of the vault at this level. The third course of bricks and those below are believed to extend the full width across the ends of all vaults. The end wall abutted the vault structure and was therefore built following the construction of the vaults themselves.
