# **BT Cable Ducting near 1150**

RAF Lakenheath, Suffolk

Archaeological Monitoring Report

SACIC Report No. 2018/038

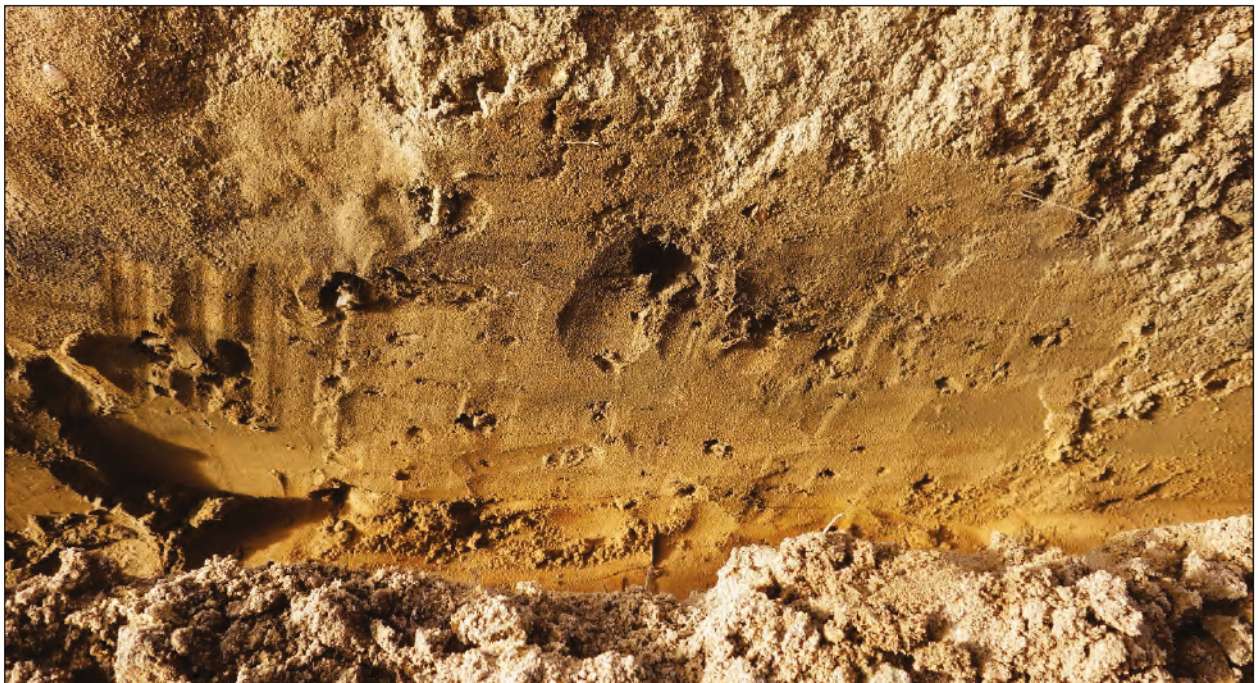
Plate 1. Trench 1, representative section facing northeast.
