# Land northeast of Anson Road, Martlesham Heath, Suffolk (MRM 175)

Archaeological Evaluation Report

SACIC Report No. 2018\_076

Report Date: August 2018

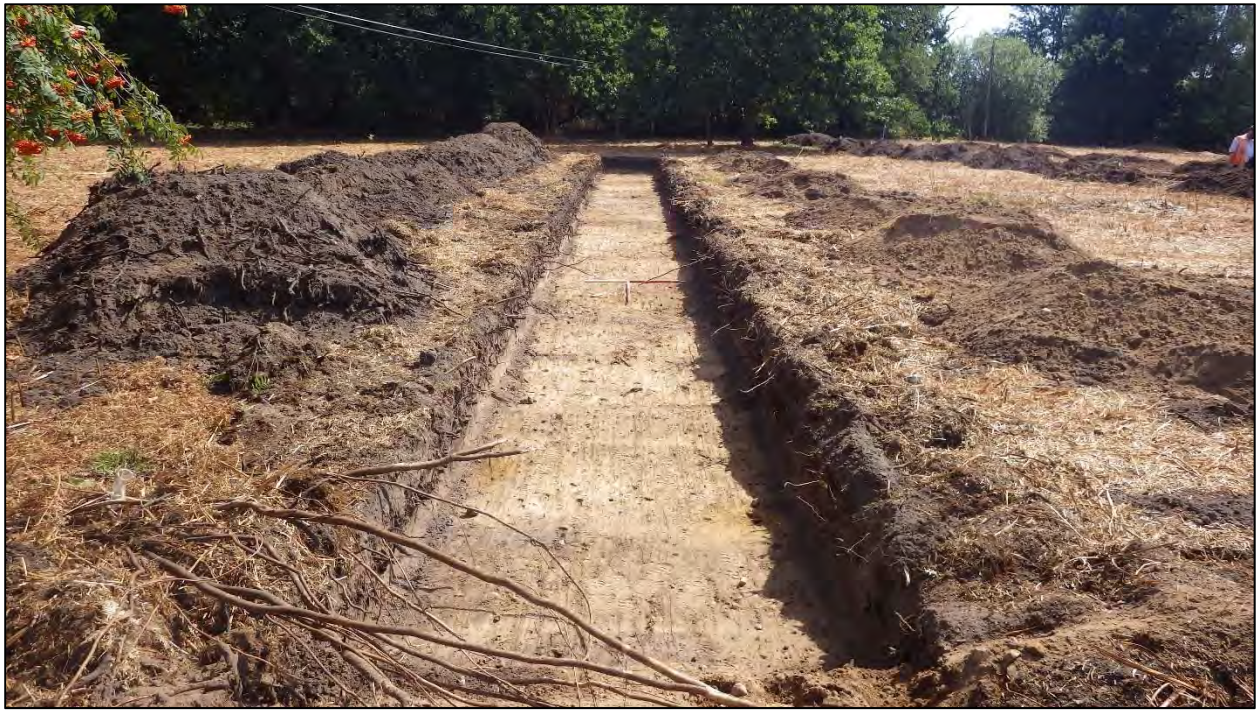
Trench 1 was 27m long, 1.8m wide and 0.40m deep, and was aligned E-W (Fig. 2; Plate 1).

No archaeological features or deposits were identified within the trench.

Plate 1: General shot of Trench 1, looking ESE

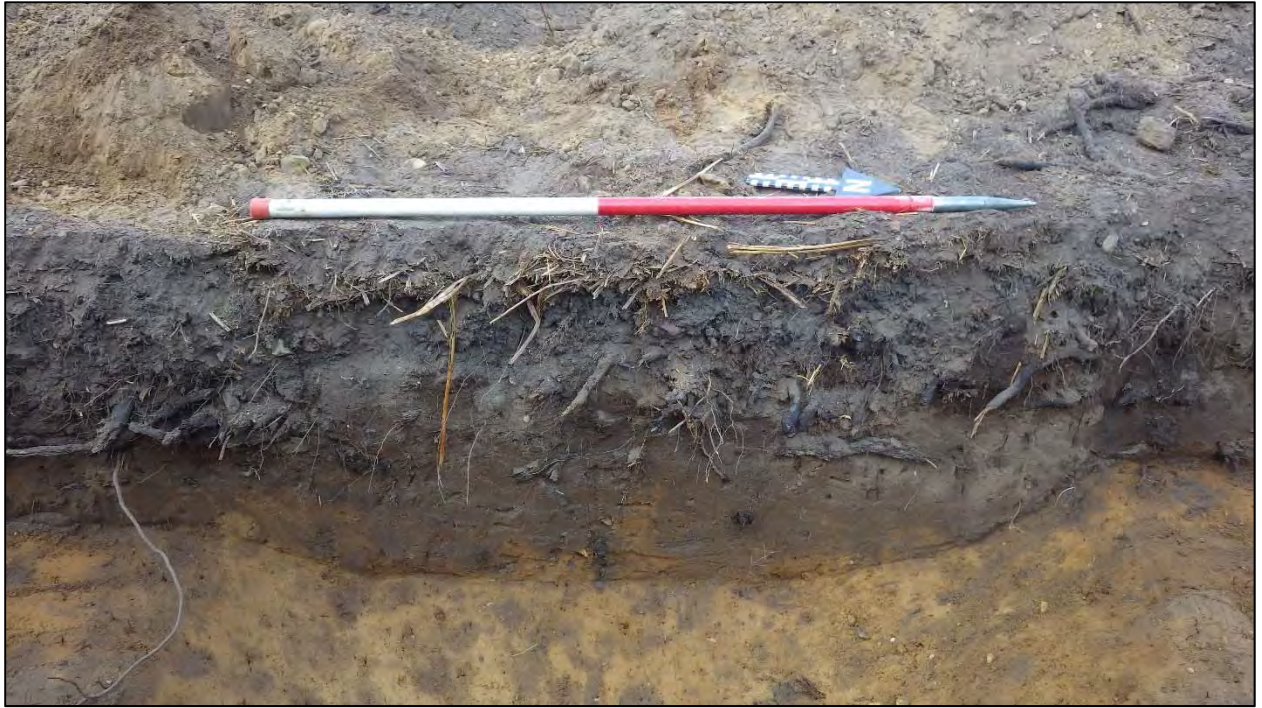
Ditch 0013 was identified 18.13m from the trench's SSE end, orientated E-W. No finds were recovered from the ditch's single fill. The ditch was still visible as an earthwork to the east of the trench on the southern side of an extant earthwork bank.

The extant earthwork bank was identified either side of the trench on a similar alignment and just to the north of Ditch 0013. The bank continued for 31.63m to the WSW of the trench and for 11.31m to the ENE before turning to head NNW. The bank was not identified within the NE or SW trench edges.

Plate 2: ESE facing section of Ditch 0013, looking WNW

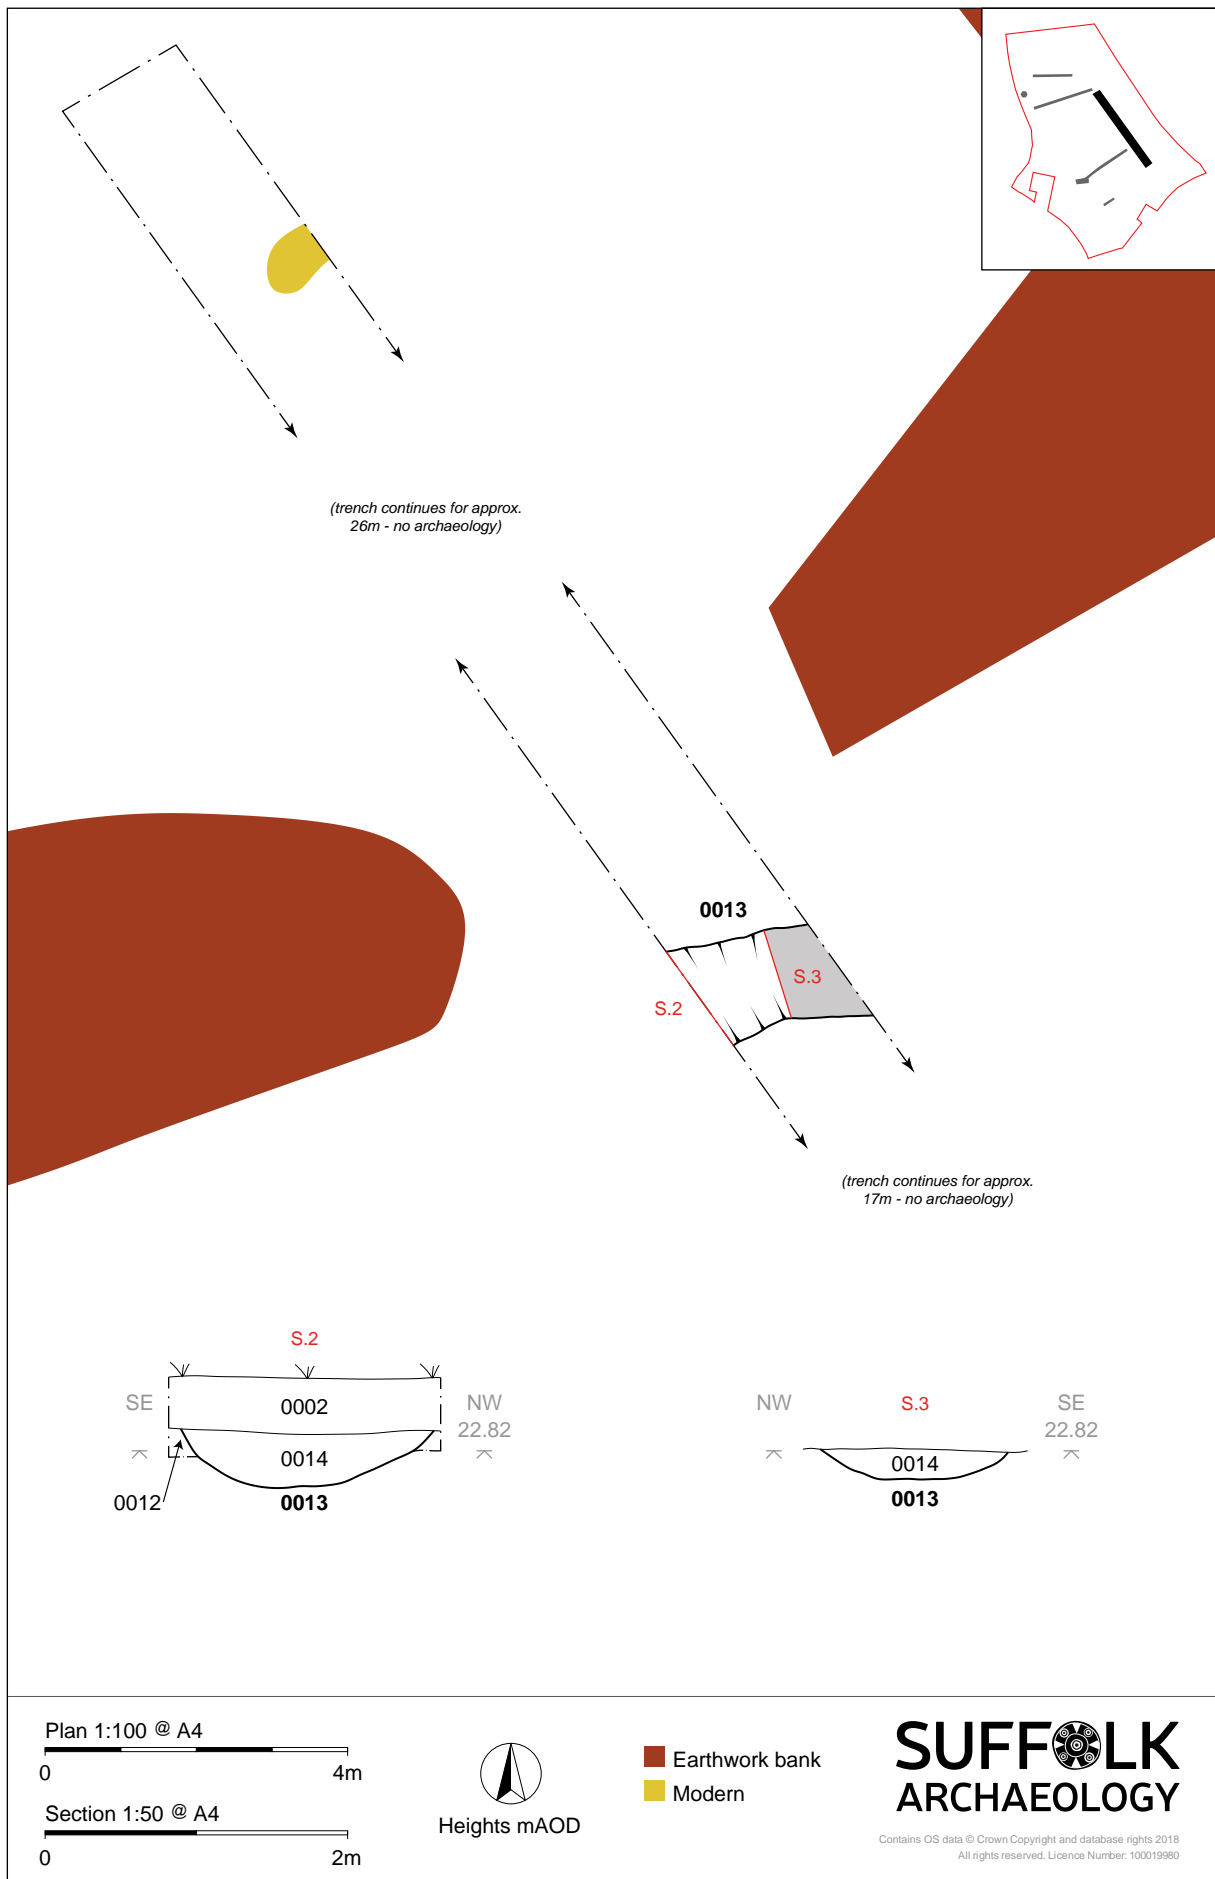
Trench 2 was 56.17m long, 1.8m wide and 0.50m deep, and was aligned NW-SE. A single ditch, 0013, was identified within the trench.

Figure 3. Plan and sections of Trench 2

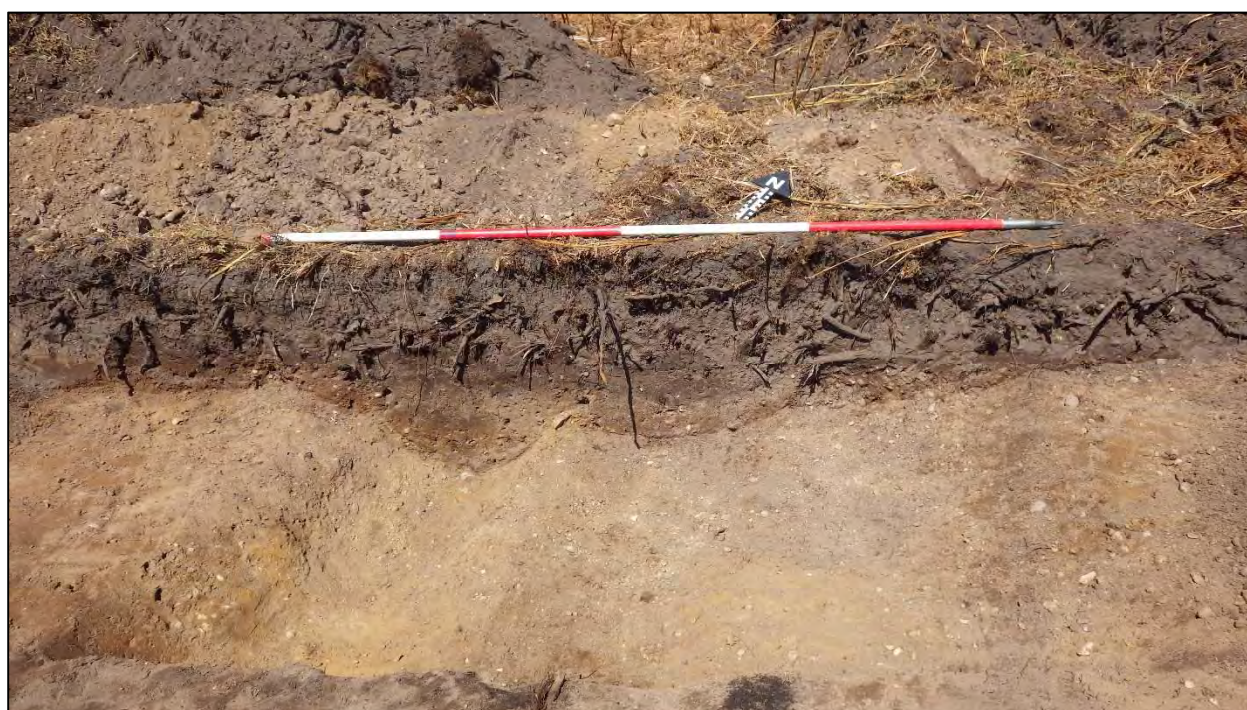
Ditch 0008 and 0010 were identified in close proximity to one another, 18.86m from the trench's ENE end, orientated NNW-SSE. No finds were recovered from either of the ditch's single fills. A clear relationship between the two ditches could not be ascertained due to the similarities in the fills suggesting they are contemporary or one could be the re-working of an early boundary.

Plate 3: SSE facing section of Ditches 0008 & 0010, looking NNW

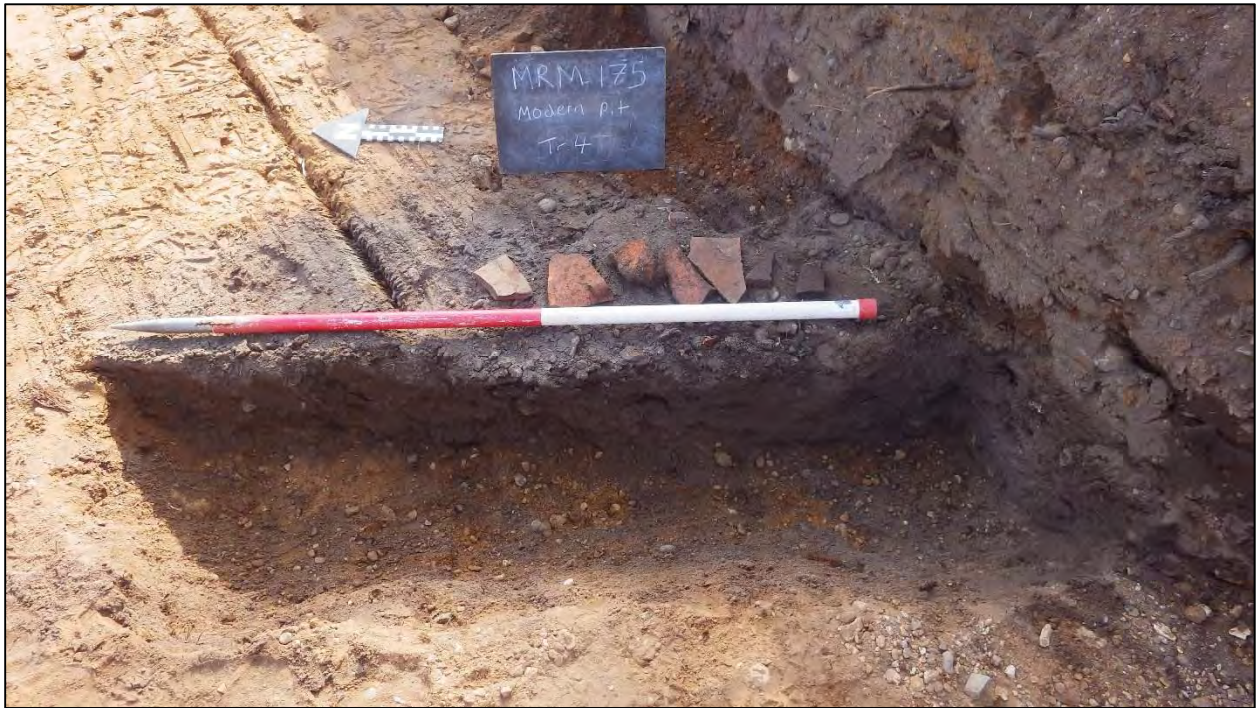
A single modern pit was identified at the SW end of the trench extending beyond the SE trench edge. Modern roof tiles were recovered from the pits single fill but were not retained.

Plate 4: Modern pit within Trench 4, looking east

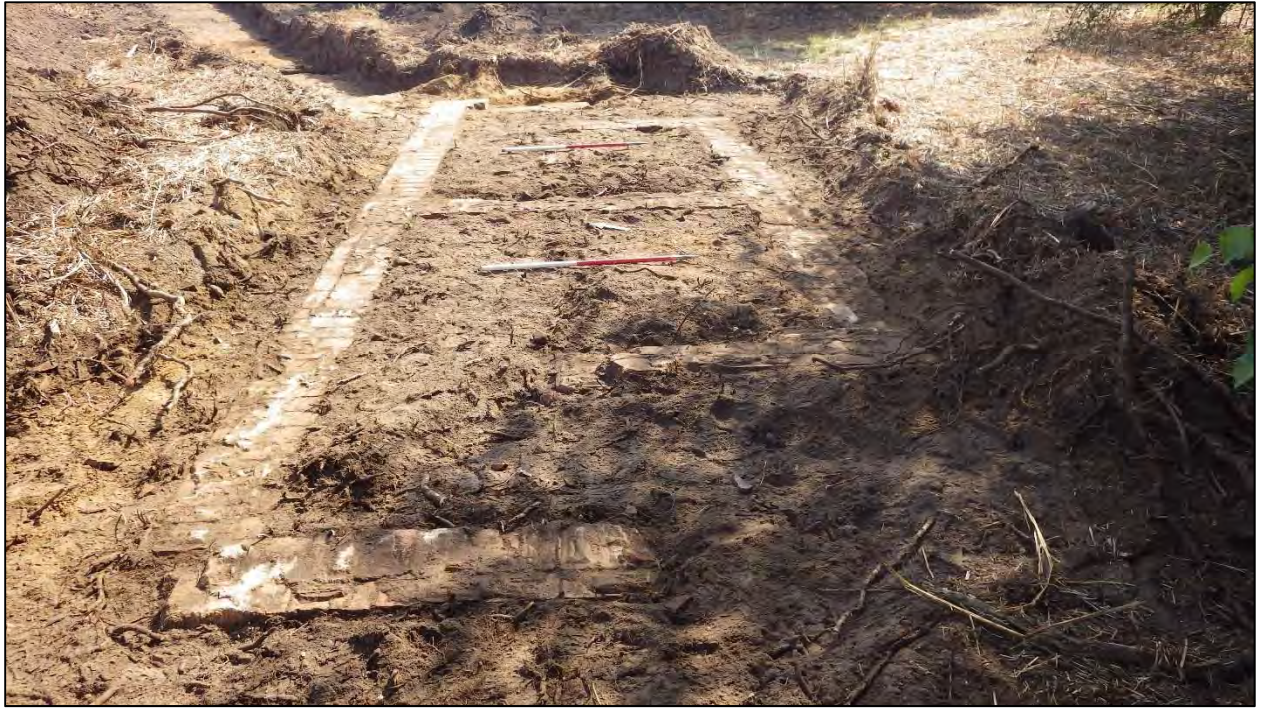
The building comprised a two-room structure, orientated approximately E-W, with a central N-S dividing wall. The external and internal walls were a brick and a half thick, constructed of red 9" frogged bricks stamped with London Brick Company. A doorway was identified at the building's eastern and western ends covered by a blast wall that extended southwards from the northern elevation of the building for 1.56m. A concrete rendering was noted on the internal face of the structure and red roof tiles were noted in the backfill of the building.

A rectangular extant earthwork platform was visible on the surface in the vicinity of the building. The platform was constructed of re-deposited natural sand that lay directly over the original topsoil layer and is likely to be the remnant of the excavated soils from the excavation for the buildings foundations, built up around the building once constructed.

Plate 5: General shot of Building 0015, looking east

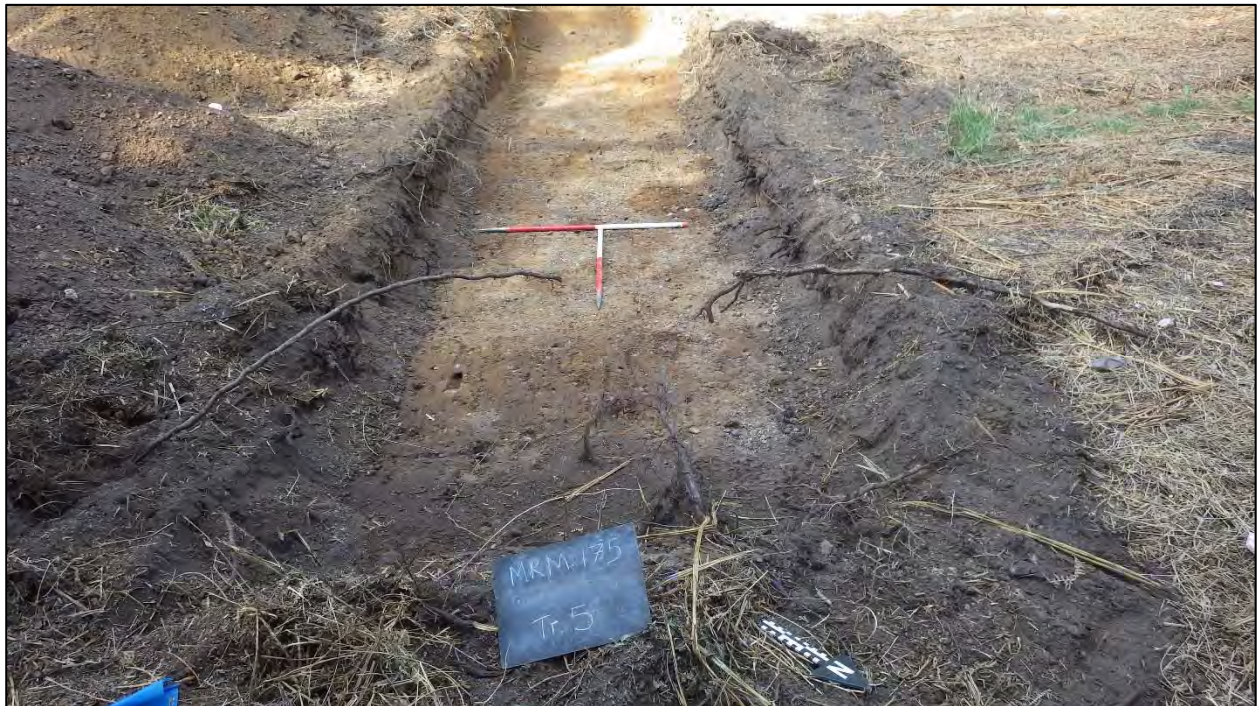
Trench 5 was 8.17m long, 1.8m wide and 0.35m deep, and was aligned NE-SW (Fig. 2; Plate 6).

A layer of re-deposited natural sand was identified at the SW end of the trench overlying the topsoil. The layer is likely to derive from a small hollow located just to the south of the trench that may have been formed from the removal of a sewer pipe. An upturned concrete manhole was also identified on the surface close to the trench.

Plate 6: General shot of Trench 5, looking southwest

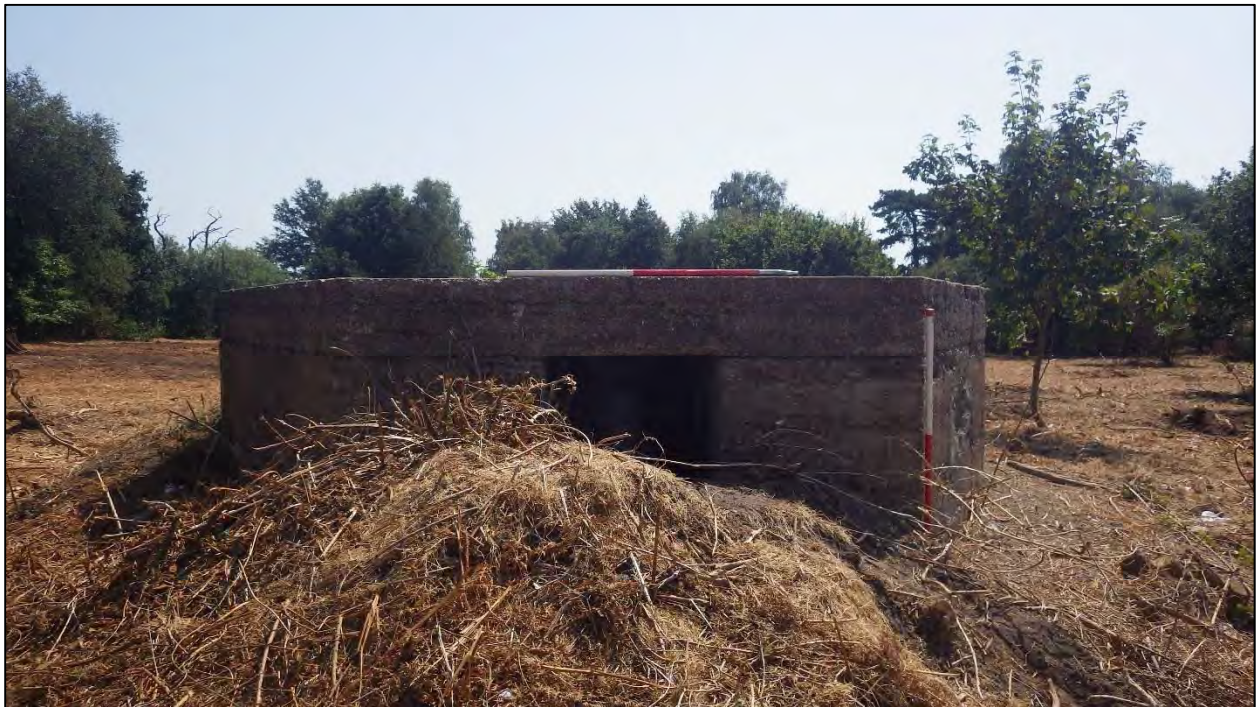
Pillbox 0020 (HER record: MRM 153) was located close to the western boundary of the site at TM 24908 45850. The pillbox is a Type 22 or FW3/22 (Brown *et al* 1996, 82) and is hexagonal in shape constructed of reinforced concrete with an internal single brick face in stretcher bond. The entrance is located in the NW elevation and has been partially blocked with brickwork to a height of 1.34m (Plate 7). Just to the north of the

doorway, within the NW elevation, is a rifle embrasure measuring 0.23m wide and 0.32m high that has been subsequently blocked with brickwork. Each of the other five elevations contain an embrasure measuring 0.77m wide and 0.34m high that have been subsequently blocked with brickwork (Plate 8). Each elevation is partially covered to the base of each embrasure by mounds of spoil.

Plate 7: NW facing elevation of pillbox 0020, looking southeast

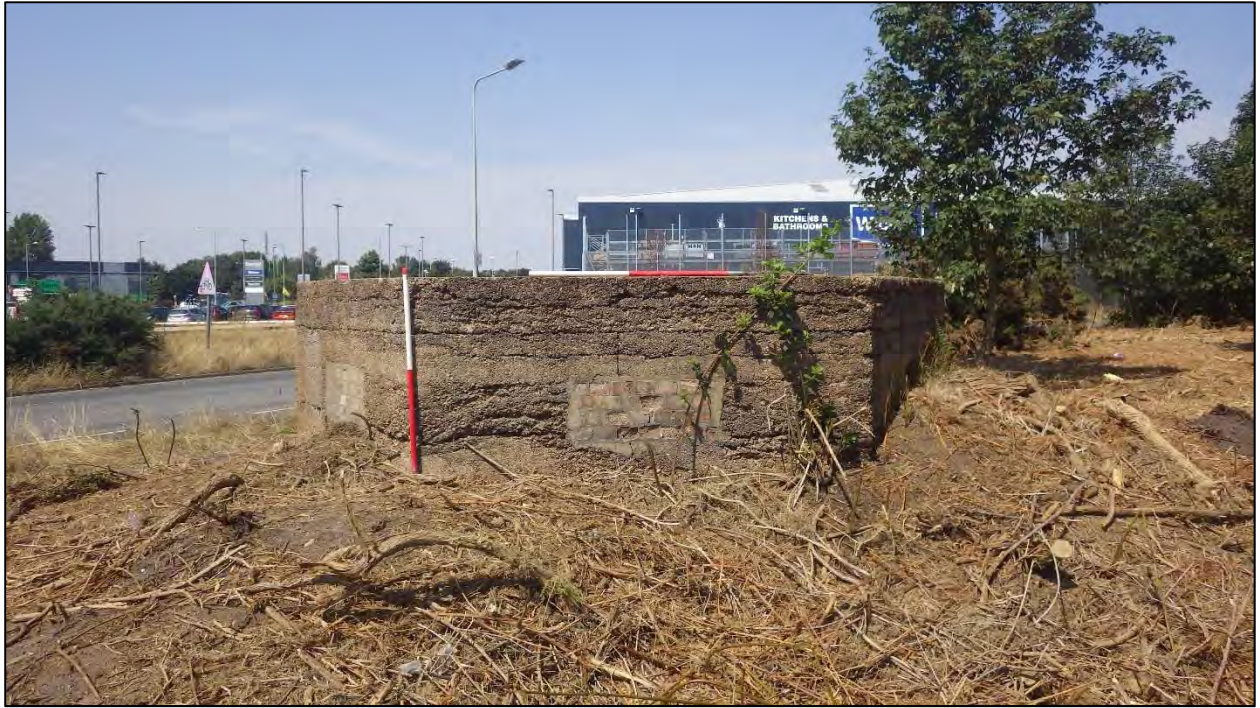
Plate 8: SE facing elevation of pillbox 0020, looking northwest

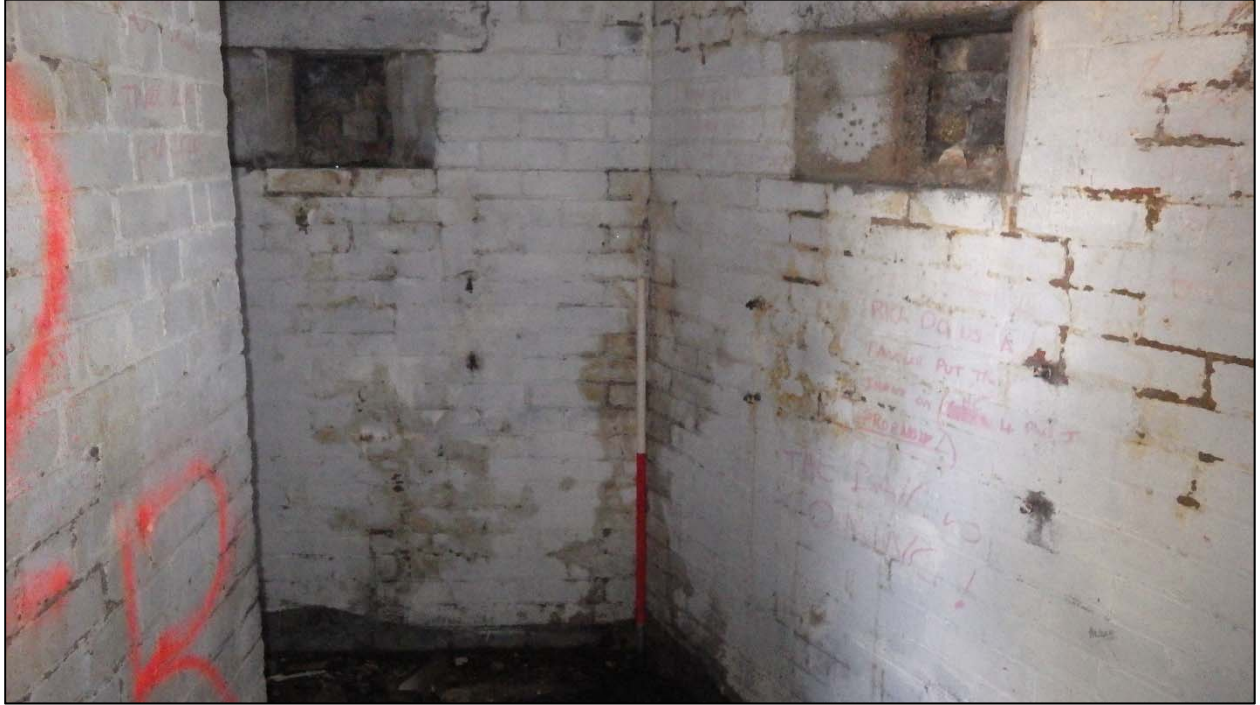
Internally a Y shaped brick wall of English bond, designed to stop ricocheting bullets (*ibid*, 79), was recorded at the centre of the pillbox. Original surviving features include nails fixed into the internal brick face below and either side of each embrasure, perhaps to hold a shelf to rest the machine gun (Plate 9), along with metal brackets fixed into the Y shaped brick wall.

Plate 9: Internal photograph of pillbox 0020, note the original nail fixings either side and below each embrasure

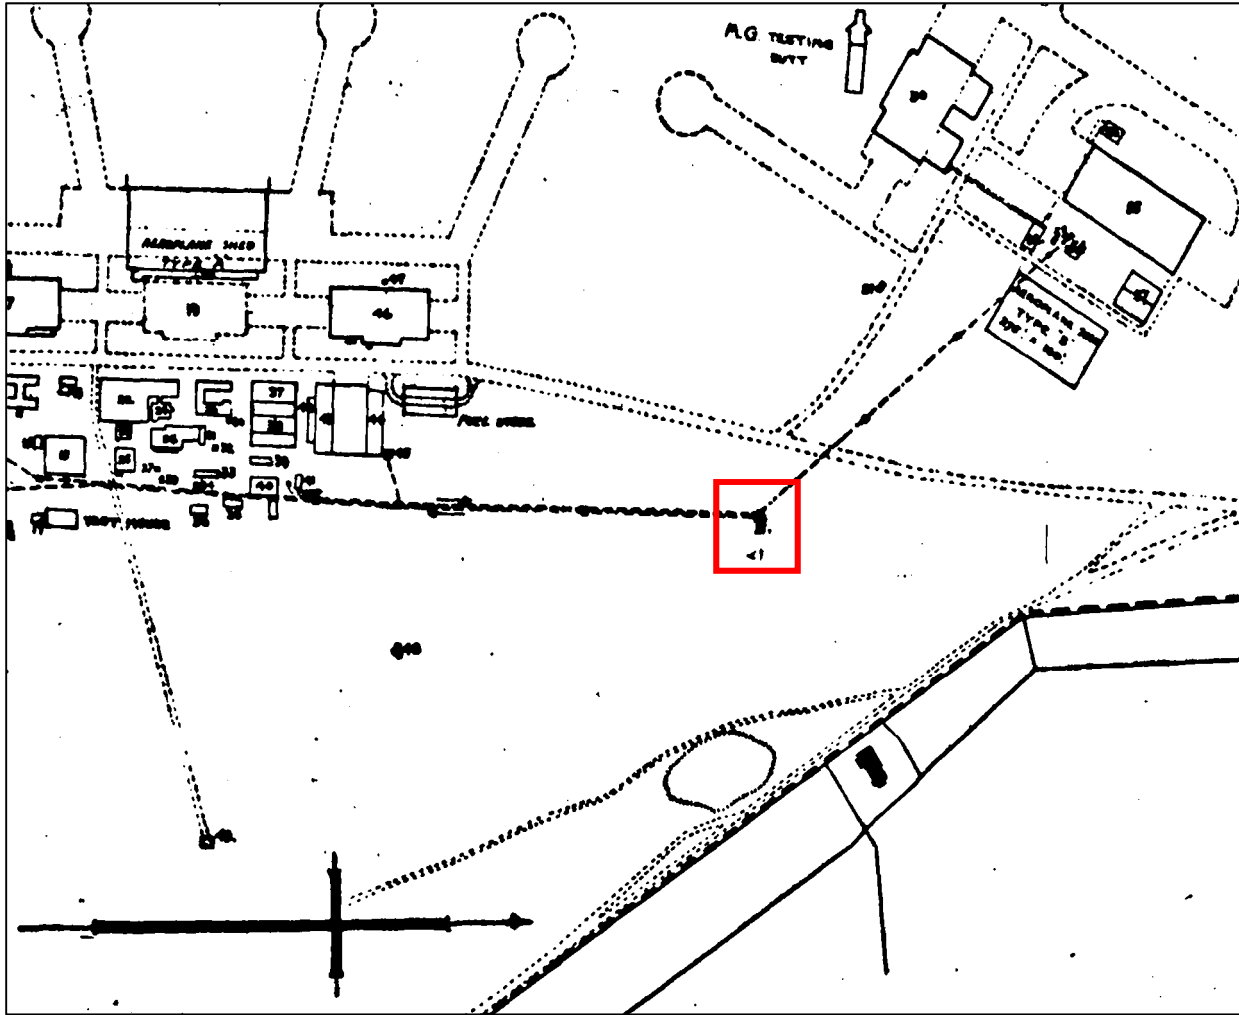
The 1925 and 1927 Air Ministry Site Plans for Martlesham Heath airfield indicates a structure once stood in the vicinity of Building 0015. The reference number on the Air Ministry Site Plans (21? & 55? respectively) indicates the buildings function was a sewerage pumphouse (Figs 7 & 8; Appendices 4 & 5). The structure is not visible on subsequent Air Ministry Site Plans produced in 1930 and 1945 (Appendices 6-8); however, it may be visible on a 1946 aerial photograph (Plate 10). The shape in plan of the building and the fact it had two rooms and that concrete render was visible on the internal walls suggests that it is more likely a latrine block serving this part of the airfield during the 1930s, opposed to the sewerage pumphouse as marked on the airfield plans. An existing latrine block still exists at Martlesham, located c.350m SSW of the site (Plate 11).

Figure 7: 1925 Air Ministry Site Plan, building highlighted in red.

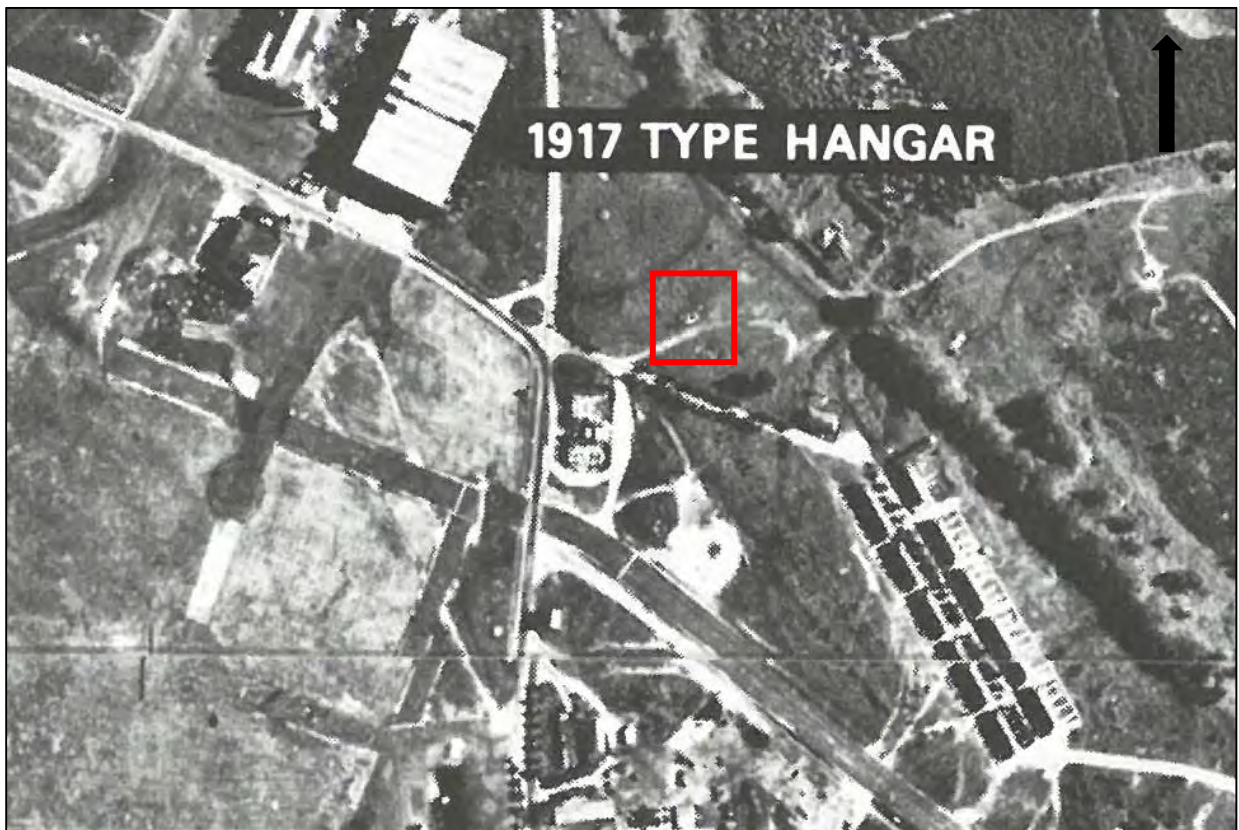
Plate 10: 1946 aerial photograph (Freeman 1978), building highlighted in red.

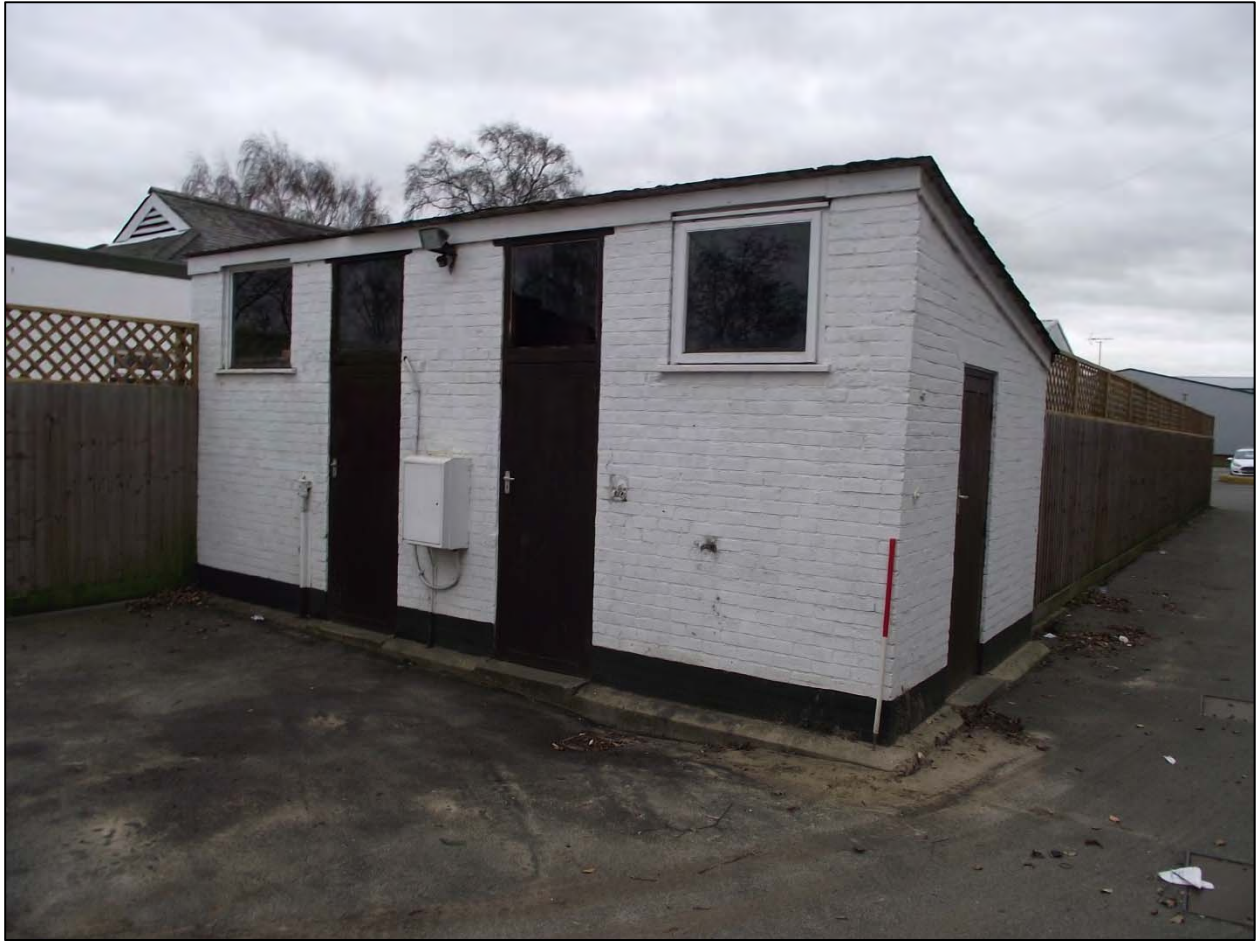
Plate 11: Surviving Latrine and Prophylactic Room (Building 18a 1930 & 1945 Airfield Site Plan; 8<sup>th</sup> in the East Airfield Survey).
