St Peter's Church (floor replacement) Yoxford, Suffolk

Archaeological Monitoring Report

SACIC Report No. 2019/023

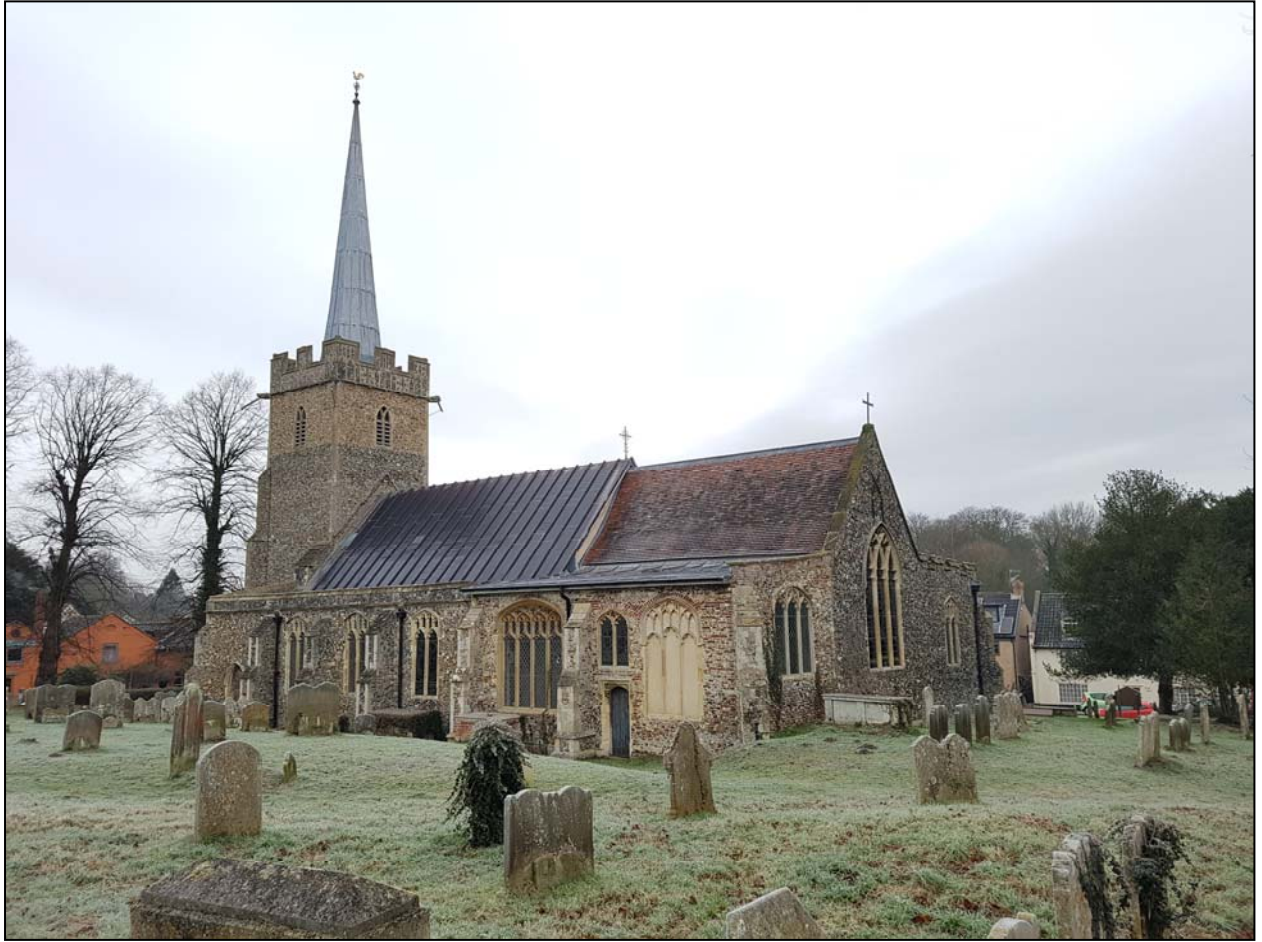
Plate 1. St Peter's Church from the south.

The exterior of the Cockfield Chapel (the nearest two bays of the south aisle), with the inclusion of brick, and the lighter colour of the fabric, can be clearly seen to be of a different phase of construction.

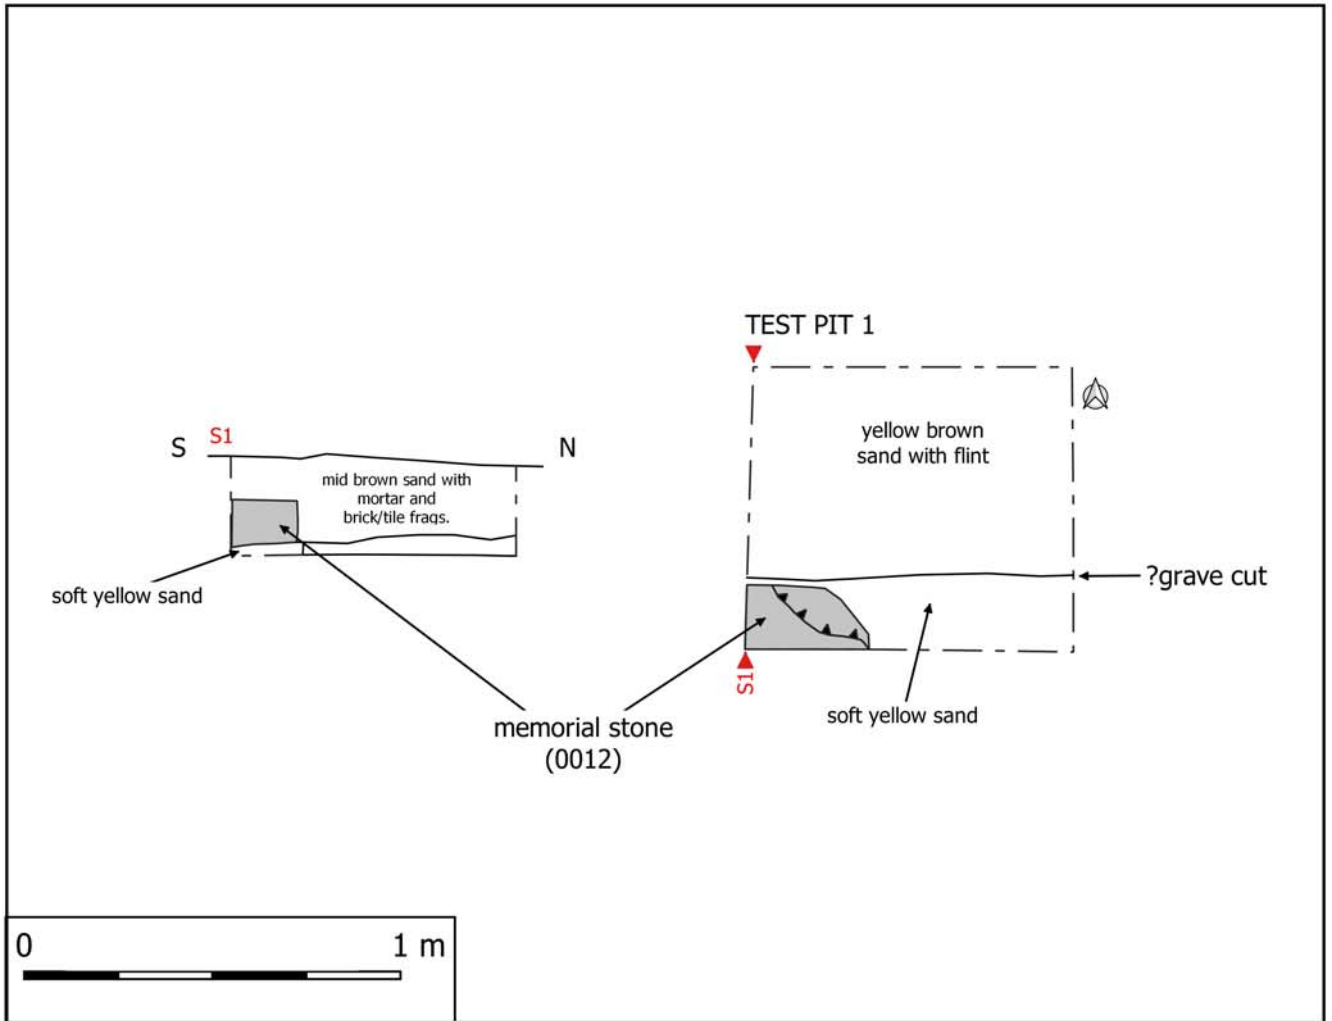
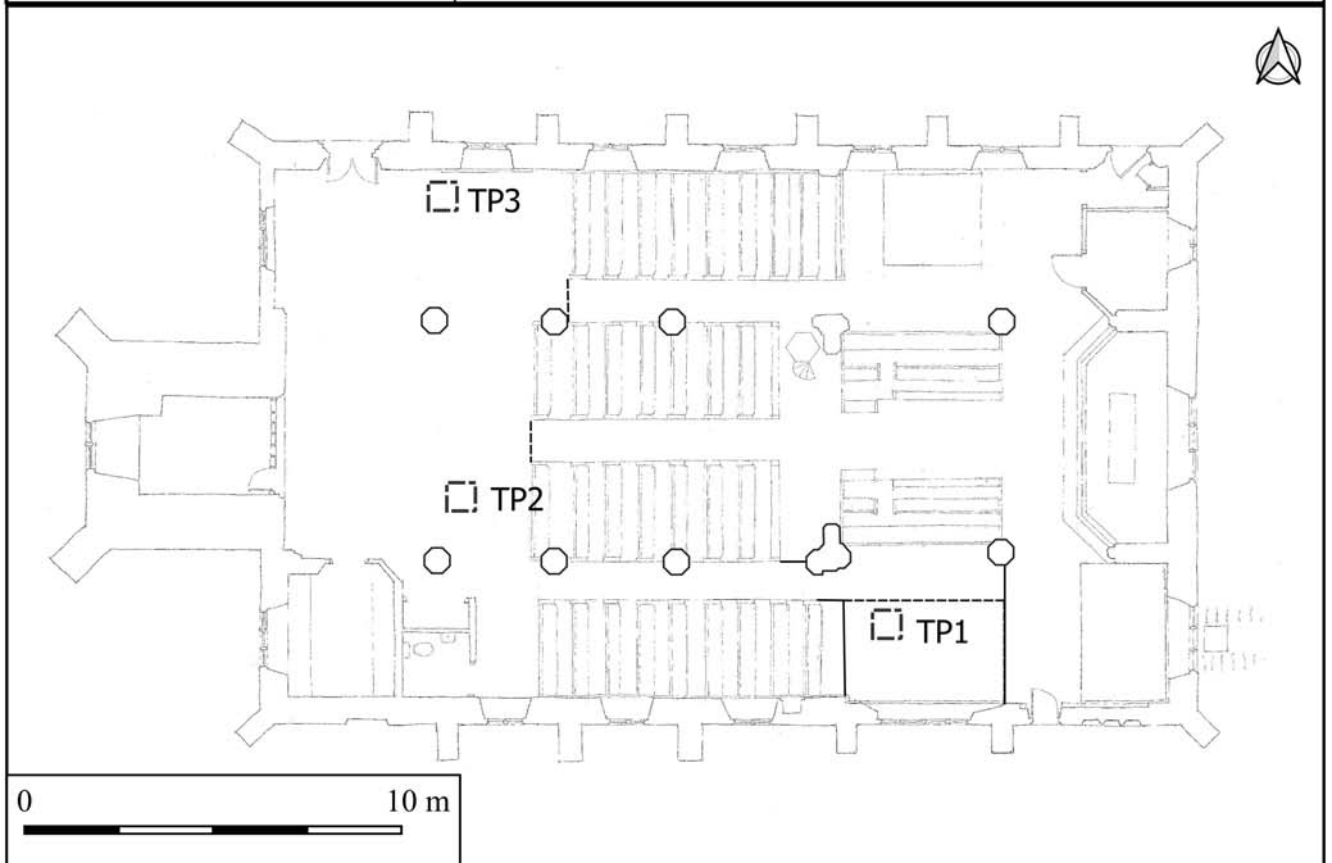
Figure 3. Test Pit Locations; Test Pit 1 Plan and section

This pit was located in the western area of raised wooden flooring within the Cockfield Chapel. It was excavated to a depth of 0.2m, the approximate construction level, at which point a deposit of compact, hard yellow/brown sand with flints was encountered. The overlying material comprised a fairly loose mid brown sand with crushed mortar and occasional small fragments of red brick/tile (Plate 2). A probable grave cut, aligned with the main axis of the church, was visible toward the southern edge of the test pit. It contained a fill of very soft and loose, clean yellow sand. The corner of a memorial stone (0012, see below) was present in the southwest corner. Its northern edge was approximately in line with the probable grave cut although the cut extended well beyond the eastern end of the stone.

These two pits were excavated towards the west end of the church in areas formerly covered by raised wooden flooring. In both cases only between 50mm and 100mm of material needed to be removed to reach the construction level. This material comprised a loose very pale yellow-brown sand with crushed mortar, gravel and occasional fragments of soft red brick and tile. Both test pits came down to the compact, hard layer of yellow/brown sand as seen in Test Pit 1. Test Pit 3 was excavated against the

western edge of the area of raised flooring so that a continuous section was exposed (Plate 3). It comprised; the existing cement floor surface (which in the area of the entrance had been temporarily retained to facilitate access to the church, c.30mm thick), over a bedding layer of dark yellow sand, c.120mm thick, which in turn overlay a c.150mm thick layer of fairly loose mid brown sand with crushed mortar and occasional small fragments of red brick/tile.

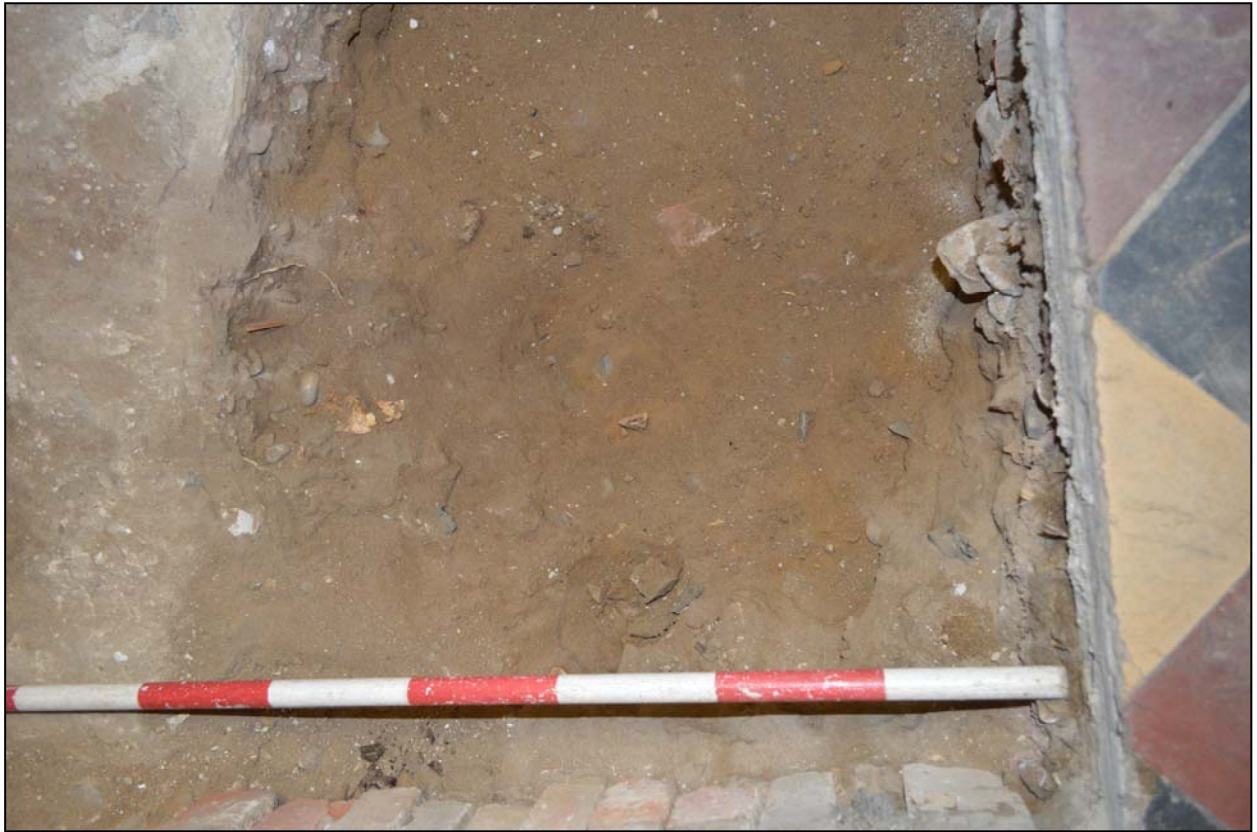
Plate 4. Grave 0004, camera facing north

Two inhumations were noted, both within the Cockfield Chapel. The first to be encountered, a child's burial (**0004**), was identified during the attempted excavation of test pit. It comprised a loose pocket of sand within which a number of bones, mainly ribs, long bones and vertebrae, were easily identifiable. Upon cleaning the area with a trowel a rectangular cut, aligned east-west was visible, measuring c.0.22m wide and at least 0.56m in length. It continued to the east under an area of Victorian tiled floor that was to be retained *in-situ* and its full dimensions could not be ascertained. The base of the cut was c.0.28m below the level of the adjacent floor. The only bone to be found *in-situ* was a large fragment of a skull, lying on its right side, which was present in the western end of the cut (Plate 4). All bone was subsequently removed and bagged for

reburial within the church. At the western end, in the vicinity of the skull, an area of dark yellow brown sandy grave fill (0005) was present. Behind the skull, a small decayed fragment of a dark timber was noted, which was possibly the remains of a timber coffin. At the time of its excavation, it was believed to have been cut into the top of a larger grave, as the underlying deposits consisted of a very loose sand, although what was thought to be a cut for this 'grave' (0002) was later identified as the edge of the foundation for the adjacent nave arcade column (0007). No dating evidence was recovered for the child burial, but the presence of a fragment of timber in the dry fill suggests it was probably late 18th or 19th century in date.

| Context Number | Feature Number | Feature Category | Description <i>Interpretation</i> | Over | Under | Cut by | Cuts |
|---|---|---|---|---|---|---|---|
| 0005 | 0004 | Grave Fill | Fill of cut 0004. Consists of dark brown sand surrounding the disturbed remains of a child's skeleton (bones photographed, bagged and left at the church for reburial). Occasional fragments of timber noted behind the skull, possibly related to a coffin but too decayed to fully interpret. <i>Grave Fill</i> | | 0006 | | |

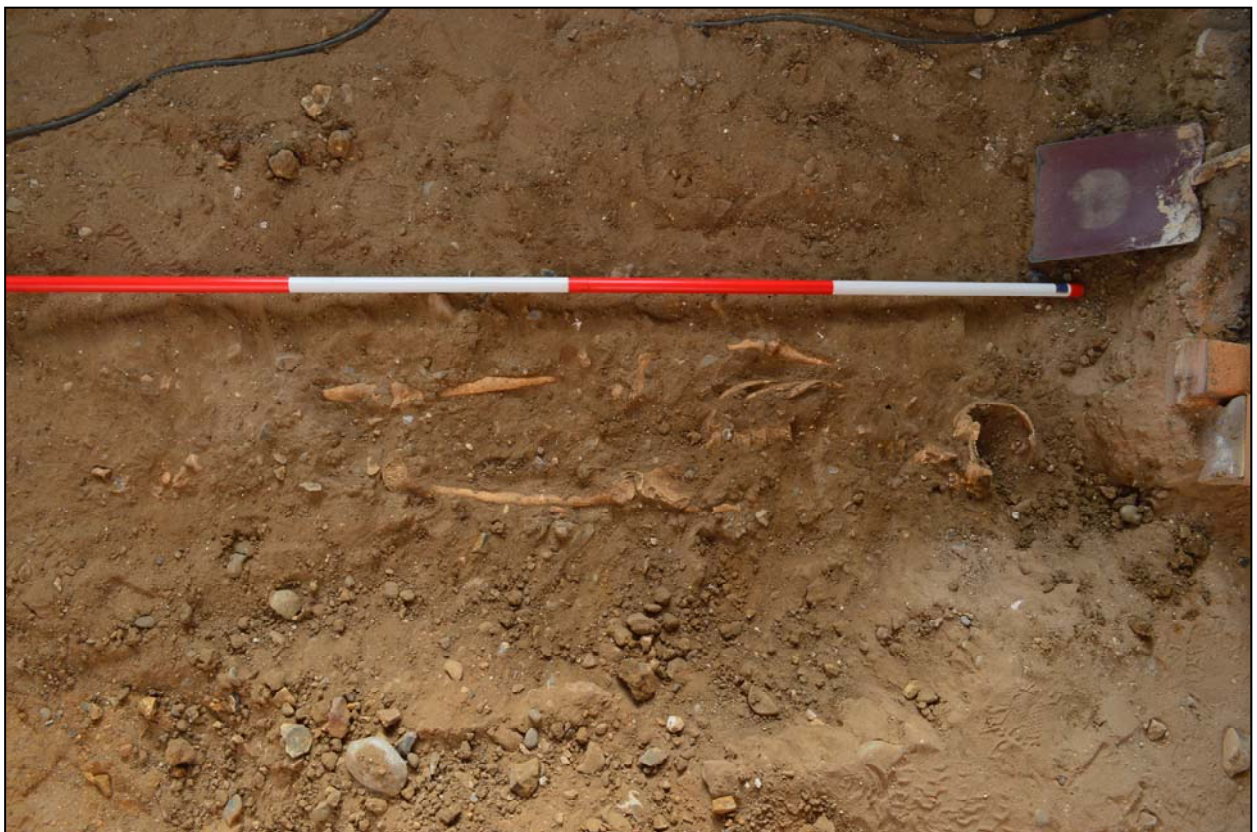
Plate 5. Grave 0008, camera facing south

The second inhumation (**0008**) comprised a complete adult skeleton, lying supine, with the arms positioned along each side (Plate 5). The majority of the skeleton was located at, or very slightly above, the construction level, although the skull sat significantly higher and was unfortunately slightly damaged. The skeleton was roughly aligned with the main axis of the church, but with a slight anti-clockwise rotation. There was no evidence for a grave cut or coffin and no associated artefacts were identified. After discussion with the Diocesan Archaeological Advisor, the onsite contractors and the project architect, it was agreed that this burial would be left *in-situ* beneath the new floor after first covering it with sand and a geotextile membrane to protect it from damage. During the ongoing works it was covered with a sheet of chipboard raised on lengths of timber to protect it from accidental damage and to keep it from public view. No dating evidence for this burial was recovered but given its location and lack of depth it may have predated the construction of the Cockfield Chapel, and had been buried in an area that was originally outside the church.

| Context Number | Feature Number | Feature Category | Description <i>Interpretation</i> | Over | Under | Cut by | Cuts |
|---|---|---|---|---|---|---|---|
| 0008 | 0008 | Grave | Human skeleton noted at surface of reduced level (0.3m below present aisle floor level). Complete adult burial, supine. Partially exposed and photographed but left <i>in-situ</i> . To be buried below new floor after adequate protection (thin layer of sand and geotextile has been discussed). <i>Inhumation. Shallow, possibly originally buried outside the church prior to the construction of the Cockfield Chapel.</i> | | | | |

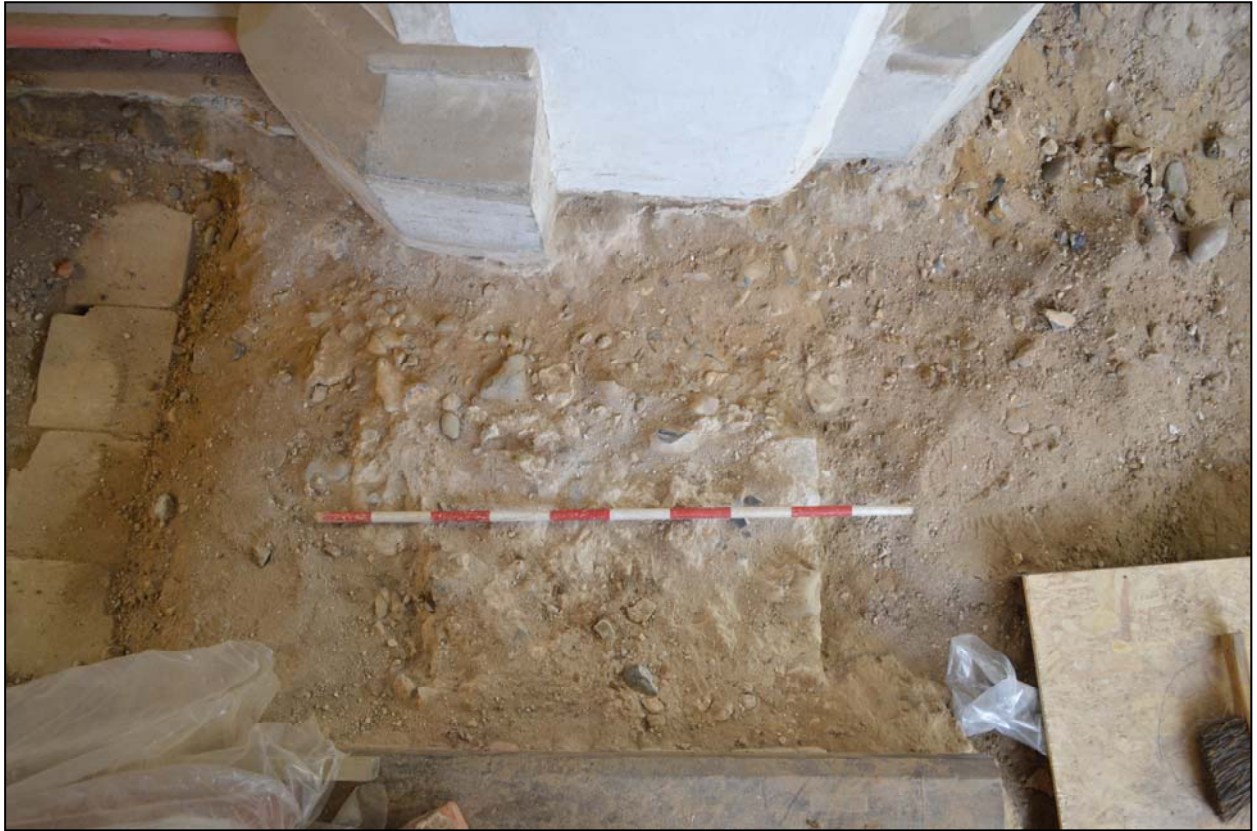
Plate 6. Flint and mortar wall (0011), camera facing north

The base of a flint and mortar wall (**0011**) was present at the western end of the Cockfield Chapel (Plate 6). It measured 0.75m in width and ran from the column supporting the south side of the chancel arch towards the south wall of the church. It had been cut away just before reaching the column, presumably during later restoration works which may have included renewal of the facing stone on the column and/or alterations to the column's foundation. No stone dressing was present although the eastern side of the wall was relatively well finished with a uniform face. The mortar was white in colour. The western face was slightly irregular in comparison. The upper surface of the wall was located c.150mm below the former floor level but would be left

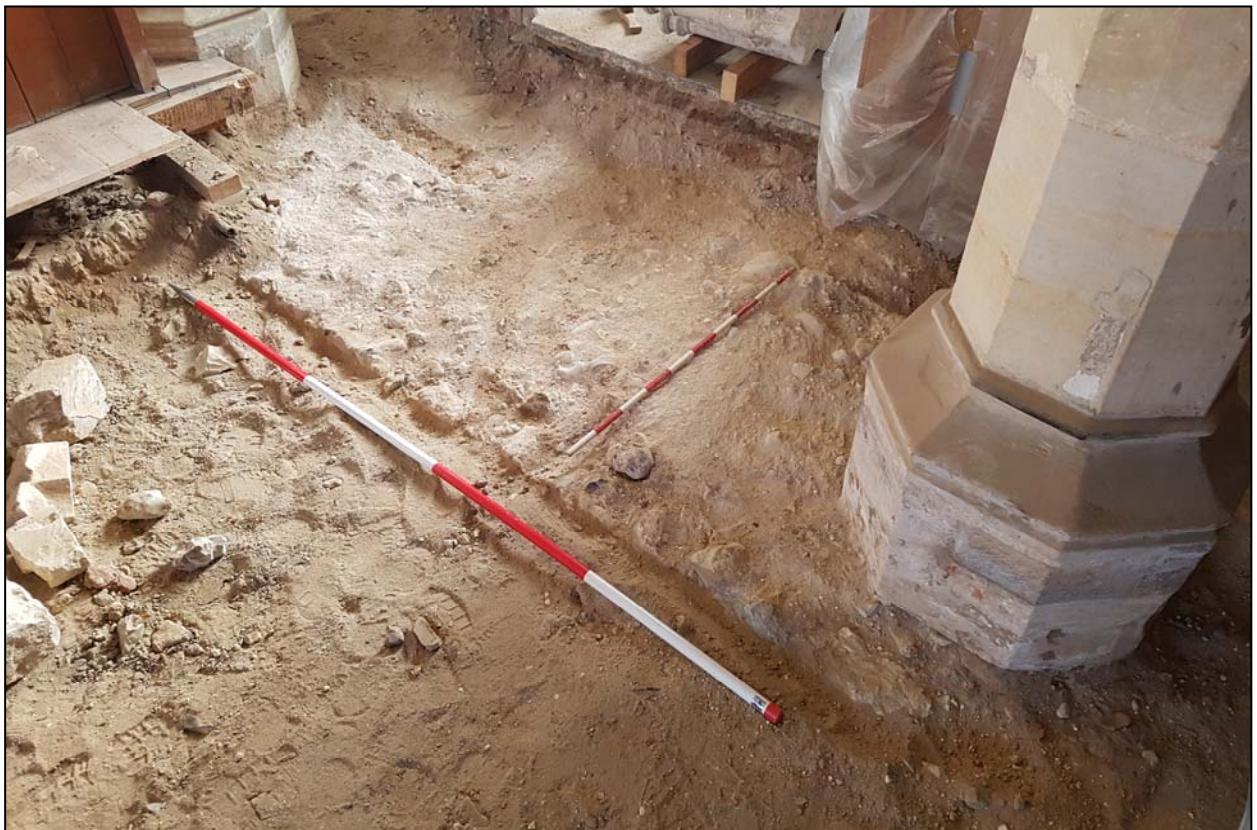
Plate 7. Flint and mortar wall (0018), camera facing south

A further segment of probable flint and mortar wall (**0018**) was recorded towards the west end of the church, running between two columns of the nave's southern arcade (Plate 7). It measured 1.1m wide at the western end but the southern side stepped in so that it was only 0.85m wide at its eastern end, where it finished flush with the southern face of the arcade column base. The northern side of the wall was well finished with largish flints laid to form a flat face. No dressed stone was noted within its construction. The southern face was less well finished although occasional large flints placed along the edge were evident. The upper surface of this wall was roughly coincidental with the construction level floor and consequently it was to be left *in-situ*. The position of this wall suggests the nave was originally walled on the south side, which would then imply that the south aisle is a later addition to the earlier structure.

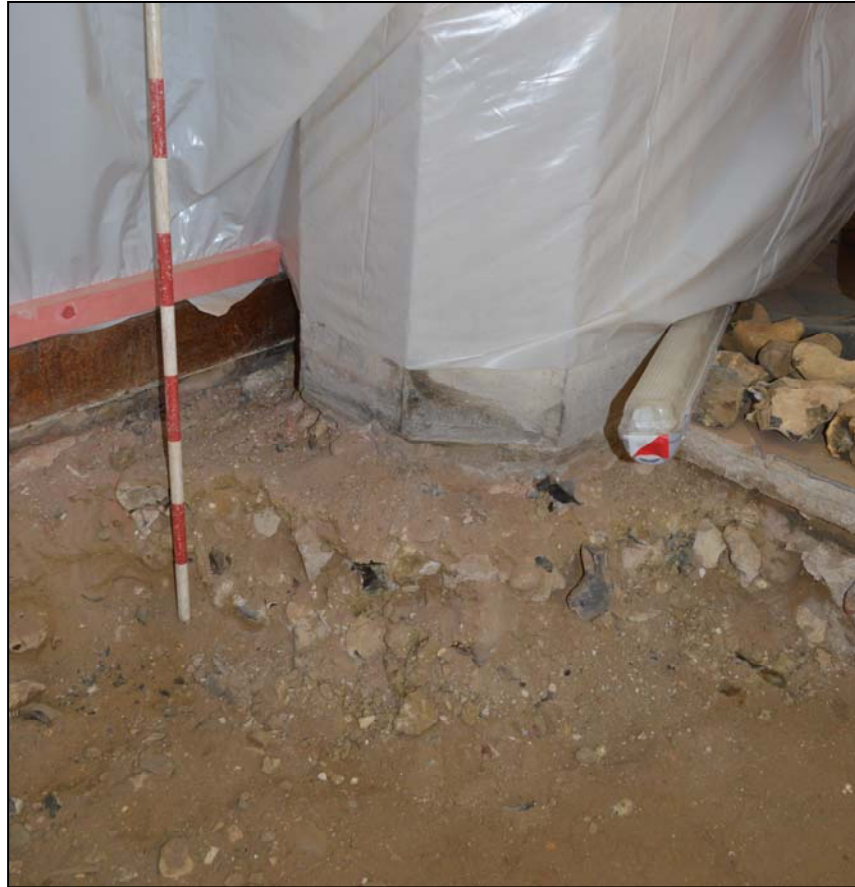
Plate 8. Flint and mortar foundation (0007), camera facing northeast

Other structural evidence noted during the monitoring was the presence of an area of flint and a yellowish mortar (**0007**) that encircled the exposed area at the base of the eastern column of the southern nave arcade/crossing (Plate 8). This was interpreted as part of the footings for this column, although given this column would have been inserted in this location when Cockfield Chapel was constructed, it may possibly have been a remnant of a former southern wall of the nave/crossing.

| Context Number | Feature Number | Feature Category | Description <i>Interpretation</i> | Over | Under | Cut by | Cuts |
|---|---|---|---|---|---|---|---|
| 0007 | 0007 | Foundation | Area of flints in weak mortar. Immediately adjacent arcade column and appears to run under the column's stonework. <i>?foundation for arcade column, probably a later underpinning (19thC?)</i> | | | | |

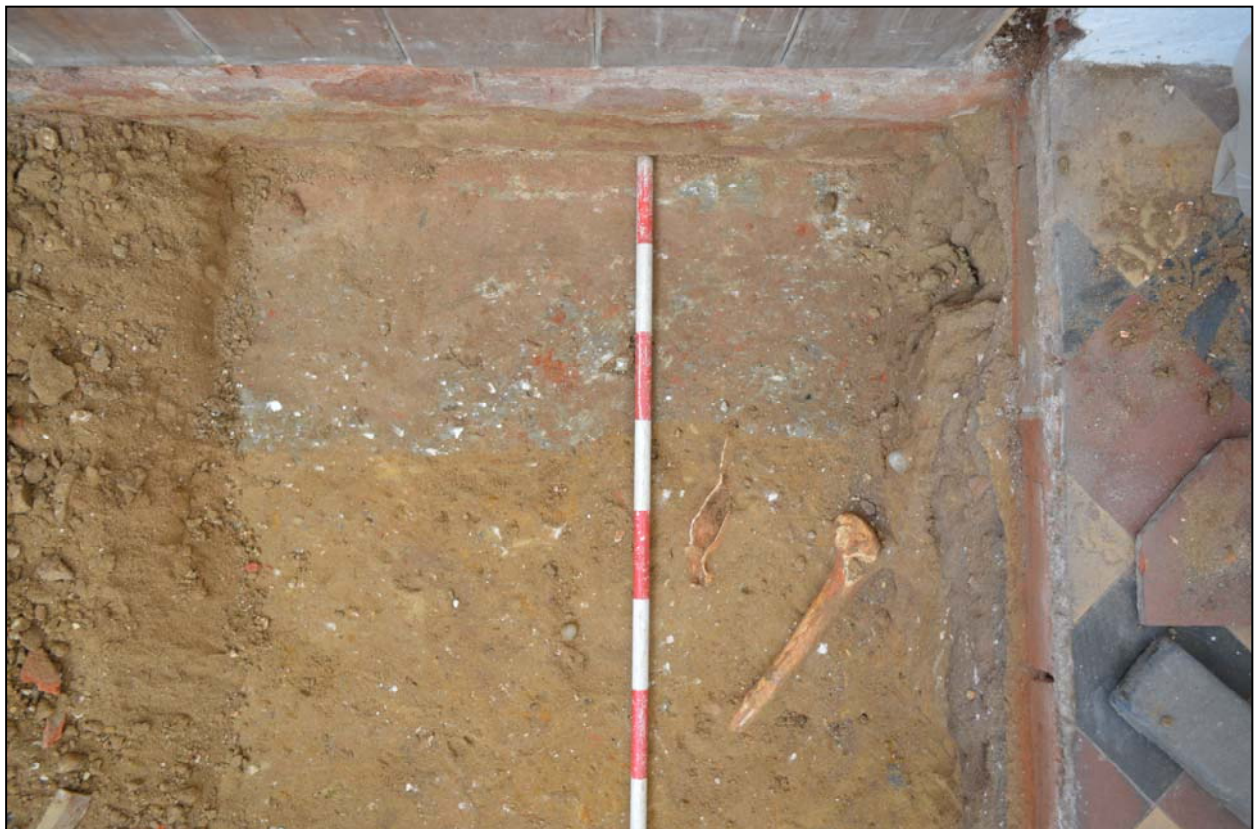
Plate 9. Cockfield Chapel foundation (0027), camera facing south

packed boulder clay (Plate 9). It was interpreted as a probable foundation for the southern wall of the Cockfield Chapel. Lying directly on top of the fill, and in the area immediately to the north, were a number of human bones, including fragments of a skull, a pelvis and a femur (0026). It is likely these originated from a single burial disturbed by the excavation of this footing.

| Context Number | Feature Number | Feature Category | Description <i>Interpretation</i> | Over | Under | Cut by | Cuts |
|---|---|---|--|---|---|---|---|
| 0027 | 0027 | Foundation | Linear cut noted adjacent south wall of Cockfield Chapel. Northern edges runs c.0.3m from and parallel with the wall. Filled with compact, dense blue-grey clay with chalk. <i>Foundation for the chapel wall.</i> | | | | |

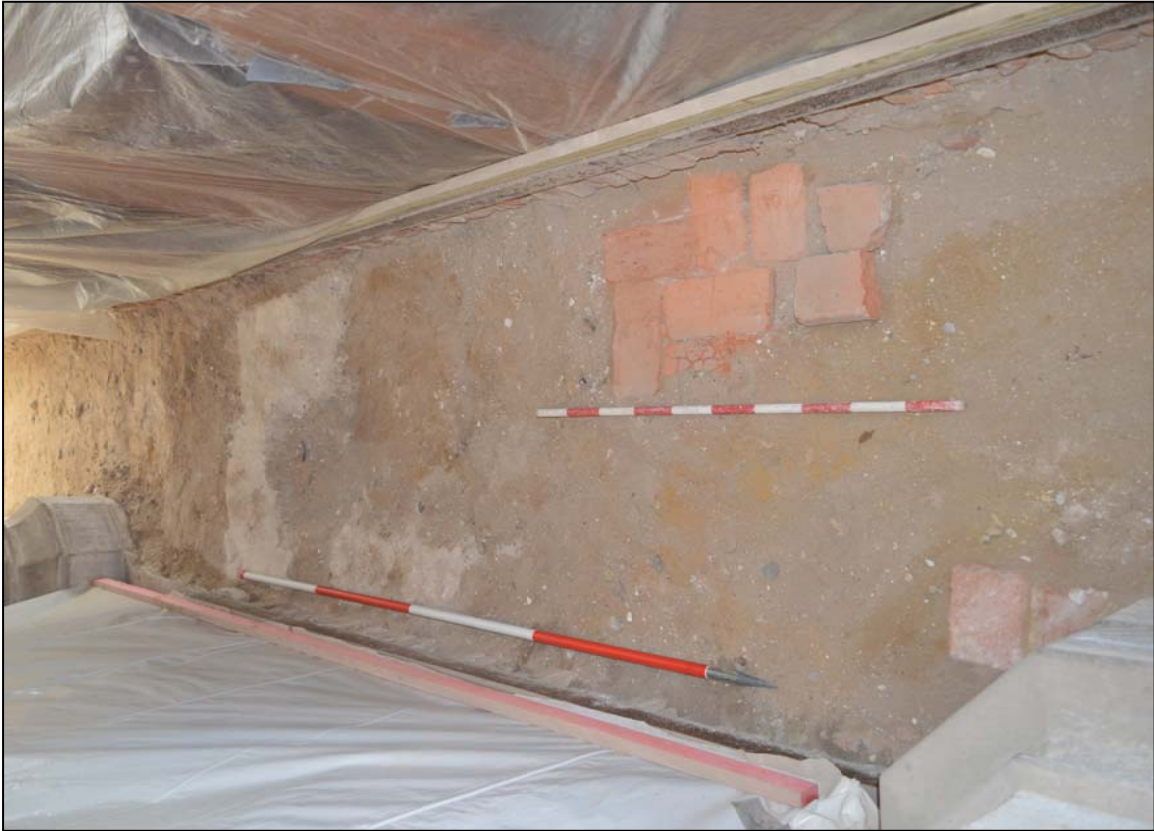
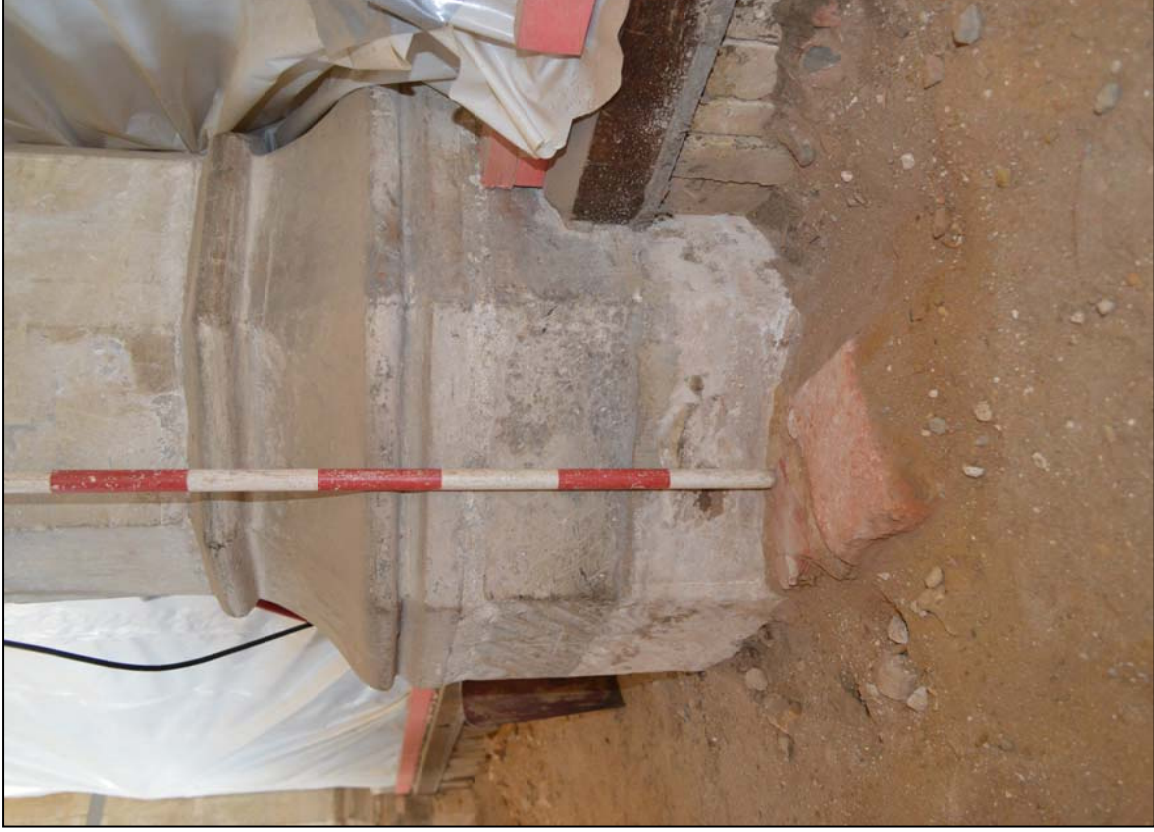
Plate 10. Surviving brick floor (0024), south aisle, camera facing east

A small area of brick flooring (**0024**) survived in the south aisle (Fig. 5). It comprised five soft red bricks of widths between 11.5cm and 13cm, lengths of between 24cm and 26cm. They were only 0.04cm thick, although the upper surfaces were very worn and uneven suggesting they were originally thicker (Plate 10). They were laid directly on the underlying sand, with no obvious bedding layer, and were approximately 0.18m below the former floor level. Adjacent to one of the nave arcade columns a further small section of this floor survived. It comprised the fragments of two bricks which were mortared together and located 0.15m below the former floor surface (Plate 11). All were removed to facilitate the laying of the new floor.

| Context Number | Feature Number | Feature Category | Description <i>Interpretation</i> | Over | Under | Cut by | Cuts |
|---|---|---|--|---|---|---|---|
| 0024 | 0024 | Floor | Small area of floor tiles surviving in south aisle. Comprises soft red tiles (or very worn bricks). Located 0.28m lower than the level of the raised wooden floor (c. 13cm below former concrete floor). Loose, appeared to be laid directly on the underlying sand layer (0001). <i>Remnant of former floor surface</i> | | | | |

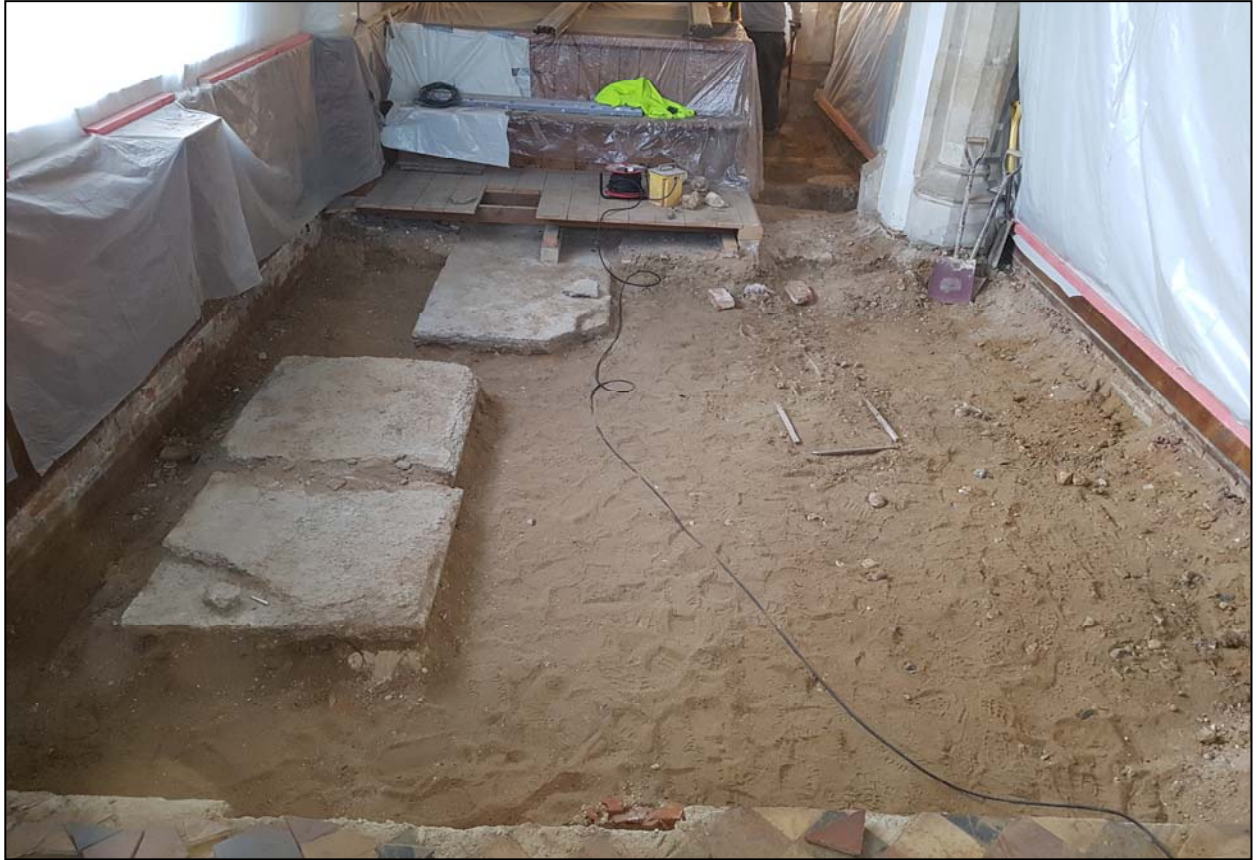
Plate 12. Memorial stones 0013 (foreground left) with 0012 behind, camera facing west

surfaces due to wear and decay, and no inscriptions were visible. Both had also suffered other damage. Both had sections of stone missing and 0013 was broken into at least two pieces.

| Context Number | Feature Number | Feature Category | Description <i>Interpretation</i> | Over | Under | Cut by | Cuts |
|---|---|---|--|---|---|---|---|
| 0012 | 0012 | Memorial Slab | Stone slab, ?Purbeck marble. Rough upper surface with no obvious inscription (worn and decayed?) <i>memorial slab over grave or possible crypt</i> | | | | |
| 0013 | 0013 | Memorial Slab | Stone slab, ?Purbeck marble. Rough upper surface with no obvious inscription (worn and decayed?) Broken in two <i>memorial slab over grave or possible crypt</i> | | | | |

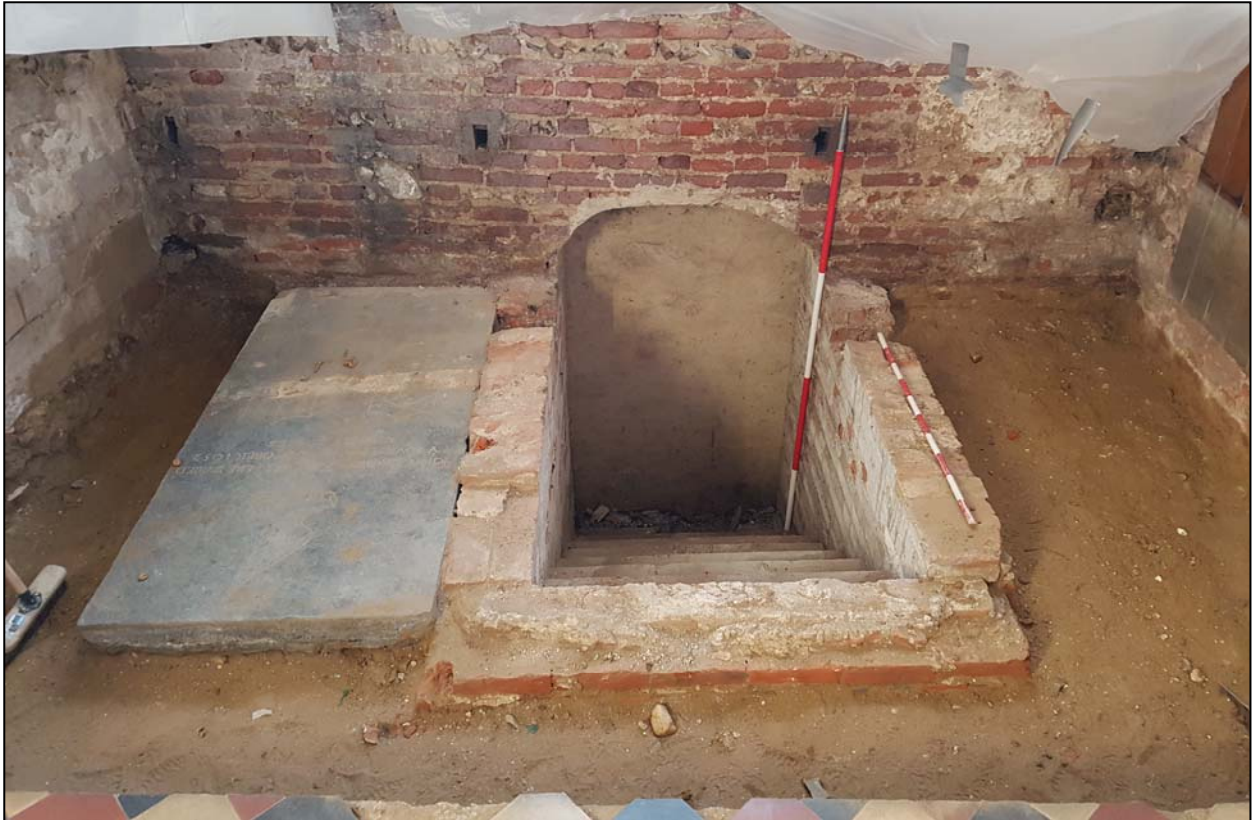
Plate 14. Memorial stone 0014 and vault entrance 0017, camera facing east

A set of brick built stairs (**0017**) leading down to a burial vault located outside the east end of the church, were centrally placed against the east wall of the Cockfield Chapel. The stairs were retained by flanking walls of red brick (Plate 14). It was noted that the whole construction was not completely perpendicular to the chapel's east wall although it was not clear if this was accidental or had some purpose, such as to avoid an obstacle. The base of the stairs ended in a short passage which ran under an arch through the east wall of the chapel. The arch appeared to have been cut through an existing wall with no supporting brick vault or lintel, the cut brickwork simply having been mortared over. The passage terminated below the chapel wall in a cement rendered wall that blocked access to the burial vault that presumably lay beyond. The stairs were not covered but had been concealed beneath an area of raised flooring. It is proposed to bridge over the stairs with a slate stone laid flush with the new floor.

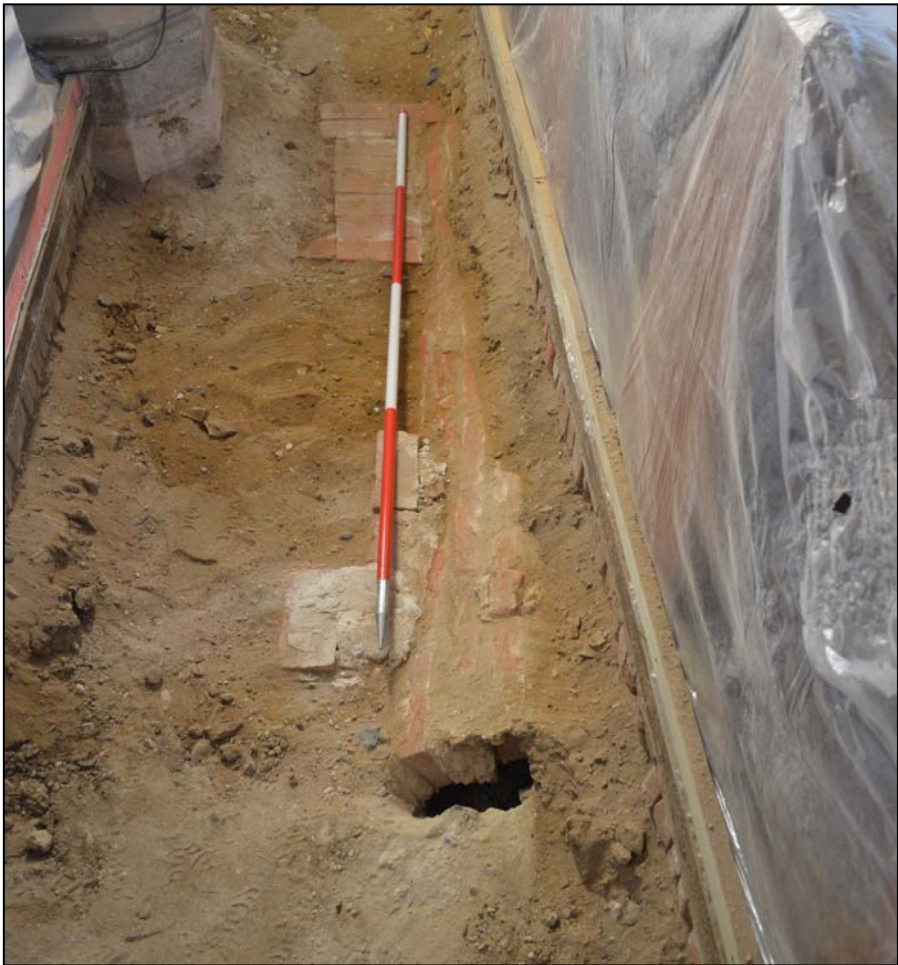
A small brick lined grave with a covering vault (**0009**), located in the south aisle, was partly exposed (Plate 15). It measured 2.28m in length and was at least 0.35m wide, although the full width could not be measured as it lay partly beneath an area of raised wooden flooring. It comprised a brick built shaft covered by a brick vault and was

Plate 15. Burial vault 0009, camera facing east

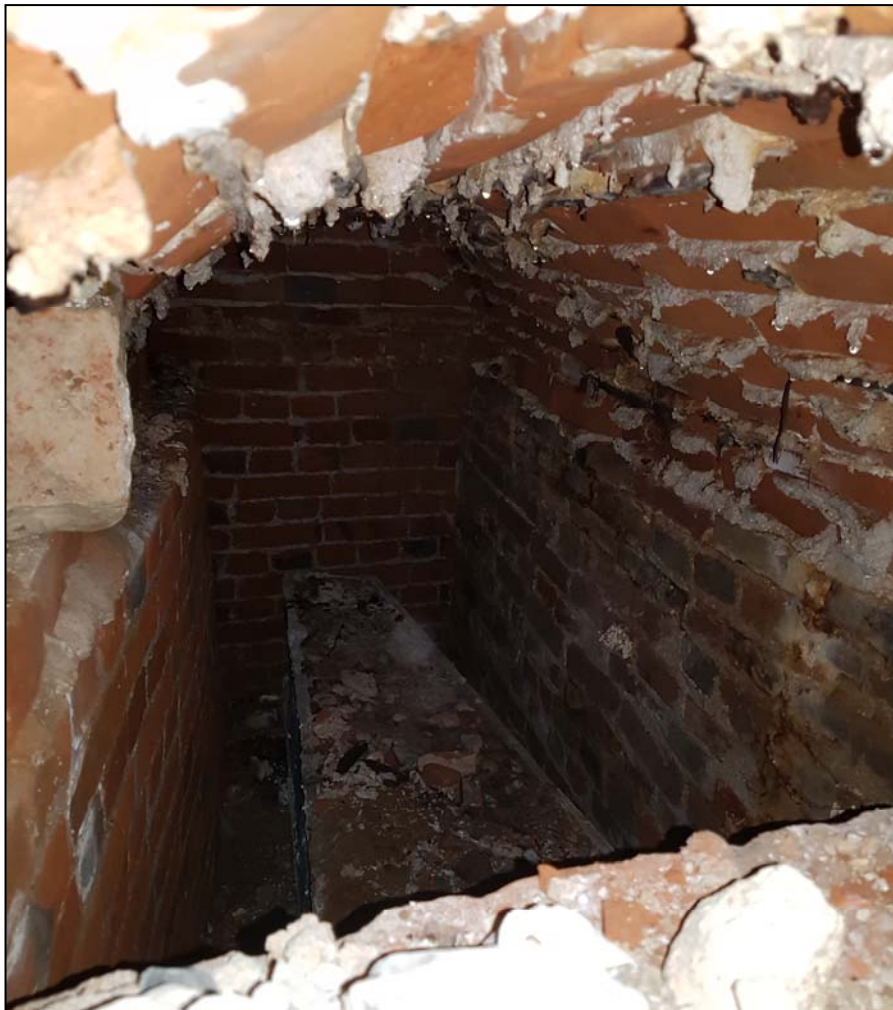
Plate 16. Interior of vault 0009 showing single coffin, camera facing east

aligned very roughly with the main axis of the church. The east end appeared to be completely closed with brickwork although an opening was present at the top of the wall at the west end through which it could be seen that the tomb contained a single coffin (Plate 16). The north wall of the structure appeared to be slightly bowed although it was not clear if this was part of the original construction or due to later soil movement. An area of additional brickwork was present on the northside of the vault, at the east end (Plate 17). It was placed between the vault and the foundation of the adjacent arcade column and may have been intended to provide some additional strength in this area. The burial vault is undated and its occupant unknown but they are likely to be named on one of the many memorials that line the church walls. Given the style of the burial, a late 18th or 19th century date would seem most likely.

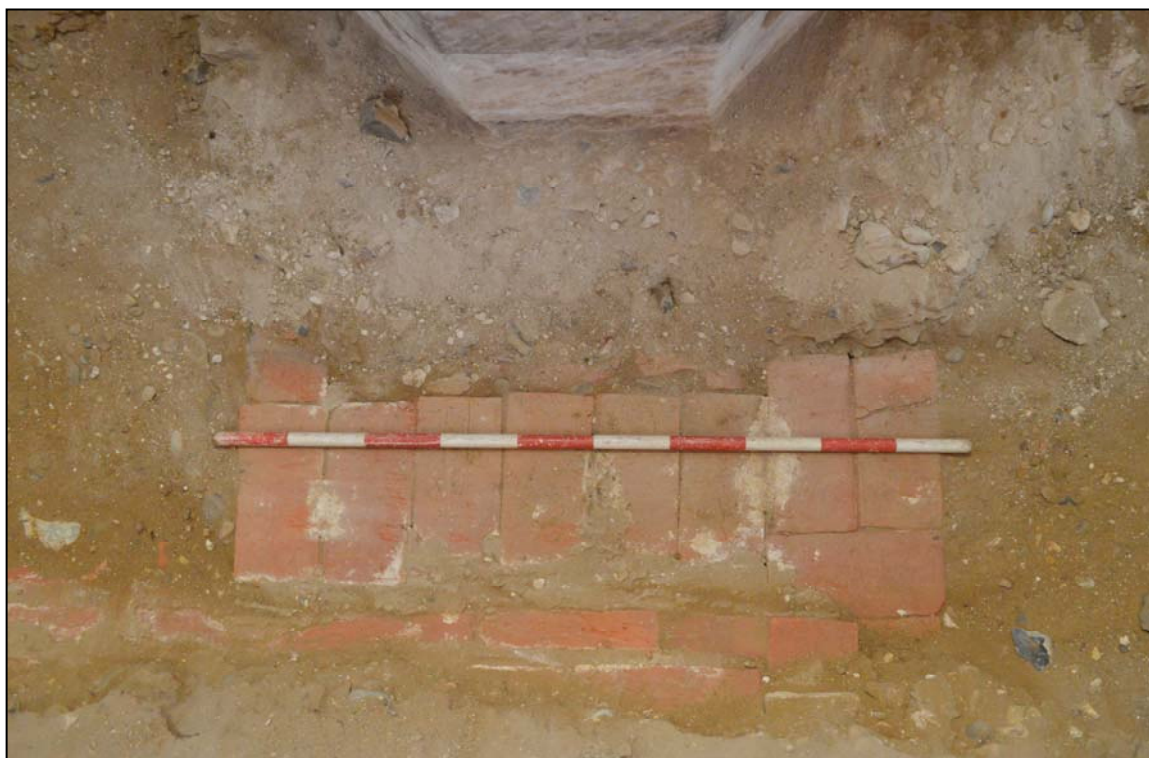
Plate 17. Brickwork adjacent vault 0009, camera facing north

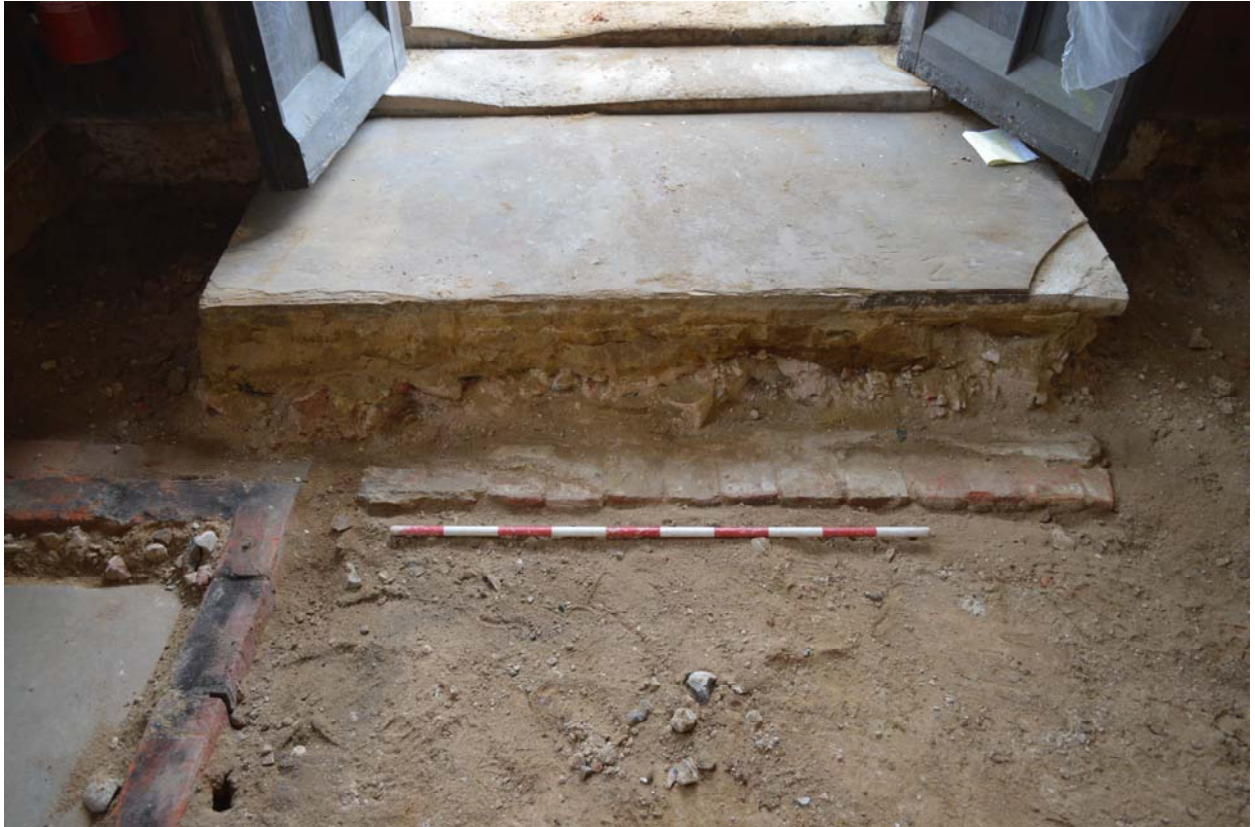
Plate 18. Memorial stone 0015 and brickwork 0019, camera facing north

A memorial slab (**0015**), probably relocated from elsewhere within the church, was located at floor level, just inside the main entrance (Plate 18). It measured 1.81m in length, was 0.79m wide and rectangular in shape. The worn remains of an inscription was present on the upper surface. It could not read at the time but it is felt that given careful cleaning and the right light that much of it would be retrievable. The stone was supported on a bed of dark yellow sand, which overlay yellow sand with brick/tile fragments and crushed mortar, as seen below the formerly adjacent cement floor (see Test Pit 3 above). Below the latter deposit, a length of brickwork (**0019**), formed of a row of headers with mortar on part of the upper surface, ran parallel with the southern edge of the slab 0015. It did not appear to be directly related to the slab but was possibly concerned with an earlier phase of entrance flooring or possibly steps.

| Context Number | Feature Number | Feature Category | Description <i>Interpretation</i> | Over | Under | Cut by | Cuts |
|---|---|---|--|---|---|---|---|
| 0015 | 0015 | Memorial Slab | Stone memorial slab laid just inside main entrance, smooth surface, worn, although some text is faintly visible. <i>memorial slab, possibly over a grave or possible crypt but its location immediately adjacent the door suggests it has been resited</i> | | | | |
