St Peter's Church (floor replacement) Yoxford, Suffolk

Archaeological Monitoring Report

SACIC Report No. 2019/023

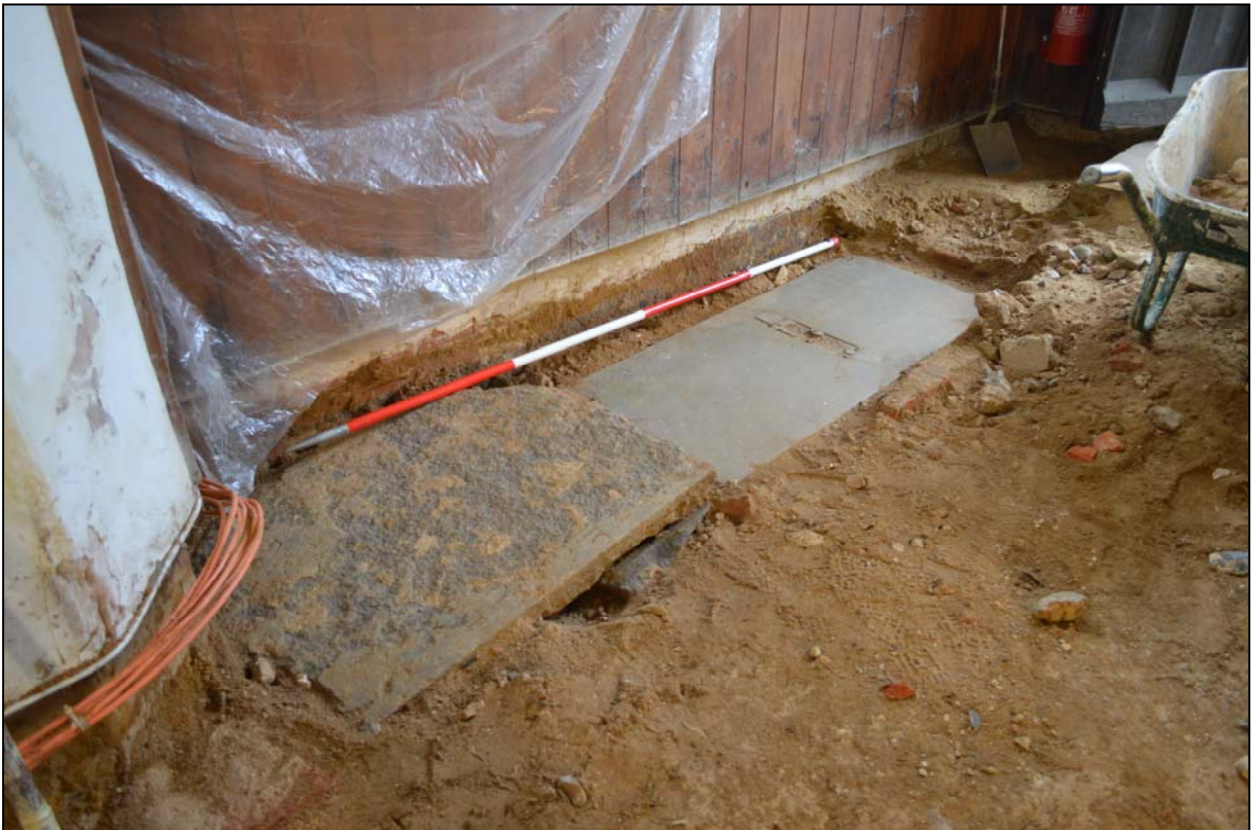
Two memorial slabs were present against the west wall in the vicinity of the entrance (Plate 19). Both had been buried under the previous floor surface. The northern of the two (**0021**), measured 1.48m by 0.62m and was aligned north-south (Plate 20). It was uninscribed, although a rectangular recess with the remains of six fixing points was present on the upper surface suggesting a metal plate had been affixed. A length of brickwork (**0020**) ran along the northern edge of the slab and partway along the eastern edge (Plate 21). To the north it was 0.23m wide (two bricks) whilst to the east it was 0.11m wide (single brick). The purpose of this brickwork was not clear. Its initial appearance suggested an association with the stone and that together they formed a burial monument but this interpretation seems doubtful. The stone's orientation, the fact the metal plate had been removed, and its burial beneath the floor surface suggests it

Plate 19. Memorial stones 0022 (foreground) and 0021, camera facing northwest

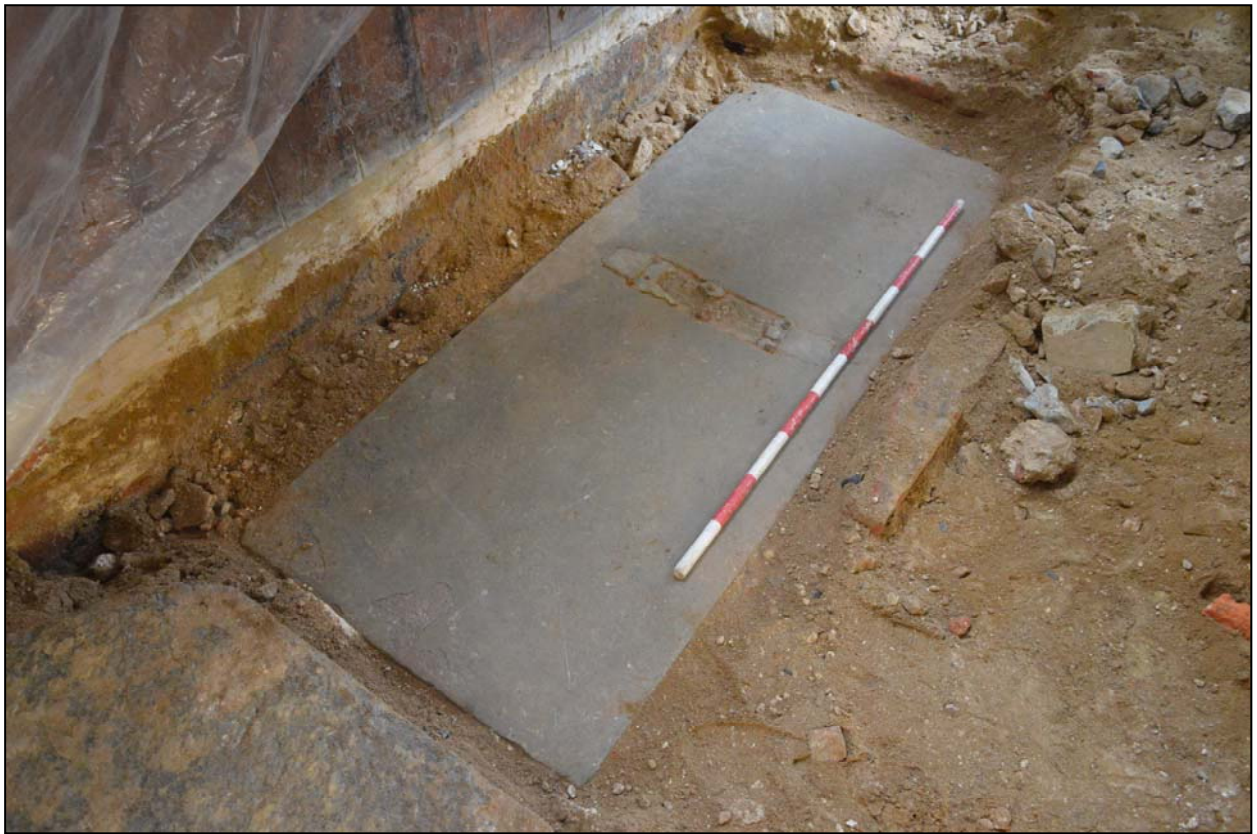
Plate 20. Memorial stone 0021, camera facing northwest

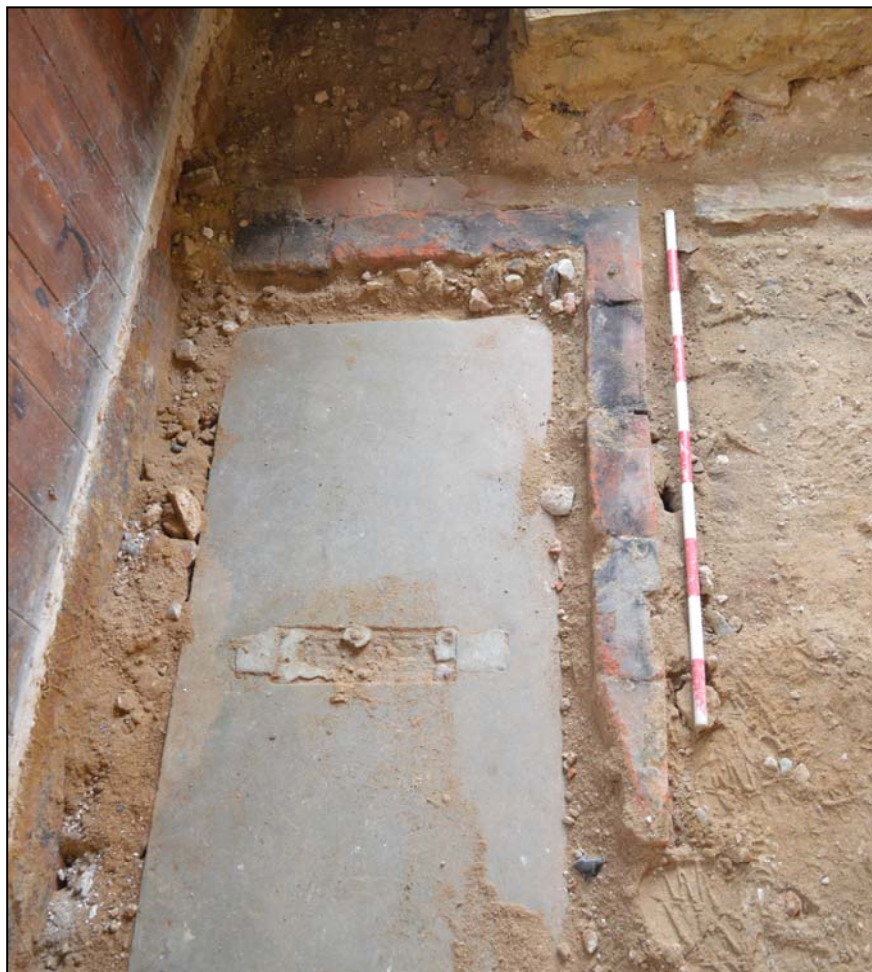
Plate 21. Memorial stone 0021 with brickwork 0020, camera facing north

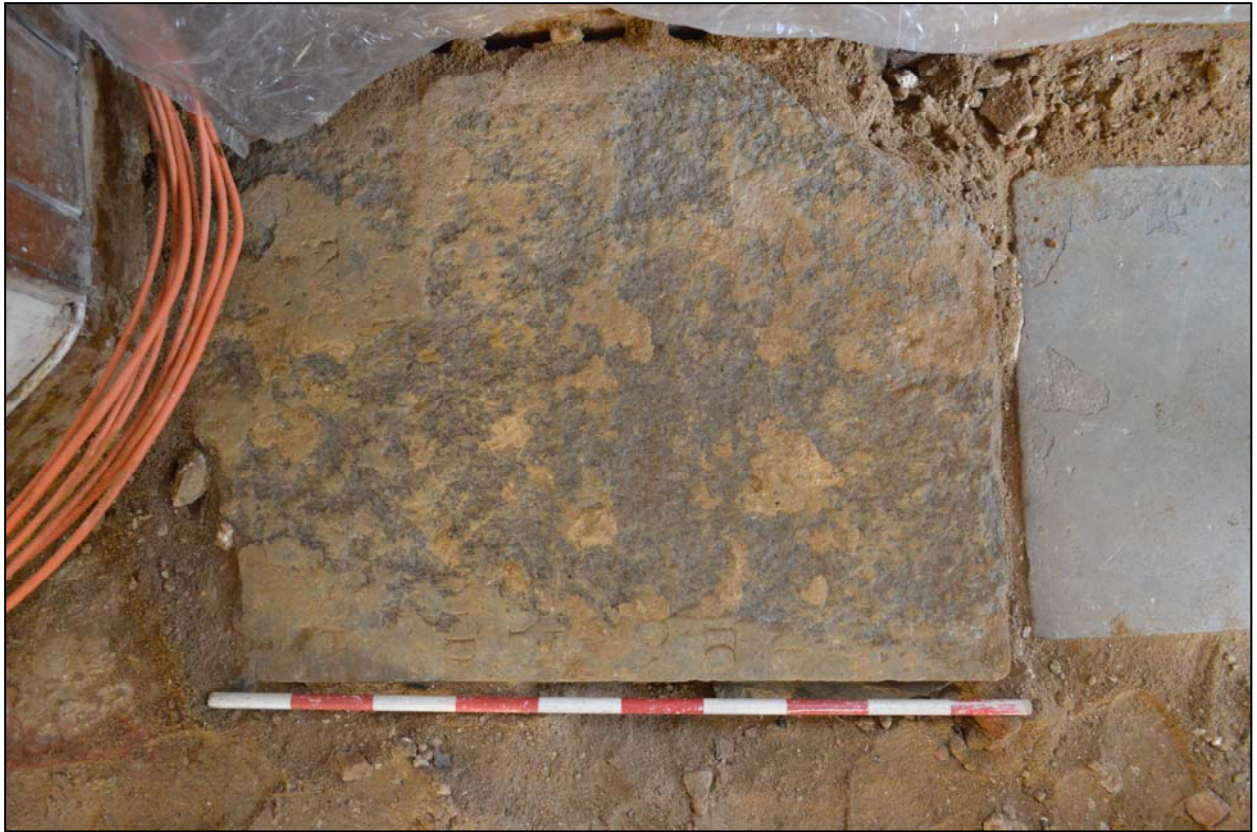
Plate 22. Memorial stone 0022, camera facing west

A second stone slab (**0022**), measuring 0.78m by 0.99m, was located to the south of 0021 (Plate 22). The upper surface was degraded and much of it had been lost although parts of an inscription could be discerned. The location and orientation of the inscription indicates the slab was a fragment that comprised the top right corner of a larger memorial stone. It lay at a slight angle, was noticeably loose, and appeared to be over a void of unknown dimensions. The purpose of this stone was unclear. It may have been bridging a void containing a service or its position here may have simply been used as part of the make-up of the floor's base.

| Context Number | Feature Number | Feature Category | Description <i>Interpretation</i> | Over | Under | Cut by | Cuts |
|---|---|---|--|---|---|---|---|
| 0022 | 0022 | Memorial Slab | Large fragment of a memorial slab. Upper surface degraded and lost but some text visible along edge. Not lying | | | | |

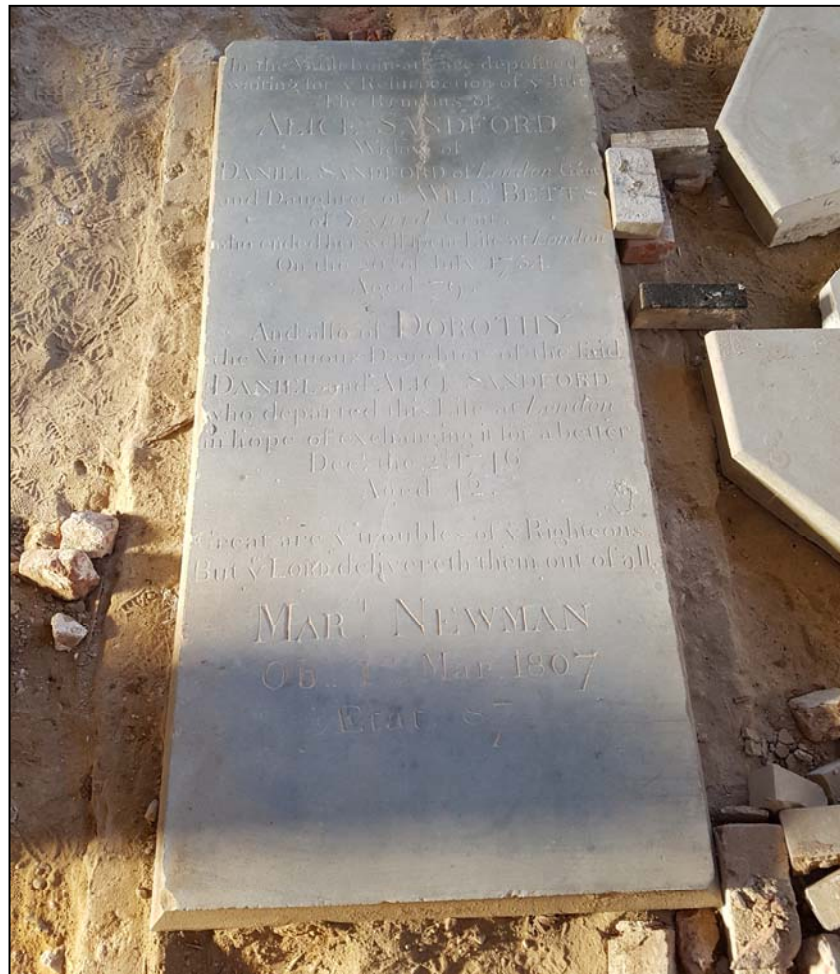
Plate 23. Memorial stone 0016, camera facing west

Removal of the raised wooden floor at the west end of the north aisle pews revealed a further memorial slab (**0016**). An inscription on the upper surface (Plate 23) reads:

In the Vault beneath are deposited
waiting for ye Resurrection of ye Just
The Remains of
ALICE SANDFORD
Widow of
DANIEL SANDFORD of *London* Gent.
and Daughter of WILL^M. BETTS
of *Yoxford* Gent.
Who ended her well spent Life at *London*
On the 20th of July 1754
Aged 79
And also of DOROTHY
The Virtuous Daughter of the said
DANIEL and ALICE SANDFORD
Who departed this life at *London*
In hope of exchanging it for a better
Dec^r. the 2nd 1746
Aged 42
Great are ye troubles of ye Righteous
But ye Lord delivereth them out of all
MAR^T. NEWMAN
Ob^t. 1st Mar. 1807
Ætat. 87

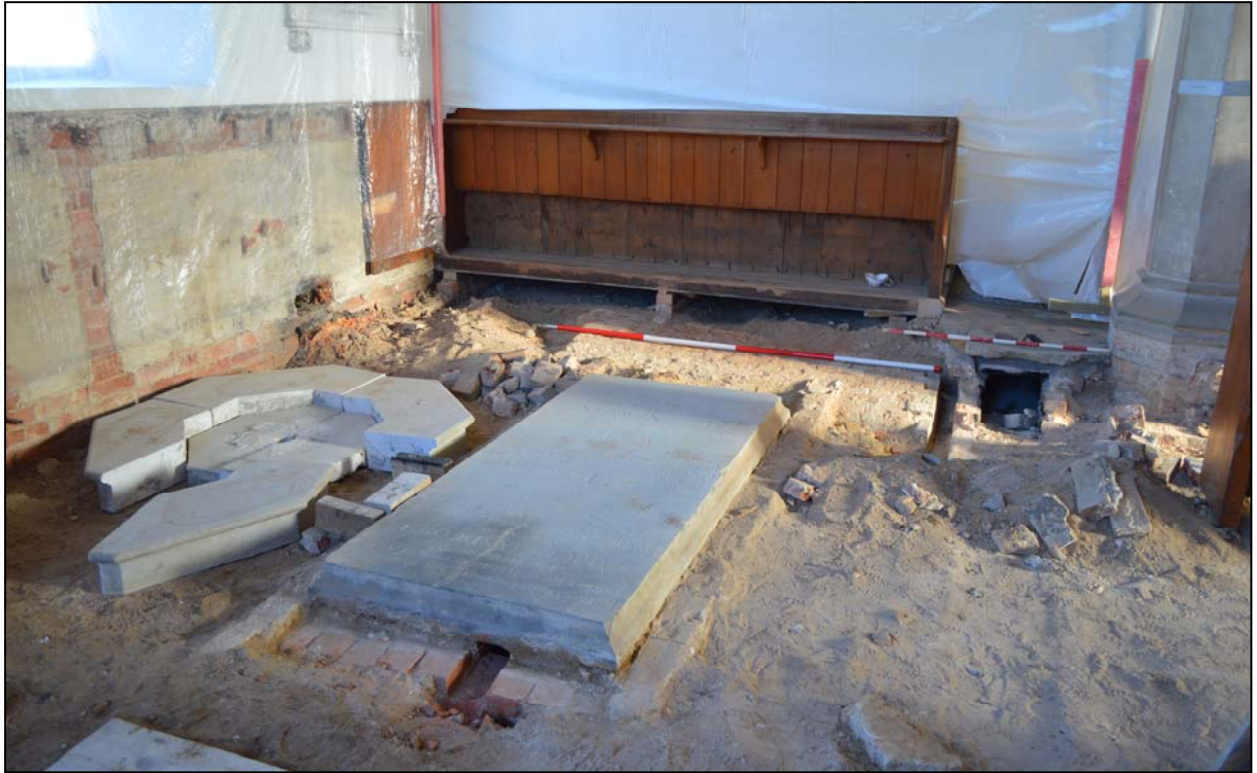
The stone sat between two lengths of brickwork that ran along its northern and southern edges, whilst its eastern and western ends rested on red brick walls which protruded by approximately 0.12m to 0.17m (Plate 24). The walls to the north and south continued beyond the ends of the memorial slab. Both had mortar on the upper surfaces with brick impressions indicating they had been at least one course higher. The wall to the north had been one of the dwarf walls that supported the raised wooden floor that had been removed from this area. The southern wall was also interpreted as a supporting dwarf wall but was unrelated to the floor that had been recently removed, possibly suggesting an earlier phase of timber flooring was once present.

Plate 24. Memorial stone 0016 with vault 0028 beyond, camera facing east

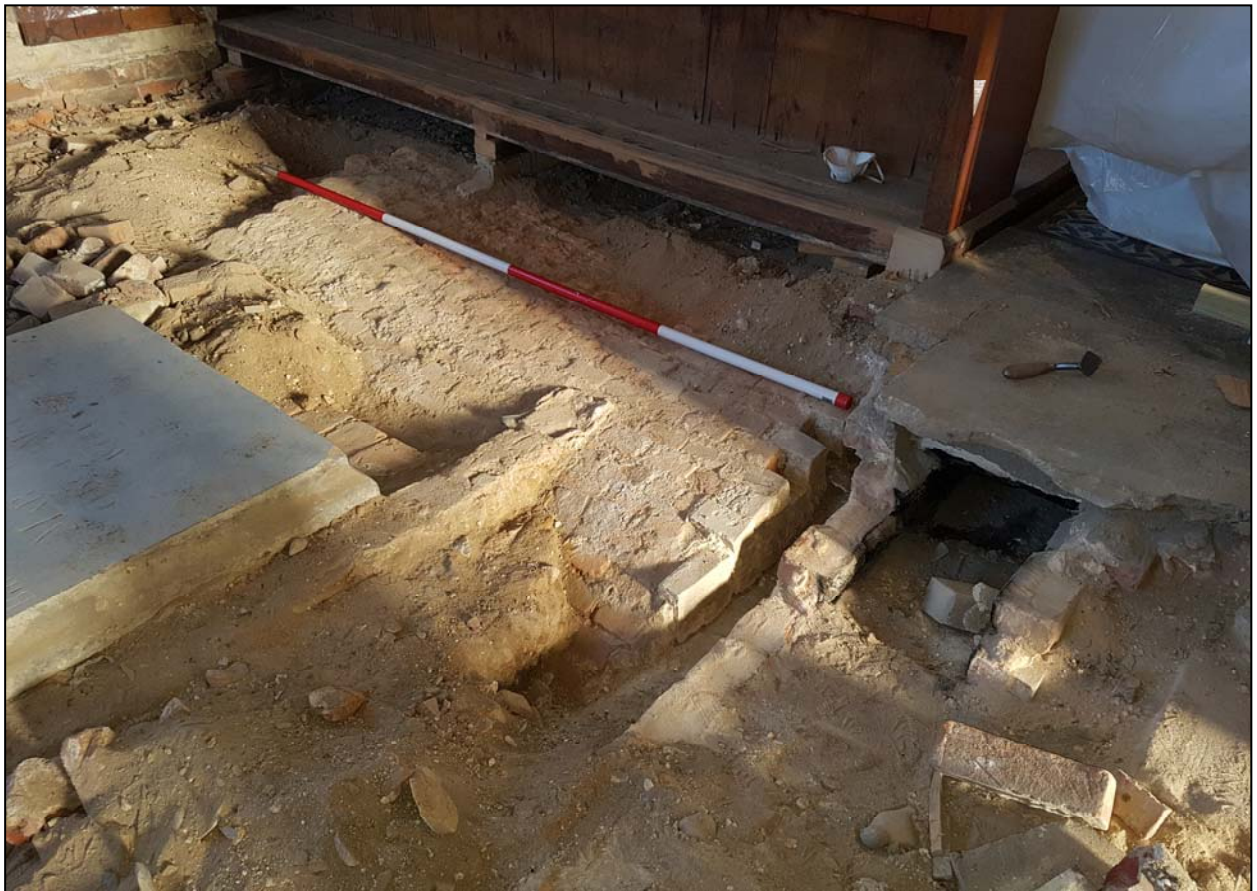
Plate 25. Vault 0028 beyond with heating duct to right, camera facing northeast

The memorial measured 0.96m by 1.98m and c.0.075m thick with moulded edges (visible in Plate 25) suggesting it was intended to stand proud of the floor surface or possibly that it was to be the lid to a box tomb. It is intended to raise the level of the stone so that it will be flush with the new floor.

| Context Number | Feature Number | Feature Category | Description <i>Interpretation</i> | Over | Under | Cut by | Cuts |
|---|---|---|--|---|---|---|---|
| 0028 | 0028 | Burial Vault | Brick built vault, associated with stairs to the west . Red brick with lime mortar. Only upper exterior seen, no access to interior. Upper northern edge has been cut back slightly during the insertion of the heating ducts, damaged area has been made good with thin white bricks. <i>Burial vault</i> | | | | |

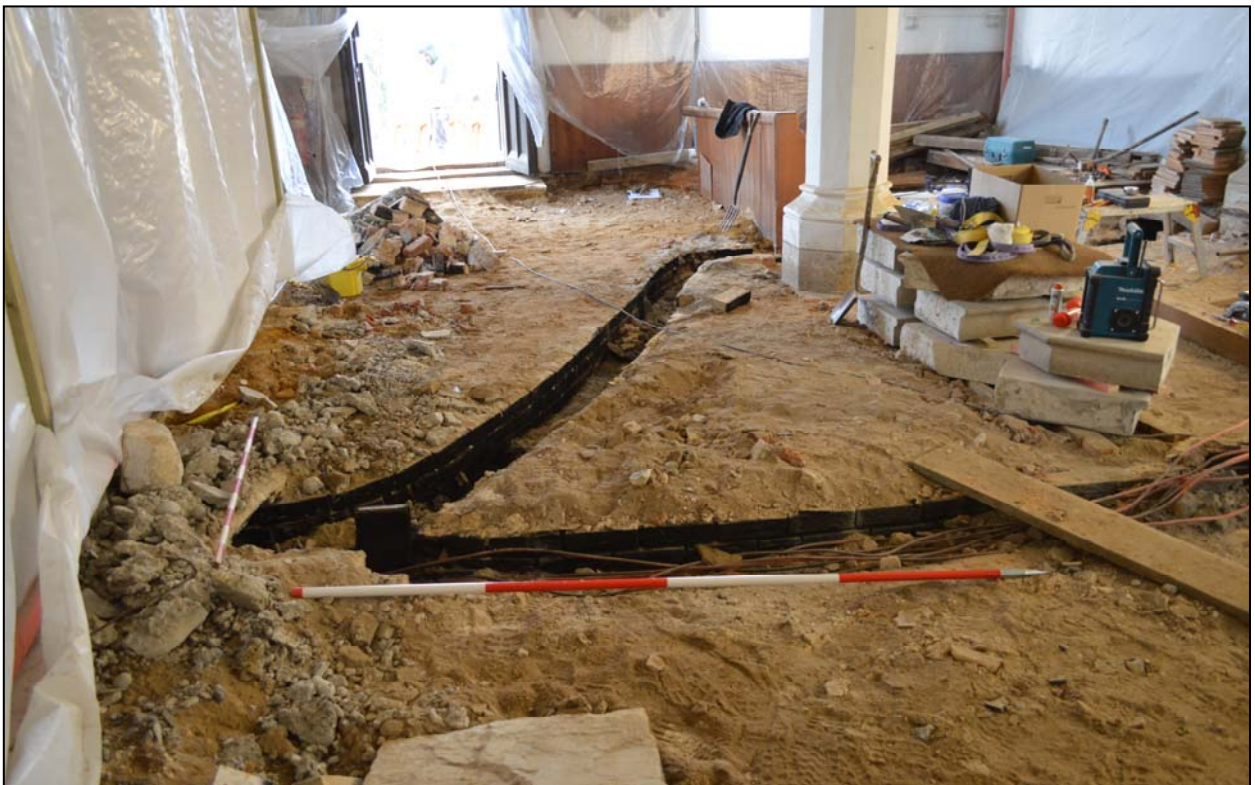
Plate 27. Heating ducts at the west end of the nave, camera facing north

A series of ducts that were undoubtedly associated with underfloor heating were noted below the areas of cement floor in the west end of the church. They comprised a base formed of stone slabs with vertical sides formed from three courses of mortared brickwork and topped with further stone slabs (Plate 27). The internal dimensions of the ducts were 0.25m wide and 0.24m high and the interior surfaces were heavily sooted, indicating they had acted as the flues from fire. Two ducts were present, one running up

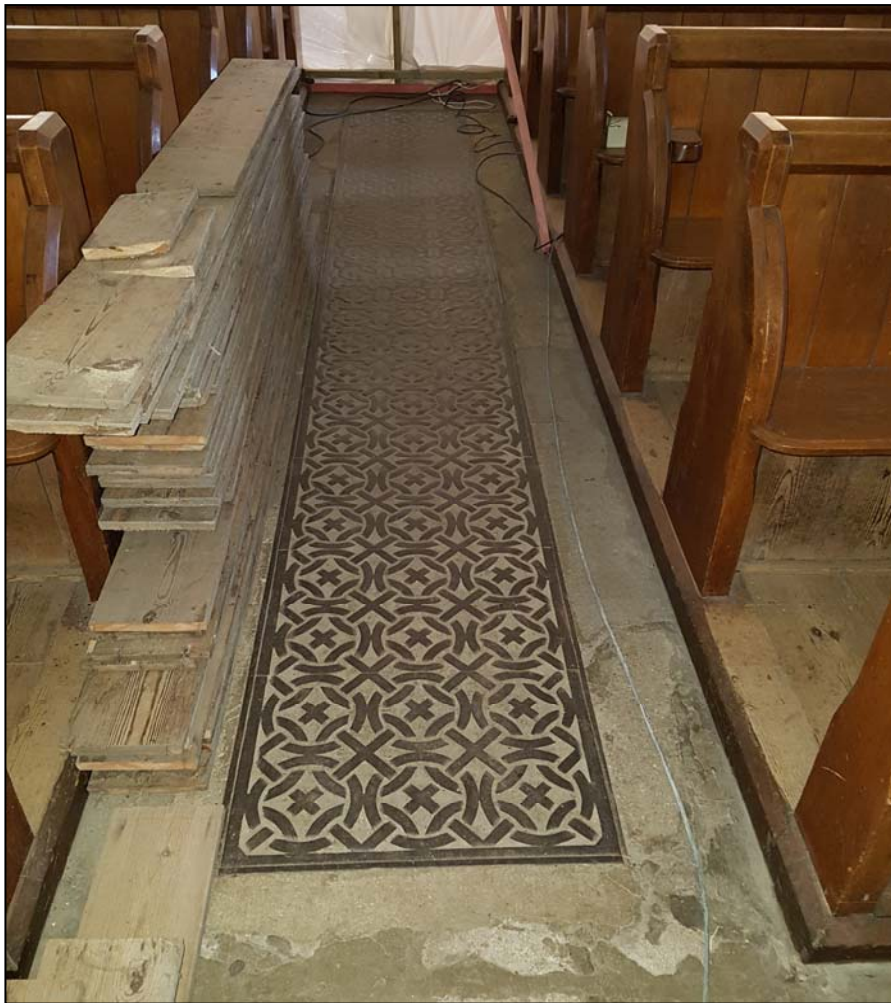
Plate 28. Cast iron panel in nave forming part of the heating system, camera facing west

the north aisle passage and one up the centre of the nave. Two large cast metal panels (Plate 28) were set into the floors of the north aisle and the central aisle which would have been heated by the hot flue gasses carried in the ducts. The two ducts came together close to the entrance to the tower and from there ran to a chimney located in the northeast corner of the tower. It was not clear where the fire was located but a low brick arch, blocked but with a vent, was noted in the exterior of the east wall of the church, close to the northeast corner. This may have been the site of an subterranean chamber, accessed from outside the church, in which the fire for the heating system was maintained. For the purpose of installing the new floor the ducts will be reduced in height, by the removal of two courses of brickwork, and filled with sand. The top stones will then be resealed on the *in-situ* remnants and the whole buried under the new floor.

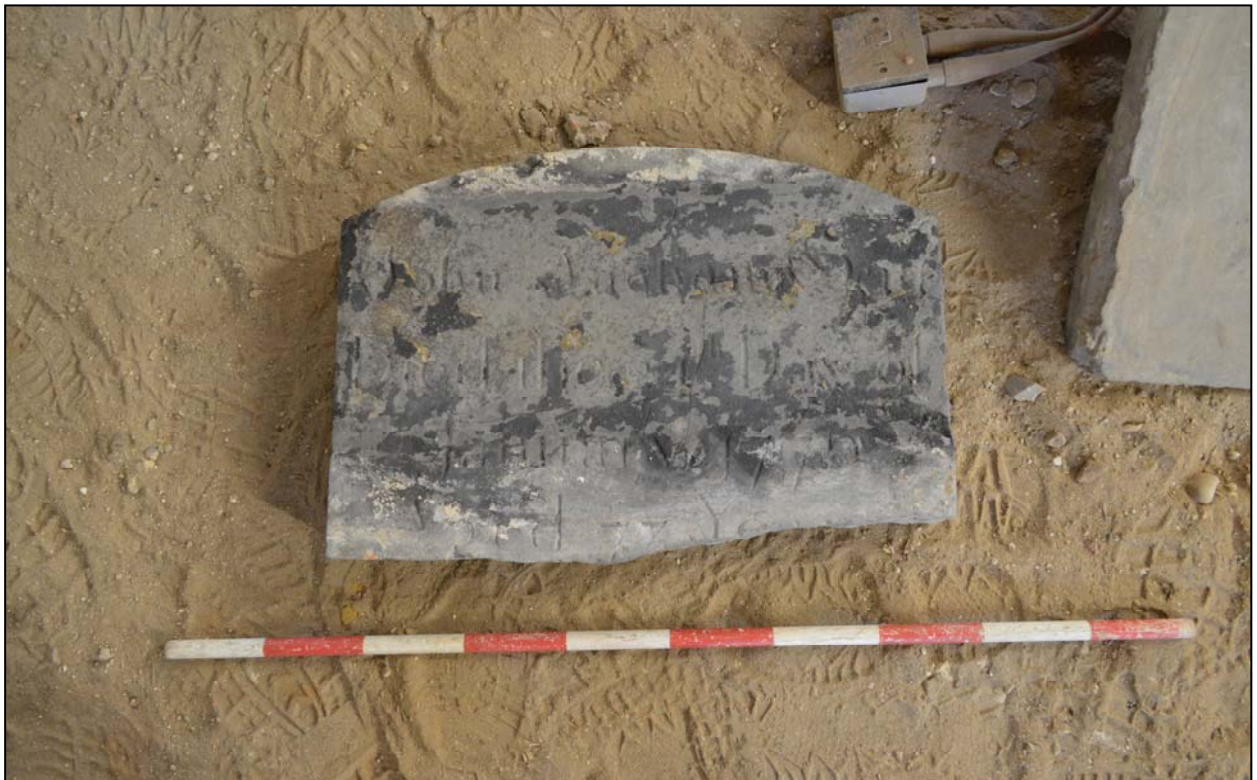
Plate 29. Fragment of a gravestone reused as a cover on one of the heating ducts

In three separate areas, an upper slab was slightly raised so they were flush with the existing floor, which would have allowed access to enable the system to be swept. One of these slabs was found to have been formed from part of a gravestone. The inscription is unclear but the date of death appears to be '24th day of January 1776' (Plate 29).

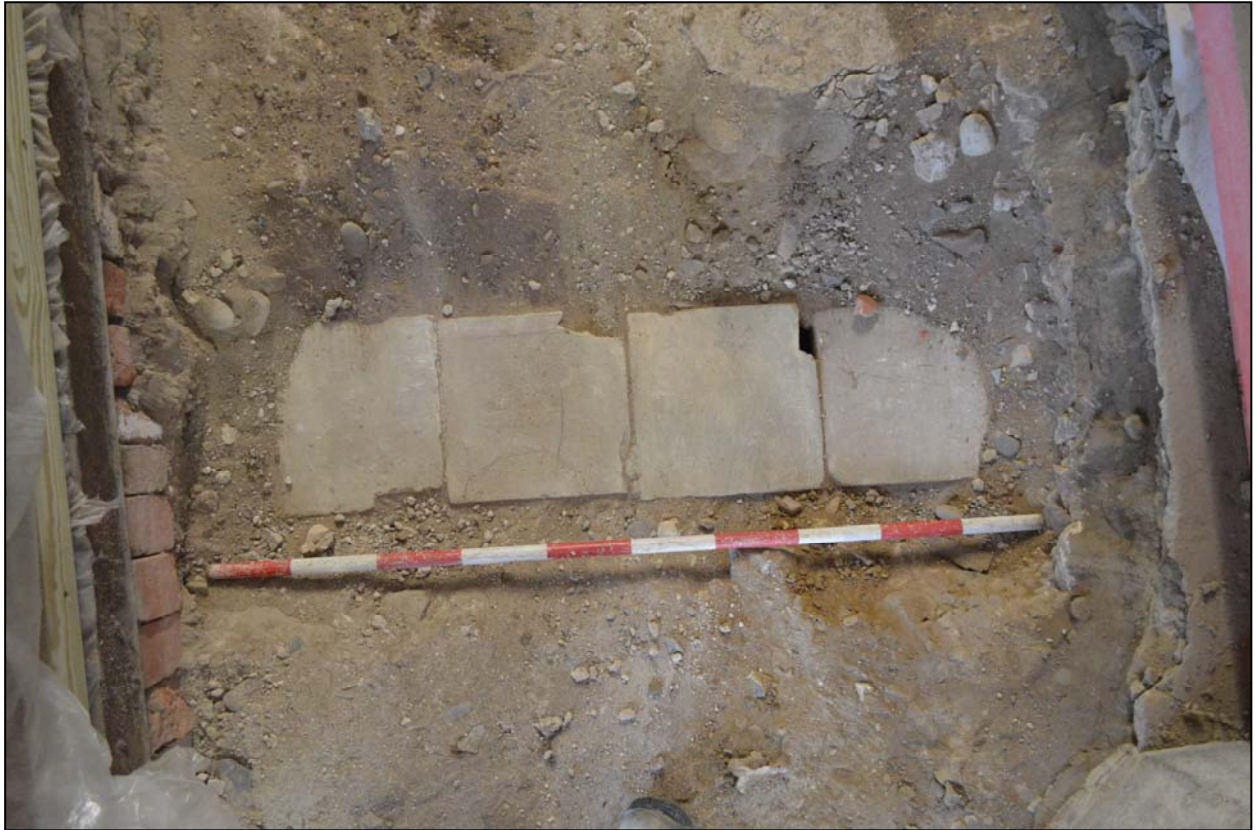
Plate 30. Probable heating duct in the south aisle, camera facing west

Two further ducts were noted running north-south across the south aisle were noted (see Fig. 5). They were narrower and topped with bricks or tiles (Plate 30) but are likely to be part of the same system, possibly forming a loop from the nave aisle duct.

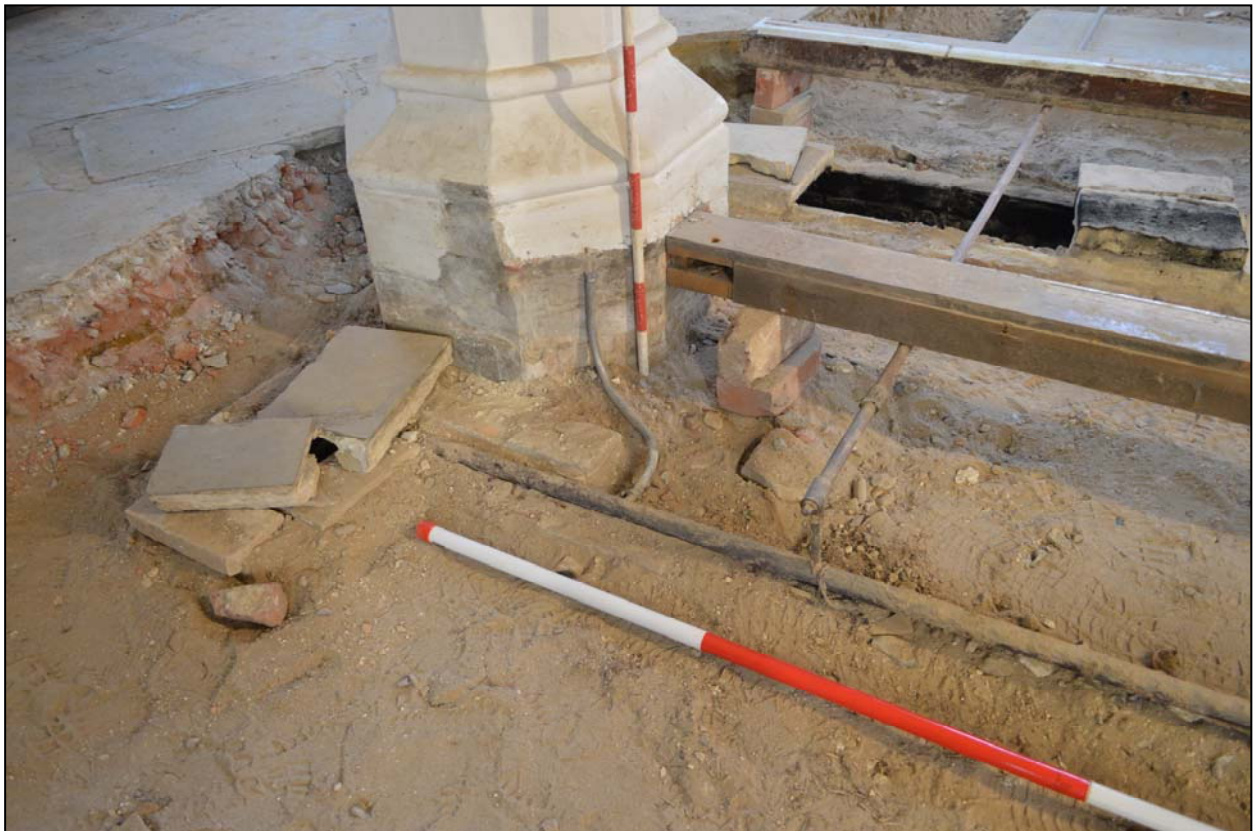
Plate 31. Gas pipes at the west end of the nave, camera facing northwest

Also noted in the west end of the church were a series of iron gas pipes. The supply entered via the north wall and ran south to a pair of pipes that ran either side of the nave, just inside the arcade columns. A further iron pipe headed towards the tower. Spurs off these led, via lead pipes, up to the columns but were then cut off at floor level (Plate 31). They presumably would have fed gaslights, or possibly heaters, mounted on the arcade columns.
