Park Farm, Chapel Road
Bucklesham, Suffolk

BUC 120
Archaeological Evaluation Report
SACIC Report No. 2018/109
Author: M. Sommers
© SACIC

Archaeological Evaluation Report

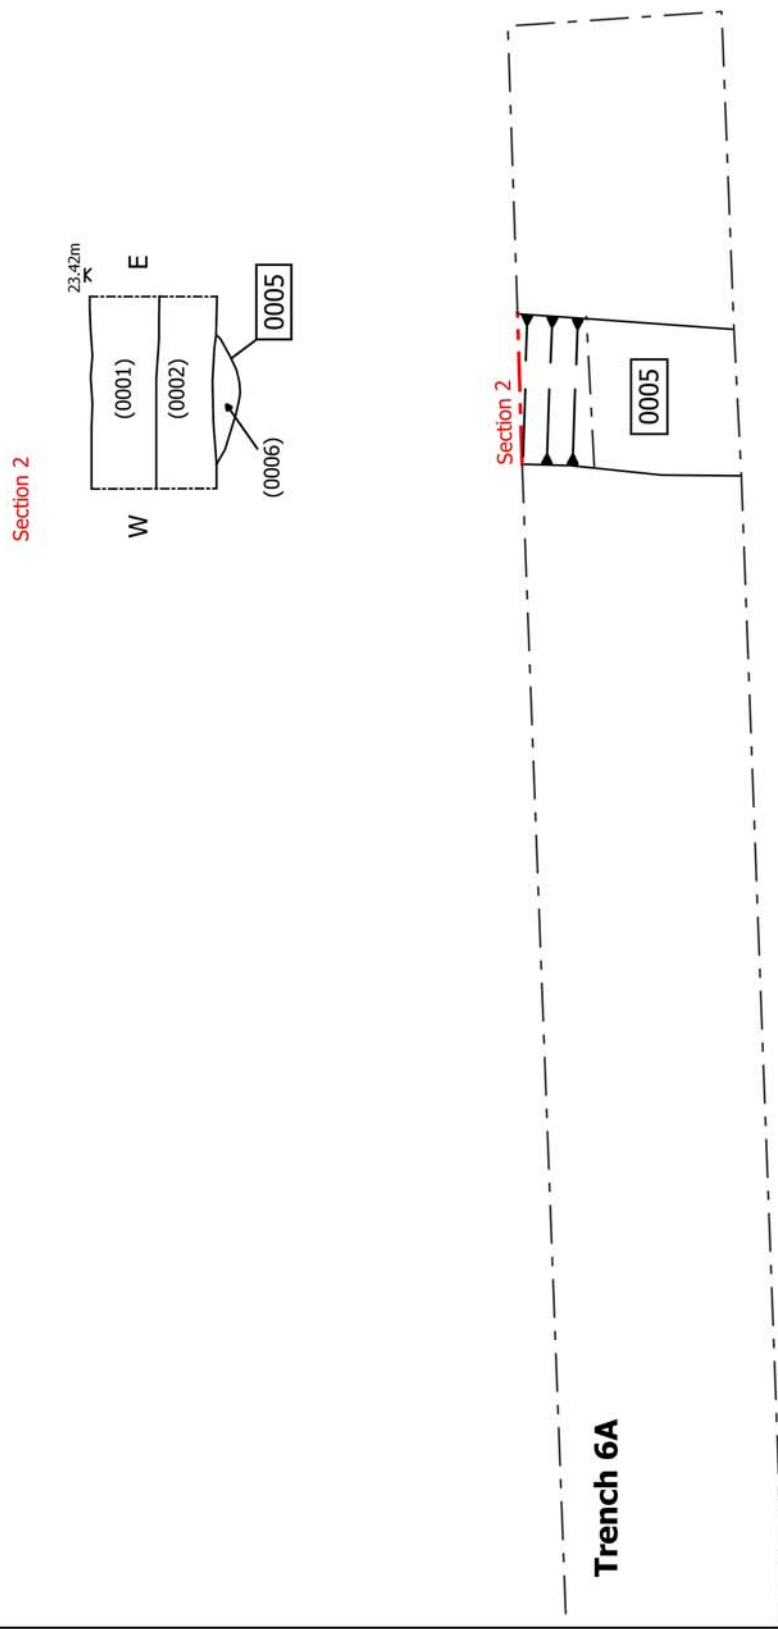
Figure 6. Ditch 0005 (Trench 6A) plan and section
13

Trench 6: Excavated in two segments, 6A and 6B. Trench 6A was aligned east-west. Natural subsoil was at a depth of c.0.7m below 0.3m of topsoil (0001) and 0.4m of subsoil (0002). A single feature was recorded comprising a linear cut (0005) interpreted as a ditch aligned roughly north-south (Fig. 6). It measured 0.9m in width and cut the natural subsoil to a depth 0.16m (Plate 3). It contained a single fill (0006) of pale to mid brown silty sand from which no finds were recovered.

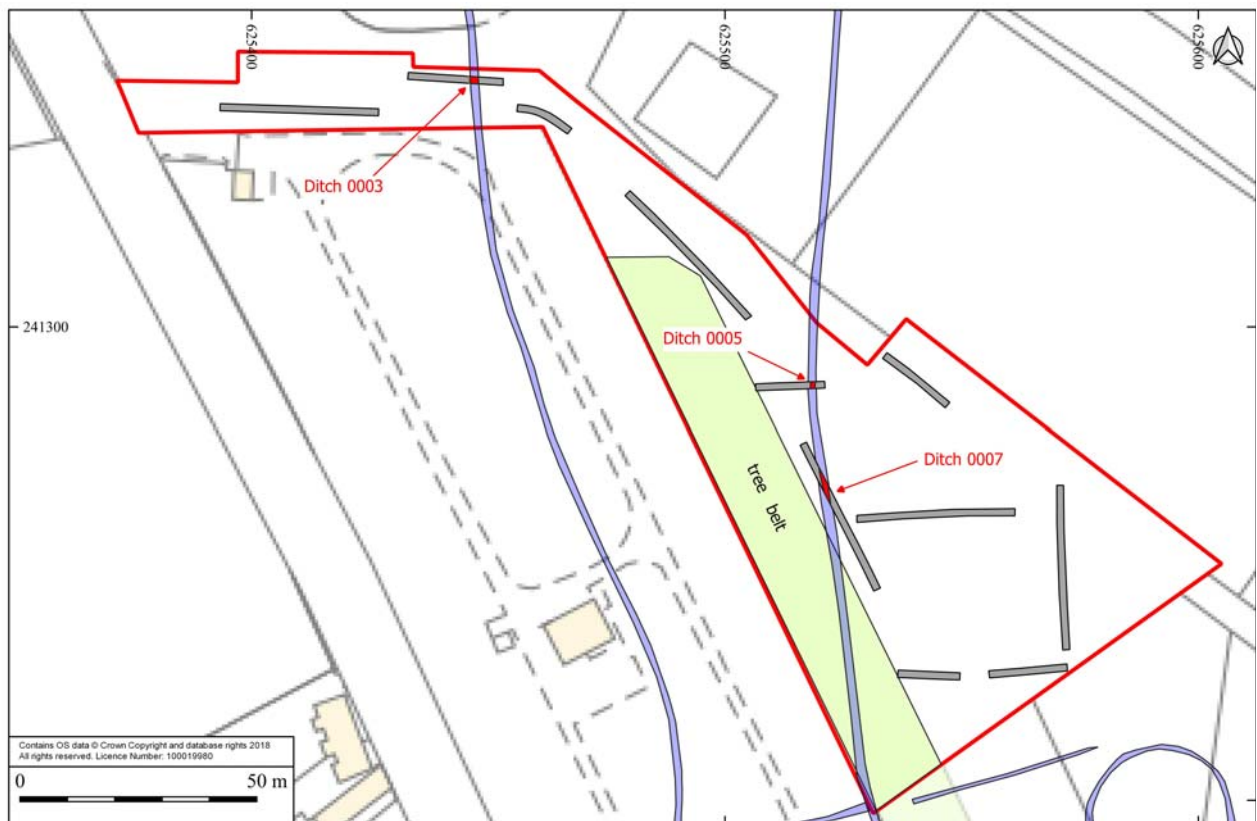
Figure 8. Summary of the evaluation results overlaid on the NMP plot

These ditches coincide with the linear features recorded by the NMP running across the phase 1 area (Fig. 8). It is beyond doubt that the ditches recorded in the evaluation trenches are the cause of the cropmarks visible in aerial photographs and this confirms that the recorded NMP features in this area a true reflection of buried archaeological evidence.

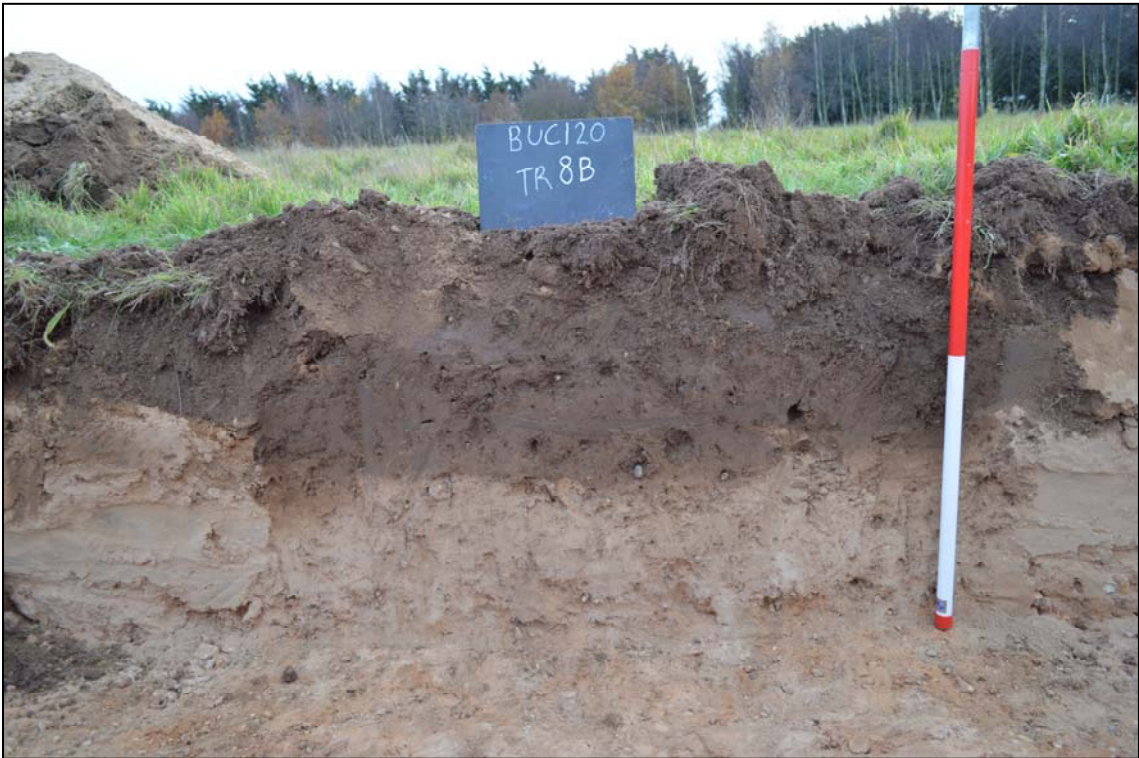
The trenches revealed a natural subsoil consisting of yellow gravelly sand which lay below an overburden that consisted of c.0.25 to 0.4m of brown sandy topsoil (0001) and a layer of mid yellow/brown or very pale yellow to white silt (colour dependant on moisture content) that varied in thickness between 0.25m to 0.6m (0002). The interface between the topsoil and the underlying subsoil was relatively abrupt suggesting previous truncation, possibly through ploughing. The interface between the subsoil (0002) and the underlying natural subsoil was uneven and there was no indication of any truncation at this depth (Plate 1).

Plate 1. Sample view of the overburden (as seen in Trench 8B)

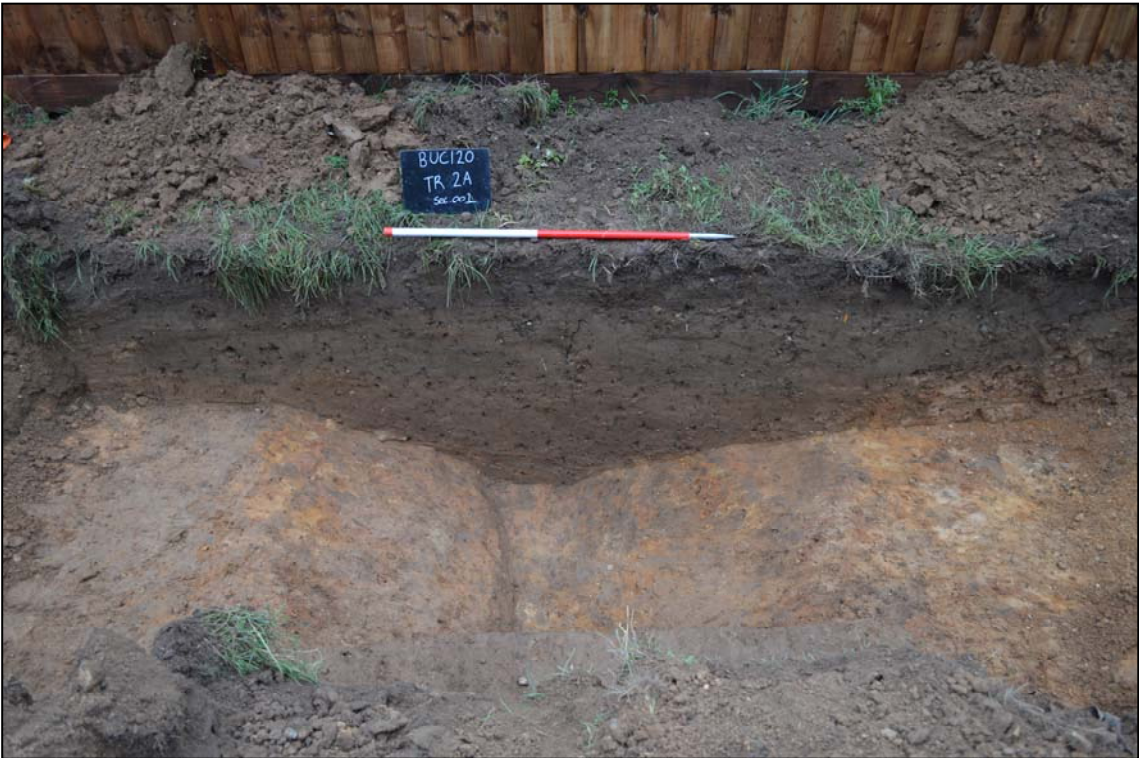
Plate 2. Ditch 0003 (Trench 2A), camera facing north

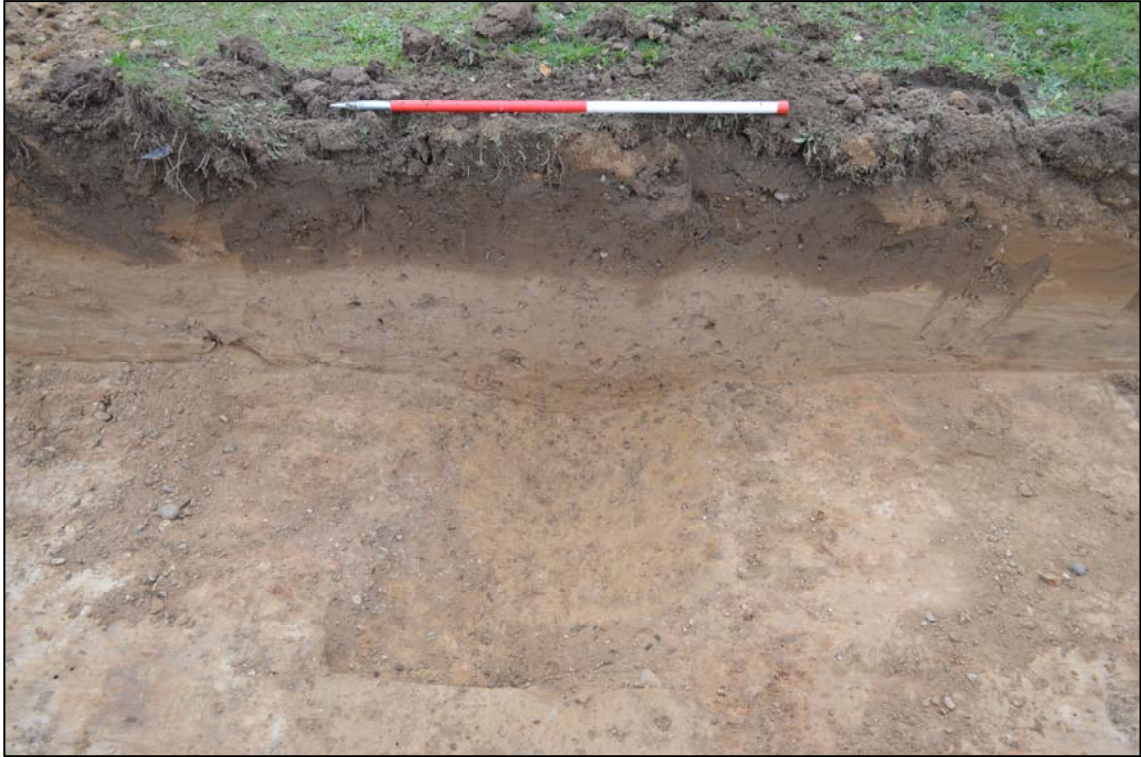
Plate 3. Ditch 0005 (Trench 6A), camera facing north

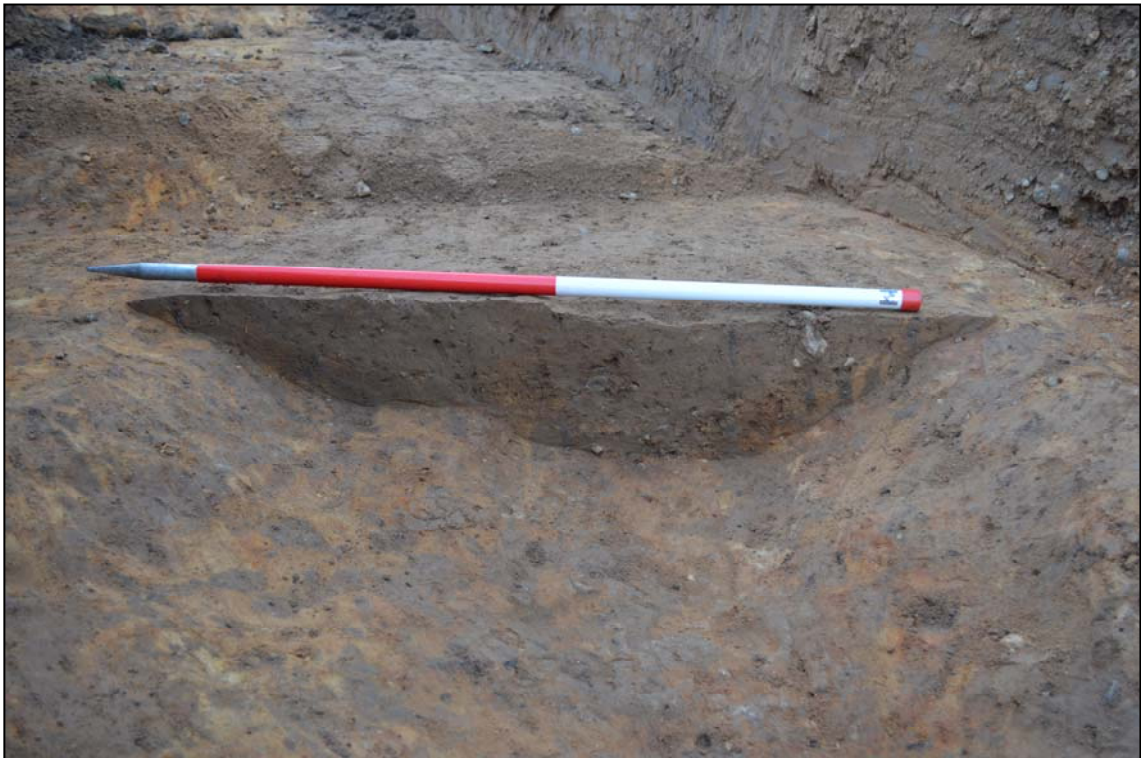
Plate 4. Ditch 0007 (Trench 7), camera facing south
