# Church of All Saints, Little Bealings, Suffolk

## BEL 023

Archaeological Monitoring Report  
SACIC Report No. 2018/107  
Author: Linzi Everett  
© SACIC

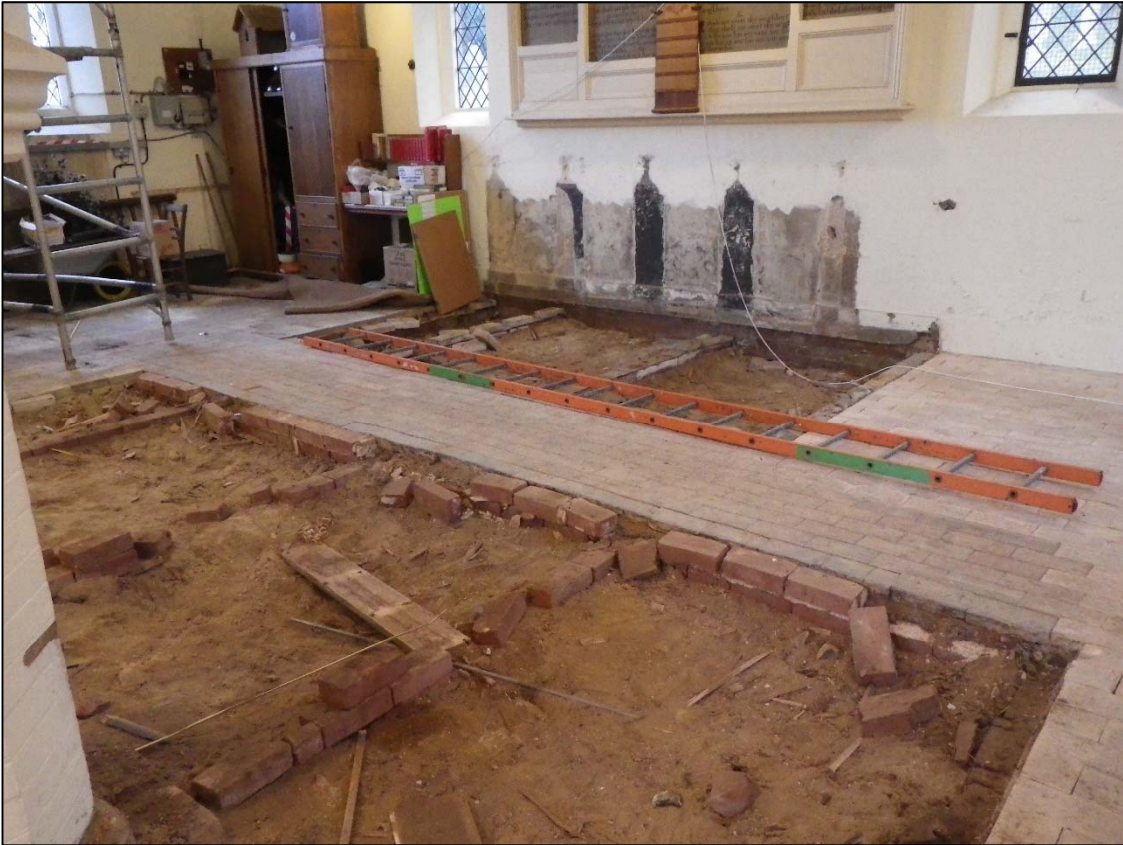
Plate 1. Area A and northern half of Area B before ground level reduction. Looking NW.

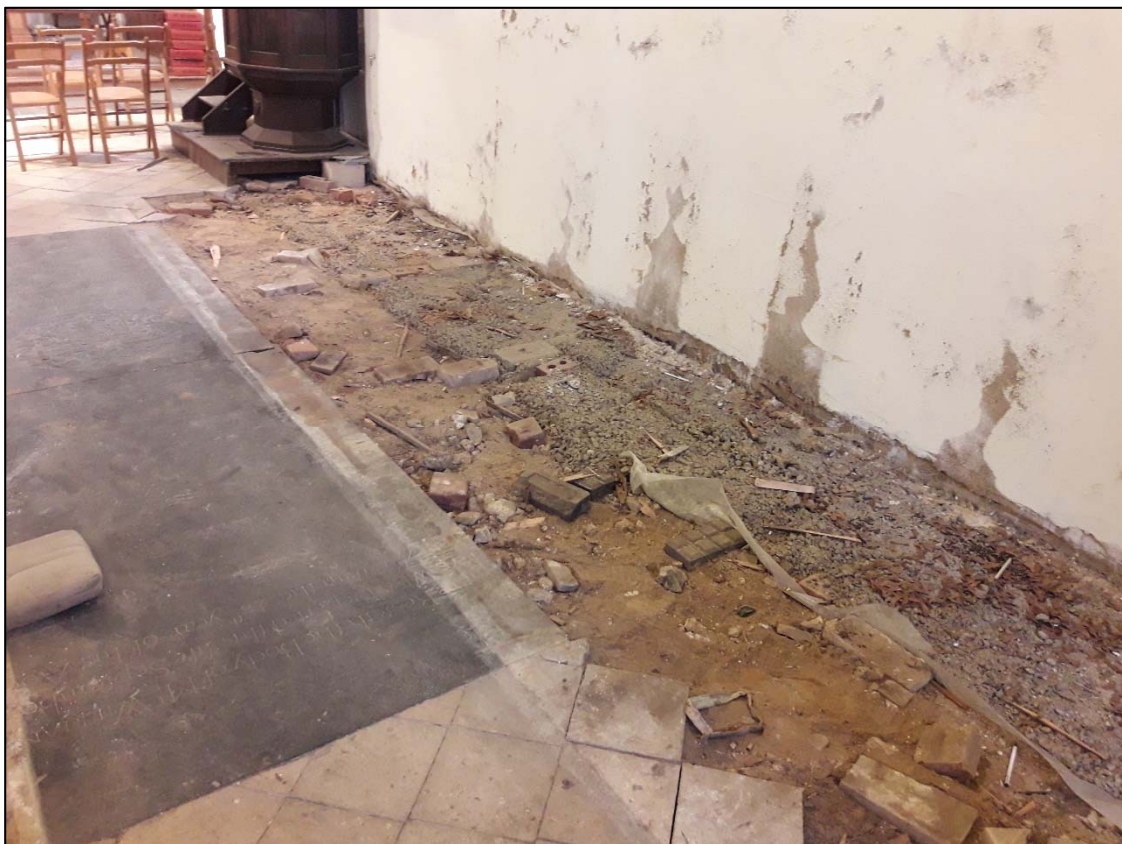
Plate 2. Area C prior to ground level reduction, showing concrete layer against the south wall of the church and ledger slabs set in the nave floor. Looking SE.

Below the pew base in area C, a layer of stony concrete had been poured over plastic sheeting up against the south wall of the church. This was approximately 0.15m thick and 0.75m wide and was presumably laid in order to alleviate damp problems under the pews. This and a thin layer of mixed deposits, brick fragments and loose detritus between the ledger slabs and the concrete were stripped from the area, revealing a series of broadly similar clay sand deposits below within which occasional post-medieval roof tile fragments were noted. Towards the eastern end of this stripped area and up against the church wall was 0025, an approximately rectangular spread of compact clay deposits measuring on average 0.4m wide and extending 2.1m from the eastern end of the strip. Light cleaning suggested that this feature had a flat, vertical face. Its location directly below a window inserted during the 16th century may suggest an association with this architectural feature, but could relate to an earlier feature replaced by the brick window, either through necessity or by design.

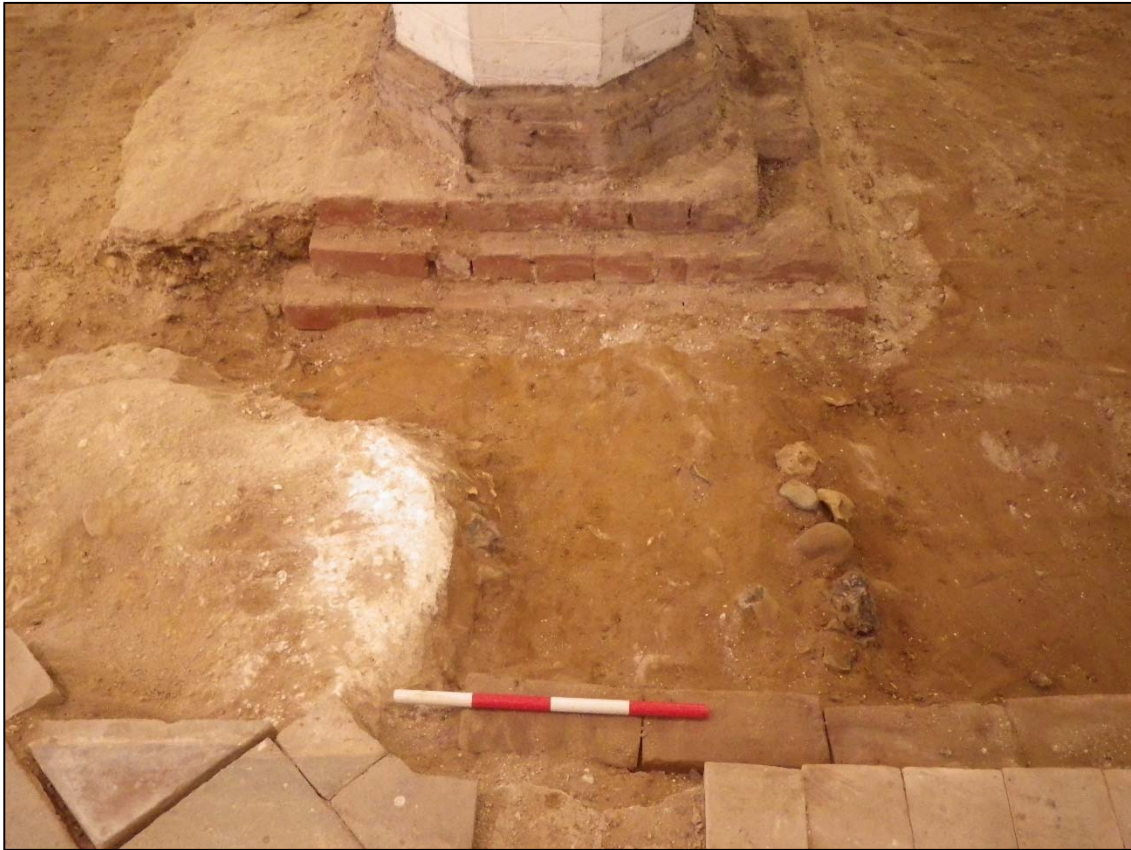
Plate 3. Evidence of the former north wall of the church (0006) cut by the Victorian brick pier plinth. Looking west, 0.4m scale.

0006 consisted of a solid, sandy shelly mortar with occasional flints and was aligned E-W along the line of the north arcade. It was well defined between the eastern pier and eastern limit of excavation, where it measured c.1.1m wide, but was also partially exposed between the eastern and western piers where its edges were less well defined. It is likely to be the base or upper footing of the former north wall of the medieval nave and a cluster of flints along its northern limit could be surviving fabric or facing of the medieval wall. On the south side of the wall line, a solid chalk feature was observed immediately below the sub-base for the tiled floor. 0010 comprised dense chalk rammed into a layer of flints over a thin layer of mid orangey brown silty sand directly over 0007. This measured c.0.8m long and c.0.55m wide and continued beyond the eastern limit of excavation. It may be the remnants of a floor surface predating the current tiles.

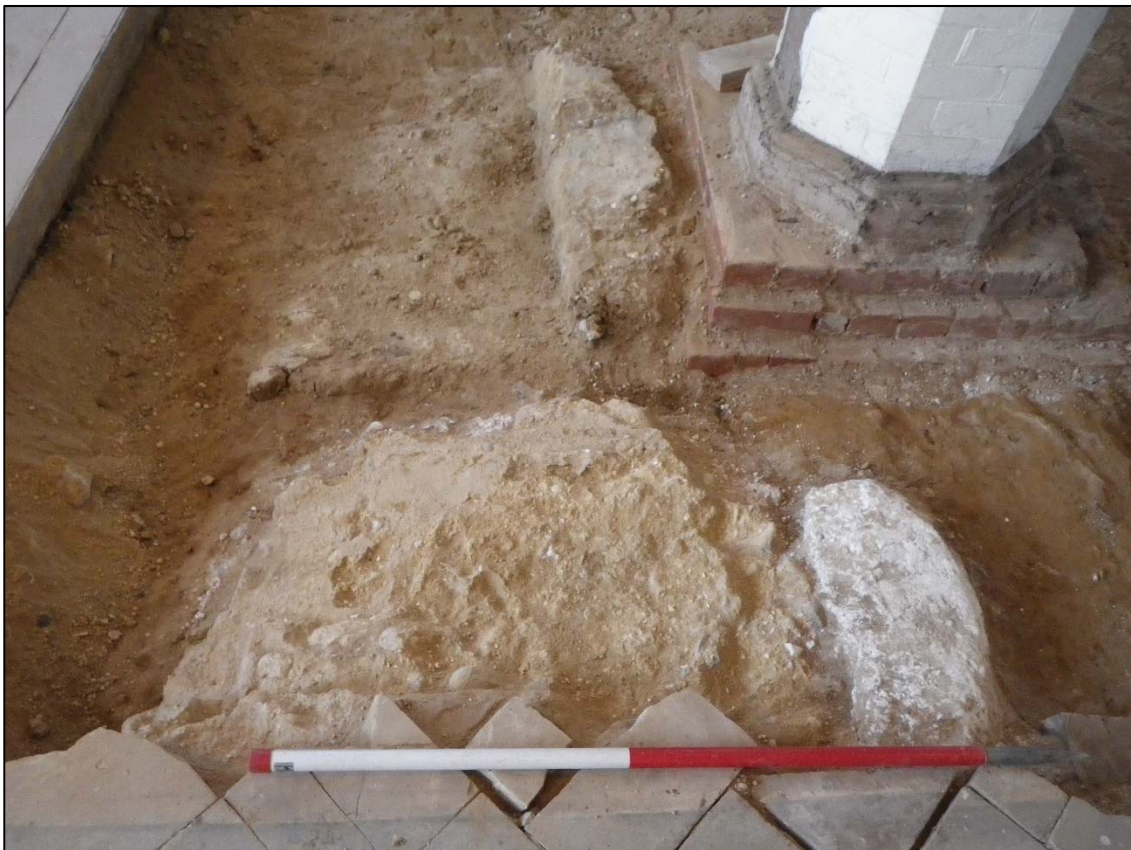
Plate 4. Mortar layer 0012, with chalk feature 0010 immediately to its north and clay feature 0017 at the top of the picture. Looking west, 1m scale.

- 0012 was a solid, shelly sand lime mortar incorporating medium flint cobbles, particularly towards the base. On its south-west corner and western edge, the surface was smooth and flat, with suggestions of tile impressions.
- 0013 was a compact, but not solid, layer of pale yellow craggy lime mortar
- 0014 was a thin layer of compact chalk containing regular flints
- 0015 was a compact mid grey brown chalky clay present over the south-east corner of layer 0012. It appeared to have been truncated to the south and west but continued beyond the eastern edge of site.

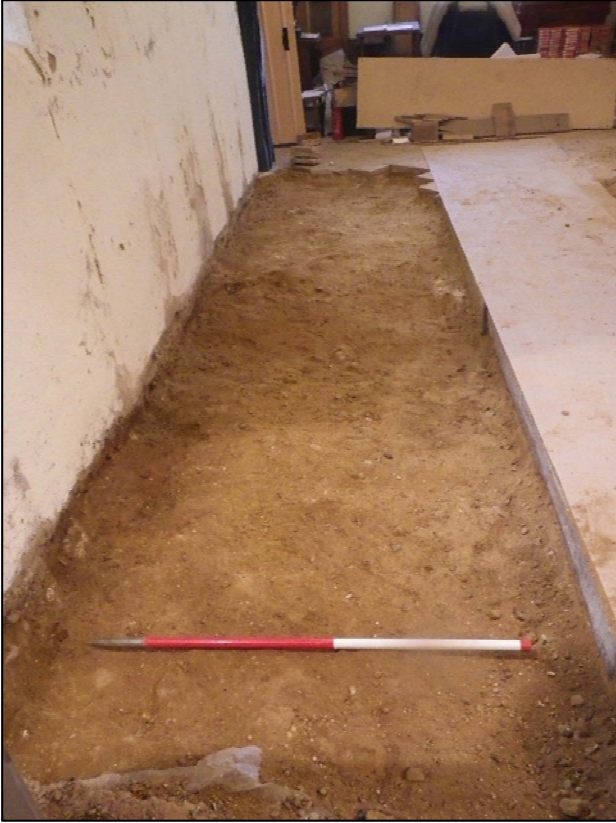
Plate 5. Area C, reduced to formation level.  
Looking west, 1m scale.

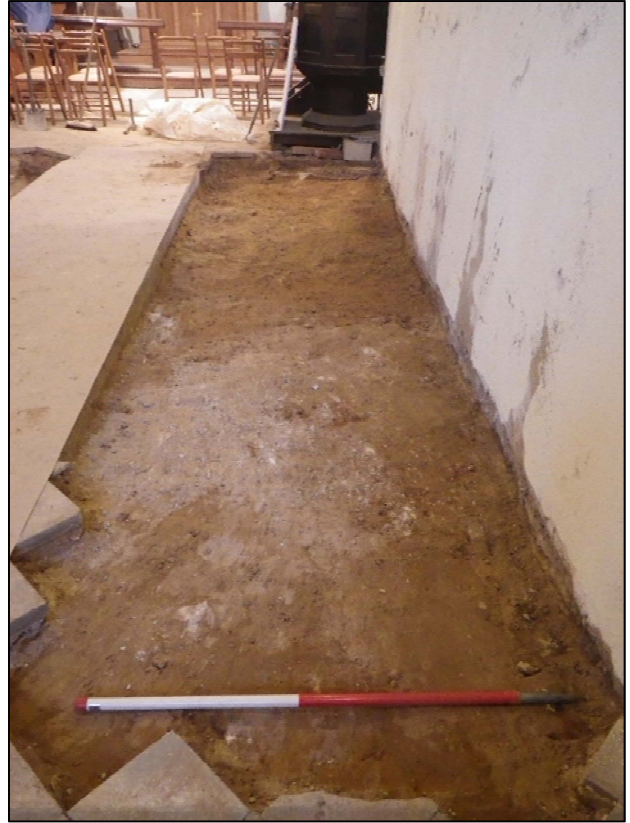
Plate 6. Area C, reduced to formation level.  
Looking east, 1m scale.

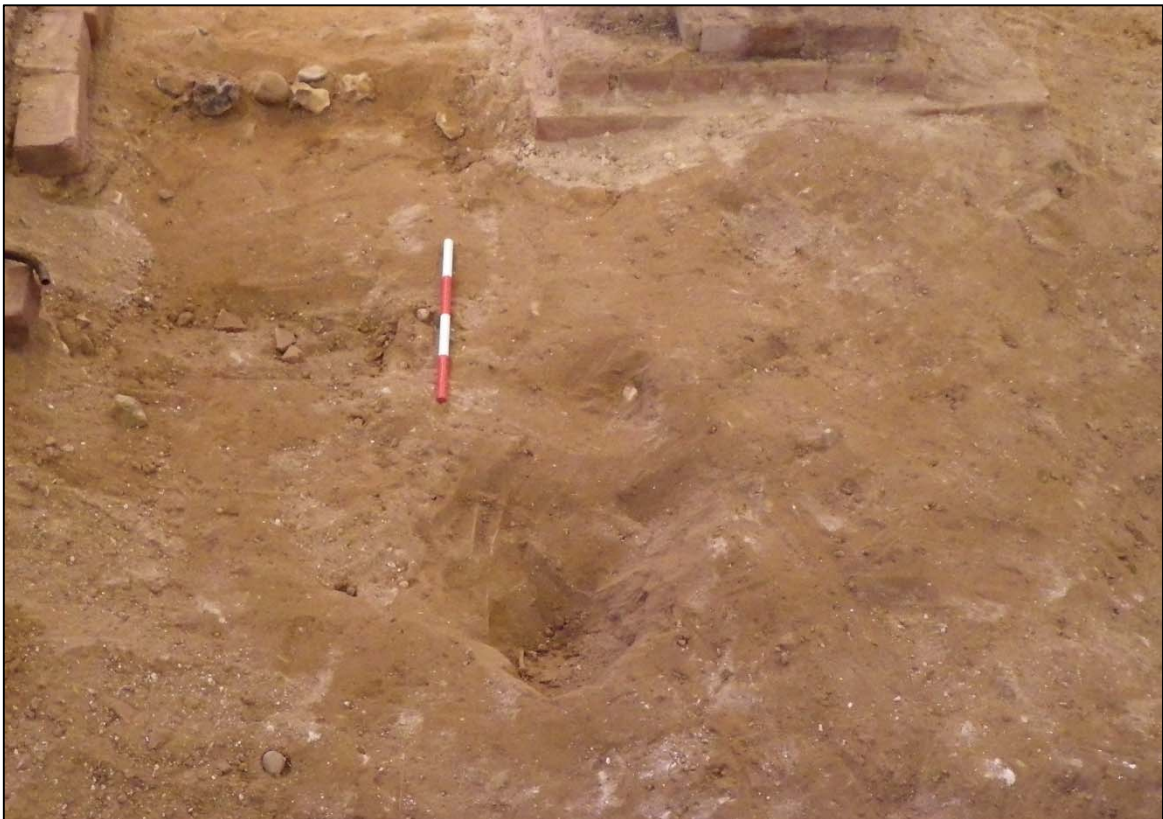
Plate 7. Possible grave 0003, with in situ bone visible in the northern end, just above the deeper area. Looking south, 0.4m scale. The flints in the top left corner of the picture may be surviving fabric of the former north wall of the church, feature 0006.

The area north of the arcade was broadly the same as area A, with a loose, dirty mortar layer covering consolidated silty sand with occasional chalky mortar patches from which disarticulated bone was dislodged. In the north-eastern corner of the area, a possible grave cut, 0003, was observed. This was orientated approximately N-S, with the southern end cut by the brick pier associated with the Victorian aisle building. This construction cut also appeared to cut a skull, whilst at the opposite end of the feature, loose material filling a small void was removed to reveal two in-situ long bones, possibly a tibia and fibula. Because no further ground level reduction was required in this location, none of the in situ bones were investigated further to confirm the presence of an articulated burial so as not to cause any unnecessary disturbance.

Possible burial 0003 was also found in this area, outside of the medieval church footprint as the northern aisle was added onto the church in 1851. If this feature was indeed an in situ burial, its north-south orientation is difficult to explain. It is possible that other burials could survive below the formation level in what used to be the churchyard beyond the medieval north wall, but no other cuts were identifiable in layer 0002 which is likely to be a mixed cemetery soil under the loose material below the pews in the north aisle.

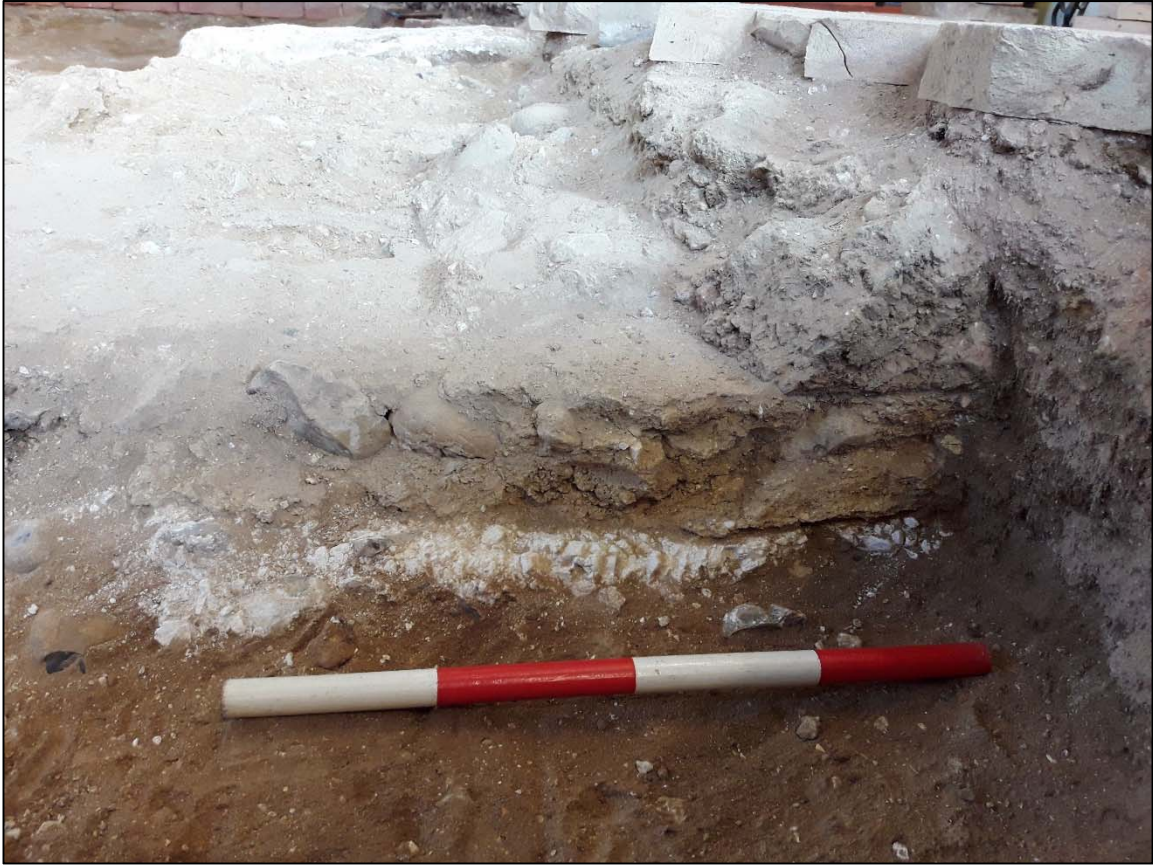
Plate 8. Section through layers 0015, 0012, 0013 and 0014. 0.4m scale, looking north.

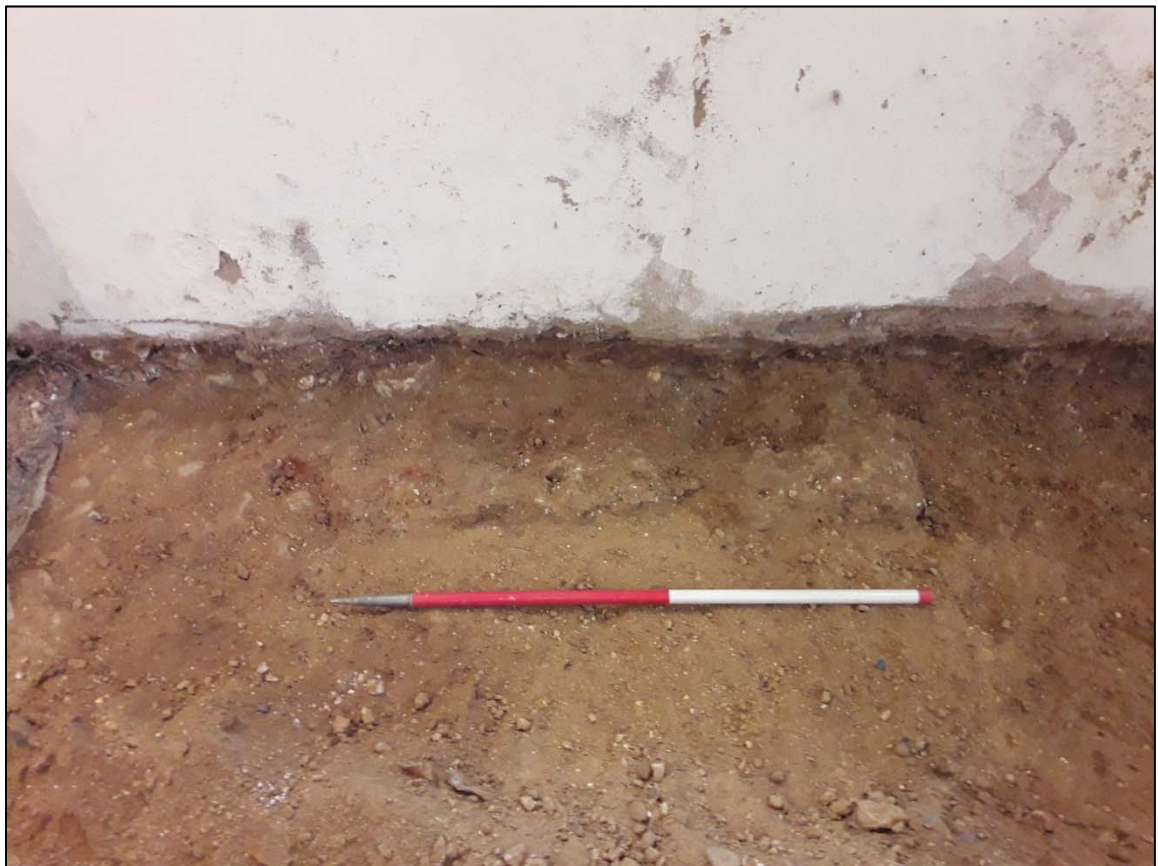
Plate 9. Clay feature 0025. 1m scale, looking south.

An area of compact/solid clay within Area C (0025), could be associated with a 16th century red brick window within the medieval fabric of the south wall of the church. It may be that this later insertion was a necessary repair, but its Reformation era date might suggest removal of features associated with a rood screen. Many rood stairs were blocked up or
