## **Park Fields Farm**

### **Archaeological Building Record**

OASIS ID: waterman2-196028

January 2015

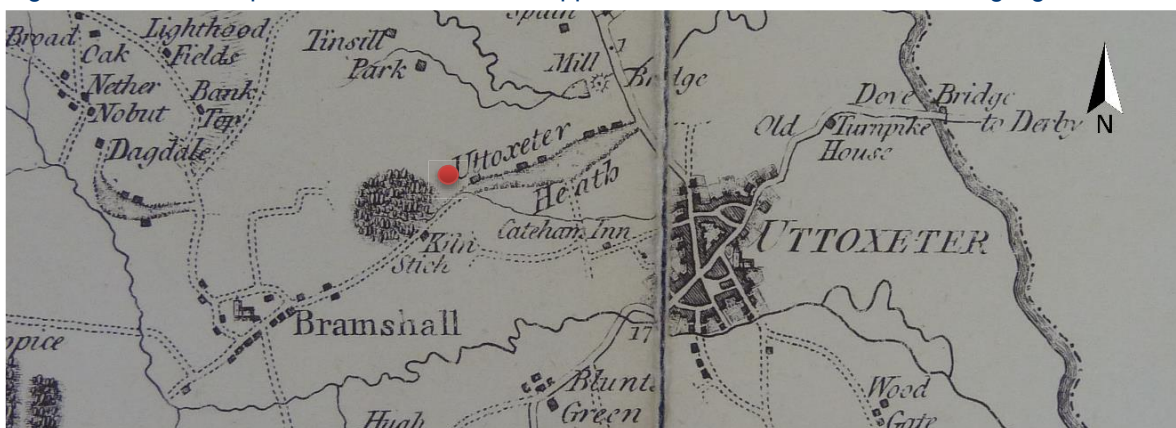
Figure 1: Yates Map of Staffordshire, 1775. Approximate location of Park Fields highlighted

- 3.2. The earliest detailed map of the area is Yates map of 1775 (Figure 1); Park Fields is not shown. The location of the farm is to the west of the settlement of Uttoxeter, on the main road to Bramshall. The map is small in scale but the location of Park Fields is believed to be on the north side of the main road, to the east of a building known as 'Kiln Stitch', a name which may have derived from a kiln production site in the close locality.

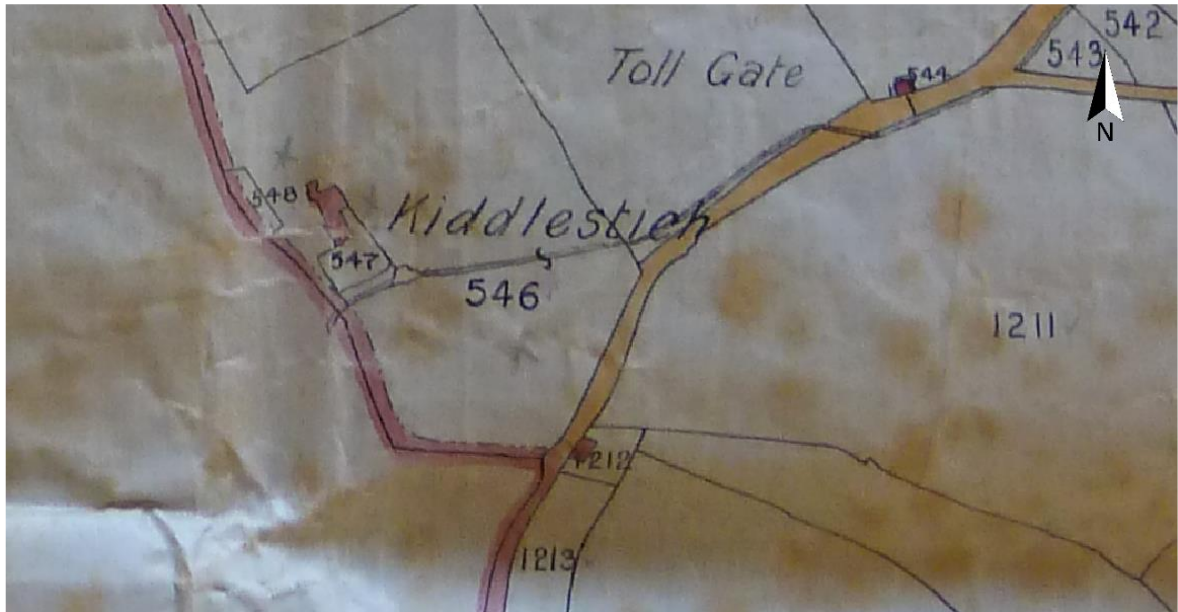
Figure 2: Uttoxeter Tithe Map, 1843

- 3.3. The earliest known source to note Park Fields is the Uttoxeter Tithe Map of 1843 (Figure 2). The farm is located to the north of Bramshall Road and was originally named 'Kiddlestick'. The map

suggests that the principal access to the property is much the same as it exists today. The full footprint of the existing farmyard does not appear to be constructed in 1843. The buildings surveyed include the principal dwelling, in an earlier form without later extension. This has an attached range of cowsheds at the north, which is today noted as single storey, with loft. The domestic garden curtilage to the south of the house appears much as it is viewed today.

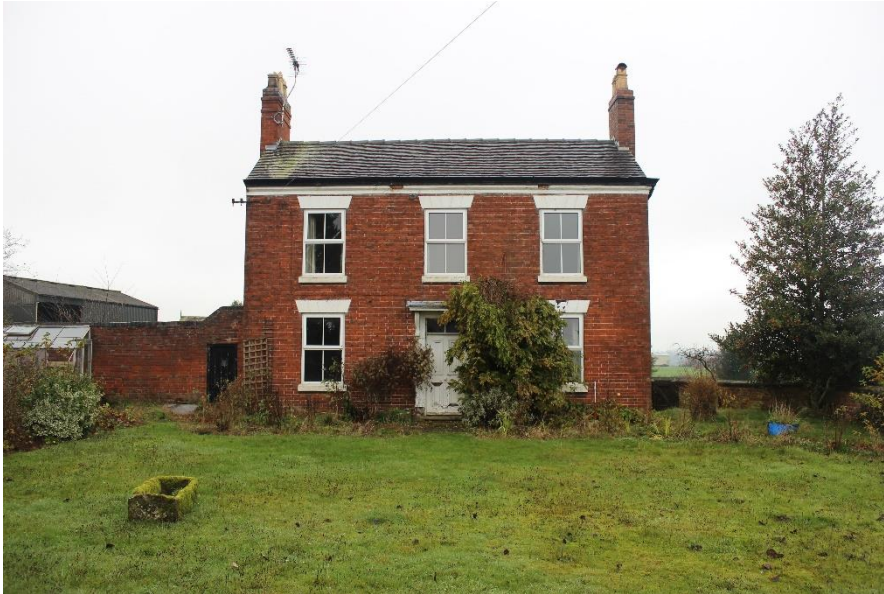
Figure 10: View of front (south) elevation

- 3.15. The front (south elevation) was likely constructed to formalise the entrance to the farm, this would have been higher in architectural standing and more 'polite' than the pre-existing (west facing) frontage. The front elevation is constructed of red brick laid in Flemish Bond. The masonry junction of the front elevations with the flanking gables, which is not tied-in nor flush, suggests that the front façade was either significantly altered or rebuilt. This may account for the inconsistencies in the masonry around the fenestration. Queen closer bricks would typically flank all the fenestration on both sides. The use of the smaller bricks here tends to be more *ad hoc* and does not adhere to any consistent pattern. This could either be a result of separate construction phases or the bricklayer adopting his own style at time of construction. The arrangement of the fenestration is likely original, although all window fittings have been replaced in recent years. Window heads are rendered to give the impression of stone in the likely absence of brick *voussoirs* behind. The central door with overlight, surround and porch supported by brackets, is believed to be original or early to this phase of the building. The elevation terminates at a painted eaves course, which supports cast iron rainwater goods. There is no parapet.

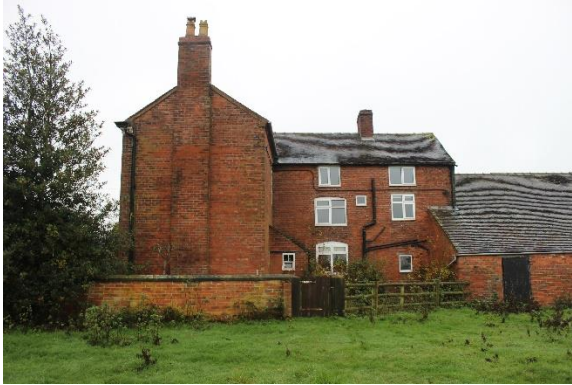
Figure 11: View of east gable

- 3.16. The gables are constructed of brick laid in an inconsistent form of English Garden Wall Bond; with infrequent number of stretcher courses between the header courses. Both gables have chimneys located in the centre, the upper portion of the west chimney has been repaired. A single bay lean-to shed, possibly a former W.C., constructed of red brick laid in Stretcher Bond is located on the west gable. A modern boot room extension also abuts the west gable but does not truncate the original brick fabric.

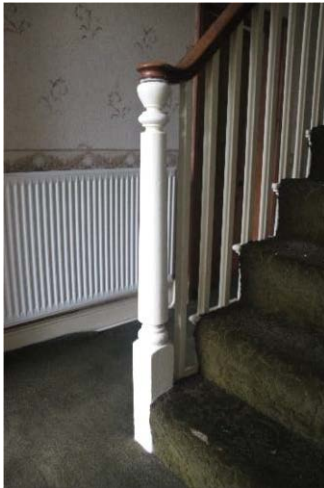
Figure 13: Detail of newel post

- 3.18. The ground floor of the dwelling contains two principal rooms, accessed via a central hall. The hall retains an original under stair cupboard and a stair which is of likely nineteenth century derivation and possibly original. The ground floor rooms, with high ceilings, would have been the formal spaces in the farmhouse and used for entertaining guests. Almost all early original fixtures, including fireplaces, have been removed with the exception of skirting, cornices and a door surround.

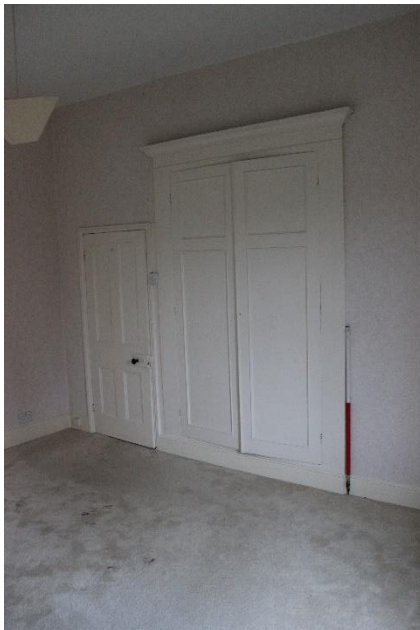
Figure 15: View of first floor room, west side

- 3.19. The first floor of the building retains its original plan in the form of two large rooms with a closet addition to the east room. The ceiling heights are unusually high, almost three metres, the reason for this is unknown but may have been that an increased height of the building was required to conceal the buildings behind so that a polite frontage was achieved for public views from the Bramshall Road at the south. The first floor would have held the principal bedrooms of the residence. With exception of doors, skirting, stair and cornices, all original or early features have been removed. The fireplaces have also been blocked and removed.

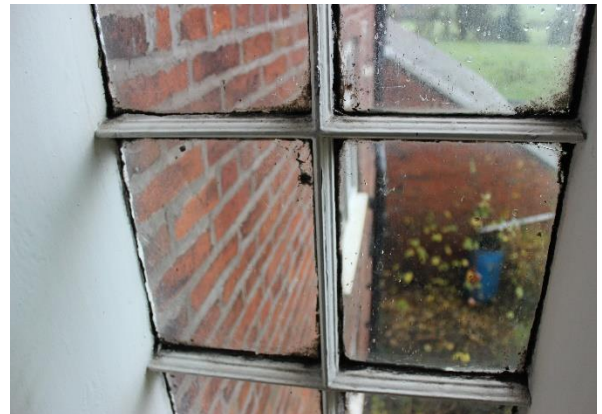
Figure 16: Detail of stair window glazing

- 3.17. The rear range abuts the north elevation of the principal pile. The north elevation of the pile holds no features, with exception of a stair light which contains the earliest glazing noted in the property.

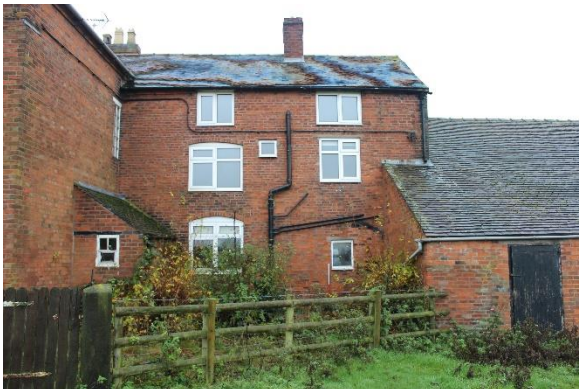
Figure 17: View of east elevation

- 3.24. The east elevation of the return has been subject to extensive alteration. Many of the windows in this elevation appear to be later insertions with the exception of two segmental arch windows. The brick masonry, which largely matches the east elevation, has also been subject to extensive alteration and repair. A larder was added to the property, likely post 1870, which is suggested by the use of Stretcher Bond. The internal entrance to the larder was likely the location of a former external door entrance.

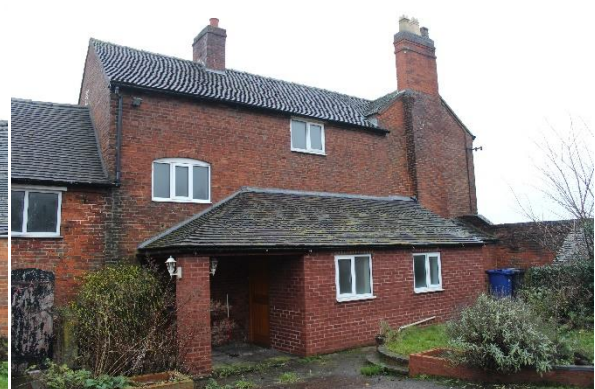
Figure 18: View of west elevation

- 3.23. The west elevation was likely the original front of the property. This is constructed of a different red brick to the principal dwelling although it is laid in the same inconsistent variant of English Garden Wall Bond. Views of the masonry suggest there has been a significant amount of repair and alteration. Two segmental arch windows, one partially blocked at ground floor, are the only known early or original windows in this elevation. A late twentieth century porch and boot room has been added to the property in recent years, concealing much of the brick masonry. The junction of the return at the north west corner, with the principal pile, is not flush or 'clean' reinforcing the suggestion that they are not contemporaneous.

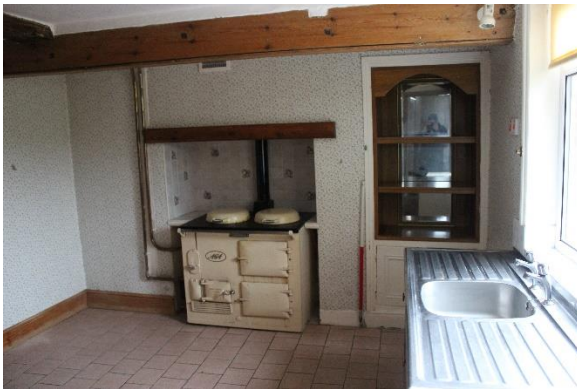
Figure 19: View of kitchen

- 3.26. The ground floor of the rear range has been subject to extensive alteration. This would have likely happened in the nineteenth century when the dwelling was extended on the south side. The kitchen is located in the south bay. Few original or early fixtures and fittings survive in this location with the exception of a nineteenth century cupboard. An early beam with a chamfered end, possibly reused, is located in the centre of the room aligned north-south. The north wall of the existing kitchen, where an Aga is currently located, may have been the former location of an inglenook type fireplace suggesting this space was the kitchen in the early dwelling. The north bay of the ground floor was likely originally one open room which has subsequently been sub-divided; this space today exists as a modern toilet, utility room and a walk-in fridge which was likely installed in the last c.100 years.

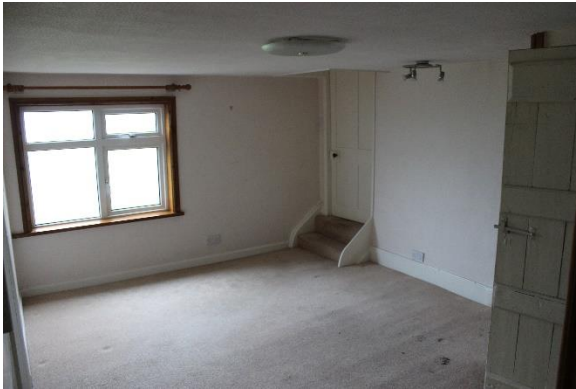
Figure 21: View of first floor room

- 3.28. The first floor of the rear range is accessed via a narrow winding stair in the south west corner of the building; this is likely of at least late nineteenth century derivation. No features of heritage merit were noted on this floor which comprises two empty rooms and a bathroom. Evidence in the loft of the cowshed suggests that the first floor was connected to the cowshed (to the north) at first floor level via a door, now blocked, in the north wall.
- 3.29. The second floor contains three attic rooms which are plain and understated in form. With the exception of doors, no early or original features were noted in this location. The chimney flue is visible in the most northern room which likely had a fireplace, now blocked.

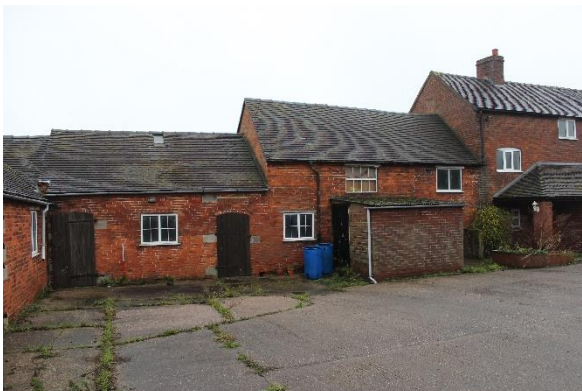
Figure 23: West elevation

- 3.33. The buildings are constructed of red brick, mostly laid in Stretcher Bond with Staffordshire Black tiled roofs. All windows have been replaced in the buildings, as have many of the doors in the segmental arch openings. Slit ventilators are located in the east elevation of the north structure. The east bay of the south structure contains stable doors, this bay may have been an addition to an original single bay building.

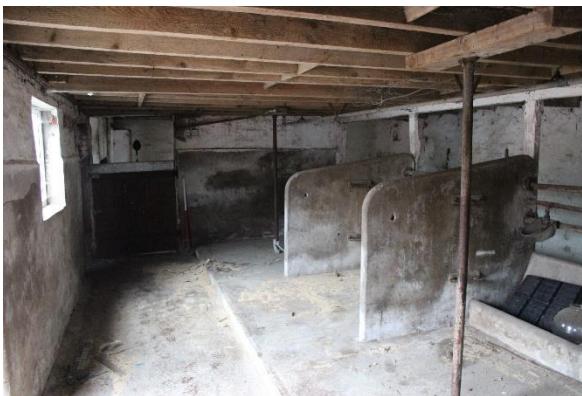
Figure 25: View of feeding passage

- 3.35. The interior of the main cowshed comprises a single longitudinal feeding passage. Double stalls are aligned through the centre of the space; these vary in date with the southern stalls constructed of brick and the northern stalls of concrete. Within each stall is a partitioned manger and water feeder, connected to pipework. Features of note in this space include two sliding windows and a sliding timber door providing connection to the interior of the east bays of the south portion of the cowshed. The date of this fenestration is unknown but is likely nineteenth century.

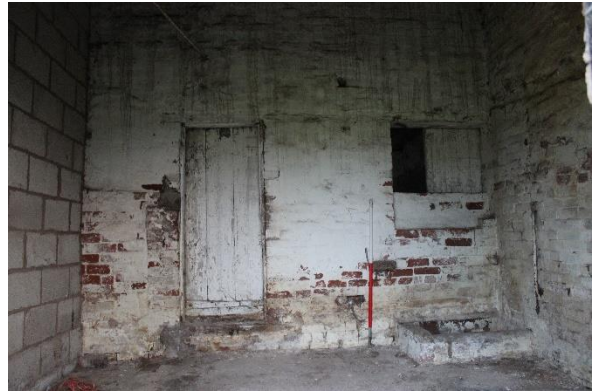
Figure 28: View of room in east bay

- 3.34. The interior, in the east side of the north structure, contains a corridor and two rooms; this was formally one room, now divided by a modern concrete block partition.

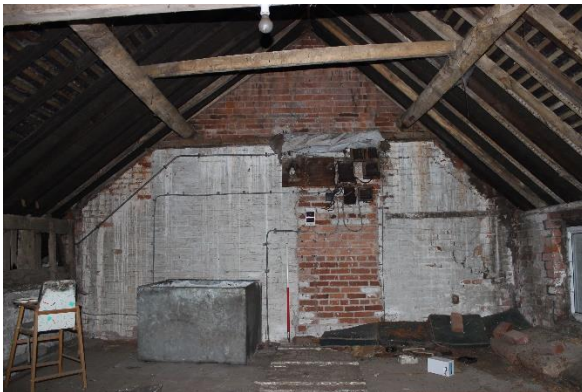
Figure 29: View of interior of loft at south end, blocked door to the rear range

- 3.37. The first floor loft expands across the cowshed on the east side of the yard, with the exception of the north bay, as discussed above. The loft was likely used as a dry store for goods, such as animal feed or grain. The roof space was in poor state of repair with limited access. The space is divided by brick partitions in locations where the roof structure changes between buildings (the north and south portion of the cowshed). A blocked door in the south wall of the loft shows the former location of a connection to the first floor of the rear range.
- 3.38. Modern additions to the cowshed include a lean-to structure on the west side. Constructed of brick, laid in stretcher bond, this was likely built in the second half of the twentieth century.

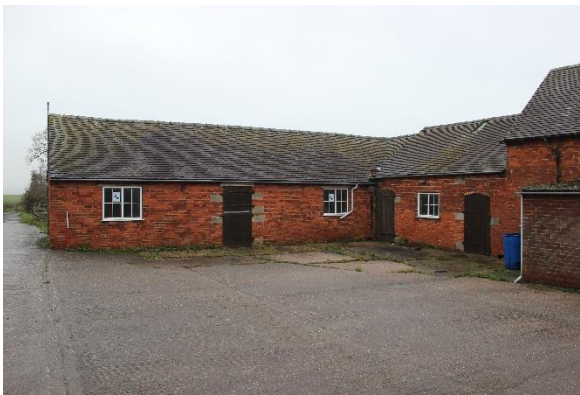
Figure 31: View of south elevation

- 3.39. The cowshed on the north side of the yard is very similar in form to the earlier adjacent shed, although historic mapping suggests this is later in construction and has no loft floor.
- 3.40. The building is constructed of red brick, laid in Stretcher Bond (a different masonry bond to the earlier cowshed). The structure is attached to the earlier cowshed at the east extent and has a gable-end to the west. All windows and doors have been replaced in recent years, stone quoins note the location of original hinges and door furniture to the entrances.
- 3.41. Internally the building contains a single longitudinal feeding passage with concrete stall partitions and mangers.

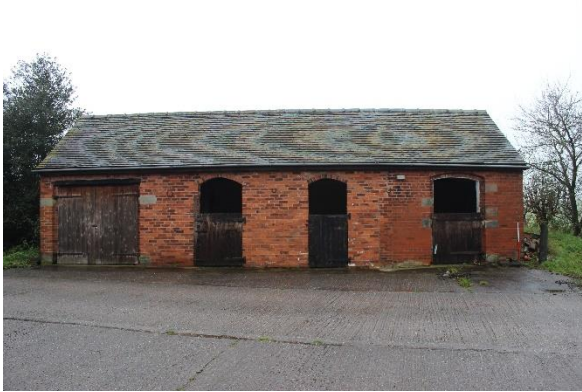
Figure 33: View of east elevation

- 3.43. The front (east) elevation has been repaired and altered during the twentieth century. The only surviving original bay is located at the building's north extent where a segmental arch opening with decorative quoin stone hinges are noted. All other openings are crude in form and likely undertaken in recent years. The south bay of the building contains a larger, modern opening; this bay may have always had a larger opening for use as a cart store.

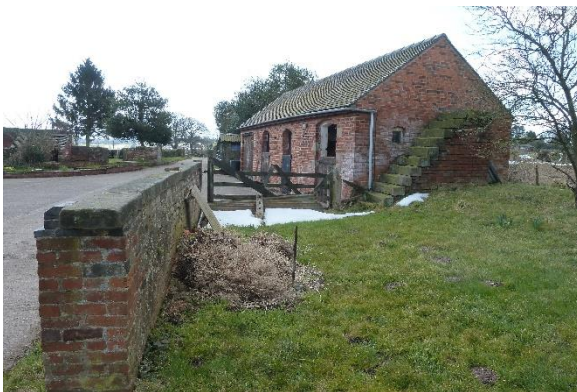
Figure 35: View from north showing external stair Figure 36: View of interior of north bay prior to its removal (picture c.2012)

- 3.44. The north gable of the building once held an external stair which had been removed by the time of inspection. This stair would have once provided access to a dry store loft, the door of which, now removed, was located in the rebuilt upper portion of the north gable. No features were noted in the south gable. The west elevation has been altered which is evident by the contrast in brick masonry; two blind openings are located at the south end of the elevation.

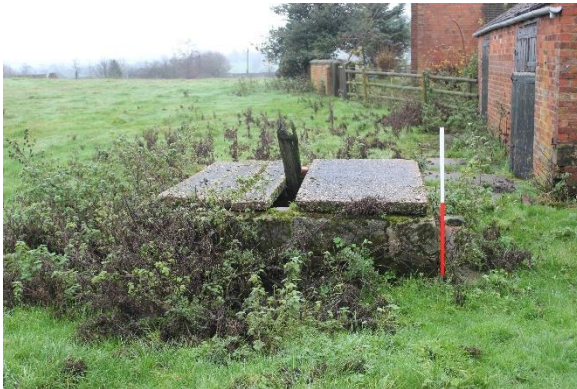
Figure 37: View of remains of pump

- 3.46. The features listed below have been noted around the Site. These are located on the archived Site plan.
- 3.47. A pump is located to the east of the Site, this is noted on the first edition Ordnance Survey. No original pump fixings were noted due to its poor condition. The well noted on the Ordnance Survey is also still in place, although covered over, on the west side of the rear range.

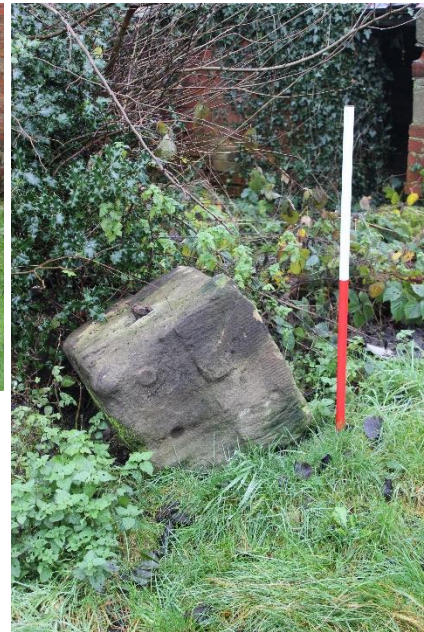
Figure 38: View of remains of cheese press

- 5.4. The original farm included a cowshed, this was attached to the north side of the dwelling. The remains of a cheese press on the Site suggests there may have once been a dairy located here, although no further fixtures and fittings were found to support this.

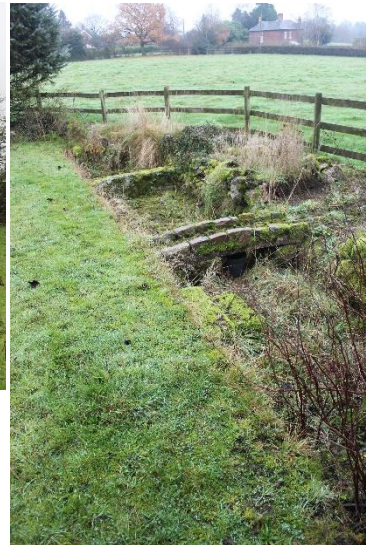
Figure 42: Haha inside south boundary of garden

- 3.52. The domestic curtilage of the farmhouse is formed by a wooden fence on the south side and brick wall on the east side. The garden has a small water feature, which was possibly constructed as a type of haha to stop livestock entering the domestic gardens.

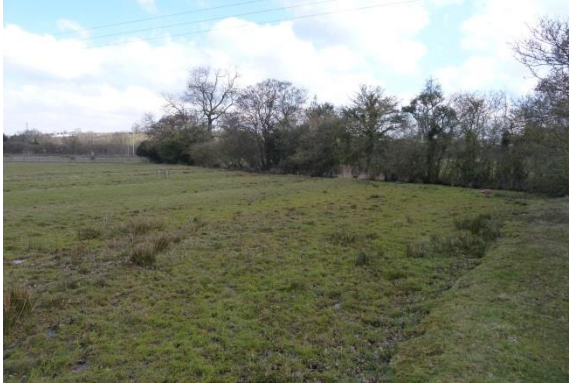
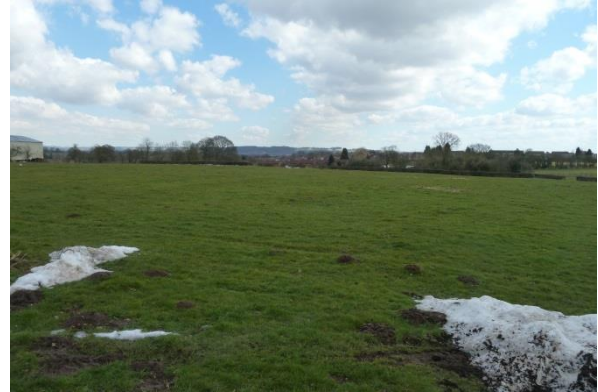
- 4.16. Outside the Site, the evidence of ridge and furrow is the only evidence of medieval occupation within the study area. This indicates that the area was mainly in use for agricultural purposes until this period.

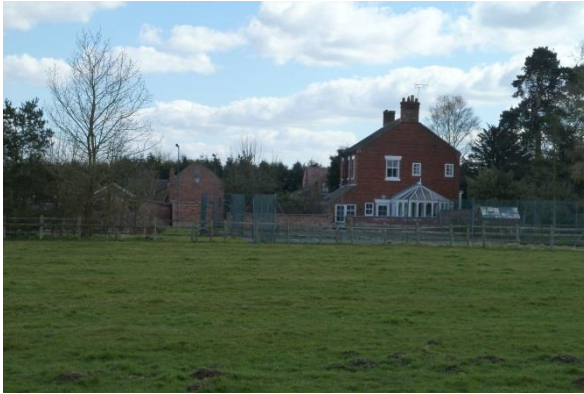
Photo 5: Bramshall Villa/ Park House (Toll Gate)

- 4.20. A second toll gate is also marked on this tithe map (see Figure 14), but not recorded on the HER. It was located on the southern turnpike, approximately 90 m to the east of the Site on the Bramshall

Road. This building is named as Bramshall Villa on the first edition OS map and as Park House from the second edition onwards. Parts of this building survive and are visible from within the Site.

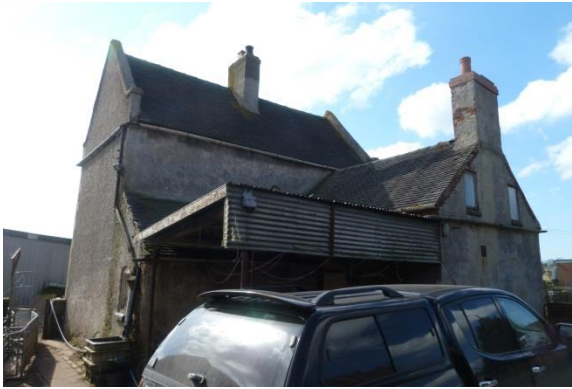
Photo 7: Parks Farm – main farm house

- 4.21. The Uttoxeter Tithe map (see Figure 14) also shows all the main farm complexes that currently survive within and around the Site were already in existence. Parks Farm, within the Site, was named as 'The Parks' and 'The Parks' as 'Parks Cottage', which was an error, as 'Parks Cottage' seems to have been an alternative name for the Toll Gate house.
- 4.22. It is interesting to note that by the time the first edition OS was published in 1887, Parks Farm is correct, but this time 'The Parks' and 'Parks Cottage' are swapped around. It is only in 1901 (second edition OS) that these properties are accurately named as 'Parks Cottage', 'The Parks' and 'Parks Farm', from east to west.

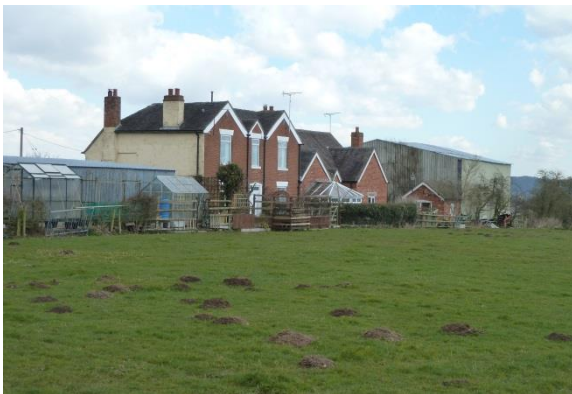
Photo 9: Moss Beds (looking north-east)

- 4.23. The farmstead known today as 'Moss Beds', in the central area of the Site, is not named on the Tithe. From the first edition OS onwards however its name has not changed.

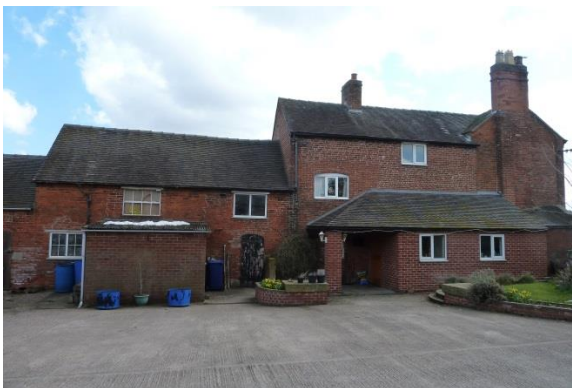
Photo 11: Park Fields

- 4.24. 'Park Fields', which abuts the south west corner of the Site, is named as 'Kiddlestich' on the Tithe. It is first named as 'Parkfields' in the first edition OS.
