Elizabeth Shaw Factory, Greenbank, Bristol

Archaeological Building Recording

February 2015

Waterman Energy, Environment & Design Limited

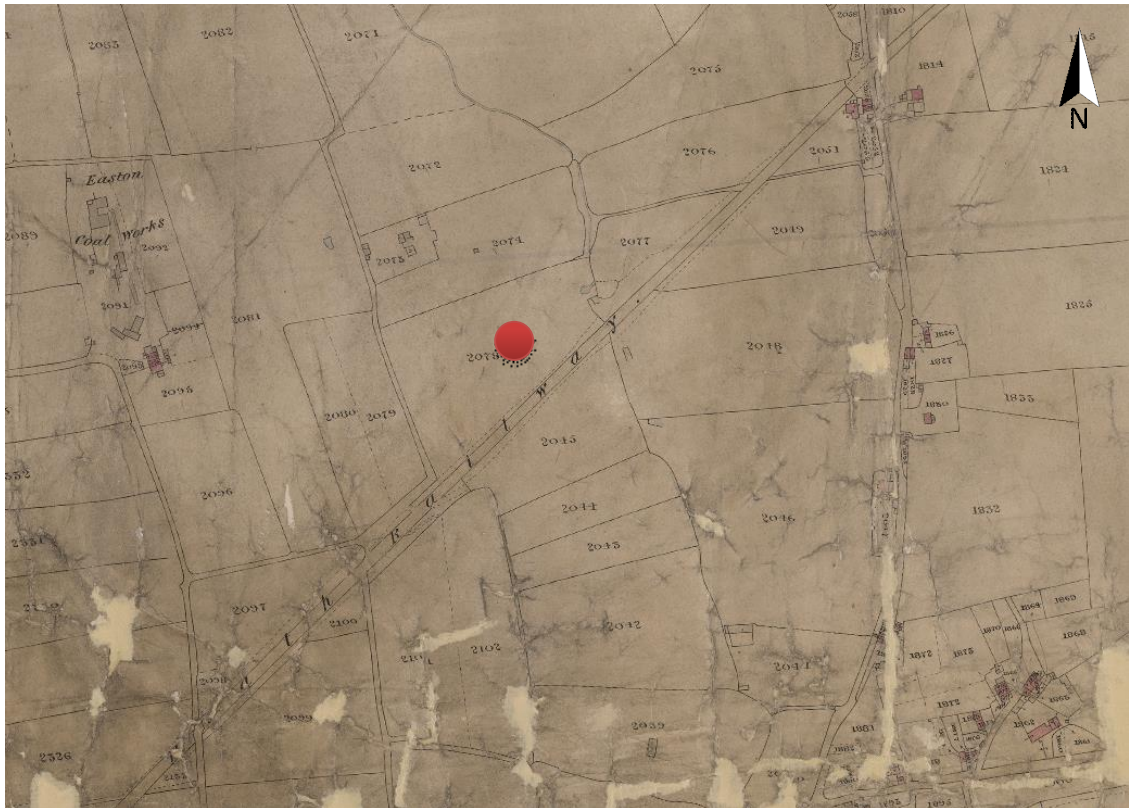
Figure 1: Parish of St George Tithe Map, 1840

- 3.4. One of the earliest maps to show the Site in detail is the Tithe map of the 1840s (Figure 1). This illustrates the character of the area prior to later industrial development. The Site, during the mid-nineteenth century, was occupied by open fields. The southern boundary of the Site was formed by the Bristol-to-Bath Railway Line, the alignment of which survives today as a public foot/cycle path.

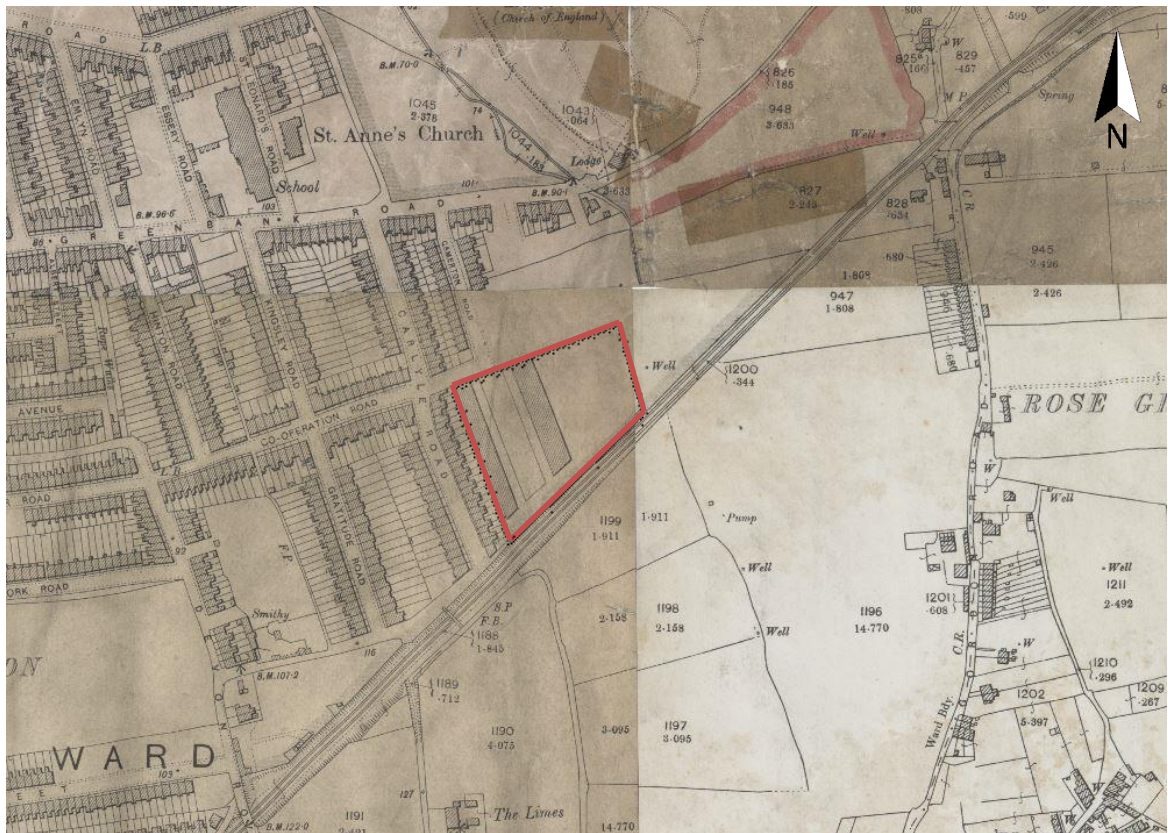
Figure 3: Ordnance Survey, 1901-1904

- 3.8. The first phase of factory construction at the Site is depicted on the 1901-1904 Ordnance Survey (OS) which shows three buildings at the western extent of the Site (Figure 3). The three ranges survive today, and are connected by bridges over alleys (known as 'hauling ways') between them, facilitating transport access and storage.

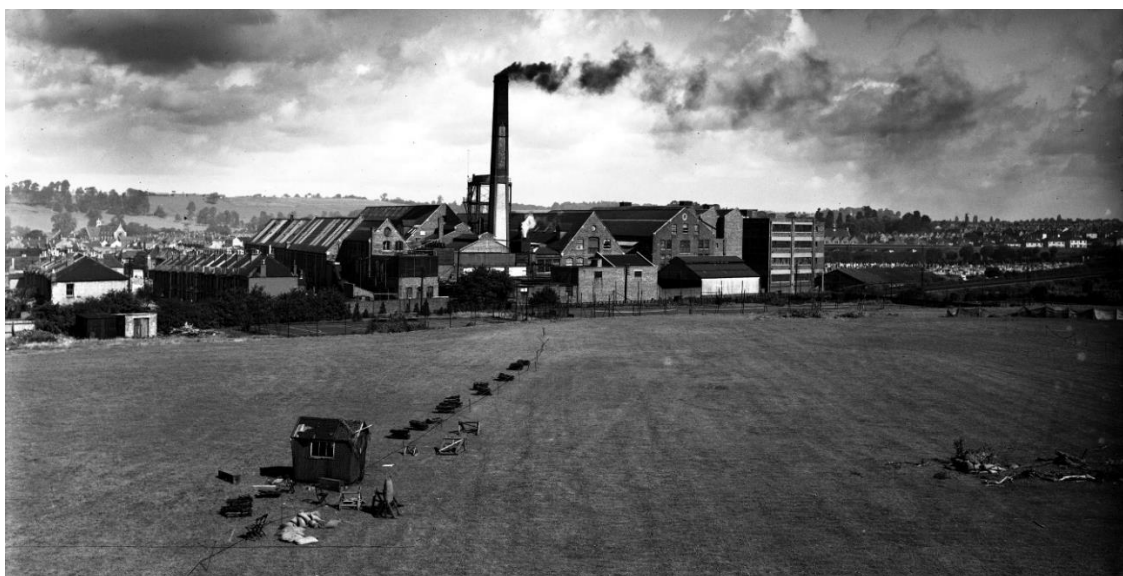
Figure 12: Photograph of Greenbank Factory, view from south. c.early 1940s

- 3.18. An image of the factory (Figure 12) is held in the Hartley Collection of Glass Plates (held at the M Shed Bristol). The image is believed to be dated from the 1940s, which is suggested by the remnants of a Home Guard training exercise in the foreground, on the Whitehall playing field, and also the barrack blocks at 'Purdown Percy'. The heavy anti-aircraft battery can be seen on the hill side in the background. The photograph shows the form of the factory as viewed from the south. The main core of the initial construction phase is discernible, with the later inter-war (reinforced concrete frame) additions at the eastern end of the Site.

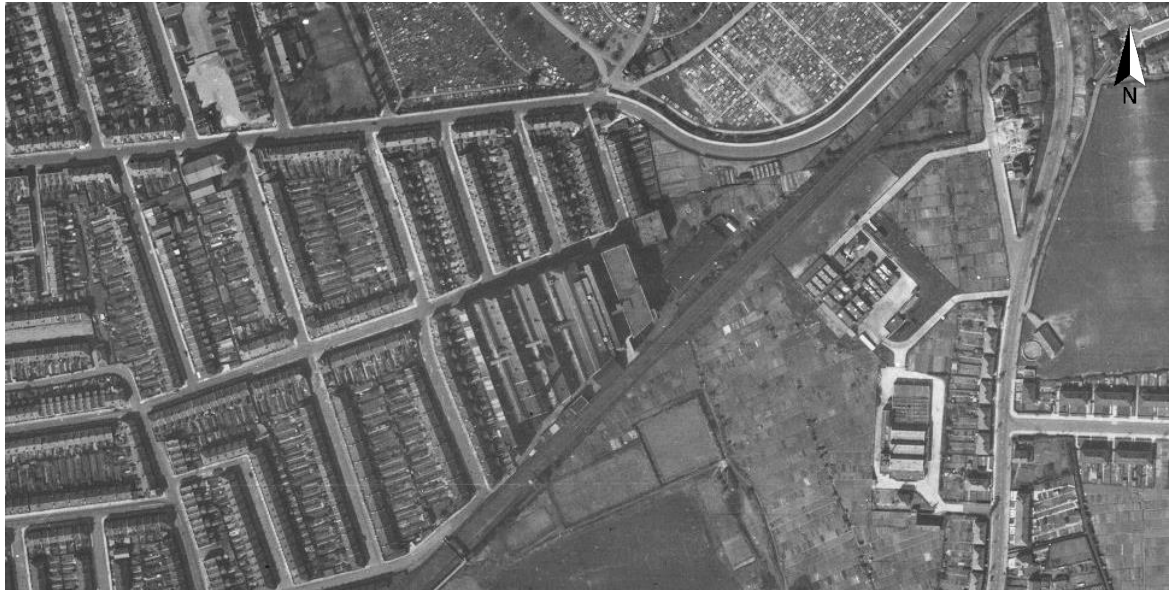
Figure 13: Aerial Photograph, 1946

- 3.19. An aerial photograph taken in 1946 (Figure 13) also shows the form of the factory site in plan. The site plan is also shown on the 1951 Ordnance Survey (Figure 14) by which time little is believed to have changed, likely as a result of post-war austerity.

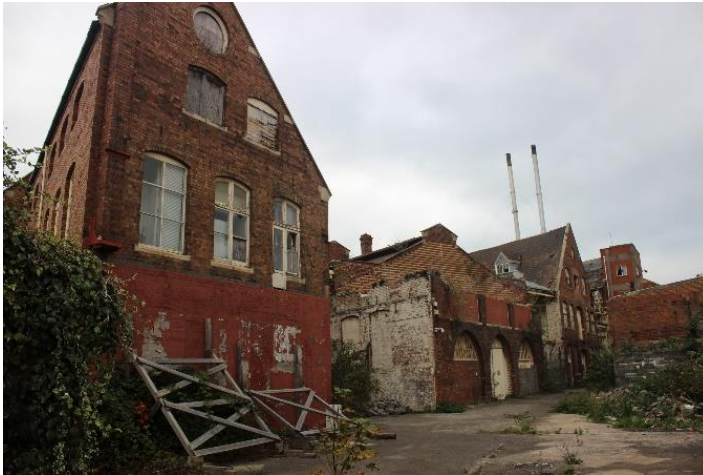
Figure 21: South gables of early factory buildings

- 3.35. The original or early factory buildings within the Site are located in the west area. These were constructed c.1901-1902. The early buildings comprise the original three ranges, with a later fourth added to the western side. They are three storeys with attic. The buildings are constructed of red brick, laid in English bond, with a hipped (north end) and gabled (south end) tiled roof. Openings are typically located within segmental arch surrounds flanked by queen closer bricks and stone (possibly Portland Stone) cills. Much of the early/original timber/metal glazing survives. Original loading doors survive in the gable ends to the individual ranges. Dormers are located in the hipped roof at the north gable end which presumably serviced the attic floor (attic floors were unsafe for access during inspection). The southern gable ends of the early ranges appear to have been subject to very little apparent alteration, although the factory's abandonment have left them in a very poor state of repair.

- 3.37. The interior of the original buildings are in a very poor state of repair. The poor condition of the roof has resulted in a significant amount of water penetration, and flooding of the timber floors throughout the buildings; this has significantly impacted the structural integrity of the timber floorboards and joists. Areas of the early interior revealed that almost all original or early fixtures and fittings appear to have been stripped from the building, this not being uncommon, as it was a building constantly changed to meet evolving operational requirements. The main factory spaces are typically formed of open plan floors enclosed by brick masonry walls. The floors above are supported internally by cast iron columns, this being a typical design of the period which maximised production space within the factory. No historic machinery was viewed throughout the Site, with the exception of a single vat which is likely of relatively modern derivation. The green and white internal glazed tiles, mentioned in the 1906 publication, were noted throughout most of the original ranges inspected.

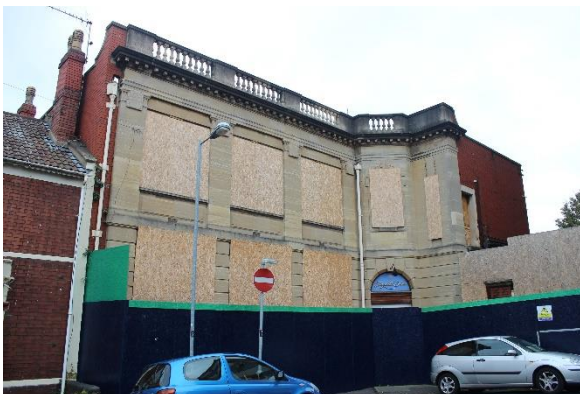
Figure 27: View of office block facade

- 3.38. The office block at the corner of Turley Road and Co-Operation Road was constructed in c.1913-1918 and is the most artistic example of architecture within the Site. The block is two stories over basement with a flat roof. The rear elevations are constructed of red brick, laid in Flemish bond. The front stone *façade* is more ornate in design. A balustrade parapet is located above a dentil cornice. The ground floor is rusticated and the fenestration is broken by pillars which terminate at decorative mouldings. The main detractor to the exterior of the building is the replacement of windows which is intrusive to the character and artistic composition of the building.

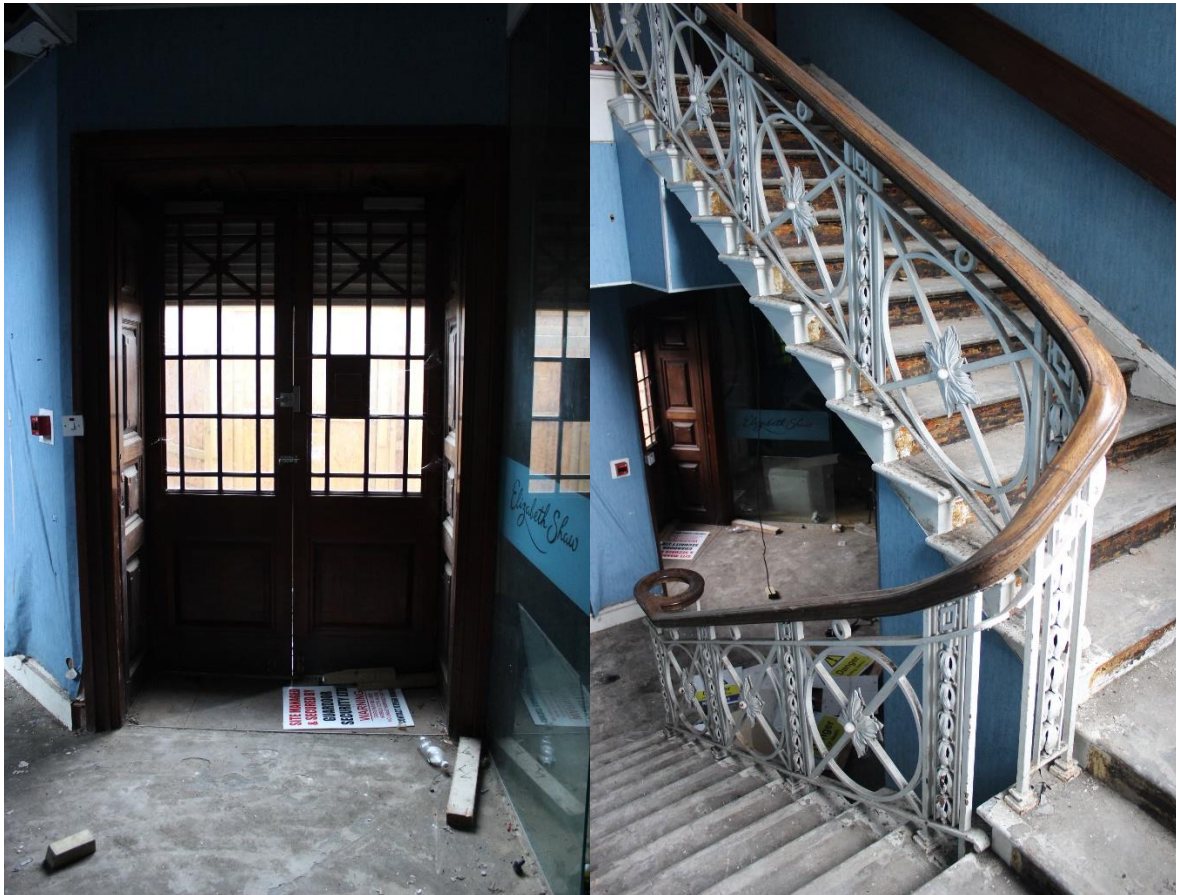
Figure 29: View of ornate principal entrance door
Figure 30: View of original principal stair and surround

- 3.39. The interior of the building has been subject to extensive alteration. This has included the installation of a suspended ceiling on the first floor and removal of almost all original or early fixtures and fittings. The basement has remained largely unaltered in plan and features such as the services passage and strong room are still discernible. Original building plans (Figures 7-10) suggest the ground floor was originally open plan and bounded by smaller offices. There is no trace left of this original plan form of the fixtures and fittings. The original footprint of first floor offices has also been removed, the only features left are the remains of skylights with moulded panel surrounds. Original features within the building, considered to be of heritage merit, include the principal stair with ornate balustrade and entrance door with timber surround.

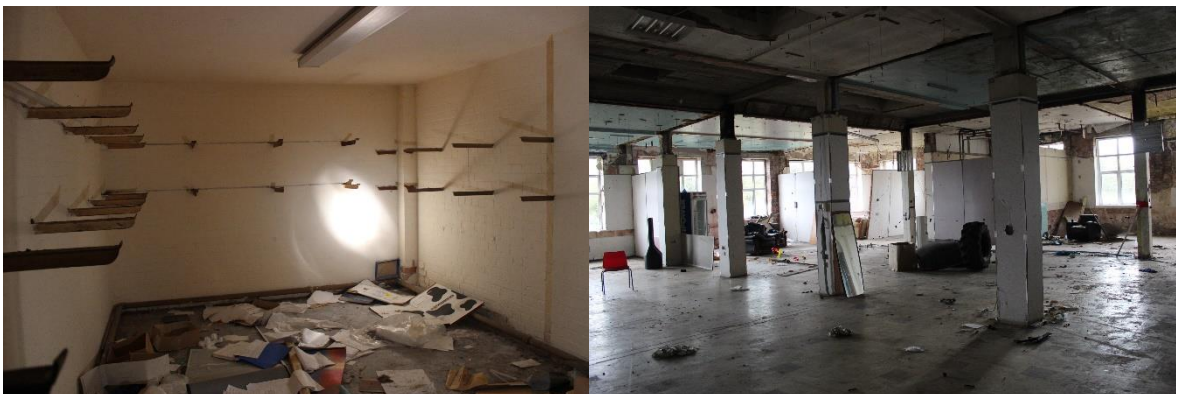
Figure 31: View of basement strong room

Figure 32: View of first floor

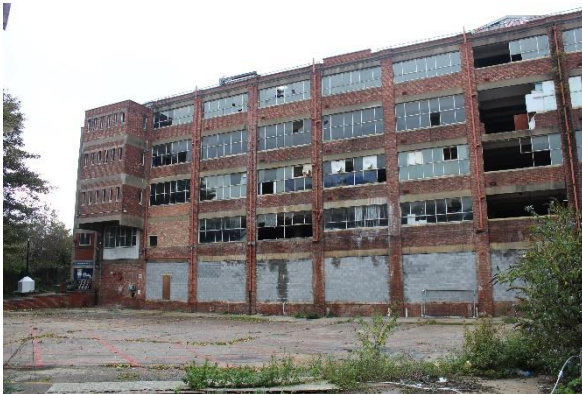
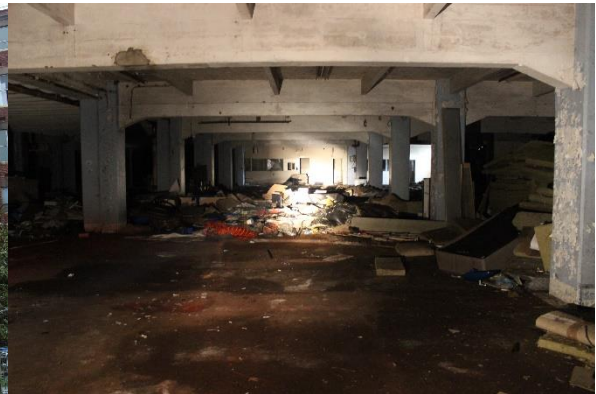
Figure 33: View of west elevation showing most principal elevation of inter-war construction

- 3.40. Inter-war construction at the Site included a block at the eastern extent of the buildings. The exact date of construction is unknown, but historic cartography suggests this may be as early as c.1918. The west block is constructed of a reinforced concrete frame which could perhaps be described as a variance of the 'Daylight Factory' which had been common from c.1916 onwards. The type of reinforcement in the concrete is unknown but a pre-c.1920 building may have used the Kahn System which had been promoted in the UK by Truscon, a subsidiary of American company Trussed Concrete Steel. No exposed reinforcement was noted for inspection. Similar examples of factory design are found in the former B.S.A Factory in Birmingham (now demolished) which was constructed c. 1914. This basic design of factory changed very little over a long period.

- 3.41. The external red brick masonry is laid in English bond and vertical brick pillars (noted on the east elevation) is believed to be clad over the concrete frame to 'soften' the harsh utilitarian façade. Historic photographs (not shown) depict the company's sign attached to the roof of the eastern elevation, suggesting this was a 'public façade' to the factory, which is further reinforced by the topography providing distant views from the east toward the elevation.

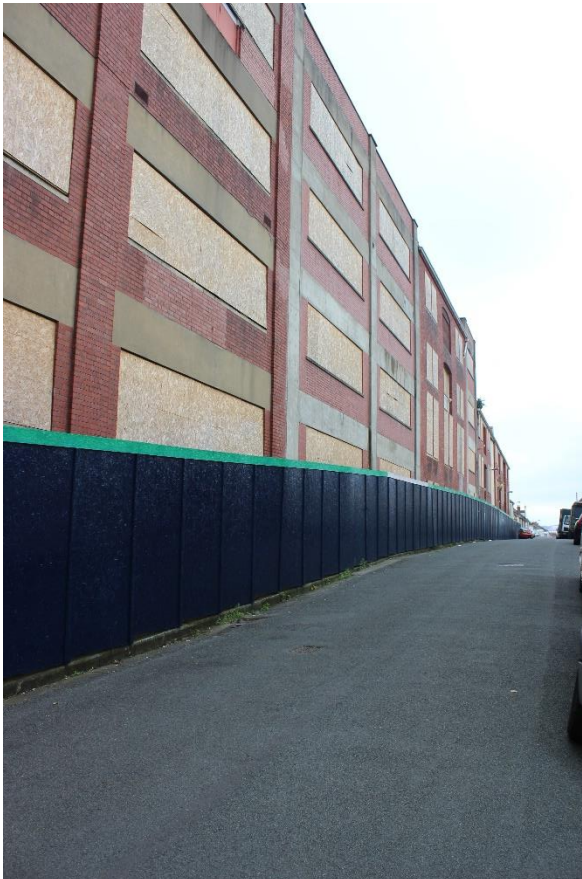
Figure 35: View of infill structures observed in north elevation from Co-Operation Street

- 3.44. Documentary evidence has suggested that the eastern portion of the factory, including the inter-war construction phase, was significantly altered in the period c.1966-1973. Work in this period included two infill additions in the eastern portion of the Site. These were located on the west side of the reinforced block, and also the infilling of an early access way on the east side of the original building ranges. This phase of construction also included smaller additions and extensions, predominantly on the eastern side of the Site.

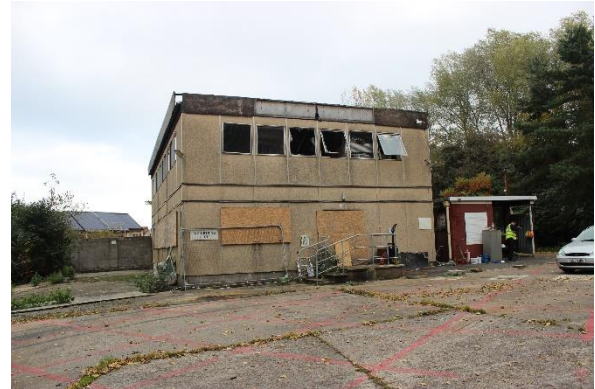
Figure 36: View of late twentieth century pre-fabricated structure in west portion of Site

- 3.47. The latest known building within the site is a detached late twentieth century two-storey prefabricated building, located on the east side of the main factory buildings.

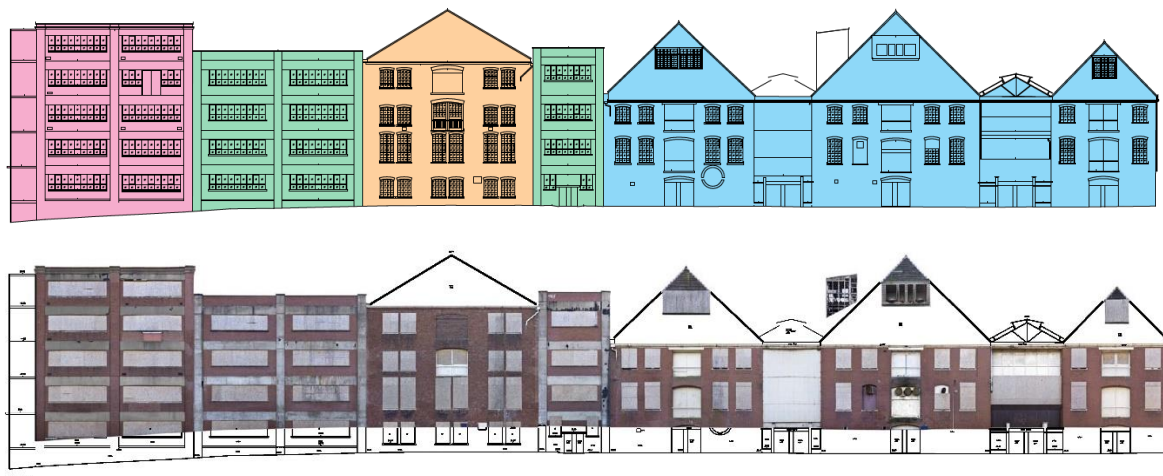
Figure 37: Northern elevation (fronting Co-Operation Road) with outline phases

- 3.48. The phases noted on the elevations below are based on site inspection (predominantly external) and documentary evidence. They are provided as an outline of building phases as currently known.

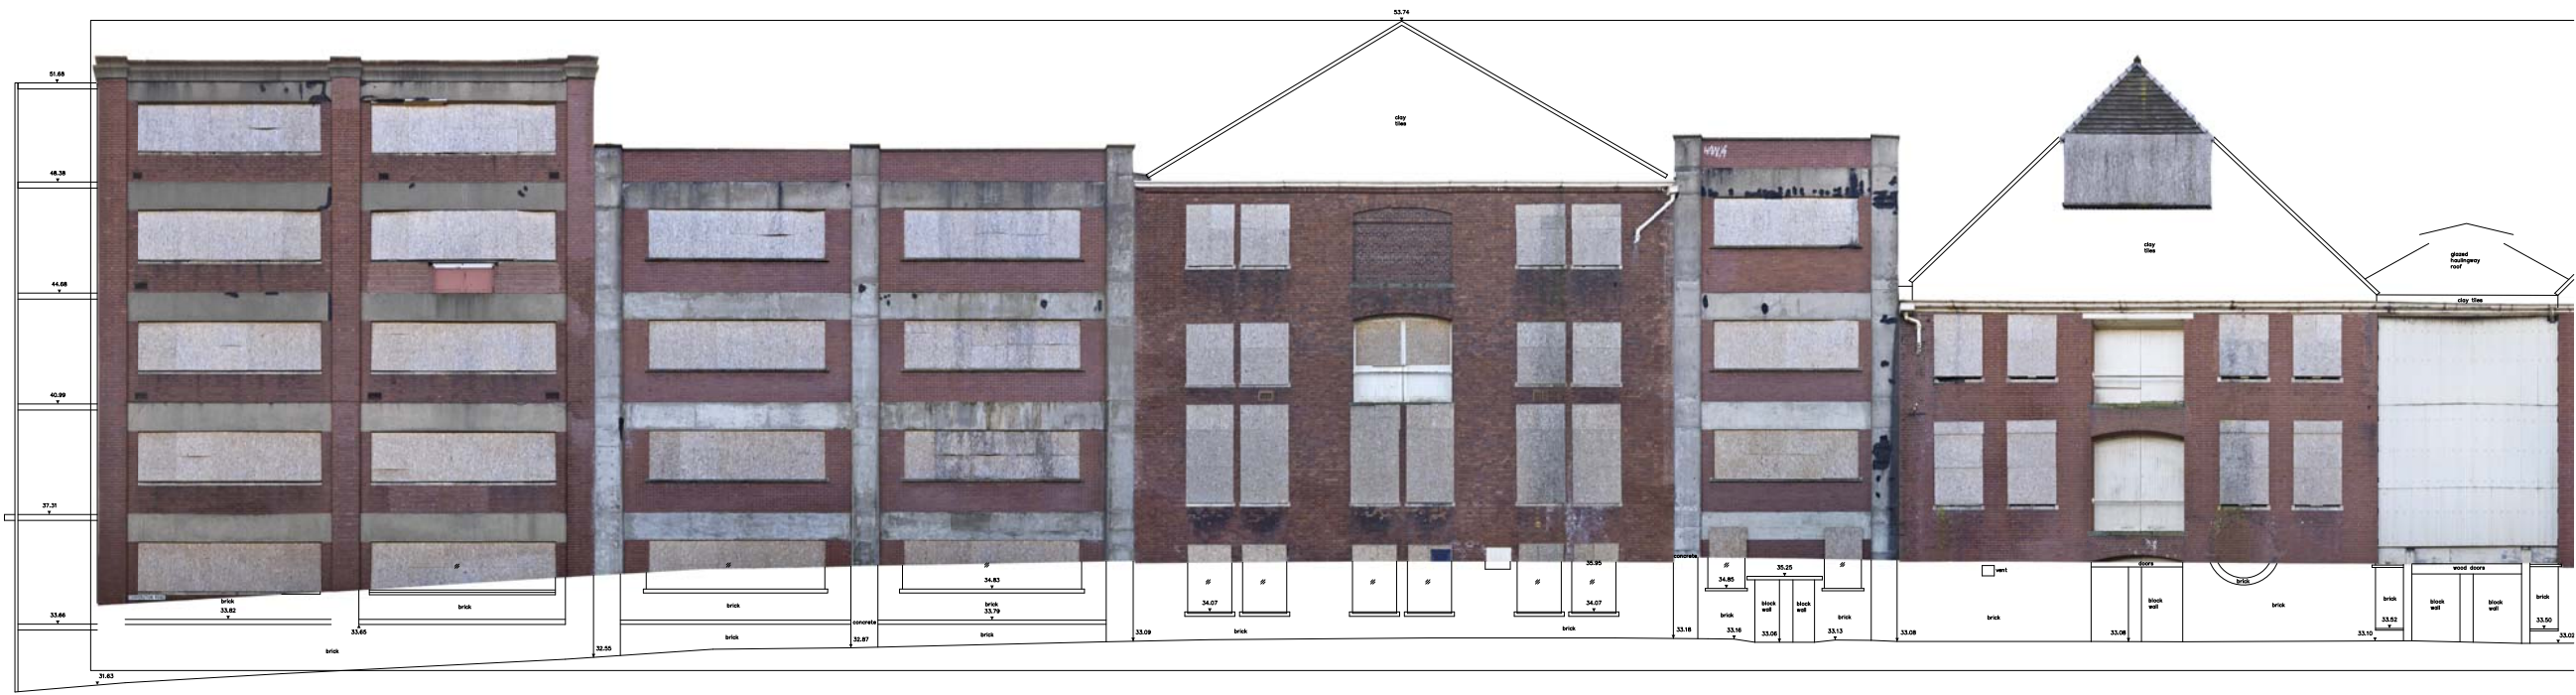
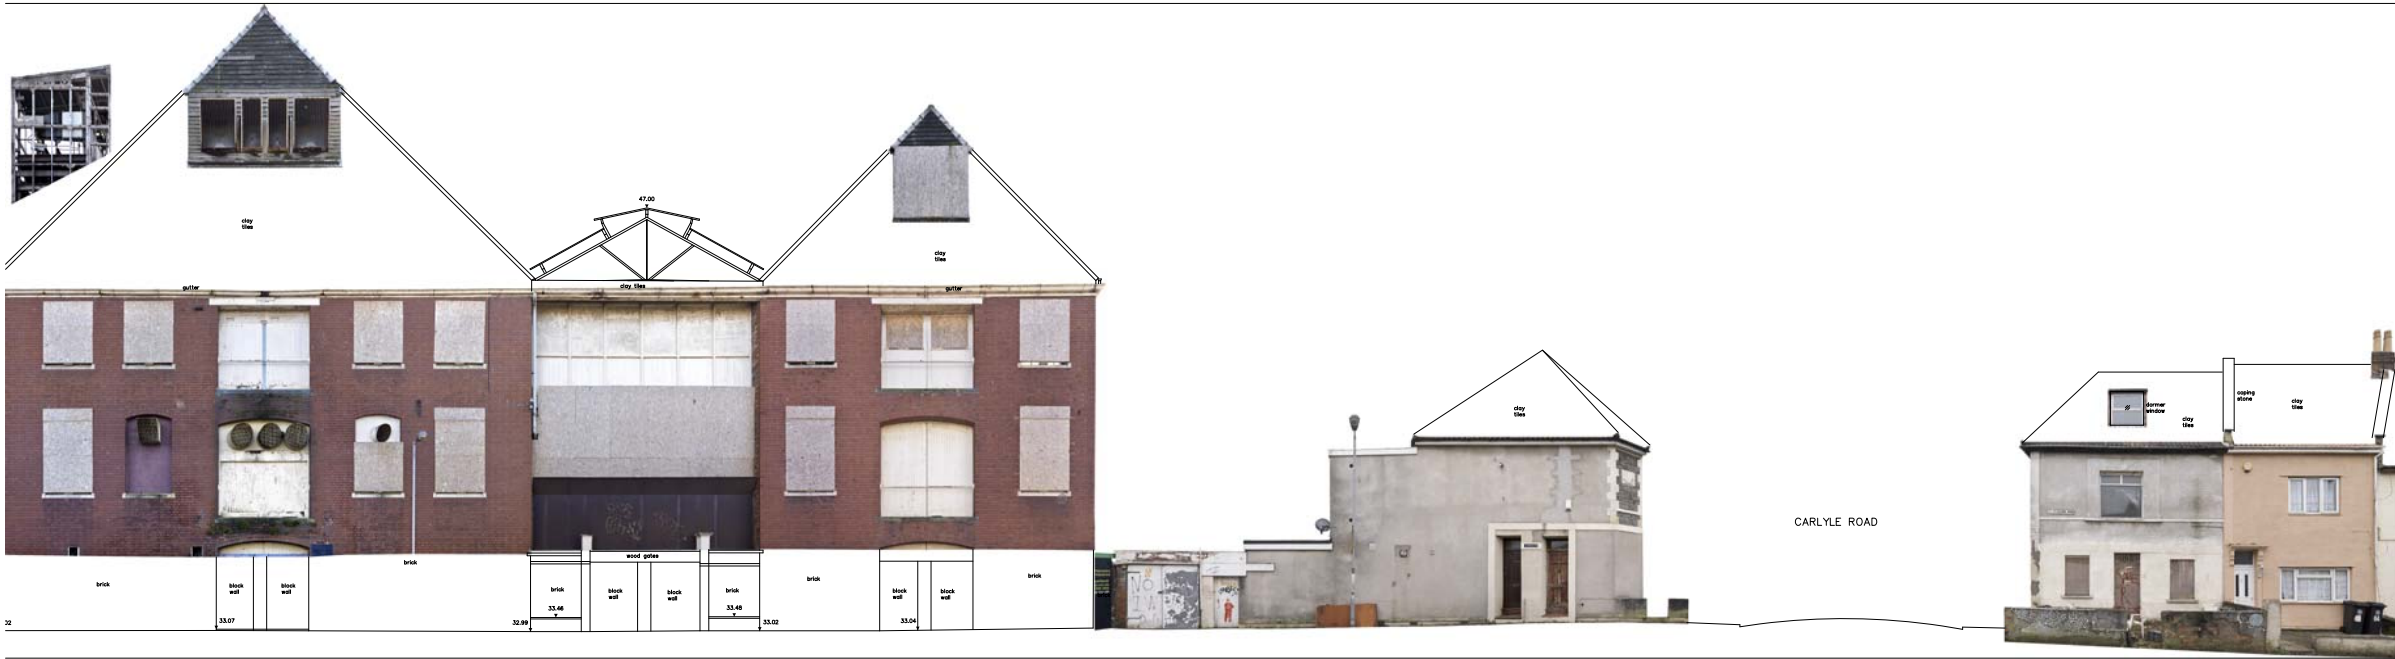
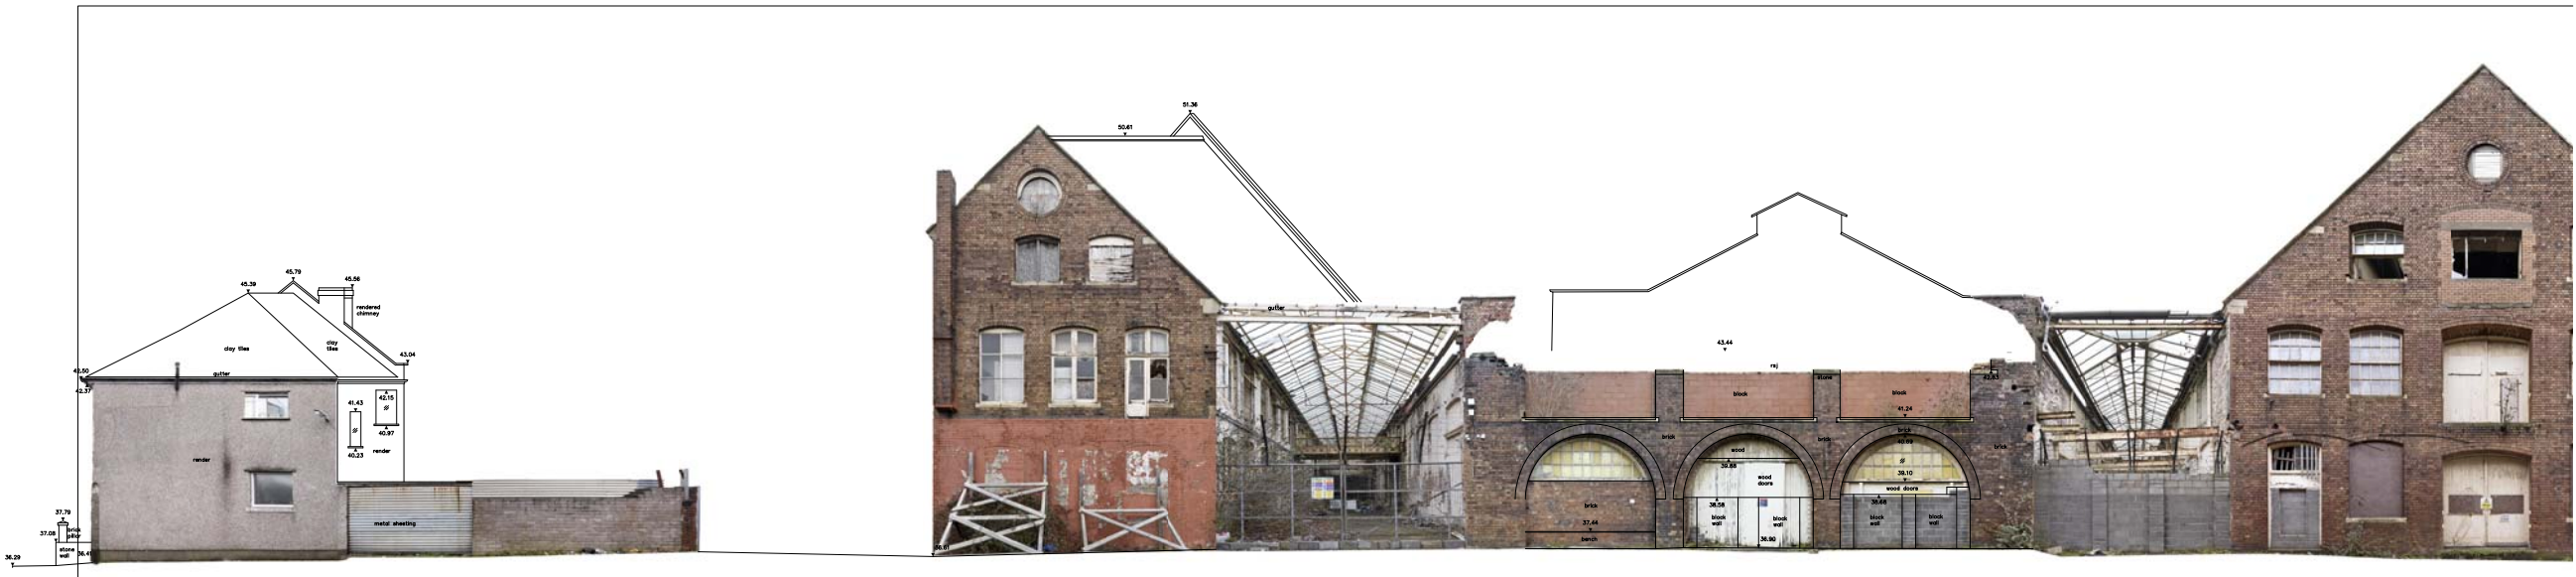
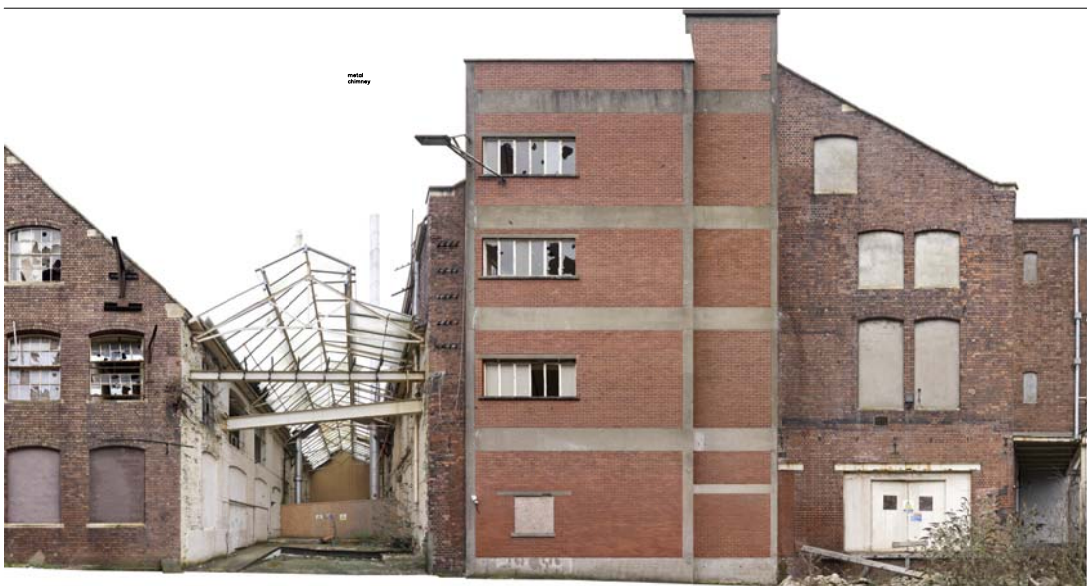
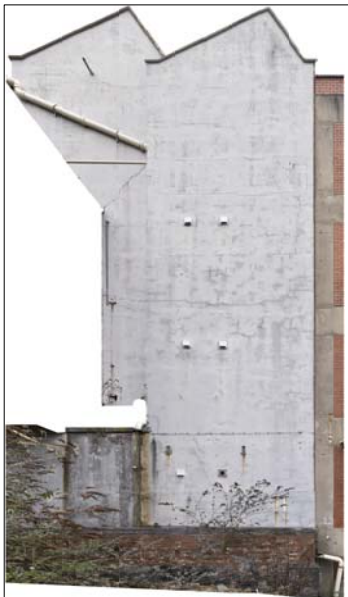
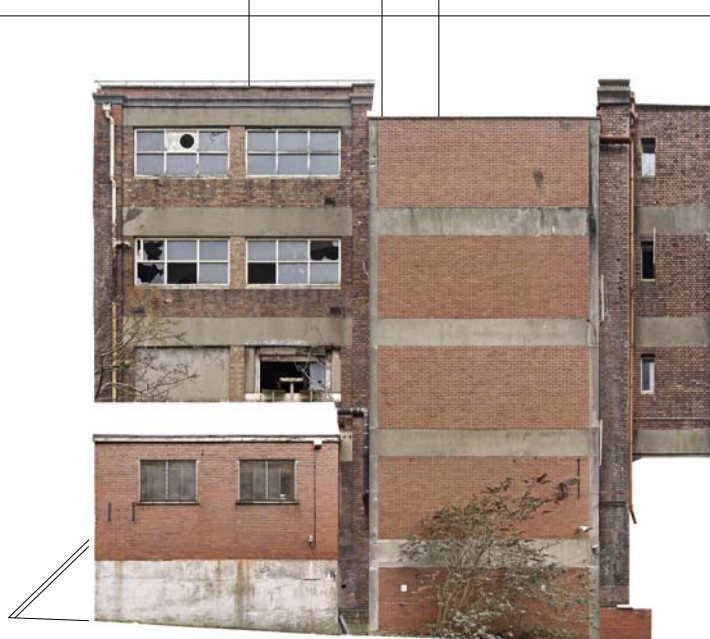
Title	ELIZABETH SHAW FACTORY DETAILED RECTIFIED PHOTOGRAPH ELEVATIONS
-------	---

15-08-RE-NORTH

15-08-RE-SOUTH
