**NEVILLE HALL  
FREELANCE ARCHAEOLOGIST & CONSULTANT**

ARCHAEOLOGICAL MONITORING & RECORDING AT  
THE METHODIST CHURCH, HIGH STREET,  
NETTLEHAM, LINCOLNSHIRE.

**National Grid Reference: TF 0062 7524**  
**Site Code: HSNE20**  
**Accession No: LCNCC: 2020.140**  
**Planning Reference: 141060**

November 2021

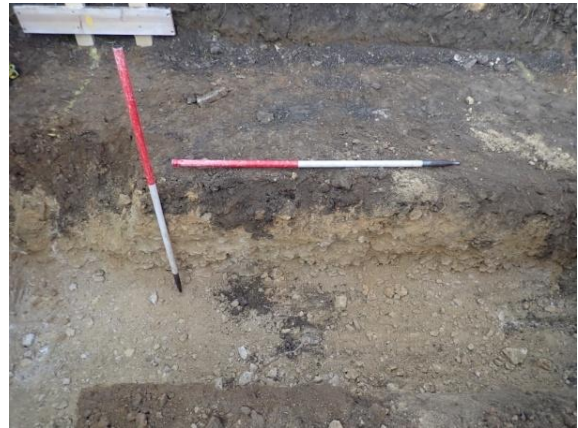
**Plate 41:** Representative Section 4, from the east

- 7.1.4 The next phase of the monitored groundworks programme here consisted of the mechanical excavation of the foundations for the new rear extension. These excavations took place from the interface of the modern made ground horizon (**003**) and the underlying natural horizon (**002**). These foundation trenches were excavated to varying lengths, to widths of between 0.50m-0.70m and to uniform depths of between 0.70m below the reduced site levels [**Plates 27, 29-34, 36-40, 42-50, 52-57 and 59-73**]. These mechanical excavations extended through remnants of the topsoil horizon (**001**) (around the margins of the site area), remnants of the modern made ground horizon (**003**), the natural horizon (**002**) and into the upper levels of the underlying limestone bedrock (**004**). The deposit sequences here were recorded within **Representative Sections 2 and 4-6 [Plates 28, 41, 51 and 58]**.

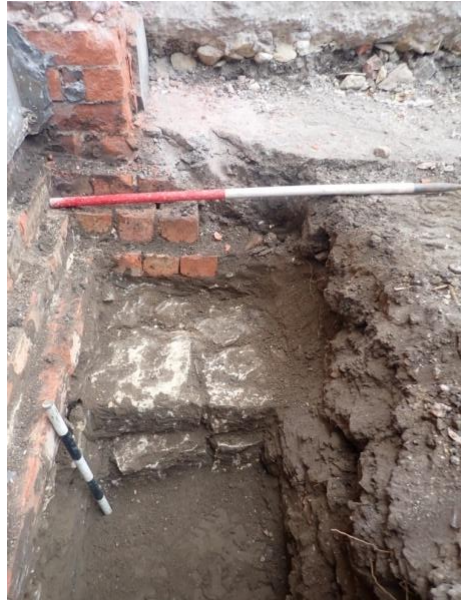
**Plate 91: Section 9 of the foundation (008), from the east**

7.2.2 The first foundation trench for the new front extension was excavated alongside the base of the exposed north elevation of the Sunday School building [Plates 80-87]. This entailed the initial mechanical removal of the concrete foundation of the former toilet block. This foundation trench was excavated through the buried soil horizon (007) to a width of 0.70m and to a depth of 0.80m below the internal site levels. The length of this first trench is featured on **Figure 5**. The topsoil horizon (007) here was relatively clean and homogeneous, deep and substantial. This excavation was confined to this horizon, which also exposed the stepped offset brick foundations of the adjoining Sunday School building of 1899. These foundations were of three courses in height. These excavations also revealed a small portion of a medieval stone wall foundation (008) at the western end of this first foundation trench. This foundation was *in situ* and was composed of two courses of worked, shaped and faced limestone blocks. There appeared to be no evidence of any mortar bonding material. This wall foundation (008) was cut into the buried soil horizon (007) and there appeared to be no associated construction trench. The brick wall foundations and the buried topsoil horizon below these foundations were recorded within **Representative Section 7 [Plates 88-89]**. The deposit sequence in the south facing section of this first foundation trench was recorded within **Representative Section 8 [Plate 90]**. The stone wall foundation (008) was recorded in detail within **Section 9 [Plates 91-93]**.

- 8.4 However, a small section of *in situ* medieval stone wall foundation was identified adjoining the Sunday School building of 1899 and at the western end of the first foundation trench excavated. This foundation was probably truncated and consisted of two courses of worked, shaped and faced limestone blocks with no evidence of any bonding material. The foundation was cut into the buried soil horizon and was also sealed

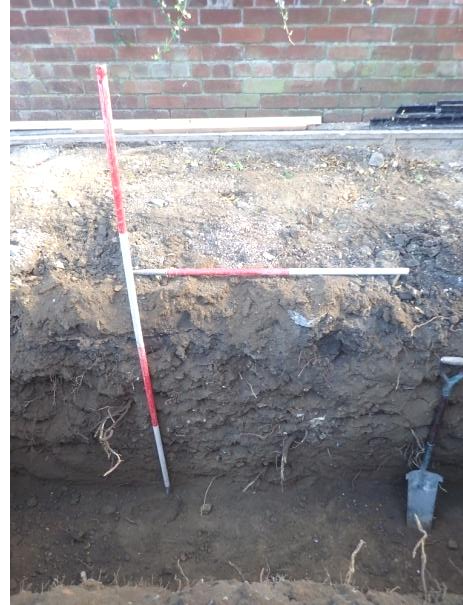
**Plate 101:** Representative Section 10, from the west

- 007** Buried topsoil horizon within the build area of the former demolished modern toilet block. Friable, mid orange brown sandy silt with small-medium brick fragments 2%, small concrete fragments 1% and spreads of dark orange brown sand. Above **(008)**. Recorded within **Representative Sections 7-8 and 10-11**. Depth - 1.49m.
- 008** Medieval stone wall foundation exposed *in situ*. Cut into **(007)** and sealed by **(007)**. Composed of two courses of worked, shaped and faced limestone bocks with no evidence of any mortar bonding material. Recorded within **Section 9**. Length - >0.95m, width - >0.90m, depth - >0.32m.
- 009** Natural horizon. Friable, light orange brown sandy silt with frequent small angular limestone fragments. Below **(007)**. Recorded within **Representative Sections 10-11**. Depth - 0.32m.
