**NEVILLE HALL
FREELANCE ARCHAEOLOGIST & CONSULTANT**

ARCHAEOLOGICAL MONITORING AND RECORDING AT
11, TOWER LANE,
SPALDING, LINCOLNSHIRE.

National Grid Reference: TF 2484 2207
Site Code: TLSP19
Accession No: LCNCC: 2019.16
Planning Reference: H16-0423-18

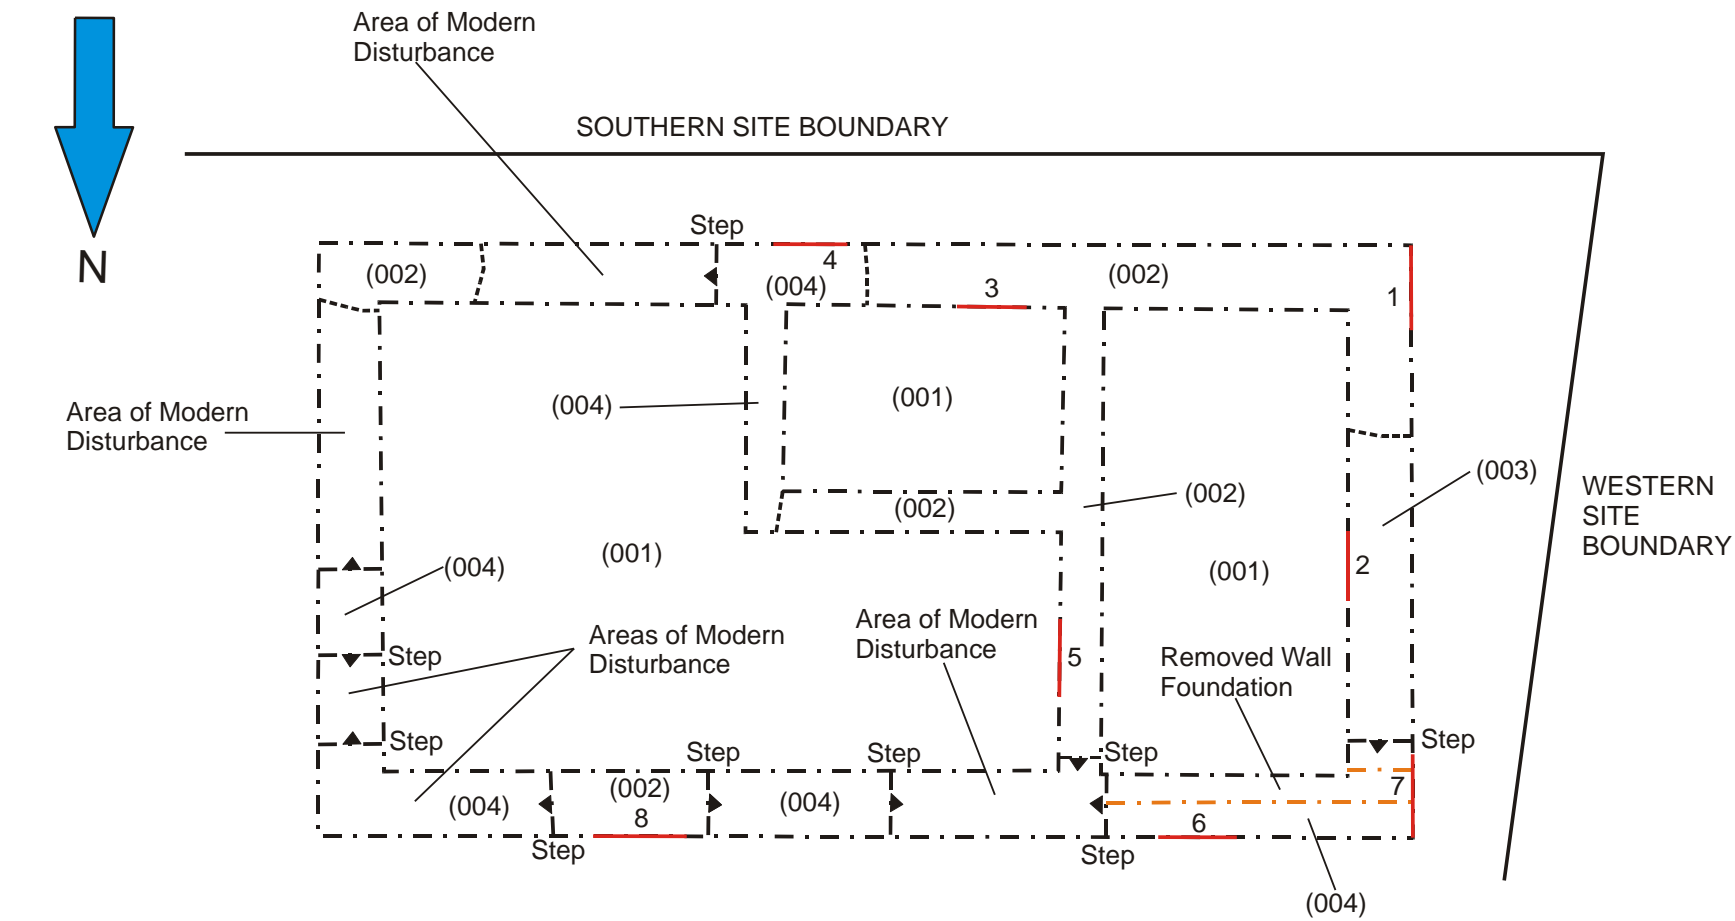
Representative Section 1, East Facing Section, scale 1:20

Figure 5: Plan of the Monitored Groundworks at a scale of 1:100 and Representative Sections 1-8 at a scale of 1:20

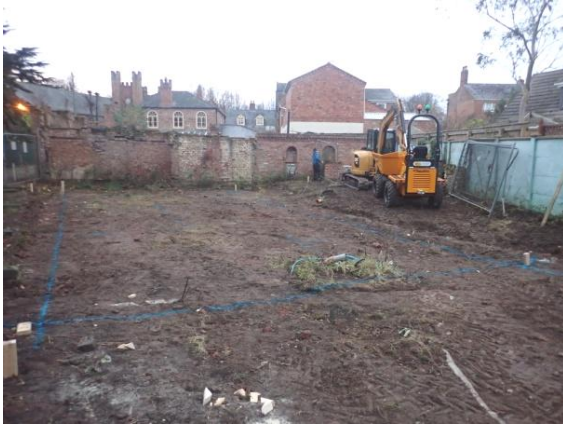
Plate 1: Pre-groundworks, from the east

- 7.1 The development site had been cleared of ground vegetation and the foundations had already been set out prior to arrival [**Plates 1-3**]. A modern made ground horizon (**001**) covered the area of the new build footprint. This was the product of the demotion and site clearance of the former Grade II listed building that had until recently, stood on this site.
- 7.2 The first trench to be excavated was situated alongside the western site boundary. This trench was excavated to a length of 7.0m, to a width of 0.80m and to depths of between 0.50m-0.60m below ground levels [**Plates 4, 6-8 and 10**]. To the south, these monitored mechanical excavations extended through the modern made ground horizon (**001**) and into the upper levels of an underlying undated buried soil horizon (**002**), which extended

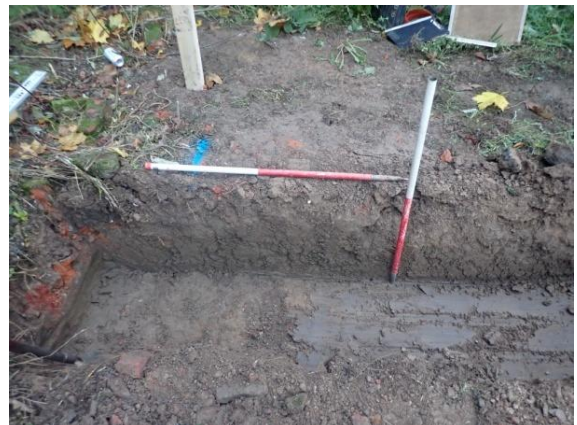
to the base of these excavations. This deposit sequence was recorded within **Representative Section 1 [Plate 5]**. Within the northern portion of this first excavated foundation trench, there followed a change to this deposit sequence. Here, these excavations went through the modern made ground horizon (001), a second modern made ground horizon (003) and the undated buried soil horizon (002) at the base of this excavation. This deposit horizon was also the product of the recent demolition and site clearance of the former Grade II listed building that had stood here. This change to the site deposit sequence here was recorded within **Representative Section 2 [Plate 9]**.

Plate 5: Representative Section 1, from the east

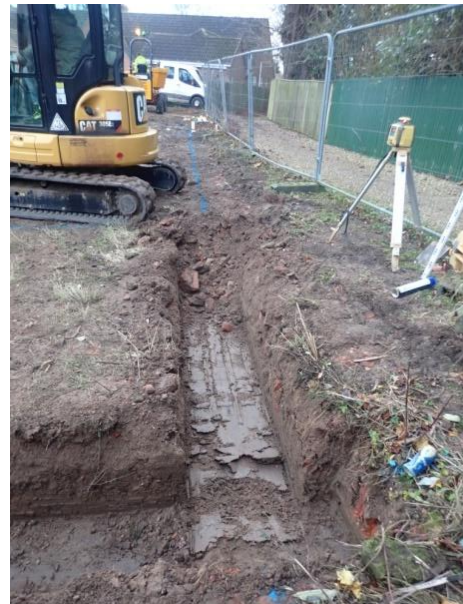
Plate 11: Excavation of the foundations, from the west

- 7.3 This was followed by the mechanical excavation of the second foundation trench, which was positioned alongside the southern site boundary. This second trench was excavated to a length of 13.50m, to a width of 0.80m and to depths of between 0.60m-0.65m below site levels [**Plates 11-16, 18-21 and 29**]. Within the western portion of this second trench, these excavations went through the modern made ground horizon (001) and into the upper levels of an underlying undated buried soil horizon (002), which extended to the base of these excavations. This deposit sequence was recorded here within **Representative Section 3 [Plate 17]**. To the east, of this there was a further change to the site deposit sequence here, with these excavations extending through the modern made ground horizon (001) and into the upper levels of the underlying natural alluvial horizon (004), which was recorded here at the base of this excavation. This change to the deposit sequence here was recorded within **Representative Section 4 [Plate 22]**. Here, the modern made ground horizon (001) was deeper and more substantial and came down directly onto the natural alluvial horizon (004). The undated buried soil horizon (002) was absent here.

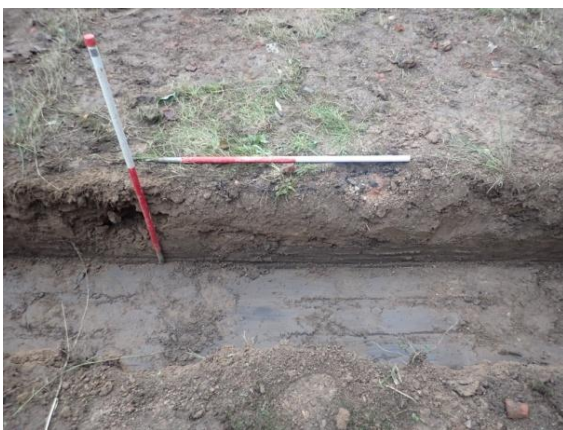
Plate 9: Representative Section 2, from the west

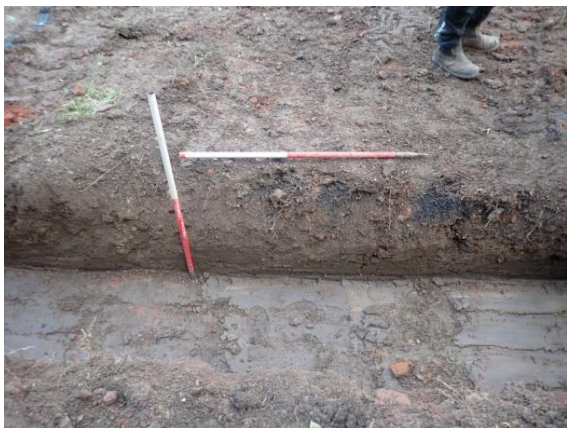
Plate 17: Representative Section 3, from the south

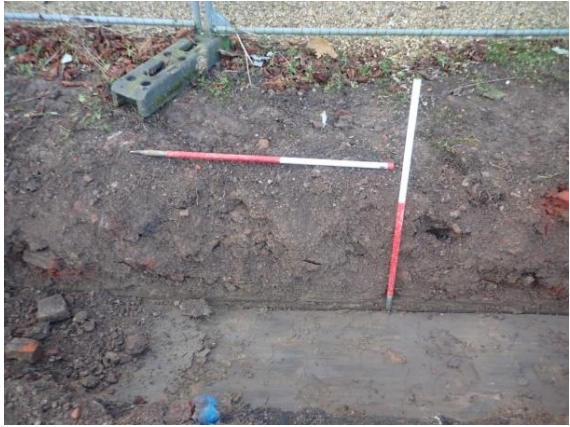
Plate 22: Representative Section 4, from the north

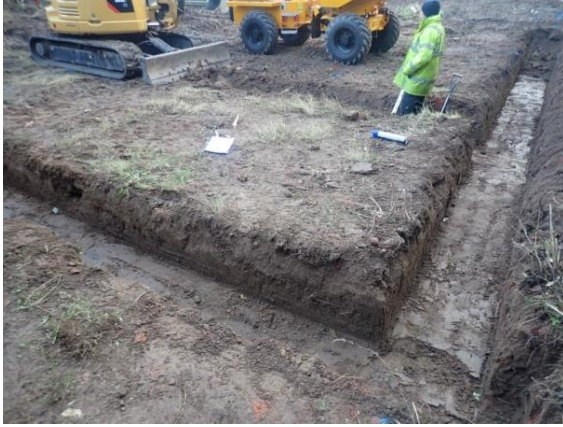
Plate 23: Excavation of the foundations, from the west

- 7.4 This was followed by the mechanical excavation of the third north-south aligned internal foundation trench, which extended along the whole width of the new build area. This third trench was excavated to a length of 6.20m, to a width of 0.50m and to a depth of 0.60m below the site levels [**Plates 23-25**]. Here, the deposit sequence consisted of the modern made ground horizon (001) and the underlying undated buried soil horizon (002), which extended to the base of these excavations. This deposit sequence was recorded within **Representative Section 5 [Plate 26]**.

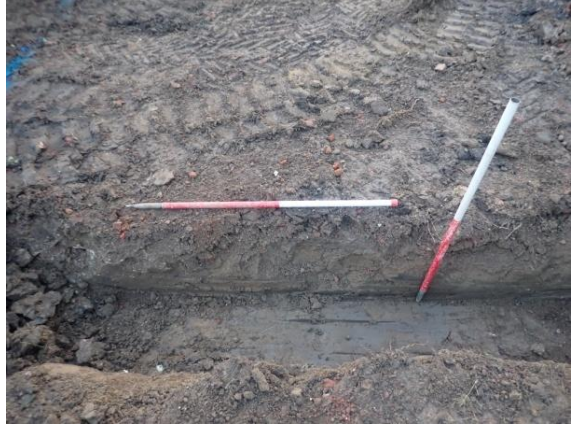
Plate 26: Representative Section 5, from the west

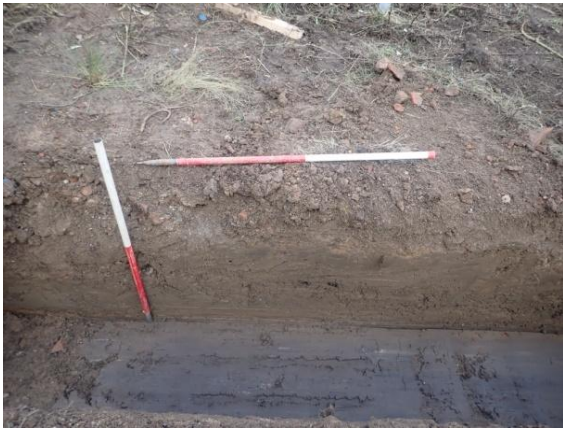
horizon (003). Within this section made ground horizon, were the linear east-west aligned remains of a grubbed out or removed brick wall foundation of the former Grade II listed house, which had stood on this site. This removed foundation was found to be cut into the underlying natural alluvial foundation (004). The line of this former foundation was discerned as extending along this part of this foundation trench and was recorded in profile within **Representative Section 7 [Plate 36]**. To the immediate north of the line of this former foundation and along the northern edge of this foundation trench, this mechanical excavation went through the modern made ground horizon (001), the undated buried soil horizon (002) and the underlying natural alluvial horizon (004), which was recorded here at the base of this excavation within **Representative Section 6 [Plate 35]**.

Plate 35: Representative Section 6, from the south

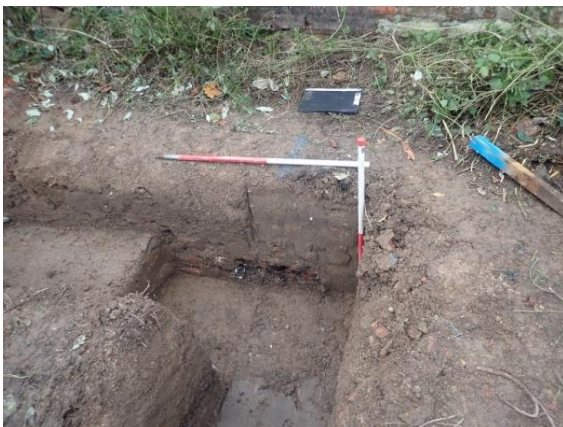
Plate 36: Representative Section 7, from the east

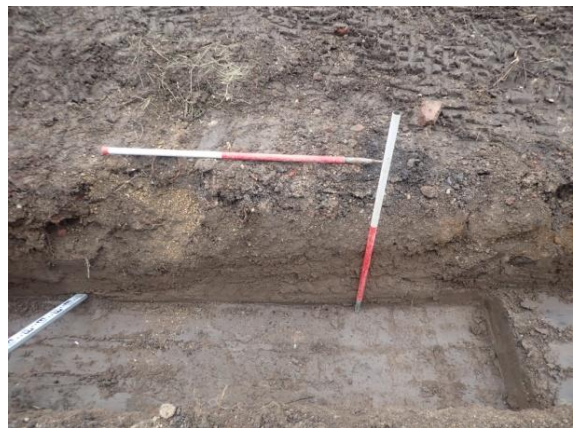
Plate 44: Representative Section 8, from the south
