**NEVILLE HALL
FREELANCE ARCHAEOLOGIST & CONSULTANT**

INTERIM REPORT ON THE RESULTS OF
ARCHAEOLOGICAL MONITORING AND RECORDING ON
LAND ADJACENT TO 'THE CHESTNUTS',
HALLGATE,
FLEET, LINCOLNSHIRE.

National Grid Reference: TF 3885 2358
Site Code: HGFL21
Accession No: LCNCC: 2021.198
Planning Reference: H05-0659-21

March 2022

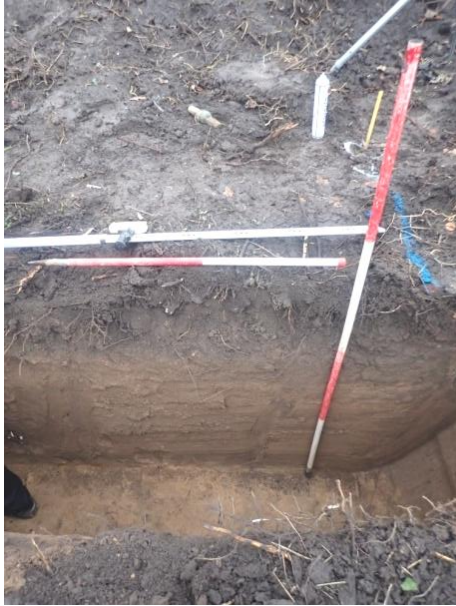
Plate 7: Representative Section 1, from the west

- 7.1.2 Over the eastern half of the new build area, these monitored mechanical excavations extended through a modern topsoil horizon (001), which was in turn above a sequence of three alluvial horizons (002), (003) and (004), with the final deposit (004) encountered at the base of the foundation excavations here. Six fragments of bottle glass of 18th-19th century date were recovered from the alluvial horizon (003). This deposit sequence was recorded within **Representative Sections 1 and 3** [Plates 7 and 23].
