### **7.5 The Exterior of Building 3**

#### **7.7 The Exterior of Building 4**

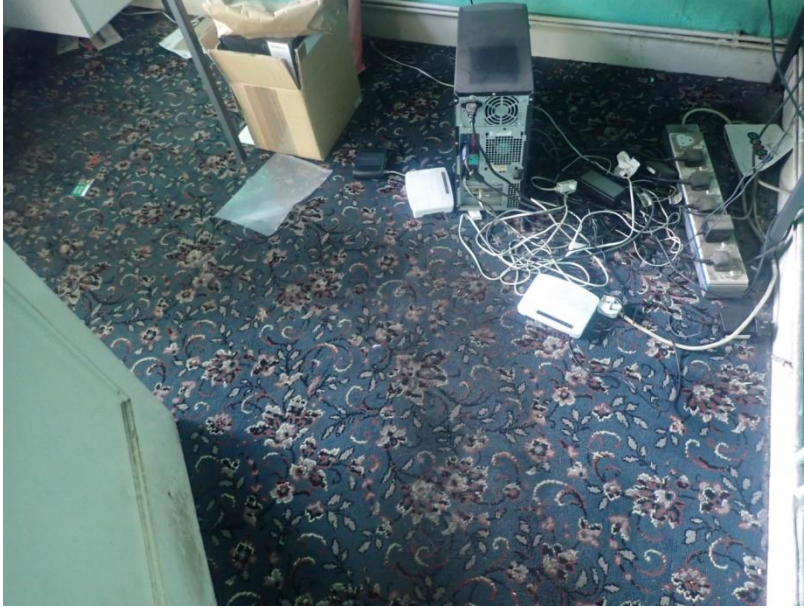
**Plate 201: View of the flooring of Cell 11, from the north-east**

**Plates 201 and 202** feature the flooring of **Cell 11**, which is covered with modern carpeting.

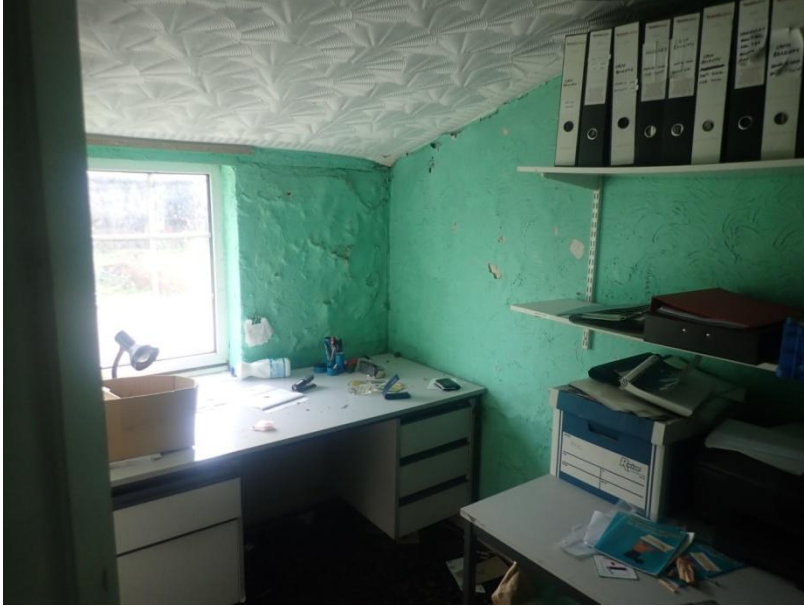
**Plate 203: General view of the interior of Cell 11, from the north-east**

**Plate 203** features a general view of the interior of **Cell 11**.

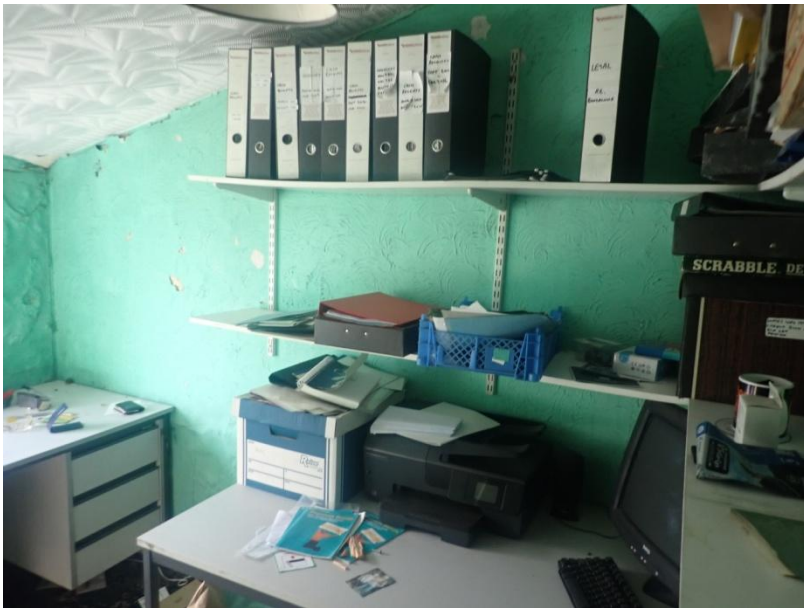
**Plate 204: View of the west wall of Cell 11, from the north-east**

**Plates 204 and 207** present views of the west wall of **Cell 11**, which has been rendered over with plasterwork.

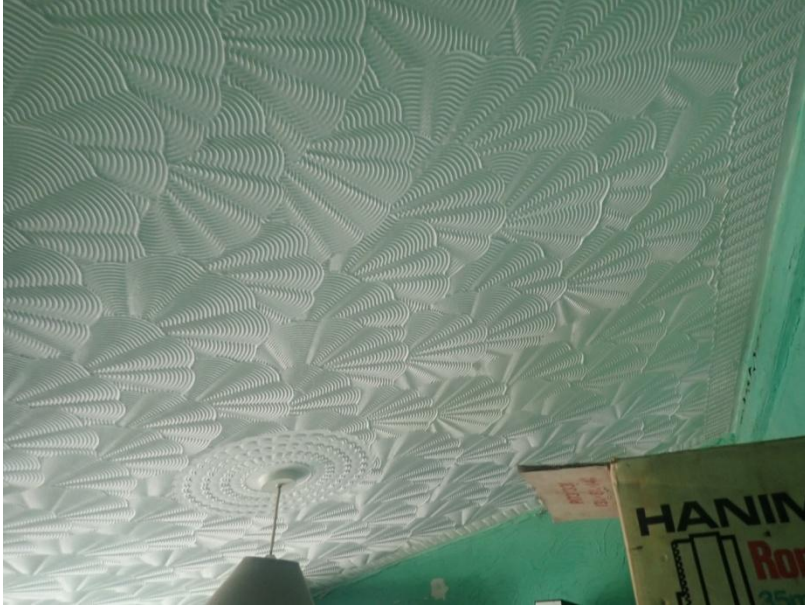
**Plate 205: View of the ceiling of Cell 11, from the north-east**

**Plates 205 and 206** furnish views of the ceiling of **Cell 11**, which has been rendered over with modern plasterwork. Its low angle reflects that of the low angled half gabled roof structure of the above rear outshut.

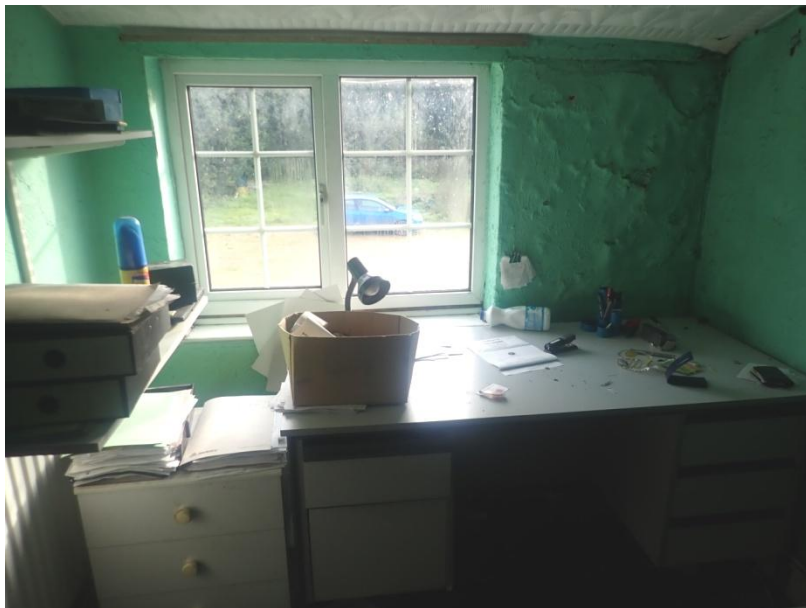
**Plate 208: View of the south wall of Cell 11, from the north-west**

**Plate 208** presents a view of the south wall of **Cell 11**, which has also been rendered over with plasterwork. Also shown is the inner face of the first floor south facing window opening that was recorded externally at the South Elevation of this building.

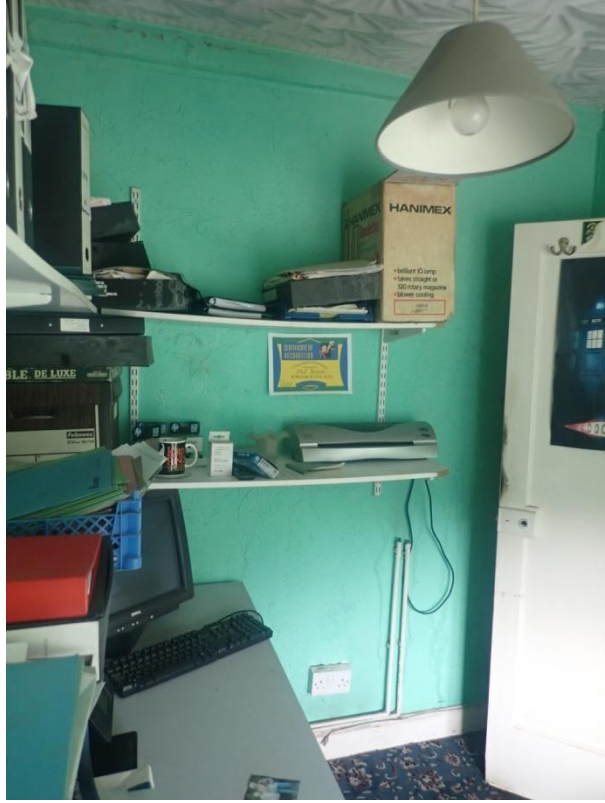
Plate 209: View of the north wall of Cell 11, from the south-west

**Plate 209** features the north wall of **Cell 11**, which has also been rendered over with plasterwork. This is also the internal dividing wall with the adjoining **Cell 12** to the north.

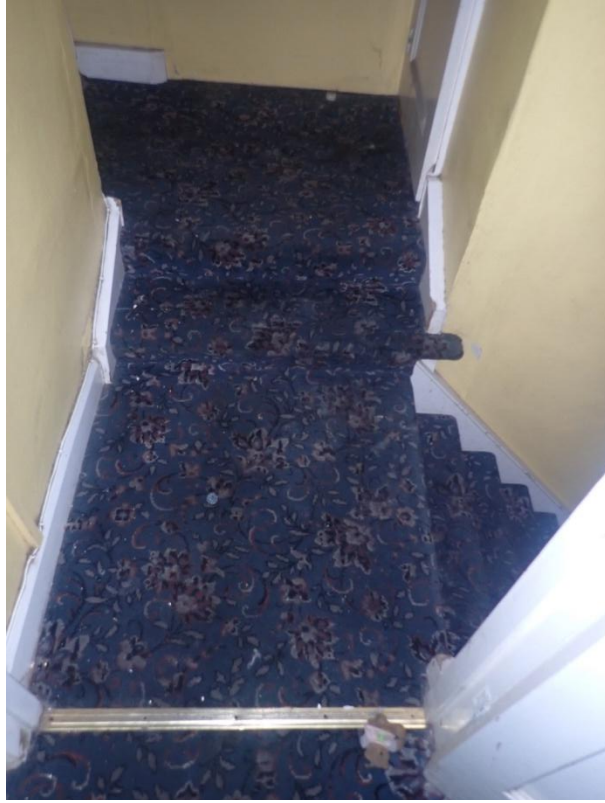
**Plate 212: View of the first floor landing of Building 2, from the south-west**

**Plate 212** features the lower levels of the first floor landing at the northern end of **Cell 10**. This shows the flooring here which is covered with modern carpeting.

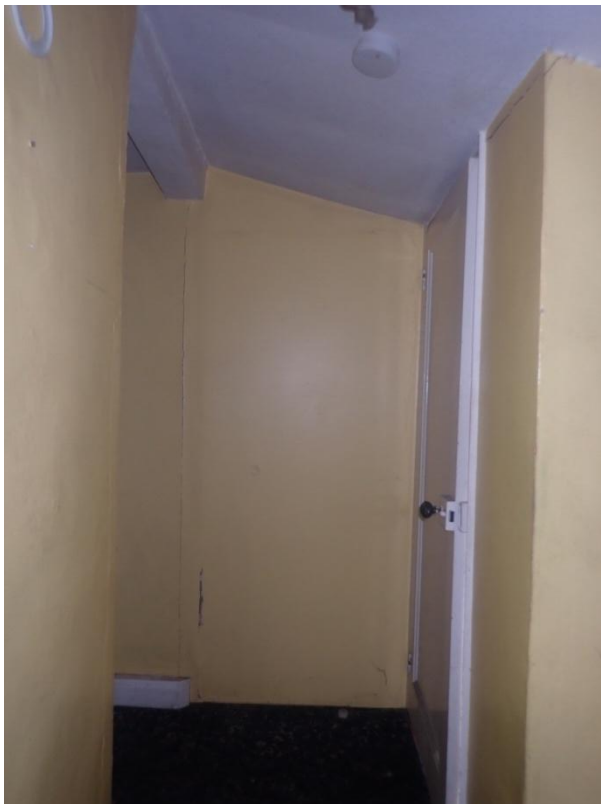
**Plate 213: View of part of the east wall of the first floor landing of Building 2, from the south-west**

**Plate 213** shows the southern portion of the east wall of the first floor landing. This east wall has been rendered over with plasterwork. Horizontal timber skirting boards are at its base.

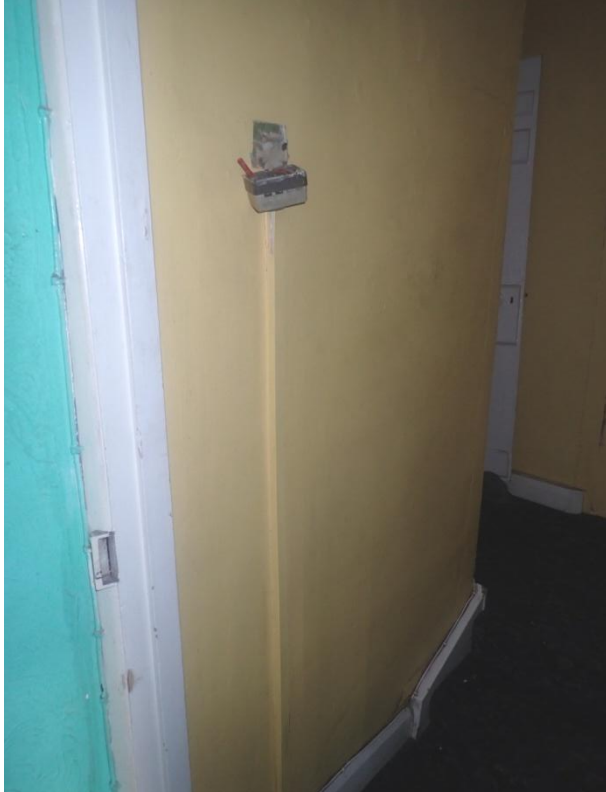
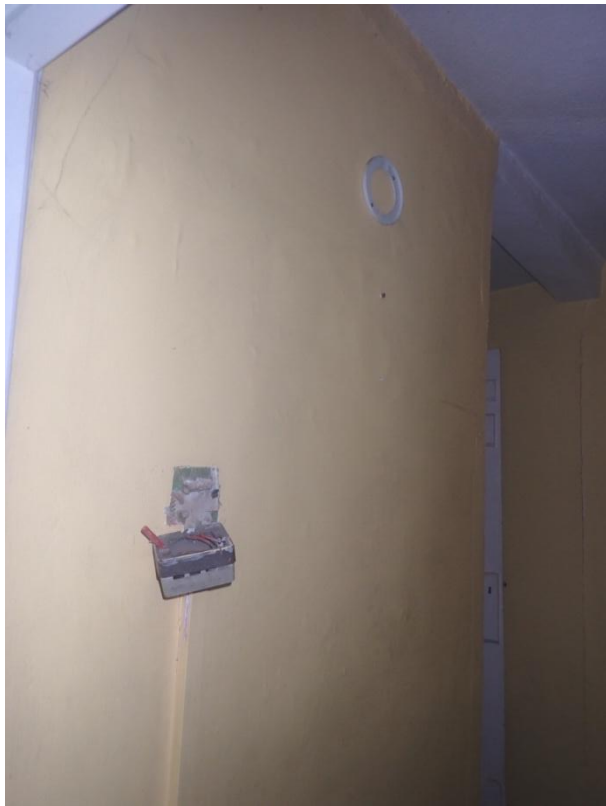
**Plates 214 and 215** present views of the north wall of this first floor landing. This north wall has been rendered over with plasterwork. Horizontal timber skirting boards are at its base.

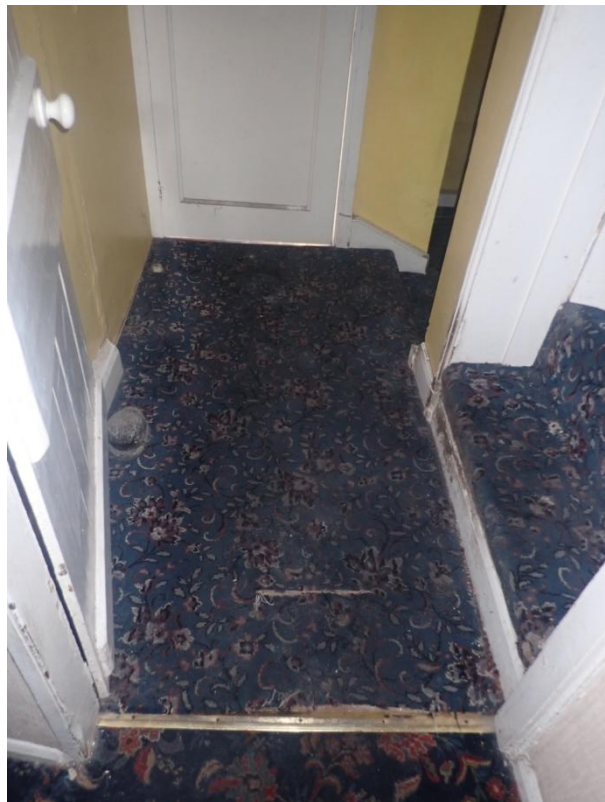
**Plate 217: View of the flooring of the upper levels of the first floor landing of Building 2, from the north-west**

**Plate 217** provides a view of the flooring of the upper levels of the first floor landing of **Building 2**. This is covered by modern carpeting

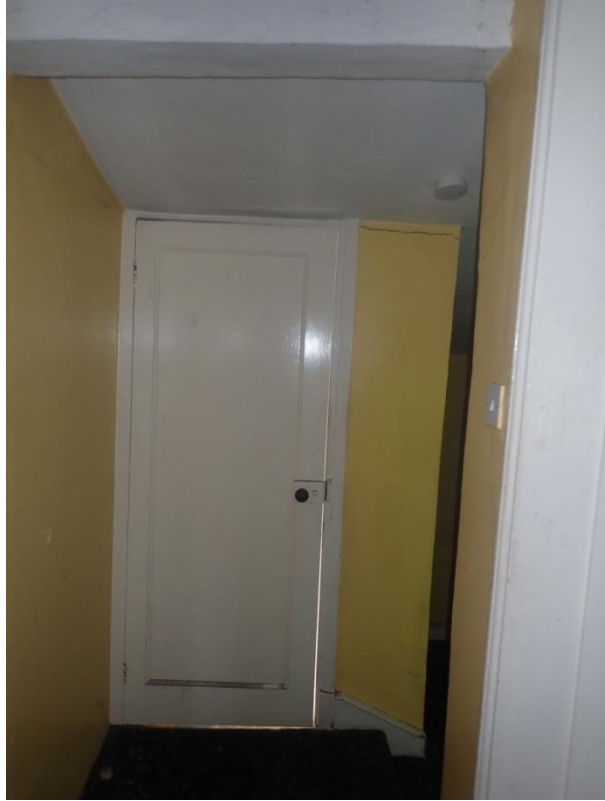
**Plate 218: View of the south wall and of the ceiling of the first floor landing of Building 2, from the north-west**

**Plate 218** provides a view of the south wall of the first floor landing, part of which has been rendered over with plasterwork. Timber skirting boards occur at its base. Much of this south wall is occupied by a south facing entrance opening that extends onto the first floor bathroom or **Cell 14** to the south. This opening is occupied by a timber frame of a head and surrounds and a simple panelled timber door.

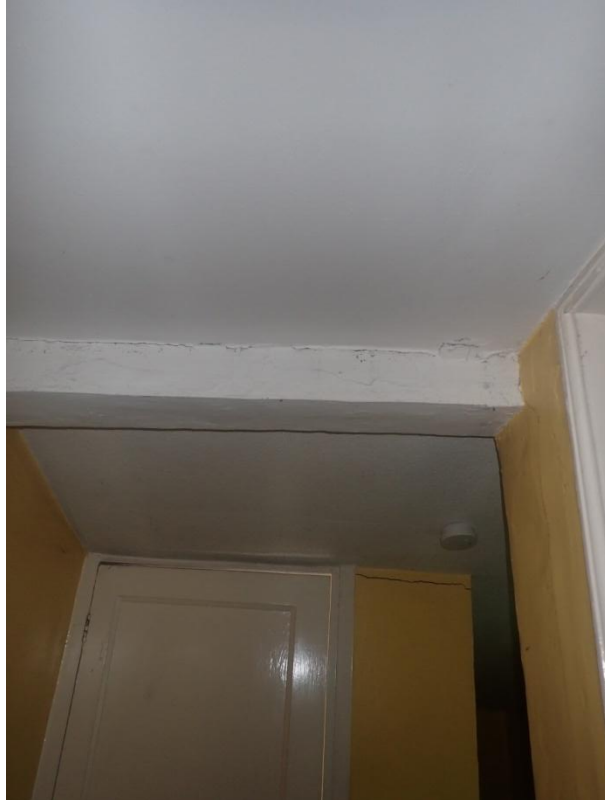
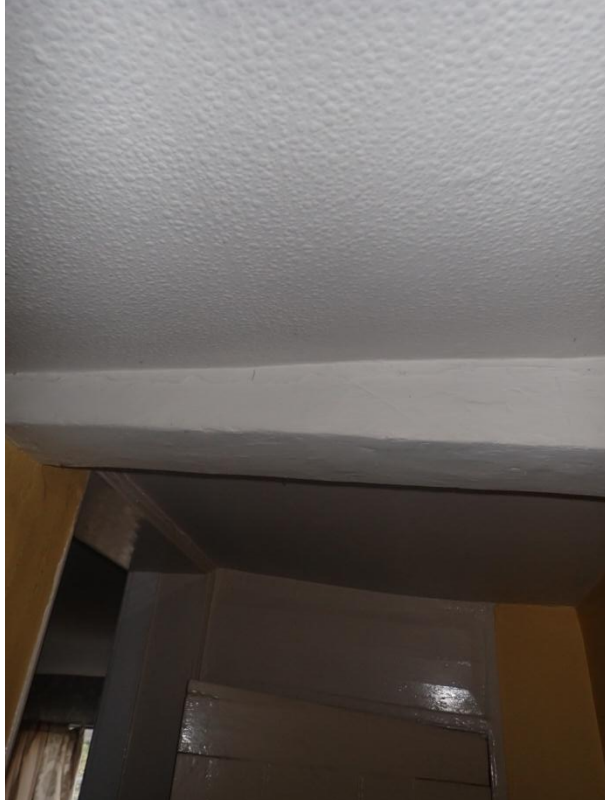
**Plates 219 and 221** feature the ceiling of this first floor landing, which is clearly in two parts. These are bisected by an east-west orientated principal horizontal timber joist. To the south of this joist, the angle of this ceiling reflects the low angle of the half gabled roof structure of the above rear outshut. To the north of this joist, the ceiling here has been rendered over with plasterwork and is part of the original main body of the public house. The joist denotes the boundary between this building and the rear outshut.

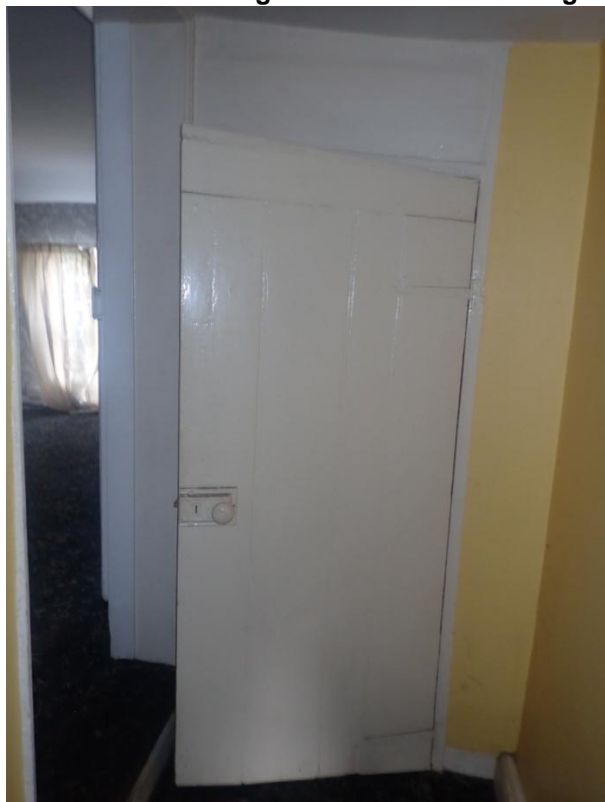
**Plate 220: View of the north wall of the first floor landing of Building 2, from the south-east**

**Plate 220** provides a view of the north wall of this first floor landing, part of which has been rendered over with plasterwork. Timber skirting boards occur at its base. A north facing entrance opening is also shown, which is occupied by a timber frame of a head and surrounds and a door that is composed of a series of vertical tongued and grooved timber planks. The door is attached to the frame by two metal strap hinges. This leads onto **Cell 13** to the north. To the left (west), is a second west facing entrance opening that is occupied by a timber frame of a head and surrounds. This extends onto **Cell 12** to the west.

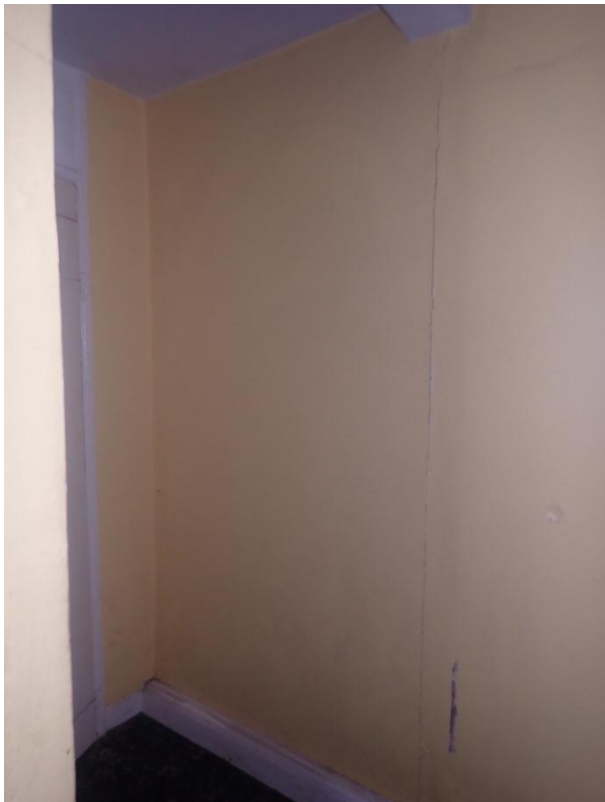
**Plate 222: View of the east wall of the first floor landing of Building 2, from the south-west**

**Plate 222** features the northern portion of the east wall of this first floor landing, which has been rendered over with plasterwork. Timber skirting boards occur at its base.

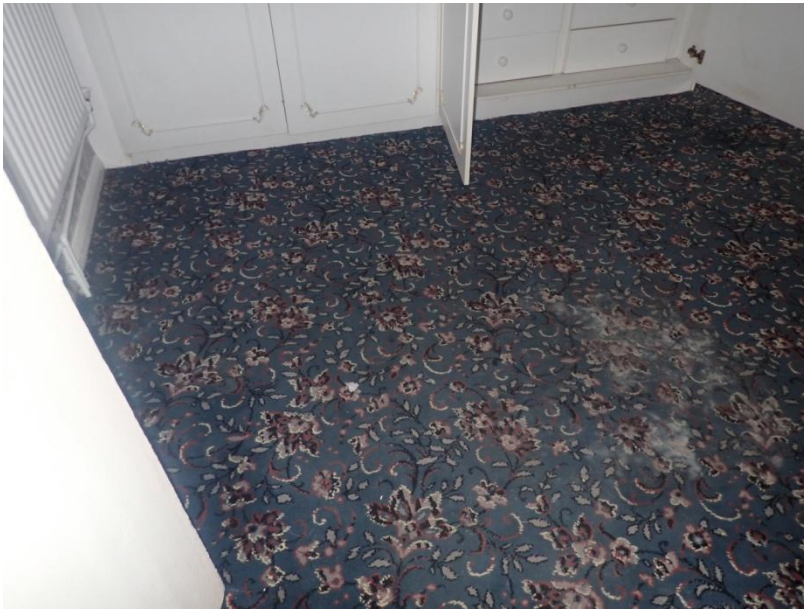
**Plate 223: View of the flooring of Cell 12, from the south-east**

**Plates 223 and 224** feature the flooring of **Cell 12**, which is carpeted.

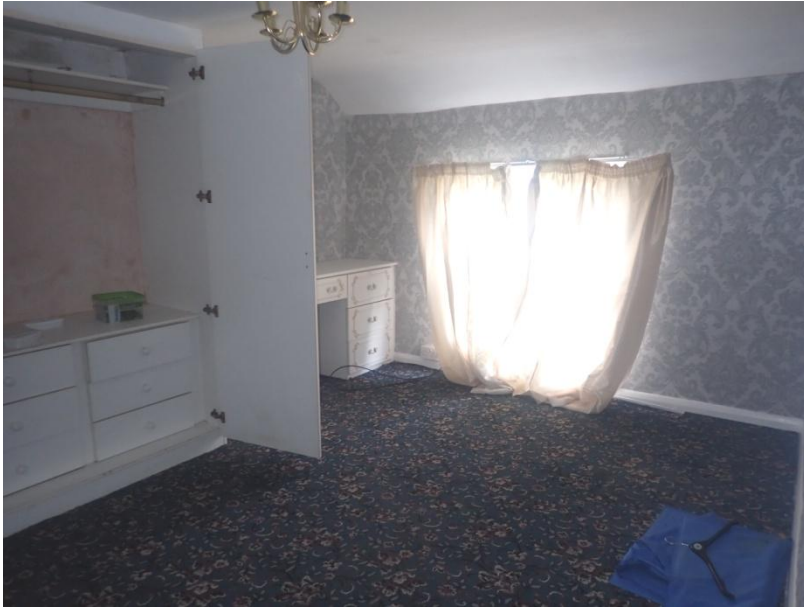
**Plate 225: General view of the interior of Cell 12, from the south-east**

**Plates 225 and 226** provide general views of the interior of **Cell 12** from south-eastern positions.

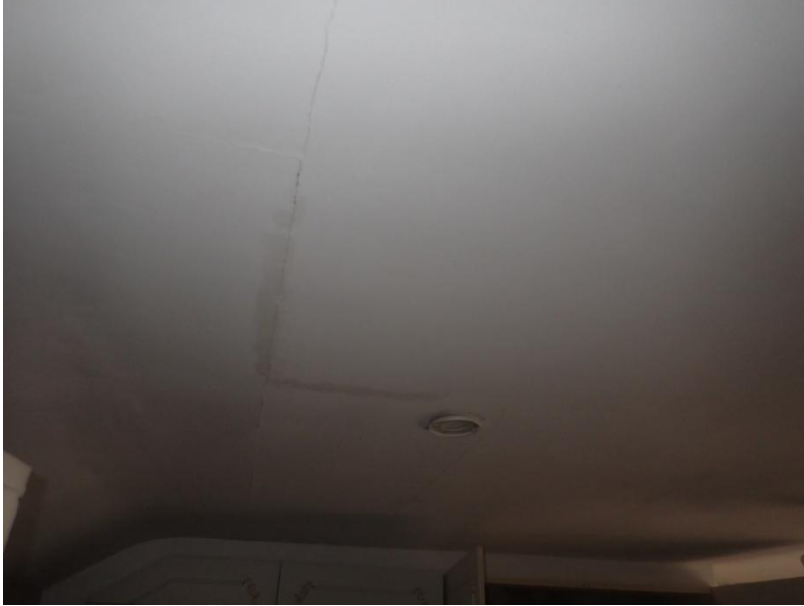
**Plate 227: View of the ceiling of Cell 12, from the south-east**

**Plates 227 and 228** show the nature of the ceiling structure of **Cell 12**, which has been rendered over with modern plasterwork.

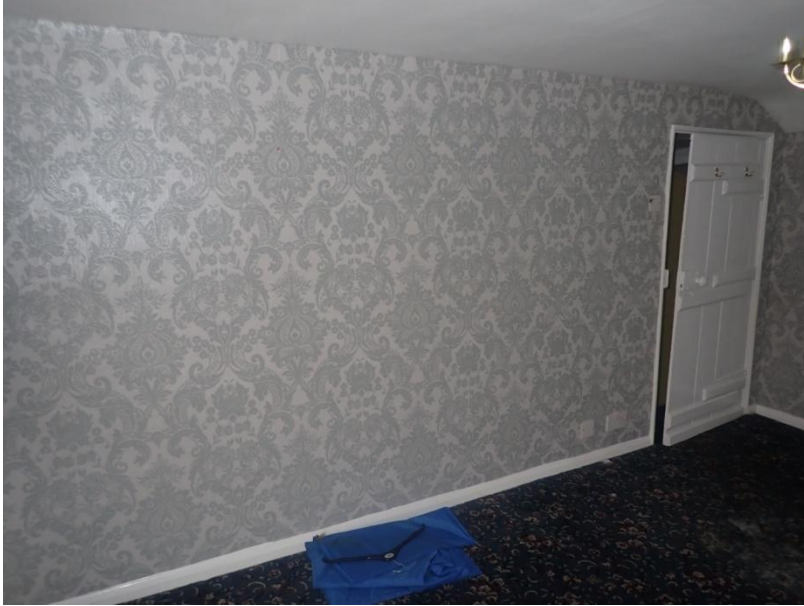
**Plate 229:** View of the east wall of Cell 12, from the north-west

**Plates 229 and 232** furnish views of the east wall of **Cell 12**, which is also the internal dividing wall with the adjoining **Cell 13**, to the east. This east wall has been covered over with modern wallpaper. Horizontal timber skirting boards occur at its base. To the right (south), is the inner face of the east facing entrance opening that leads onto the first floor landing. This opening is occupied by a timber frame of a head and surrounds and by a door that is composed of a series of vertical tongued and grooved timber planks that are in turn affixed to an internal framework of horizontal timbers.

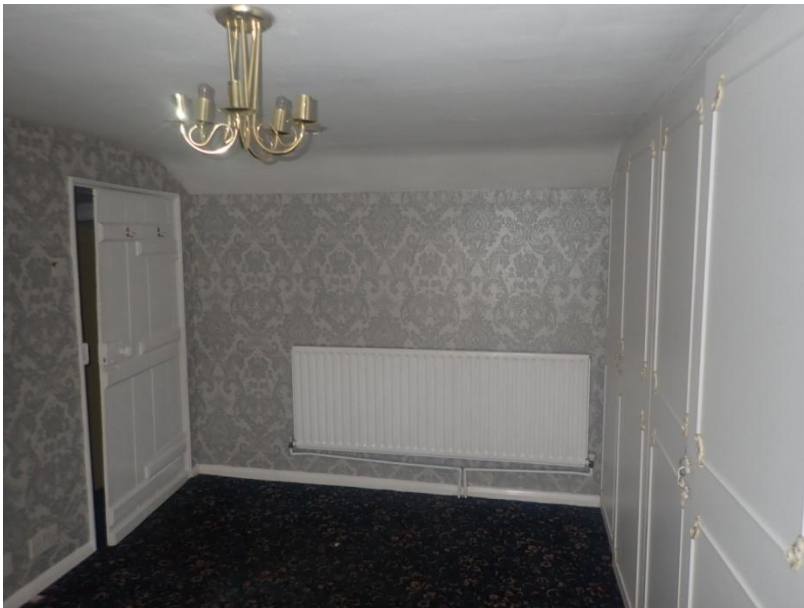
**Plate 230** View of the south wall of Cell 12, from the north-west

**Plate 230** presents a view of the south wall of **Cell 12**, which is covered over with modern wallpaper. Horizontal timber skirting boards occur at its base. The angle of the gabled roof of the building may be observed above this south wall.

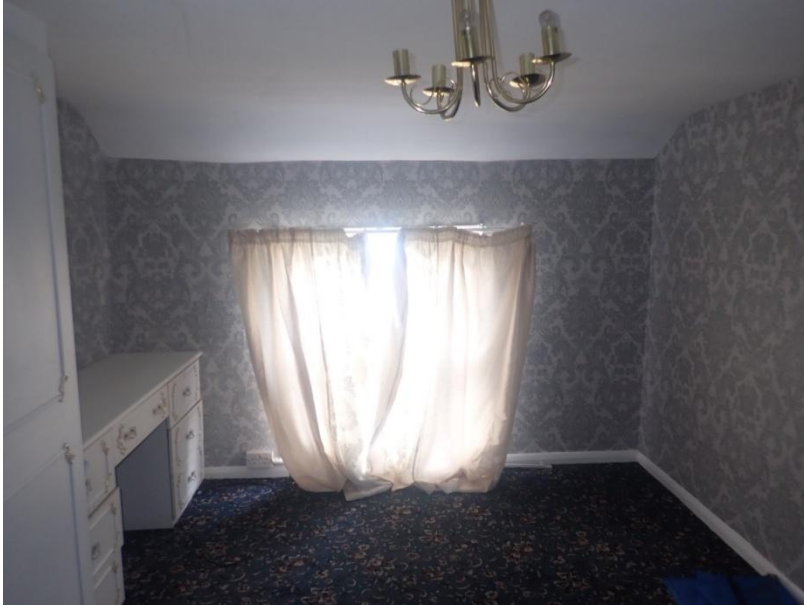
**Plate 231: View of the north wall of Cell 12, from the south-west**

**Plate 231** presents a view of the north wall of **Cell 12**, which is covered over with modern wallpaper. Horizontal timber skirting boards occur at its base. The central feature of this north wall is the inner face of the first floor north facing window opening that was recorded externally at the North Elevation of the building. The angle of the gabled roof of the building may be observed above this north wall.

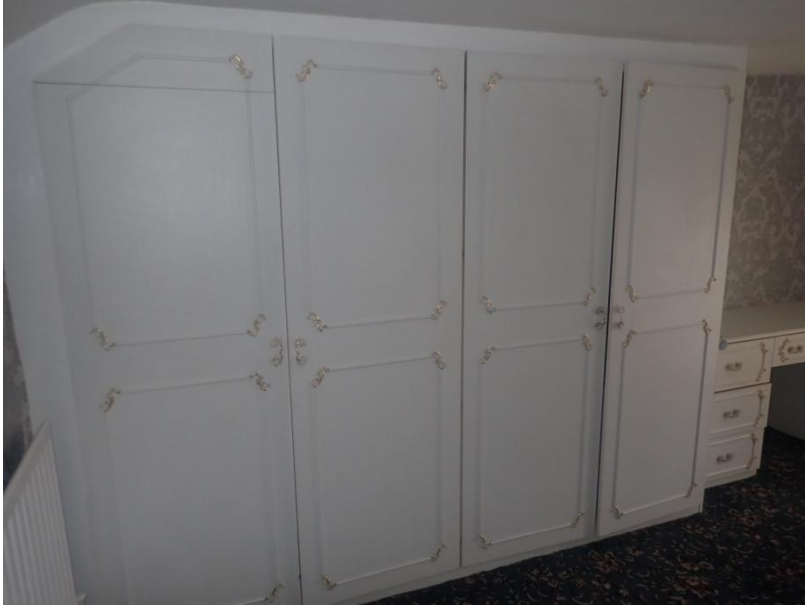
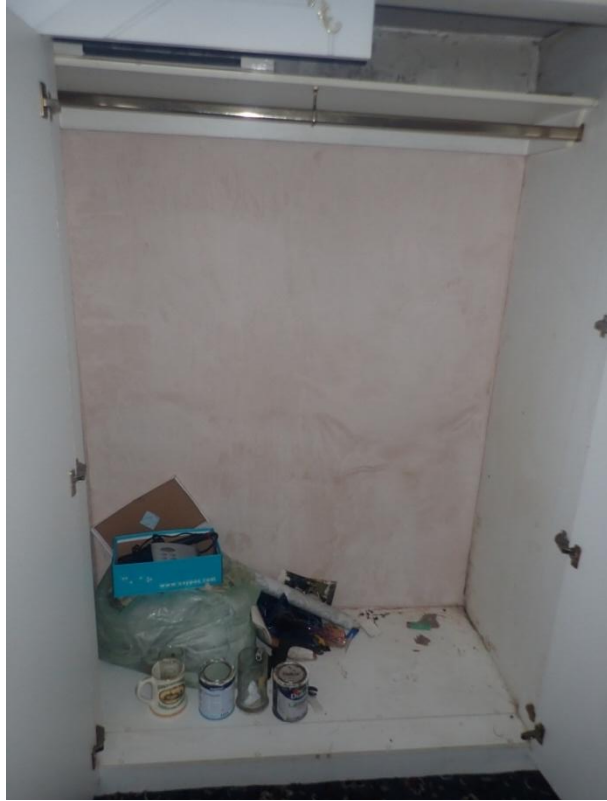
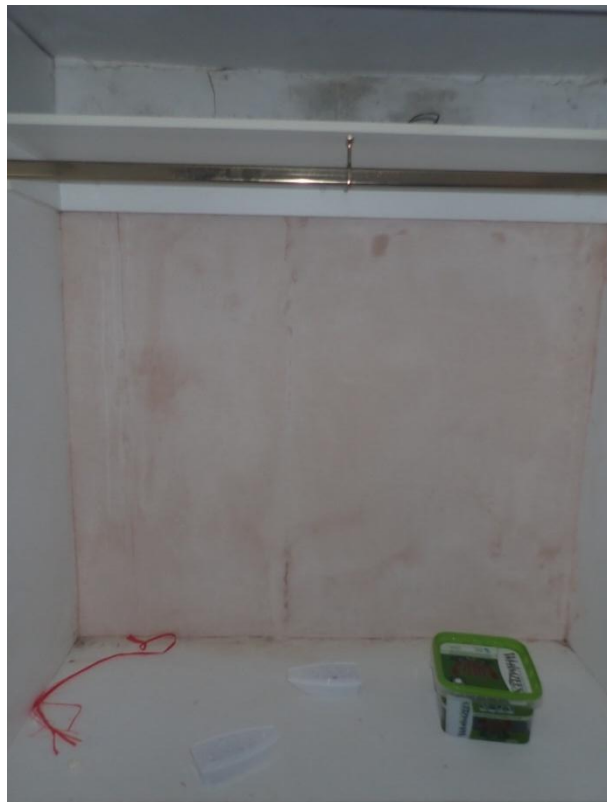
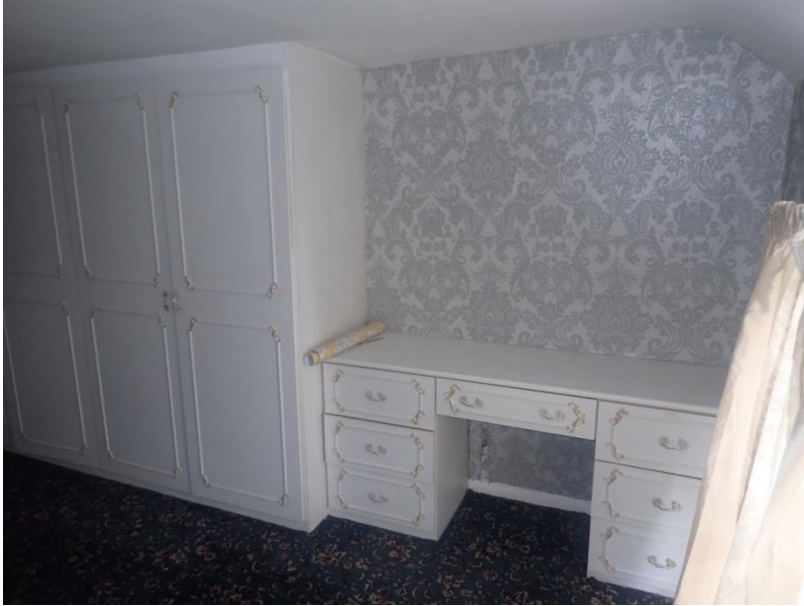
**Plates 233-238** provide a number of views from differing vantage points of the west wall of **Cell 12**, much of which is occupied by modern fitted cupboards. Outside of the modern fitted cupboards, the wall is covered with modern wallpaper. Horizontal timber skirting boards occur at its base. **Plates 235 and 236** feature the interiors of the fitted cupboards and feature the plasterwork rendering here.

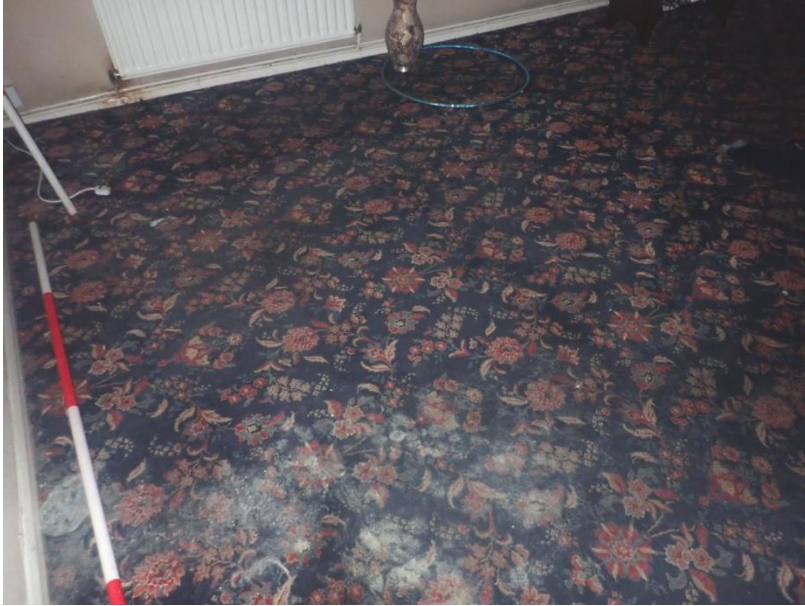
**Plate 239: View of the flooring of Cell 13, from the south**

**Plates 239 and 240** feature the flooring of **Cell 13**, which is carpeted.

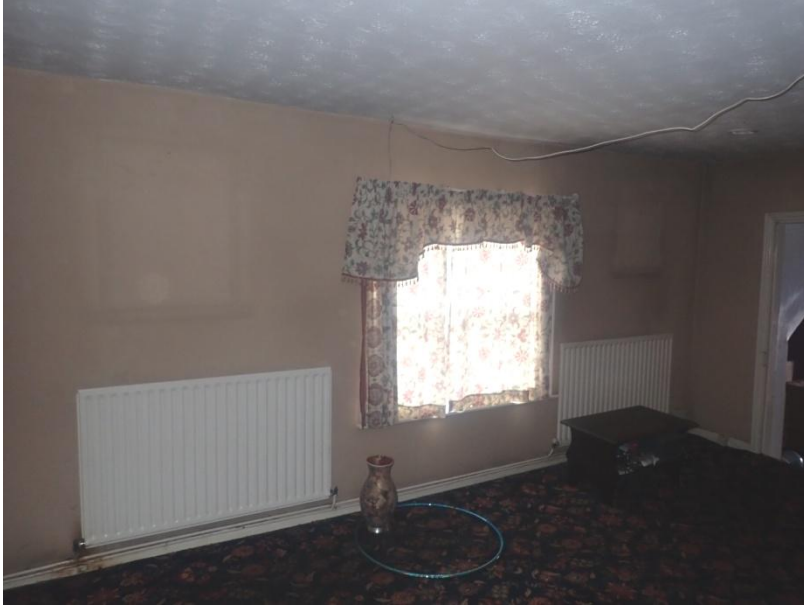
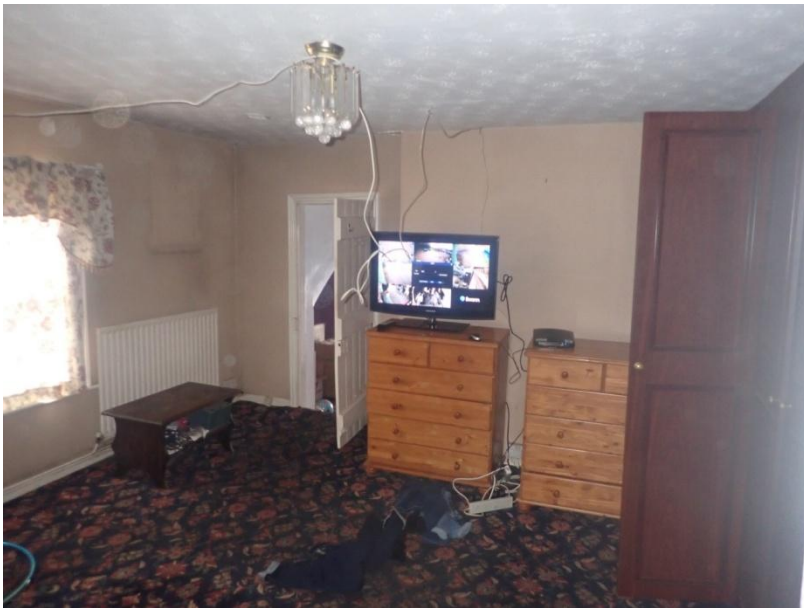
**Plates 241 and 242 provide general views of the interior of Cell 13.**

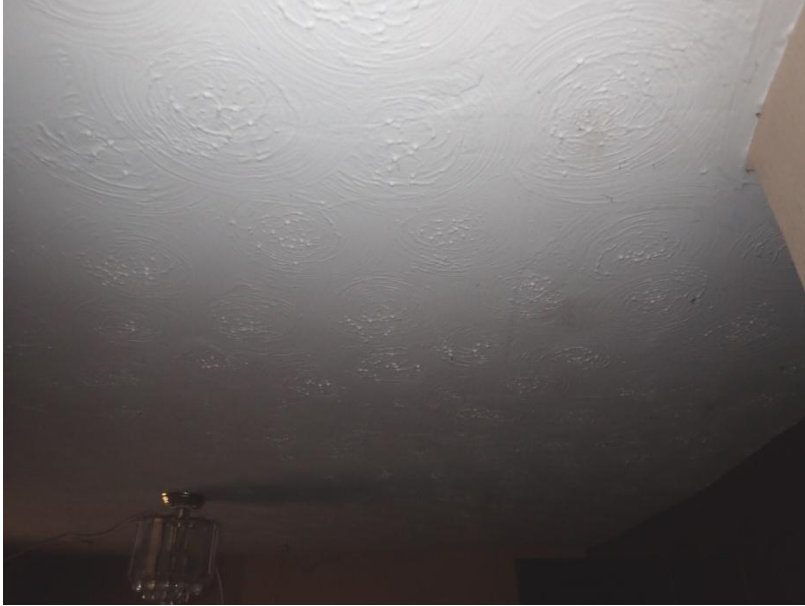
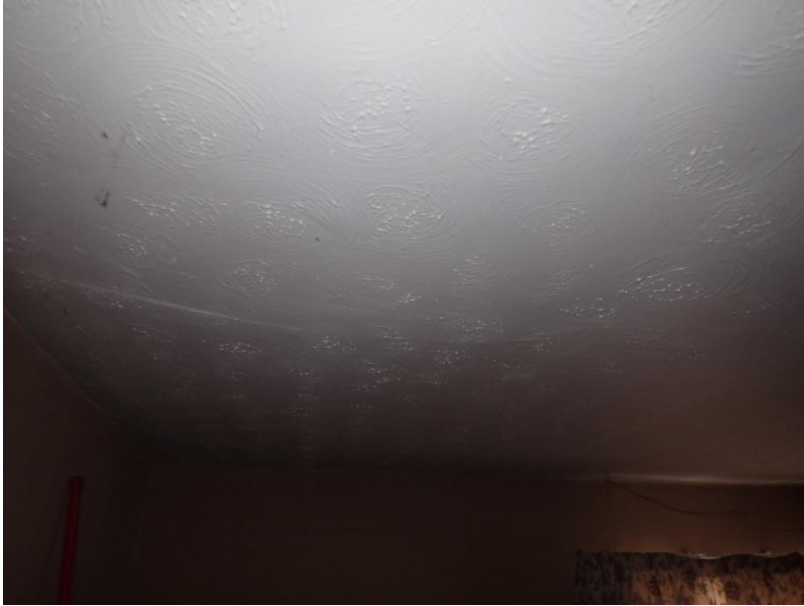
**Plates 243-245** feature the nature of the ceiling structure of **Cell 13**, which has been rendered over with modern plasterwork.

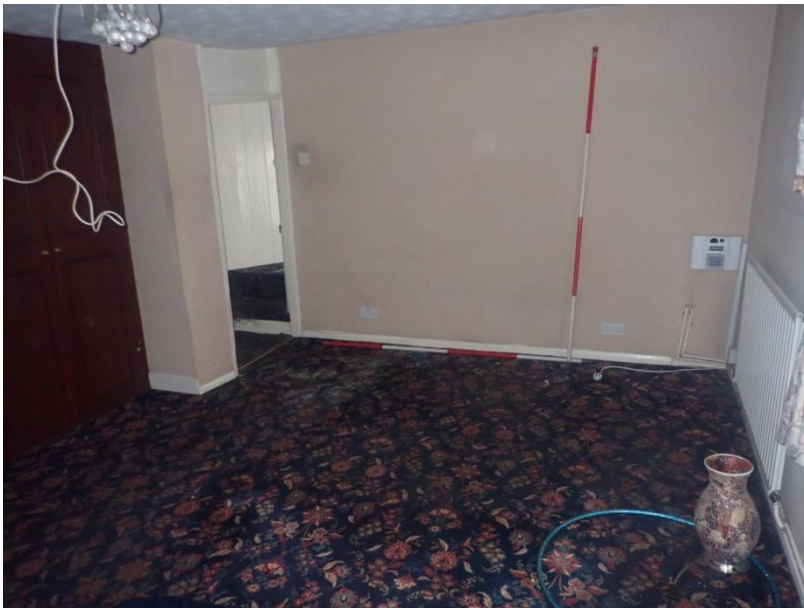
**Plate 246: View of the west wall of Cell 13, from the north-east**

**Plate 246** presents a view of the west wall of **Cell 13**, which has been rendered over with plasterwork. Horizontal timber skirting boards occurs at its base. This is also the internal dividing wall with the adjoining **Cell 12** to the west.

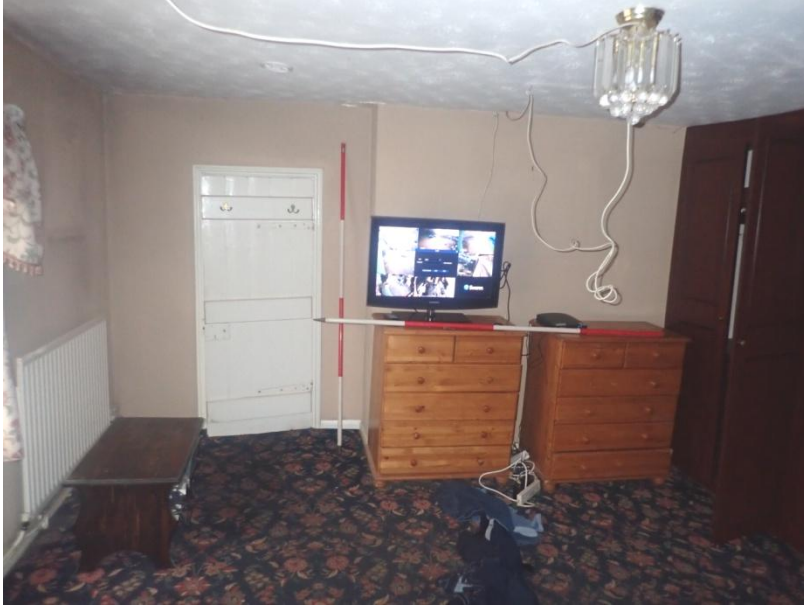
**Plate 247: View of the east wall of Cell 13. from the north-west**

**Plate 247** presents a view of the east wall of **Cell 13**, which is also the internal dividing wall with the adjoining **Cell 2** to the east. This east wall has also been rendered over with plasterwork. Horizontal timber skirting boards occurs at its base. Also shown is part of a chimney breast and to the left (north), is the inner face of an east facing entrance opening that extends onto **Cell 2** to the east. This opening is occupied by a timber frame of a head and surrounds and by a timber door that is composed of a series of vertical tongued and grooved timber planks that are attached to an internal framework of horizontal timbers.

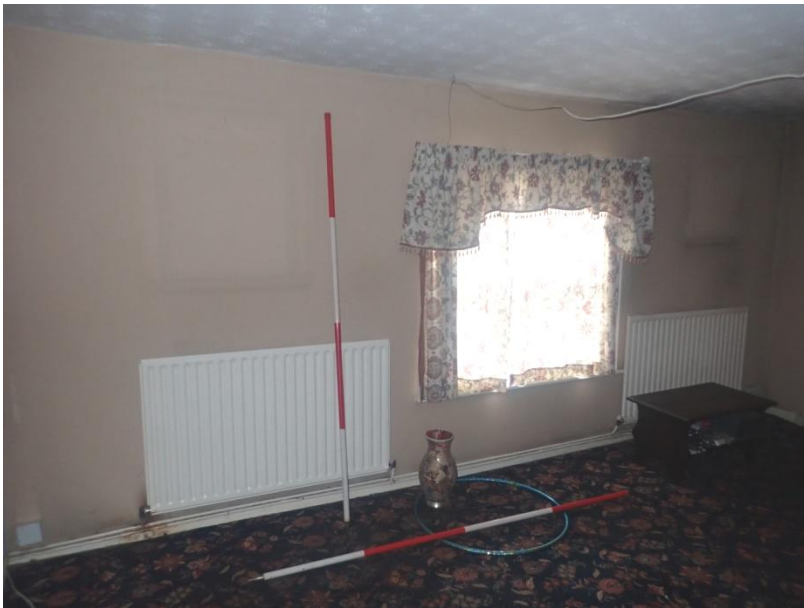
**Plate 248: View of the north wall of Cell 13, from the south-west**

**Plate 248** features the north wall of **Cell 13**, which has been rendered over with plasterwork. Horizontal timber skirting boards occurs at its base. Also shown is the inner face of the first floor north facing window opening that was recorded externally at the North Elevation of this building.

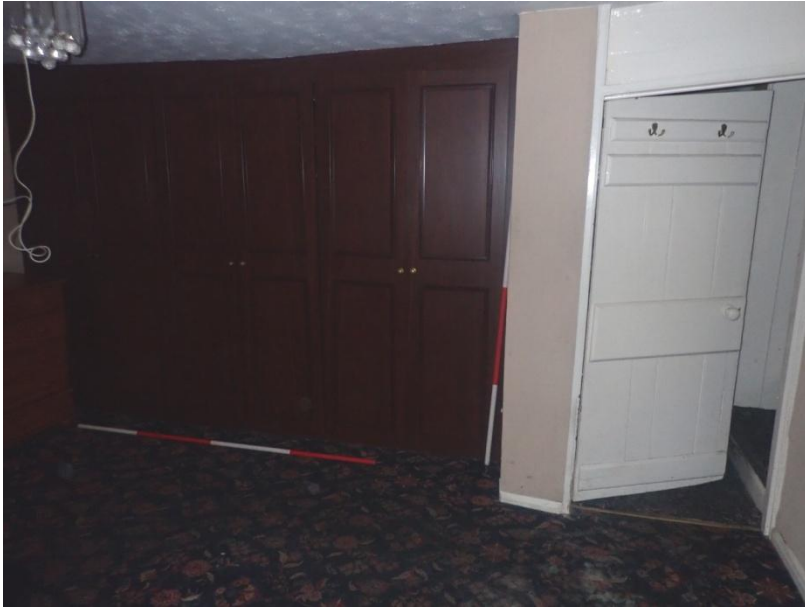
**Plate 249: View of the south-wall of Cell 13, from the north-west**

**Plates 249-252** feature the south wall of **Cell 13**, much of which is occupied by modern fitted cupboards. To the right (west), is the inner face of a south facing entrance opening that leads onto the first floor landing. This opening is occupied by a timber frame of a head and surrounds and by a timber door that is composed of a series of vertical tongued and grooved timber planks that are attached to an internal framework of horizontal timbers. **Plates 250-252** feature the interiors of the fitted cupboards, which show modern plasterwork rendering. Horizontal timber skirting boards occurs at its base.

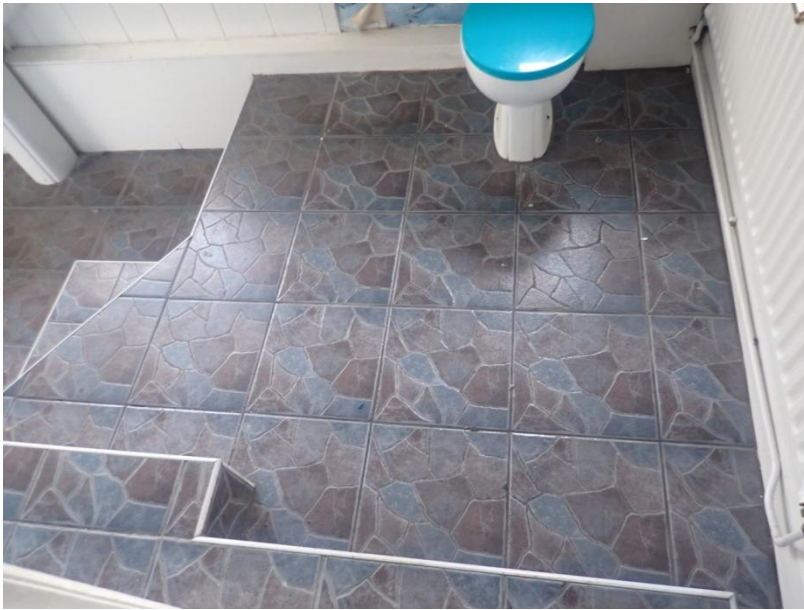
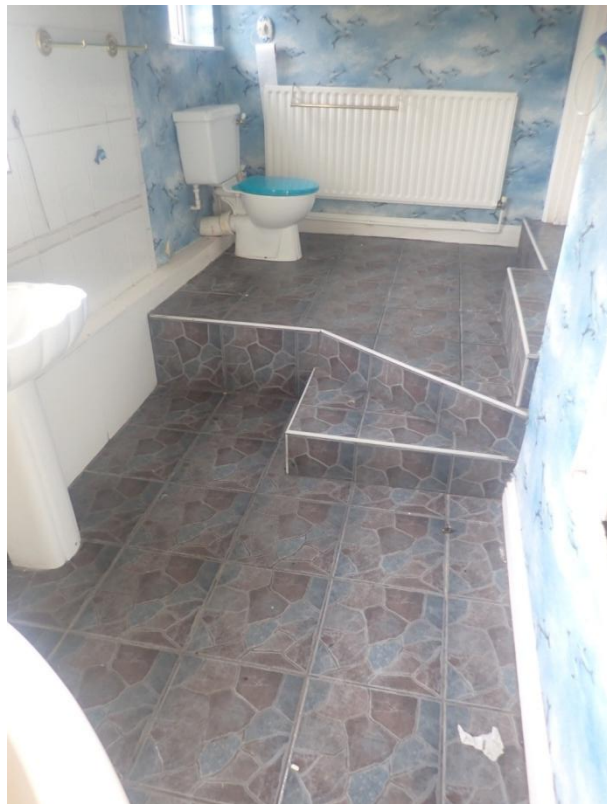
**Plates 253-254 and 256** present several views of the nature of the flooring of **Cell 14**, which is of modern ceramic floor tiling on two levels.

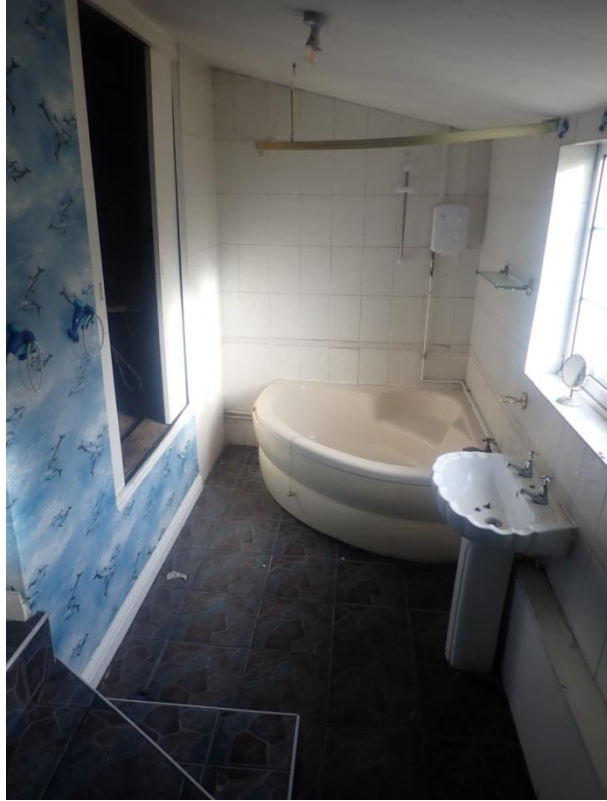
**Plate 255: General view of the interior of Cell 14, from the west**

**Plate 255** presents a general view of the interior of **Cell 14** from a south-western perspective.
