### **7.5 The Exterior of Building 3**

#### **7.7 The Exterior of Building 4**

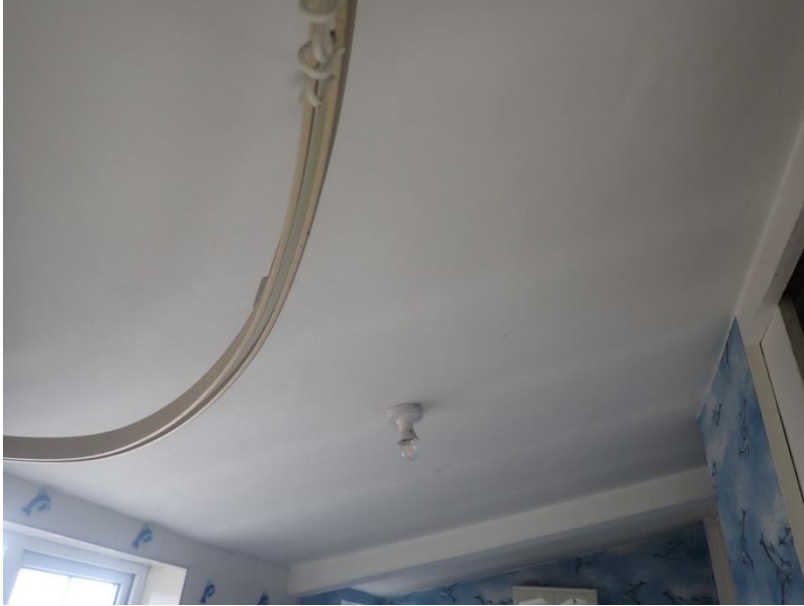
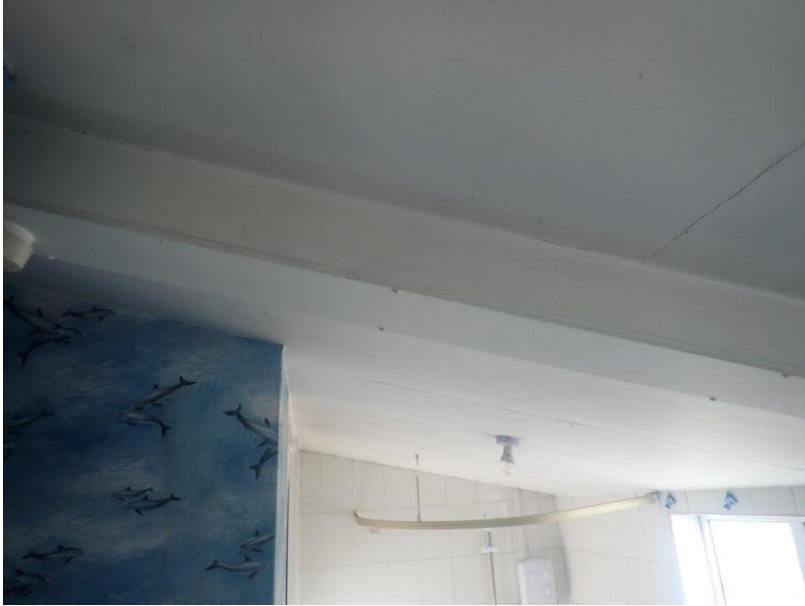
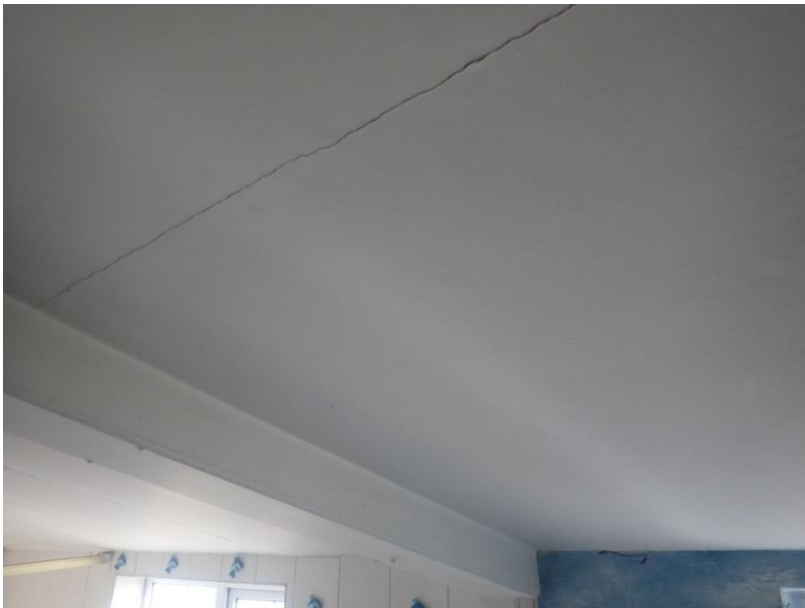
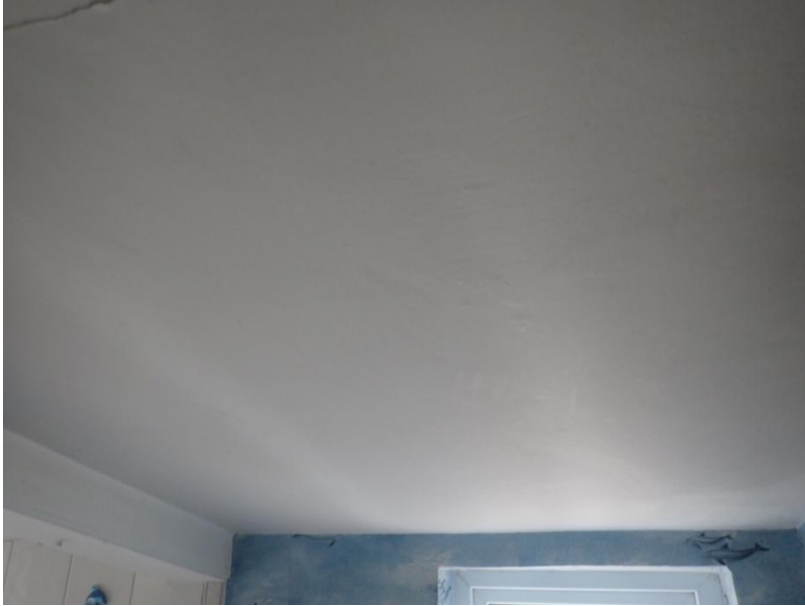
**Plates 257-261** furnish a number of views of the nature of the ceiling structure of **Cell 14**, which has been rendered over with modern plasterwork. Its low angle reflects the low angled half gabled roof structure of the above rear outshut. Of particular note is the angled and north-south orientated principal rafter, which has been boxed in.

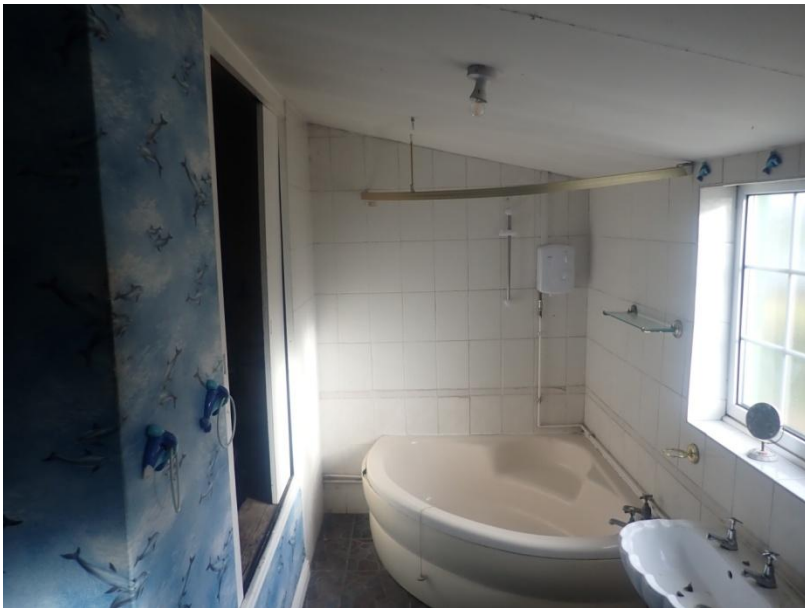
**Plate 262: View of the east wall of Cell 14, from the south-west**

**Plate 262** presents a view of the east wall of **Cell 14**, which is covered over with modern ceramic wall tiles.

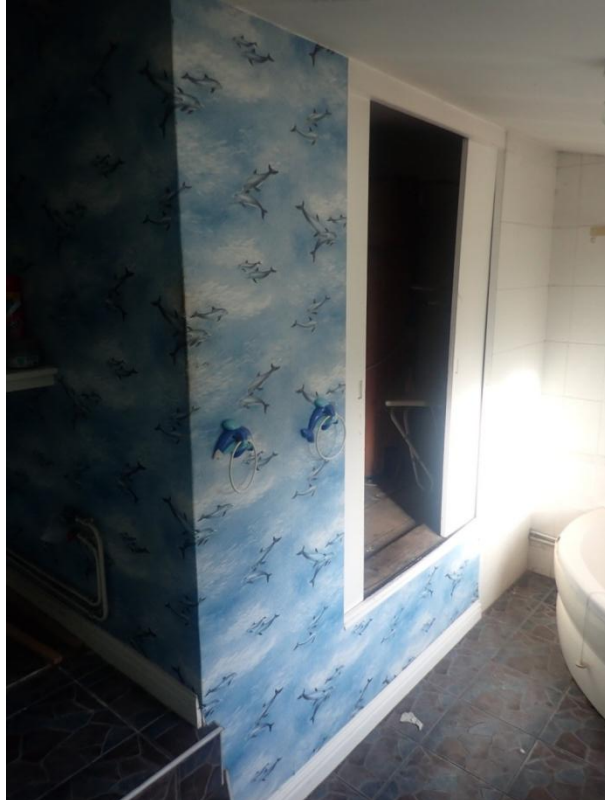
**Plate 263: View of the north wall of Cell 14, from the south-west**

**Plate 263** features the eastern portion of the north wall of **Cell 14**, which has been covered over with modern wallpaper. This north wall also houses a built in modern airing cupboard, from which the external panel here has been removed. Horizontal timber skirting boards occur at its base.

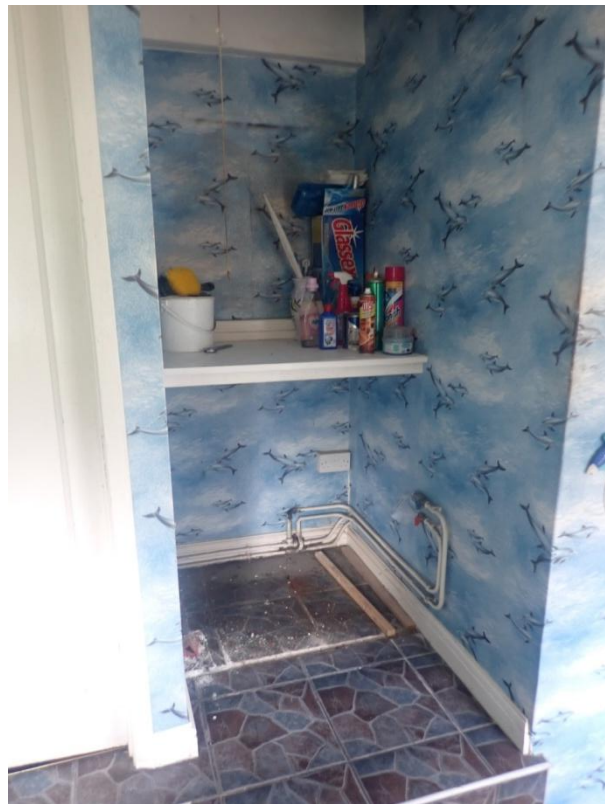
**Plate 264: View of the north wall of Cell 14, from the south-west**

**Plate 264** shows an alcove which houses a wash hand basin within the north wall of **Cell 14**, which has been covered over with modern wallpaper. Horizontal timber skirting boards occur at its base.

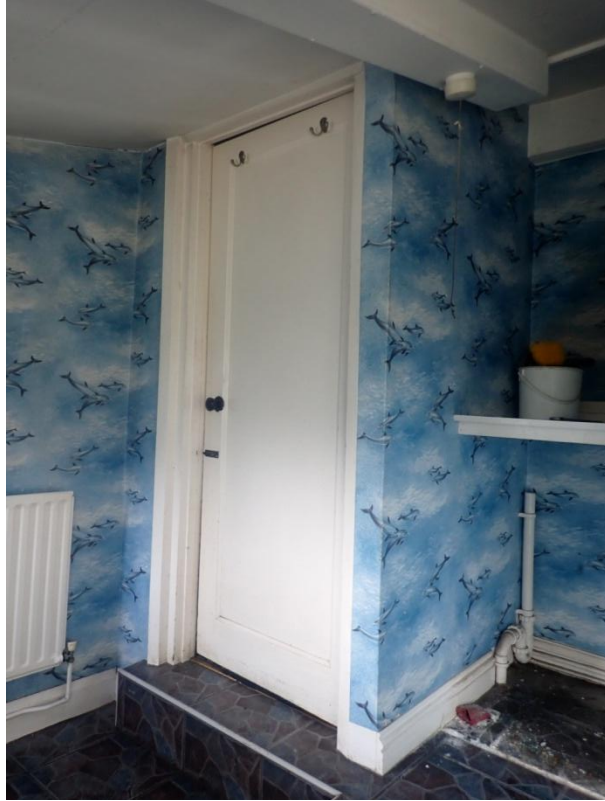
**Plate 265:** View of the north wall of Cell 14, from the south-east

**Plate 265** presents a view of the western portion of the north wall of **Cell 14** and shows the north facing entrance opening that leads onto the first floor landing of **Building 2**. This opening is occupied by a timber frame of a head, surrounds and architrave and by a modern panelled timber door.

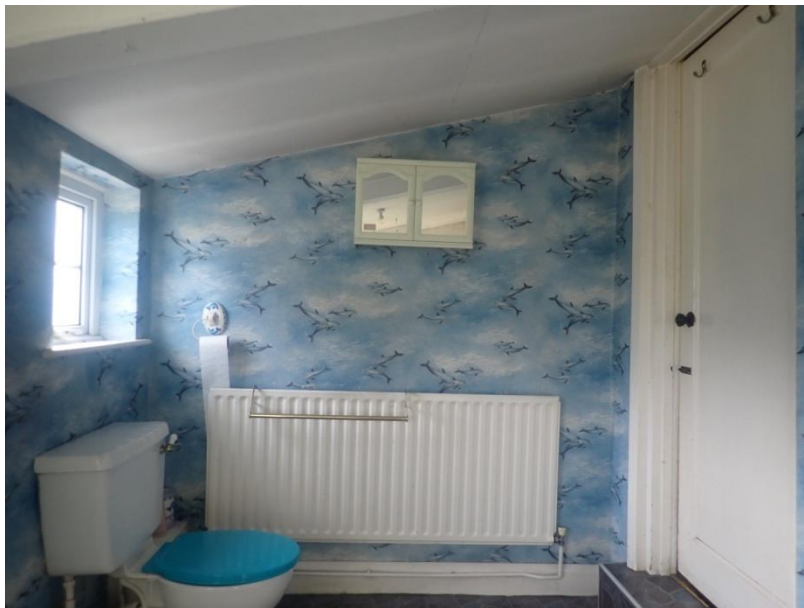
**Plate 266:** View of the west wall of Cell 14, from the north-east

**Plate 266** features the west wall of **Cell 14**, which has been covered over with modern wallpaper. Horizontal timber skirting boards occur at its base.

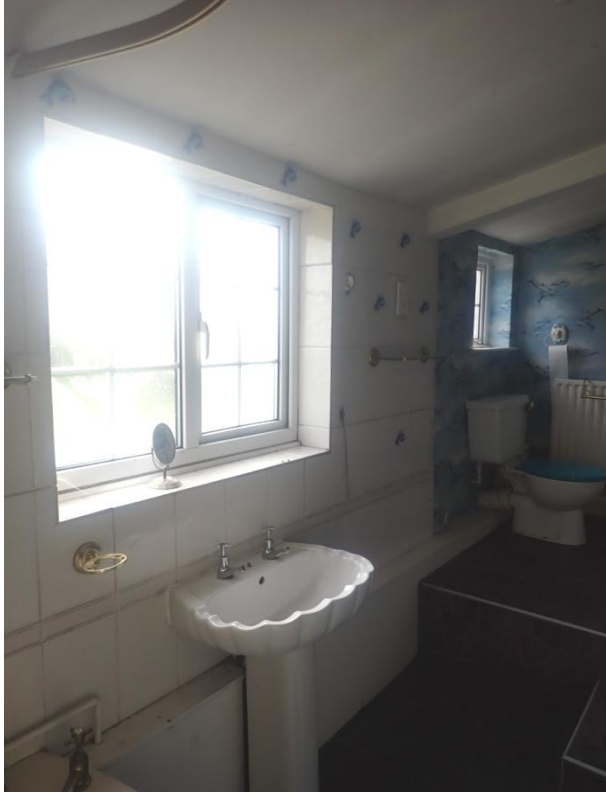
Plate 267: View of the north wall of Cell 14, from the north-east

**Plates 267 and 268** show the south wall of **Cell 14**, which has been covered over with modern ceramic wall tiling. Also featured are the slightly recessed inner faces of two south facing first floor window openings that were recorded externally at the South Elevation of this building.

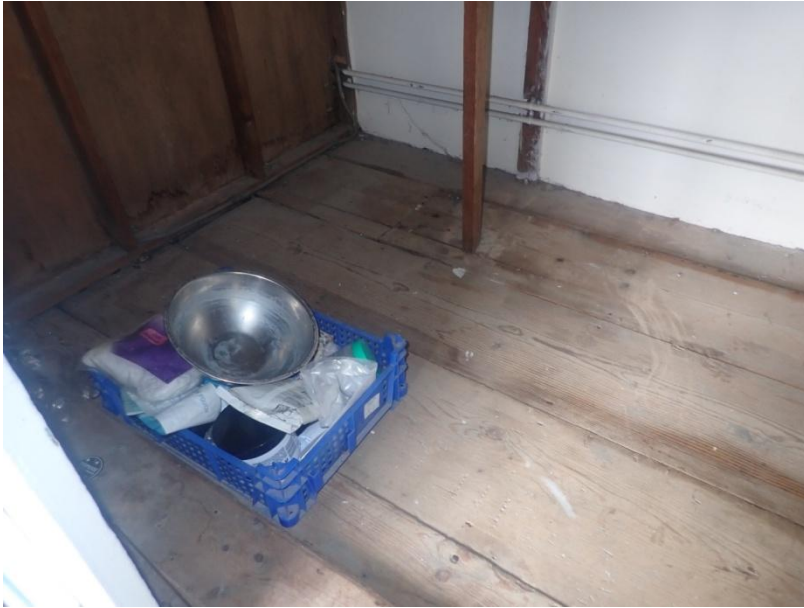
**Plate 269:** View of the airing cupboard within the north wall of Cell 14, from the south-east

**Plates 269-278** feature the interior of the airing cupboard, which has been built into the north wall of **Cell 14**. The base is of horizontal timber planking. The west side is of timber boarding, which is attached to an internal framework and vertical and horizontal timbers, whilst the northern and eastern sides are original portions of the west and north walls of this first floor bathroom, which

have been rendered over with modern plasterwork. The ceiling inside here has also been rendered over with modern plasterwork.

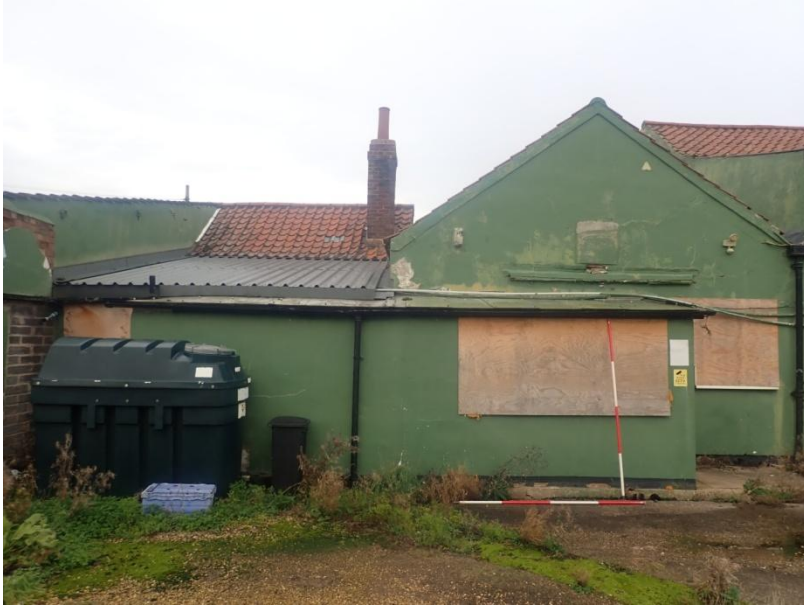
**Plate 279: View of the South Elevation of Building 3, from the south-east**

**Plates 279 and 281** present detailed views of the South Elevation of **Building 3**. The entire wall fabric of this Elevation has been covered over with a modern cement rendering. At ground floor levels is a boarded up south facing window opening. At mid levels are the remains of a former external canopy. It may also be observed that this building is bonded to **Building 4** to the south-west and south.

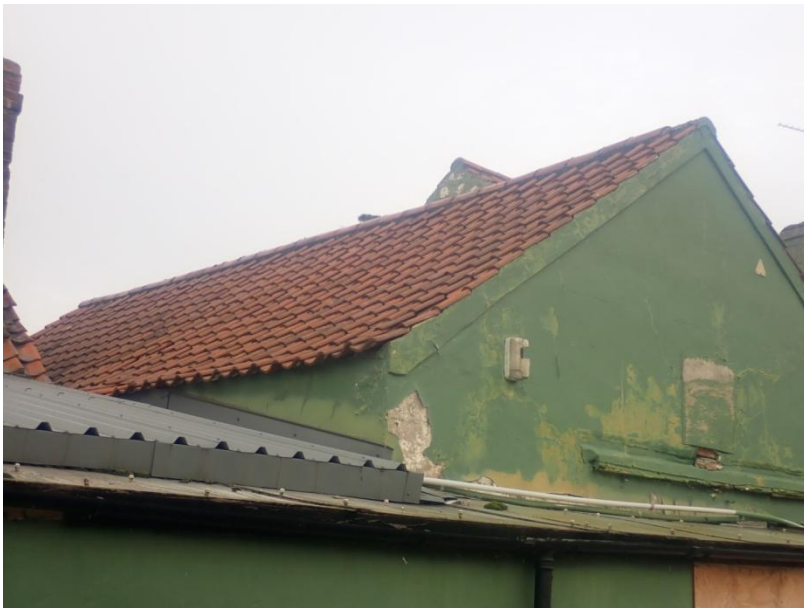
**Plate 280: View of Building 3, from the south-west**

**Plates 280** presents a view of a small visible portion of the West Elevation of **Building 3**, which has been covered with the same modern cement rendering and also shows the gabled roof of this building with its roof covering of red pantiles.

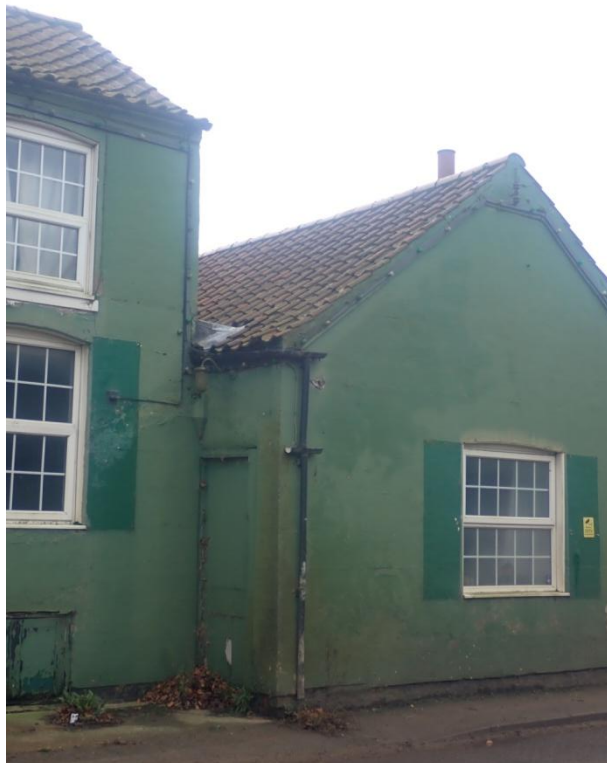
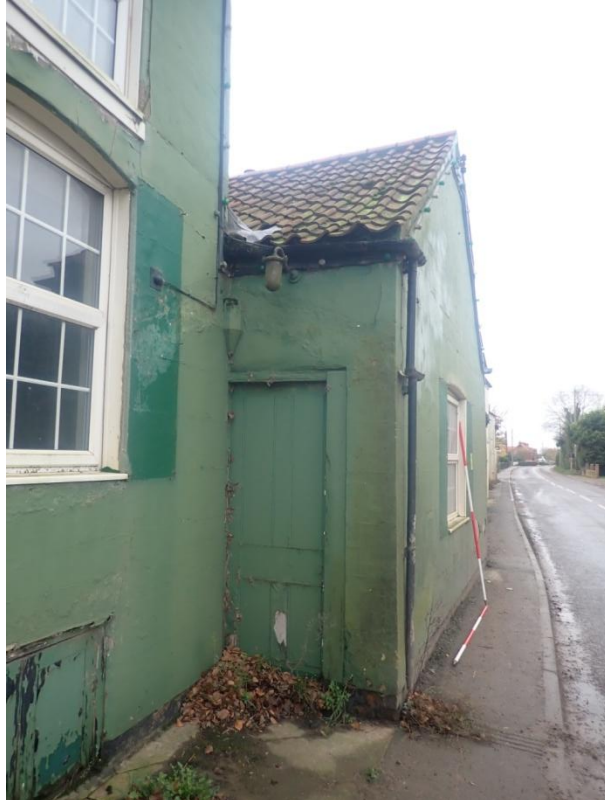
**Plates 282 and 283** show the northern end of **Building 3** and in particular the small visible portion of the East Elevation of this building, which has been covered with the same modern cement rendering. Also of particular note is the partially blocked off east facing entrance opening, which is occupied by a timber frame of a head and surrounds and by a panelled timber door. At just below roof levels is modern horizontal Upvc guttering, which extends on to modern vertical Upvc downpipe.

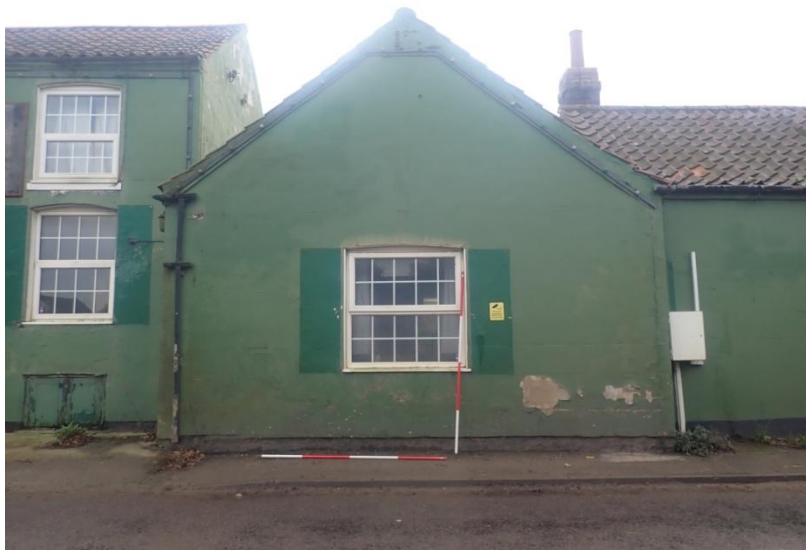
**Plate 284: View of the North Elevation of Building 3, from the north-west**

**Plates 284-286** present several views of the North Elevation of **Building 3**. Here also, the entire wall fabric of this Elevation has been covered over with the same modern cement rendering. Also featured is a north facing ground floor window opening, which is probably an original feature and which is occupied by a modern glazed Upvc window.

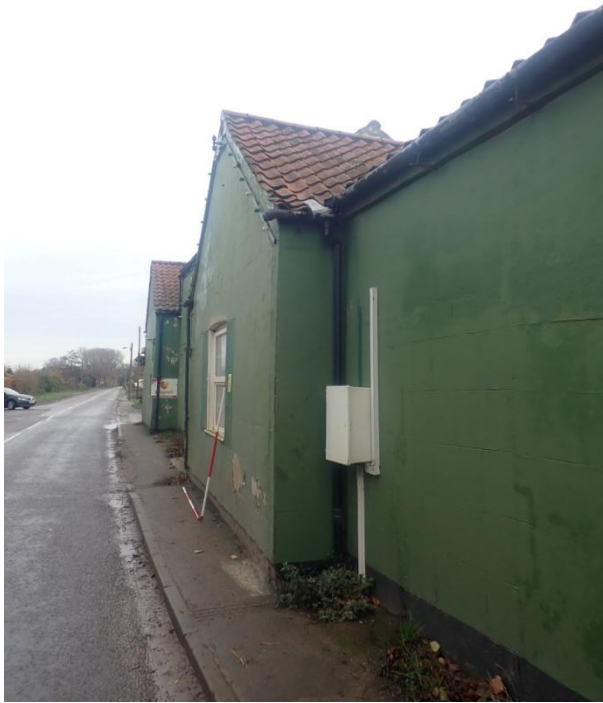
**Plate 287: View of the North Elevation of Building 3, from the west**

**Plate 287** presents a view of a small portion of the West Elevation of this building. Here also, the entire wall fabric of this Elevation has been covered over with the same modern cement rendering. Also shown is a small section of modern horizontal Upvc guttering that leads onto a further modern vertical Upvc downpipe.

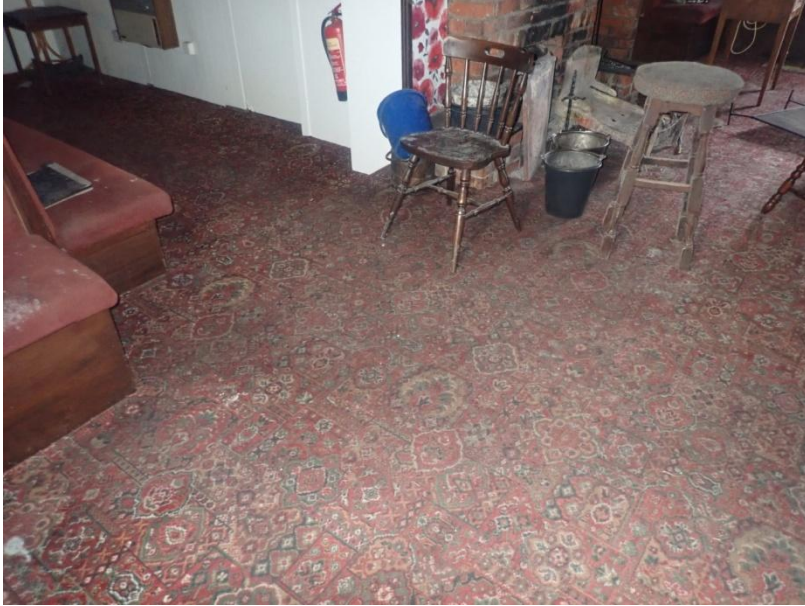
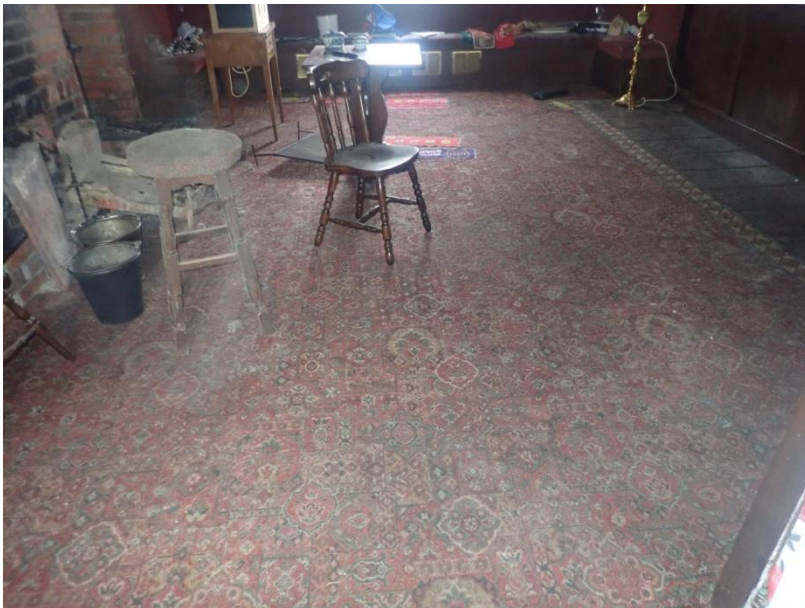
**Plates 290 and 291** furnish several images of the flooring of **Cell 15**, which has been covered with modern carpeting. A series of modern ceramic floor tiles occur at the public bar area.

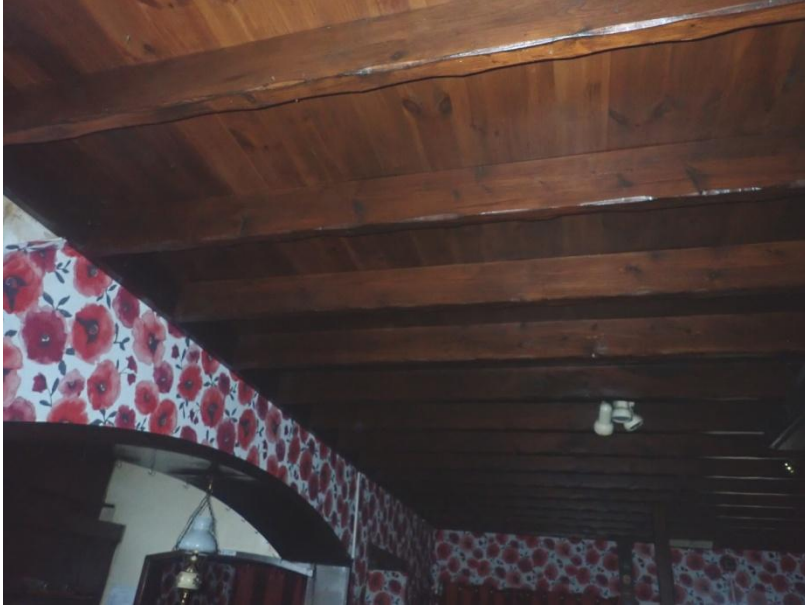
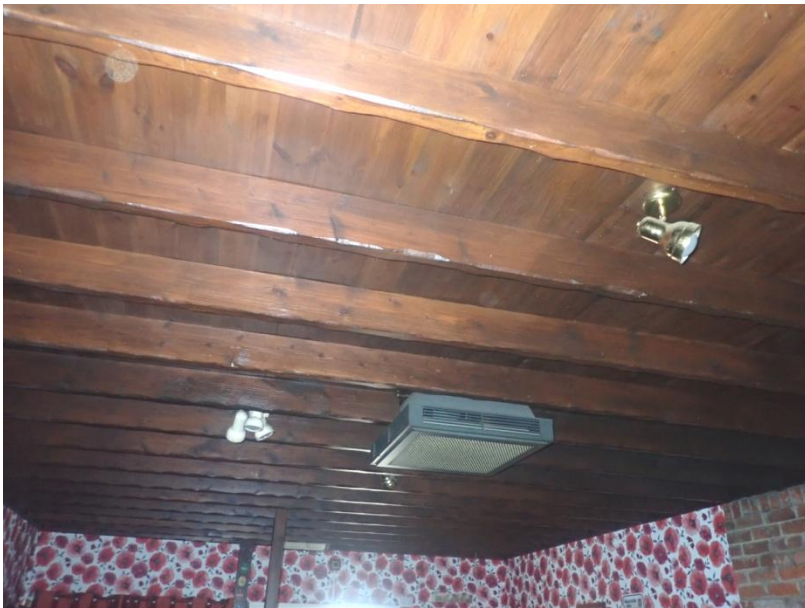
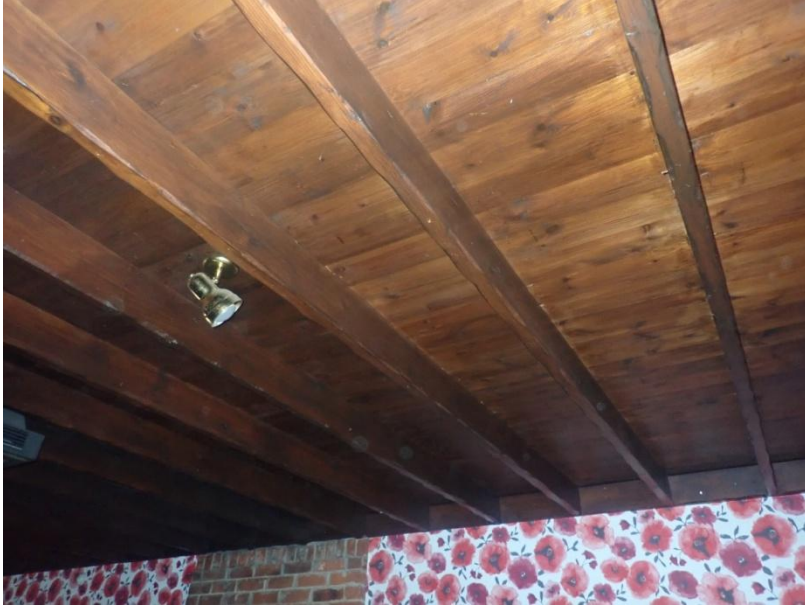
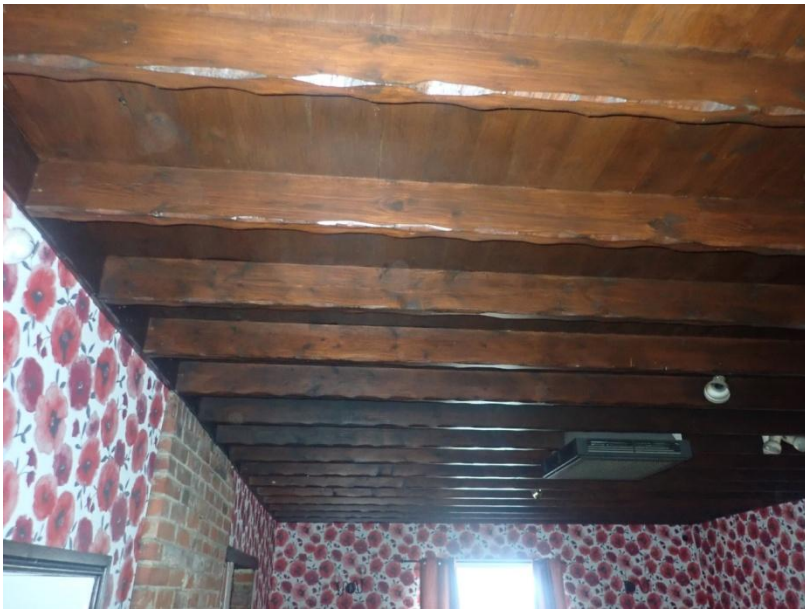
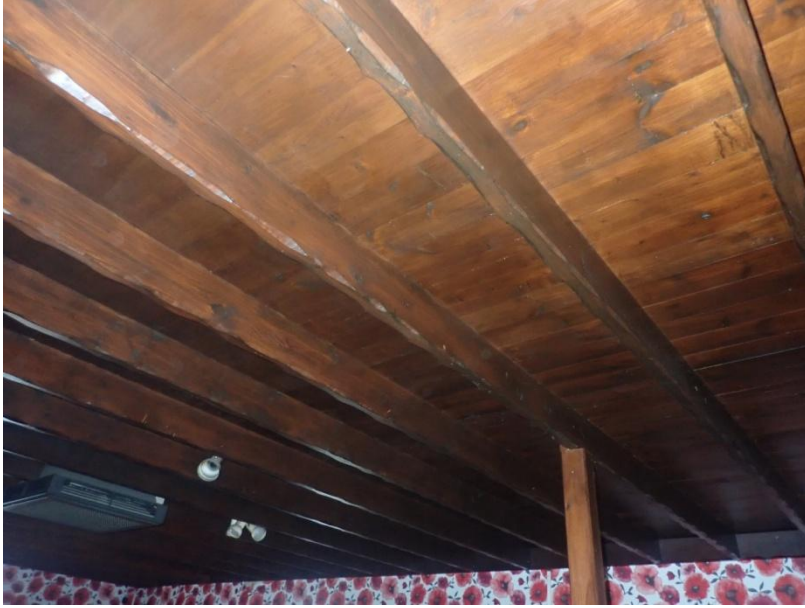
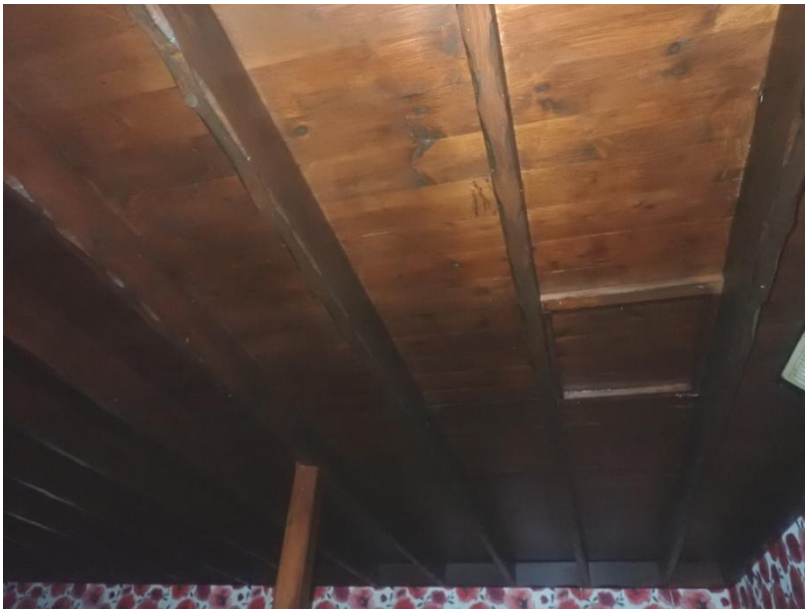
**Plates 298-303** provide a number of views from differing vantage points of the nature of the ceiling structure of **Cell 15**. This consists of a series of east-west orientated and moulded horizontal timber joists. These provide support to the first floor, floor covering of horizontal timber planking, which are on a different north-south alignment.

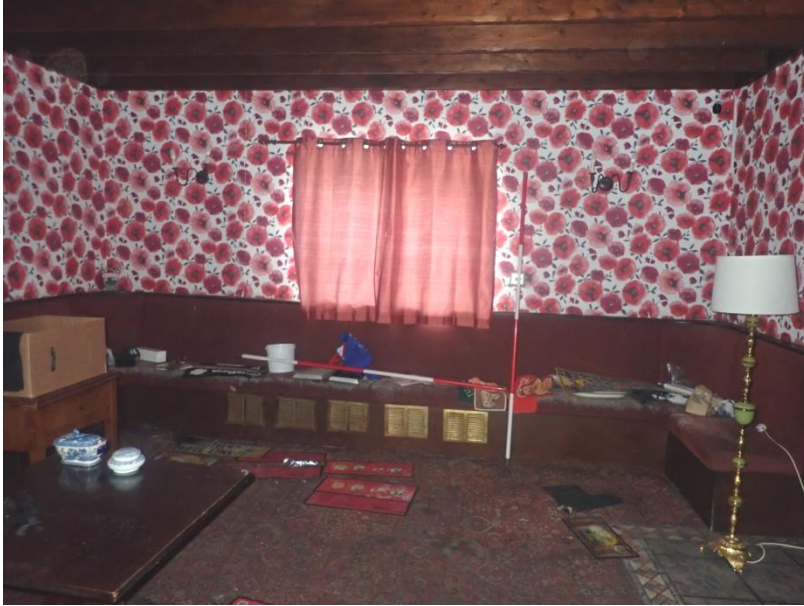
**Plate 304: View of the north wall of Cell 15, from the south-east**

**Plate 304** presents a view of the north wall of **Cell 15**. This has been covered with modern wallpaper. The lower levels have modern timber panelling attached to the wall fabric along with modern soft furnishings/seating. Also featured is the inner face of the ground floor north facing window opening that was recorded externally at the North Elevation of this building.

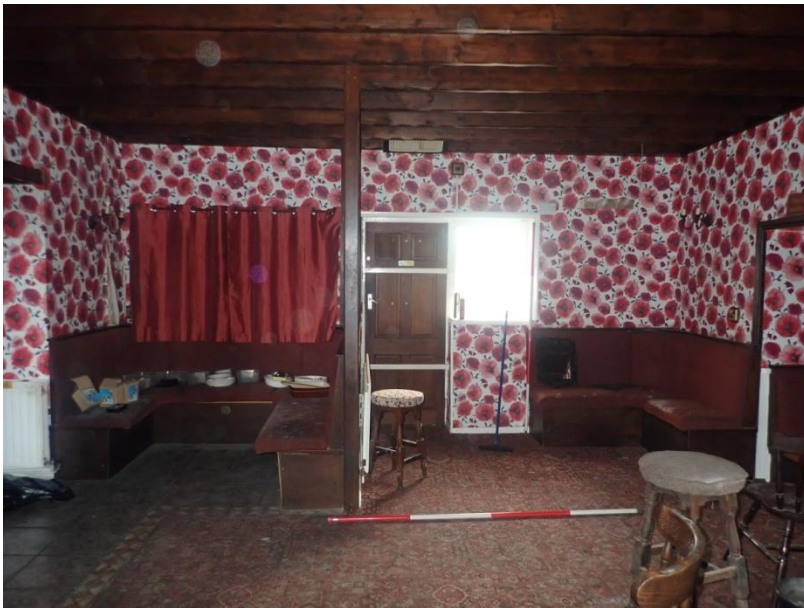
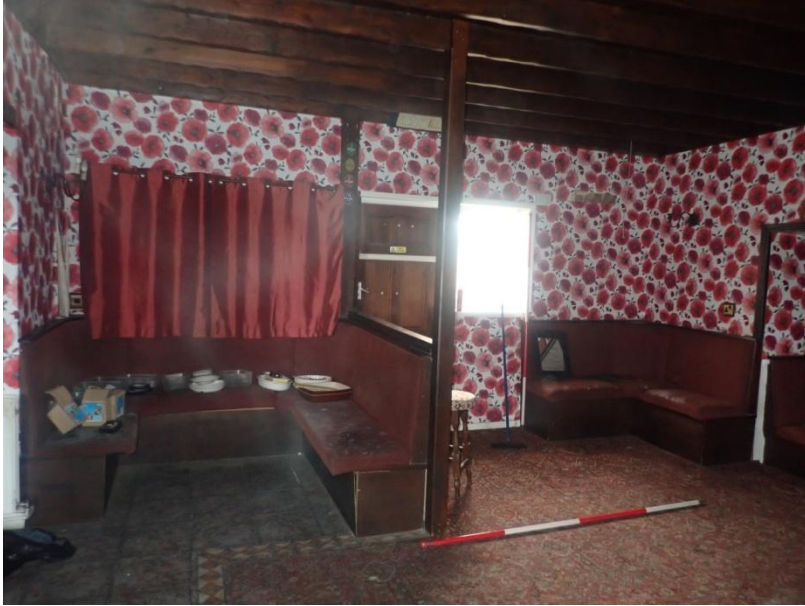
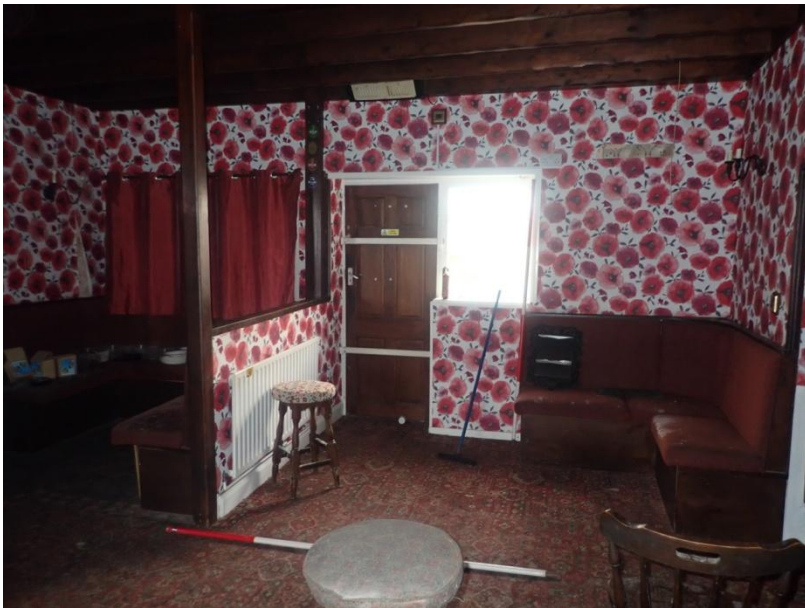
**Plates 305-307** present several views of the south wall of **Cell 15**. This has been covered with modern wallpaper. The lower levels have modern timber panelling attached to the wall fabric along with modern soft furnishings/seating. Horizontal timber skirting boards occur at its base. Also featured is the inner face of a south facing ground floor window opening that was recorded externally at the South Elevation of this building. A low partition bisects the seating here. At the northern end of the partition is a vertical timber which extends upwards to the ceiling. To the right (west), are the inner faces of a south facing entrance opening that is occupied by a timber frame of a head and surrounds and a modern panelled timber door along with the inner face of an adjacent south facing window opening with a timber window frame of a head and surrounds and a modern glazed timber casement window. Both openings were originally external, but are now within the interior of **Building 4**.

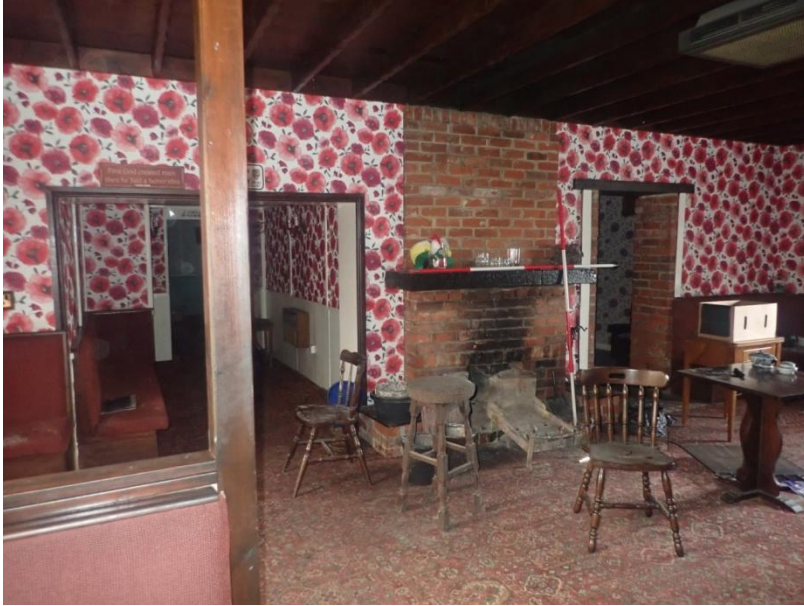
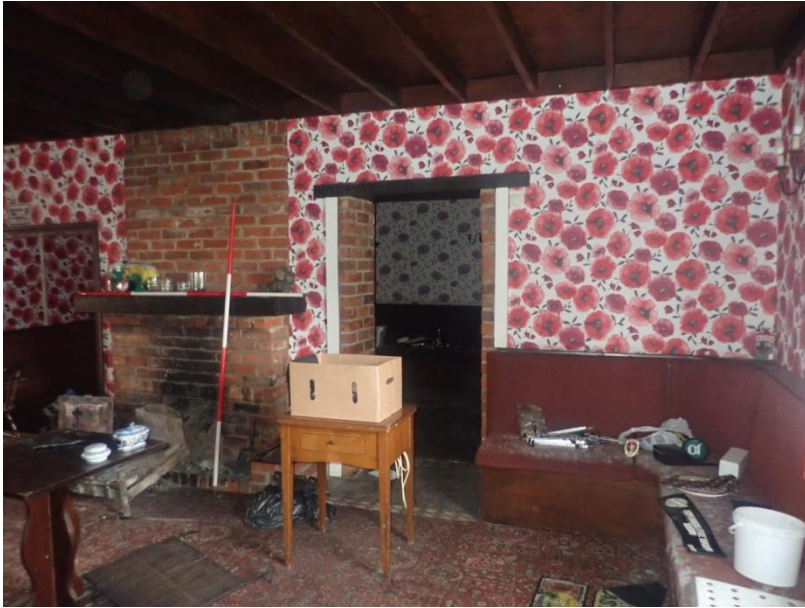
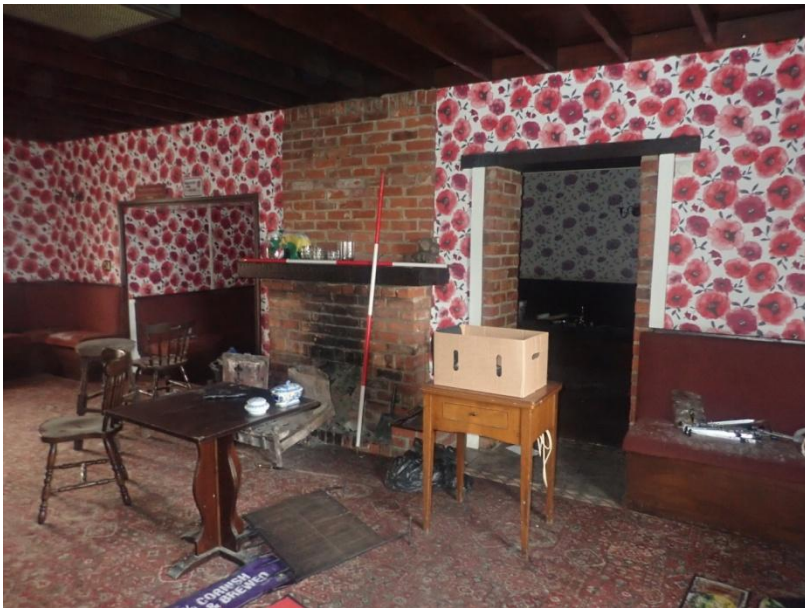
**Plates 308-311** present a number of views of the west wall of **Cell 15**, much of which is covered with wallpaper. This is also the internal dividing wall with the adjoining **Cells 16-18**. At the northern and southern ends are further modern soft furnishings/seating at the lower levels. The central feature of this west wall is the vertical brick fireplace backing. The brickwork here is composed of courses of brick stretchers in Stretcher Bond. At the base of the fireplace backing is a fireplace/surround with a brickwork base topped with timber to either side. To the right (north), is an open west facing access into the adjoining **Cell 18** of **Building 5**. This opening is flanked to either side with brickwork in Stretcher Bond and above the opening is an horizontal timber lintel which is inserted into the fabric of the west wall. To the left (south), is a second open access that extends onto the adjoining **Cell 16** of **Building 4**. This further west facing opening is occupied by a wide timber frame of a head, surrounds and architrave.

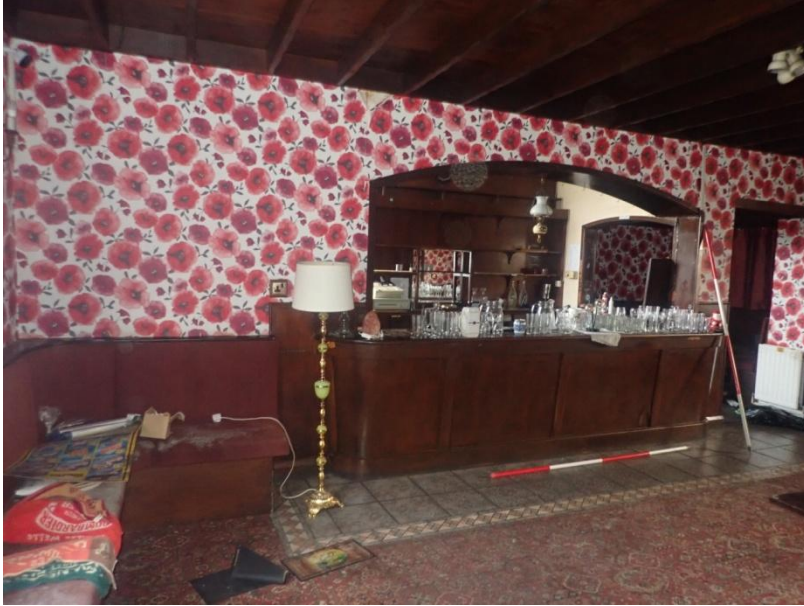
**Plate 312: View of the east wall of Cell 15, from the north-west**

**Plates 312-316** furnish a number of views of the east wall of **Cell 15**, which also houses the front face of the public bar with its vertical timber panelling and timber counter top. The bar opening itself is edged with vertical timbers to either side with a curved head also in timber. The remainder of this east wall, which is also the internal dividing wall with the adjoining **Cell 6** to the east, has been covered with modern wallpaper with modern soft furnishings/seating at the lower levels. To the right (south), is the east facing open access that leads onto the adjoining **Cell 5** to the east. Above this opening is an horizontal timber lintel which is inserted into the fabric of the east wall.

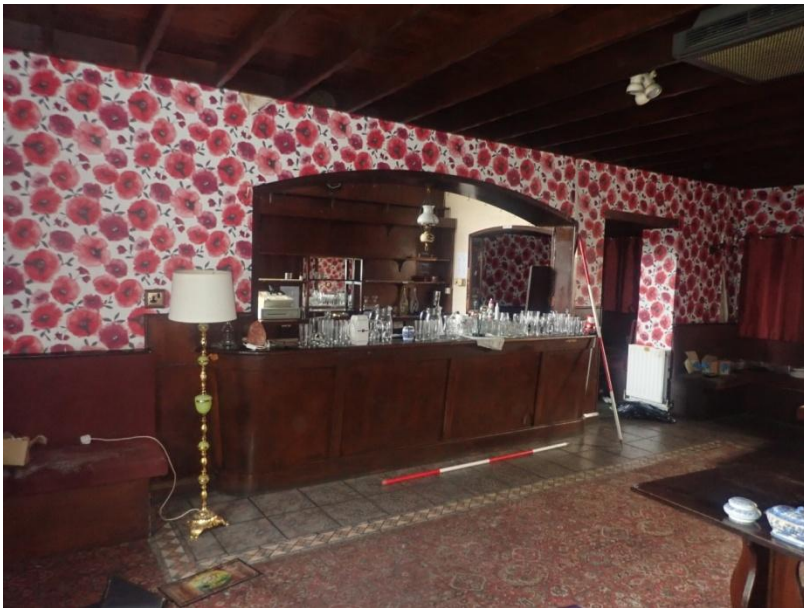
**Plate 313: View of the east wall of Cell 15, from the north-west**

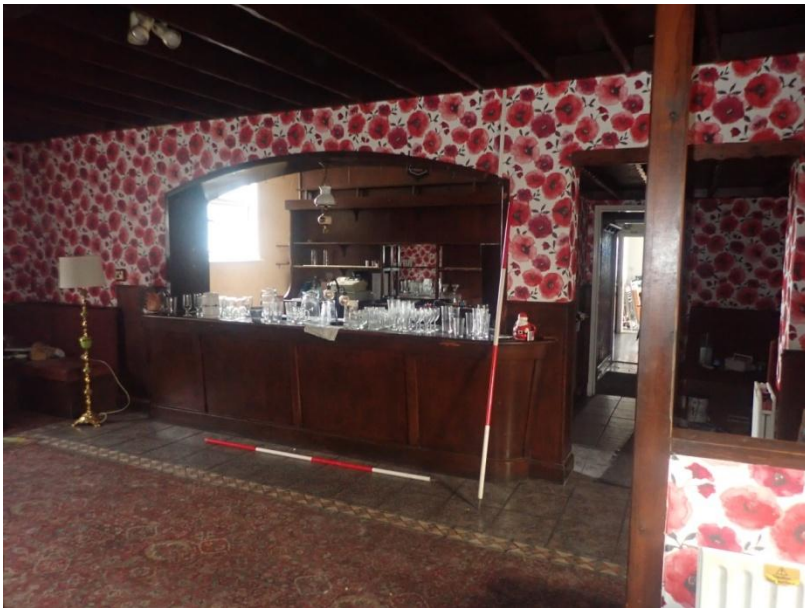
Plate 315: View of the east wall of Cell 15, from the south-west

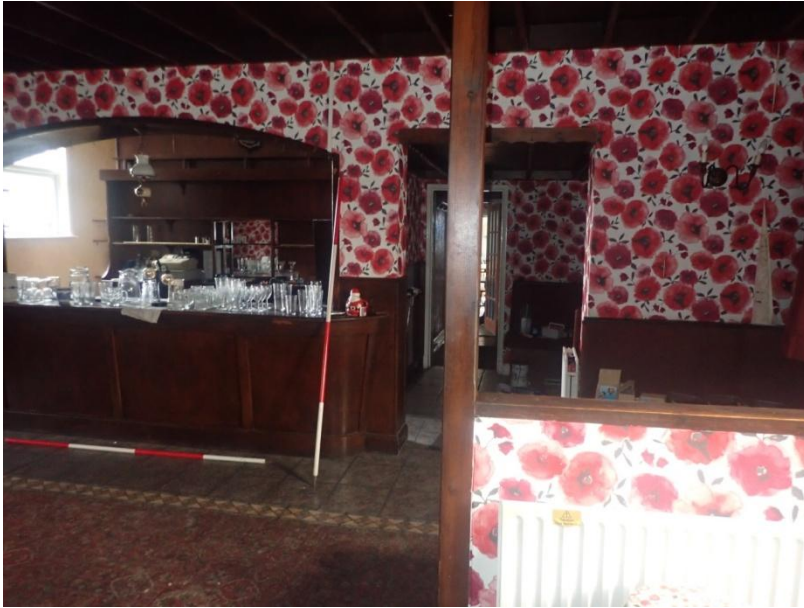
**Plate 316: View of the east wall of Cell 15, from the west**

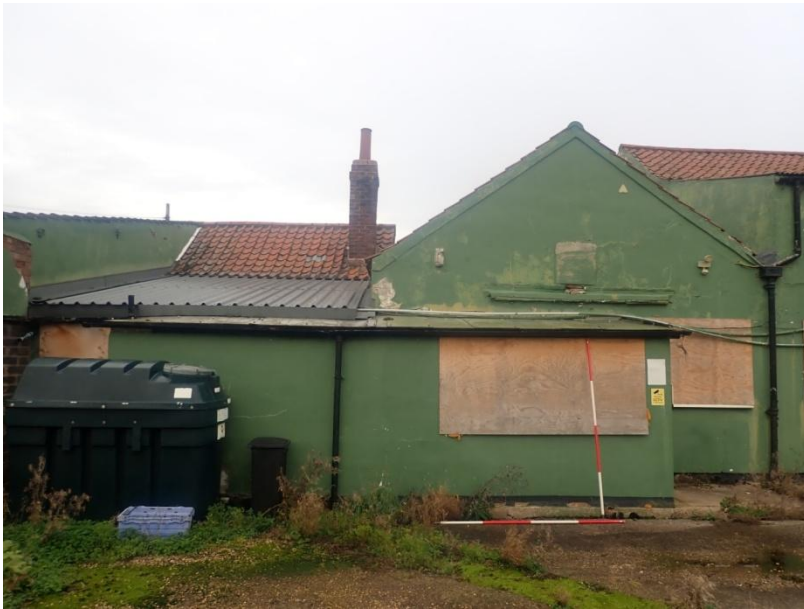
**Plate 317: View of the South Elevation of Building 4, from the south-east**

**Plates 317-320** present several views from various southern positions of the South Elevation and a small section of the East Elevation of this building. **Building 4** is bonded to **Building 3** to the east and north-east, to **Building 5** to the north and to **Building 6** to the west. **Building 4** would appear to be a modern addition to this public house complex. It is of one storey in height and possesses a low angled half gabled roof with a mix of roof coverings of corrugated metal sheeting and of corrugated plastic roof sheeting. The entire wall fabric of these Elevations has been covered over with modern cement rendering. At just below roof levels is modern horizontal Upvc guttering that extends onto a slightly off centre vertical modern Upvc downpipe. Also featured are two south facing window openings, both of which have been entirely boarded over. Within the small section of the East Elevation is a boarded up east facing entrance opening.

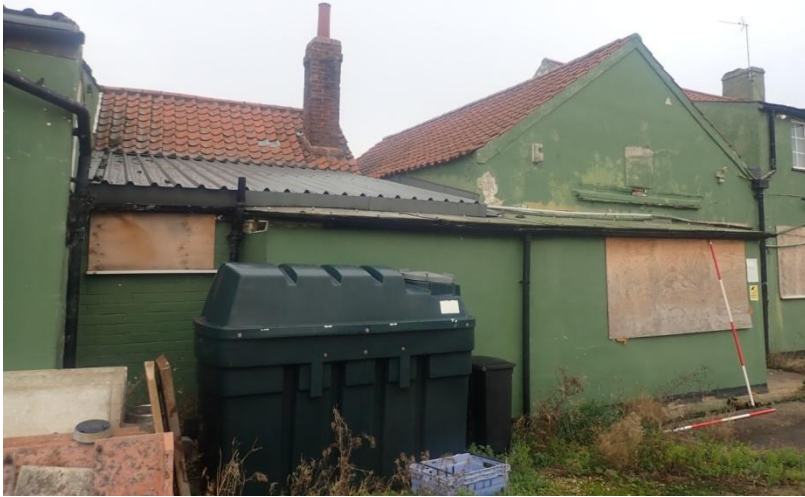
**Plate 318: View of the South Elevation of Building 4, from the south-west**

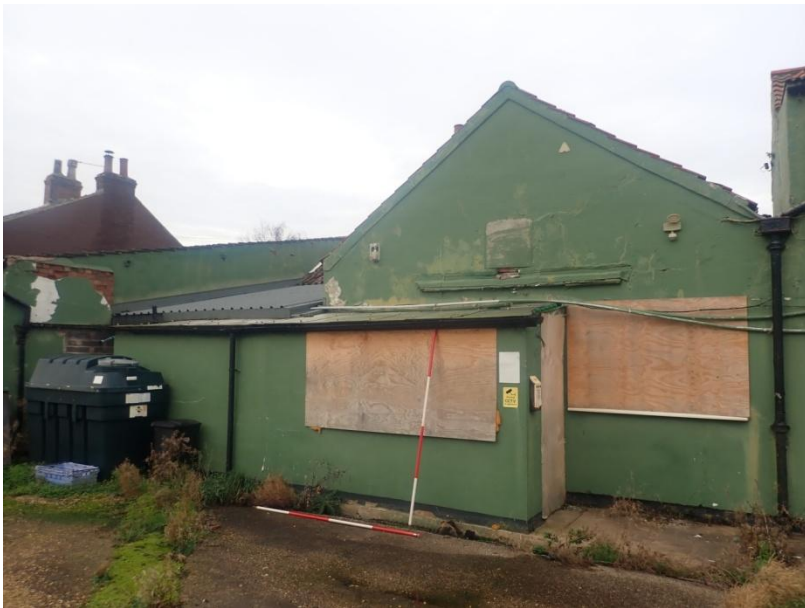
**Plate 319: View of the South Elevation of Building 4, from the south-east**

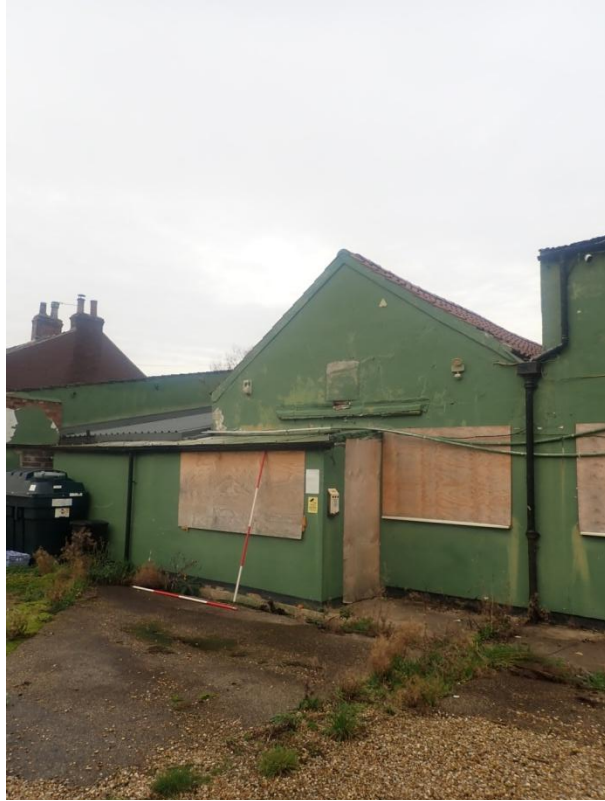
**Plate 320: View of the South Elevation of Building 4, from the south-east**

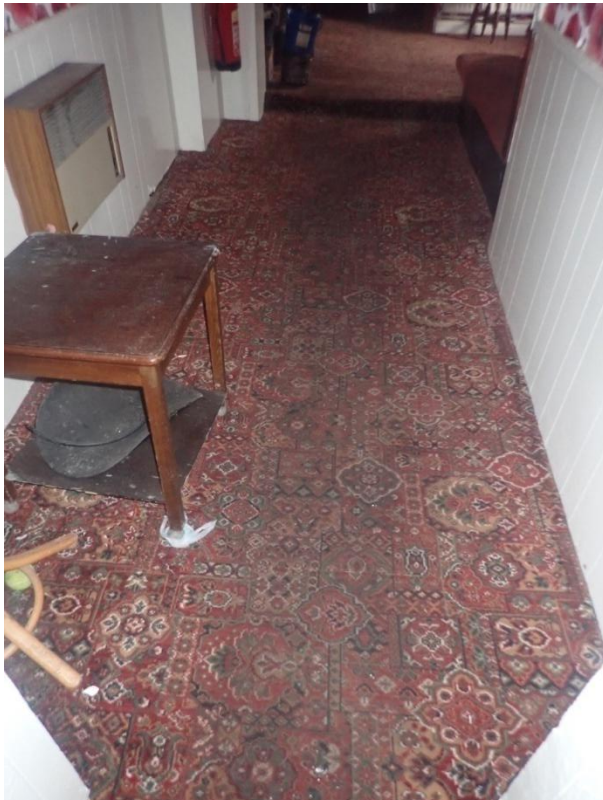
**Plate 323: View of the flooring of Cell 16, from the south-west**

**Plate 323** features the flooring of **Cell 16**, which is covered with modern carpeting.
