### **7.5 The Exterior of Building 3**

#### **7.7 The Exterior of Building 4**

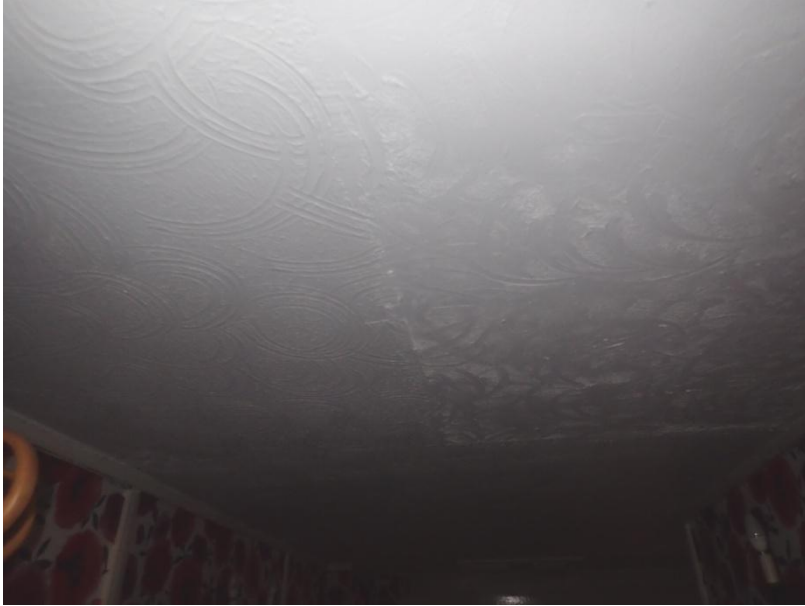
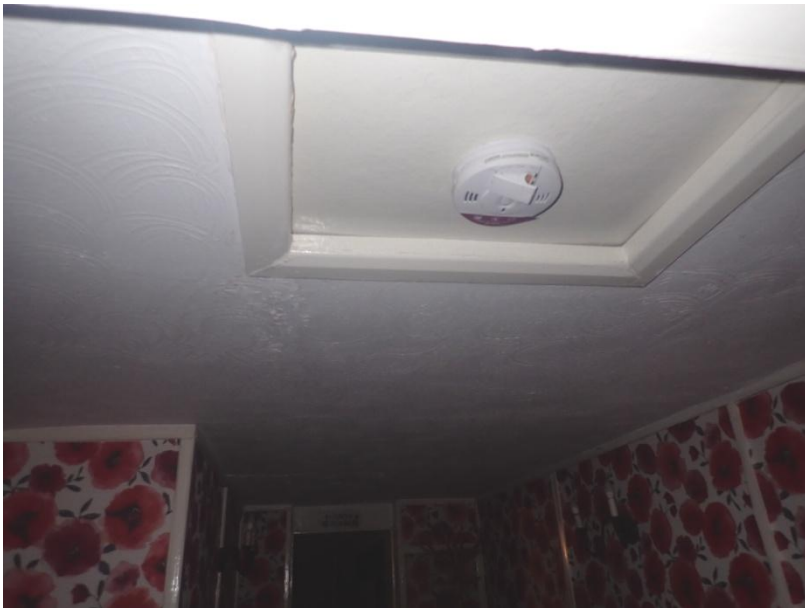
**Plate 324: View of the ceiling of Cell 16, from the south-west**

**Plate 325: View of the ceiling of Cell 16, from the north-east**

**Plates 324-325** provide views of the nature of the ceiling structure of **Cell 16**, which has been rendered over with plasterwork. **Plate 320** also features a small timber hatch, which provided access into the roof space of **Building 4**.

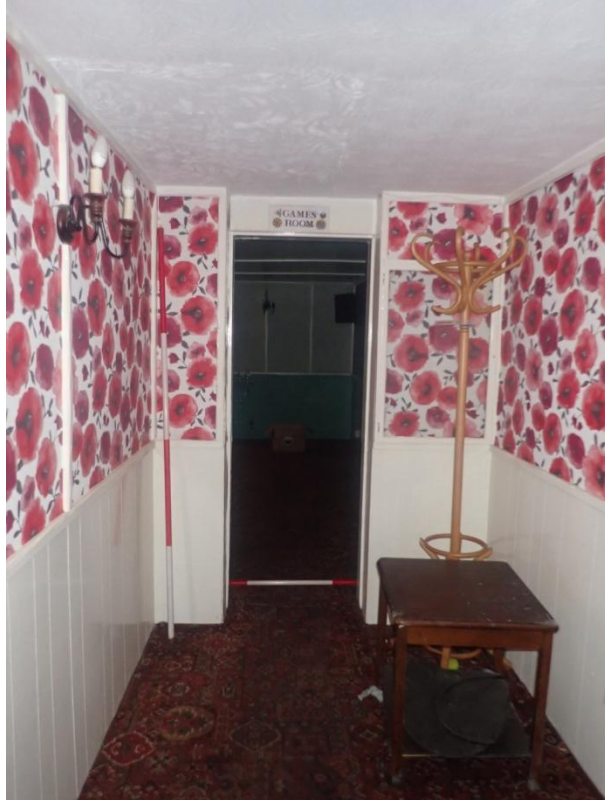
**Plate 326** furnishes a detailed view of the west wall of **Cell 16**. Most of the wall fabric has been covered over with modern wallpaper within a framework of vertical and horizontal timbers, whilst the lower levels of the wall have timber panelling. The central feature of this west wall is the west facing entrance opening, which extends onto a former games room or **Cell 24** and the interior of **Building 6**. This opening is occupied by a timber frame of a head and surrounds.

**Plate 326: View of the west wall of Cell 16, from the north-east**

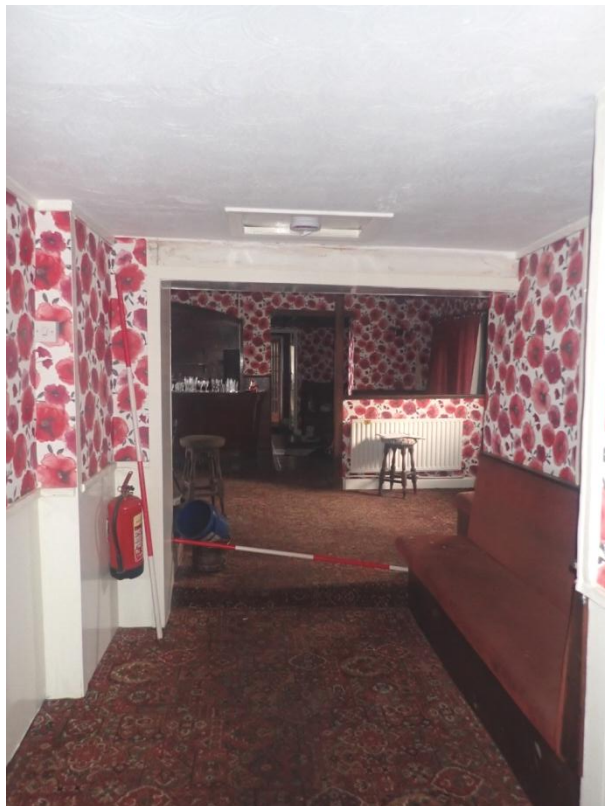
**Plate 327: View of the eastern end of Cell 16, from the south-west**

**Plate 327** features the eastern end of **Cell 16**, with its open access into the interior of **Cell 15** to the east or the former public lounge bar of the public house. This image shows the inner face of the access opening, which is contained within a wide timber frame of a head and one surround. To the left (north) is a small section of walling, which has been covered with modern wallpaper with timber panelling at its lower levels.

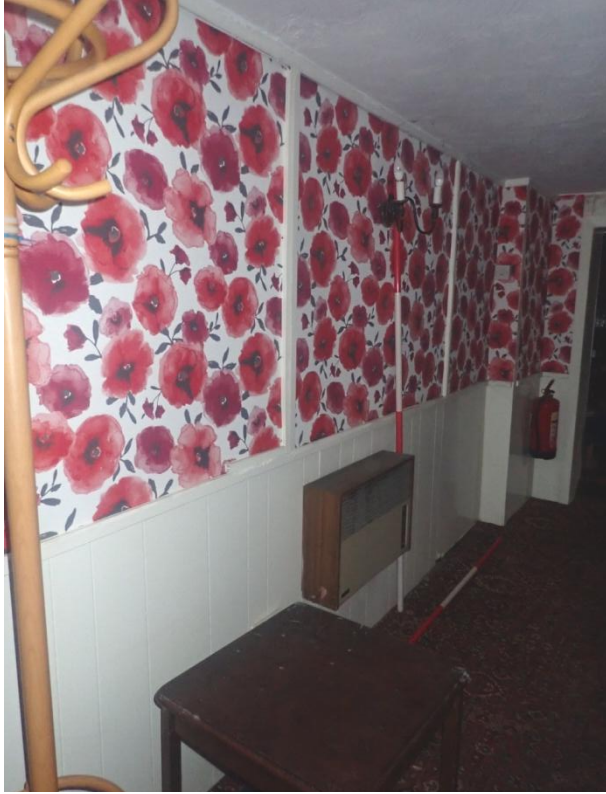
**Plate 328: View of the north wall of Cell 16, from the south-west**

**Plate 328** provides a view of the north wall of **Cell 16**, much of which has been covered with modern wallpaper within a framework of vertical and horizontal timbers, whilst the lower levels of the wall have timber panelling.

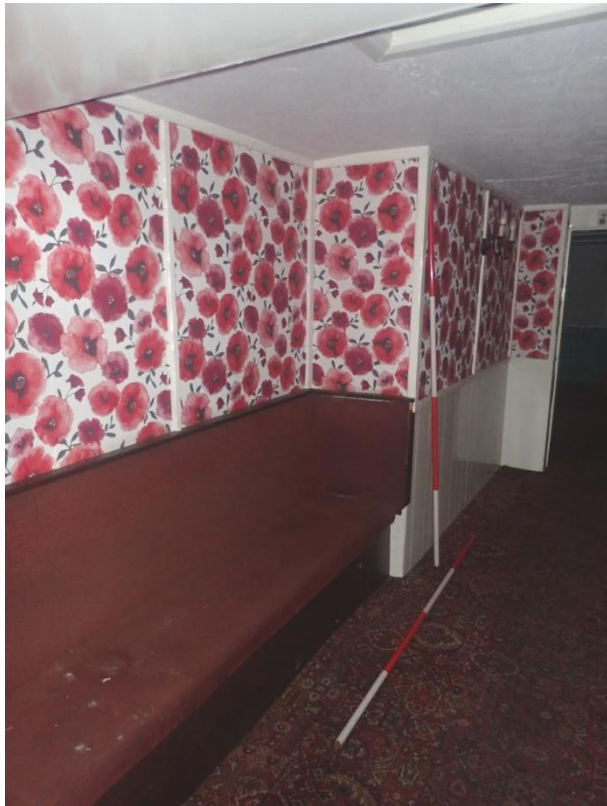
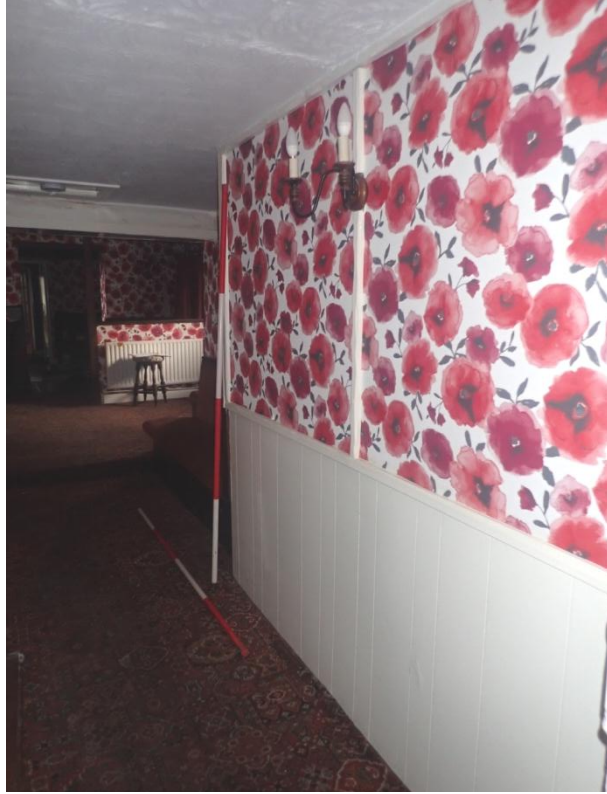
**Plate 329: View of the south wall of Cell 16, from the north-east**

**Plate 330: View of the south wall of Cell 16, from the north-west**

**Plates 329 and 330** show the south wall of **Cell 16**, which is dog-legged. Much of this north wall has been covered with modern wallpaper within a framework of vertical and horizontal timbers, whilst the lower levels of the wall have timber panelling. To the east is further modern soft furnishings/seating.

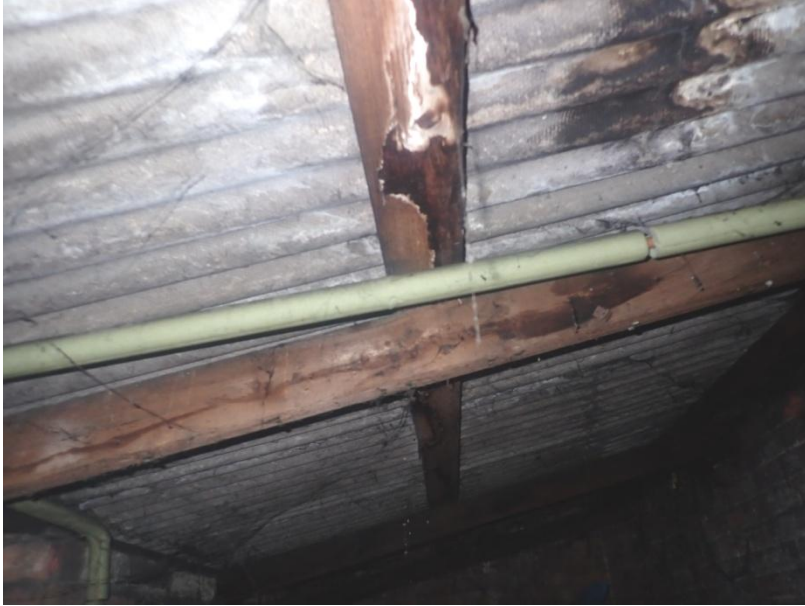
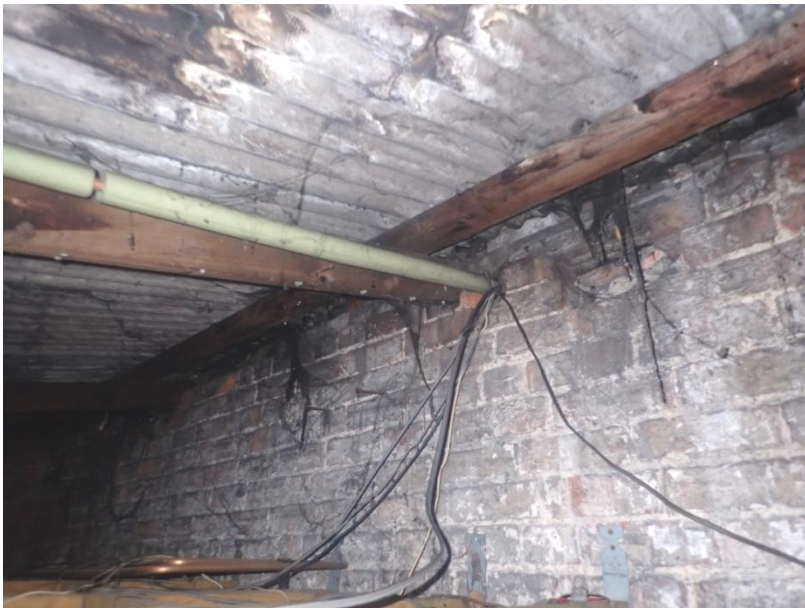
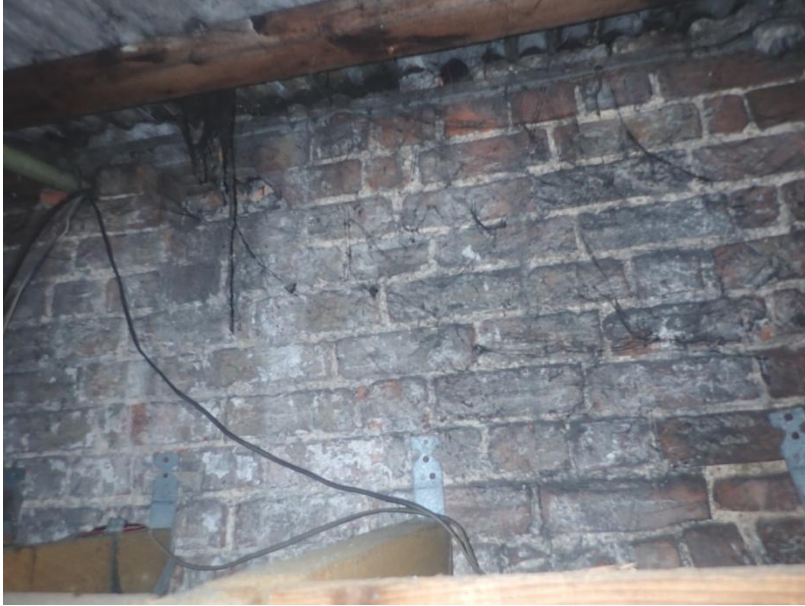
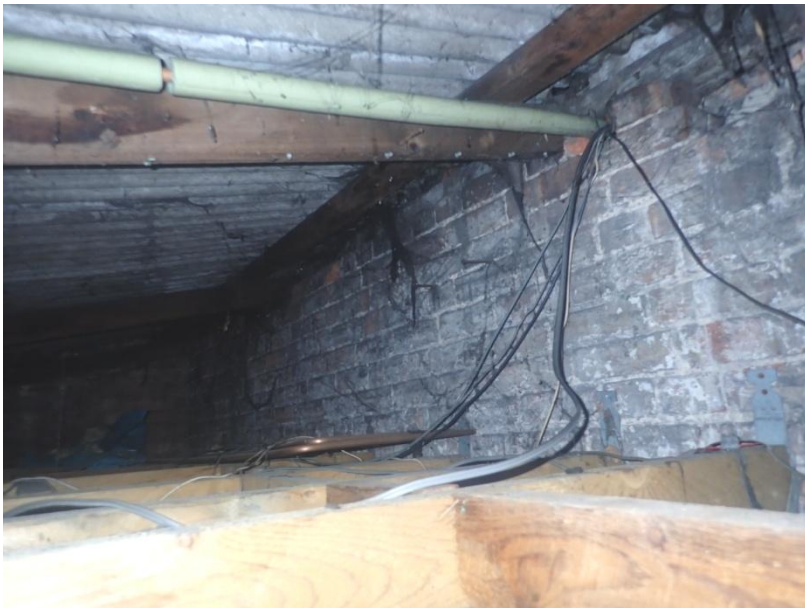
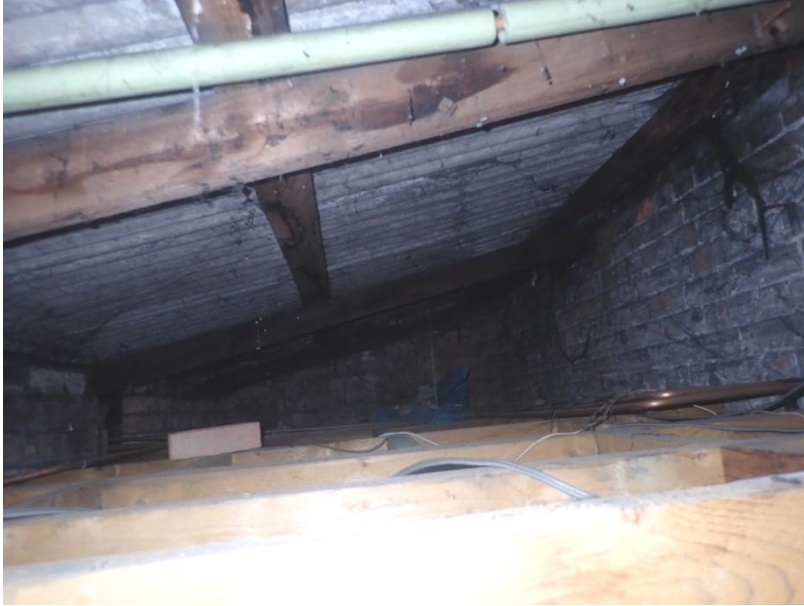
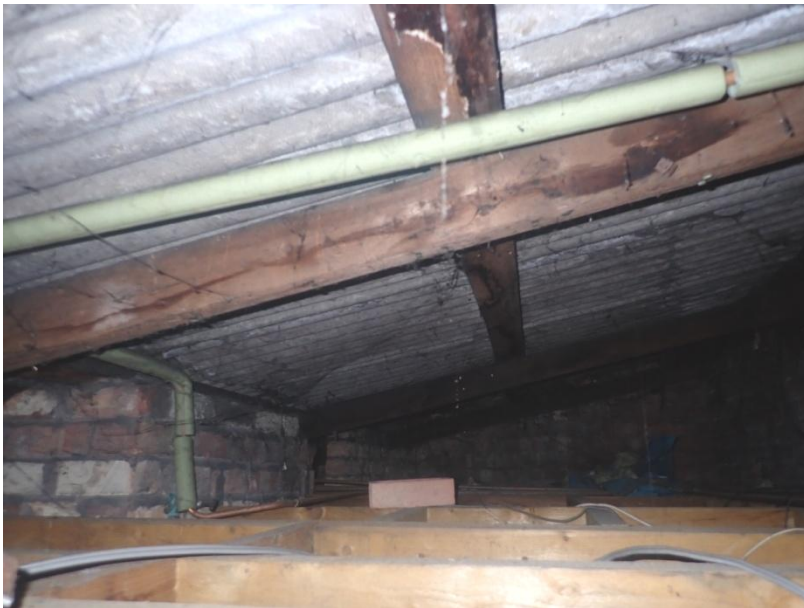
**Plates 331-336** present a number of views of the roof space above **Cell 16**. This is a relatively simple timber framework of north-south orientated angled timber rafters and east-west aligned horizontal timber purlins to which is attached the roof covering of sheets of corrugated metal. Of particular note is the exposed brickwork wall fabric to the north, which is part of the upper levels of the South Elevation of the adjoining **Building 5**. The northern ends of the timber rafters of this roof structure are inserted into this wall fabric, which is mostly composed of courses of brick stretchers and of further courses of mixed brick headers and brick stretchers.

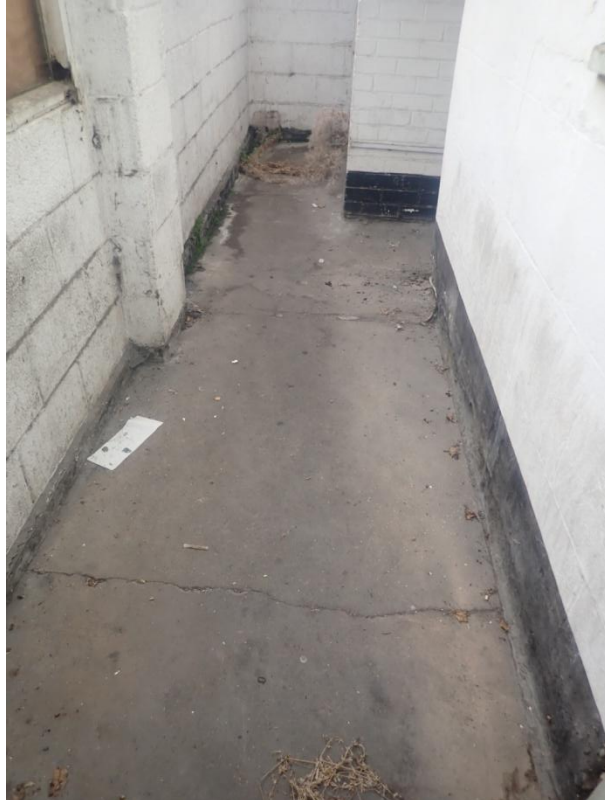
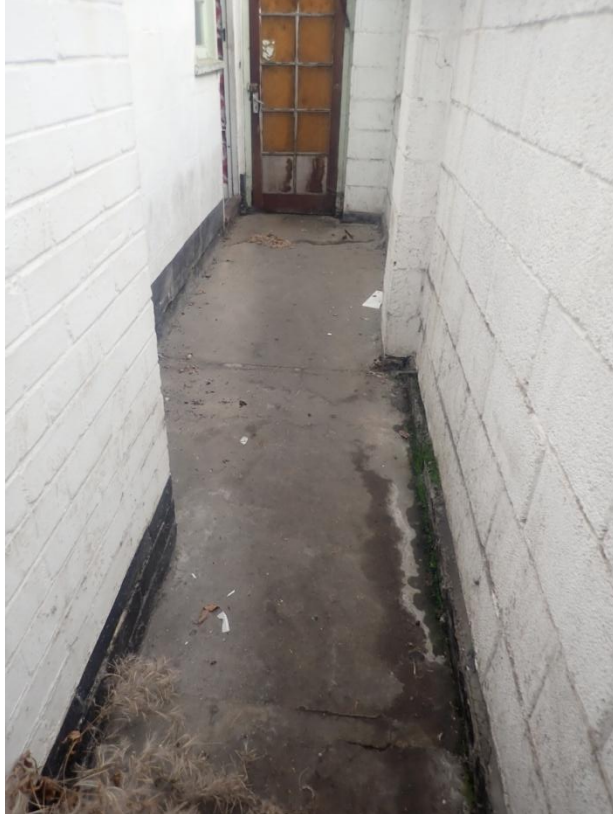
**Plates 337 and 340** feature the nature of the flooring of the Corridor, which is of modern concrete.

**Plate 337: View of the flooring of the Corridor leading to Cell 17, from the north-east**

**Plate 340: View of the flooring of the Corridor leading to Cell 17, from the south-west**

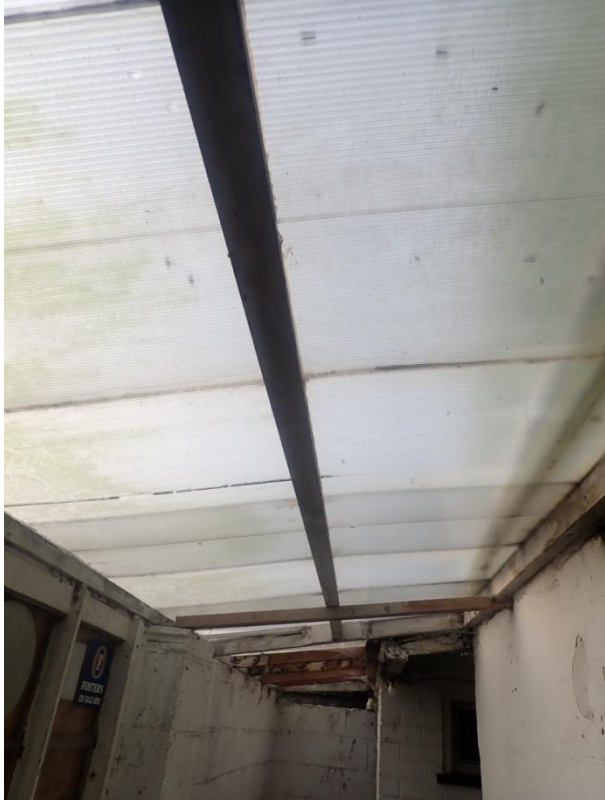
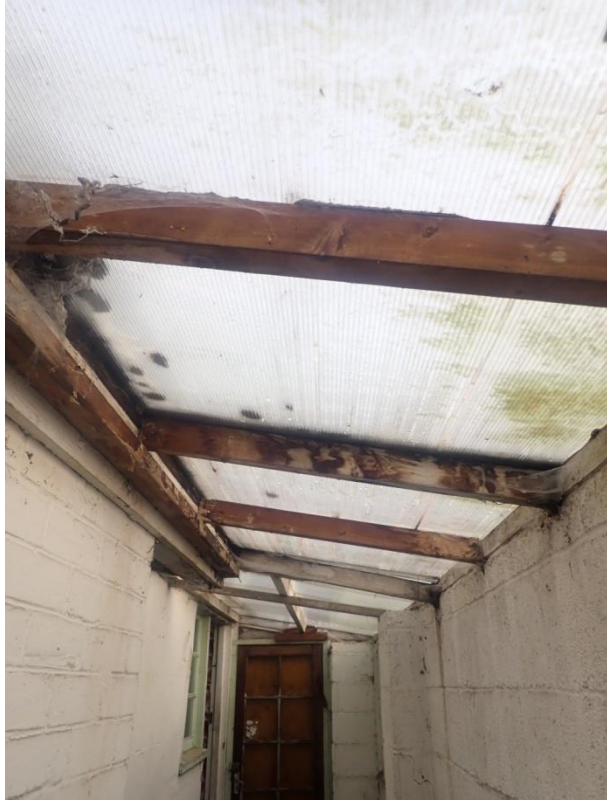
**Plates 338 and 342** feature the nature of the roofing structure of the Corridor, which is composed of modern plastic sheeting attached to a framework of low angled timber rafters and horizontal timber purlins.

**Plate 338: View of the roofing structure of the Corridor leading to Cell 17, from the north-east**

**Plate 342: View of the roofing structure of the Corridor leading to Cell 17, from the south-west**

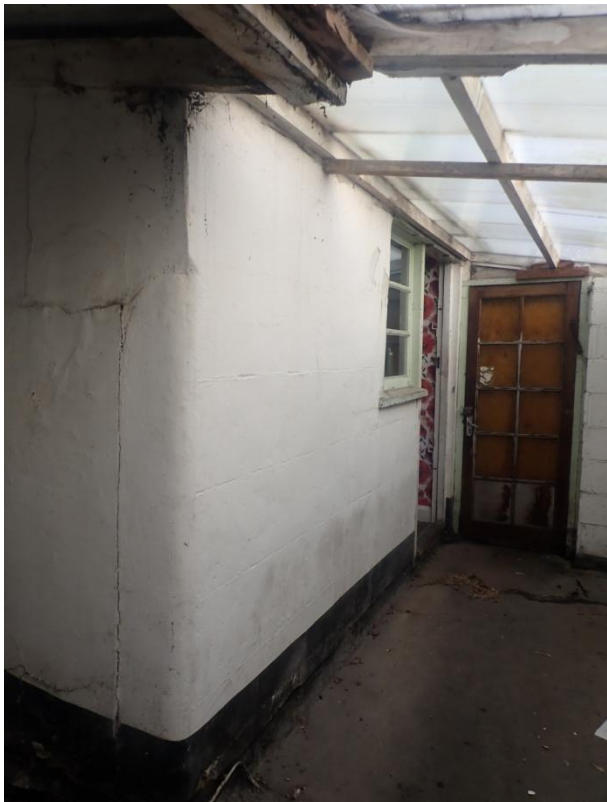
**Plate 343** features a portion of the north wall of the Corridor. This is also part of the former external South Elevation to **Building 3**. This is probably constructed of brickwork, which has been covered over with modern cement rendering. Also shown is the outer face of south facing ground floor window and entrance openings that were recorded internally within **Cell 15** of **Building 3**.

**Plate 343: View of the north wall of the Corridor leading to Cell 17, from the south-west**

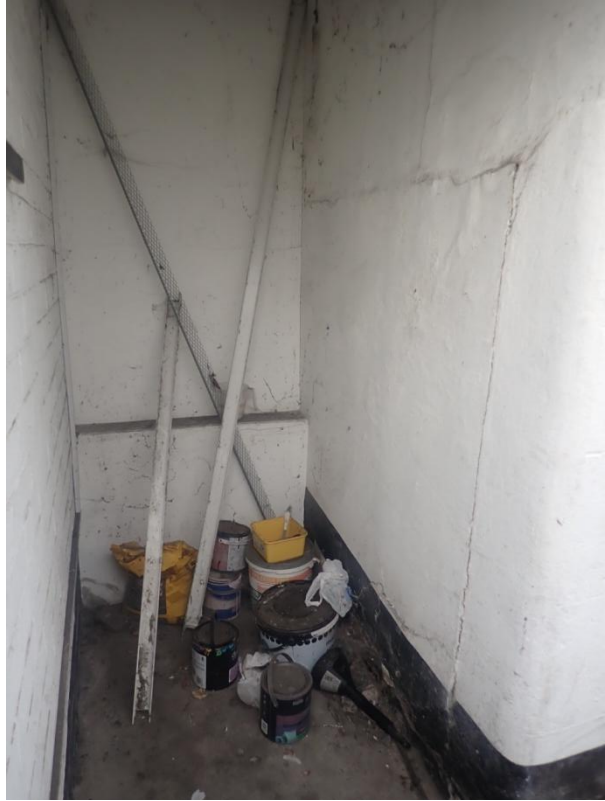
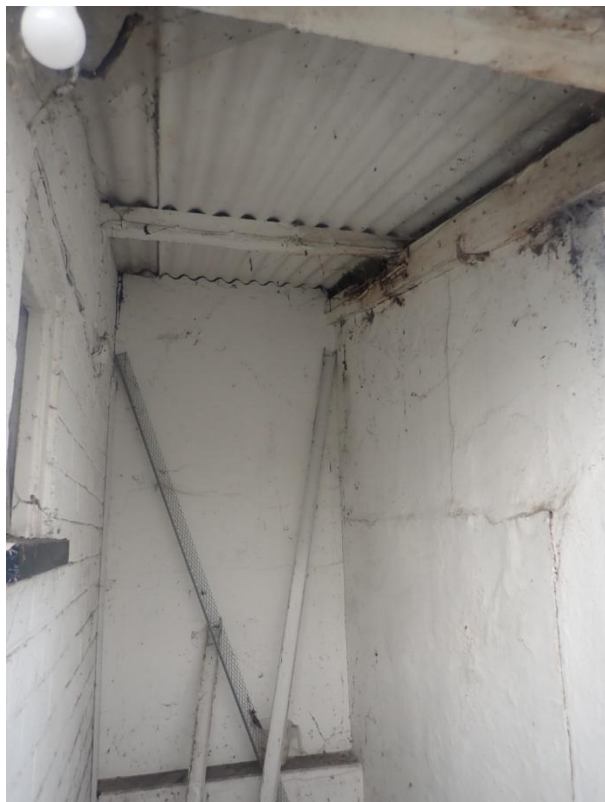
**Plates 344 and 345** feature an alcove within the northern side of the Corridor. The eastern face of which is part of the former external West Elevation to **Building 3**. This is also probably constructed of brickwork, which has been covered over with modern cement rendering. Adjoining this, the north face of this alcove is an external face to **Cell 16** of **Building 4**. This is also probably constructed of brickwork, which has also been covered over with modern cement rendering. Above this alcove is a small portion of the low angled half gabled roof structure of **Building 4**, with its roof covering of sheets of corrugated metal that is supported on a timber framework of low angled timber rafters and horizontal timber purlins.

**Plate 344: View of the alcove within the north wall of the Corridor leading to Cell 17, from the south**

**Plate 345: View of the alcove within the north wall of the Corridor leading to Cell 17, from the south**

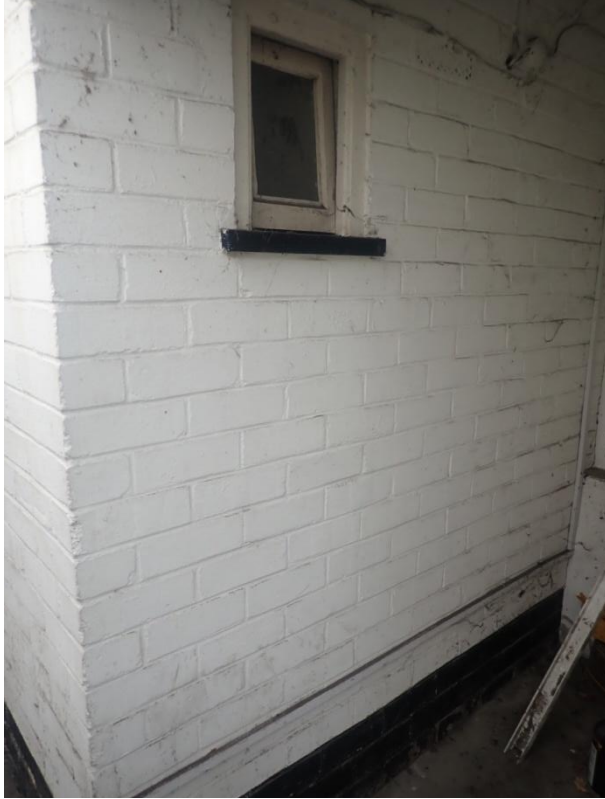
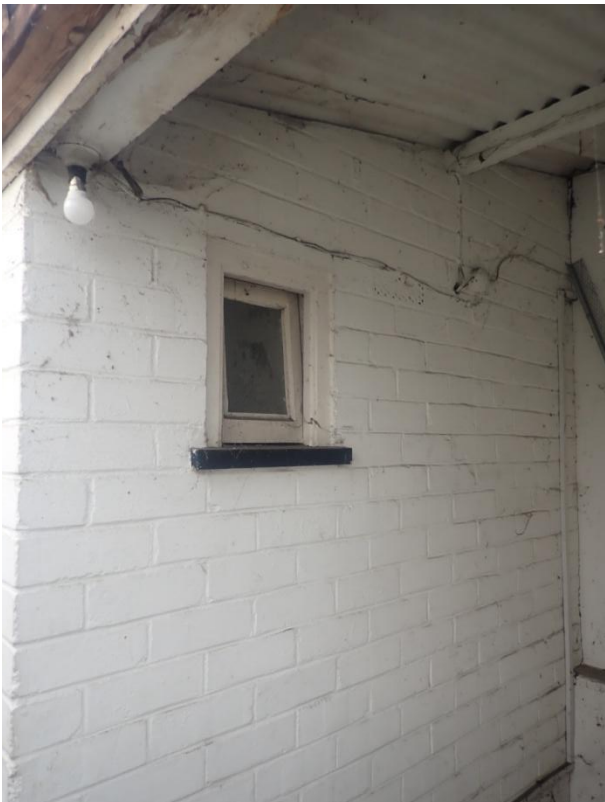
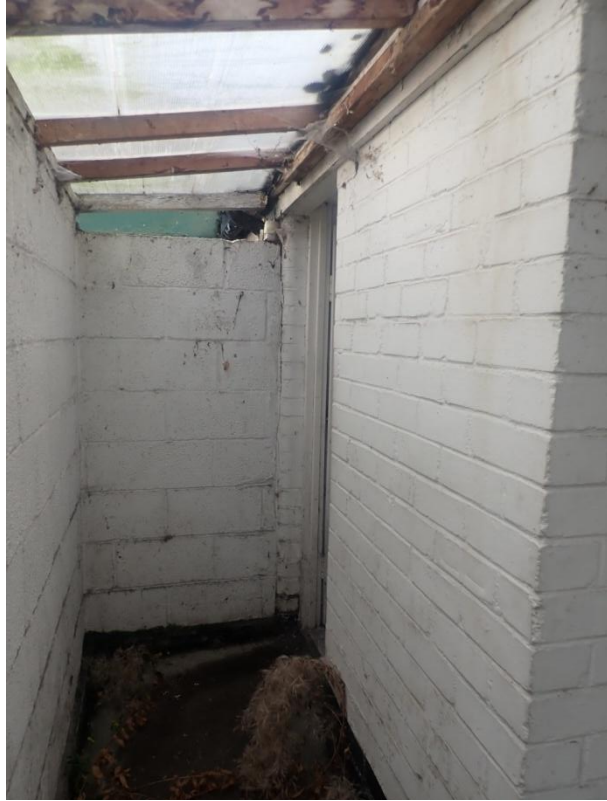
**Plates 346-348** present several views of the external eastern and southern faces of **Cell 17**. The brickwork is composed of courses of brick stretchers in Stretcher Bond. A small glazed east facing timber casement window is also featured within the eastern face.

**Plate 346: View of the exterior of Cell 17 within the Corridor leading to Cell 17, from the south-east**

**Plate 347: View of the exterior of Cell 17 within the Corridor leading to Cell 17, from the south-east**

**Plate 348: View of the exterior of Cell 17 within the Corridor leading to Cell 17, from the north-east**

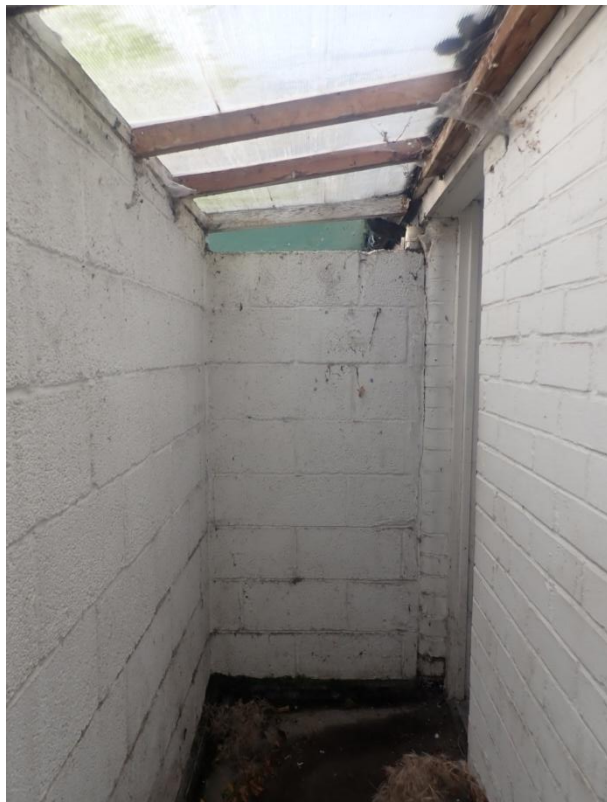
**Plate 349: View of the west wall of the Corridor leading to Cell 17, from the north-east**

**Plate 349** provides a view of the west wall or the western end of the Corridor. The wall fabric here is composed of courses of modern breeze blockwork.

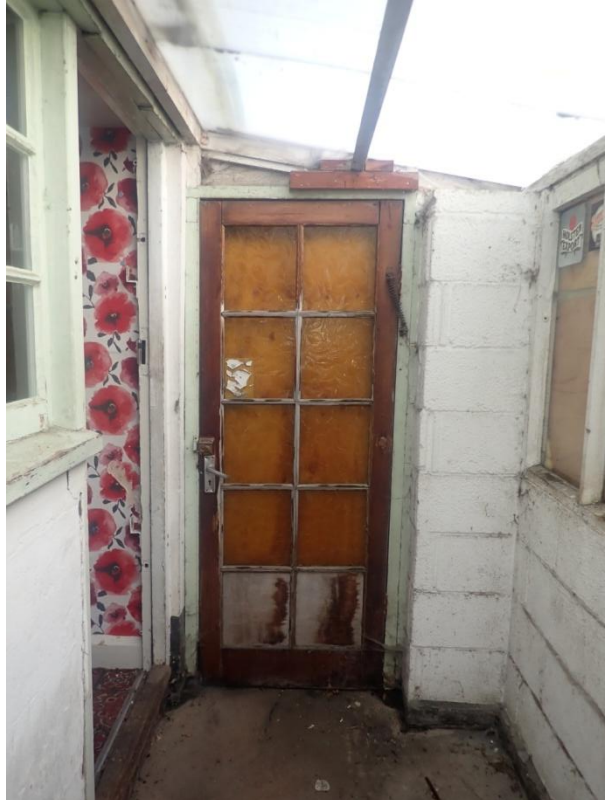
**Plate 350: View of the east wall of the Corridor leading to Cell 17, from the south-west**

**Plate 350** shows the east wall or the eastern end of the Corridor. The wall fabric here is composed of courses of modern breeze blockwork. Also featured is the inner face of the east facing entrance opening that was recorded externally at the East Elevation of this building and which is boarded over. This inner face is occupied by a timber frame of a head and surrounds and by an unglazed modern glass panelled timber door.

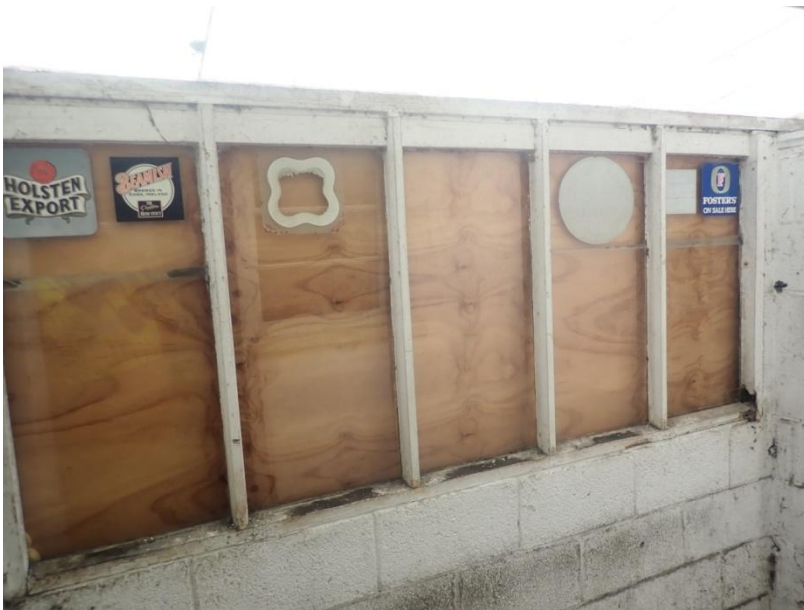
**Plate 353:** View of the south wall of the Corridor leading to Cell 17, from the north

**Plates 351-354** furnish several images of the south wall of the Corridor, the wall fabric of which is composed of courses of modern breeze blockwork. Also featured is the inner face of a south

facing window opening that was recorded externally at the South Elevation of this building, and which is boarded over. This is a modern glazed timber casement window.

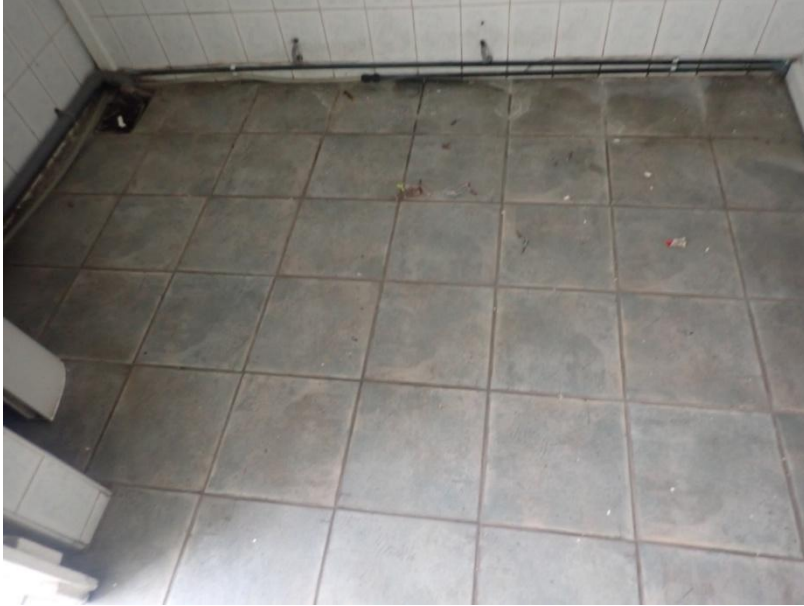
**Plate 356: View of the interior of Cell 17, from the south-east**

**Plates 355-374** present a large number of images of the interior of **Cell 17**. All of the walls and the floors of **Cell 17** have been laid with modern ceramic wall and floor tiling. The ceilings of **Cell 17** have been rendered over with modern plasterwork.

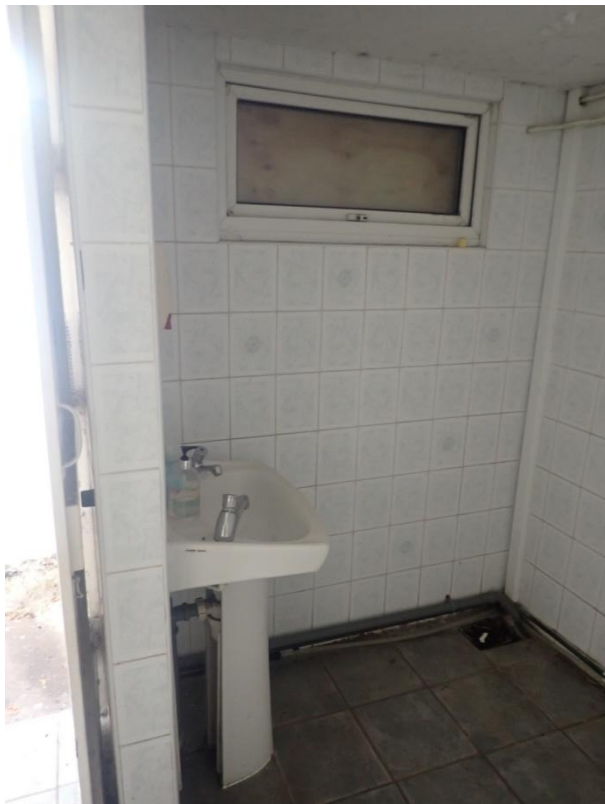
**Plate 361: View of the interior of Cell 17, from the north-east**

**Plate 361** presents a view of the inner face of a modern glazed timber casement window with a timber frame of a head and surrounds.

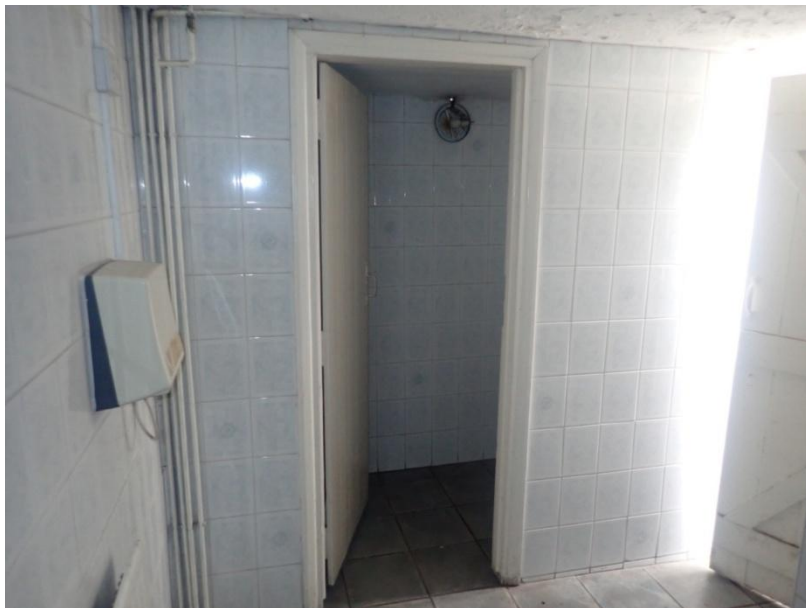
**Plate 363: View of the interior of Cell 17, from the south-west**

**Plates 362-364** also show the inner face of the main south facing entrance opening into **Cell 17**, which is occupied by a timber frame of a head and surrounds and by a timber door that is composed of a series of vertical tongued and grooved timber planks that are affixed to an internal timber framework of angled and horizontal timbers. The entrance opening into the main toilet is also featured and is occupied by a timber frame of a head and surrounds and by a second door

that is also composed of a series of vertical tongued and grooved timber planks that are affixed to an internal timber framework of angled and horizontal timbers.

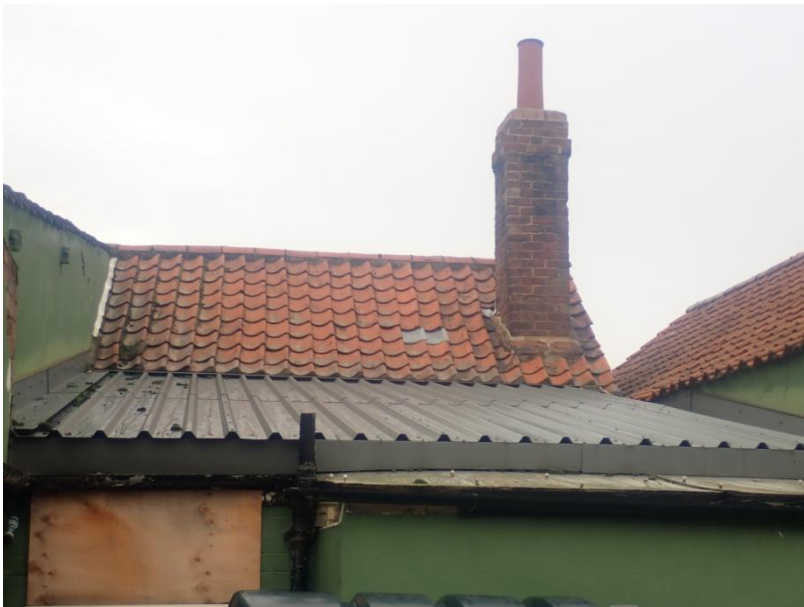
**Plate 375: View of the roofing of Building 5, from the south-east**

**Building 5** is a single storey building of this former public house complex. This has a gabled roof with a roof covering of red pantiles and a vertical brick chimney stack at the eastern end of the roof. The southern side of this roof is featured in detail on **Plate 375**. The chimney stack is

composed of courses of courses of brick stretchers and is topped with a ceramic chimney pot. **Building 5** is bonded to **Building 3** to the east and to **Buildings 4 and 6** to the south.

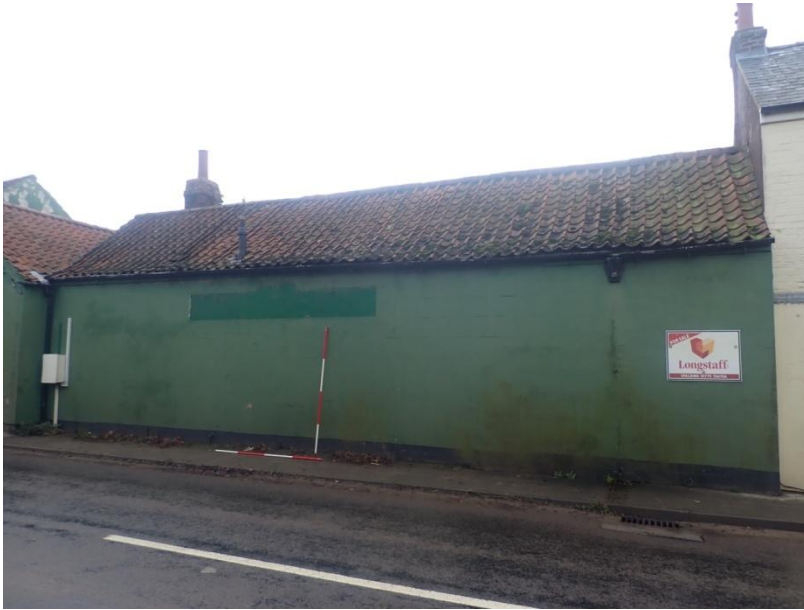
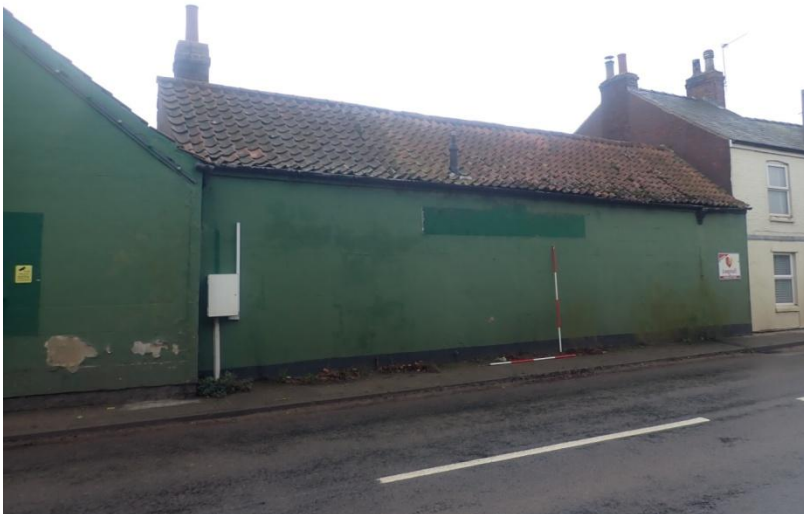
**Plates 376 and 377** present detailed views of the North Elevation of **Building 5**. The wall fabric of this Elevation has been entirely covered over with modern cement rendering. The northern side of the gabled roof with its roof covering of red pantiles is also featured. At just below roof levels is modern horizontal Upvc guttering.

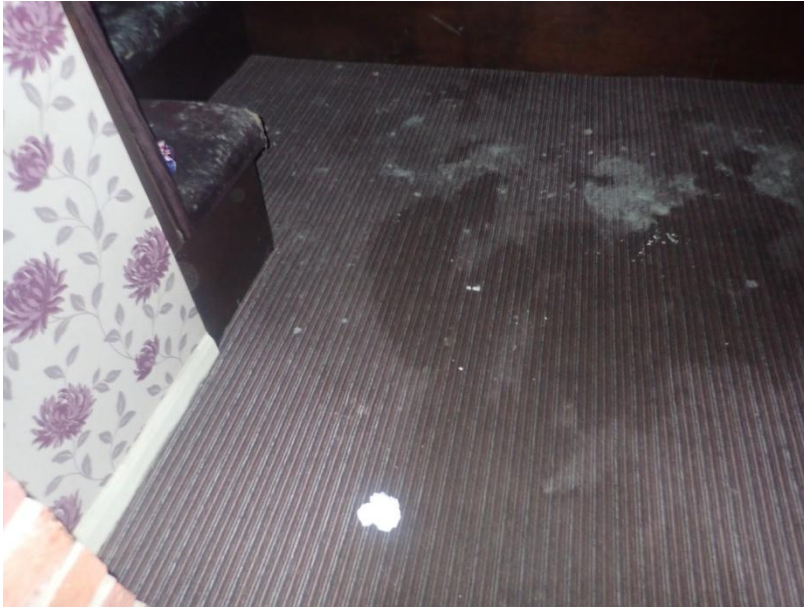
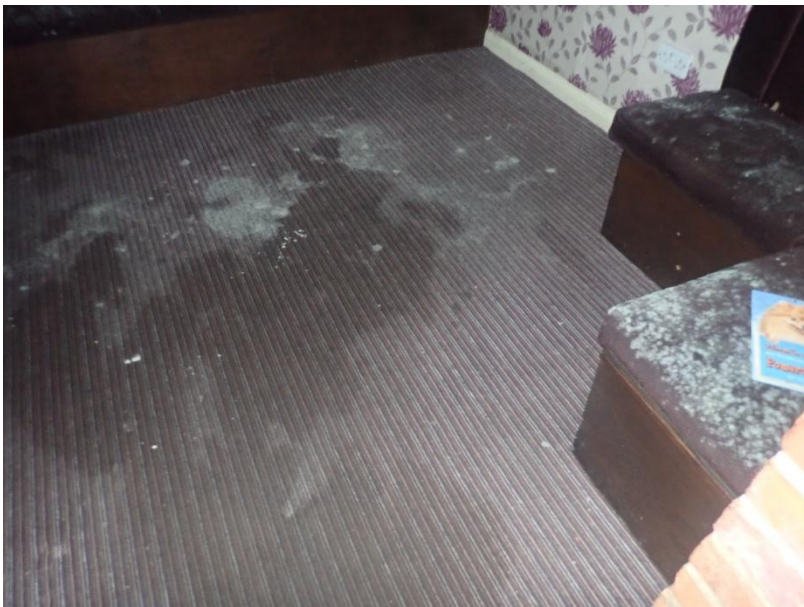
**Plates 378 and 379** illustrate the nature of the flooring of **Cell 18**, which has been covered with modern carpeting.

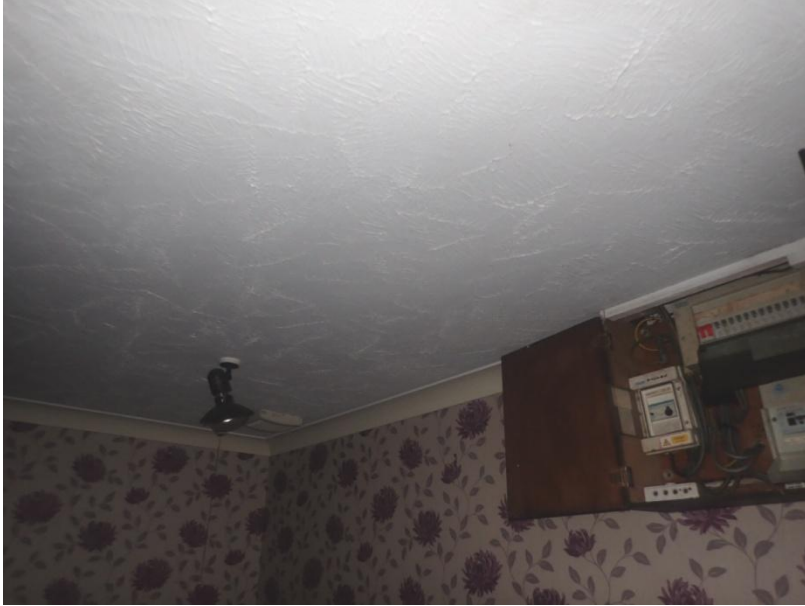
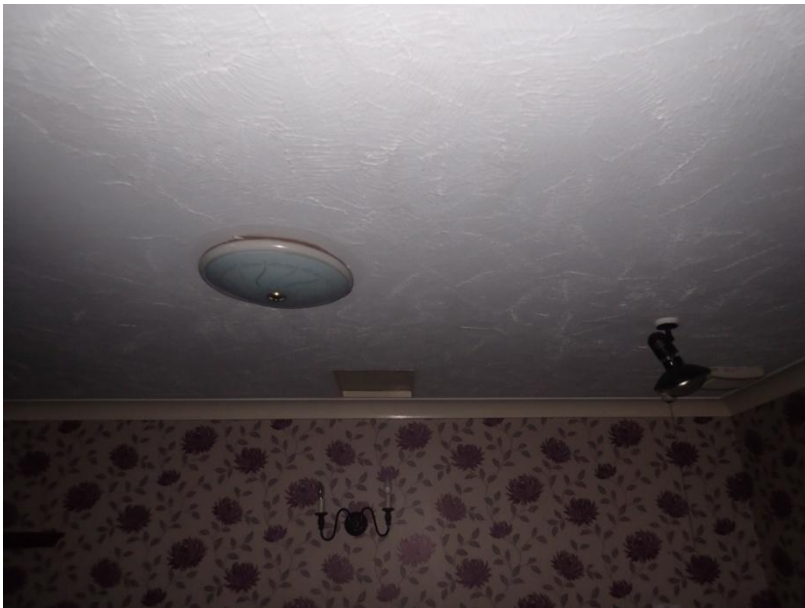
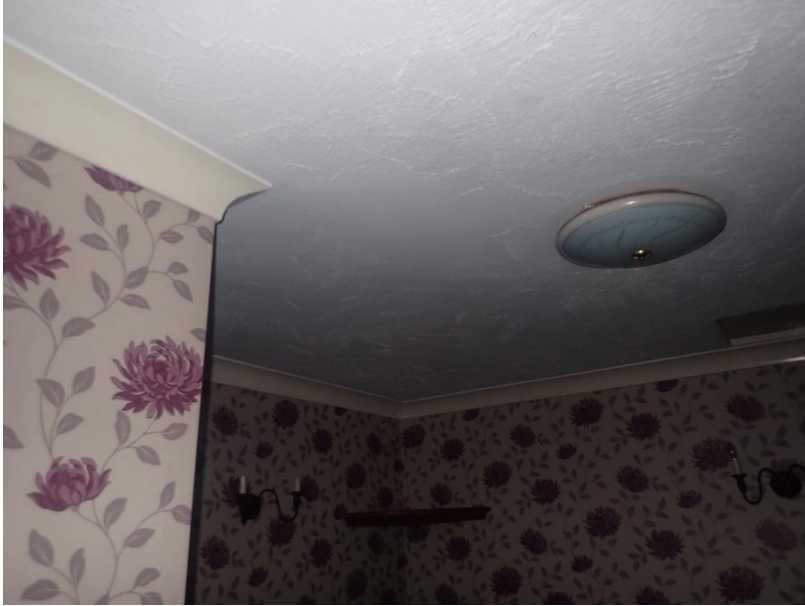
**Plates 380-382** show the nature of the ceiling structure of **Cell 18**, which has been rendered over with modern plasterwork.

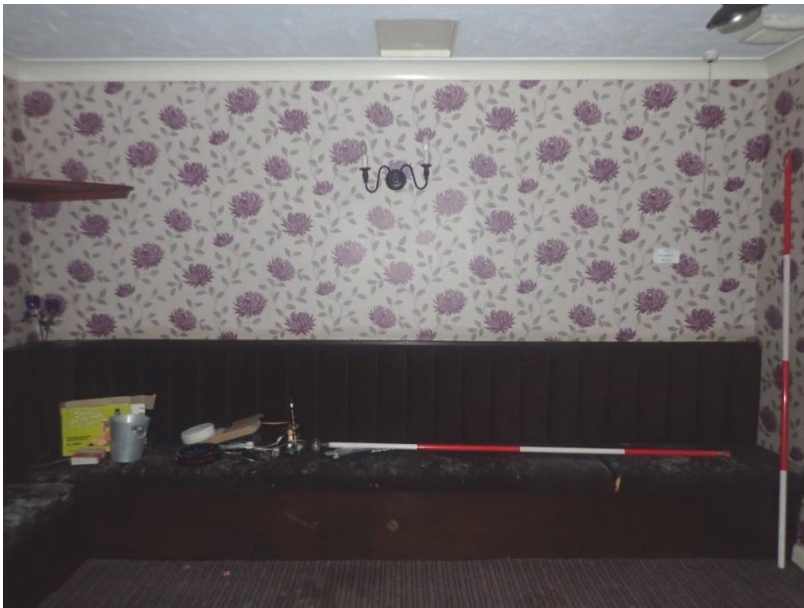
**Plate 385: View of the west wall of Cell 18, from the south-east**

**Plate 385** features the west wall of **Cell 18**, which has been covered over with modern wallpaper. Plaster cornice work may be seen at the uppermost levels. The lower levels of the west wall are occupied by modern soft furnishings/seating. This is also the internal dividing wall with the adjoining **Cells 21 and 22** to the west.

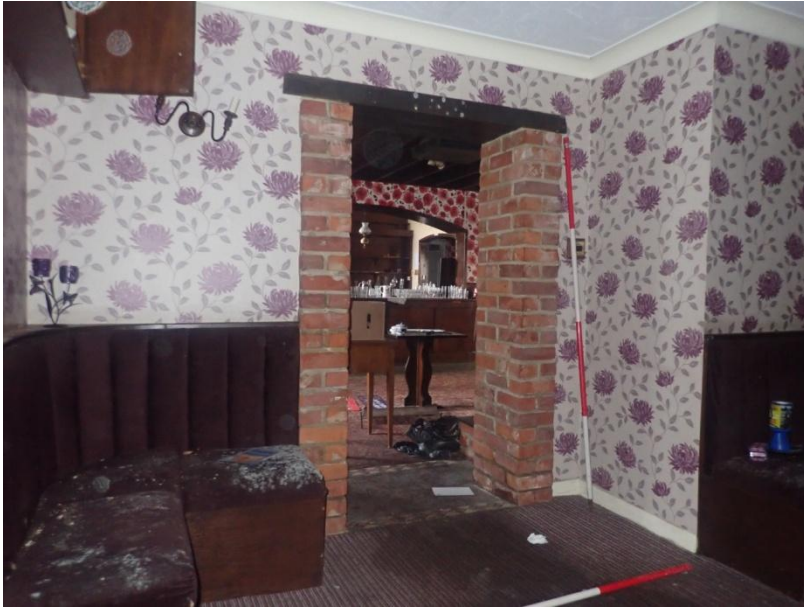
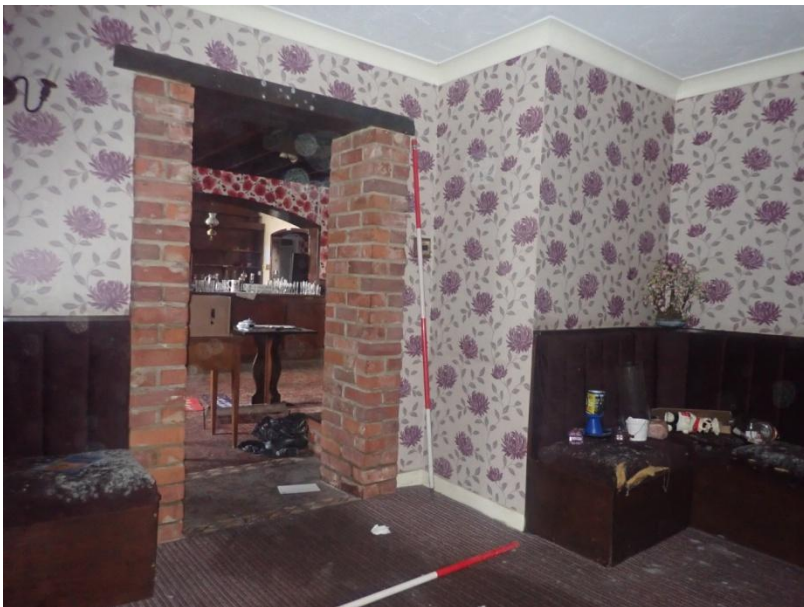
**Plates 386 and 387** show the east wall of **Cell 18**, which is also the internal dividing wall with the adjoining **Cell 15** of **Building 3** to the east. This east wall has also been covered over with modern wallpaper. Plaster cornice work may be seen at the uppermost levels. The lower levels of the east wall are occupied by modern soft furnishings/seating. The central features of this east wall are the chimney breast to the right (south) and the open access into the adjoining **Cell 15** to the east. This open access is flanked to either side by brickwork composed of courses of brick

stretchers. Above the opening is an horizontal timber lintel, which has been incorporated into the wall fabric here.

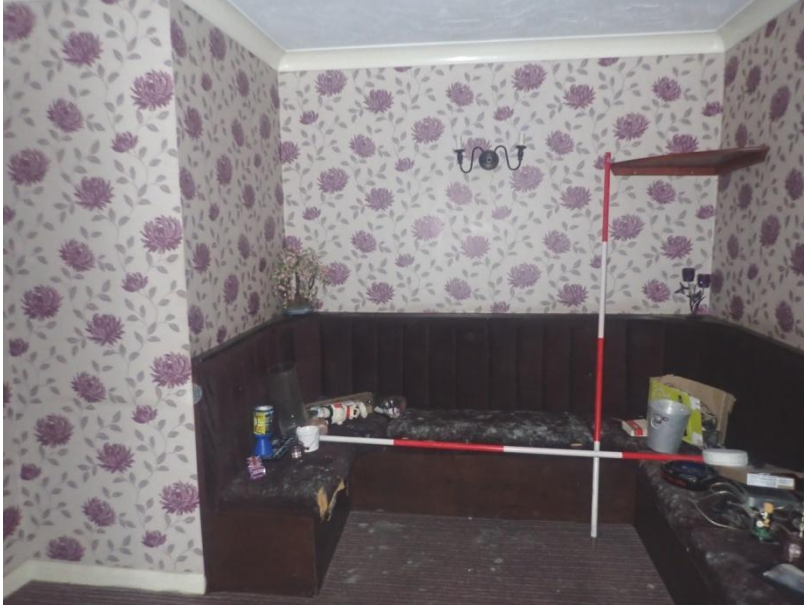
**Plate 388: View of the south wall of Cell 18, from the north-west**

**Plate 388** provides a view of the south wall of **Cell 18**, which is also the internal dividing wall with the adjoining **Cell 16** to the south. This south wall has also been covered over with modern wallpaper. Plaster cornice work may be seen at the uppermost levels. The lower levels of the south wall are occupied by modern soft furnishings/seating.
