### **7.5 The Exterior of Building 3**

#### **7.7 The Exterior of Building 4**

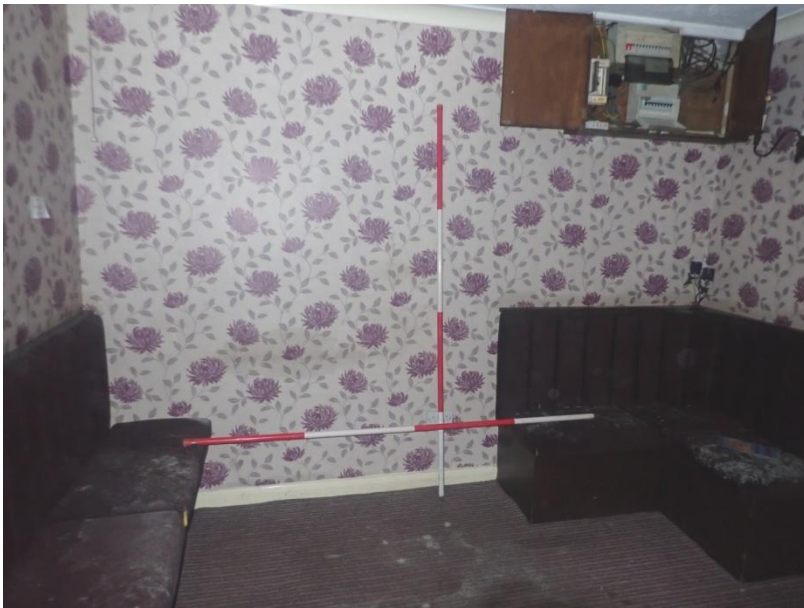
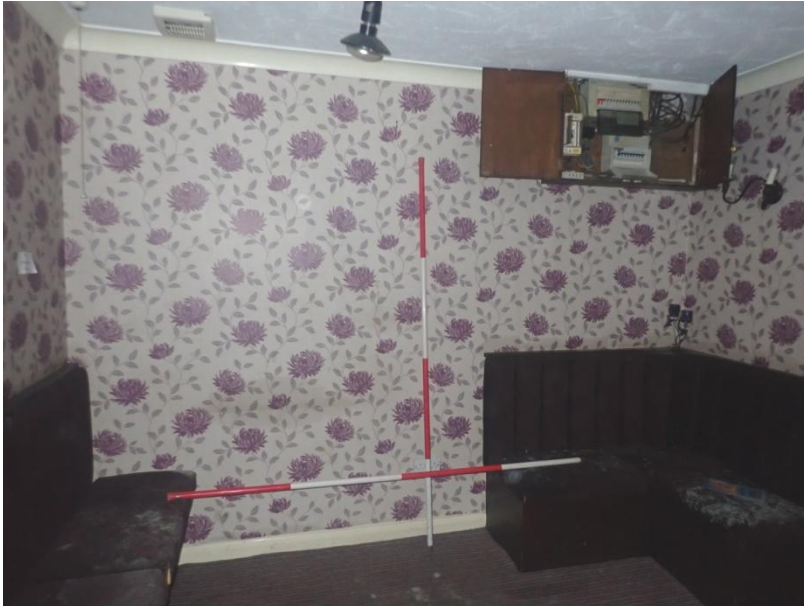
**Plates 389 and 390** show the north wall of **Cell 18**, which has also been covered over with modern wallpaper. Plaster cornice work may be seen at the uppermost levels. The lower levels of the north wall are occupied by modern soft furnishings/seating and by horizontal timber skirting boards at the base.

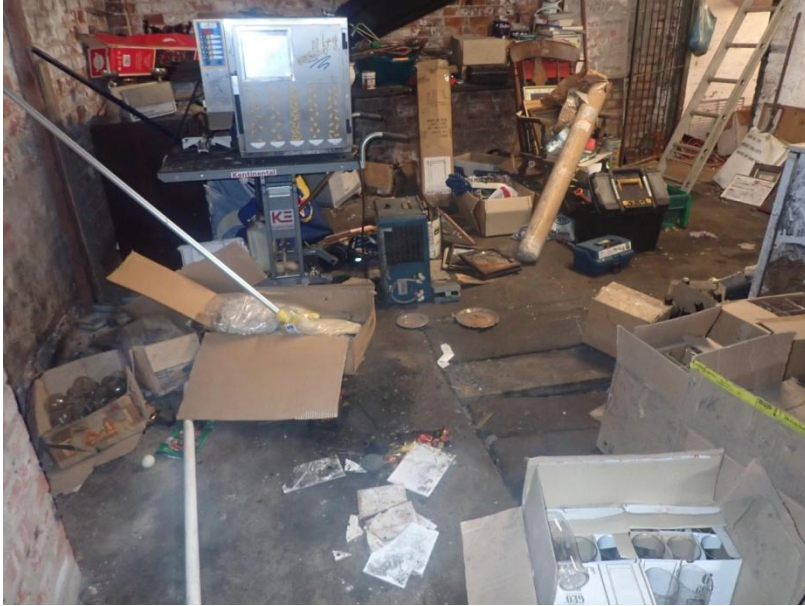
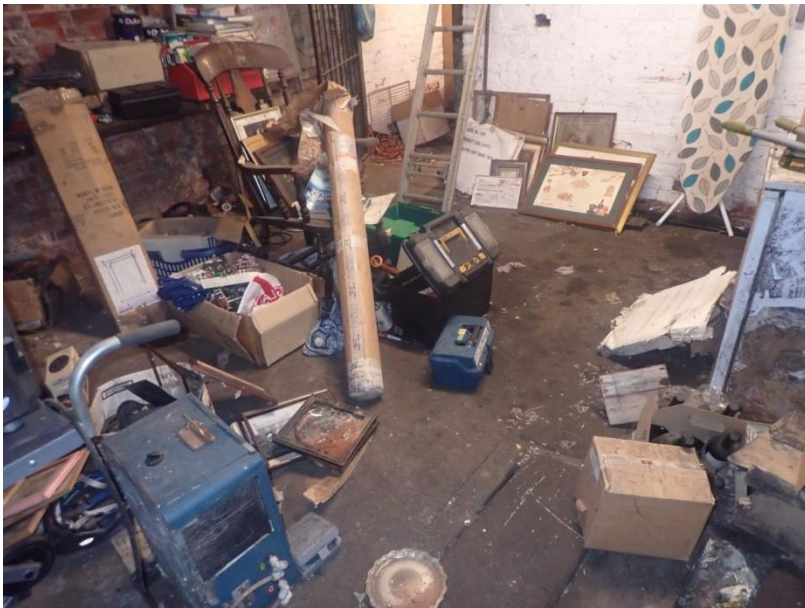
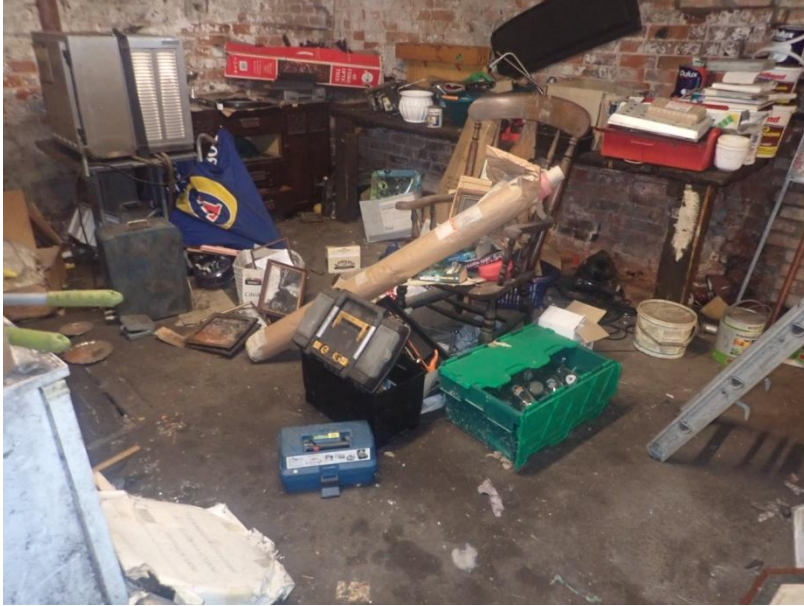
**Plates 392-394** feature the nature of the flooring of **Cell 19**, which is of modern concrete.

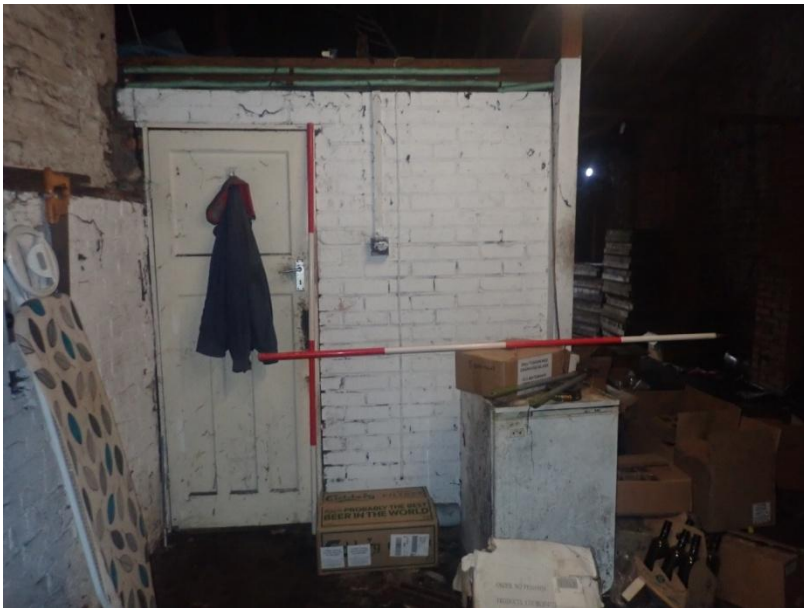
**Plate 395:** View of the south wall of Cell 19, from the north-west

**Plate 395** provides a view of the probable remnants of the former south wall of **Cell 19**, and hence of this western portion of **Building 5**. This surviving remnant is of brick, which is composed of courses of brick stretchers in Stretcher Bond. To the left (east) and built into this wall fabric is a south facing entrance opening, which extends onto the adjoining **Cell 24** of **Building 6**. This opening is occupied by a timber frame of a head and surrounds and by a modern panelled timber door.

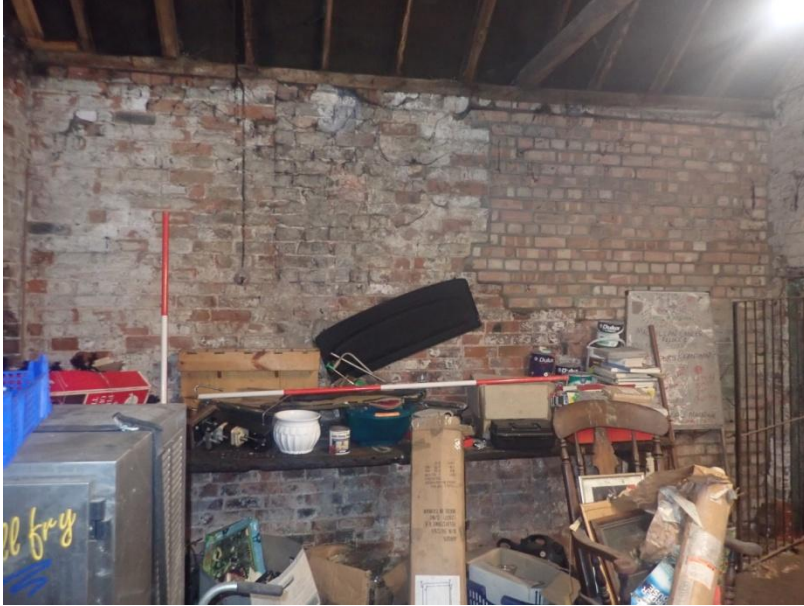
**Plate 396: View of the north wall of Cell 19, from the south-west**

**Plates 396 and 397** provide detailed views of the north wall of **Cell 19**. The detail of the brickwork wall fabric of the western portion of this north wall has become partially obscured by being covered with paintwork. The eastern portion of this north wall has been the subject of modern repair and the brickwork here is composed of 2-3 courses of brick stretchers alternating with single courses of brick headers in a variation of English Garden Wall Bond. Horizontal timber wallplates extend along the top of this north wall.

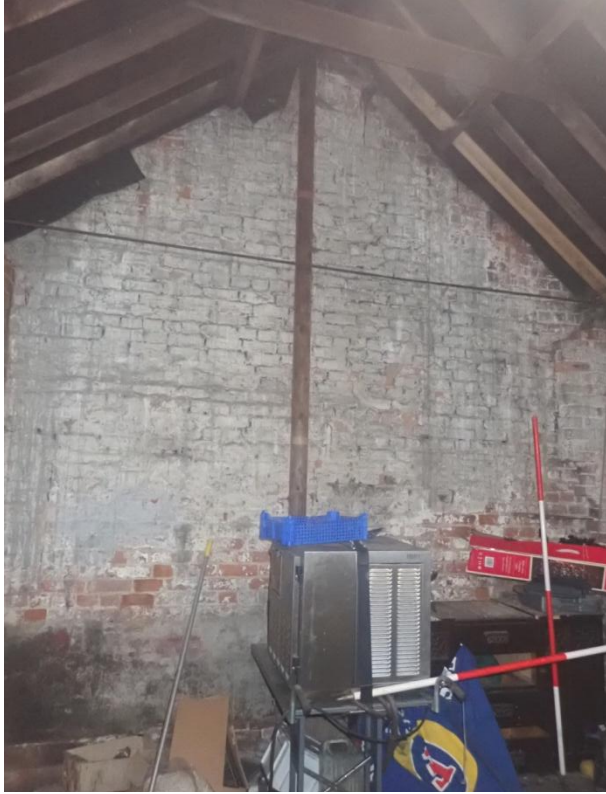
**Plate 398: View of the west wall of Cell 19, from the north-east**

**Plates 398 and 399** present detailed images of the west wall of **Cell 19**. Much of the detail of the brickwork wall fabric of this west wall has become obscured by being covered with paintwork. However, it is still possible to discern individual courses of brick headers and of brick stretchers. The western ends of the horizontal timber purlins of the overlying roof structure may be seen to be inserted into the uppermost levels of this brickwork wall fabric.

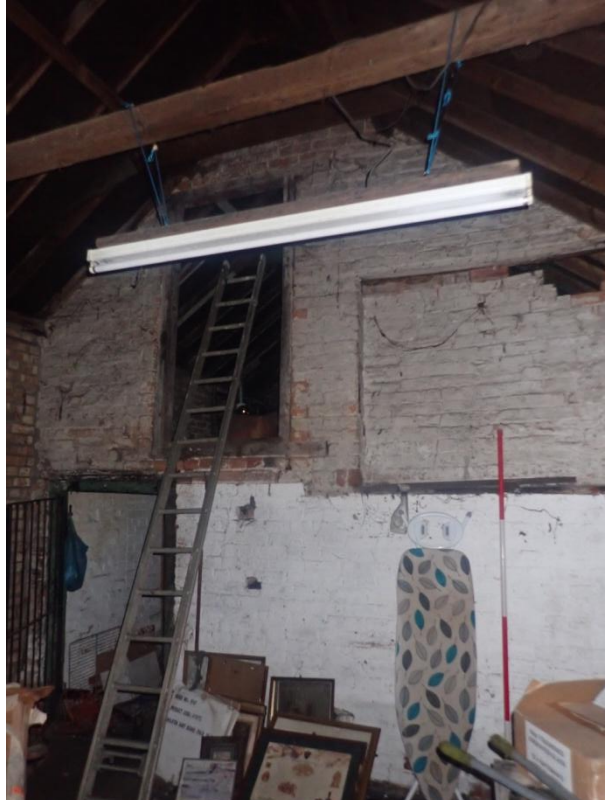
**Plate 400: View of the east wall of Cell 19, from the south-west**

**Plates 400-402** furnish several detailed views of the east wall of **Cell 19**. Here also, much of the detail of the brickwork wall fabric of this east wall has become obscured by being covered with paintwork. However, it is still possible to discern individual courses of brick headers and of brick stretchers. The eastern ends of the horizontal timber purlins of the overlying roof structure may be seen to be inserted into the uppermost levels of this brickwork wall fabric. To the right (south), is a probable infilled east facing former internal window opening. This former opening has been

infilled with brick. The detail here has also become obscured by being covered over with paintwork, though individual courses of brick stretchers may be observed. This former opening has the remnants of a timber frame of a head and surrounds incorporated into the brickwork wall fabric here. To the left (north), and at ground floor levels is an east facing entrance opening, which extends onto **Cell 21** to the east. This opening is occupied by a timber frame of a head and surrounds and by a modern metal gridded door. It may also be seen that a mezzanine floor has been added to this portion of **Building 5** and a further east facing mezzanine entrance opening may also be observed. This second opening is also occupied by a timber frame of a head, surrounds and a timber threshold at the base of the opening. This leads onto the adjoining **Cell 20** to the east.

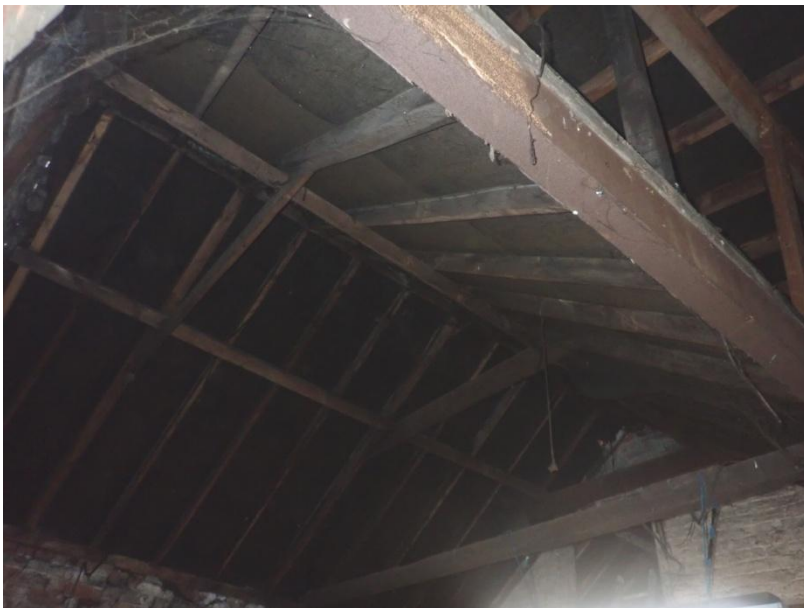
**Plate 403: View of the roof supporting structure of Cell 19, from the south-west**

**Plates 403-408** present a number of views from differing positions of the nature of the roof supporting structure of **Cell 19** and hence of the western end of **Building 5**. This structure comprises a framework of timber rafters and of horizontal timber purlins that extend along both sides of this structure along with further horizontal timber purlins at the roof apex. The upper ends of the rafters are attached to the purlins at the roof apex, whilst their basal ends are attached to the timber wallplates that extend along the top of the north wall. At the upper levels and attached to the rafters are several horizontal timber collars. At the lower levels, and also affixed to the rafters are several horizontal timber tie beams. Both the collars and the tie beams provide additional support and reinforcement to this structure.
