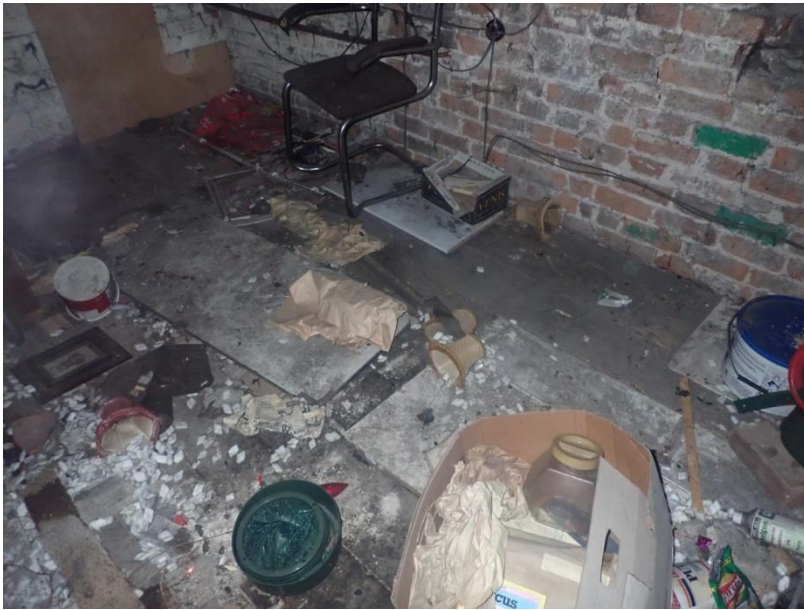
**Plate 409: View of the flooring of Cell 20, from the north-west**

**Plates 409 and 410** show the nature of the flooring of **Cell 20**, which is of horizontal timber planking.

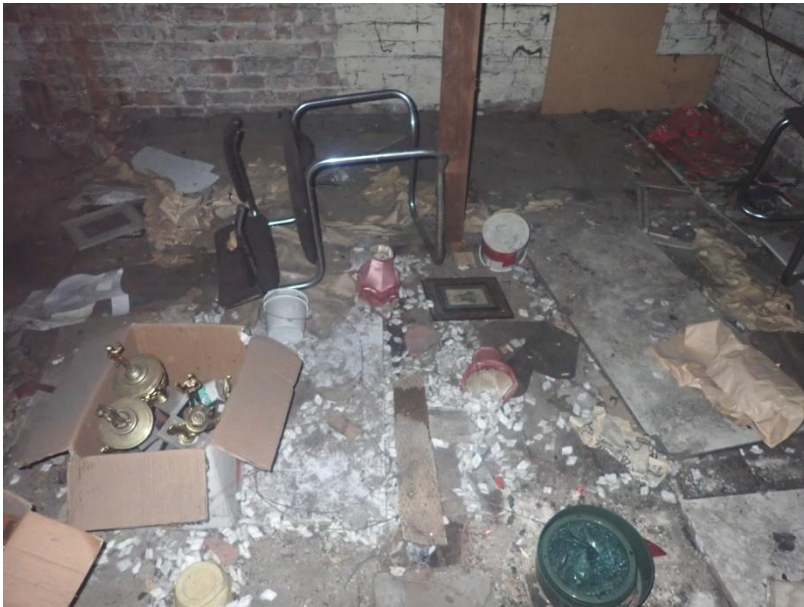
**Plate 410: View of the flooring of Cell 20, from the south-west**

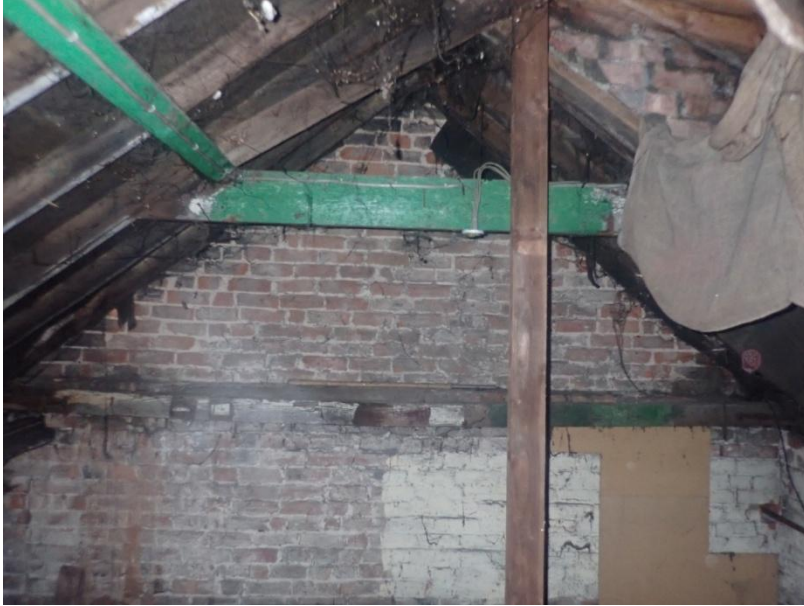
**Plate 411: View of the east wall of Cell 20, from the south-west**

**Plate 411** presents a detailed view of the east wall of **Cell 20**. The brickwork wall fabric of this east wall is mostly composed of courses of brick stretchers with further occasional courses of mixed brick headers and brick stretchers. The eastern ends of the horizontal timber purlins of the overlying roof structure may be seen to be inserted into the uppermost levels of the brickwork wall fabric here.

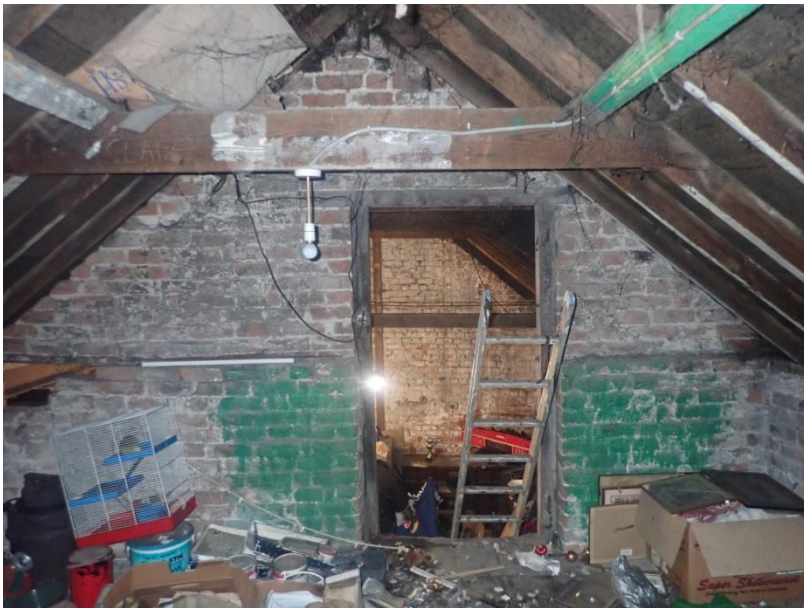
**Plate 412: View of the west wall of Cell 20, from the east**

**Plate 412** provides a detailed image of the west wall of **Cell 20**. The brickwork wall fabric of this west wall is mostly composed of courses of brick stretchers with further occasional courses of mixed brick headers and brick stretchers. The western ends of the horizontal timber purlins of the overlying roof structure may be seen to be inserted into the uppermost levels of the brickwork wall fabric here. Also featured is the west facing entrance opening, which leads onto the adjoining **Cell 19** to the west. This opening is occupied by a timber frame of a head and surrounds and by a timber threshold at the base of the opening.

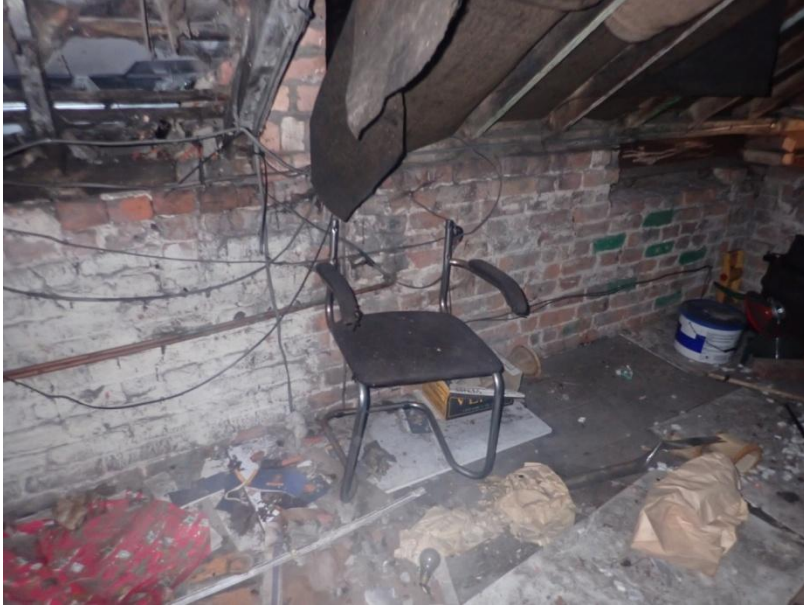
**Plate 413:** View of the south wall of Cell 20, from the north-east

**Plate 413** presents a view of the low south wall of **Cell 20**. The brickwork wall fabric of this south wall is mostly composed of courses of brick stretchers with further occasional courses of mixed brick headers and brick stretchers. Horizontal timber wallplates may be seen to extend along the top of this south wall.

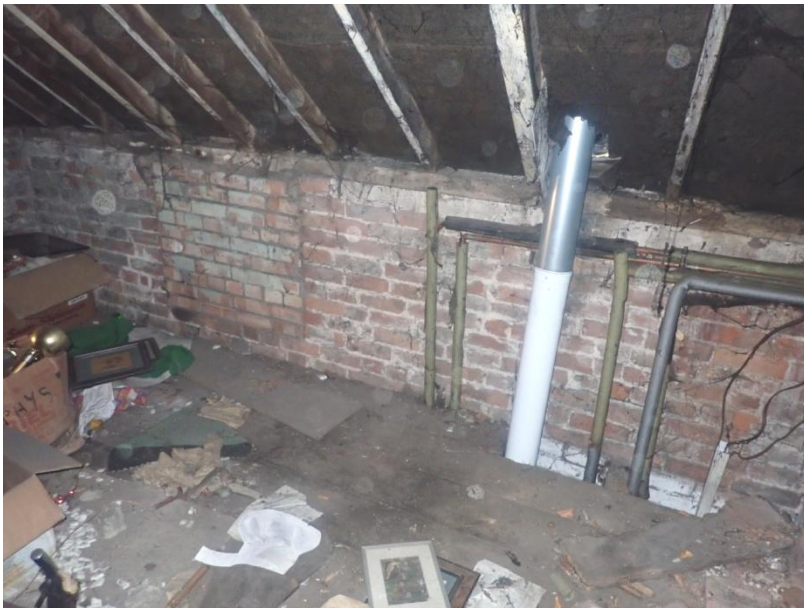
**Plate 414:** View of the north wall of Cell 20, from the south-west

**Plate 414** furnishes a detailed view of the low north wall of **Cell 20**. The brickwork wall fabric of this north wall is mostly composed of courses of brick stretchers with further occasional courses of mixed brick headers and brick stretchers. Horizontal timber wallplates may be seen to extend along the top of this north wall. The remains of an infilled former first floor north facing window opening may also be observed within this wall fabric. The brick infilling is composed of three courses of brick stretchers alternating with single courses of brick headers in English Garden Wall Bond.

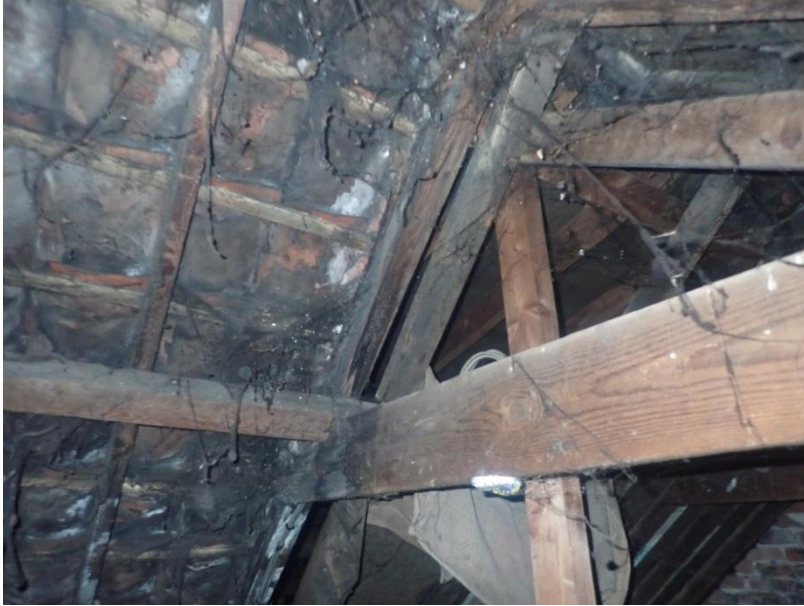
**Plate 415: View of the roof supporting structure of Cell 20, from the north-east**

**Plates 415-425** present a large number of images of the nature of the roof supporting structure of **Cell 20** and hence of the central portion of **Building 5**. This structure comprises a framework of timber rafters and of horizontal timber purlins that extend along both sides of this structure along with further horizontal timber purlins at the roof apex. The upper ends of the rafters are attached to the purlins at the roof apex, whilst their basal ends are attached to the timber wallplates that extend along the top of the low north and south walls. At the upper levels and attached to the rafters are several horizontal timber collars. The collars provide additional support and reinforcement to this structure.

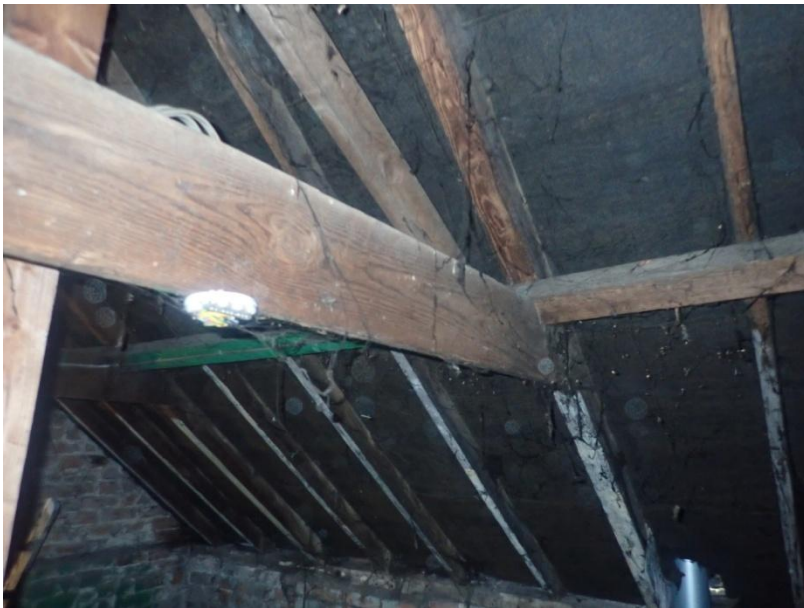
**Plate 416: View of the roof supporting structure of Cell 20, from the south-east**

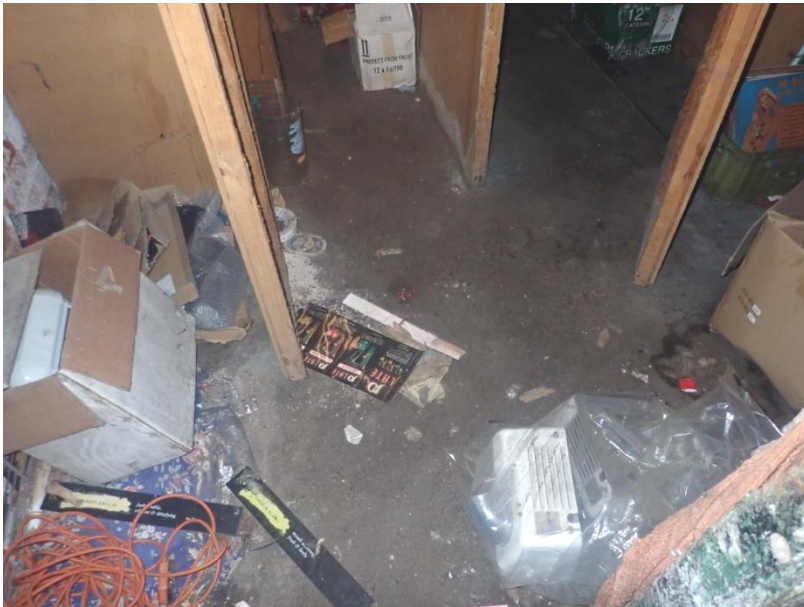
**Plate 426: View of the flooring of Cell 21, from the north-west**

**Plates 426 and 427** illustrate the nature of the flooring of **Cell 21**, which is of modern concrete.

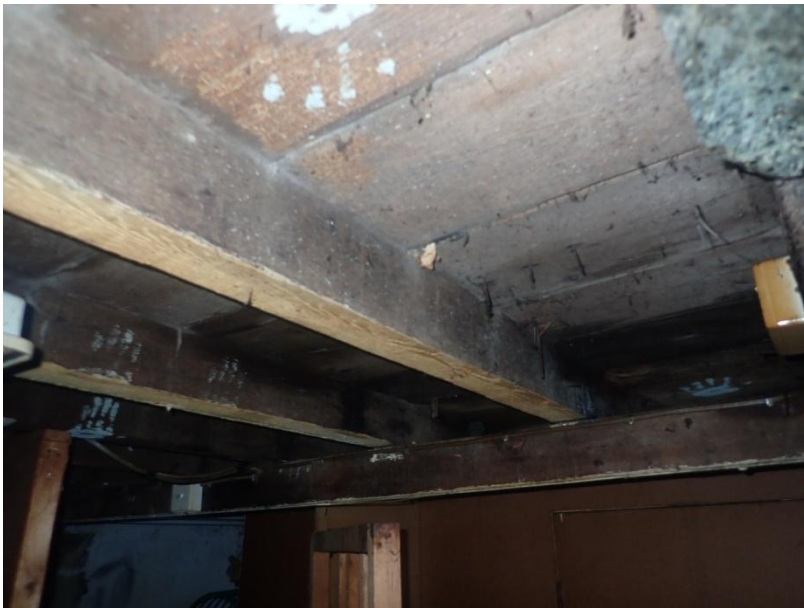
**Plate 428: View of the ceiling of Cell 21, from the south-east**

**Plates 428-430** present views of the nature of the ceiling structure of **Cell 21**. This is composed of a series of horizontal timber joists that are orientated from north-south. These in turn support the mezzanine floor covering above of horizontal timber planking, which are aligned from east-west.

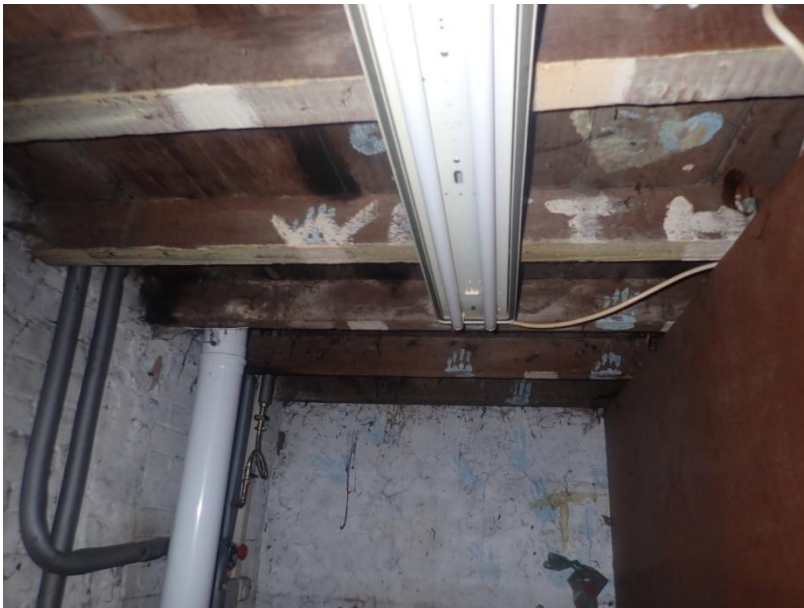
**Plate 430:** View of the ceiling of Cell 21, from the north-west

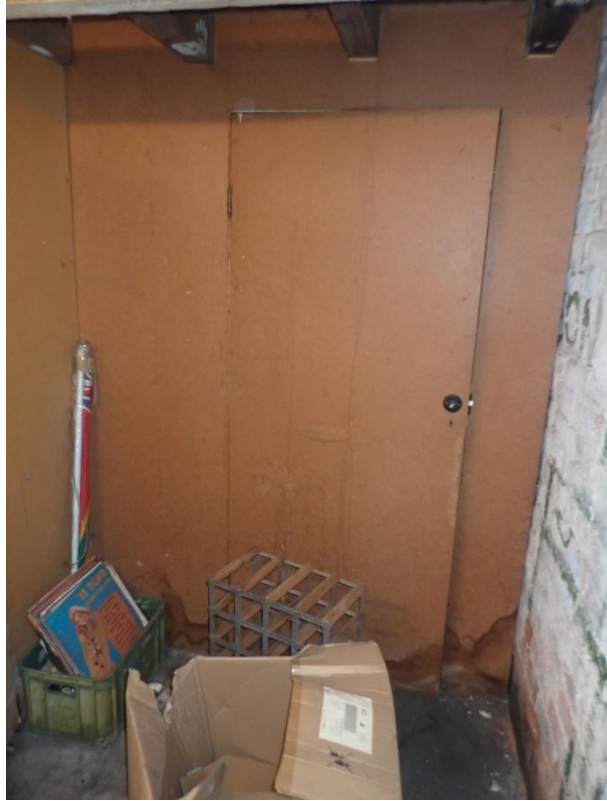
**Plate 431: View of the interior of Cell 21, from the north-west**

**Plates 431** provides a view of a modern hardboard partition with door, which separates this **Cell 21** from **Cell 23** to the south.

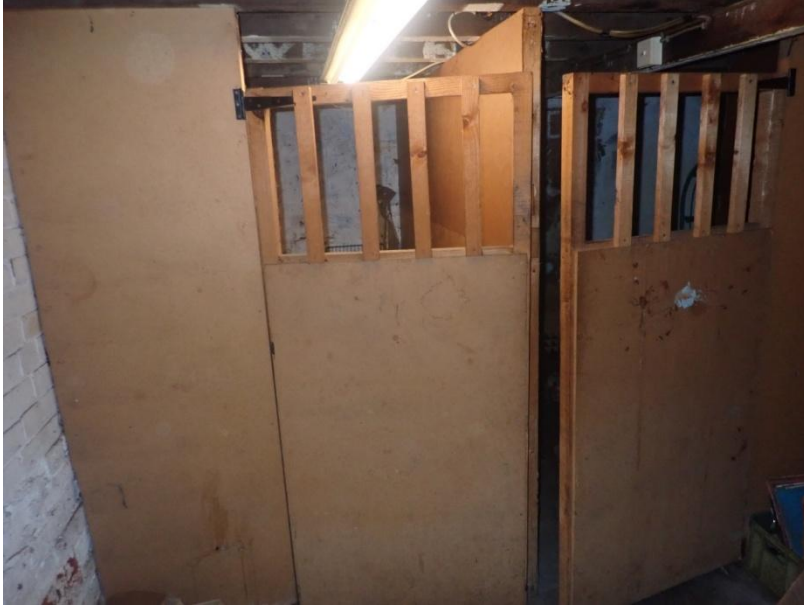
**Plate 433: View of the interior of Cell 21, from the north-west**

**Plate 433** provides a further view of the hardboard and timber door that extends onto the adjoining **Cell 22**, to the right (south) and also of the second hardboard and timber door that leads onto the boiler room of **Cell 21** to the east.

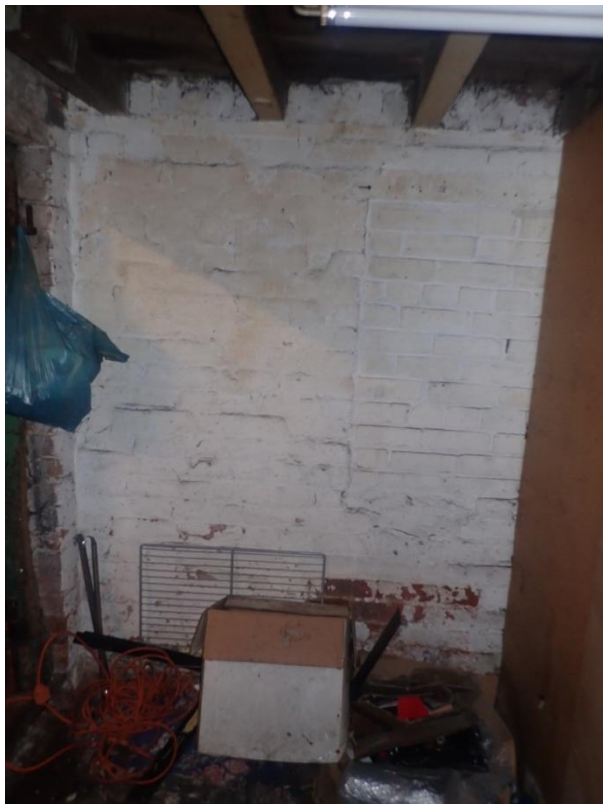
**Plate 434: View of the interior of Cell 21, from the south-east**

**Plate 434** features part of the north wall of **Cell 21**. Here the detail of the brickwork wall fabric has become obscured by being covered over with paintwork.

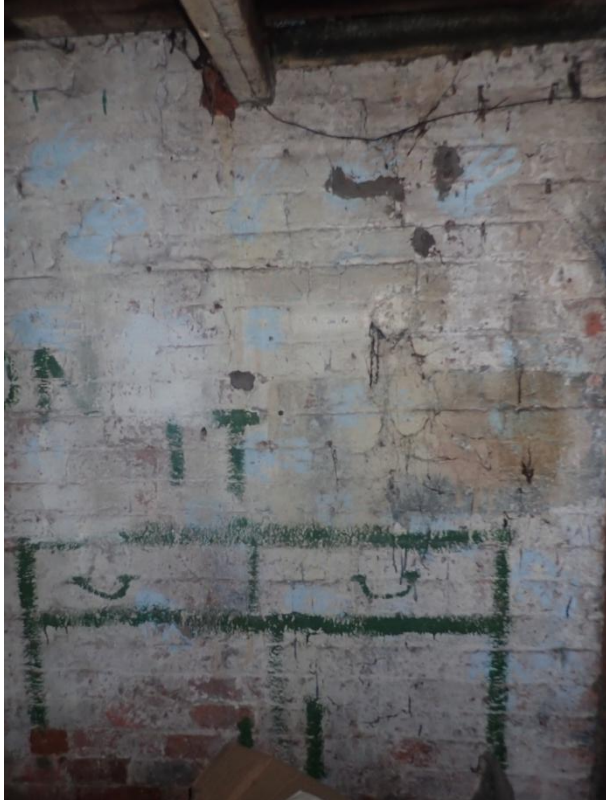
**Plate 436: View of the interior of Cell 21, from the east**

**Plate 436** provides a detailed view of the remainder of the west wall of **Cell 21**. Here also, the detail of the underlying brickwork wall fabric has become obscured by being covered over with paintwork.

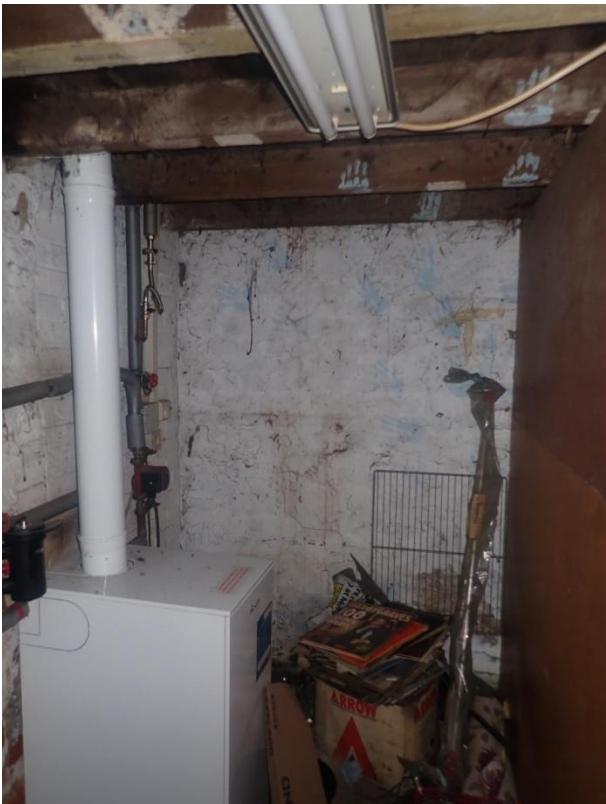
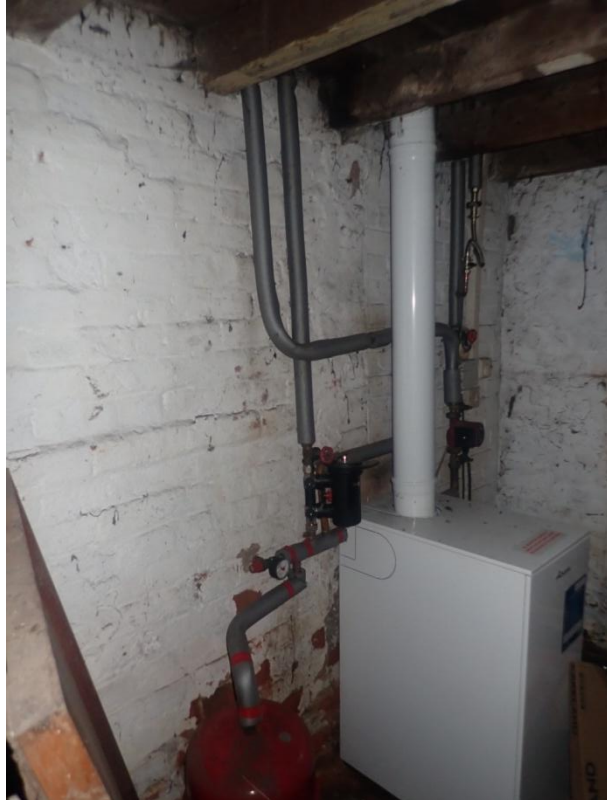
**Plates 437 and 438** detail the interior of the boiler room of **Cell 21**. The east and the north walls are shown of brick, though here also the detail of the underlying brickwork wall fabric has become obscured by being covered over with paintwork. To the right (south), is the internal modern hardboard partition that separates this boiler room from **Cell 22** to the south.

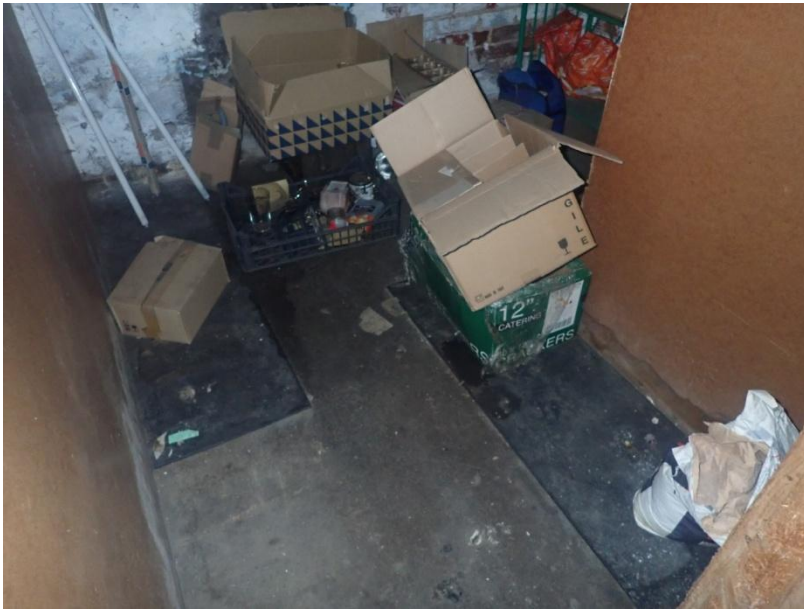
**Plate 440: View of the flooring of Cell 22, from the south-west**

**Plates 440 and 441** illustrate the nature of the flooring of **Cell 22**, which is of modern concrete.

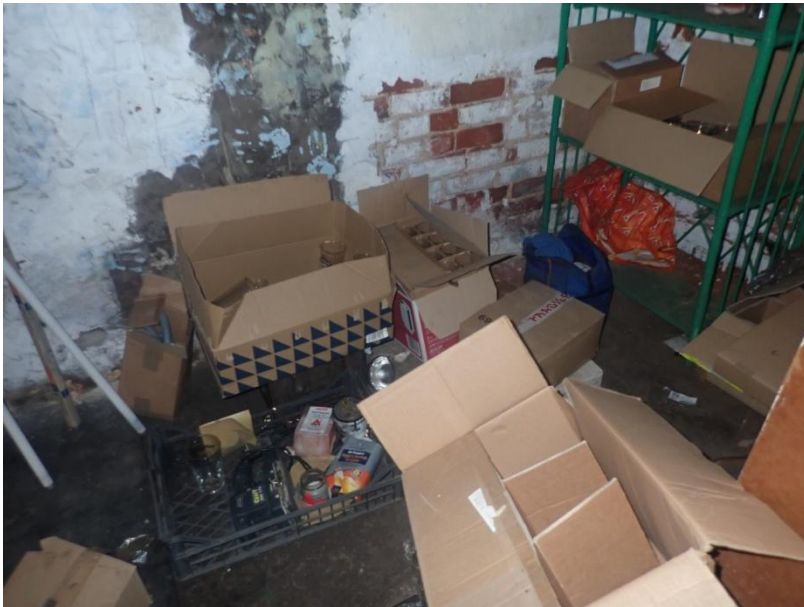
**Plate 441: View of the flooring of Cell 22, from the south-west**

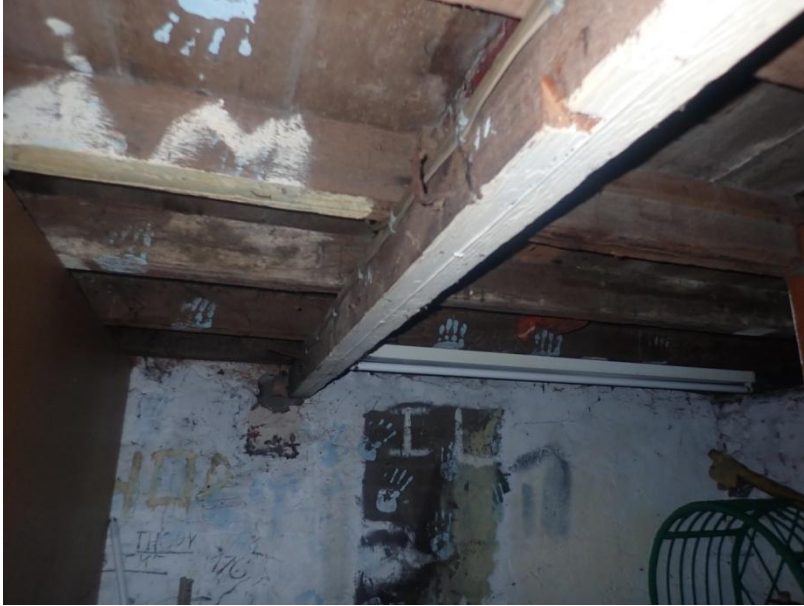
**Plate 442: View of the ceiling structure of Cell 22, from the south-west**

**Plates 442 and 443** provide detailed views of the nature of the ceiling structure of **Cell 22**. This is composed of a series of horizontal timber joists that are orientated from north-south. These in turn support the mezzanine floor covering above of horizontal timber planking, which are aligned from east-west.

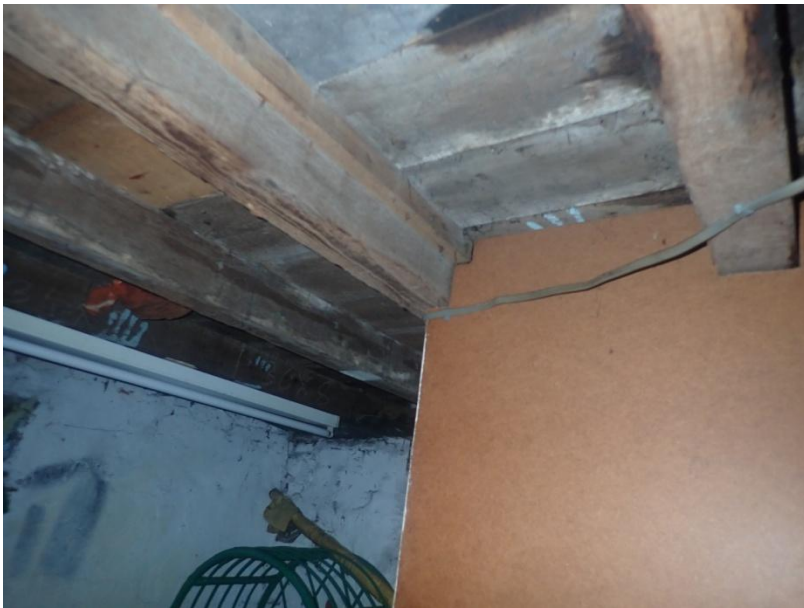
**Plate 443: View of the ceiling structure of Cell 22, from the north-west**

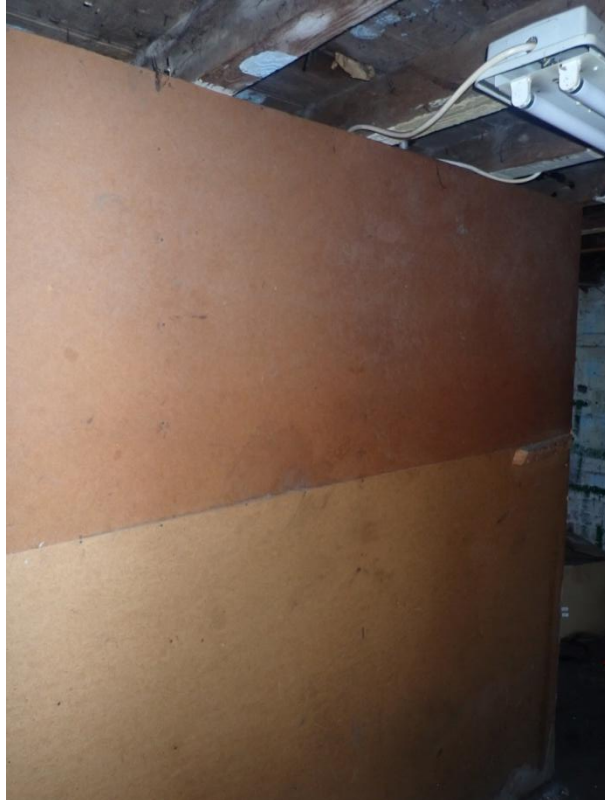
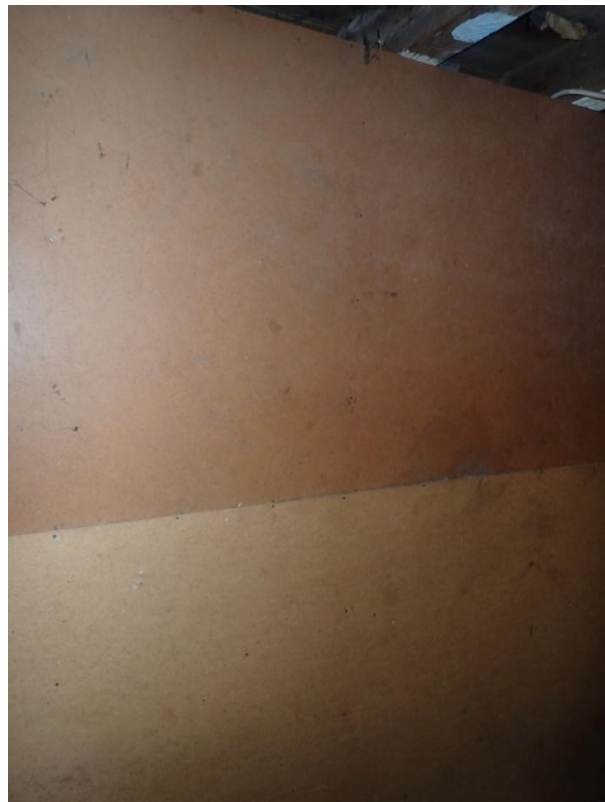
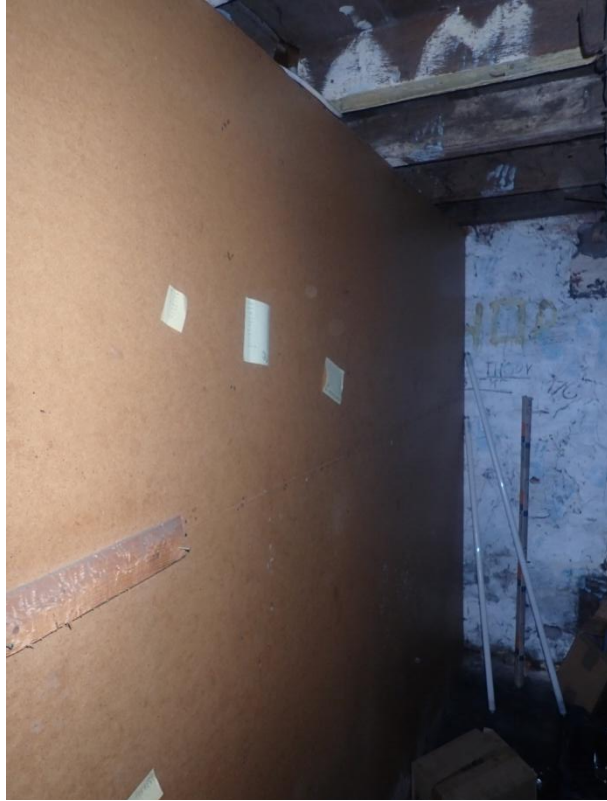
**Plates 444-446** feature the modern internal hardboard partition between **Cell 22** and **Cell 21** to the north.

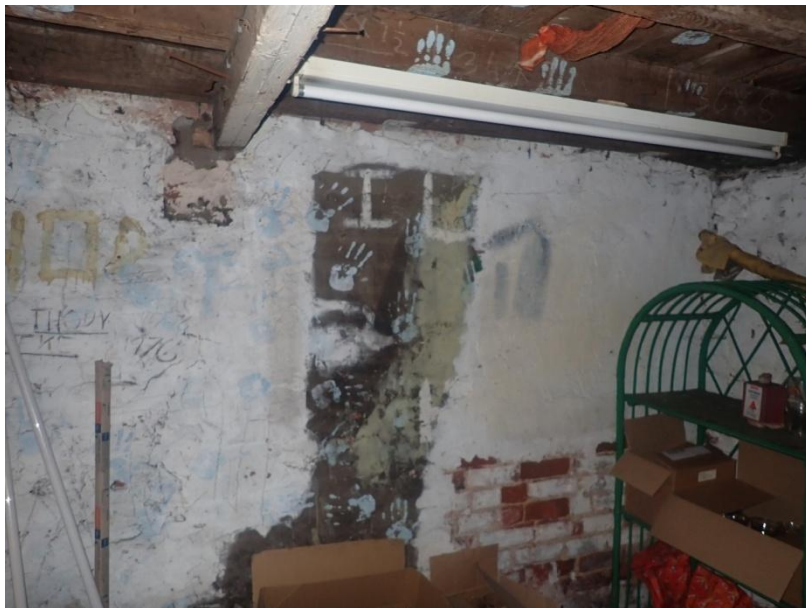
**Plate 447: View of the interior of Cell 22, from the north-west**

**Plate 447** presents a view of the east wall of **Cell 22**, which though constructed of brick, much of the detail of this underlying brickwork has become obscured by being painted over. At the lower levels, where this is absent, courses of brick stretchers and of mixed brick headers and brick stretches may be observed.

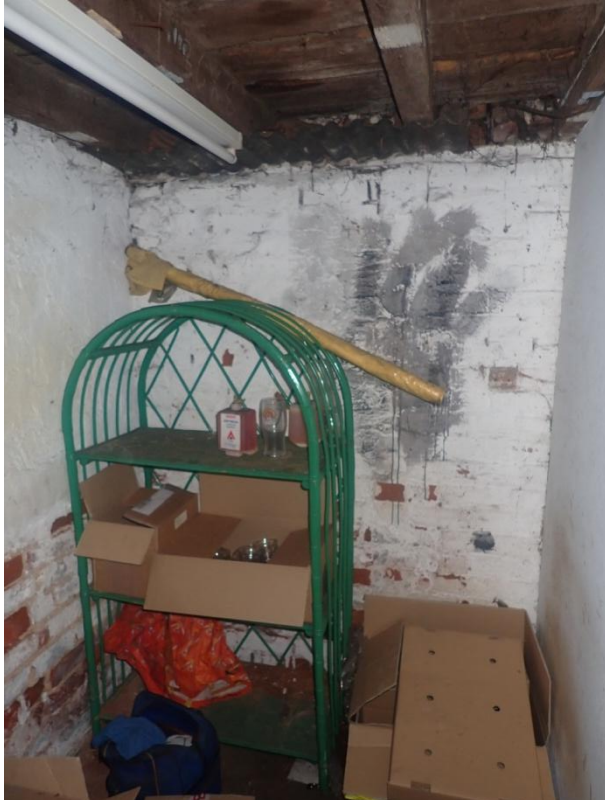
**Plate 448: View of the interior of Cell 22, from the north**

**Plate 448** presents a view of the south wall of **Cell 22**. Here also, the detail of the underlying brickwork wall fabric here has become obscured by being covered over with paintwork.

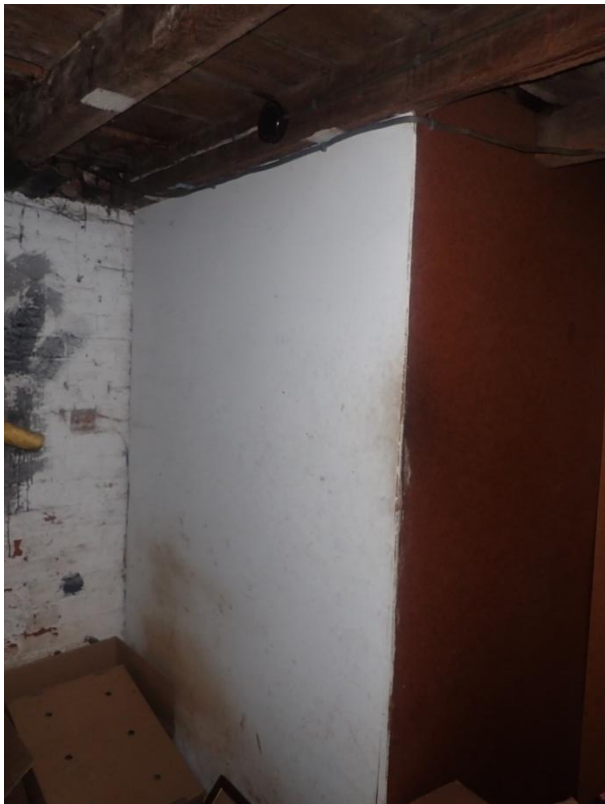
**Plate 449: View of the interior of Cell 22, from the north-east**

**Plates 449 and 450** feature the modern hardboard partition between this **Cell 22** and **Cell 23** to the south-west. The inner face of the modern hardboard and timber door that leads onto **Cell 21** to the west is also shown.

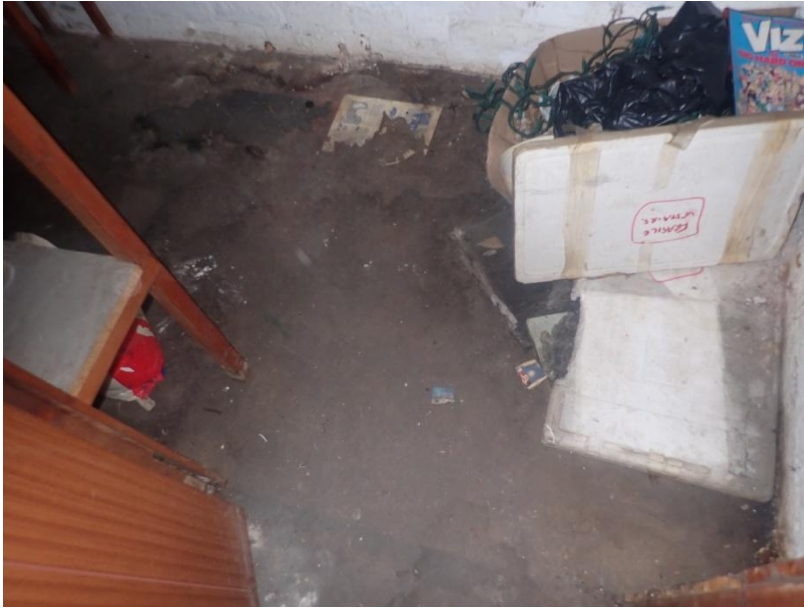
**Plates 451 and 452** feature the nature of the flooring of **Cell 23**, which is of modern concrete.

**Plate 451: View of the flooring of Cell 23, from the north-west**

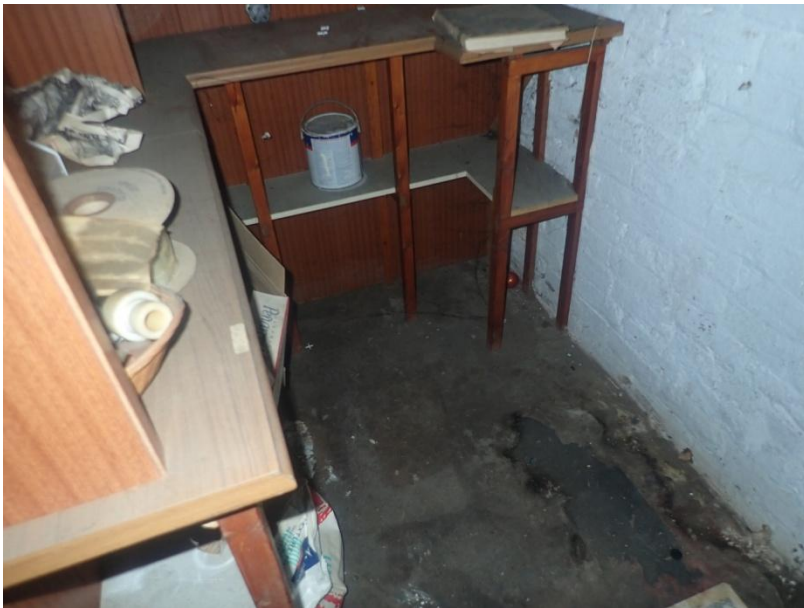
**Plate 452: View of the flooring of Cell 23, from the south-west**

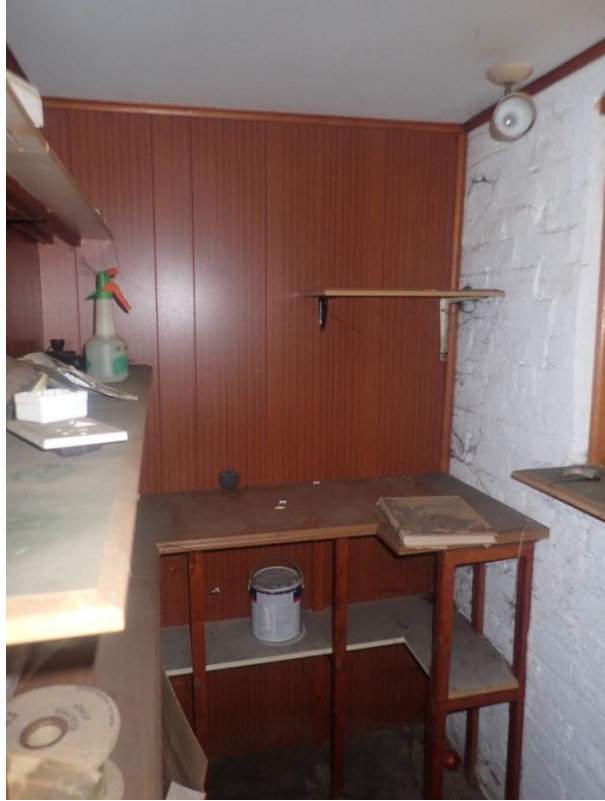
**Plate 453: View of the interior of Cell 23, from the south-west**

**Plate 453** shows the east wall of **Cell 23**, which is composed of modern timber panelling.

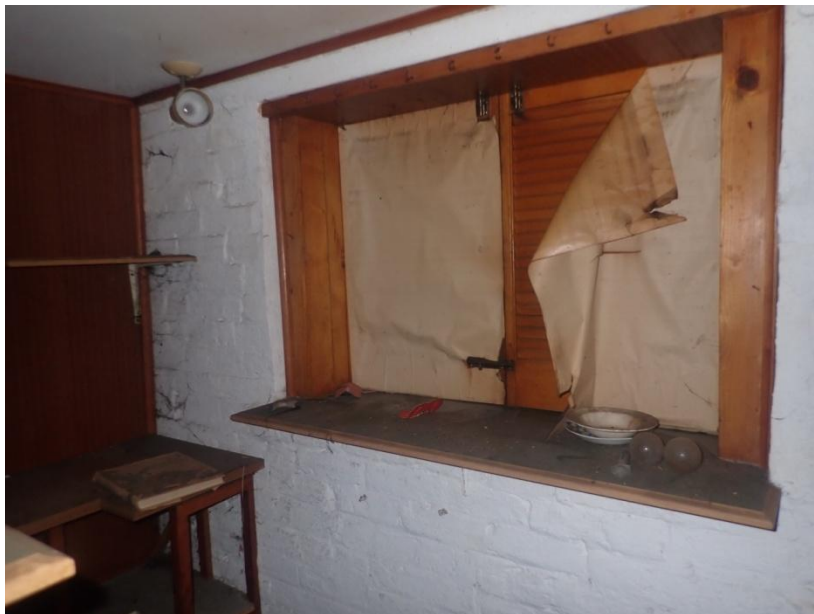
**Plates 454 and 455** present views of the south wall of **Cell 23**, the detail of the underlying brickwork wall fabric of which, has become obscured by being covered over with paintwork. The central feature here is the slightly recessed inner face of a modern timber serving hatch/counter, which served the former games room (**Cell 24**) to the public house to the east.

**Plate 454: View of the interior of Cell 23, from the north-west**

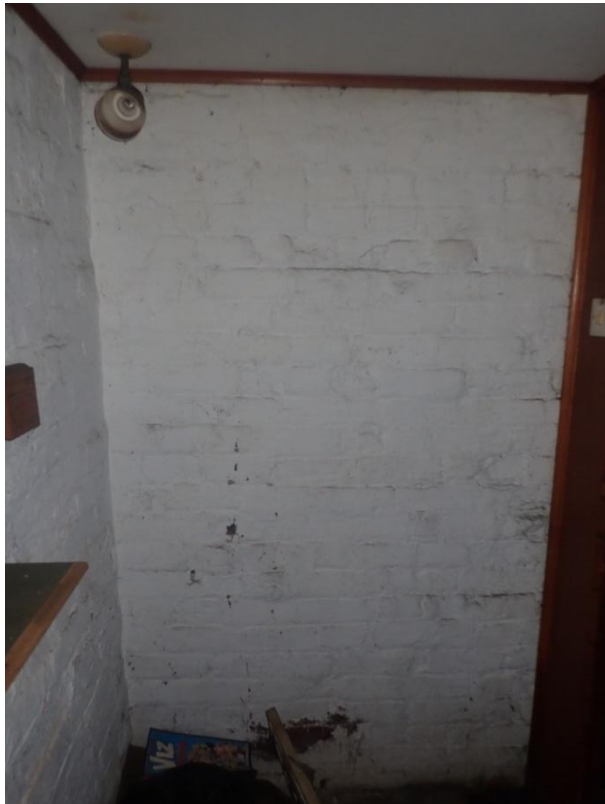
**Plate 456: View of the interior of Cell 23, from the north-east**

**Plate 456** provides a detailed view of the west wall of **Cell 23**. Here also, the detail of the underlying brickwork wall fabric of which, has become obscured by being covered over with paintwork.

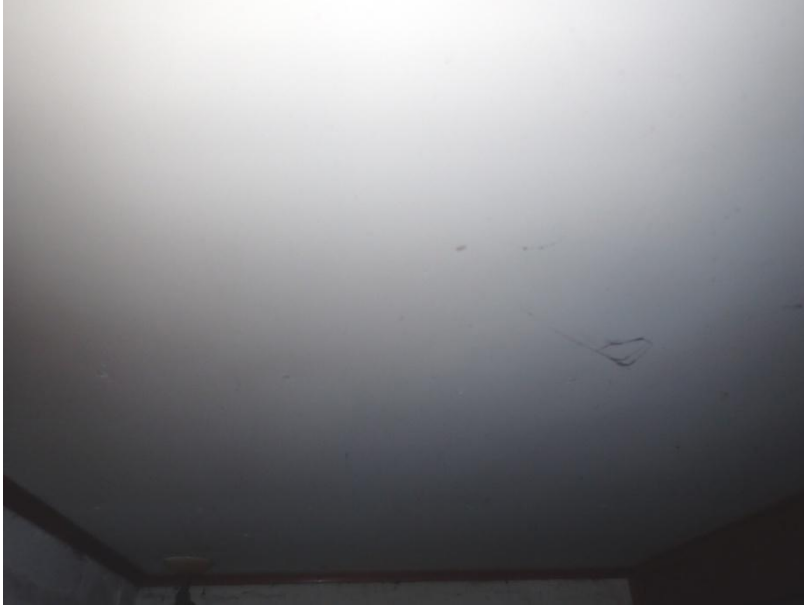
**Plate 457: View of the ceiling of Cell 23, from the north-east**

**Plates 457 and 458** illustrate the nature of the ceiling structure of **Cell 23**, which has been rendered over with modern plasterwork.

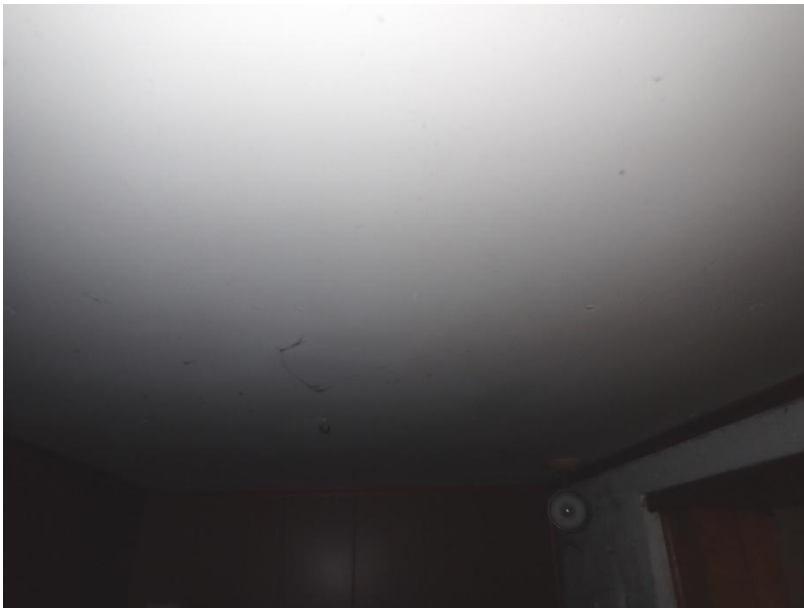
**Plate 458: View of the ceiling of Cell 23, from the south-east**

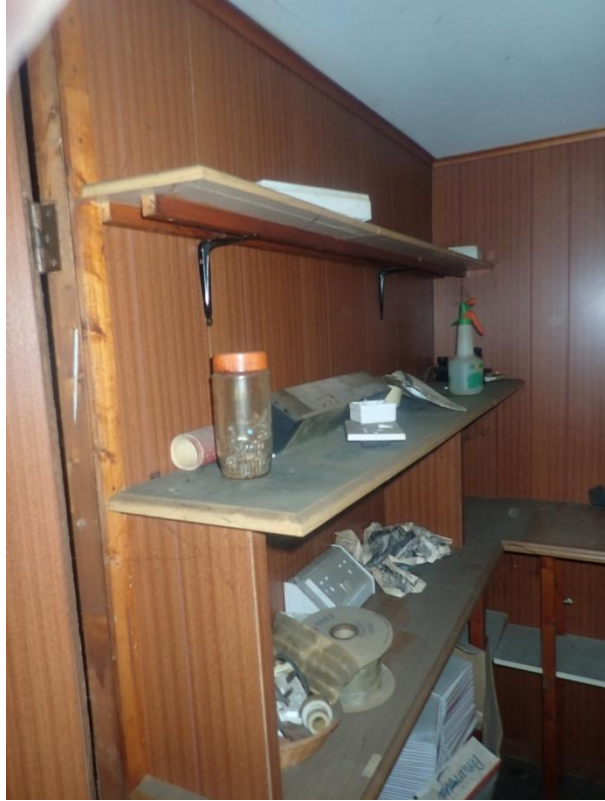
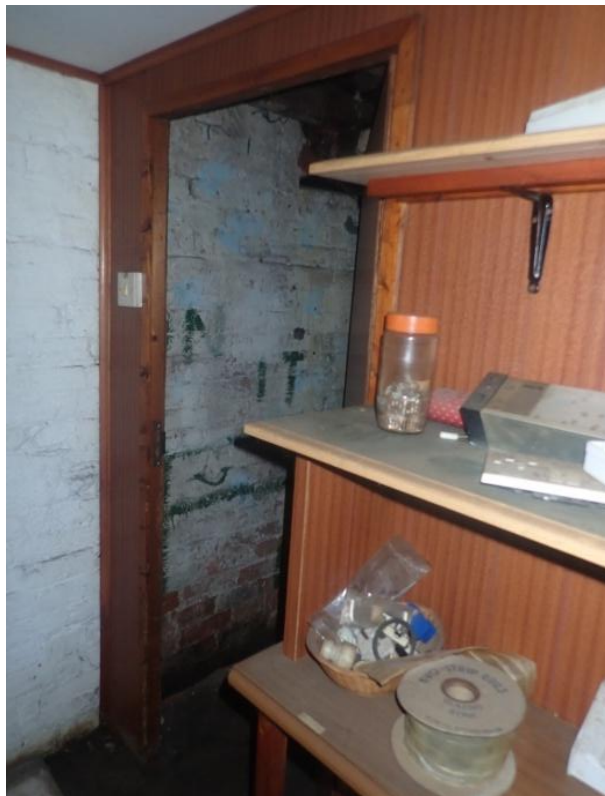
**Plates 459 and 460** provide views of the north wall of **Cell 23**, which is composed of modern timber panelling. Also shown is the north facing entrance opening, which leads onto the adjoining **Cell 21** to the north. This opening is occupied by a modern timber frame of a head and surrounds and by a modern timber panelled door.

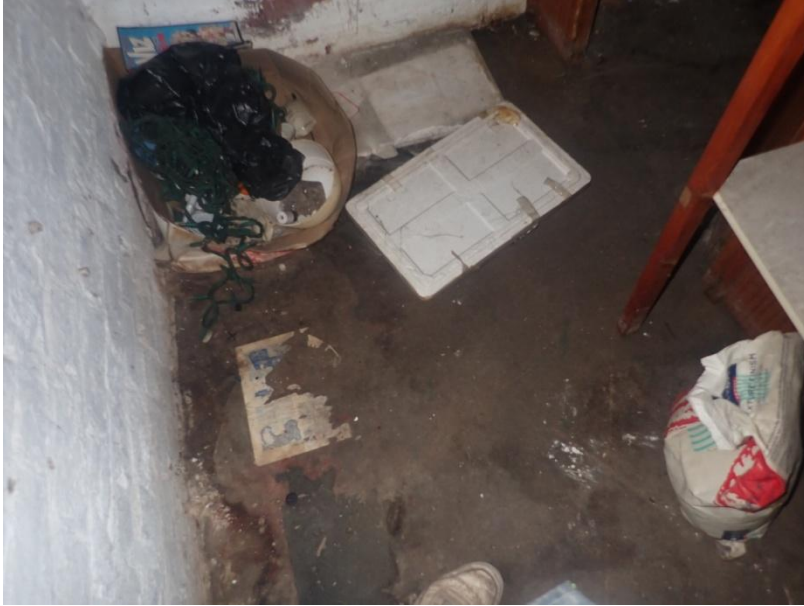
**Plate 461: View of the flooring of Cell 23, from the north-east**

**Plate 461** provides a further view of the nature of the flooring of **Cell 23**, which is of modern concrete.

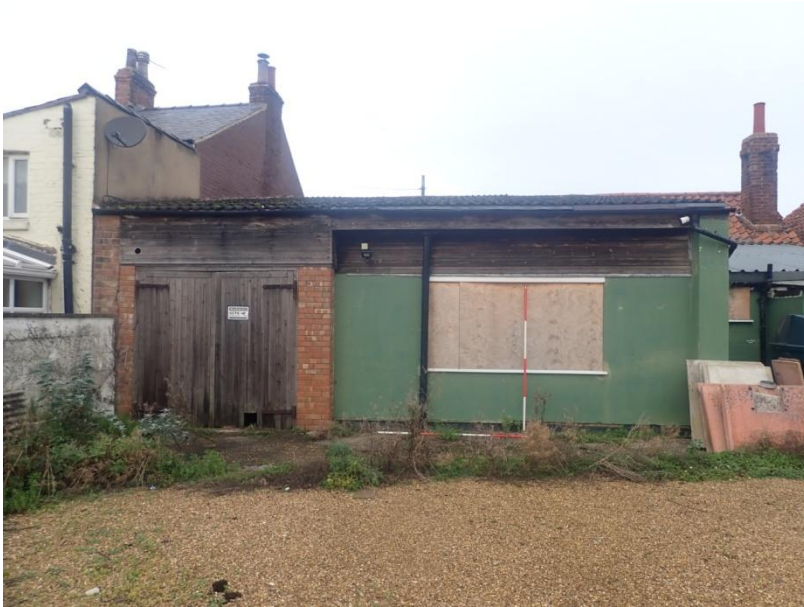
**Plate 462: View of the South Elevation of Building 6, from the south-east**

**Plates 462 and 463** show the South Elevation of **Building 6**, which is clearly a modern addition to this former pubic house complex. This is a single storey building with a low angled half gabled roof and a roof covering of sheets of corrugated metal, which had a former dual role with the eastern portion comprising a former games room and with the western portion along with **Cell 10** of **Building 5** to the north, functioning as a former working commercial garage. This duality of purpose is reflected in the appearance of this South Elevation, the eastern portion of the brickwork wall fabric of which has been covered over with modern cement rendering. Above this rendering and at just below roof levels is modern timber weatherboarding, which also extends westwards to the upper levels of the western portion of this building. Also within this eastern portion is a blocked off south facing window opening that has been boarded over.

Within the western portion of the building, the brickwork is visible as two columns which flank both sides. This brickwork is composed of courses of brick stretchers. Enclosed by these two columns is a south facing entrance opening, that is occupied by a timber frame of a head and surrounds and by a pair of timber doors, each in turn composed of a series of vertical tongued and grooved timber planks. The doors are attached to the frame by two pairs of cast metal strap hinges. A vertical metal pillar may also be seen to be supporting the frontal roof structure of the building. At just below roof levels is modern Upvc horizontal guttering that extends onto a vertical modern Upvc downpipe to the east.

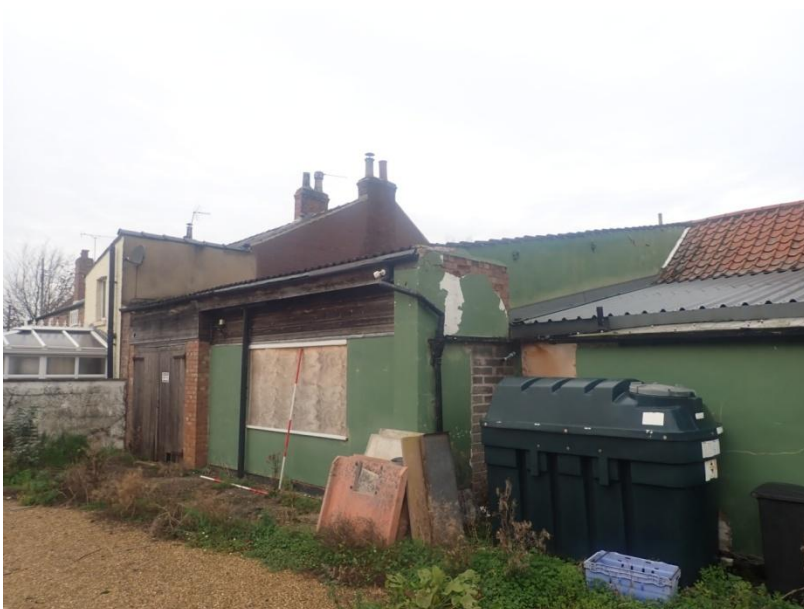
**Plate 464: View of the East Elevation of Building 6, from the south-east**

**Plate 464** provides a view of the East Elevation of this building. Most of the brickwork wall fabric on this Elevation has been covered with modern cement rendering. A portion of this brickwork is exposed, where this rendering is absent however. Here, this is composed of a mix of courses of

brick stretchers, of courses of mixed brick headers and stretchers and a single course of brick headers.

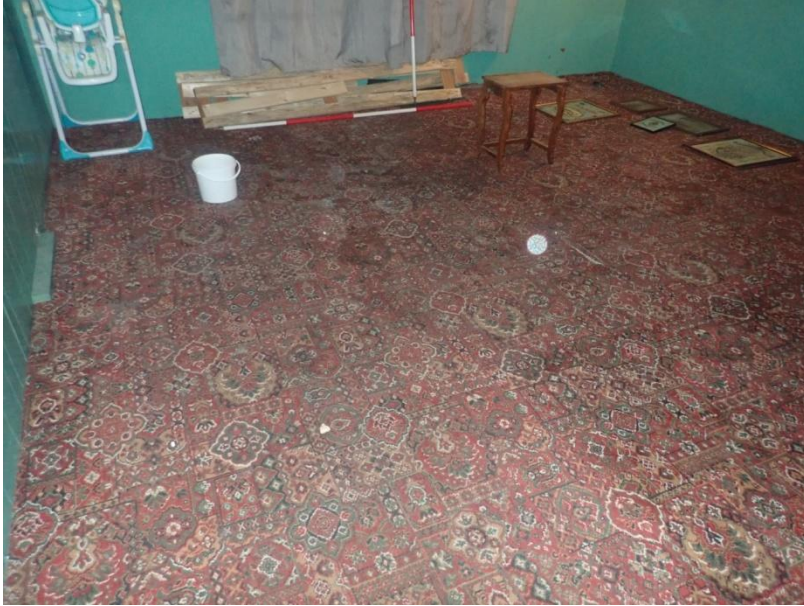
**Plate 467: View of the flooring of Cell 24, from the north-east**

**Plates 467 and 468** feature the nature of the flooring of **Cell 24**, which is covered with modern carpeting.
