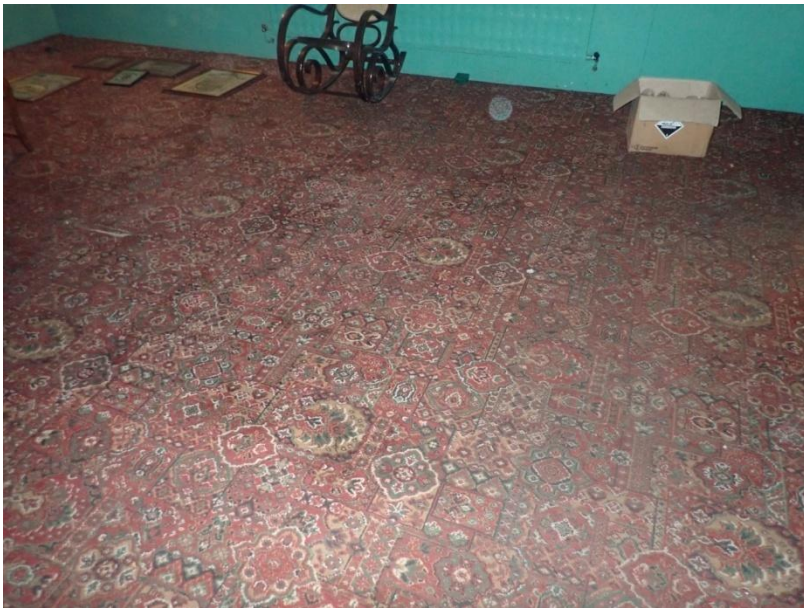
**Plate 468: View of the flooring of Cell 24, from the north-east**

**Plates 467 and 468** feature the nature of the flooring of **Cell 24**, which is covered with modern carpeting.

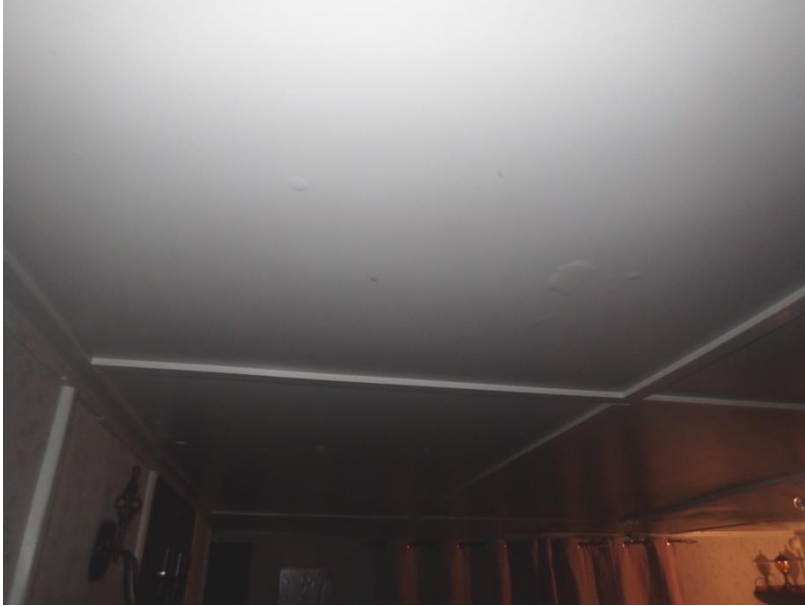
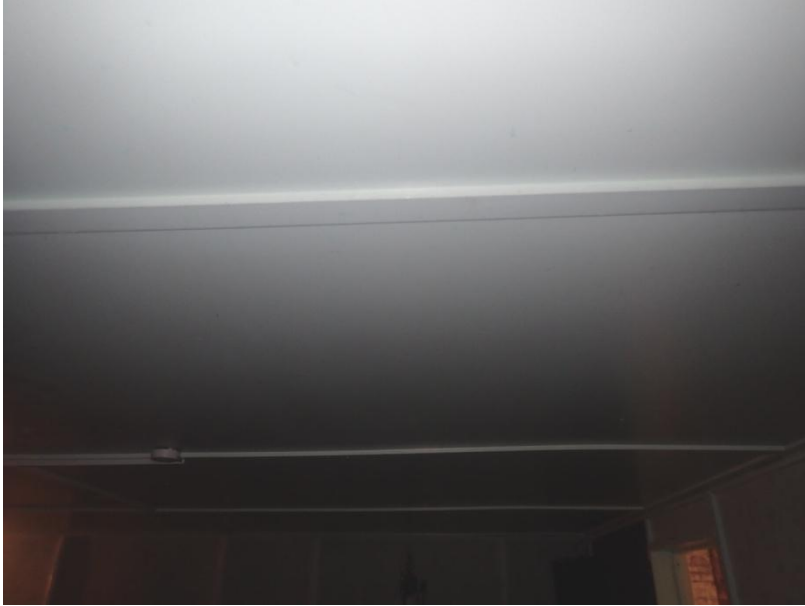
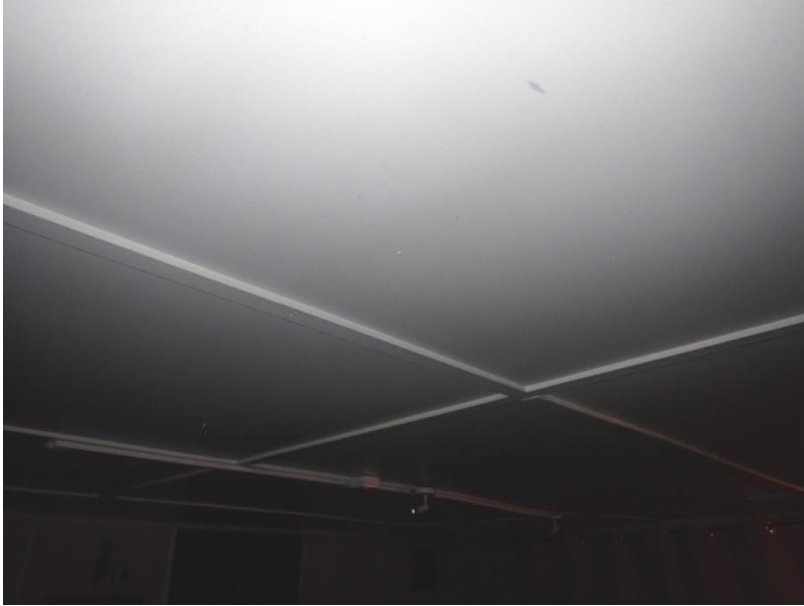
**Plates 469-474** feature a number of views from differing positions of the nature of the ceiling structure of **Cell 24**. This consists of a timber framework within which the ceiling surface has been rendered over with modern plasterwork.

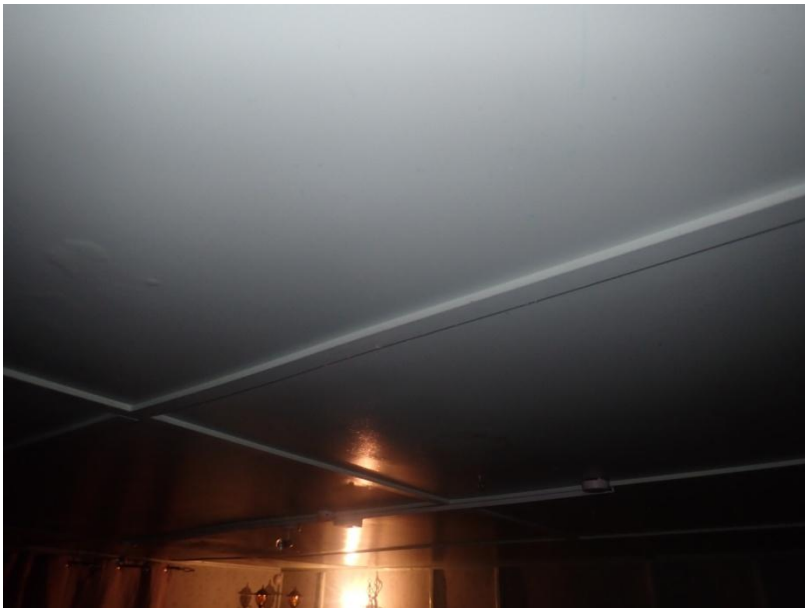
**Plate 470: View of the ceiling of Cell 24, from the north-east**

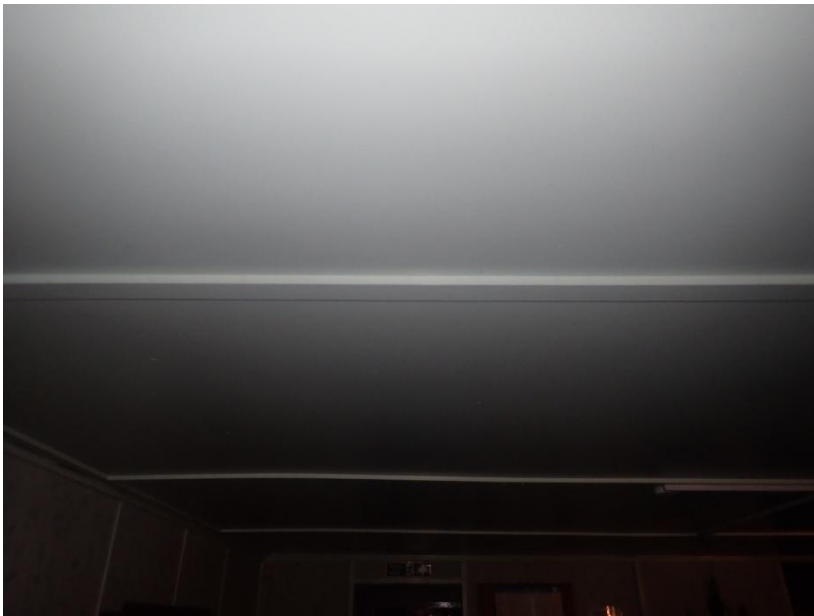
**Plate 472: View of the ceiling of Cell 24, from the north-east**

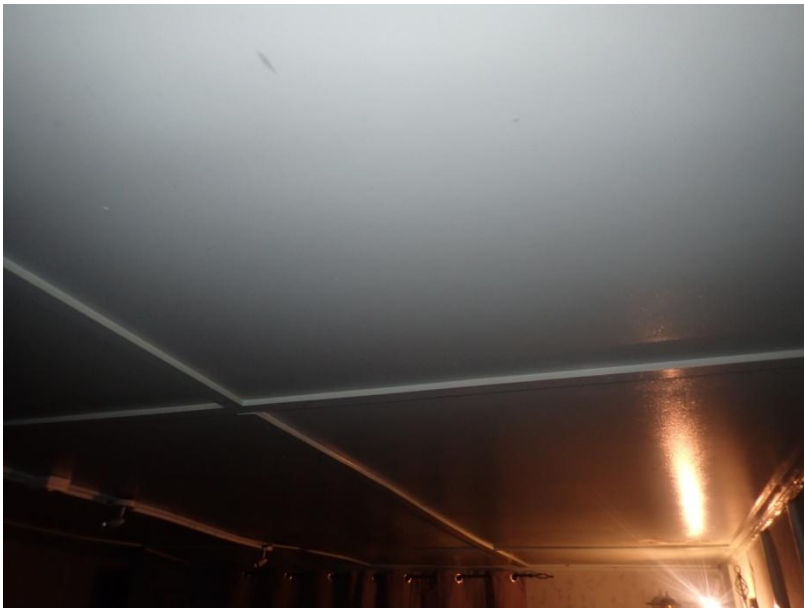
**Plate 474: View of the ceiling of Cell 24, from the north-west**

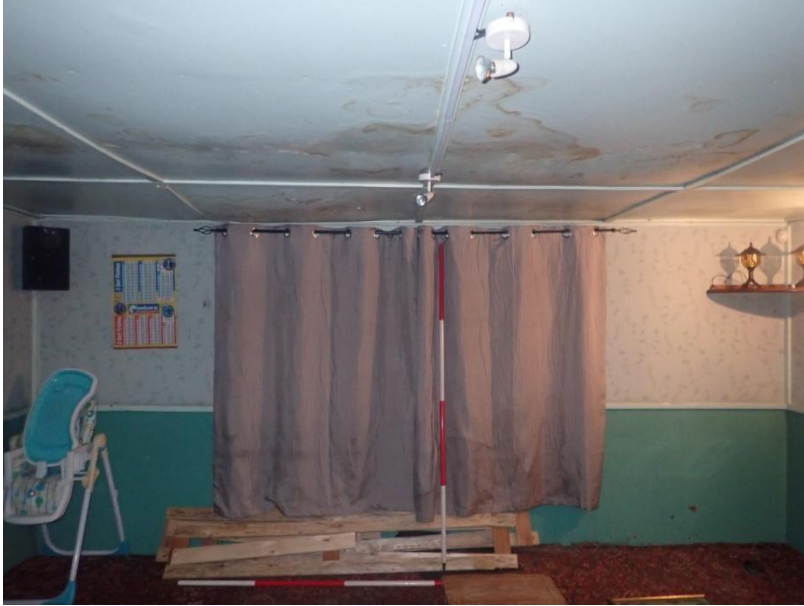
**Plate 475: View of the south wall of Cell 24, from the north-west**

**Plate 475** presents a detailed view of the south wall of **Cell 24**. The wall fabric here has been covered over with modern wallpaper with horizontal timber dado rails inserted into this fabric at mid levels. Also shown is the inner face of the south facing window opening that was recorded externally at the South Elevation of this building and which was boarded over.

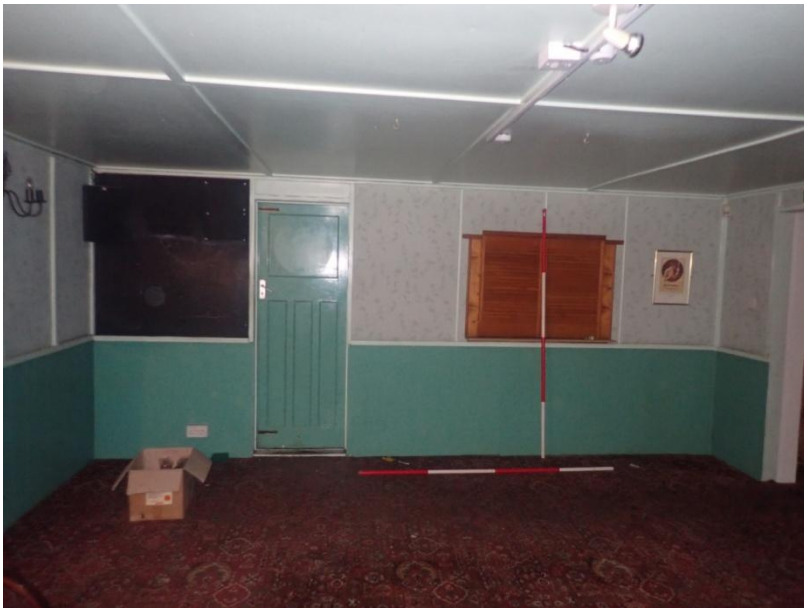
**Plate 476** furnishes a view of the north wall of **Cell 24**, which is also the internal dividing wall with the adjacent **Cells 22 and 23 of Building 5** to the north. The wall fabric here has also been covered over with modern wallpaper with horizontal timber dado rails inserted into this fabric at mid levels. Also shown is the inner face of the north facing entrance opening that leads onto **Cell 19** to the north. This opening is occupied by a timber frame of a head and surrounds and by a modern panelled timber door. To the right (east), is the outer face of the modern timber serving hatch, that was also recorded within the adjacent **Cell 22 of Building 5** to the north.

**Plate 476: View of the north wall of Cell 24, from the south-east**

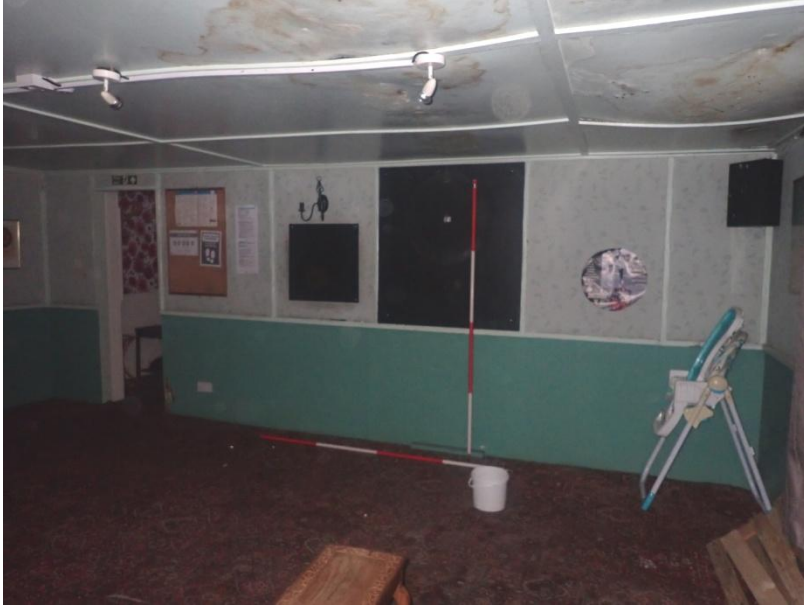
**Plate 477: View of the east wall of Cell 24, from the south-west**

**Plates 477 and 478** present views of the east wall of **Cell 24**, which has also been covered over with modern wallpaper with horizontal timber dado rails inserted into this fabric at mid levels. To the left (north), is the open access which leads onto **Cell 16 of Building 4** to the east.

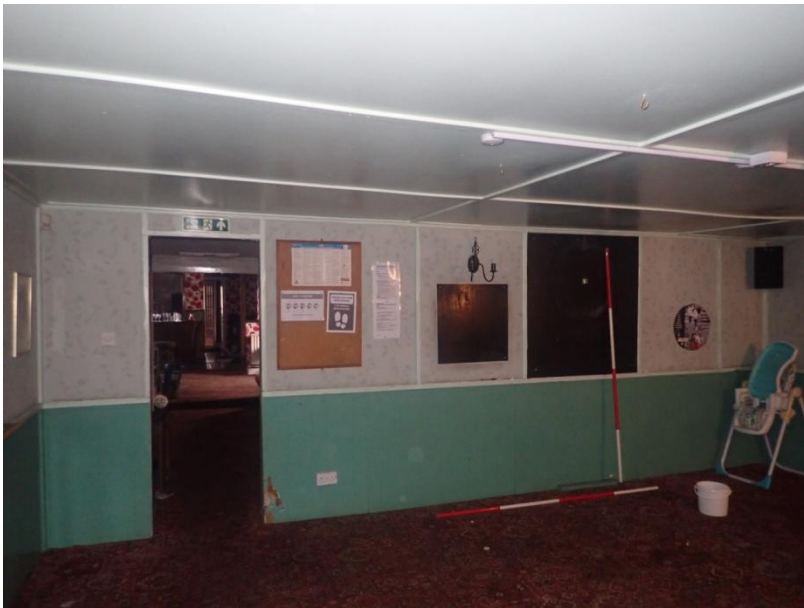
**Plate 478: View of the east wall of Cell 24, from the north-west**

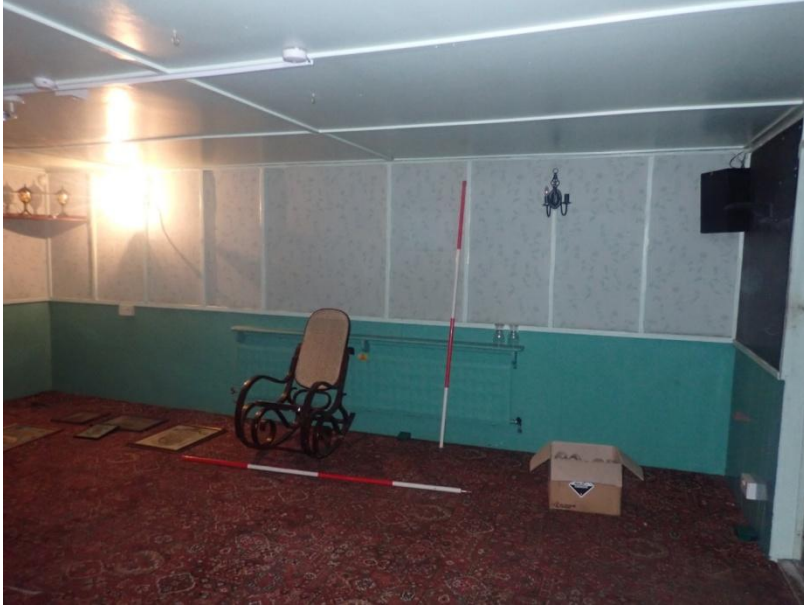
**Plate 479: View of the west wall of Cell 24, from the north-east**

**Plates 479 and 480** provide views of the west wall of **Cell 24**, which has also been covered over with modern wallpaper with horizontal timber dado rails inserted into this fabric at mid levels.

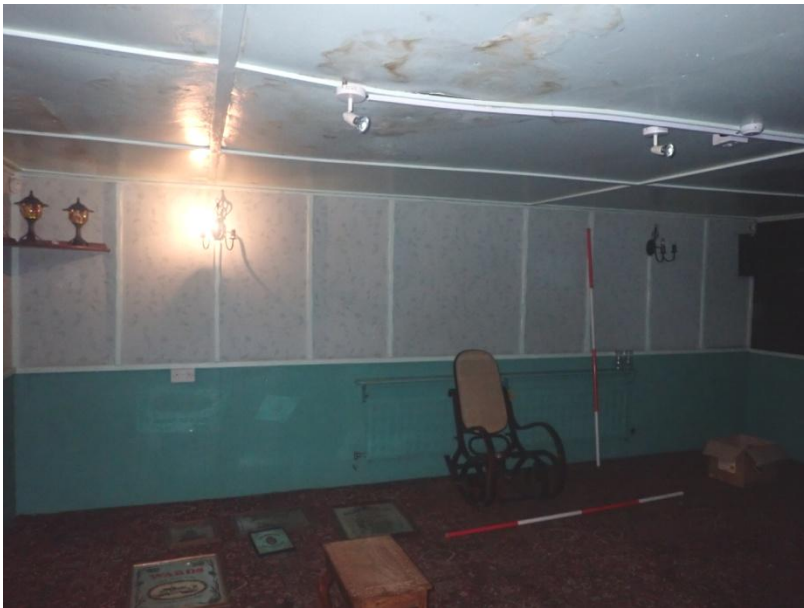
**Plate 480: View of the west wall of Cell 24, from the south-east**

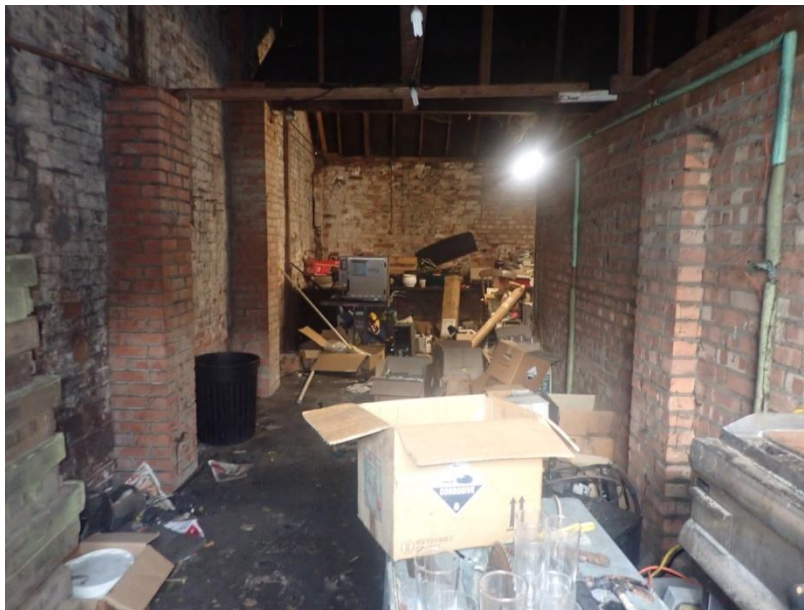
**Plate 482: General view of the interior of Cell 25, from the south-east**

**Plate 482** provides a general view of the interior of **Cell 25** from a south-eastern position. This formerly functioned as a garage. This space is incorporated with the adjoining **Cell 19 of Building 5** to the north. This combined formed the whole former garage space. A portion of the original South Elevation of the older **Building 5**, would have been removed to accommodate this modern function.

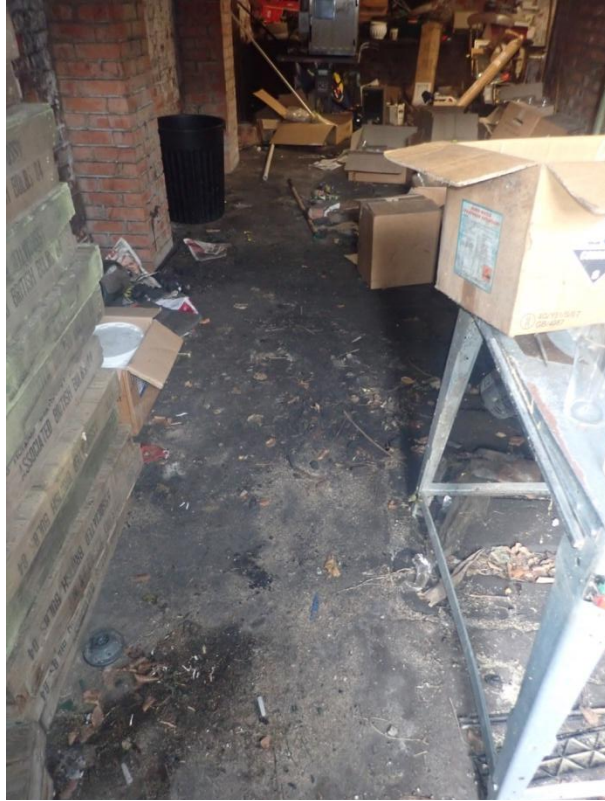
**Plate 483: View of the flooring of Cell 25, from the south-east**

**Plate 483** provides a view of the nature of the flooring of **Cell 25**, which is of modern concrete.

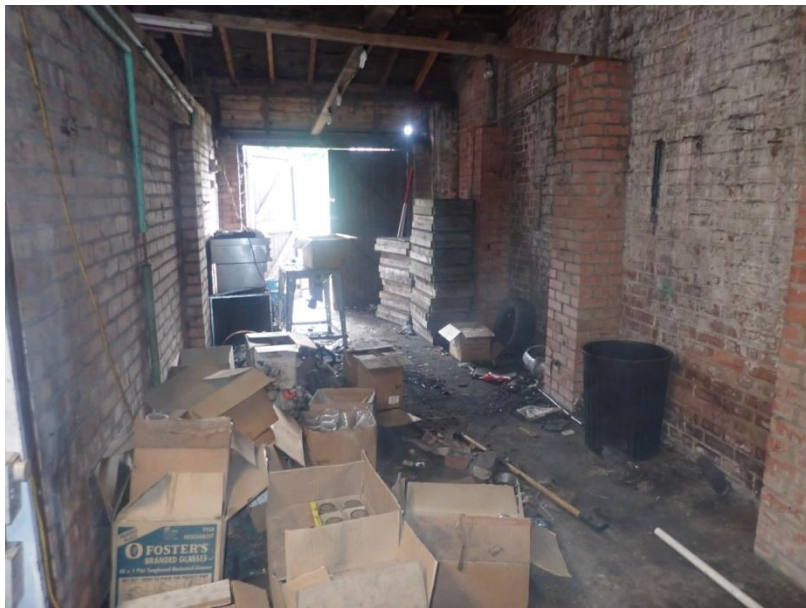
**Plate 484: General view of the interior of Cell 25, from the north-west**

**Plate 484** provides a further general view of the interior of **Cell 25** from a different north-western vantage point.

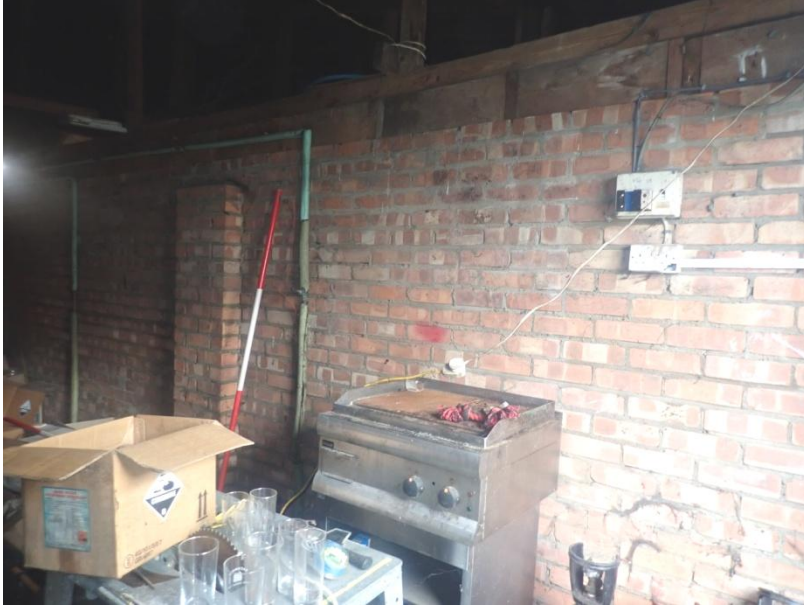
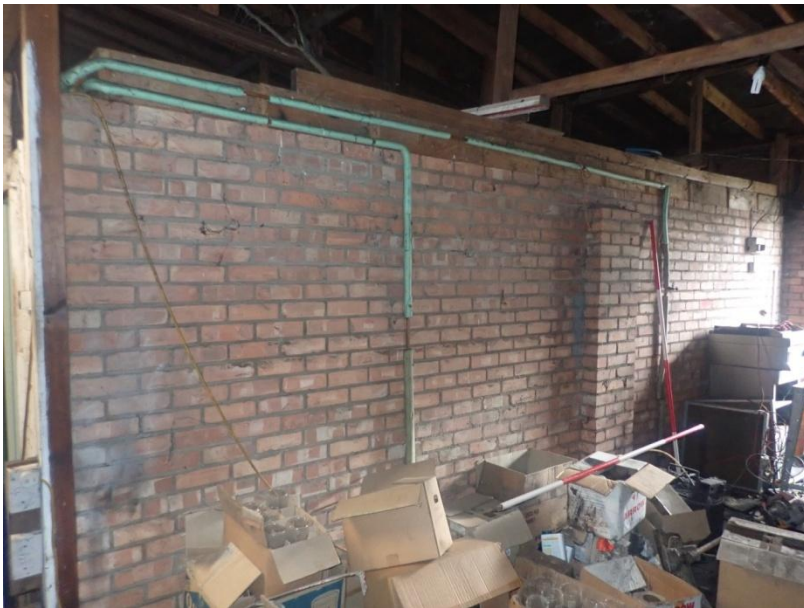
**Plate 485: View of the east wall of Cell 25, from the south-west**

**Plate 486: View of the east wall of Cell 25, from the north-west**

**Plates 485 and 486** furnish views of the east wall of **Cell 25**, which is also the internal dividing wall with the adjacent **Cell 24** to the east. The brickwork wall fabric here, including that of the bonded vertical brick column is composed of courses of brick stretchers in Stretcher Bond.

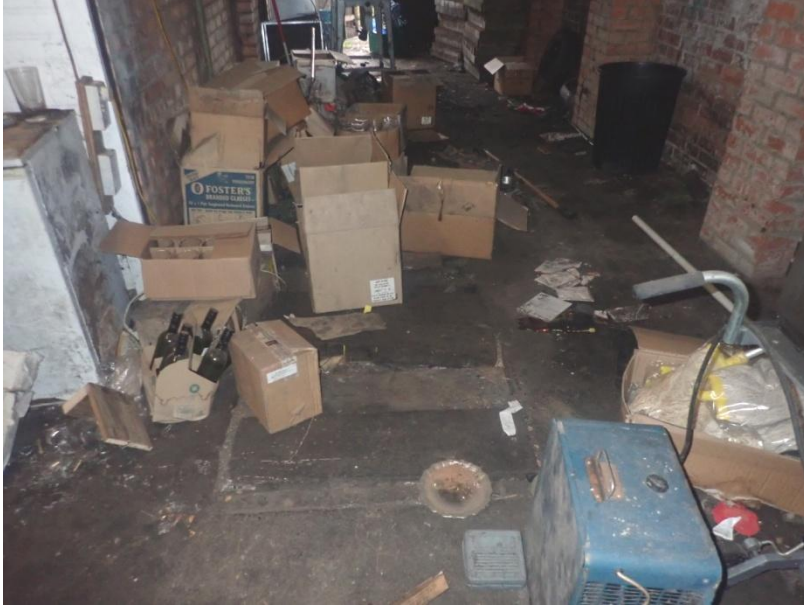
**Plate 487** View of the flooring of Cell 25, from the north-west

**Plate 487** provides a further view of the nature of the flooring of **Cell 25**, from a different north-western perspective, which is of modern concrete. Sunk into this flooring is a former vehicle inspection pit.

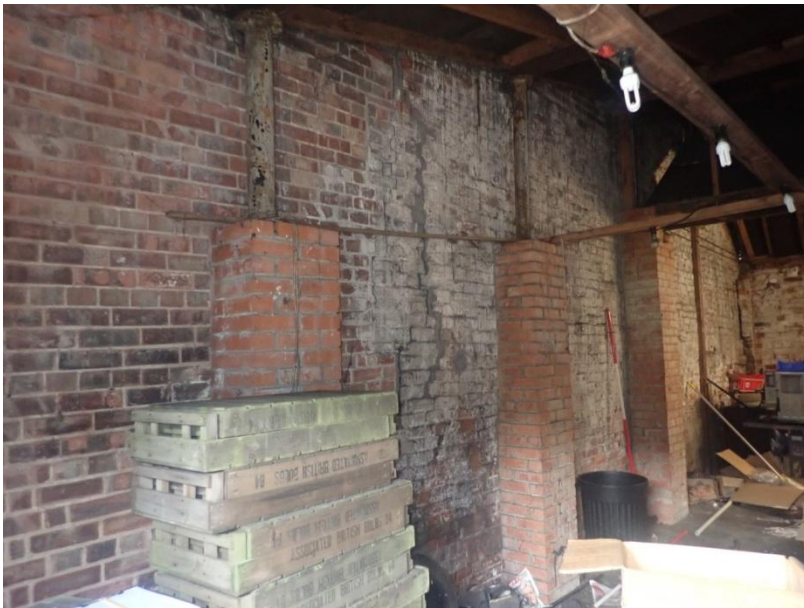
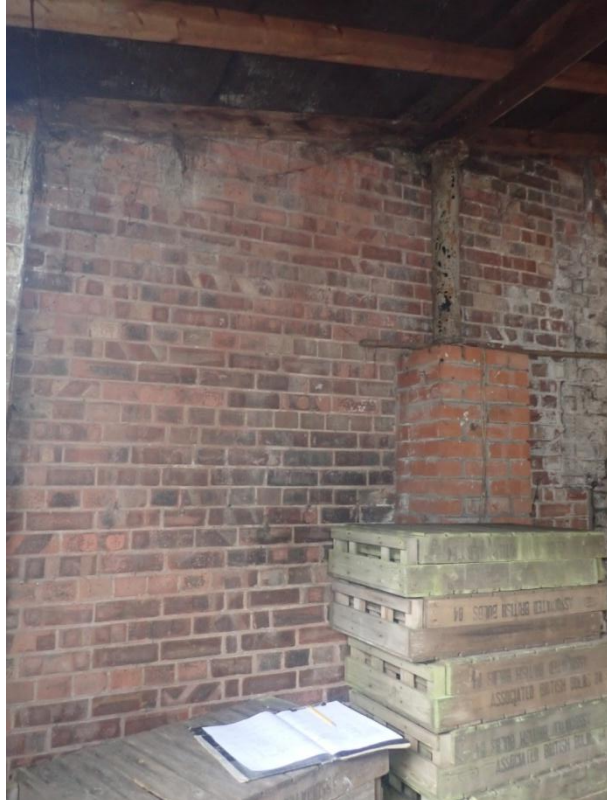
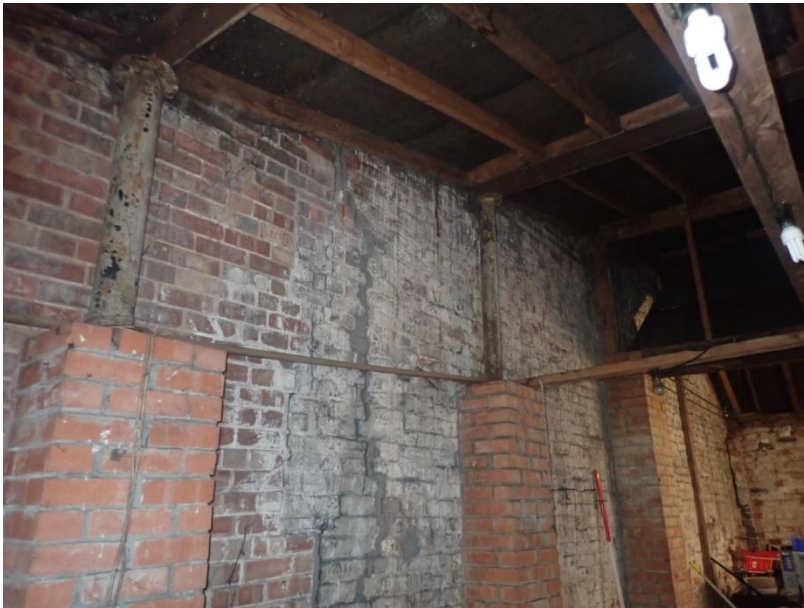
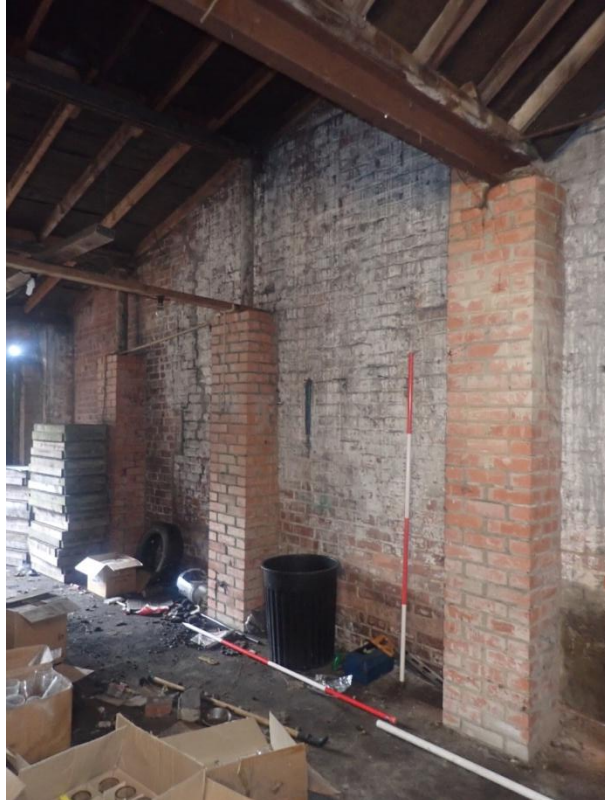
**Plate 488:** View of the west wall of Cell 25, from the south-east

**Plates 488-491** provide several images of the west wall of **Cell 25**. Most of this wall fabric pertains to the East Elevation of an adjoining building, which is outside of the scope of this survey. Additional new brickwork associated with the construction of the modern **Building 6** is featured to the south. This brickwork is composed of three courses of brick stretchers that alternate with single courses of brick headers in English Garden Wall Bond. The three bonded vertical brick columns are part of this modern construction and are each composed of courses of brick stretchers.

Plate 489: View of the west wall of Cell 25, from the south-east

Plate 490: View of the west wall of Cell 25, from the south-east

**Plate 491: View of the west wall of Cell 25, from the north-east**

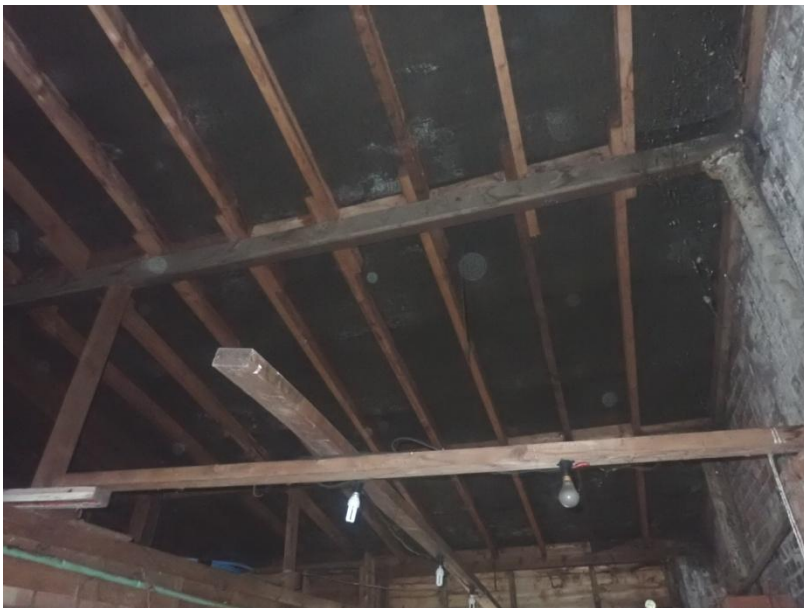
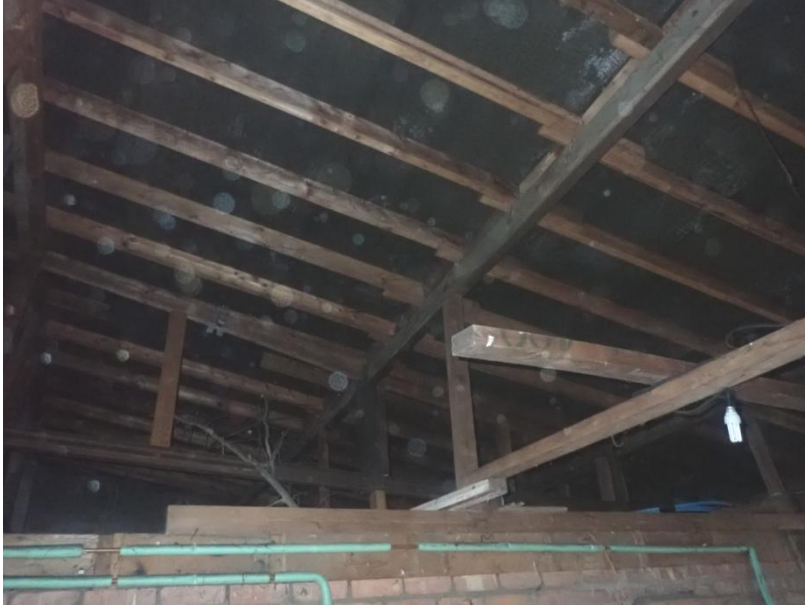
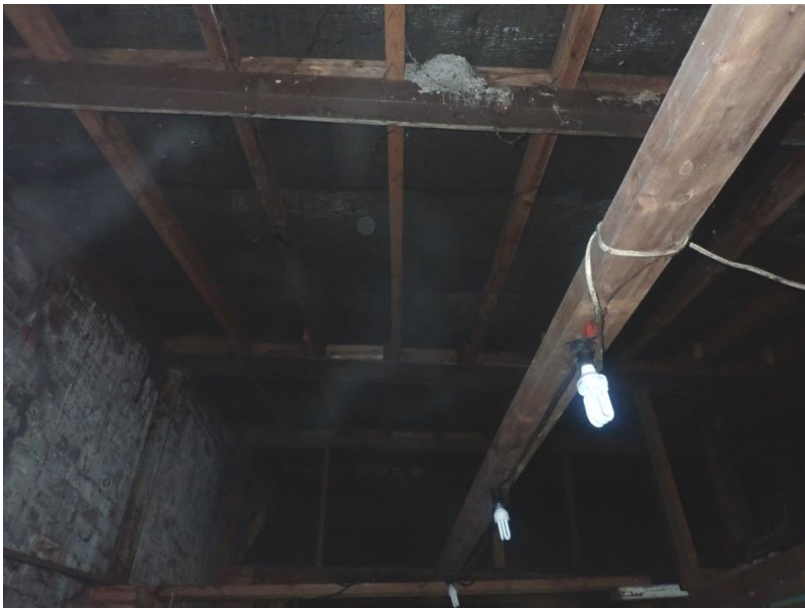
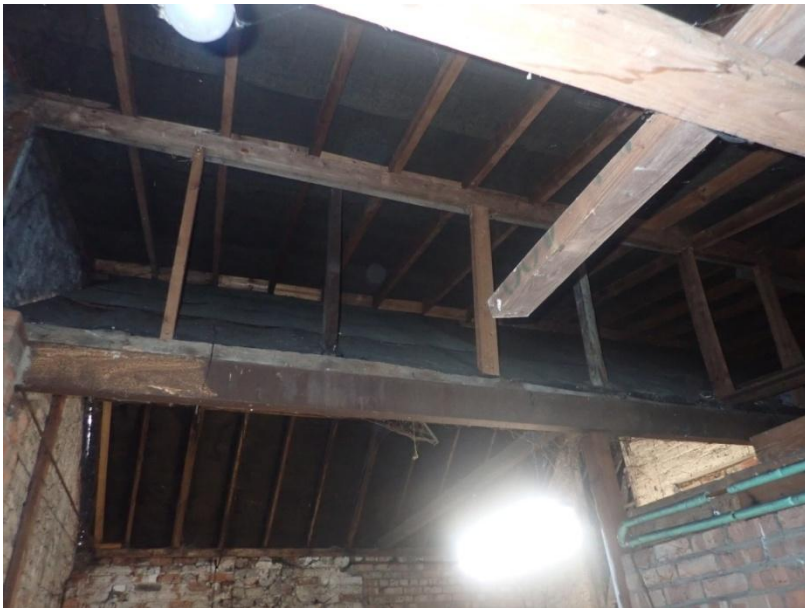
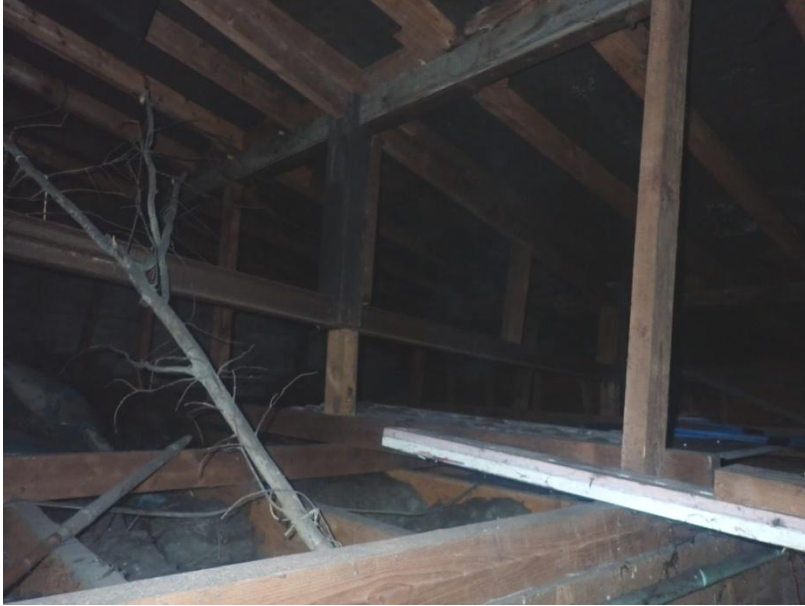
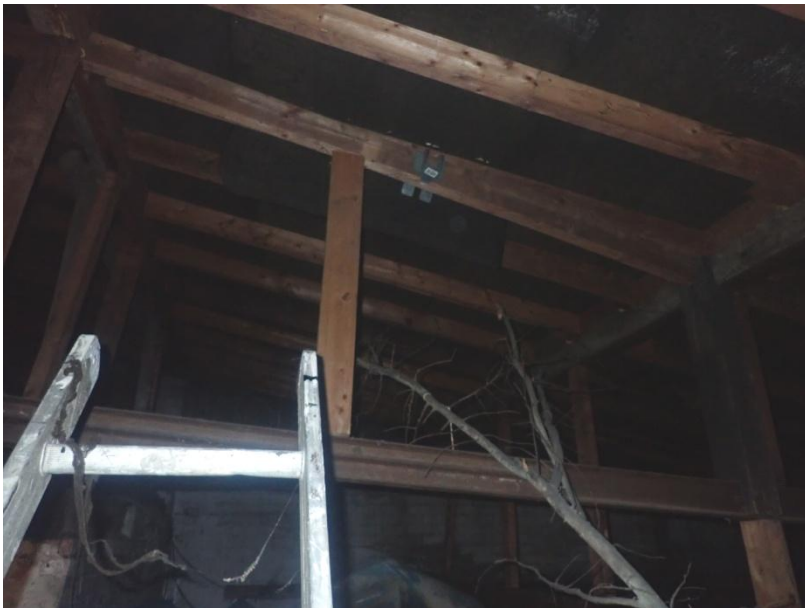
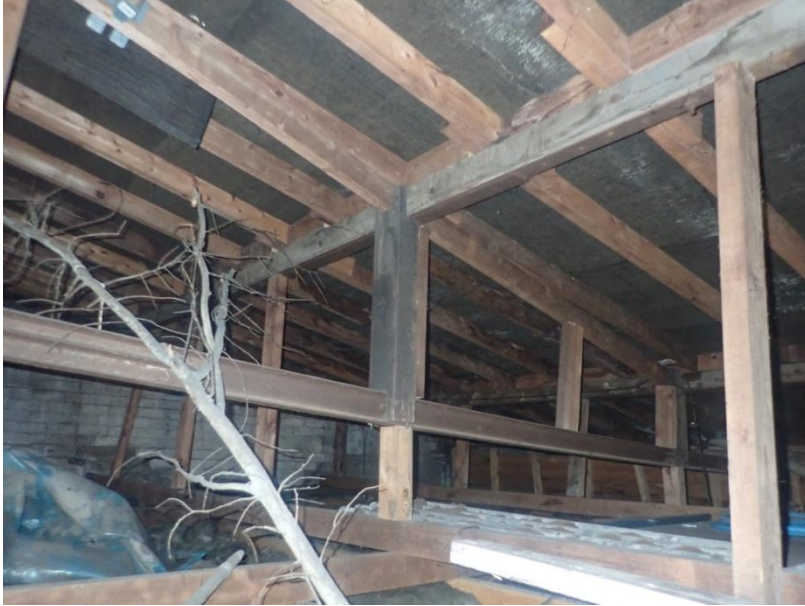
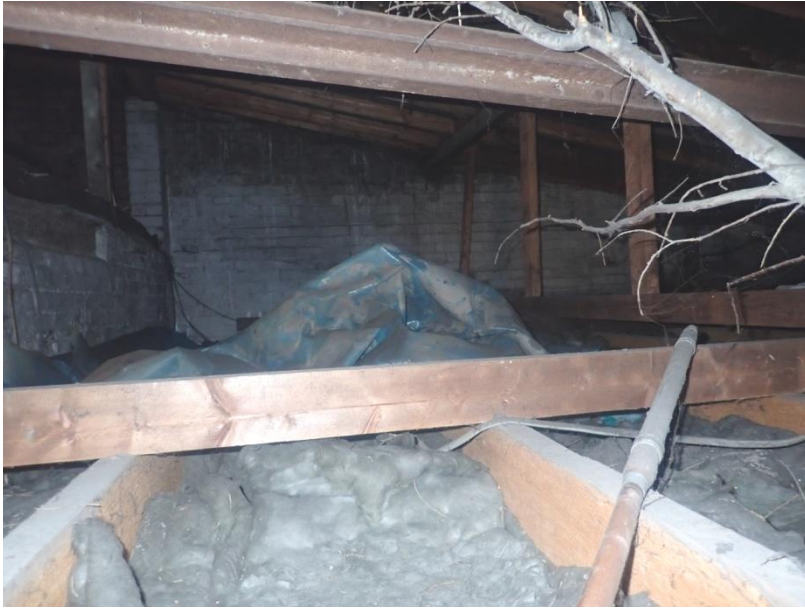
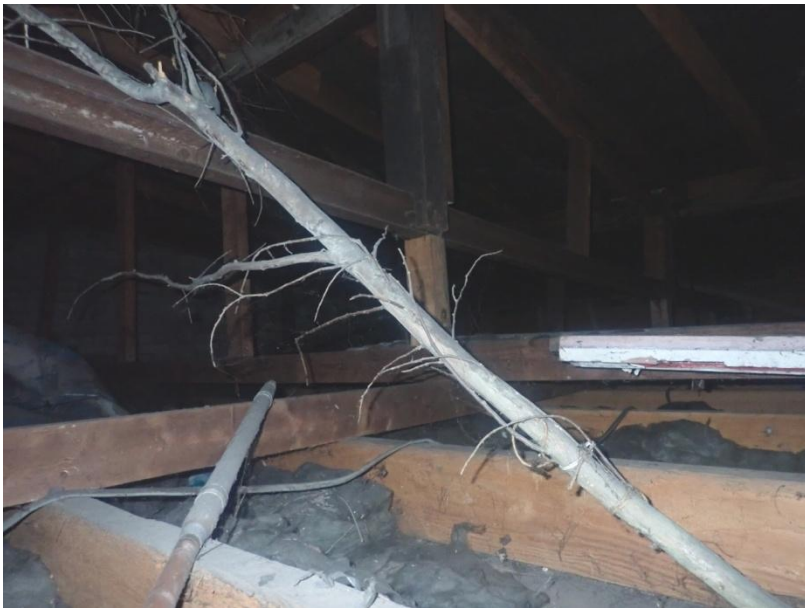
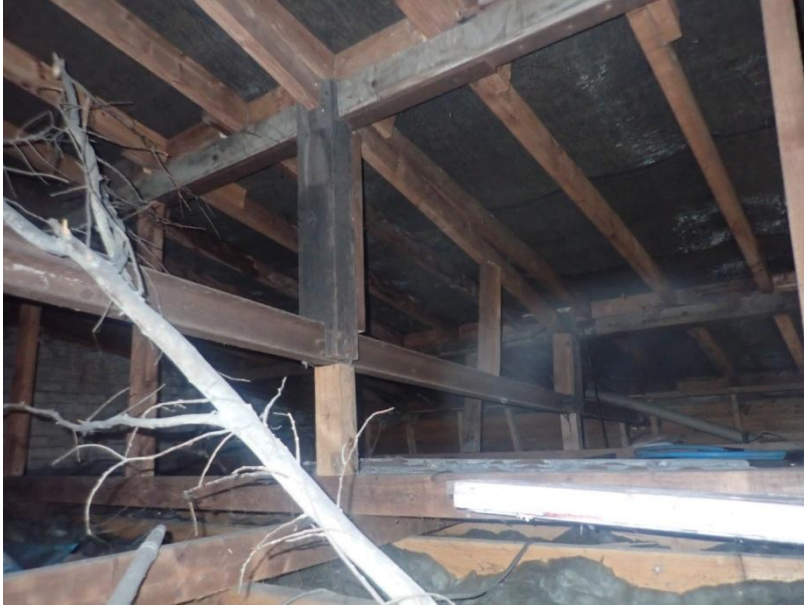
**Plate 492: View of the roof supporting structure of Building 6, from the north-west**

**Plates 492-503** present a number of views of the nature of the roof supporting structure of **Building 6**. This is a low angled half gabled roof structure, which consists of a framework of a series of north-south orientated timber rafters and east-west aligned timber purlins. Providing additional strength and reinforcement to this structure are several half gabled timber roof trusses.

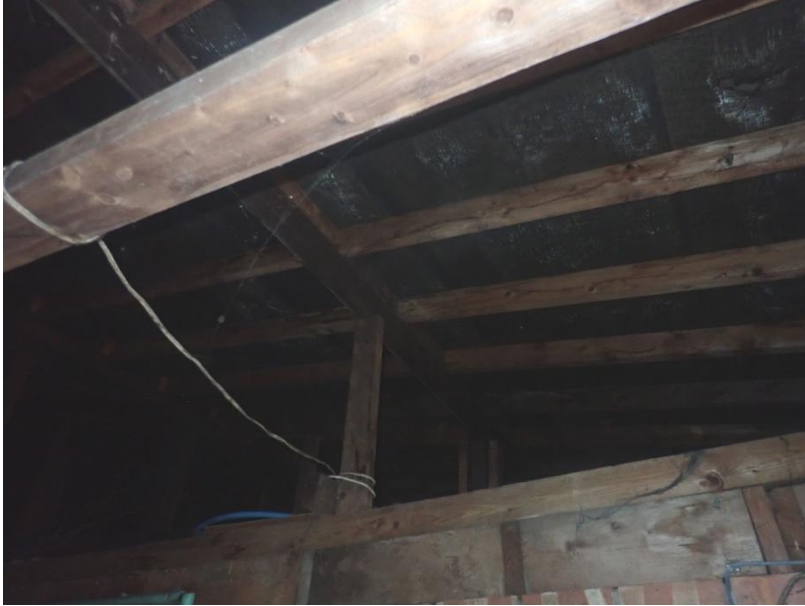
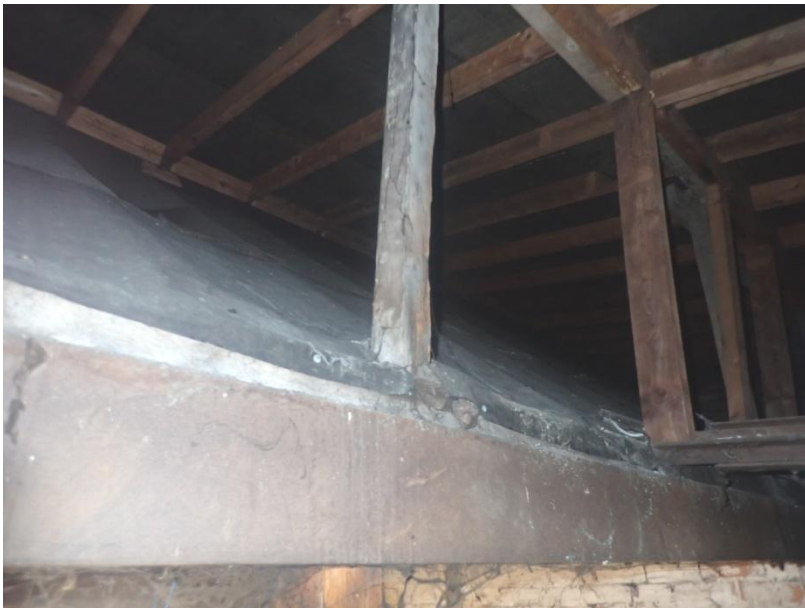
**Plate 495: View of the roof supporting structure of Building 6, from the south-west**

**Plates 495 and 500** show the southern side of the by now submerged former gabled roof structure of the adjoining and earlier **Building 5**. This earlier roof structure has become subsumed by the subsequent construction and addition of the modern roof structure of **Building 6**.

**Plate 500: View of the roof supporting structure of Building 6, from the south-west**

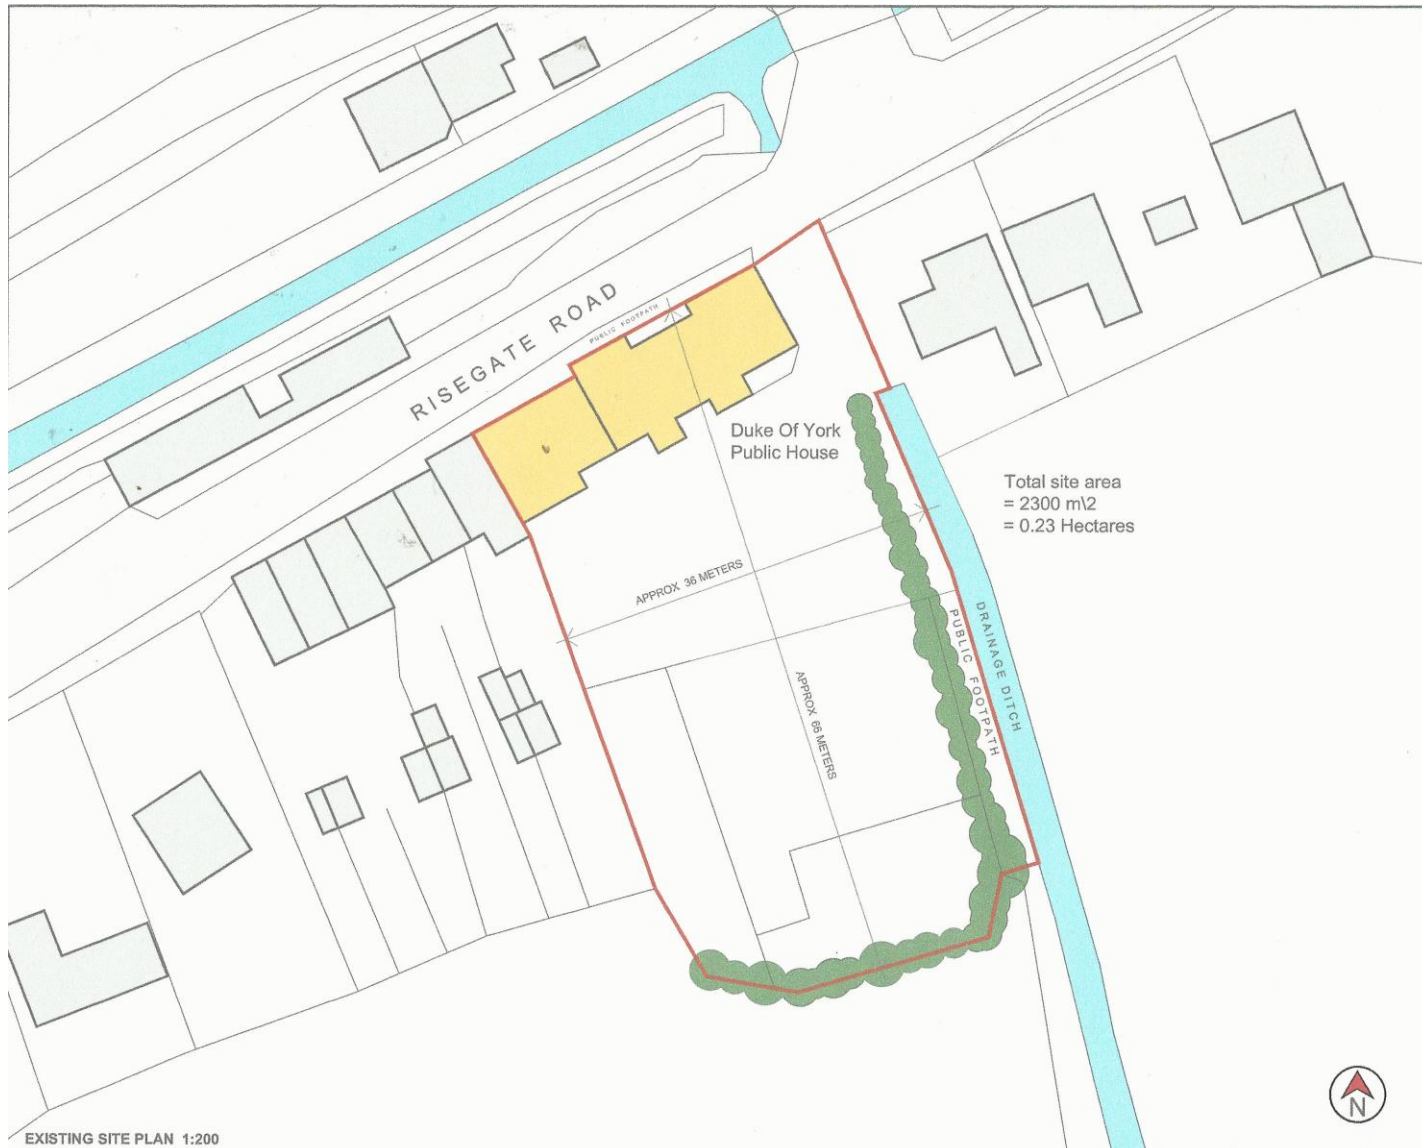
**Figure 3:** Plan showing the existing layout of the development site at an original scale of 1:200, (extract from Architects plan)

- 3.16 **Figures 2 and 3** show the existing layout of this proposed development site.
