**NEVILLE HALL
FREELANCE ARCHAEOLOGIST & CONSULTANT**

HISTORIC BUILDING RECORDING AT THE
FORMER DUKE OF YORK PUBLIC HOUSE,
106, RISEGATE ROAD,
GOSBERTON RISEGATE, LINCOLNSHIRE

January 2023

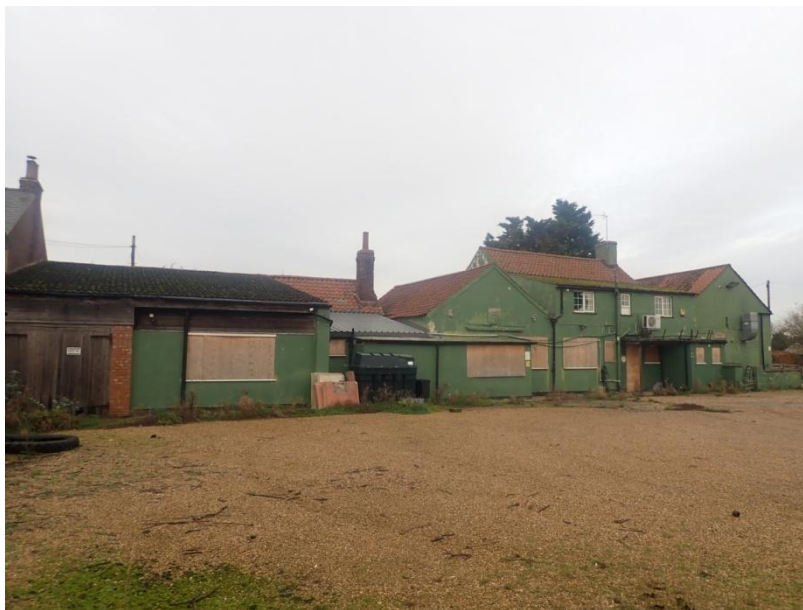
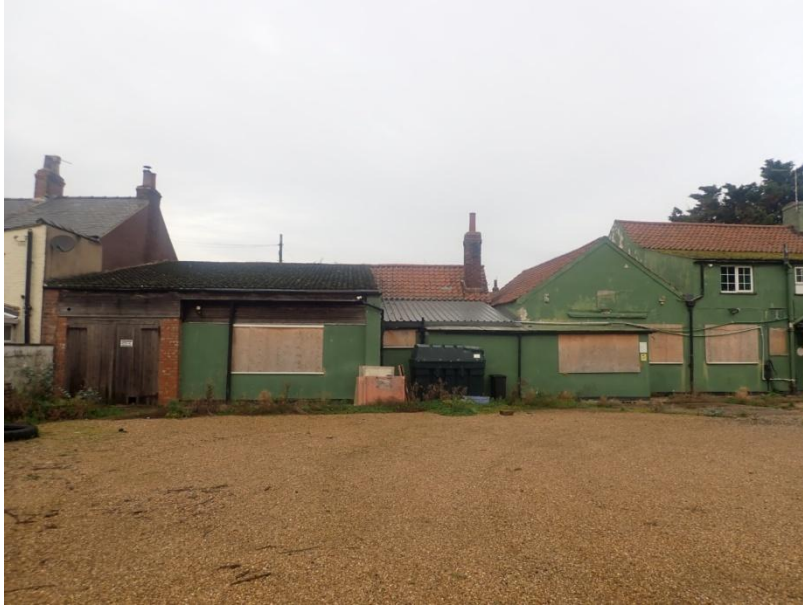
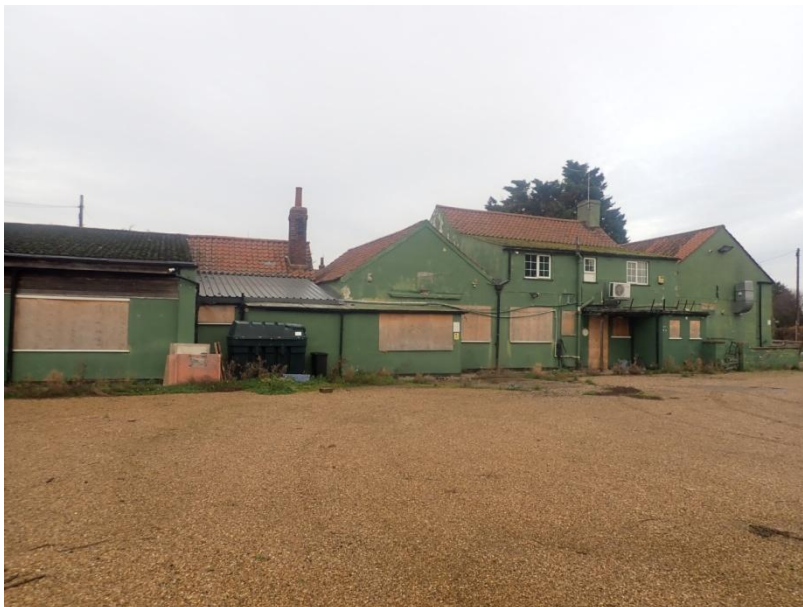
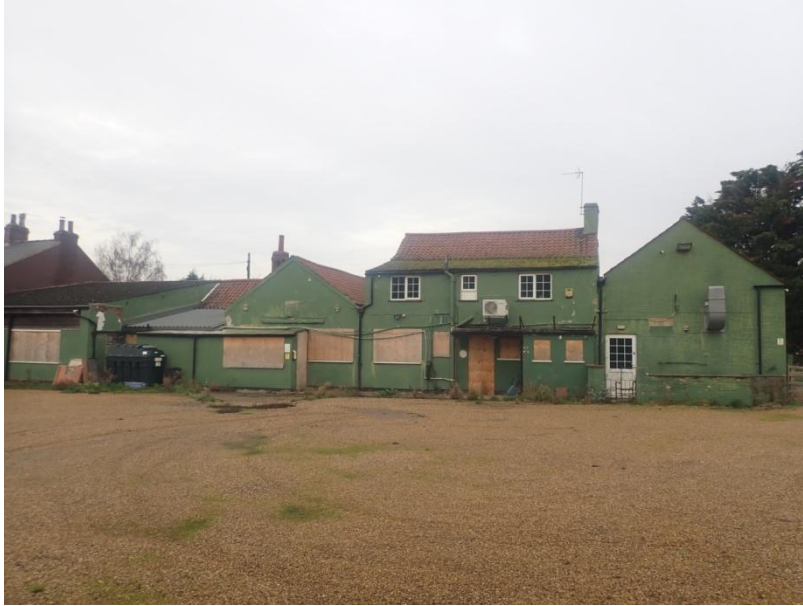
Plate 1: General view of the Duke of York public house complex, from the south-west

Plates 1-4 present views of the rear of this public house complex and features, from west-east, the single storey **Building 6**, with its large and low angled half gabled roof, **Building 5** in the background with the brick chimney stack and its gabled roof with roof covering of red pantiles, **Building 4** in the foreground, a single storey modern extension or addition to this complex, the single storey **Building 3** with its gabled roof and roof covering of red pantiles, **Building 2**, the two storey main body of the former public house with its gabled roof with roof covering of red pantiles and second brick chimney stack along with its rear outshut and at the

eastern end of this complex - **Building 1**, a two storey building with a further gabled roof and a roof covering of red pantiles.

Plate 2: General view of the Duke of York public house complex, from the south

Plate 3: General view of the Duke of York public house complex, from the south-west

Plate 4: General view of the Duke of York public house complex, from the south

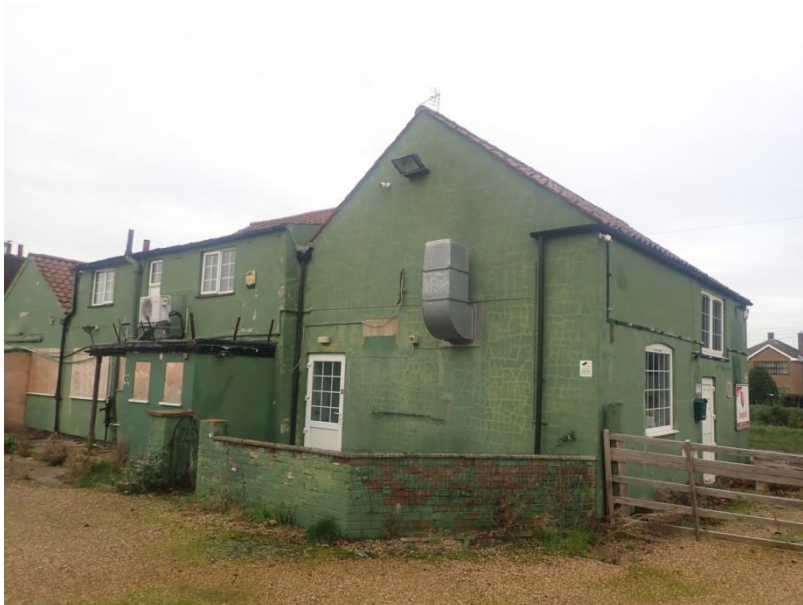
Plate 5: General view of the Duke of York public house complex, from the south-east

Plate 5 presents a general view of the eastern end of this former public house complex with the two storey **Building 1** in the foreground with the two storey **Building 2** with its rear outshut and the two storey **Building 3** in the background.

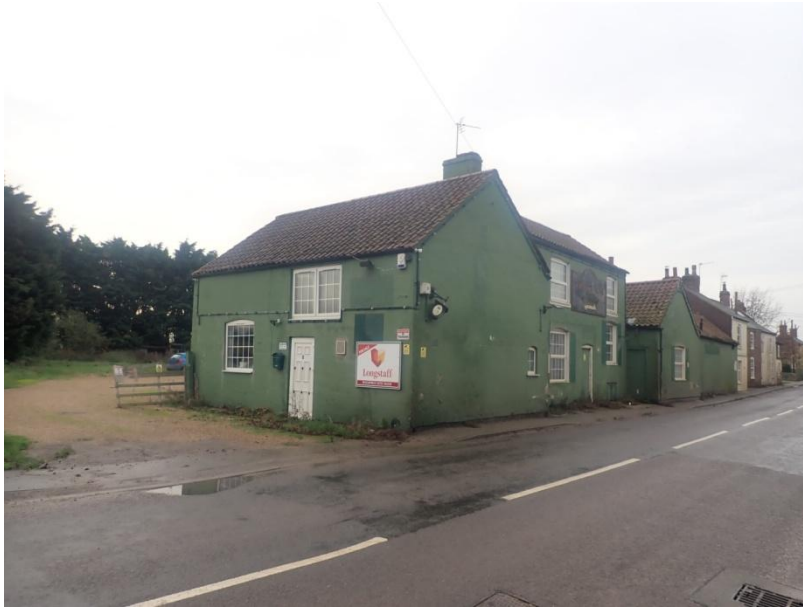
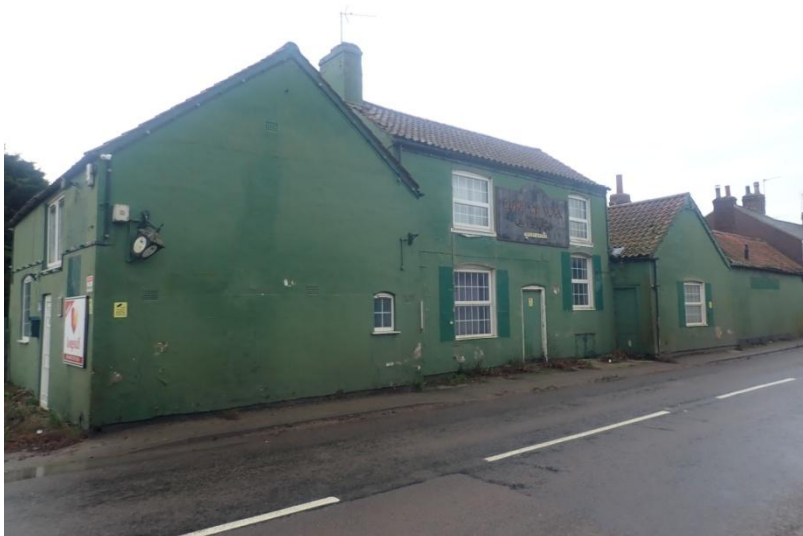
Plates 6 and 7 furnish general views of the former public house complex from north-eastern vantage points with the two storey **Building 1** in the foreground, with the two storey **Building 2**, the single storey **Building 3** and the single storey **Building 5** in the background and to the rear.

Plate 6: General view of the Duke of York public house complex, from the north-east

Plate 7: General view of the Duke of York public house complex, from the north-east

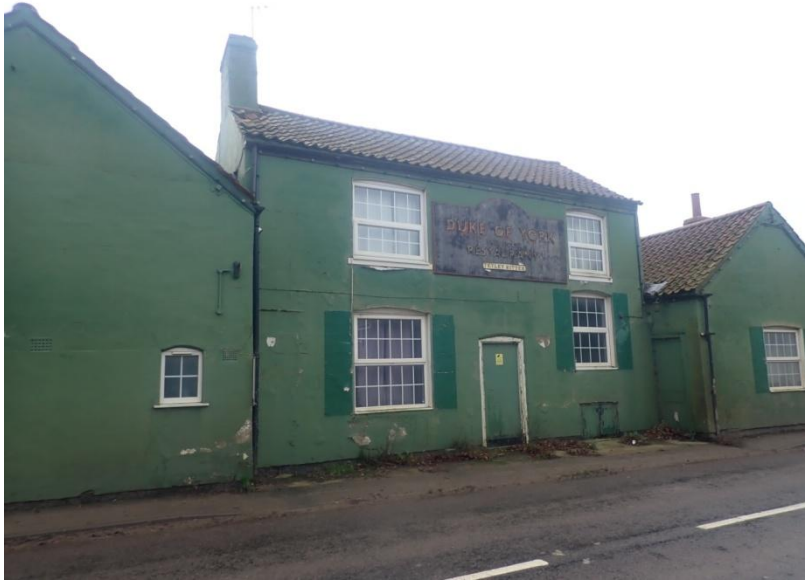
Plate 8 provides a general view of the street frontage and of the frontal portion of the two storey **Building 2**, the main body of the former Duke of York public house, which is flanked by the two storey **Building 1** to the east and by the single storey **Building 3** to the west.

Plate 8: General view of the Duke of York public house complex, from the north

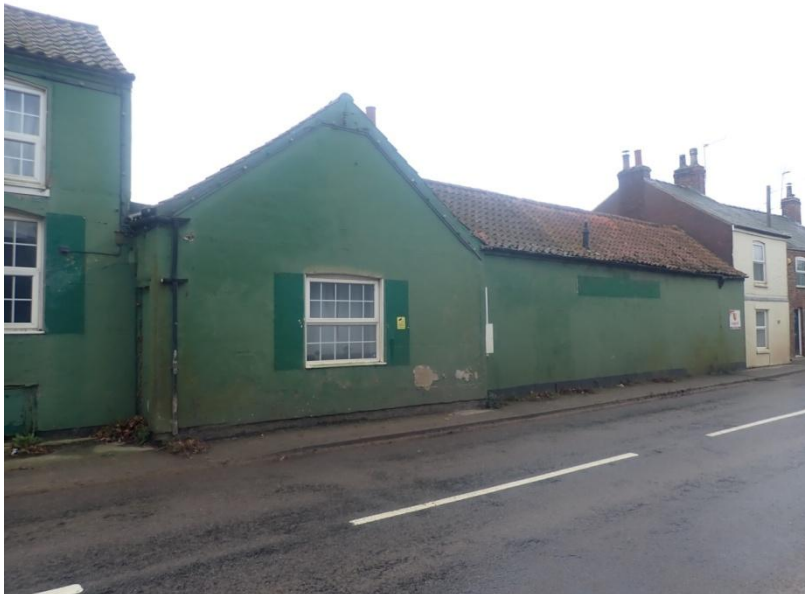
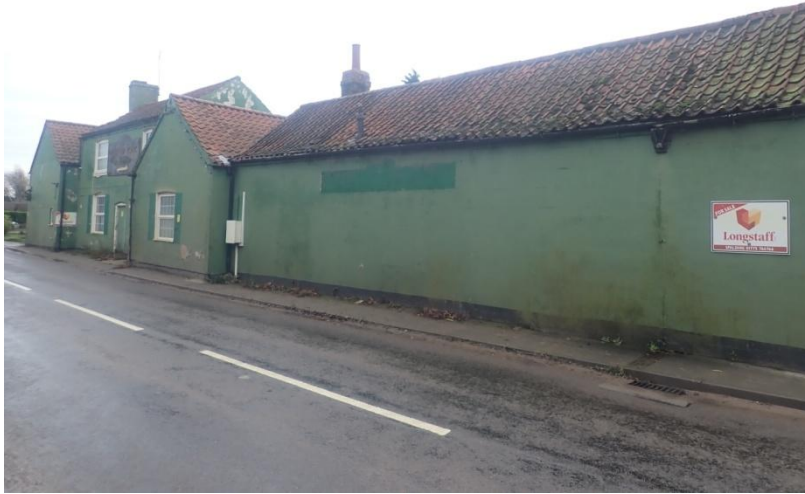
Plate 9: General view of the Duke of York public house complex, from the north-east

Plates 9 and 10 present general views in the main of the single storey **Buildings 3 and 5** of this former public house complex. **Plate 10** also features the two storey **Buildings 2 and 1** in the background and to the rear.

Plate 10: General view of the Duke of York public house complex, from the north-west

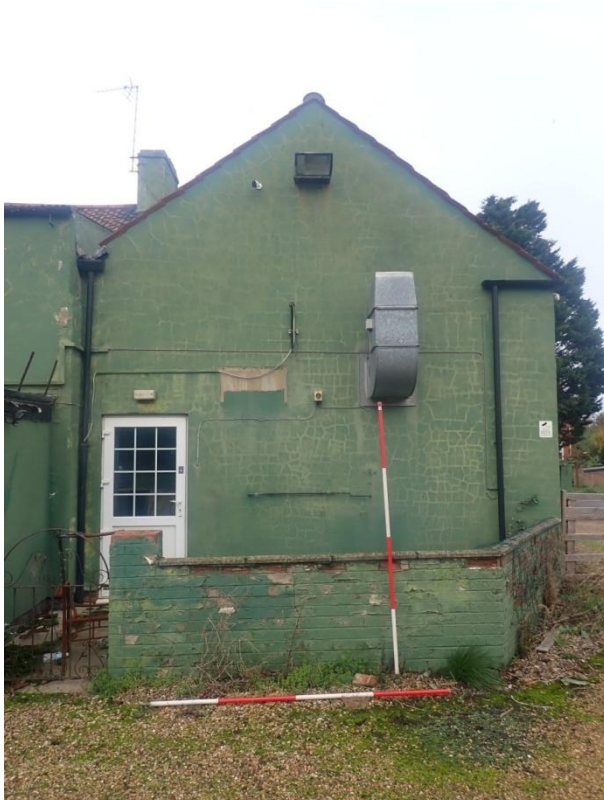
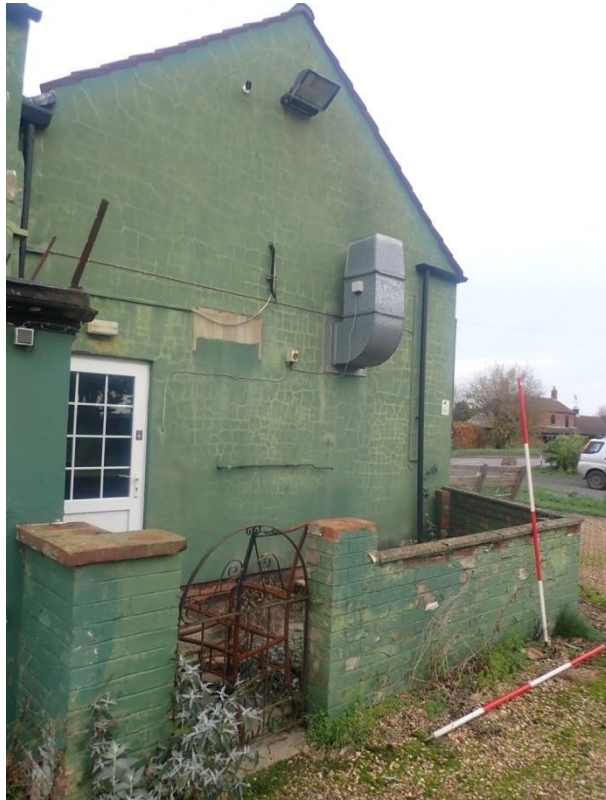
Plate 11: View of the South Elevation of Building 1, from the south-east

Plate 12: View of the South Elevation of Building 1, from the south-west

Plates 11 and 12 feature the South Elevation of **Building 1**. The entire Elevation appears to have been rendered over with modern cement. No first or ground floor former window openings are apparent. At either ends of this Elevation are two modern vertical Upvc downpipes. Also featured is the outer face of a south facing modern entrance opening. This is occupied by a modern glazed Upvc door. Also shown is the exterior metal flue of an interior kitchen extractor fan.

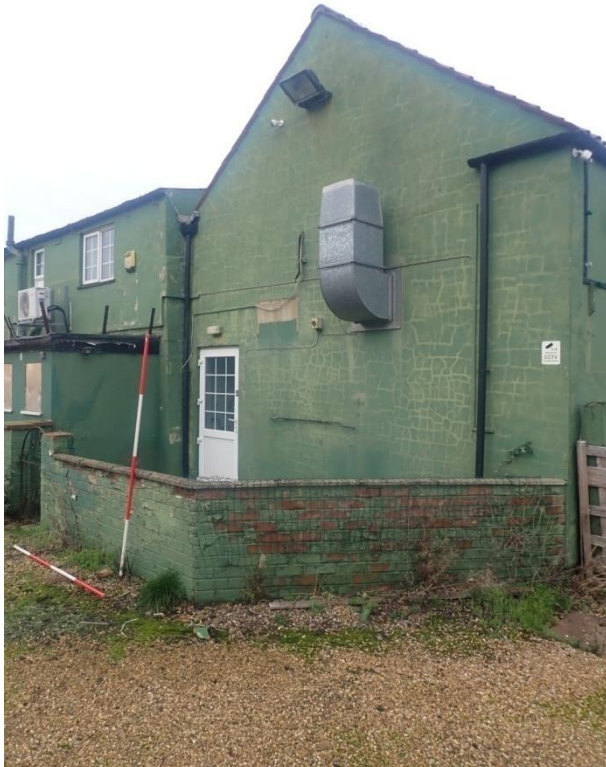
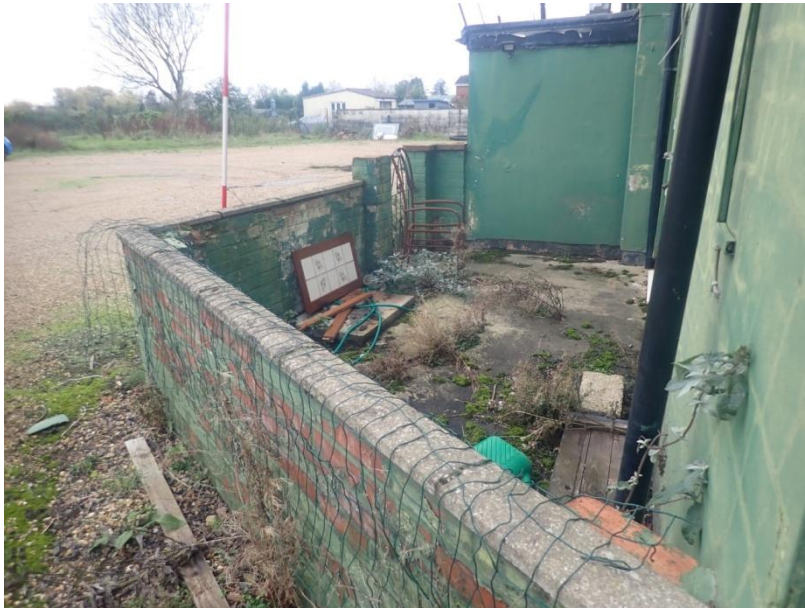
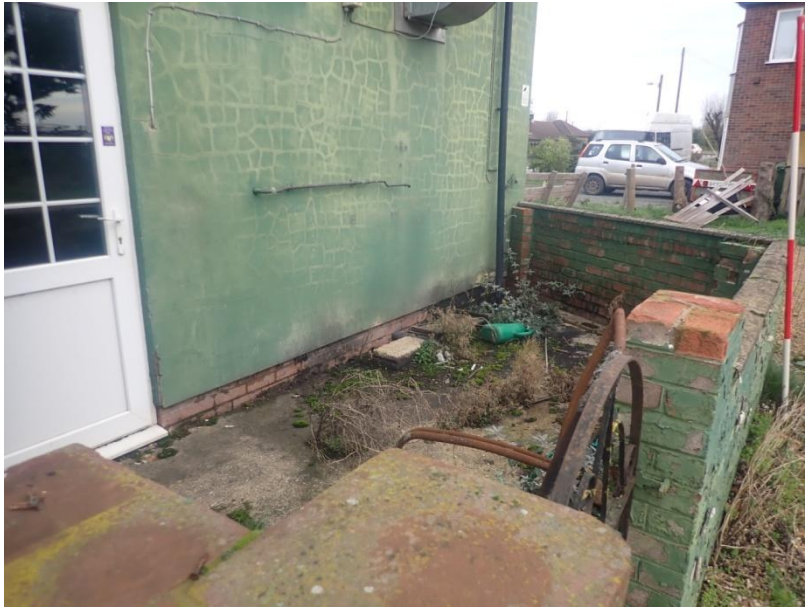
Plate 13 provides a further view of the South Elevation of **Building 1**. At the rear of this Elevation is a small enclosed rear yard with a modern concrete surface. The yard is enclosed within a low wall, which is composed of courses of brick stretchers in Stretcher Bond. Atop the brickwork is a series of modern concrete coping stones. A modern metal gateway is also shown within the low wall, providing an access to the rear of **Building 1**. **Plates 14 and 15** provide further detailed views of this low modern enclosing wall and rear yard from differing positions.

Plate 13: View of the South Elevation of Building 1, from the south-east

Plate 14: View of the small enclosed rear yard at the South Elevation of Building 1, from the north-east

Plate 15: View of the small enclosed rear yard at the South Elevation of Building 1, from the south-west

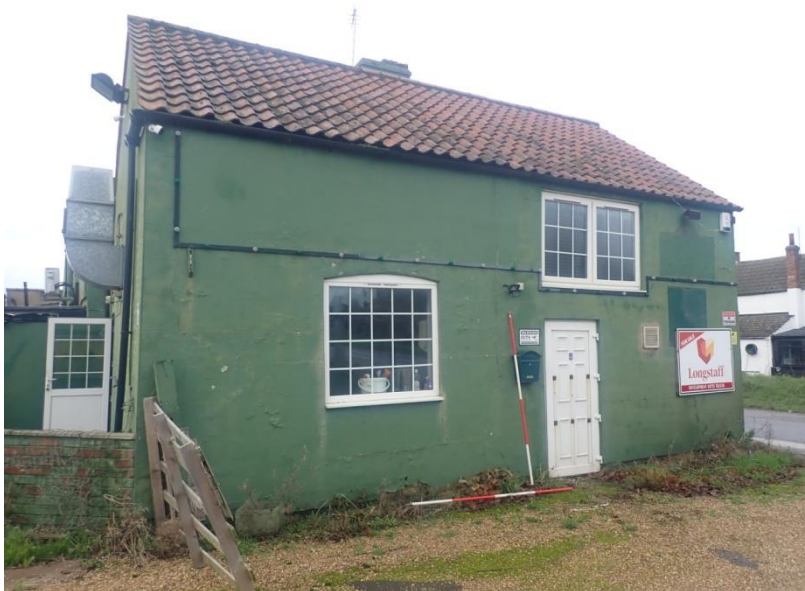
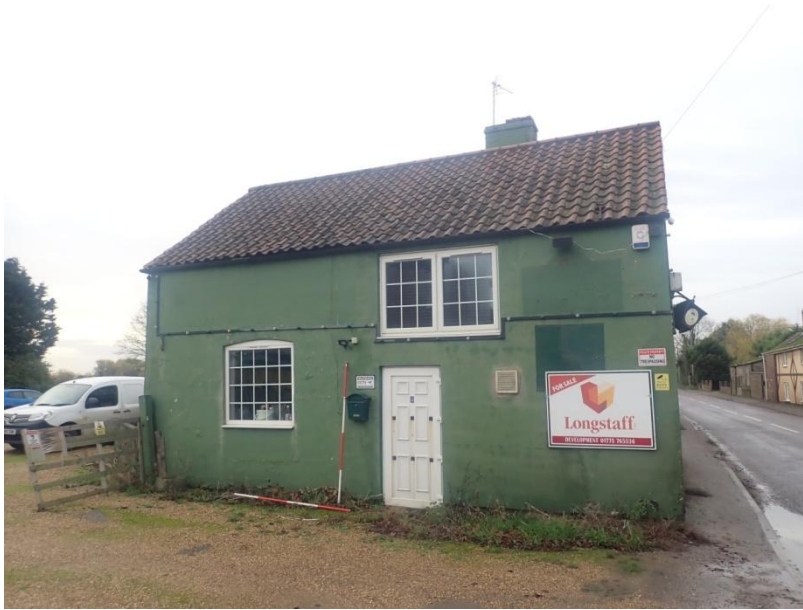
Plates 16 and 17 provide detailed views of the East Elevation of **Building 1**. Here also, the entire external area of this East Elevation has been covered over with a modern cement rendering. At just below roof levels is modern horizontal Upvc guttering. At the ground floor level is an east facing window opening, which may be original. This is occupied by a modern glazed Upvc casement window. To the right (north), of this is an east facing ground floor entrance opening, within which is a modern Upvc panelled door. This opening may also be an original feature. At first floor levels is a further east facing window opening. This may also be original and is occupied by a second modern glazed Upvc casement window.

Plate 16: View of the East Elevation of Building 1, from the north-east

Plate 17: View of the East Elevation of Building 1, from the north-east

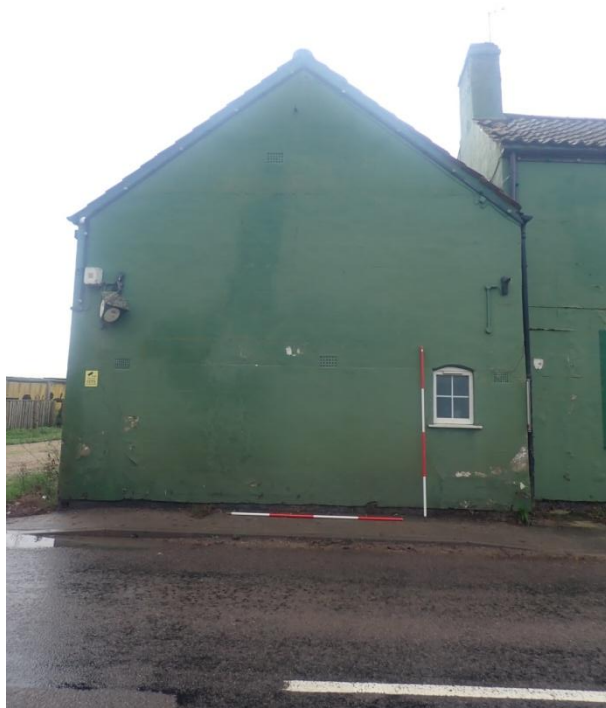
Plate 18 furnishes a detailed image of the North Elevation of **Building 1**. Here also, the entire external area of this North Elevation has been covered over with a modern cement rendering. This Elevation is also mostly absent of further window openings with the exception of a small north facing ground floor window opening, which is occupied by a modern Upvc casement window. This may also be an original opening.

Plate 18: View of the North Elevation of Building 1, from the north-west

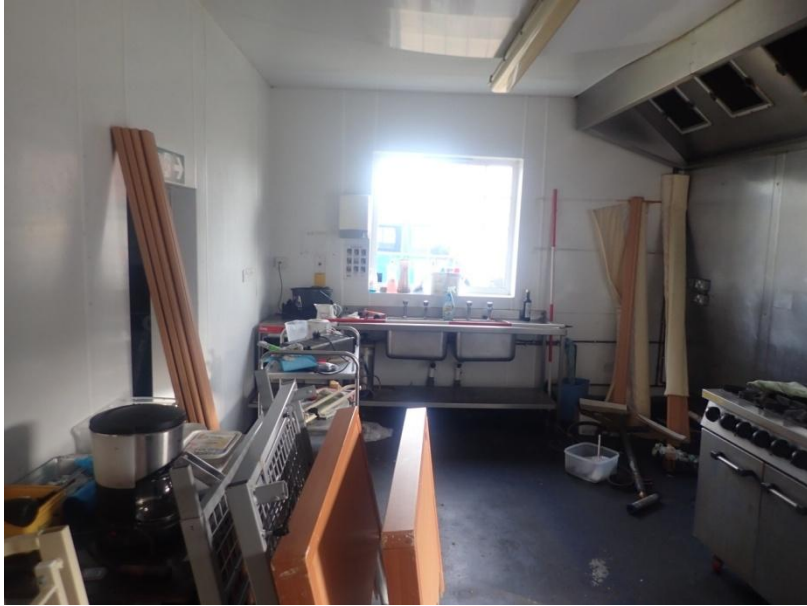
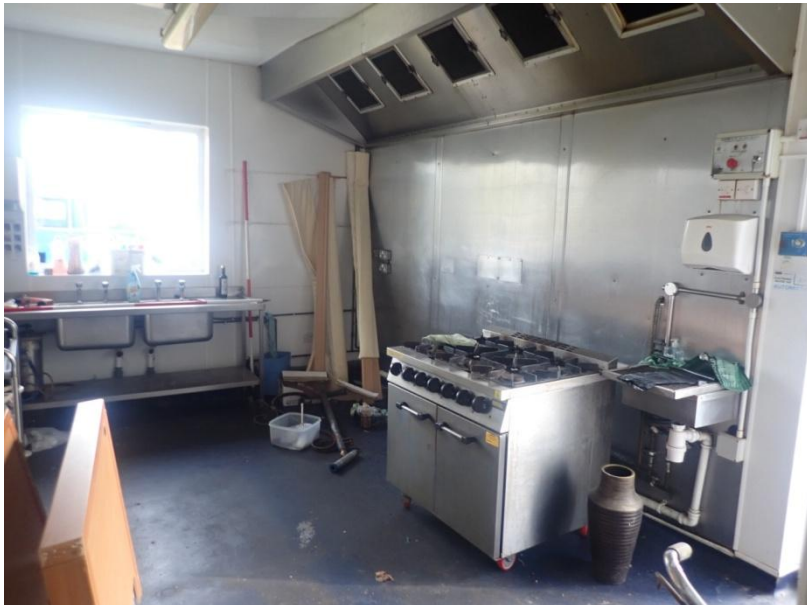
Plate 19: General view of the interior of Cell 1, from the south-west

Plate 20: General view of the interior of Cell 1, from the north-west

Plates 19 and 20 provide general views of the interior of **Cell 1** from south-western positions. This was the modern kitchen to the former public house complex.

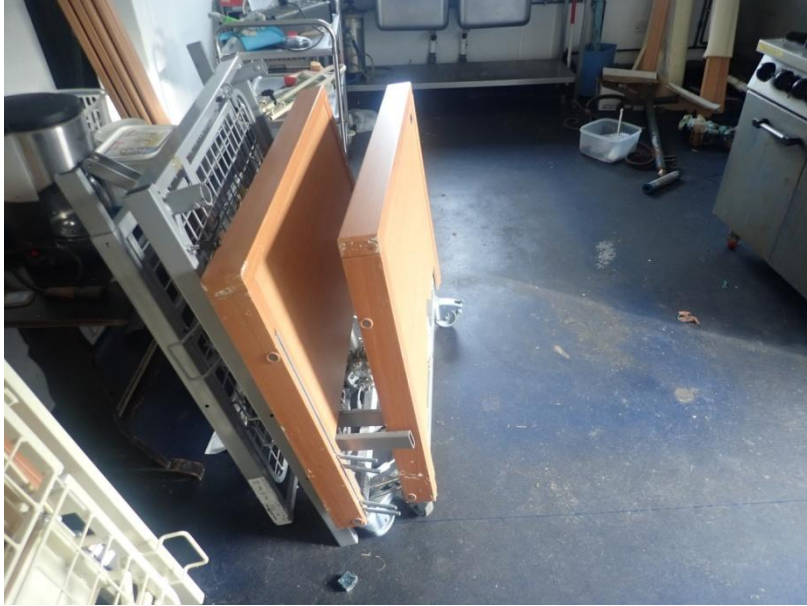
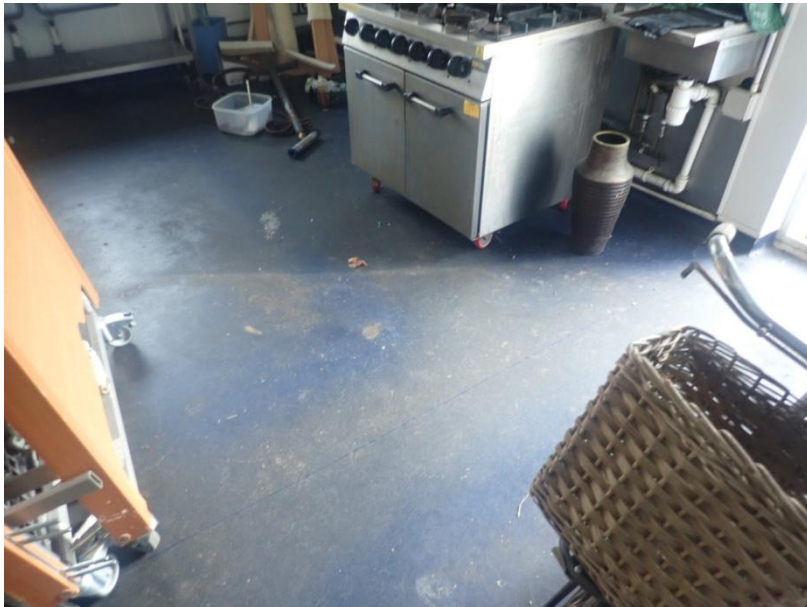
Plates 21 and 22 feature the nature of the flooring of **Cell 1**, which is of modern concrete.

Plate 21: View of the flooring of Cell 1, from the south-west

Plate 22: View of the flooring of Cell 1, from the south-west

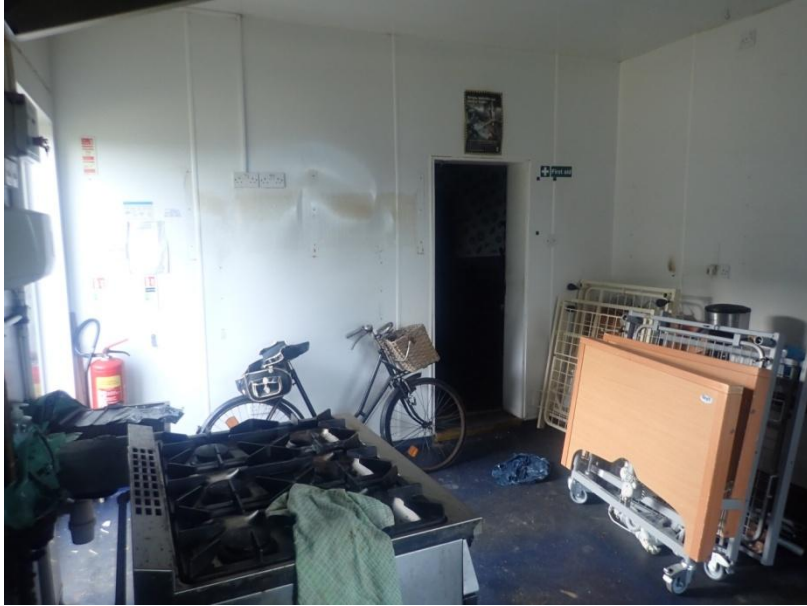
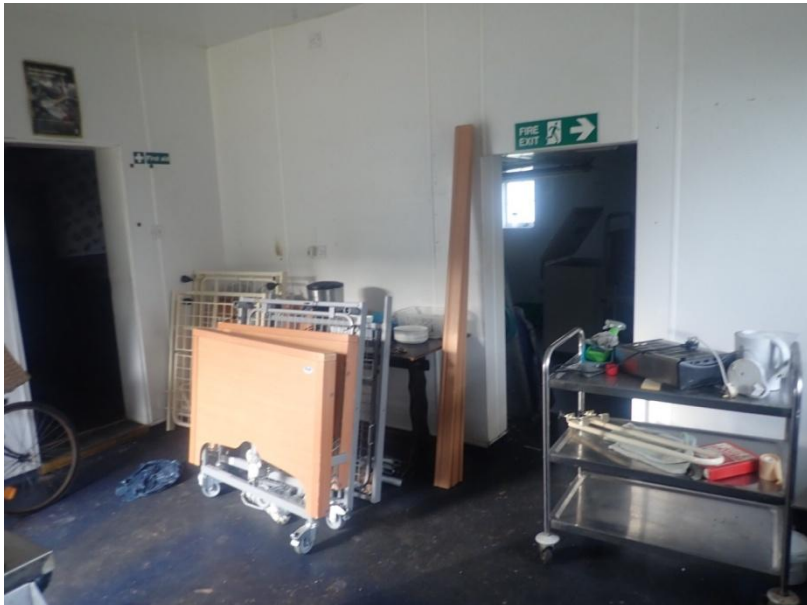
Plates 23 and 24 present further general views of the interior of **Cell 1**, from different south-eastern vantage points.

Plate 23: General view of the interior of Cell 1, from the south-east

Plate 24: General view of the interior of Cell 1, from the south-east

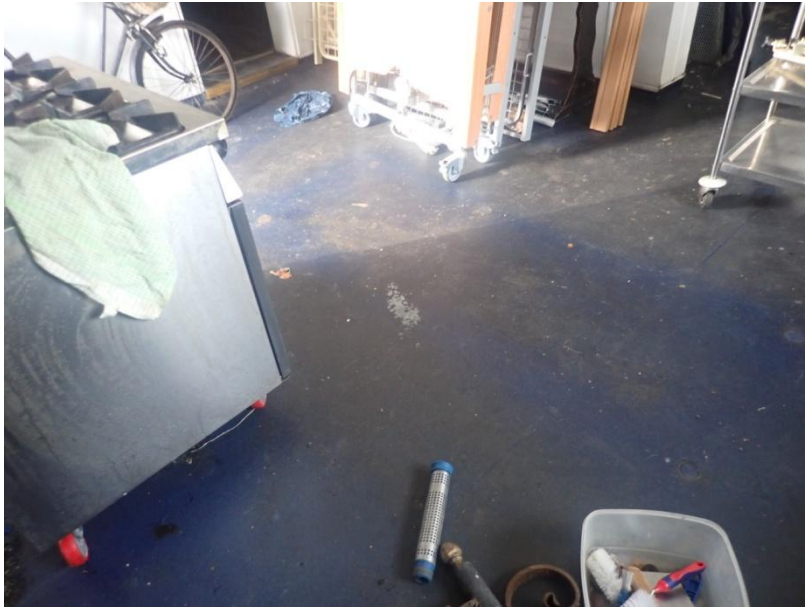
Plates 25 and 26 present further views of the modern concrete flooring of Cell 1.

Plate 25: View of the flooring of Cell 1, from the north

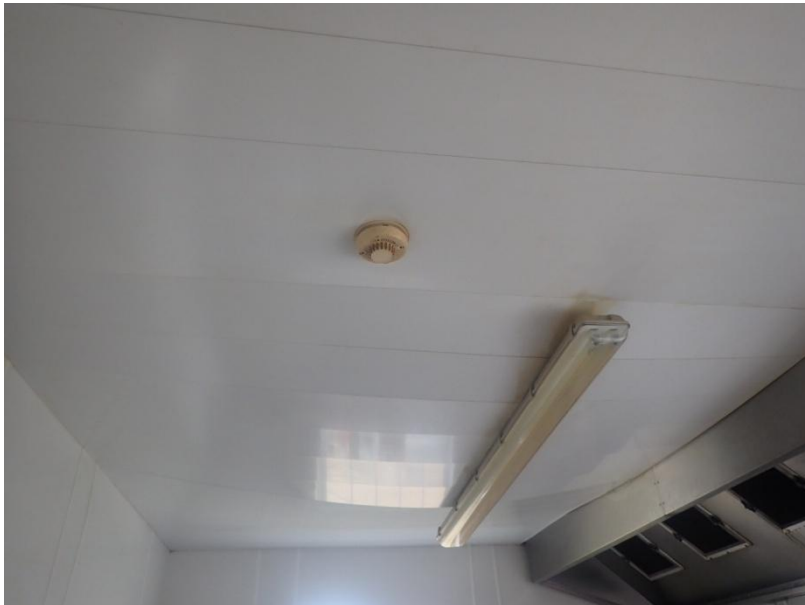
Plate 26: View of the ceiling of Cell 1, from the south-west

Plates 26-28 furnish several images of the nature of the modern suspended ceiling of **Cell 1**, which is of modern Upvc.

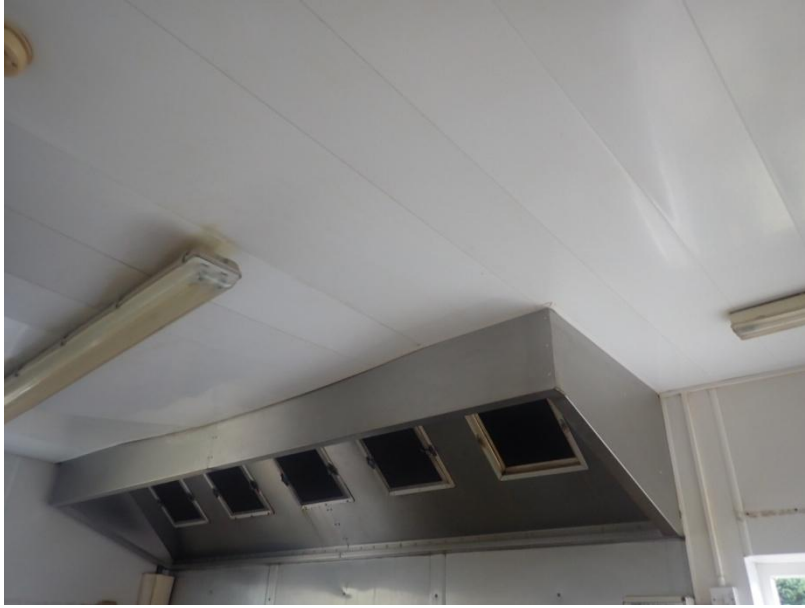
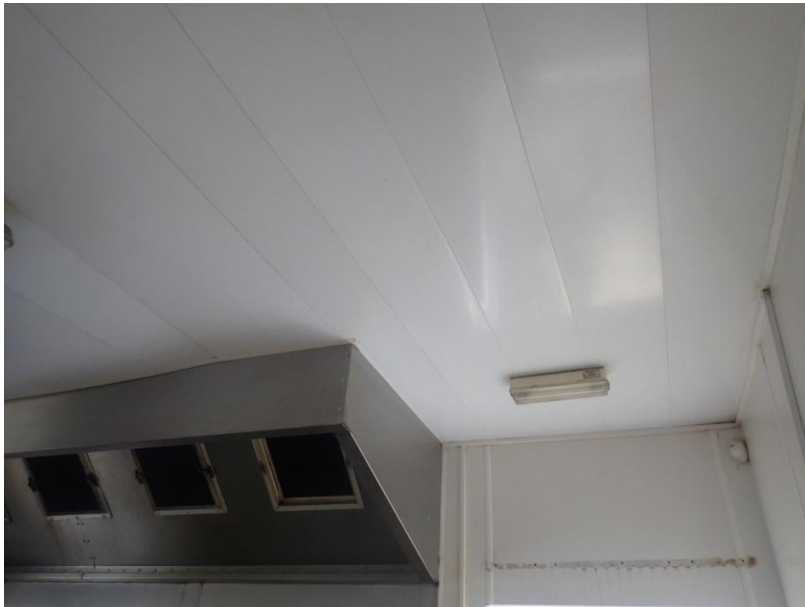
Plate 27: View of the ceiling of Cell 1, from the north-west

Plate 28: View of the ceiling of Cell 1, from the north

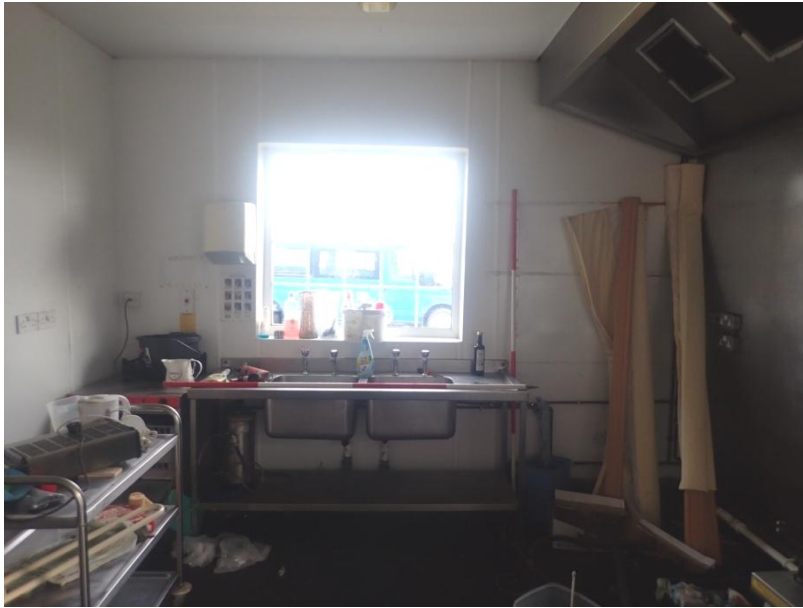
Plate 29: View of the east wall of Cell 1, from the south-west

Plate 29 provides a detailed view of the east wall of **Cell 1**, including that of the inner face of the slightly recessed ground floor east facing window opening that was recorded externally at the East Elevation of this building. This entire east wall has been covered over with modern Upvc sheeting.

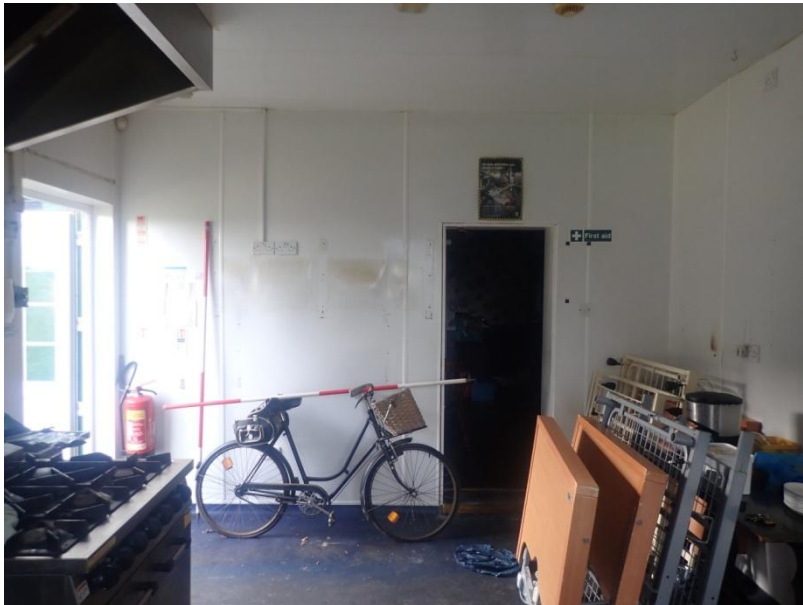
Plate 30: View of the west wall of Cell 1, from the north-east

Plate 30 features the opposing west wall of **Cell 1**, which has also been entirely covered over with modern Upvc sheeting. This is also the internal dividing wall with the adjacent **Cells 8 and 9 of Building 2** to the west. To the right (north), is an internal ground floor west facing entrance opening, which is occupied by a timber frame. This extends **onto Cell 8 of Building 2**.

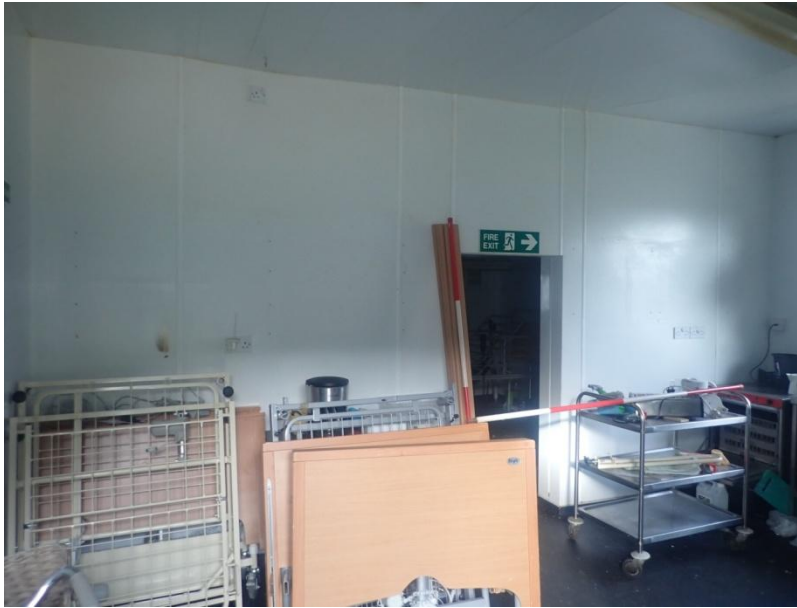
Plate 31 presents a detailed view of the north wall of **Cell 1**, which is also the internal dividing wall with the adjoining **Cell 2**, to the north. Here also, this entire north wall has been covered over with modern Upvc sheeting. Also shown is the north facing entrance opening that leads onto the adjoining **Cell 2** to the north. Both a door frame and a door were absent from this opening, which is of modern Upvc.

Plate 31: View of the north wall of Cell 1, from the south-west

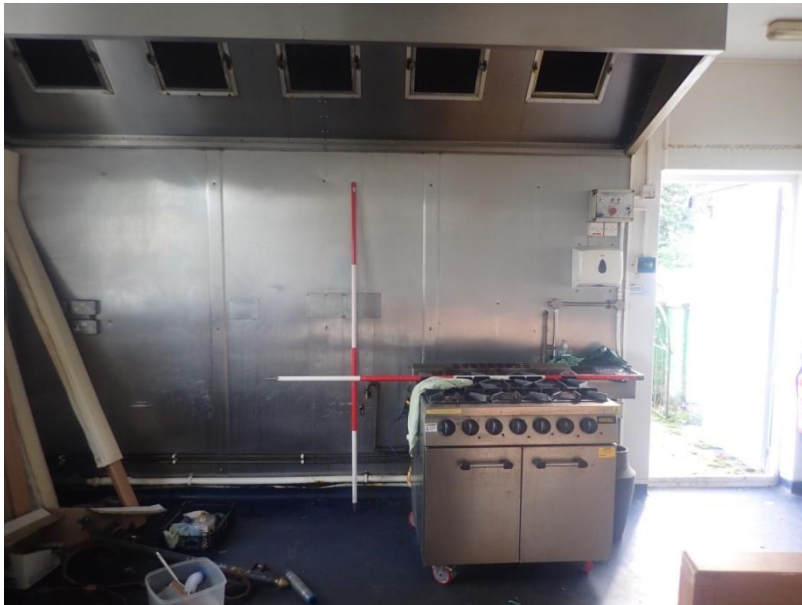
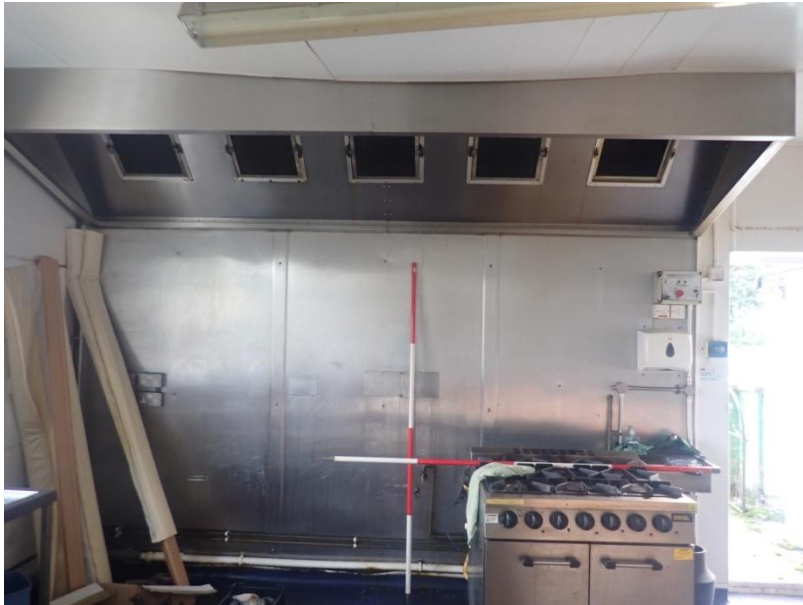
Plate 32: View of the south wall of Cell 1, from the north-west

Plates 32-34 show the south wall of **Cell 1**, most of which is occupied by a modern stainless steel backing with extractor fans above this. To the right (west), is the inner face of the ground floor south facing entrance opening that was recorded externally at the South Elevation of this building. This slightly recessed opening is occupied by a modern Upvc frame with modern Upvc wall sheeting covering the wall above the opening.

Plate 33: View of the south wall of Cell 1, from the north-west

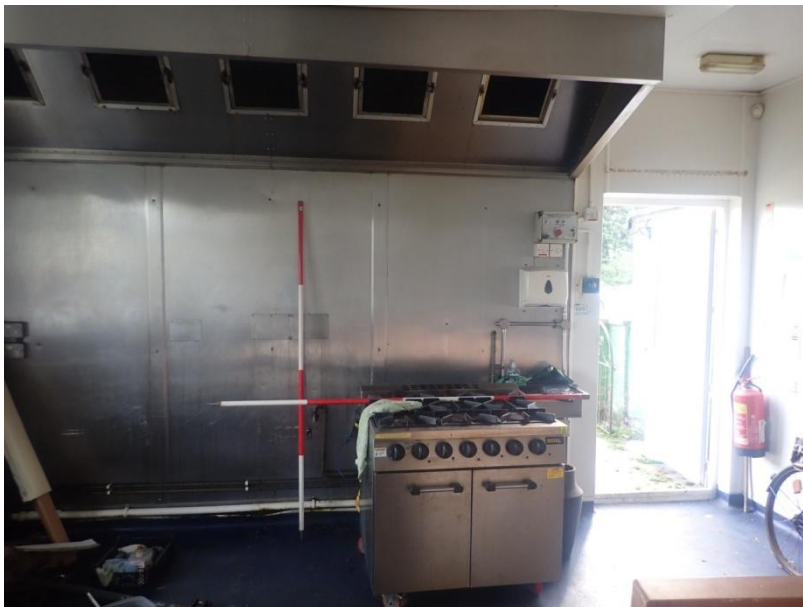
Plate 34: View of the south wall of Cell 1, from the north-west

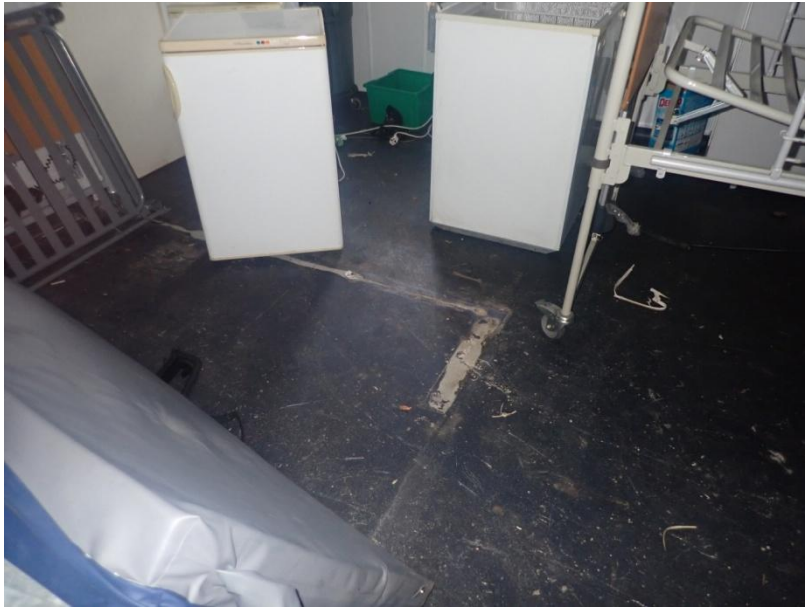
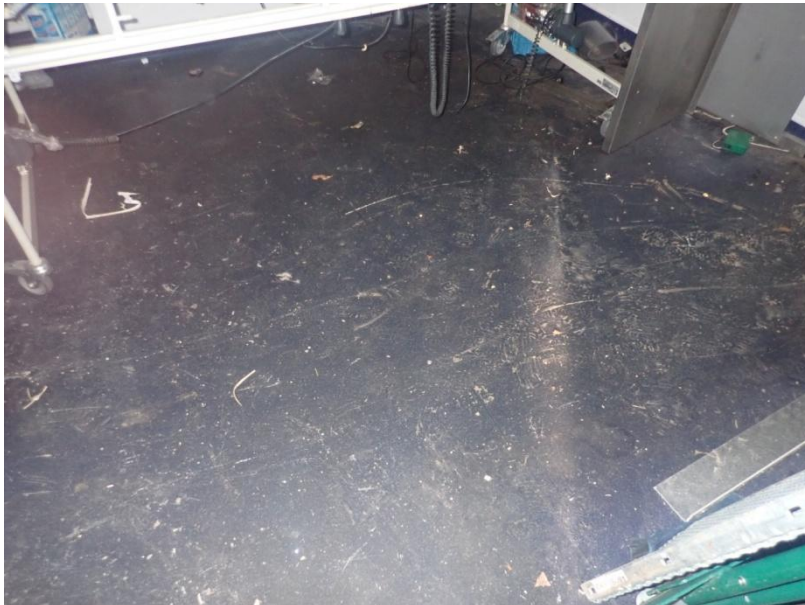
Plates 35 and 36 feature the nature of the flooring of **Cell 2**, which is of modern concrete.

Plate 35: View of the flooring of Cell 1, from the south-east

Plate 36: View of the flooring of Cell 1, from the south-west

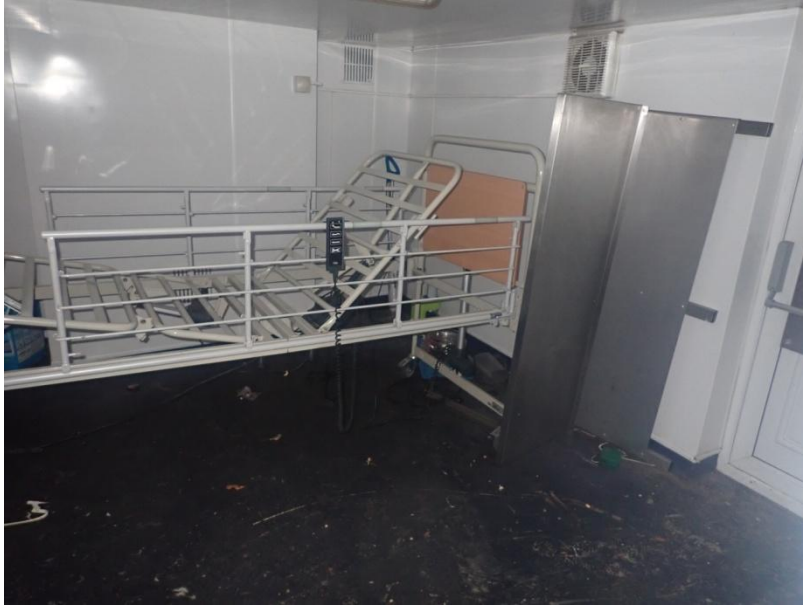
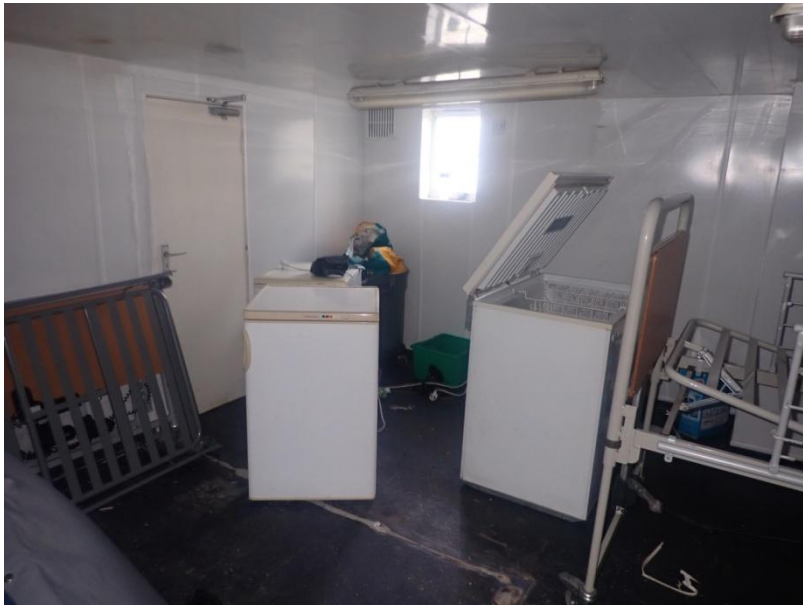
Plates 37 and 38 provide general views of the interior of **Cell 2** from various southern positions.

Plate 37: General view of the interior of Cell 2, from the south-west

Plate 38: General view of the interior of Cell 2, from the south-east

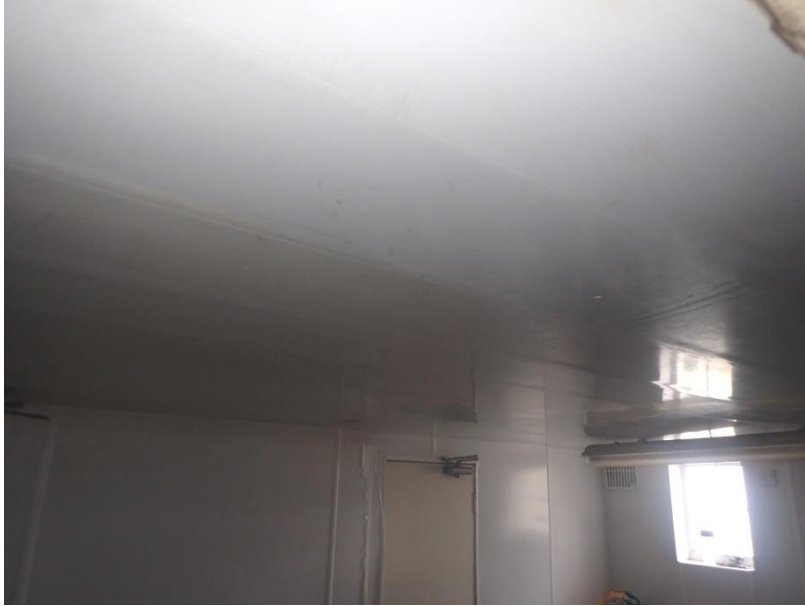
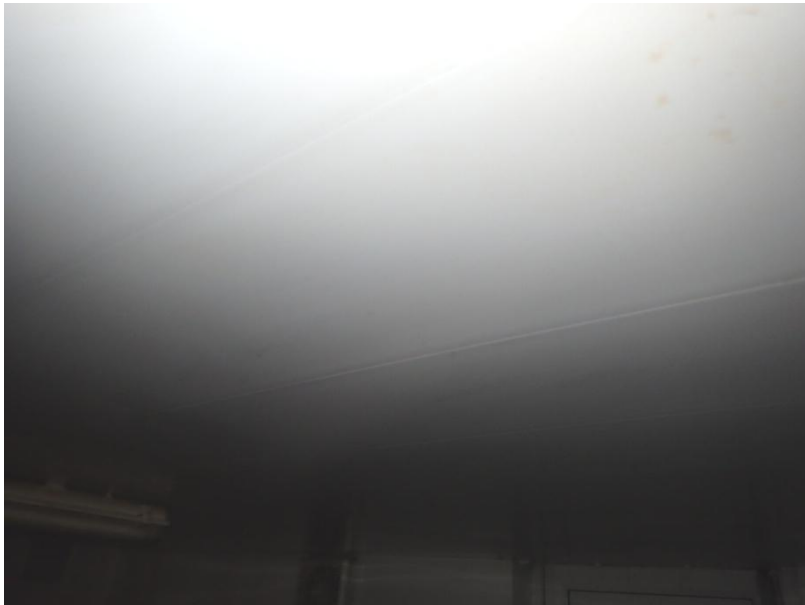
Plates 39 and 40 feature the modern suspended Upvc ceiling of Cell 2.

Plate 39: View of the ceiling of Cell 2, from the south-east

Plate 40: View of the ceiling of Cell 2, from the south-west

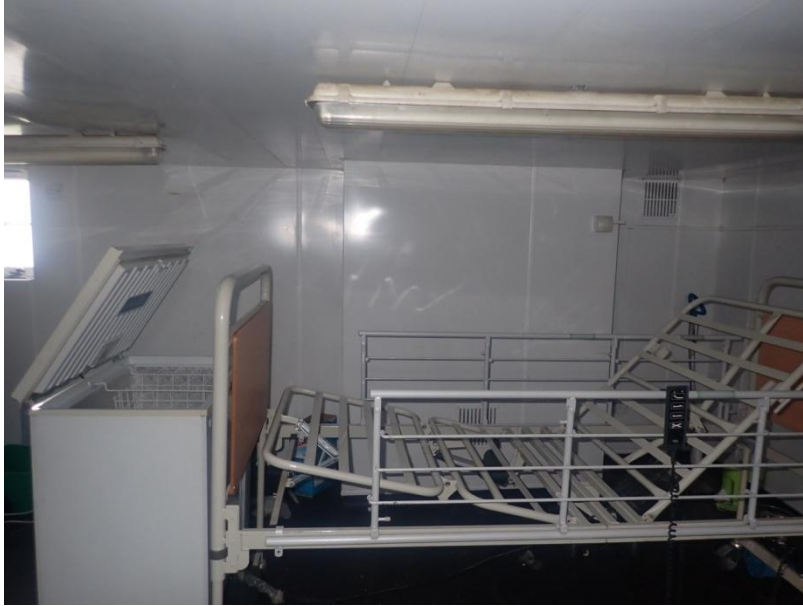
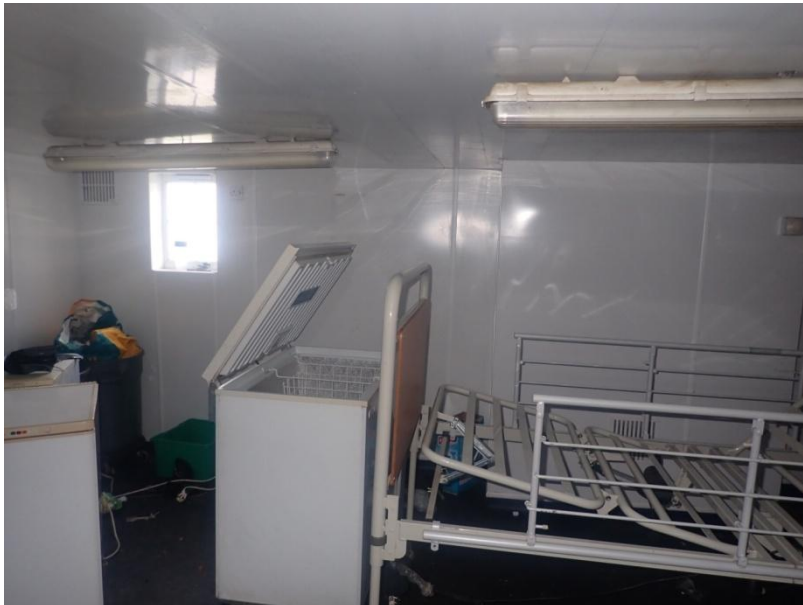
Plates 41 and 42 show the north wall of **Cell 2**. Here also, the whole area of this north wall has been covered over with modern Upvc sheeting. To the left (west), is the inner face of the slightly recessed north facing ground floor window opening that was recorded externally at the North Elevation of this building.

Plate 41: View of the north wall of Cell 2, from the south

Plate 42: View of the north wall of Cell 2, from the south-east
