**NEVILLE HALL
FREELANCE ARCHAEOLOGIST & CONSULTANT**

HISTORIC BUILDING RECORDING AT THE
FORMER DUKE OF YORK PUBLIC HOUSE,
106, RISEGATE ROAD,
GOSBERTON RISEGATE, LINCOLNSHIRE

January 2023

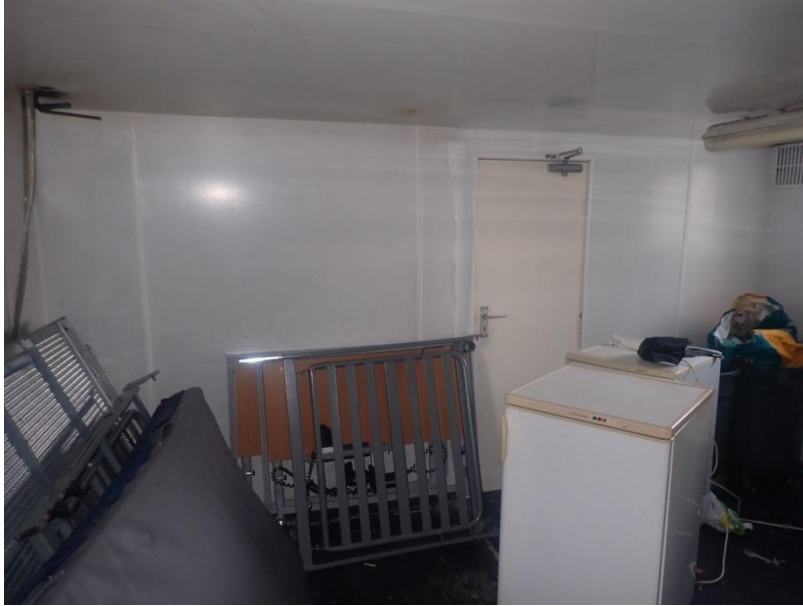
Plate 43 presents a detailed view of the west wall of **Cell 2**. Here also, the area of this west wall has been covered over with modern Upvc sheeting. This is also the internal dividing wall with the adjacent **Cell 8 of Building 2** to the west. To the right (north), is a west facing entrance opening that is occupied by a modern timber frame of a head and surrounds and a probable timber door that has been covered over with modern hardboard sheeting. This originally led on into the interior of **Building 2**, but has been blocked off.

Plate 43: View of the west wall of Cell 2, from the east

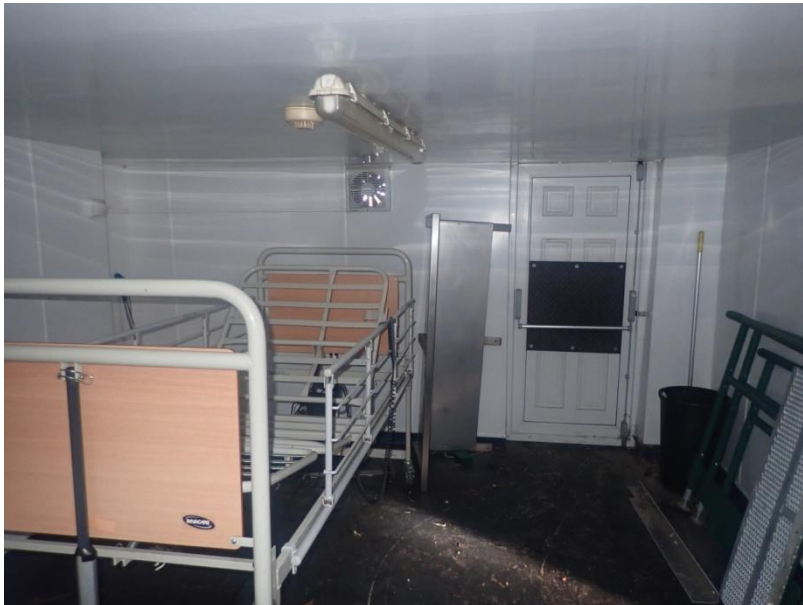
Plate 44: View of the east wall of Cell 2, from the south-west

Plate 44 features the east wall of **Cell 2**. Here also, the area of this east wall has been covered over with modern Upvc sheeting. To the right (south), is the inner face of the east facing entrance opening that was recorded externally at the East Elevation of this building.

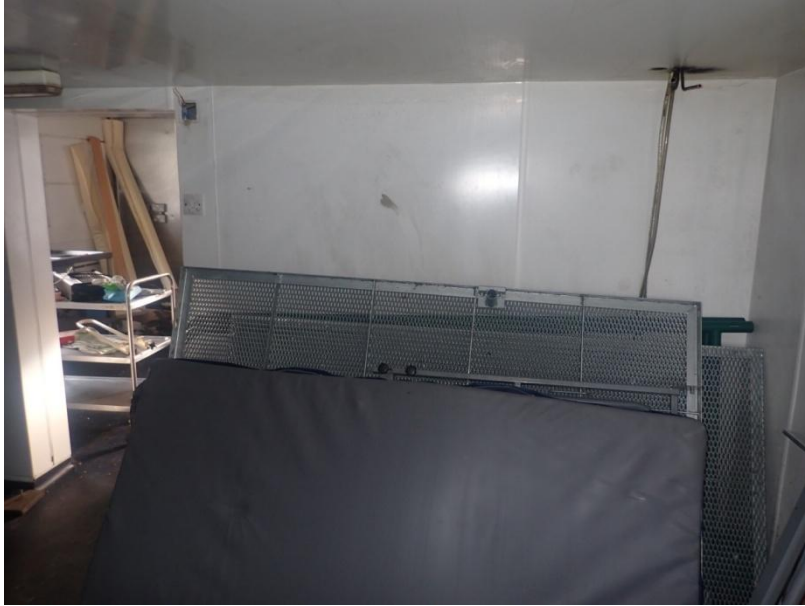
Plates 45 and 46 present images of the south wall of **Cell 2**, which is also the internal dividing wall with the adjoining **Cell 1** to the south. Here also, the area of this south wall has been covered over with modern Upvc sheeting. To the left (east), is the inner face of the south facing entrance reopening that extends onto **Cell 1**. Both a door frame and a door are absent.

Plate 45: View of the south wall of Cell 2, from the north-west

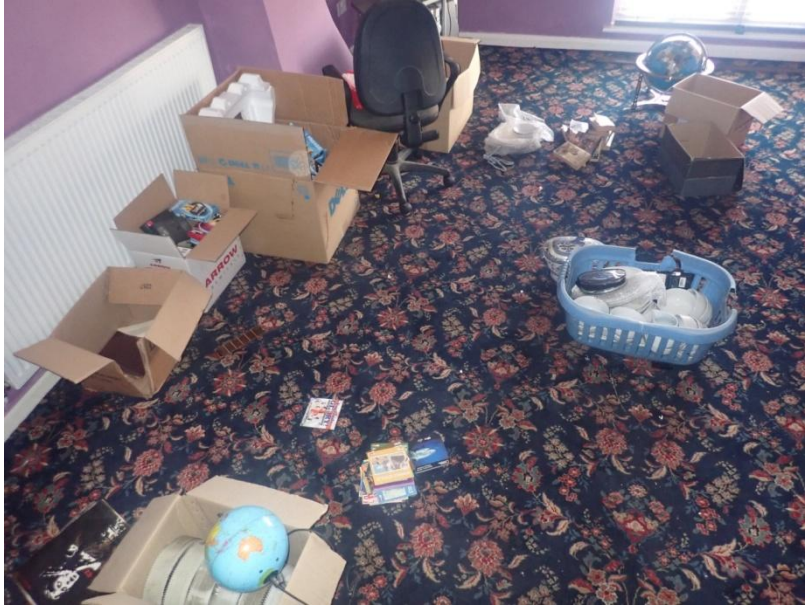
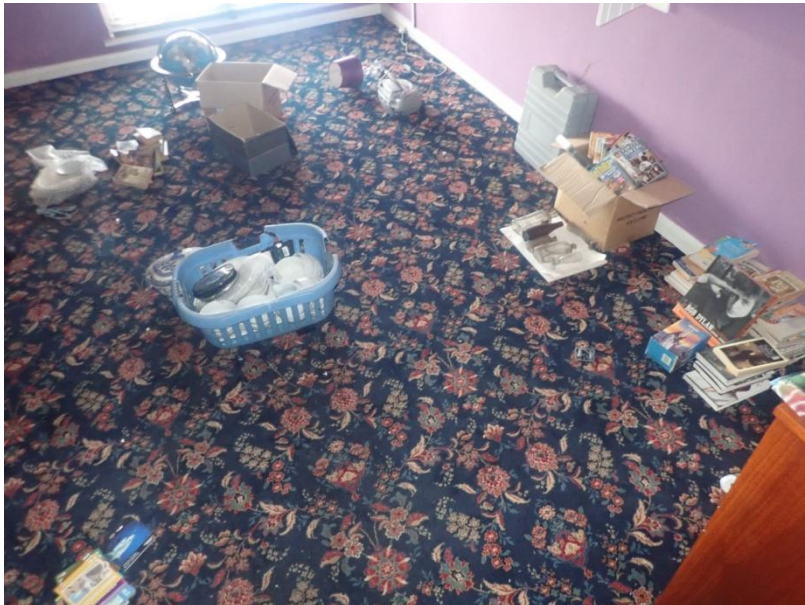
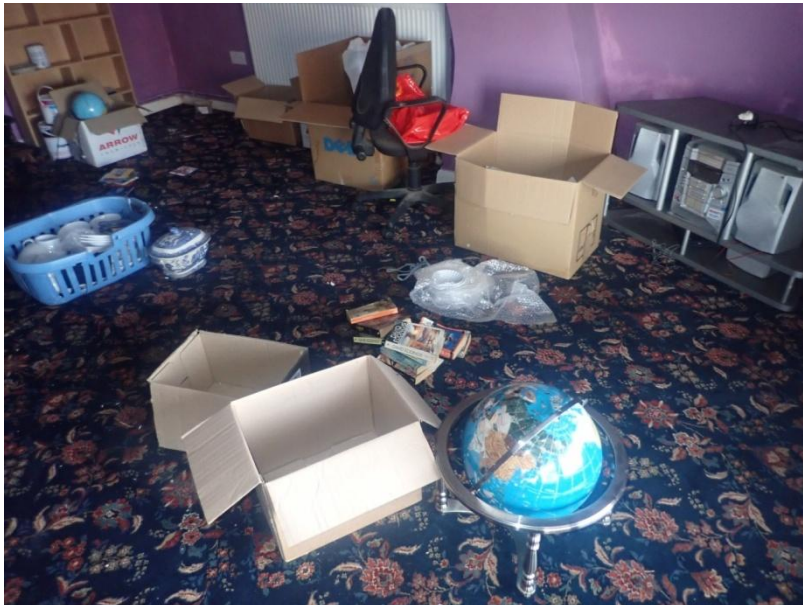
Plates 47-50 present a number of views from different vantage points of the flooring of **Cell 3**, which is covered with modern carpeting.

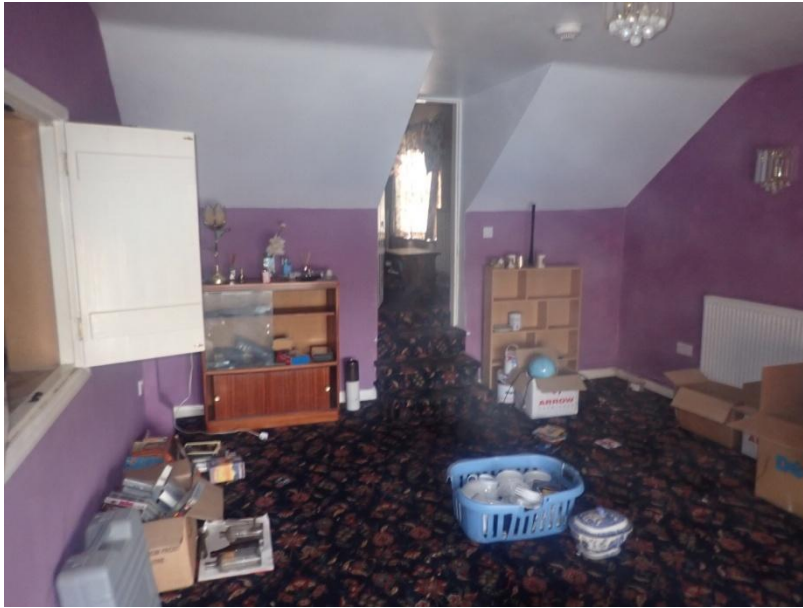
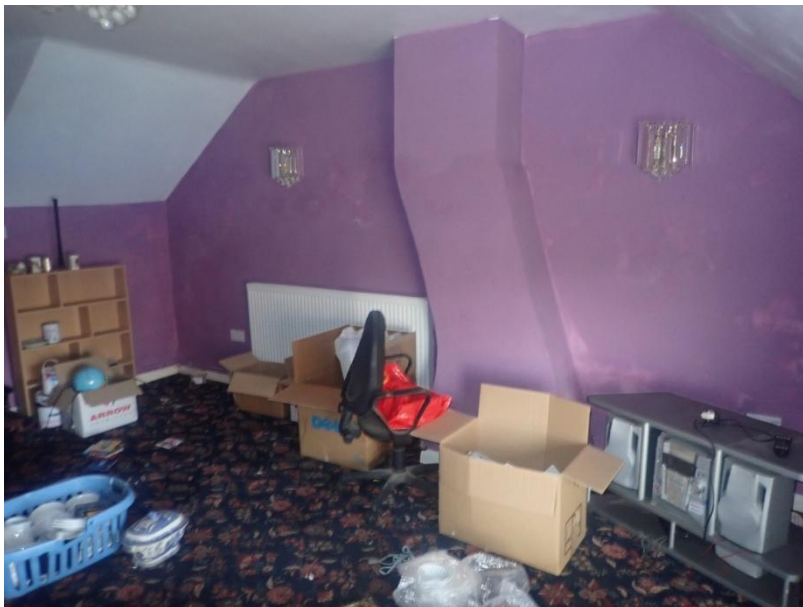
Plates 51 and 52 furnish several general views of the interior of **Cell 3** from south-eastern positions.

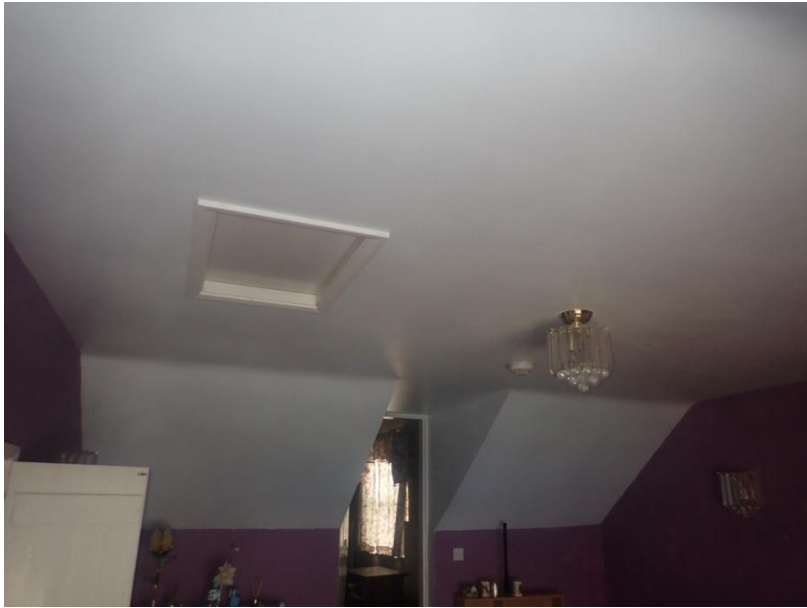
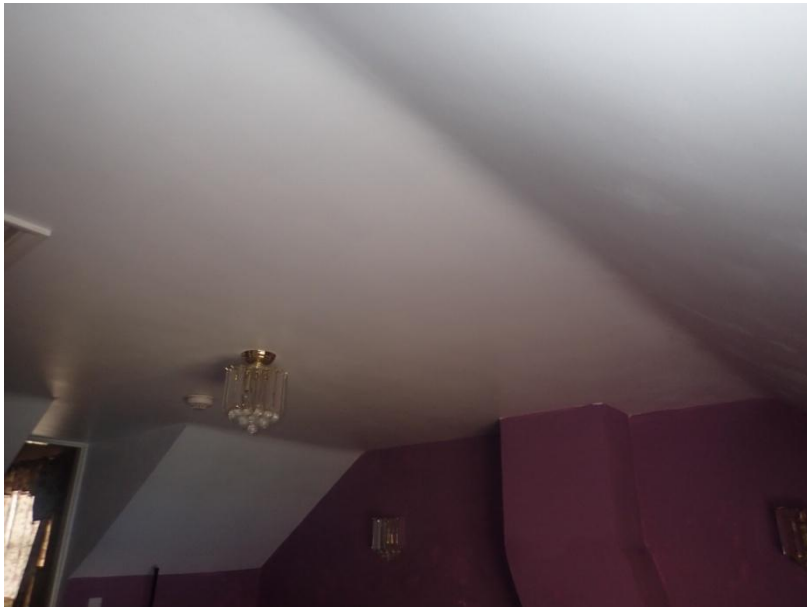
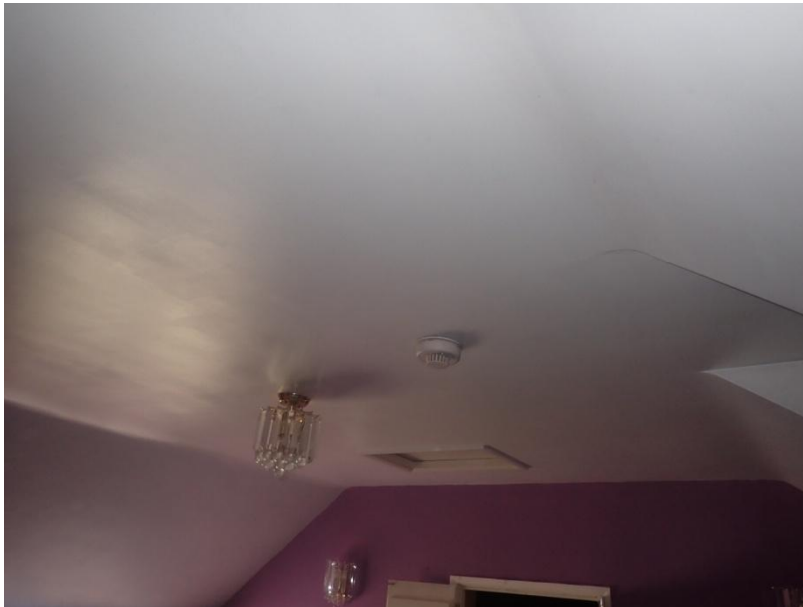
Plates 53-56 provide a number of views from different vantage points of the nature of the ceiling of **Cell 3**, which has been rendered over with modern plasterwork. **Cell 3** occupies much of the internal roof space of the northern portion of **Building 1**.

Plate 53: View of the ceiling of Cell 3, from the south-east

Plate 54: View of the ceiling of Cell 3, from the south-east

Plate 56: View of the ceiling of Cell 3, from the north-west

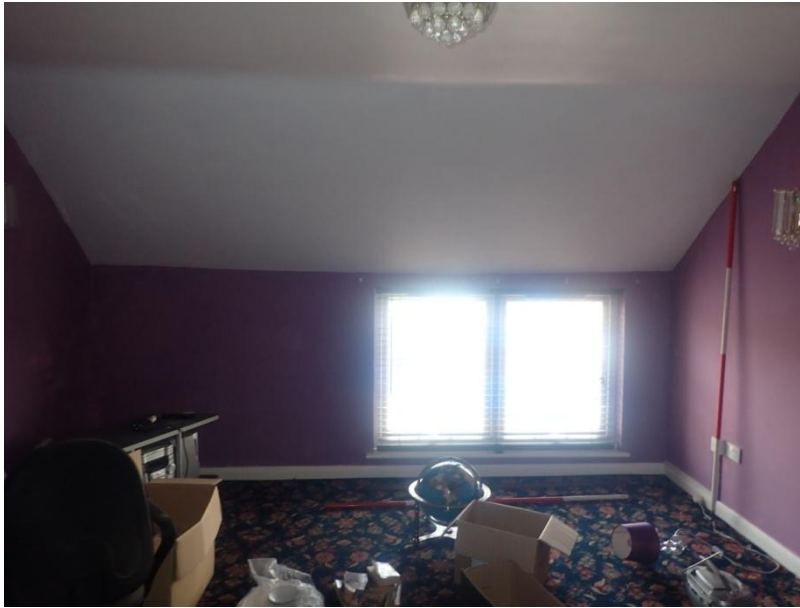
Plate 57: View of the east wall of Cell 3, from the south-west

Plate 57 furnishes a view of the low east wall of **Cell 3**, which has been rendered over with modern plasterwork. Modern horizontal timber skirting boards occur along its base. The central feature is the inner face of the east facing first floor window opening that was recorded externally at the East Elevation of this building. It may also be observed that the mid and lower levels of the angled line of the gabled roof of **Building 1** occur at the upper levels above this low east wall.

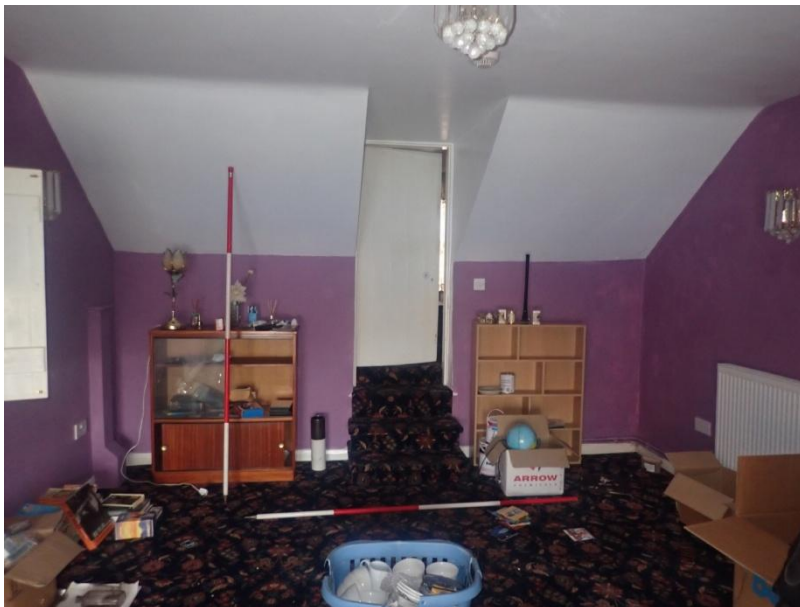
Plate 58: View of the west wall of Cell 3, from the south-east

Plate 58 presents a detailed view of the west wall of **Cell 3**, which has been rendered over with modern plasterwork. Modern horizontal timber skirting boards occur along its base. This is also the internal dividing wall with the adjacent **Cell 13 of Building 2** to the west. The central feature of this west wall is the inner face of a first floor west facing entrance opening that extends onto the adjoining **Building 2** to the west. Several timber steps extend upwards to this entrance opening, emphasising the difference in first floor levels between this **Building 1** and the adjoining **Building 2**. This entrance opening is occupied by a modern timber frame of a head and surrounds and by a timber door that has been covered over with modern hardboard. It may also be observed that the mid and lower levels of the angled line of the gabled roof of **Building 1** occur at the upper levels above this west wall.

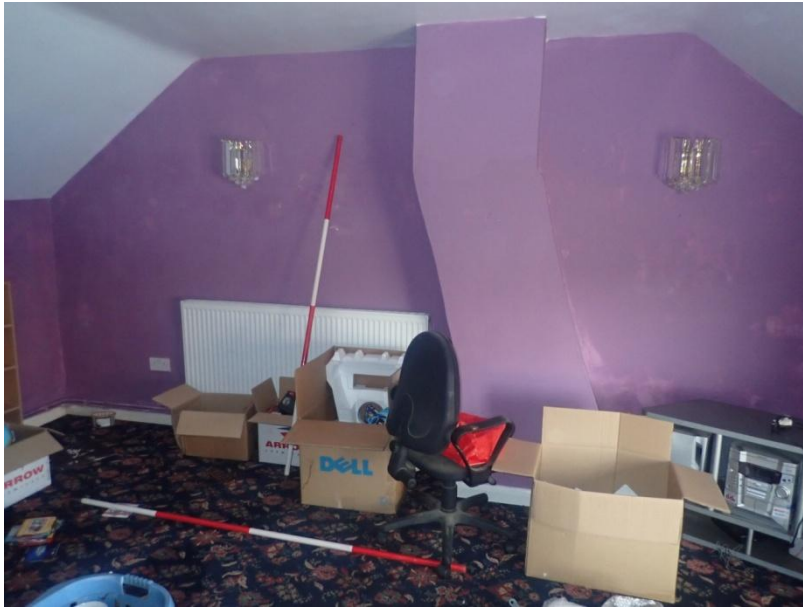
Plate 59: View of the north wall of Cell 3, from the south-east

Plate 59 features the north wall of **Cell 3**, which has been rendered over with modern plasterwork. Modern horizontal timber skirting boards occur along its base. The central feature of this north wall is the winding internal chimney breast. This is worthy of note as an accompanying external chimney stack is no longer present. It is clear that this is also an original feature. The lines of the angled gabled roof of **Building 1** flank either side of this north wall.

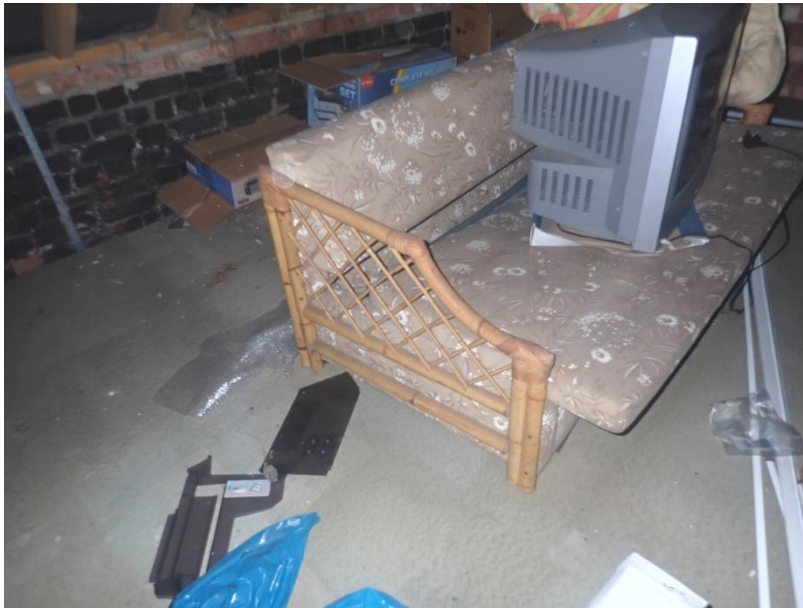
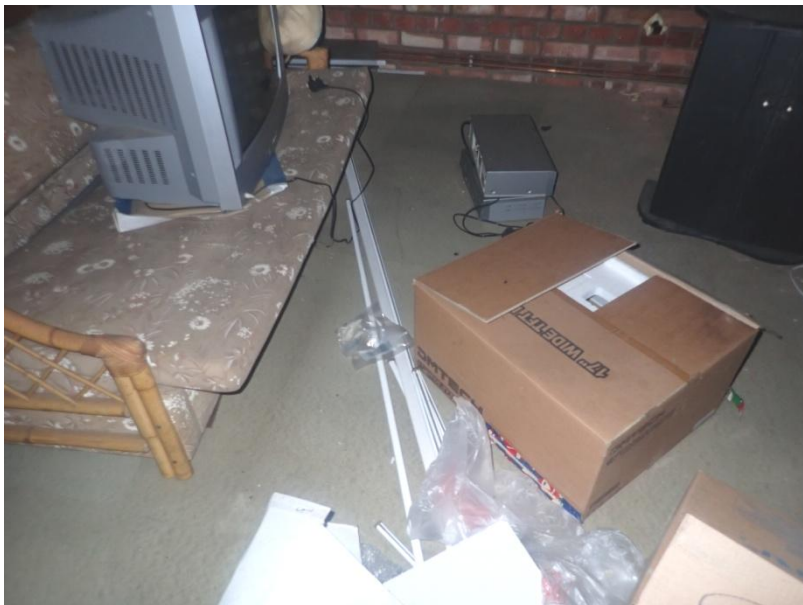
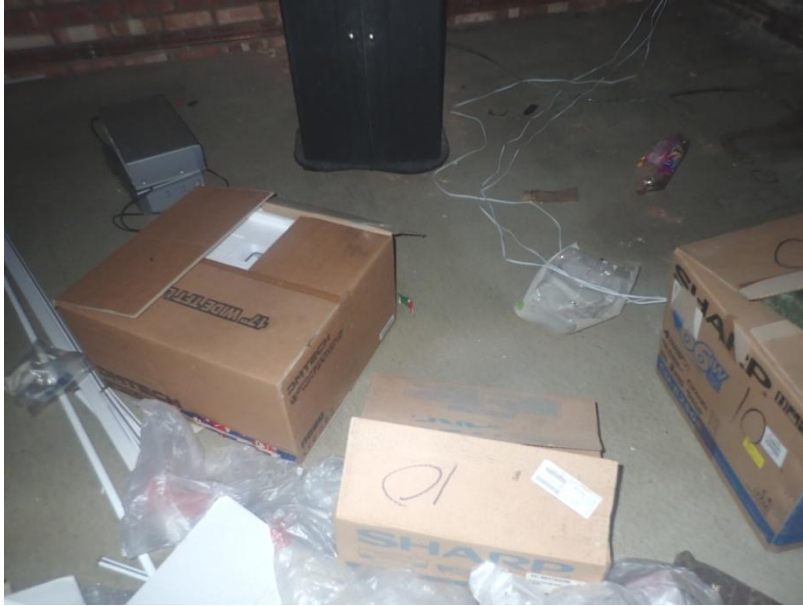
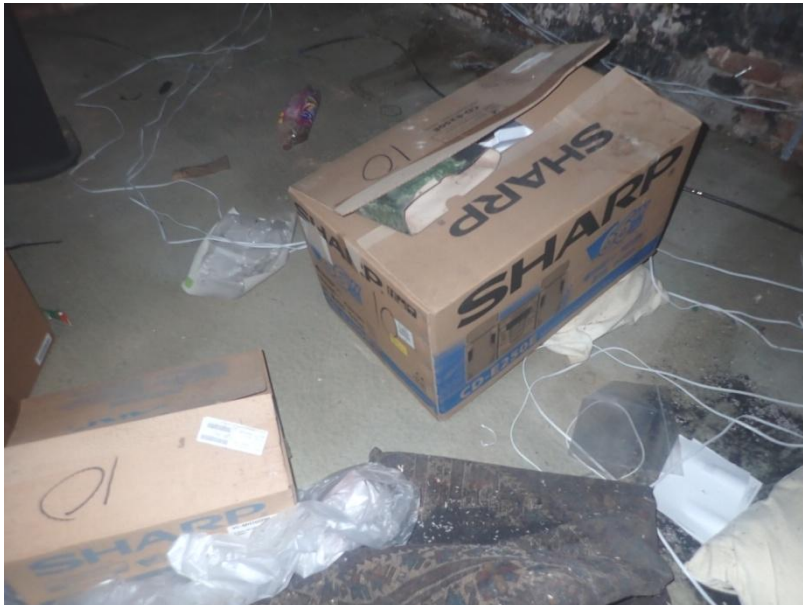
Plates 61-64 present a number of views of the nature of the flooring of **Cell 4**, which is of modern hardboard.

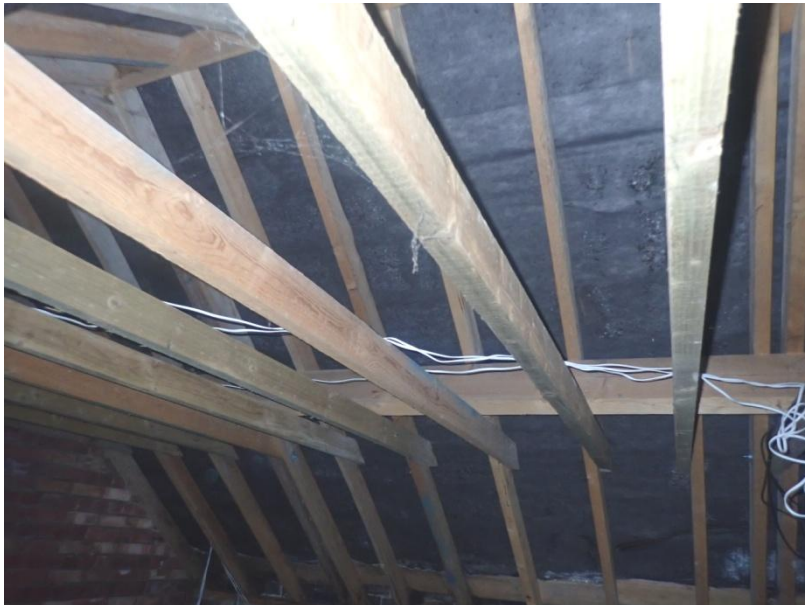
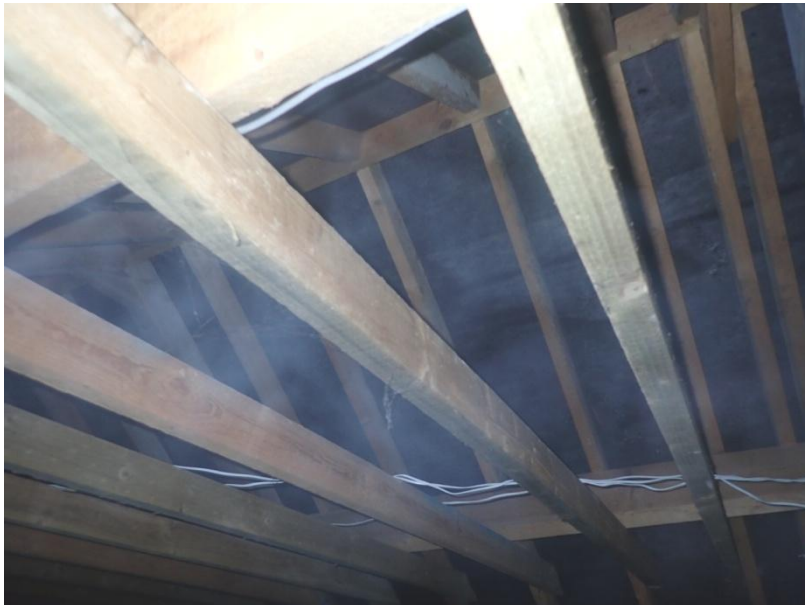
Plates 66-69 present views of the nature of the roof supporting structure of **Cell 4** and hence of **Building 1**. This is a modern addition and a relatively simple structure. This consists of a framework of timber rafters and a series of horizontal timber purlins that extend along both sides of this structure and also at the roof apex. The basal ends of the timber rafters are attached to the horizontal timber wallplates that run along the top of the low east and west walls, whilst their upper ends are affixed to the horizontal timber purlins at the roof apex. At the mid levels are a series of further horizontal timber tie beams, the ends of which are attached to the timber rafters.

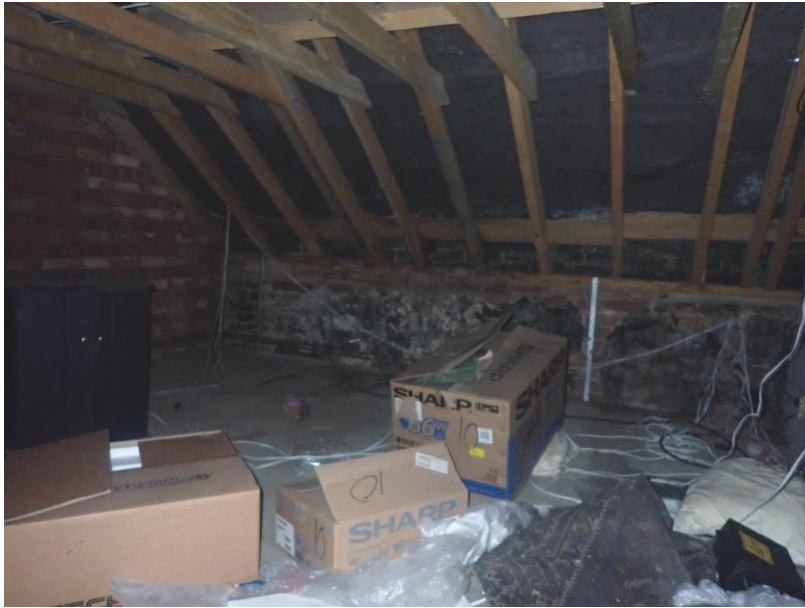
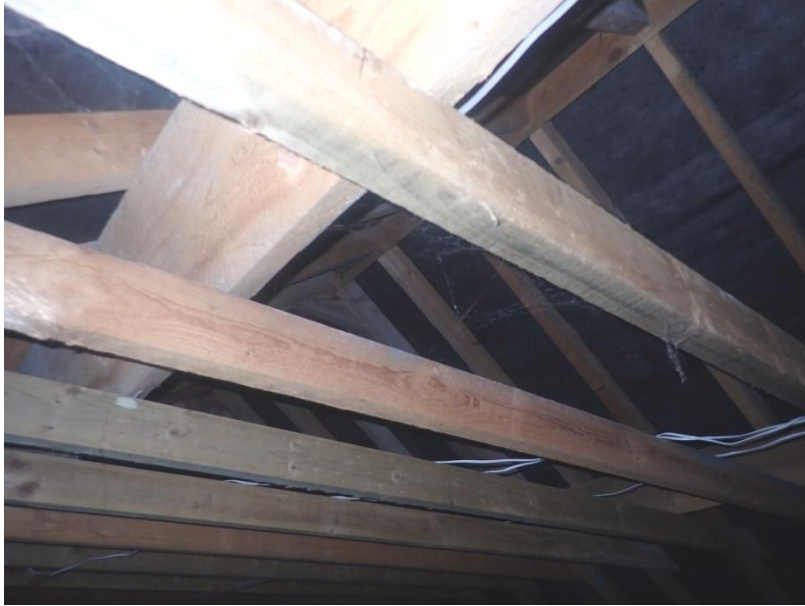
Plate 67: View of the roof supporting structure of Cell 4, from the north-east

Plate 69: View of the roof supporting structure of Cell 4, from the north

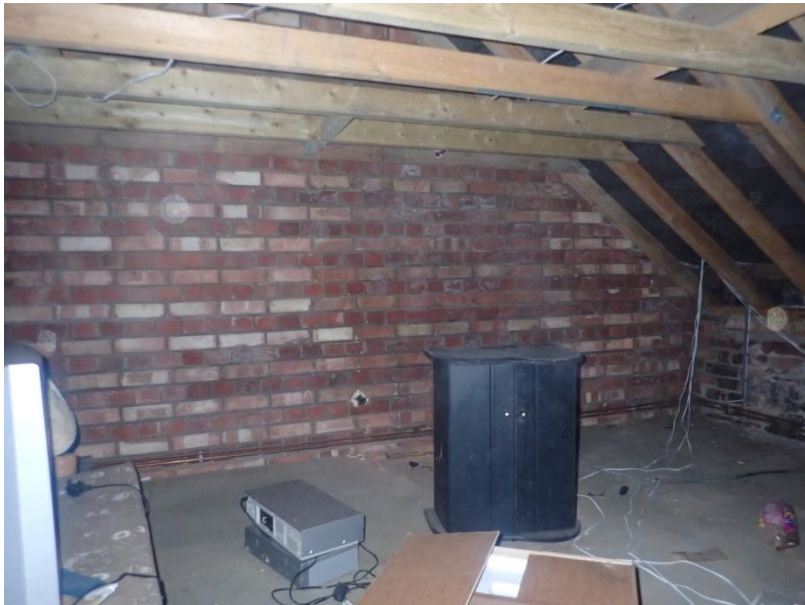
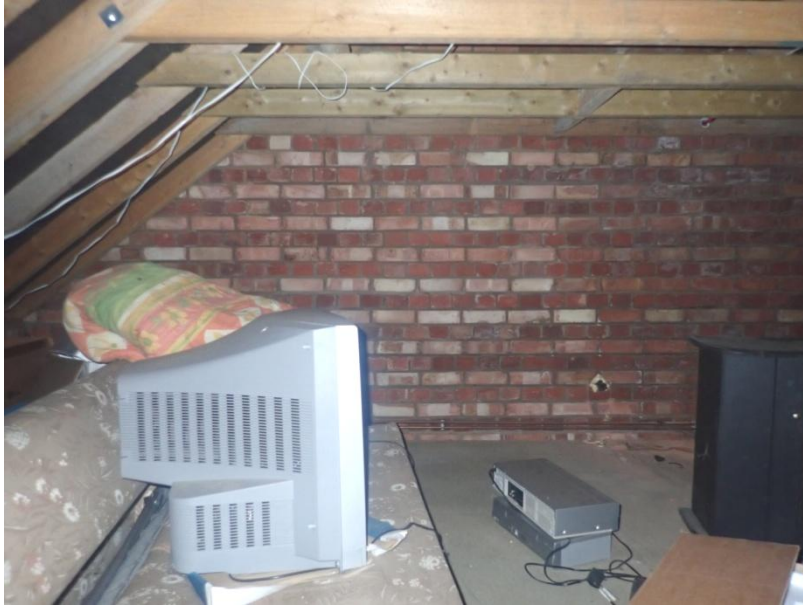
Plates 70 and 71 furnish detailed views of the lower levels of the south wall of **Cell 4**. The brickwork wall fabric here is composed of courses of brick stretchers that alternate with courses of brick headers in English Bond.

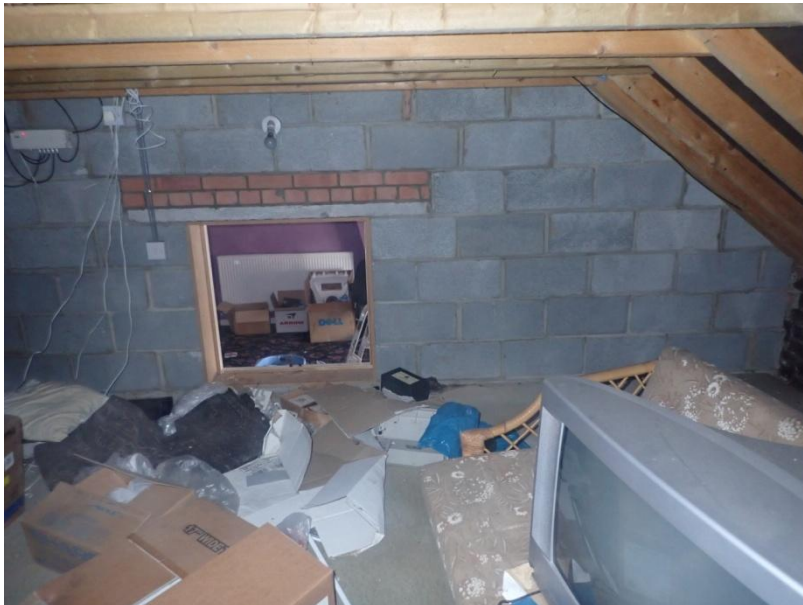
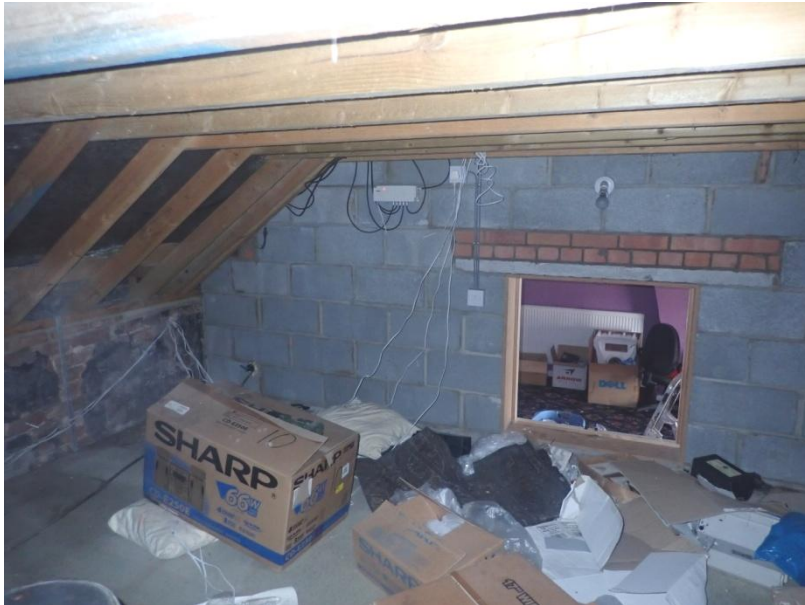
Plates 72 and 73 feature the north wall of **Cell 4**, which is also the internal dividing wall with the adjoining **Cell 3** to the north. The wall fabric here is composed of courses of modern breeze blockwork and so this is clearly a modern addition. Inserted into this wall fabric is the north facing opening that extends onto the adjoining **Cell 3**. The inner face of this is shown with a timber frame of a head and surrounds.

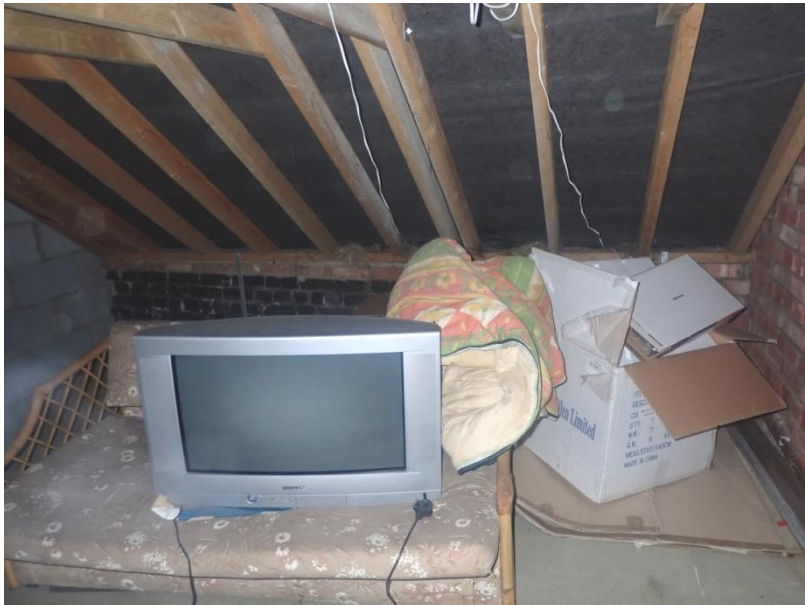
Plate 74: View of the east wall of Cell 4, from the south-west

Plate 74 presents a view of the low east wall of **Cell 4**. The brickwork wall fabric here is composed of courses of brick stretchers that alternate with courses of brick headers in English Bond. An horizontal timber wallplate may be seen to extend along the top of this low east wall.

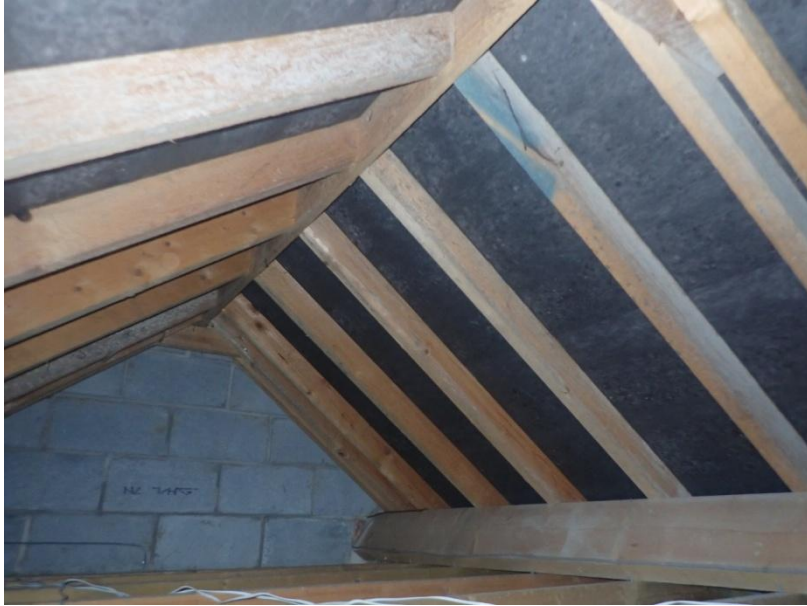
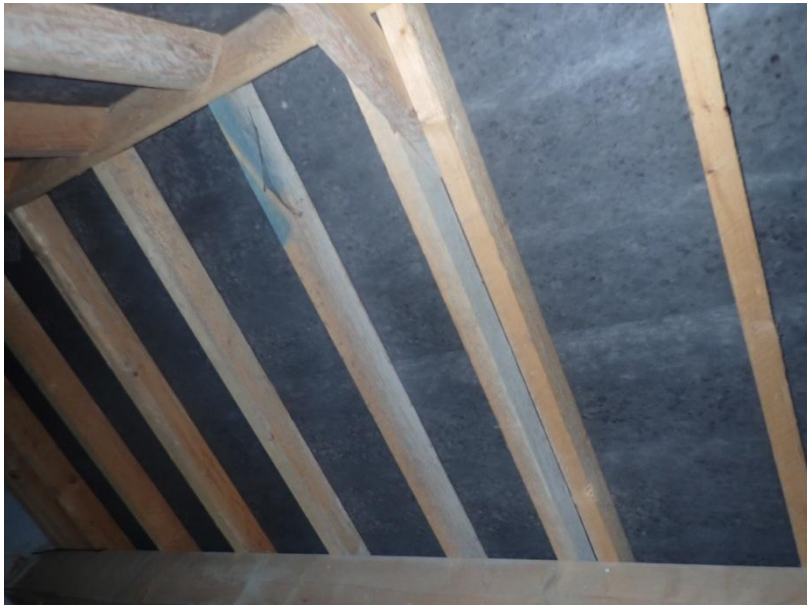
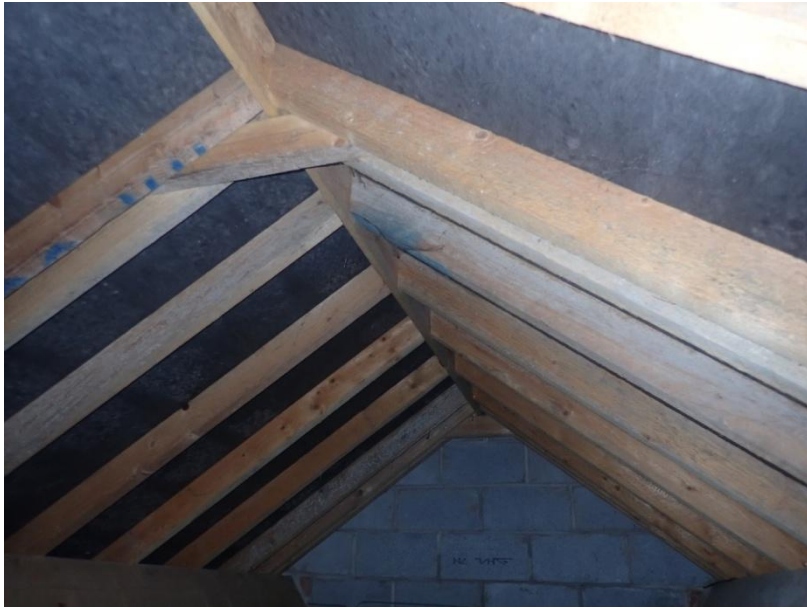
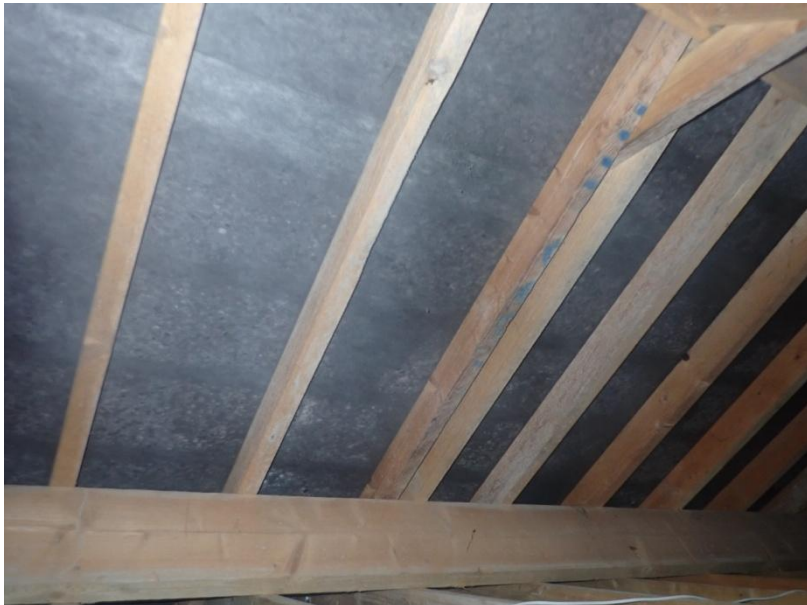
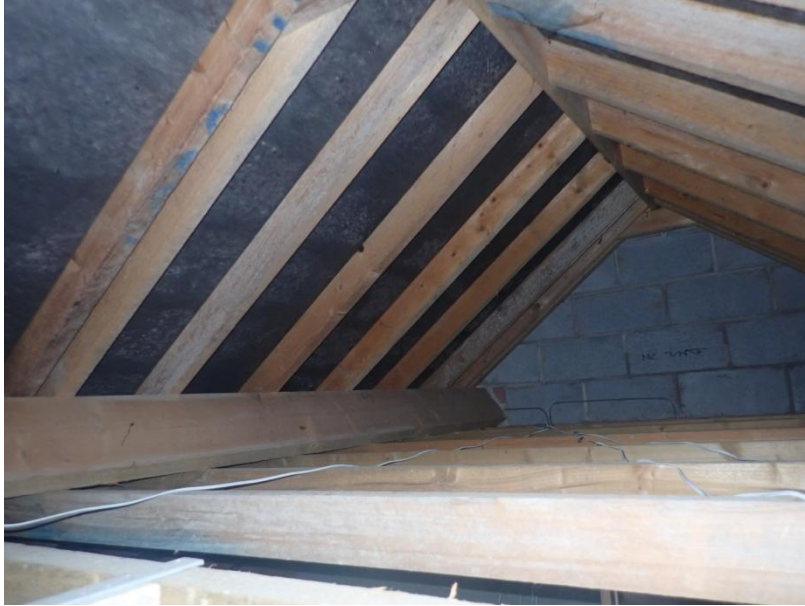
Plate 75: View of the roof supporting structure of Cell 4, from the south-west

Plate 76: View of the roof supporting structure of Cell 4, from the south-west

Plates 75-79 present further views from differing positions of the nature of the roof supporting structure of **Cell 4** and hence of **Building 1**. **Plates 75 and 79** show the upper levels of the north wall of **Cell 4**, which is composed of courses of modern breeze blockwork.

Plate 77: View of the roof supporting structure of Cell 4, from the south-east

Plate 78: View of the roof supporting structure of Cell 4, from the south-east

Plate 79: View of the roof supporting structure of Cell 4, from the south-east

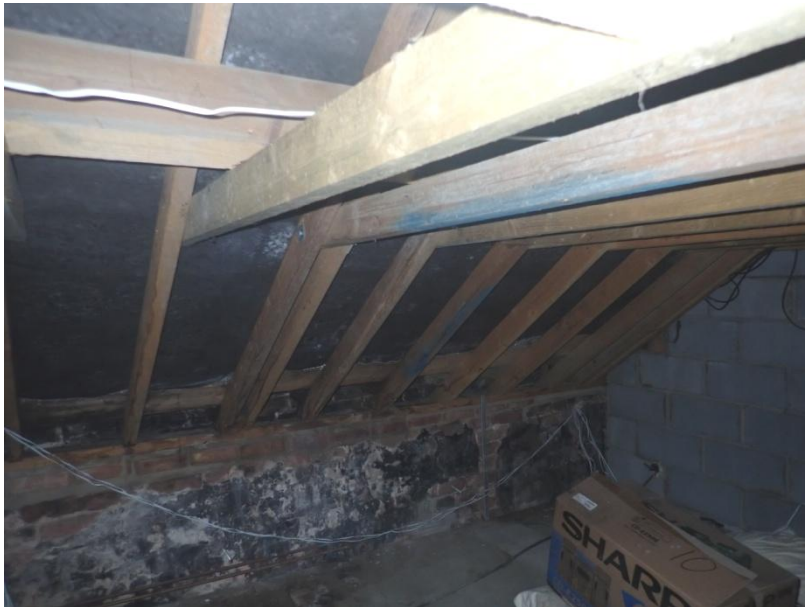
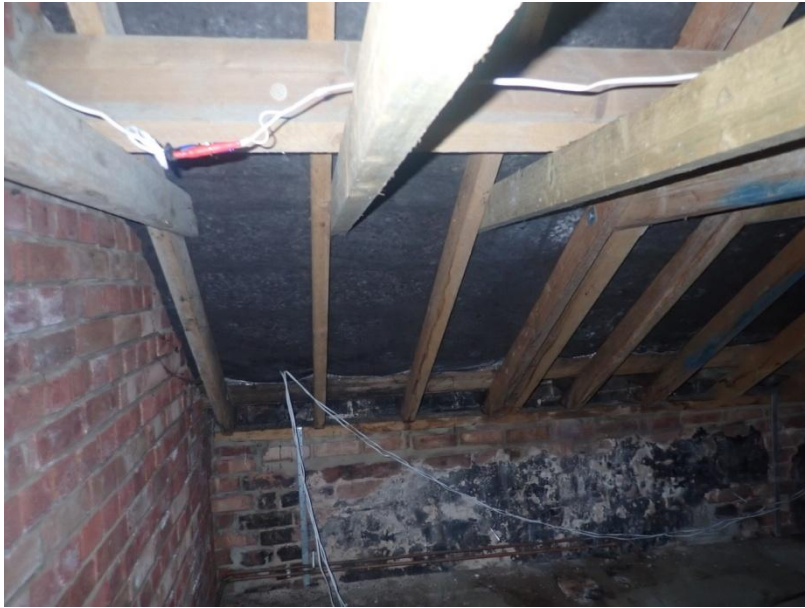
Plates 80 and 81 present further views of the low west wall of Cell 4.

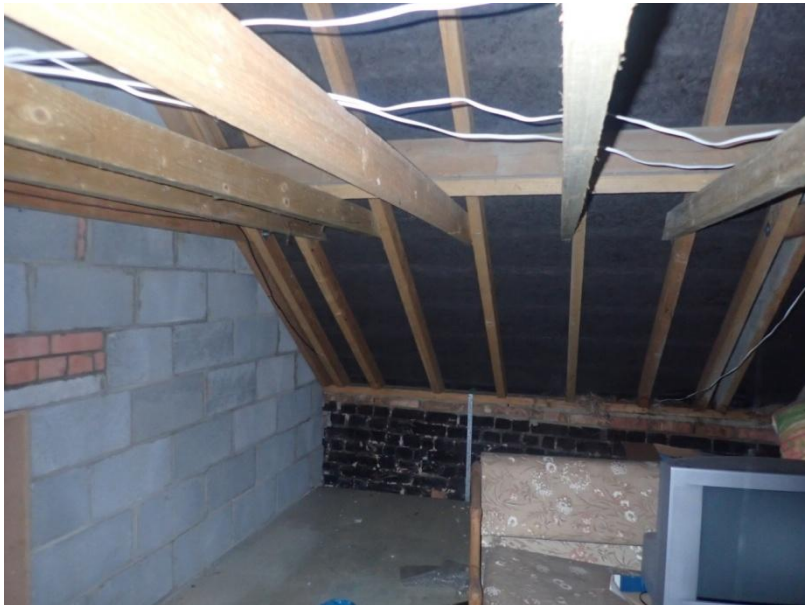
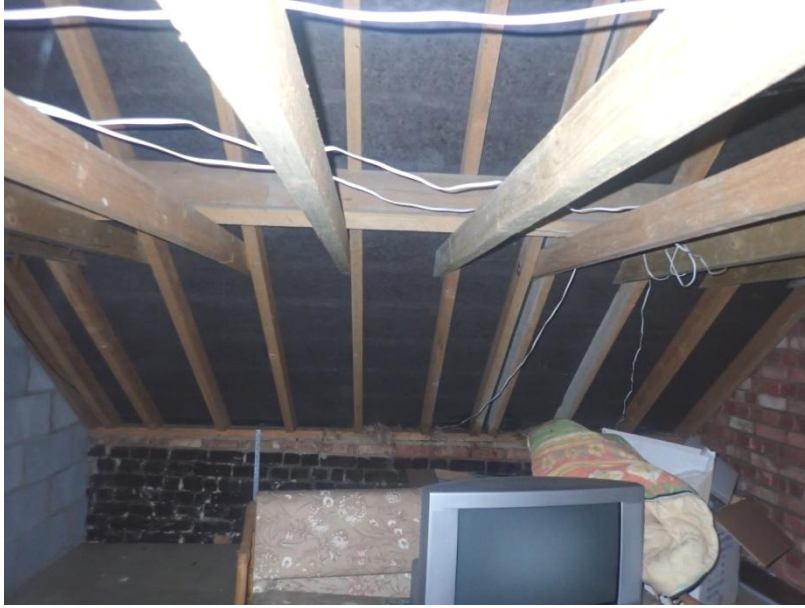
Plates 82 and 83 provide further views of the low east wall of Cell 4.

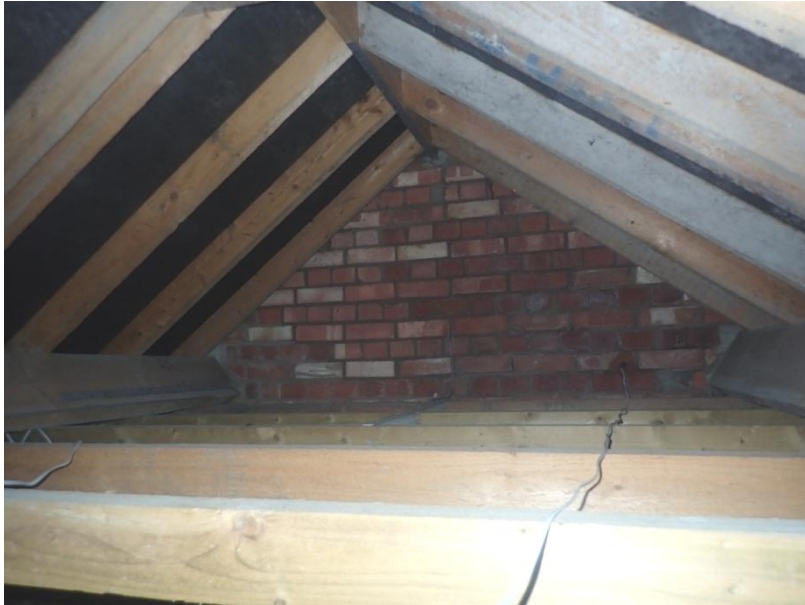
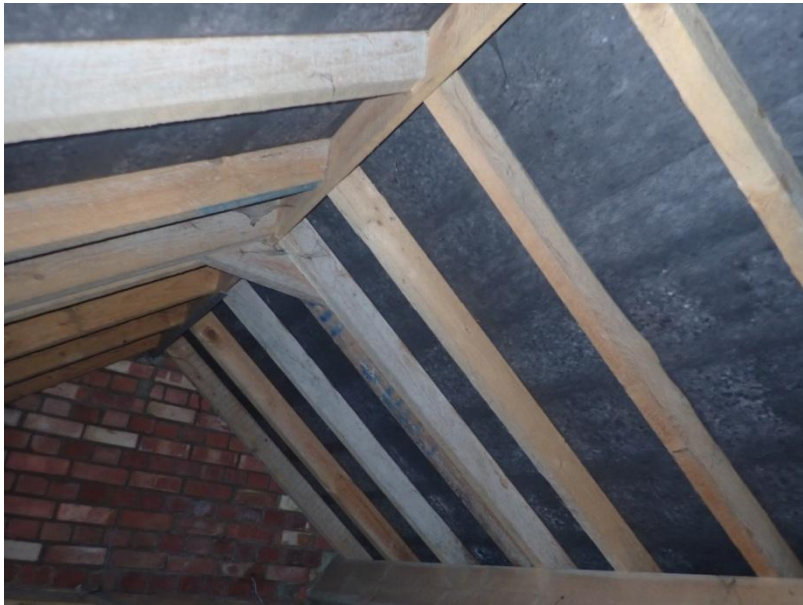
Plates 84-88 present further views from differing positions of the nature of the roof supporting structure of **Cell 4** and hence of **Building 1**. **Plates 84 and 87** also feature the upper levels of the south wall of **Cell 4**, where the brickwork here is of English Bond.

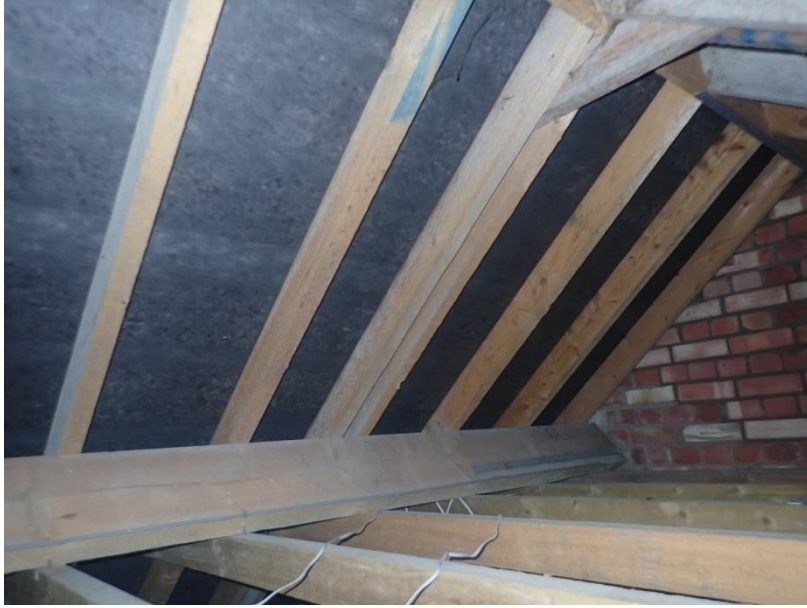
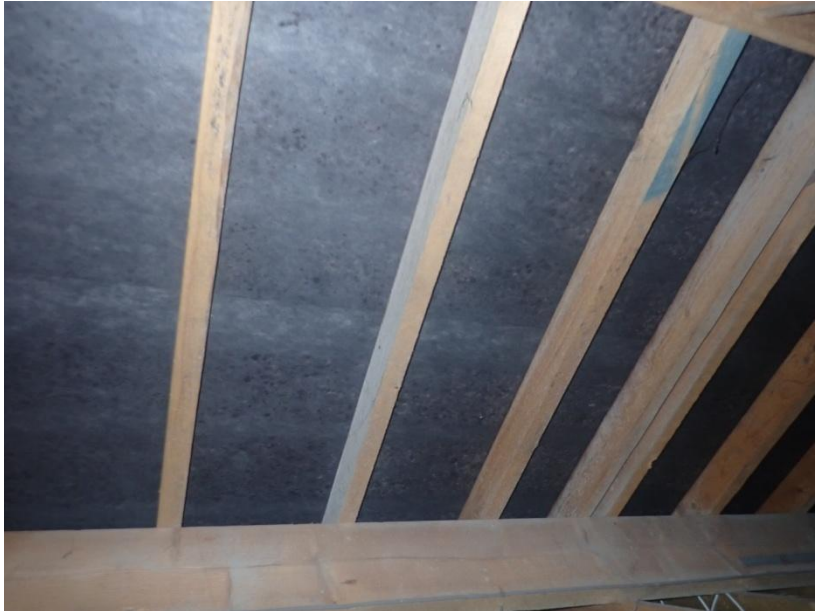
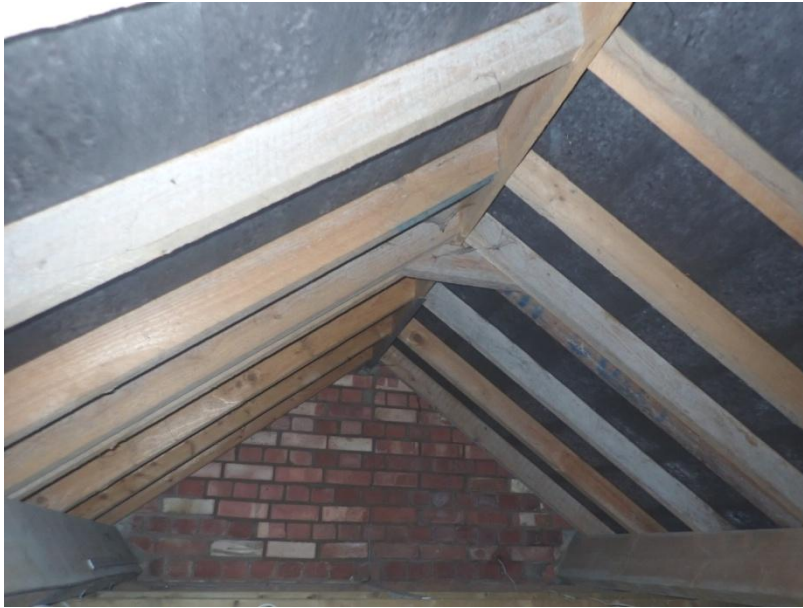
Plate 85: View of the roof supporting structure of Cell 4, from the north-west

Plate 86: View of the roof supporting structure of Cell 4, from the west

Plate 87: View of the roof supporting structure of Cell 4, from the north-east
