**NEVILLE HALL
FREELANCE ARCHAEOLOGIST & CONSULTANT**

HISTORIC BUILDING RECORDING AT THE
FORMER DUKE OF YORK PUBLIC HOUSE,
106, RISEGATE ROAD,
GOSBERTON RISEGATE, LINCOLNSHIRE

January 2023

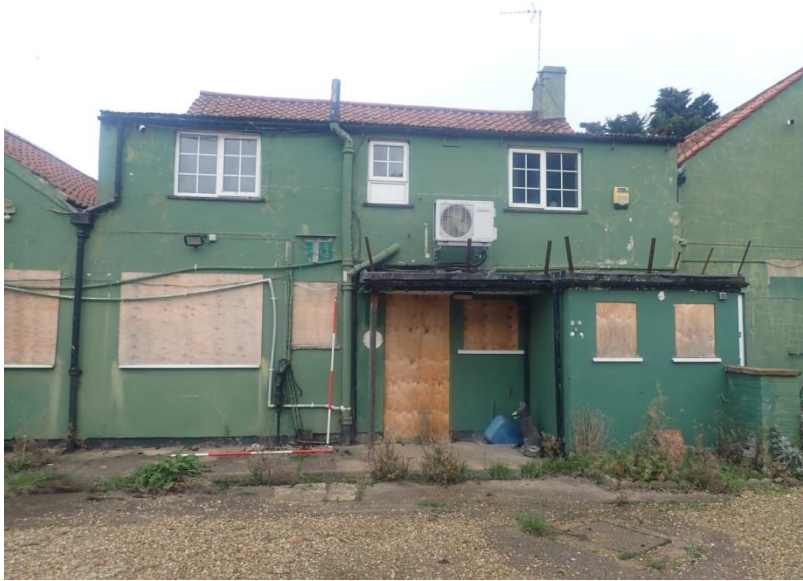
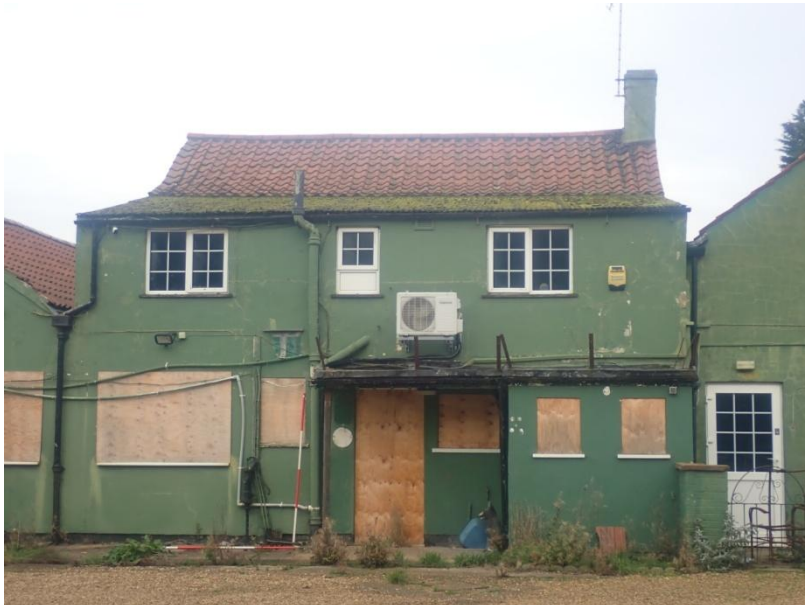
Plates 89-92 present a number of detailed views of the South Elevation of **Building 2**, which is in effect the South Elevation of the later rear outshut of the main body of the public house. It may be observed that the entirety of the wall fabric of this South Elevation has been covered over with modern cement rendering. At just below roof levels is modern horizontal Upvc guttering that extends onto a winding vertical modern Upvc downpipe at the western end of this Elevation. Also visible is an off centre vertical metal soilpipe.

At first floor levels are three south facing modern glazed Upvc casement windows, each with timber sills at the base of each opening.

At ground floor levels and to the left (west) are two ground floor window openings that have been boarded over. To the right (east), is a rear south facing entrance opening into this building, which has also been boarded over. Further to the right (east) of this, is a third south facing ground floor window opening that has similarly been boarded over. To the right (east) of this and bonded to the eastern end of this South Elevation is a single storey modern toilet extension, the wall fabric of which has also been entirely rendered over. This has a flat roof which extends westwards to a modern canopy over the rear ground floor entrance opening. Two further south facing window openings within the modern single storey toilet extension have also been boarded over.

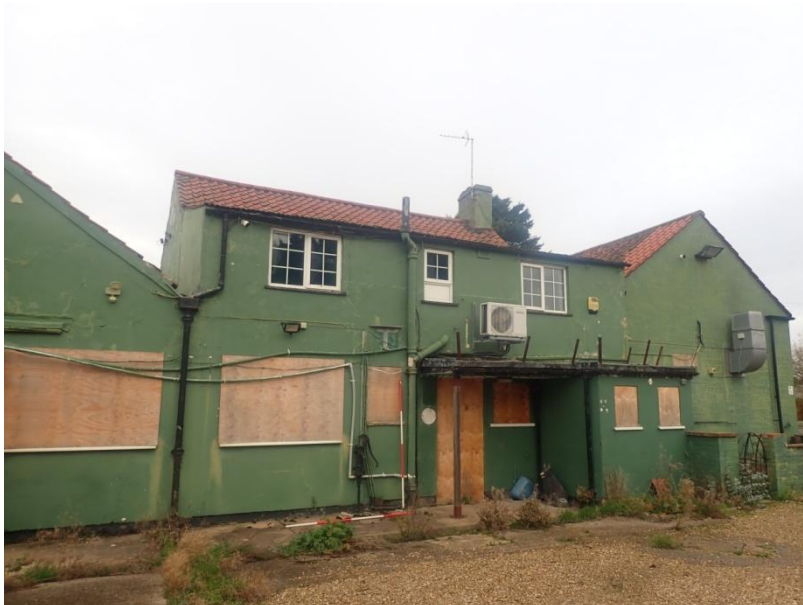
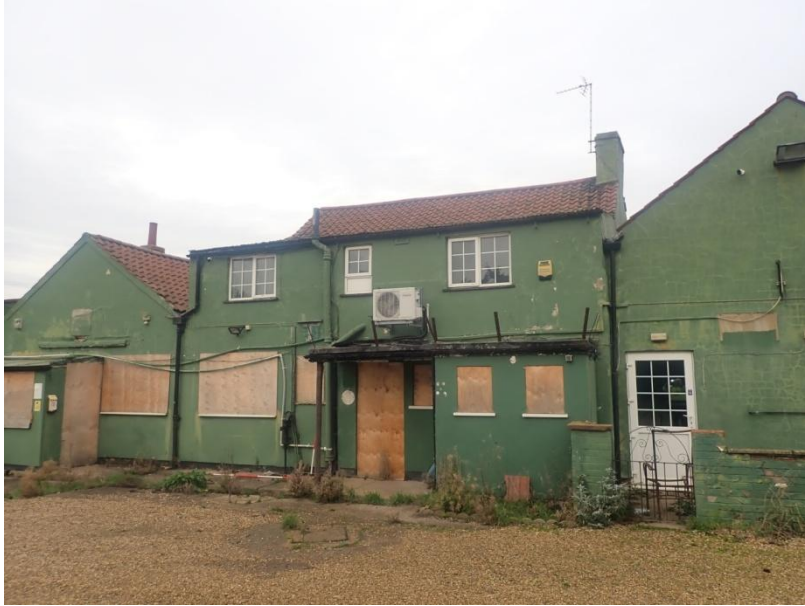
Plate 90: View of the South Elevation of Building 2, from the south-west

Plate 91: View of the South Elevation of Building 2, from the south-east

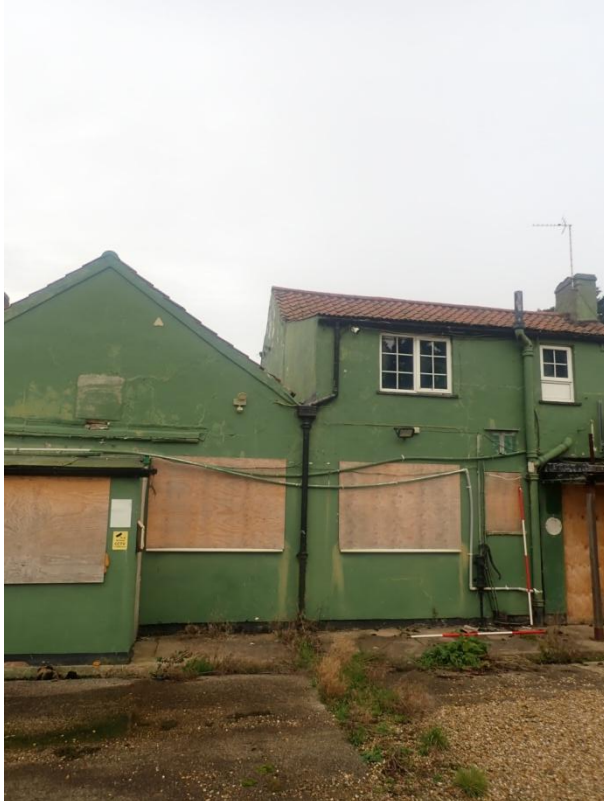
Plate 93: View of the South Elevation of Building 2, from the south-west

Plate 93 provides a view of the upper levels of the West Elevation of the main and original body of the public house along with the upper levels of the West Elevation of the bonded rear outshut. Here also, the entire wall fabric of both Elevations have been covered over with modern cement rendering.

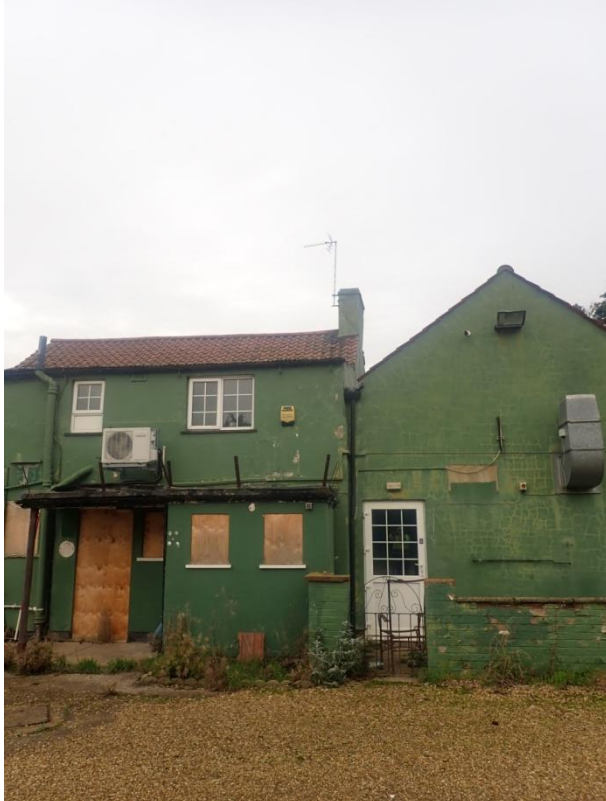
Plate 94: View of the South Elevation of Building 2, from the south-east

Plate 94 also features the upper levels of the East Elevation of the main and original body of the public house along with the upper levels of the East Elevation of the bonded rear outshut. Here also, the entire wall fabric of both Elevations have been covered over with modern cement rendering.

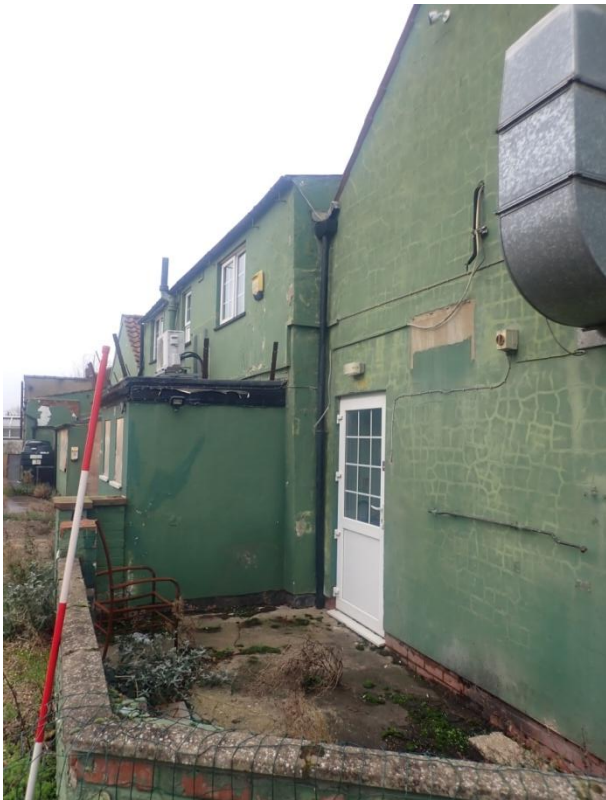
Plate 95: View of the South Elevation of Building 2, from the north-east

Plate 95 presents an image of the East Elevations of the modern single storey toilet extension and also of the lower levels of the rear outshut from a north-eastern vantage point. Here also, the entire wall fabric of both Elevations have been covered over with modern cement rendering.

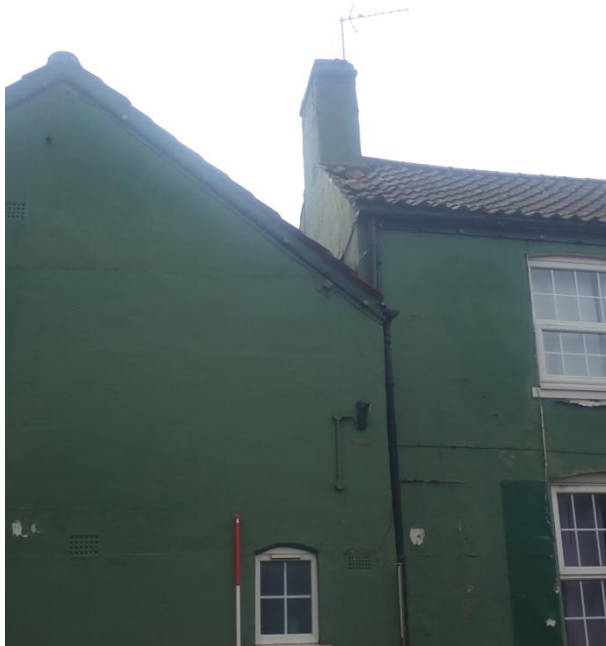
Plate 96: View of the North Elevation of Building 2, from the north-west

Plate 96 provides a view from a different north-western perspective of the upper levels of the East Elevation of the main and original body of the public house, the wall fabric of which has also been entirely covered over with modern cement rendering.

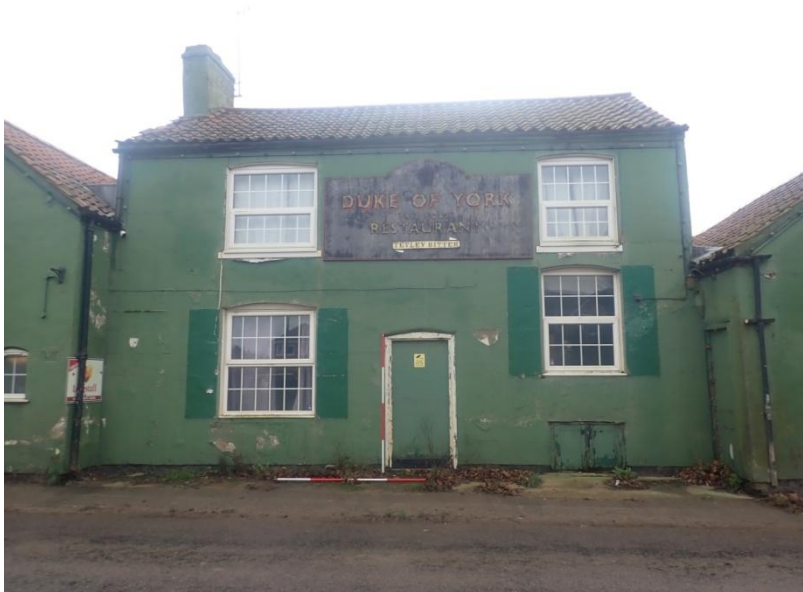
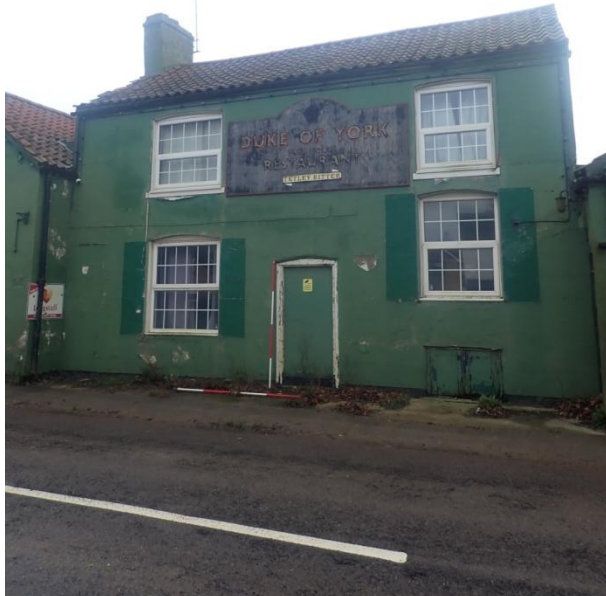
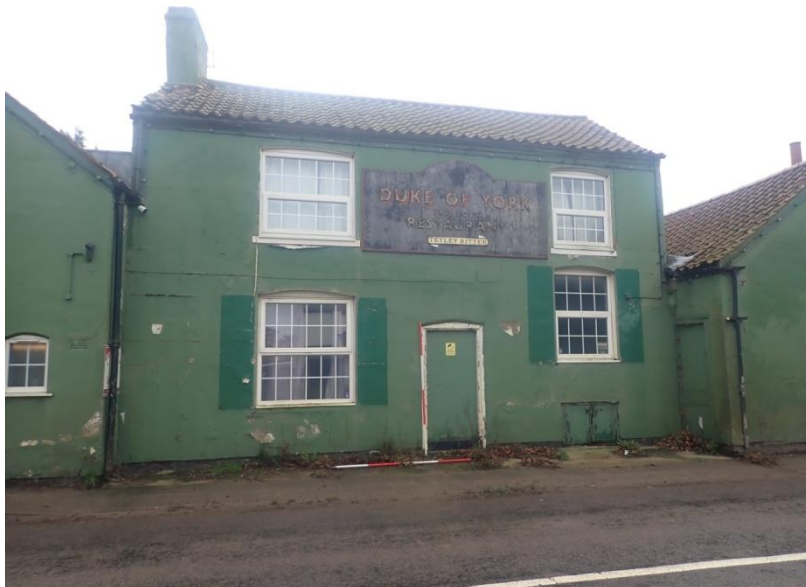
Plates 97-99 furnish several views of the North Elevation of the original public house building. Here also, the entire wall fabric of this North Elevation has been covered over with modern cement rendering. At just below roof levels is modern horizontal Upvc guttering, which is attached to horizontal timber fascia boards. At first floor levels are two north facing window openings that are both occupied by modern glazed Upvc casement windows. At ground floor levels is the main former access into the building off the Risegate Road street frontage. This north facing entrance opening is occupied by a timber frame of a head and surrounds. The remainder of the opening has been infilled with timber boarding. At ground floor levels are two further north facing window openings.

These north facing ground floor window openings are similarly occupied by two further modern glazed Upvc casement windows. At street levels and to the right (west) is the hatched opening into the basement of the building through which brewery deliveries were made. This opening is occupied by a timber frame and a pair of panelled timber doors.

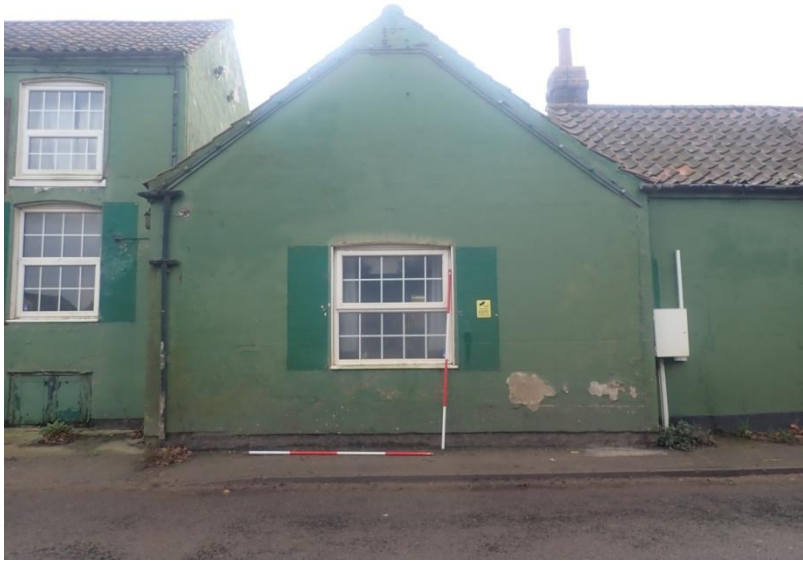
Plate 100: View of the West Elevation of Building 2, from the north-west

Plate 100 provides a view of the upper levels of the West Elevation of the main and original body of the public house, the wall fabric of which has also been entirely covered over with modern cement rendering.

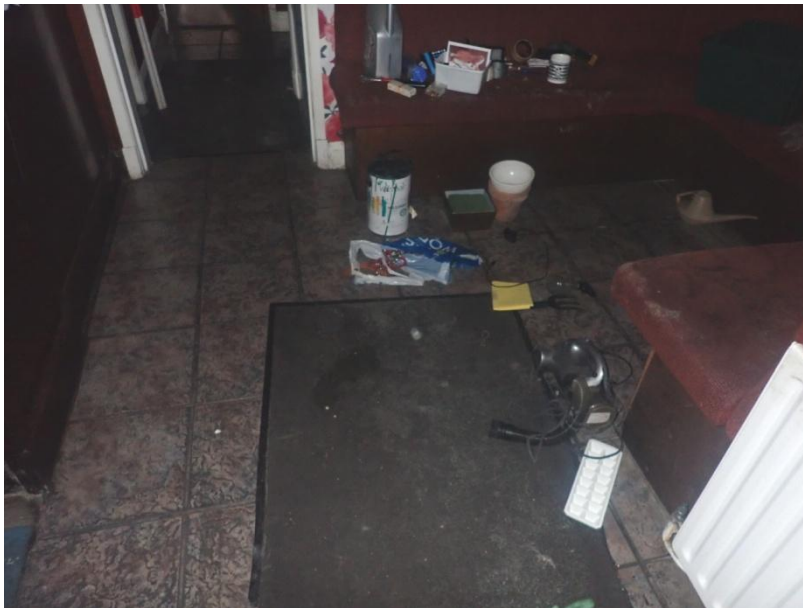
Plate 101: View of the flooring of Cell 5, from the south-west

Plates 101 and 103 furnish views from different perspectives of the nature of the flooring of **Cell 5**, which is of modern ceramic tiling.

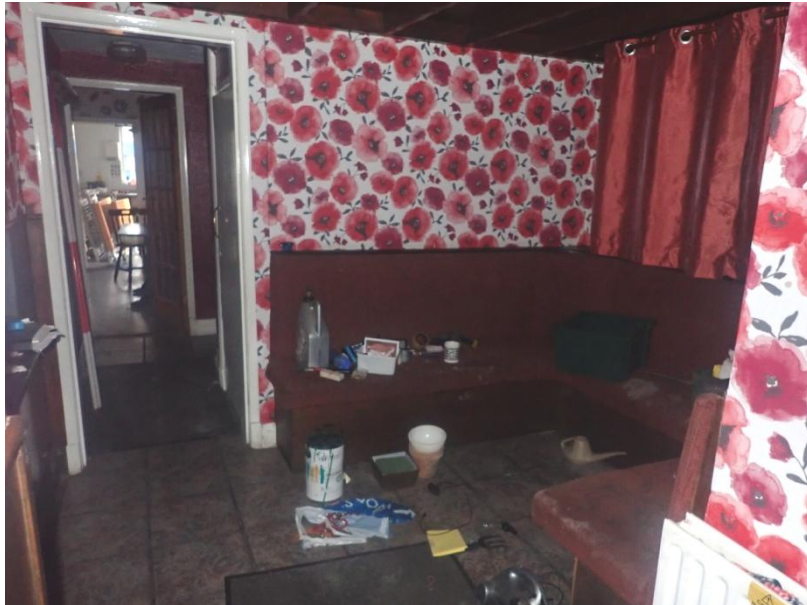
Plate 102: General view of the interior of Cell 5, from the south-west

Plate 102 furnishes a general view of the interior of **Cell 5** from a south-western position.

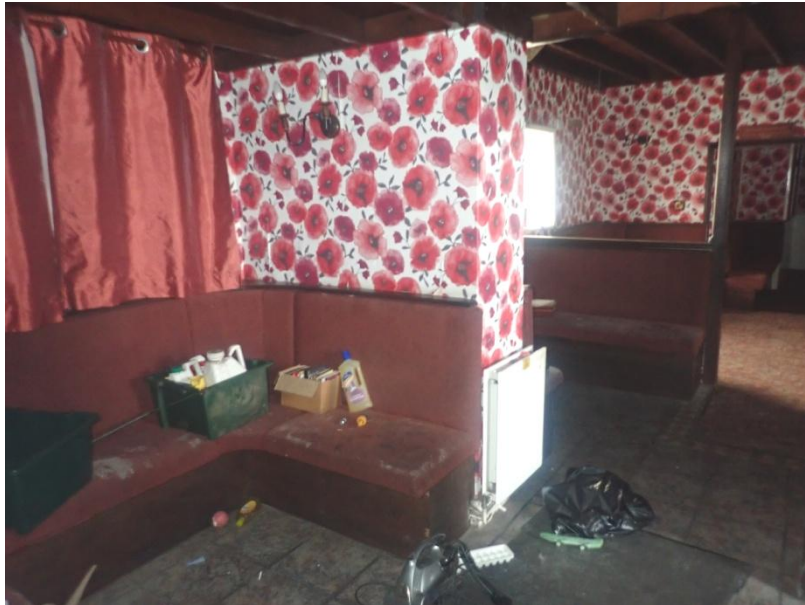
Plate 104: General view of the interior of Cell 5, from the north-east

Plate 104 provides a further general view of the interior of **Cell 5** from a different north-eastern vantage point.

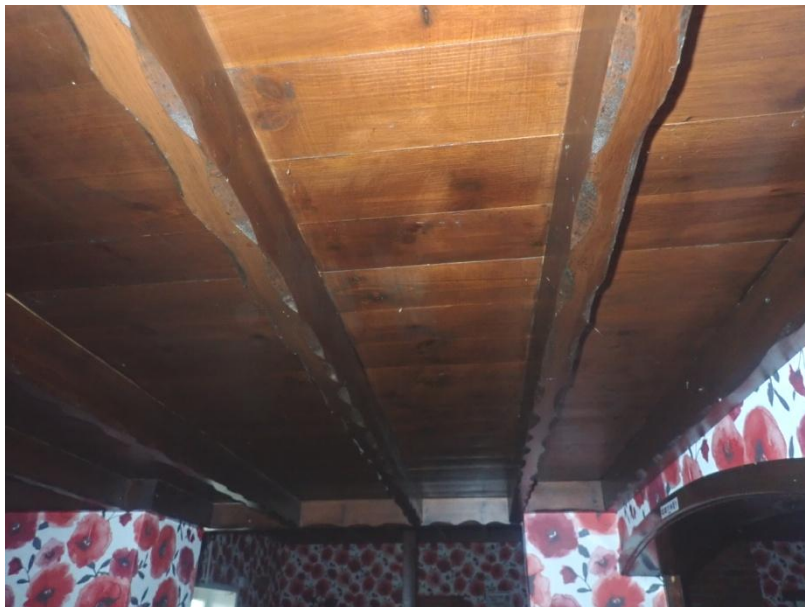
Plate 105: View of the ceiling of Cell 5, from the north-east

Plates 105 and 106 present images of the nature of the modern ceiling structure of **Cell 5** with its east-west orientated horizontal moulded timber joists, which support a first floor flooring above of north-south orientated horizontal timber floor planking.

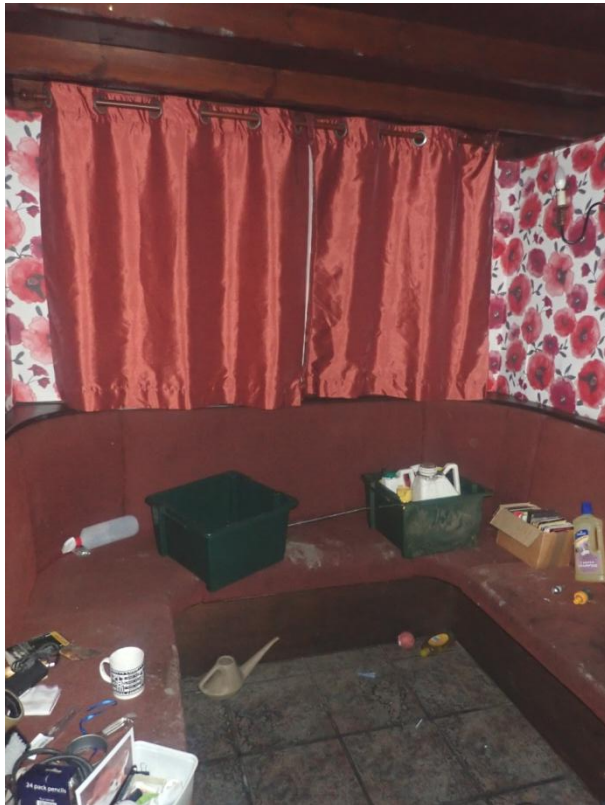
Plate 107: View of the south wall of Cell 5, from the north-west

Plate 107 features the south wall of **Cell 5** and shows the inner face of one of the boarded over south facing window openings that was recorded at the South Elevation of this building. This south wall has a wall covering of modern wallpaper with modern soft furnishings/seating occupying the lower levels of this south wall.

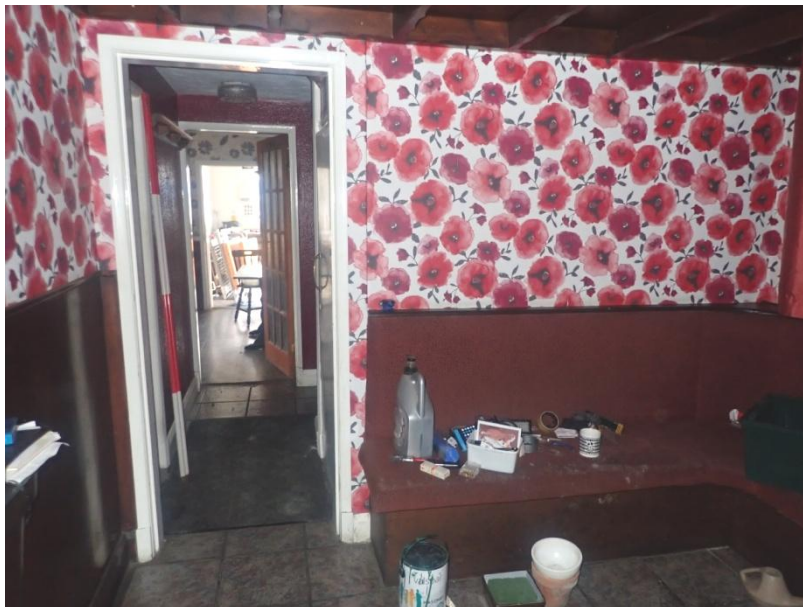
Plate 109: View of the east wall of Cell 5, from the south-west

Plate 109 features the east wall of **Cell 5**. Here also, the wall fabric is covered over with modern wallpaper with modern soft furnishings/seating occupying the lower levels of this east wall. This is also the internal dividing wall with the adjoining **Cell 7** to the east. To the left (north), is an east facing entrance opening that extends onto a ground floor lobby (**Cell 7**) with further access to ground floor toilets (**Cell 9**). This entrance opening is occupied by a modern timber frame only. A door is absent.

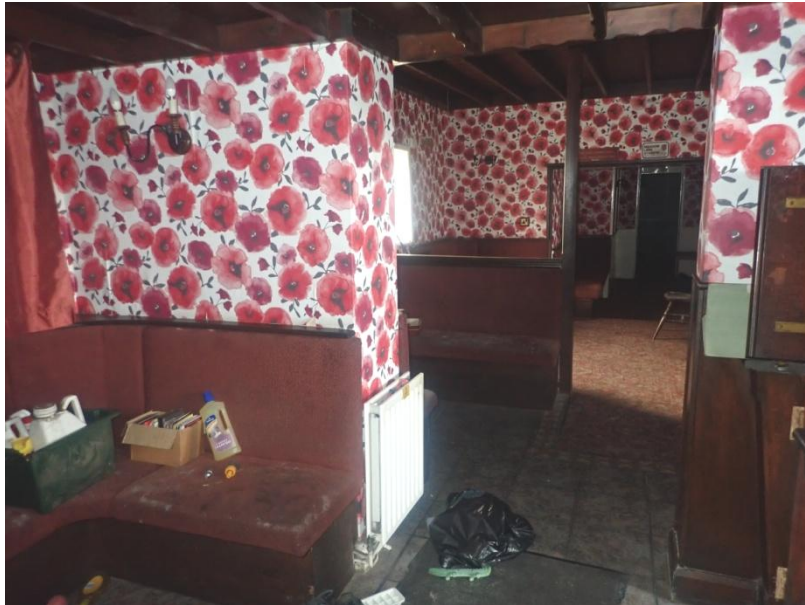
Plate 110: View of the west wall of Cell 5, from the north-east

Plate 110 presents a view of the west wall of **Cell 5** and of its open access into the main part of the public lounge of the public house to the west (**Cell 15**). Here also, the wall fabric is covered over with modern wallpaper with modern soft furnishings/seating occupying the lower levels of this west wall.

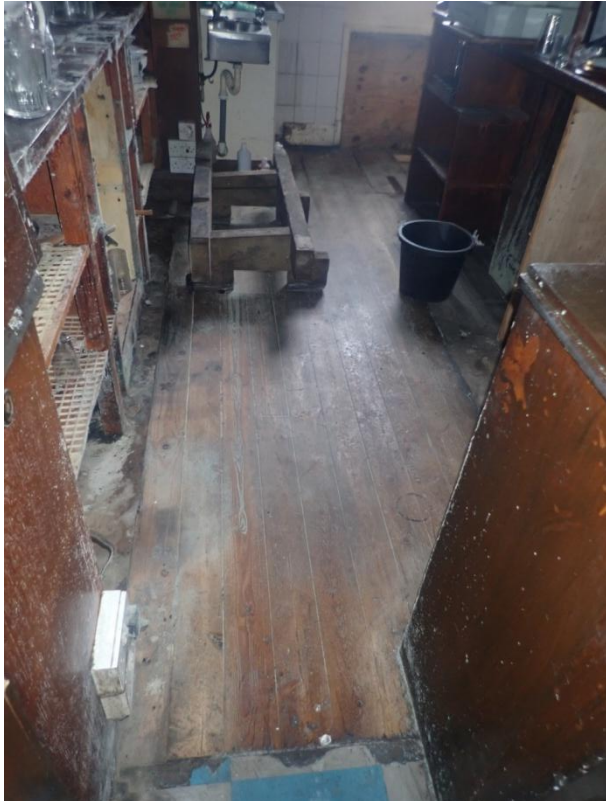
Plate 111: View of the flooring of Cell 6, from the south-east

Plates 111 and 113 provide views of the nature of the flooring of **Cell 6** from different perspectives, which is of horizontal timber planking.

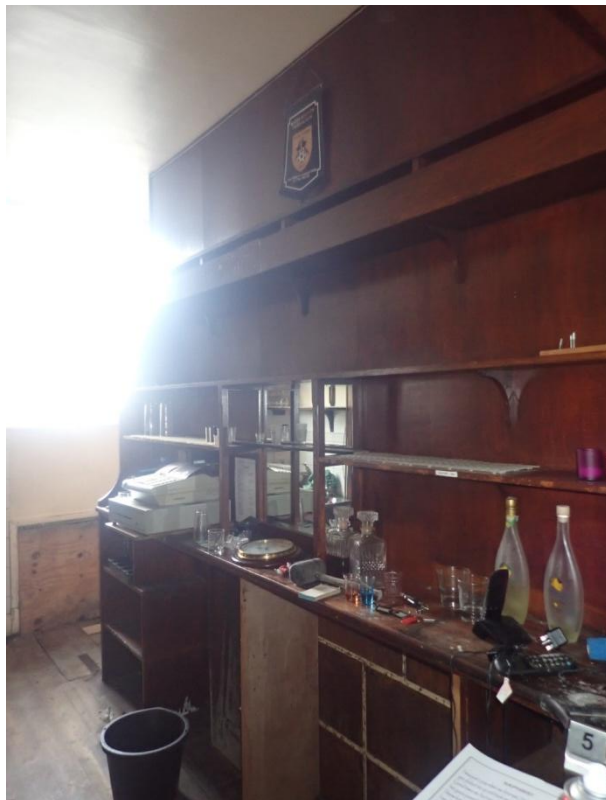
Plate 112: View of the rear serving area of the public bar, from the south-west

Plate 112 presents a view of the rear serving area of the public bar with its mahogany fixtures and fittings.

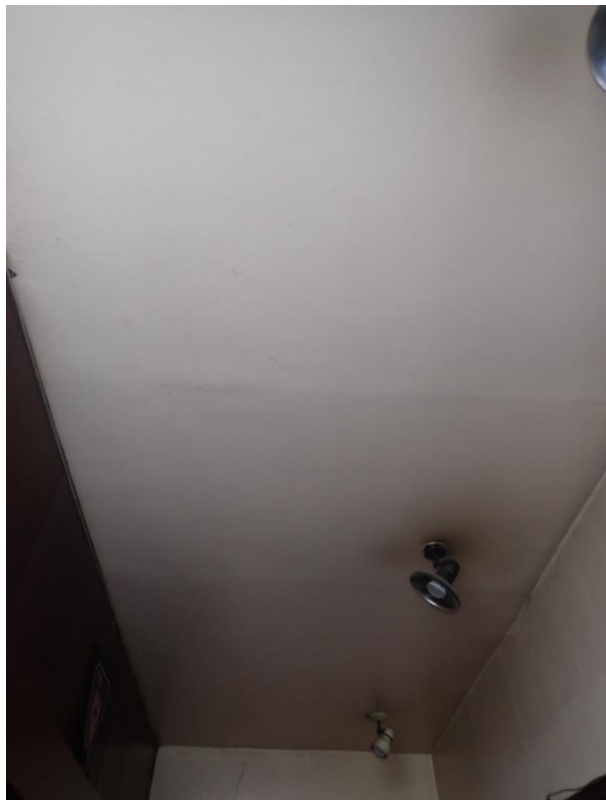
Plate 114: View of the ceiling of Cell 6, from the north-west

Plate 114 features the nature of the ceiling of the frontal area of **Cell 6**, which has been rendered over with modern plasterwork.

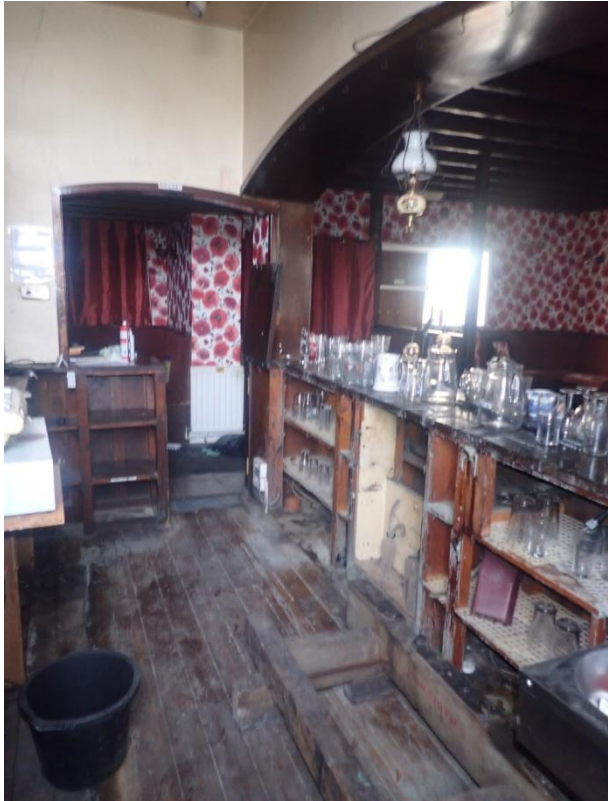
Plate 115: General view of the interior of Cell 6, from the north-west

Plate 115 furnishes a general view of the interior of **Cell 6** from a north-western vantage point.

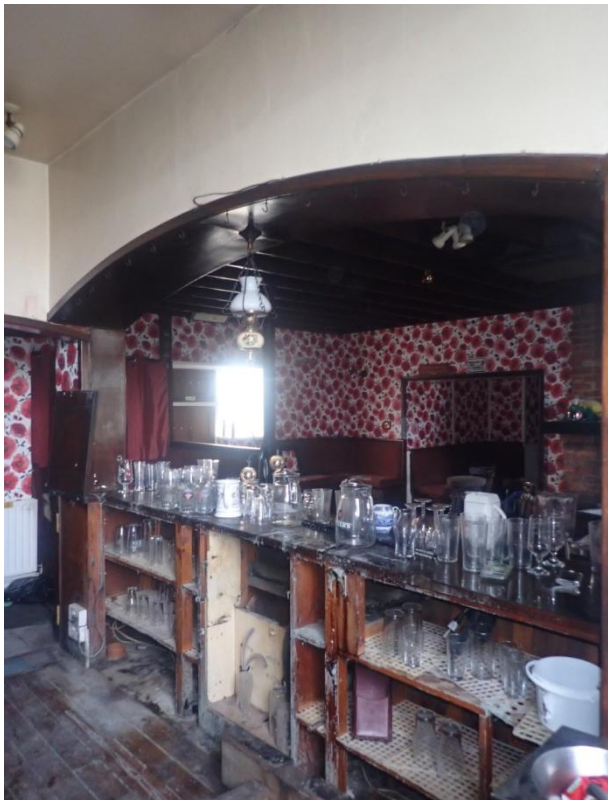
Plate 116: View of the rear of the public bar, from the north-west

Plates 116 and 117 provide views from differing perspectives of the rear of the public bar with its fixtures and fittings.

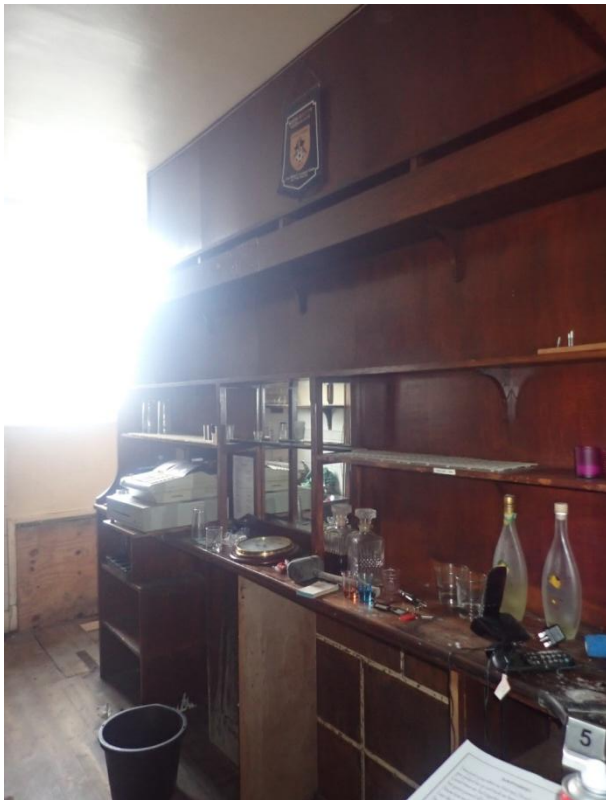
Plate 118: View of the rear service area of the public bar, from the south-west

Plates 118-120 present further views from differing positions of the rear serving area of the public bar with its mahogany fixtures and fittings.

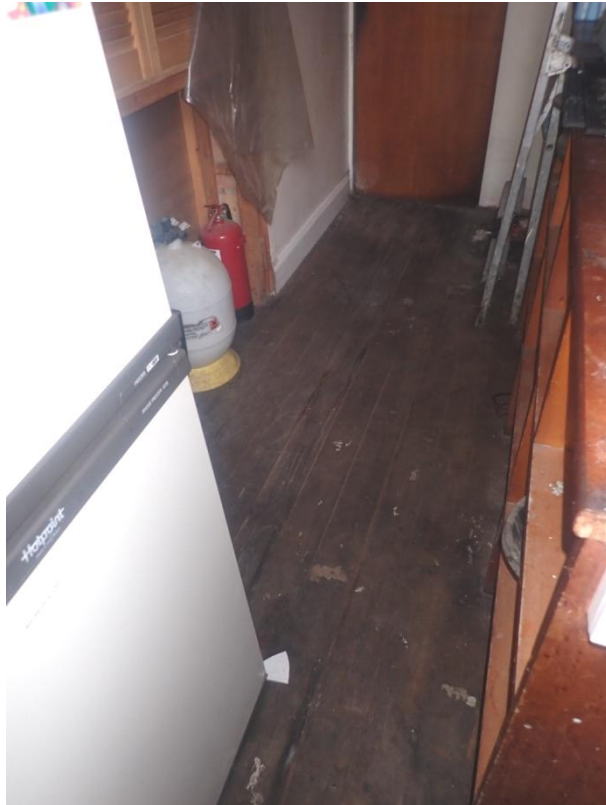
Plate 122: View of the flooring at the rear of Cell 6, from the north-west

Plate 122 and 129 provide further views of the nature of the flooring at the rear of **Cell 6**, which is of horizontal timber planking.

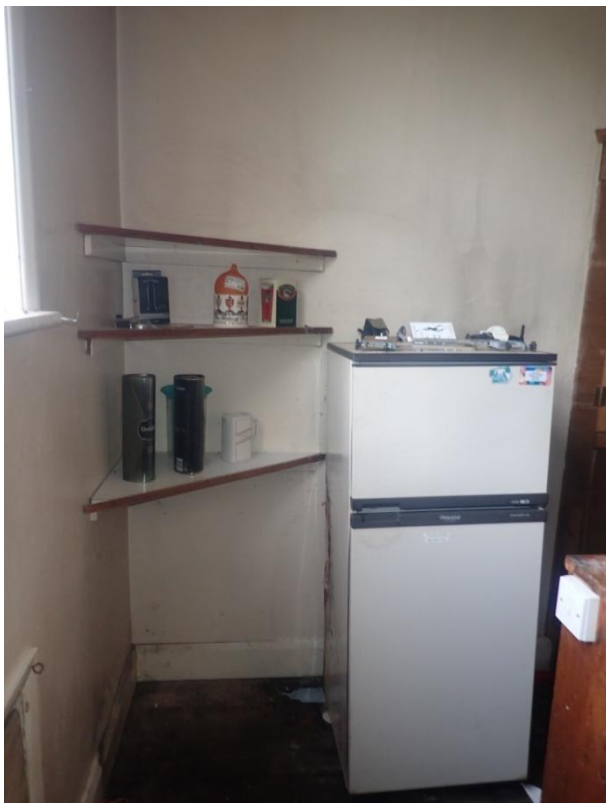
Plate 123: View of the northern portion of the east wall of Cell 6, from the south-west

Plate 123 features the western portion of the east wall of **Cell 6**, which has been rendered over with modern plasterwork. This is also the internal dividing wall with the adjoining **Cell 8** to the east.

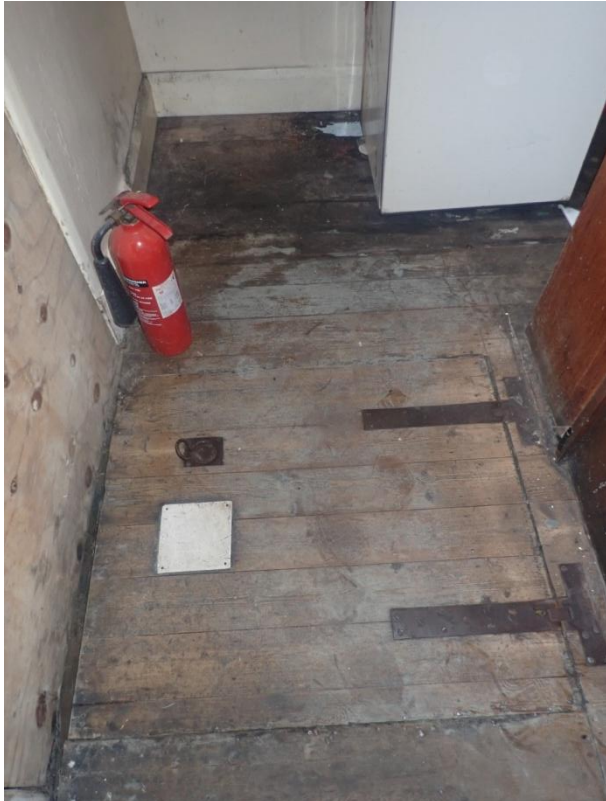
Plate 124: View of part of the flooring of Cell 6, from the south-west

Plate 124 presents a further view of the nature of the flooring at the northern end of **Cell 6**, which is also of horizontal timber planking. Set into this flooring is a timber trap door or hatch which leads onto the public house/bar basement. Unfortunately, this was sealed at the time of this survey, such that the basement below could not be accessed.

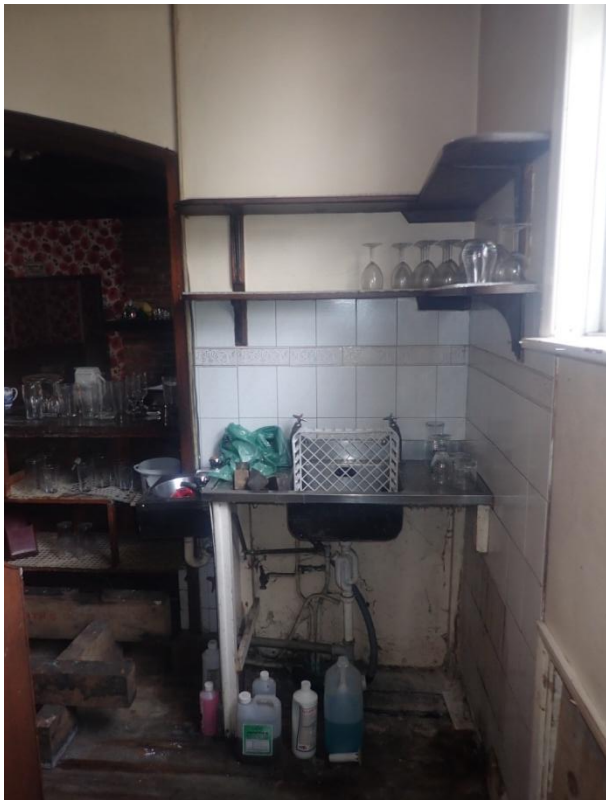
Plate 125: View of the northern portion of the west wall of Cell 6, from the north-east

Plates 125 and 126 show the northern portion of the west wall of **Cell 6**, and beside the rear of the public bar, which has also been rendered over with modern plasterwork. This is also part of an internal dividing wall with the adjacent **Cell 15** to the west.

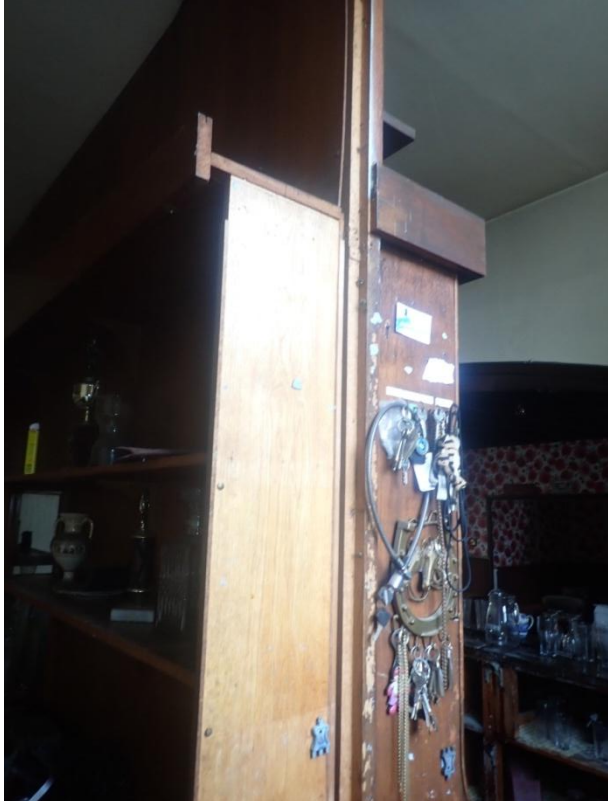
Plate 128: View of the rear storage area of Cell 6, from the north-east

Plates 127 and 128 provide views of the northern end of the rear wooden storage area of **Cell 6** with its fixtures and fittings.

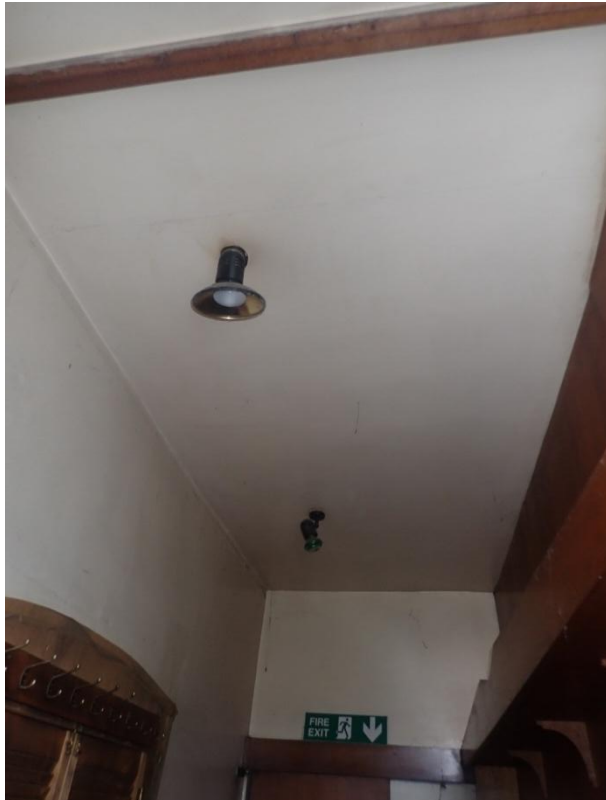
Plate 130: View of the ceiling of the rear of Cell 6, from the north-west

Plate 130 provides a further view of the nature of the ceiling structure at the rear of **Cell 6**, which has been rendered over with modern plasterwork.

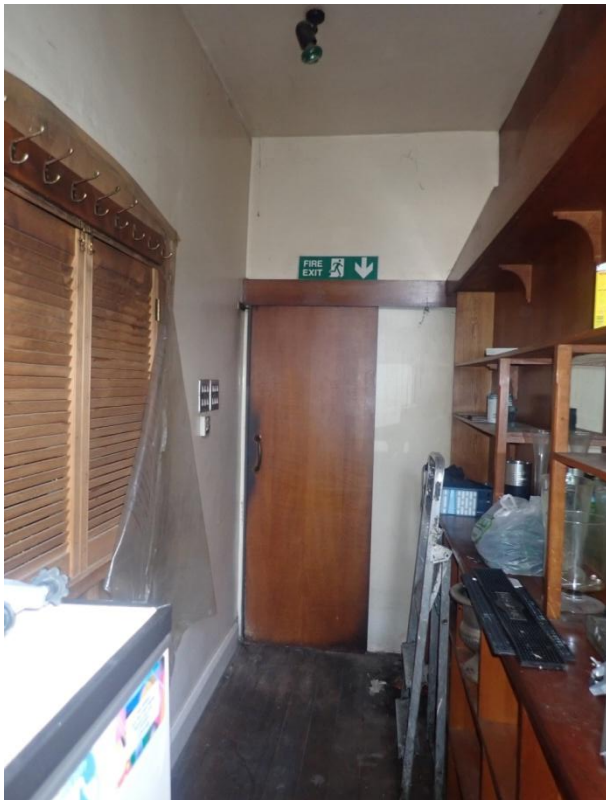
Plate 131: General view of the interior of the rear of Cell 6, from the north-west

Plate 131 furnishes a general view of the interior of the rear of **Cell 6** from a north-eastern vantage point. This also shows the eastern portion of the south wall of **Cell 6**, which has also been rendered over with modern plasterwork. This is also the internal dividing wall with the adjoining **Cell 7** to the south. Inserted into this eastern portion of the south wall is a modern south facing entrance opening, that leads onto **Cell 7**. This opening is occupied by a modern timber door that is attached to a modern sliding mechanism.

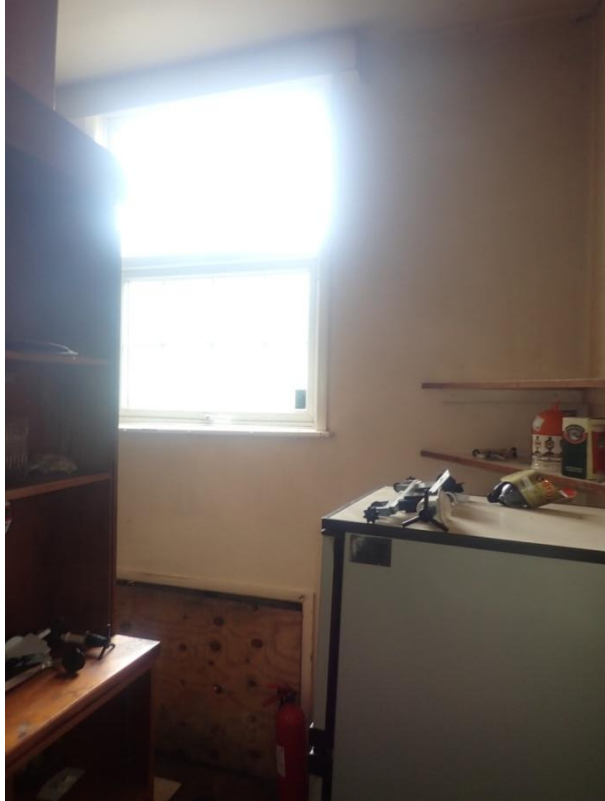
Plate 132: View of the eastern portion of the north wall of Cell 6, from the south-east

Plate 132 shows the eastern portion of the north wall of **Cell 6**, which has also been rendered over with modern plasterwork. To the left (west), is also featured the inner face of a ground floor north facing window opening that was recorded externally at the North Elevation of this building.

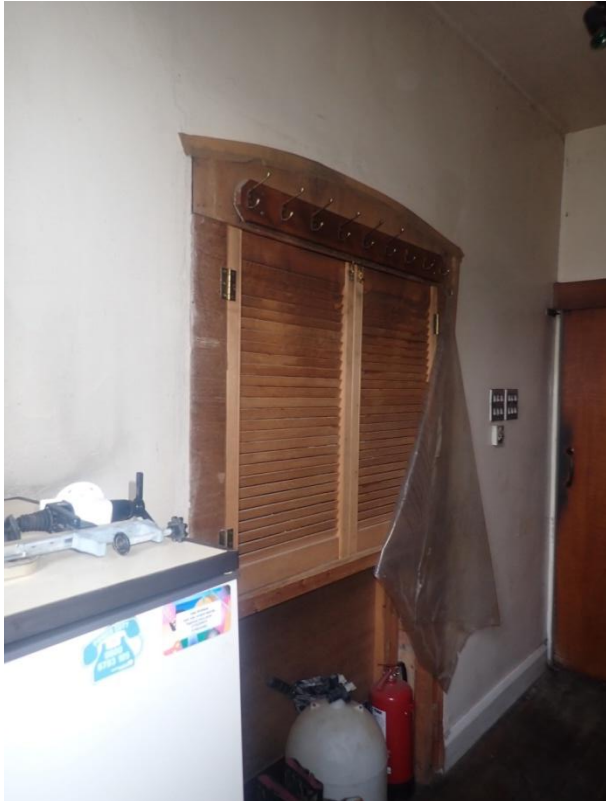
Plate 133: View of the east wall of Cell 6, from the north-west

Plates 133-135 present several further images from differing positions of the east wall of **Cell 6**. This has also been rendered over with modern plasterwork. This is also the internal dividing wall with the adjacent **Cell 8** to the east. Horizontal timber skirting boards occur along its base. Also shown is a modern timber servery hatch, which serviced the ground floor dining room to the east (**Cell 8**).

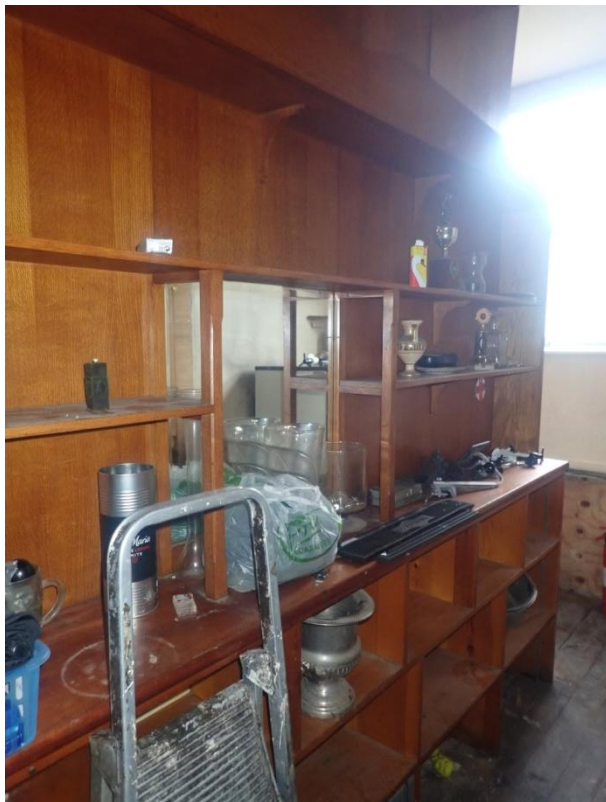
Plate 136: View of the rear storage area of Cell 6, from the south-east

Plates 136-138 furnish further views of the rear wooden storage area of **Cell 6** with its fixtures and fittings.

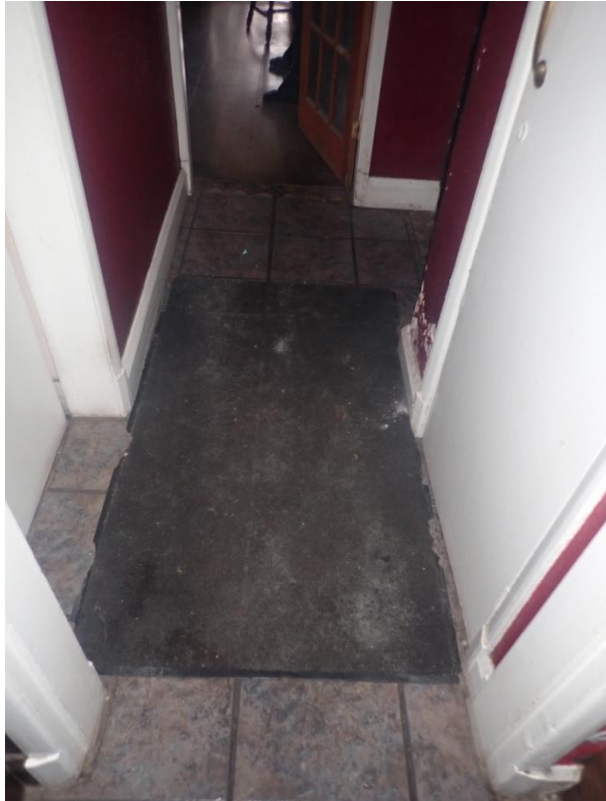
Plate 139: View of the flooring of Cell 7, from the south-west

Plates 139 and 141-142 present a number of views of the nature of the flooring of **Cell 7** from different vantage points. This is of modern ceramic floor tiling with further areas of matting.

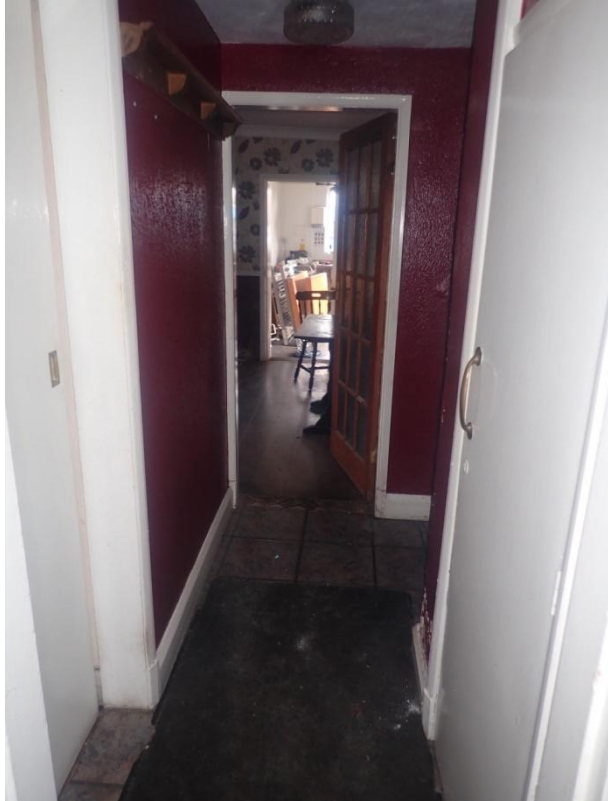
Plate 140: General view of the interior of Cell 7, from the south-west

Plate 140 provides a general view of the interior of **Cell 7** from a south-western position

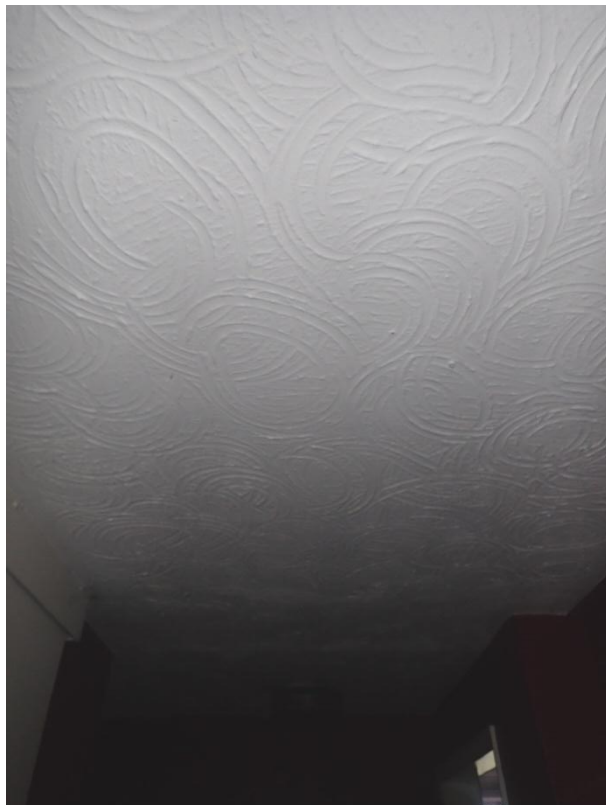
Plate 143: View of the ceiling of Cell 7, from the south-east

Plates 143-145 present several images of the nature of the ceiling structure of **Cell 7**, which has been rendered over with modern plasterwork.

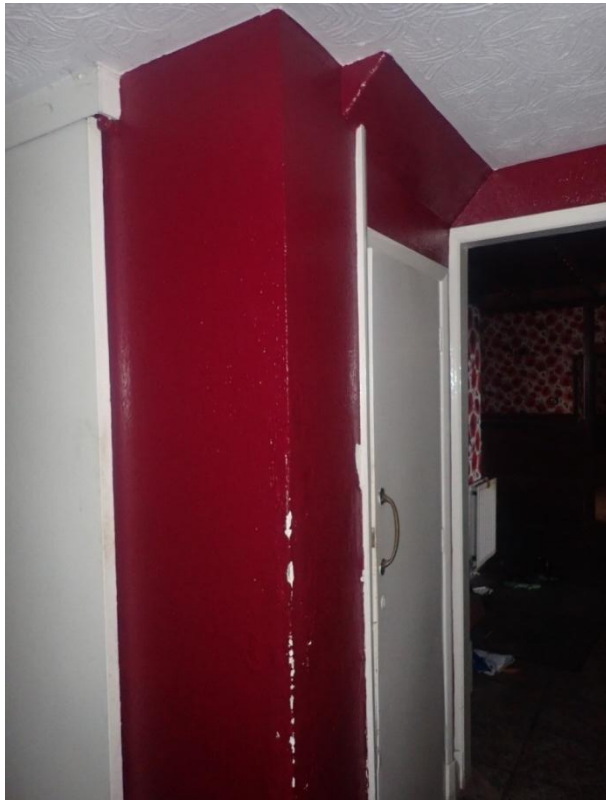
Plate 147: View of the western portion of the South Wall of Cell 7, from the north-east

Plates 146 and 147 and 149-150 show the western portion of the south wall of **Cell 7**, which has also been rendered over with modern plasterwork. Inserted into this wall fabric is an entrance into a storage cupboard comprising a timber door and a door frame of a head and surrounds. At the base of the wall are horizontal timber skirting boards.

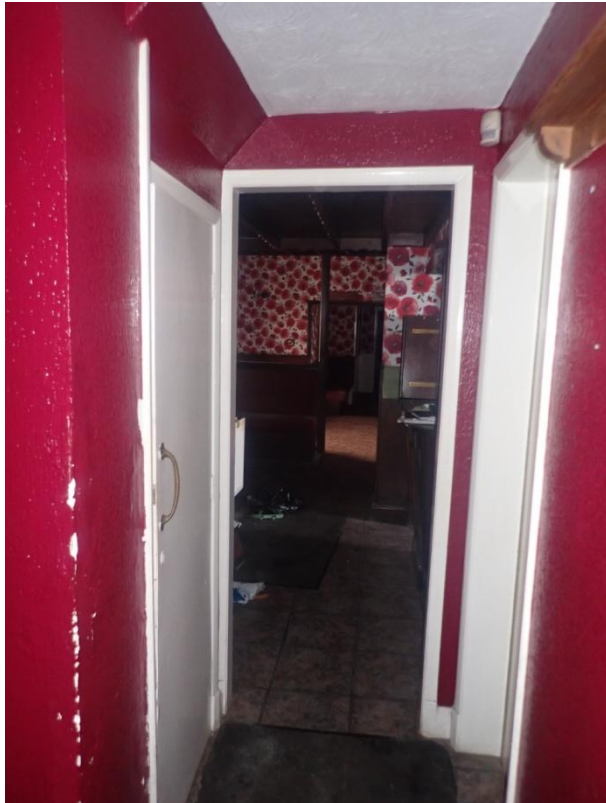
Plate 148: View of the northern portion of the west wall of Cell 7, from the north-east

Plate 148 features the northern portion of the west wall of **Cell 7**, which is also the internal dividing wall with the adjoining **Cell 5** to the west. This wall has also been rendered over with modern plasterwork. Occupying much of this west wall is the west facing entrance opening that extends onto **Cell 5** to the west. This opening is occupied by a timber frame of a head and surrounds only. A small section of horizontal timber skirting board also occurs at its base.
