**NEVILLE HALL
FREELANCE ARCHAEOLOGIST & CONSULTANT**

HISTORIC BUILDING RECORDING AT THE
FORMER DUKE OF YORK PUBLIC HOUSE,
106, RISEGATE ROAD,
GOSBERTON RISEGATE, LINCOLNSHIRE

January 2023

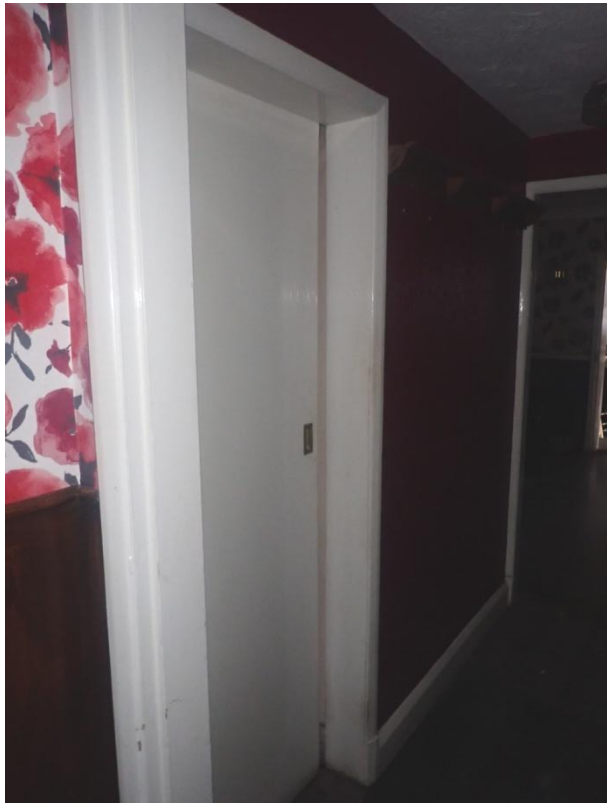
Plate 151: View of the north wall of Cell 7, from the south-west

Plates 151 features the north wall of **Cell 7**, which also been rendered over with modern plasterwork. Horizontal timber skirting boards occur at its base. In the foreground is a north facing entrance opening that extends onto **Cell 6** to the north. This opening is occupied by a timber frame of a head and surrounds and by a modern timber sliding door.

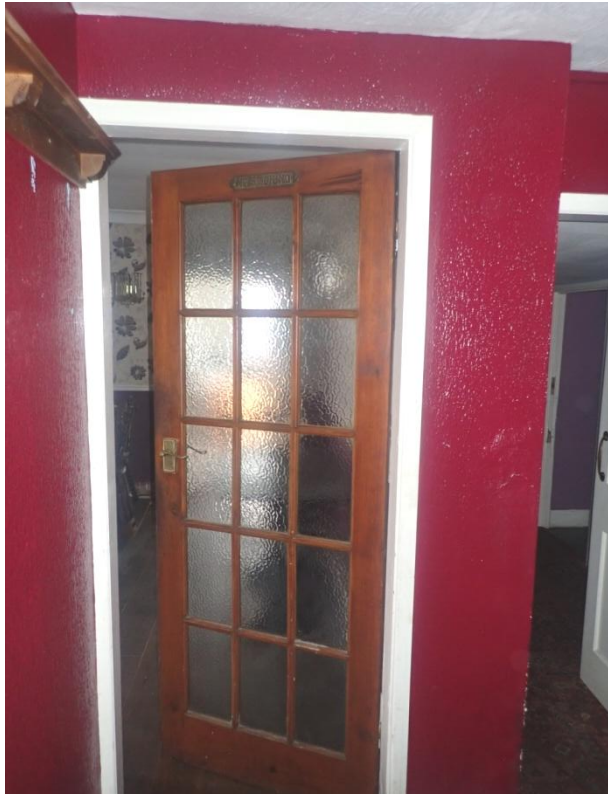
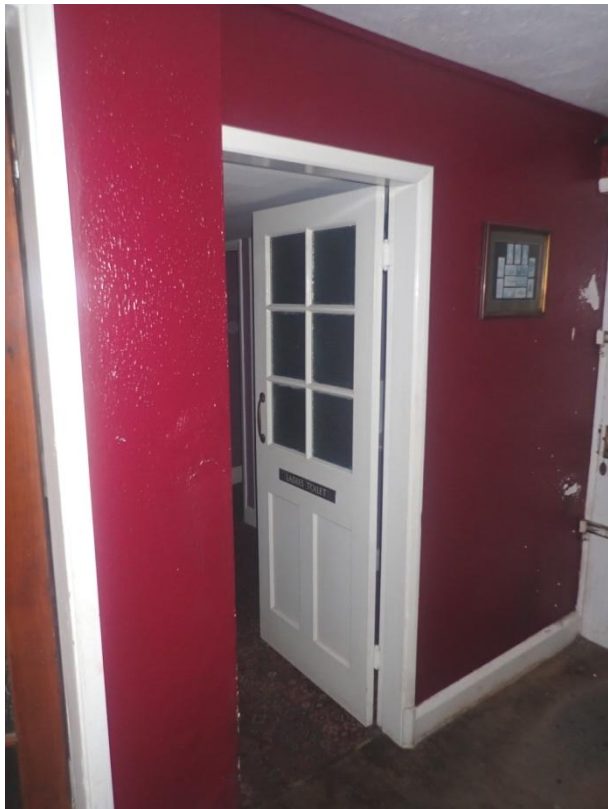
Plate 152: View of the east wall of Cell 7, from the south-west

Plate 153: View of the east wall of Cell 7, from the north-west

Plates 152 and 153 show the east wall of **Cell 7**, which also been rendered over with modern plasterwork. Horizontal timber skirting boards occur at its base. To the left (north), is an east facing entrance opening that extends onto **Cell 8** to the east. This opening is occupied by a timber frame of a head and surrounds and by a modern timber glazed panel door. To the right (south), is a second east facing entrance opening that extends onto ground floor toilets (**Cell 9**). This second opening is occupied by a timber frame of a head and surrounds and by a further modern timber partially glazed and partially panelled door.

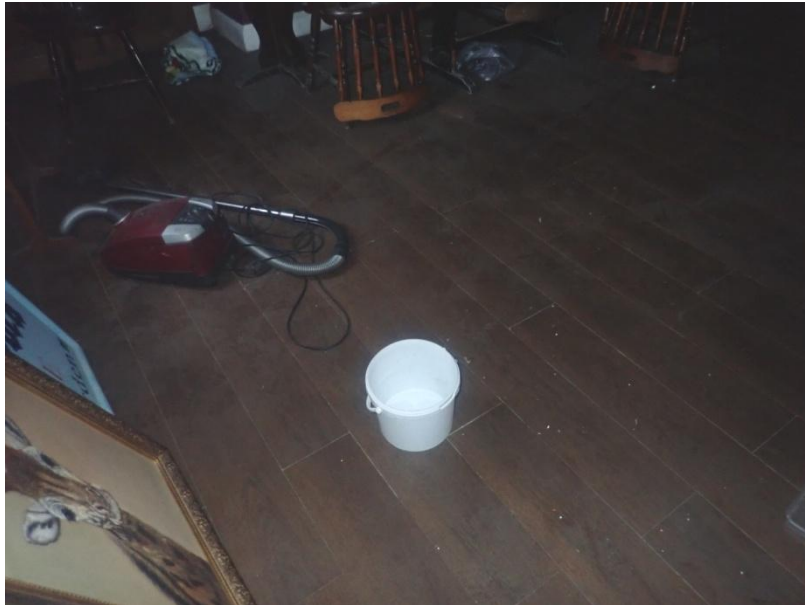
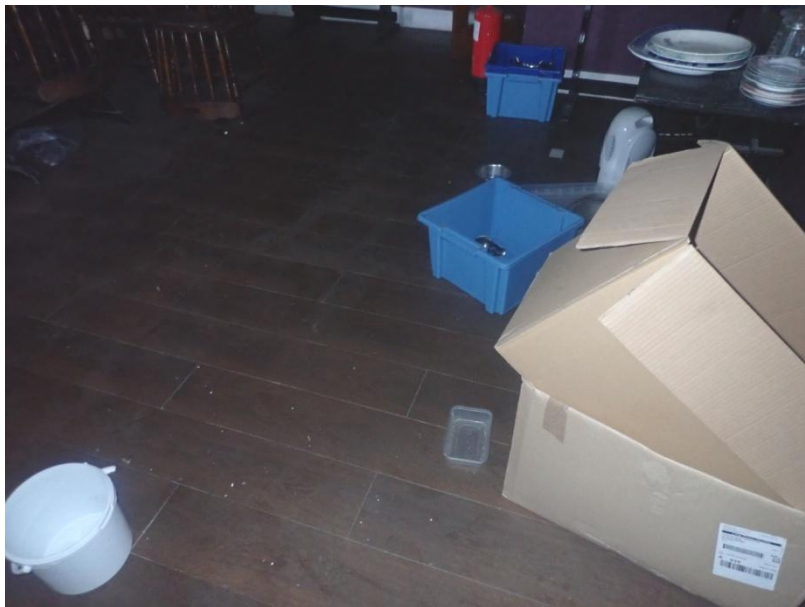
Plate 155: View of the flooring of Cell 8, from the south

Plate 156: View of the flooring of Cell 8, from the south-west

Plates 155 and 156 feature the nature of the flooring of **Cell 8**, which is of horizontal timber planking.

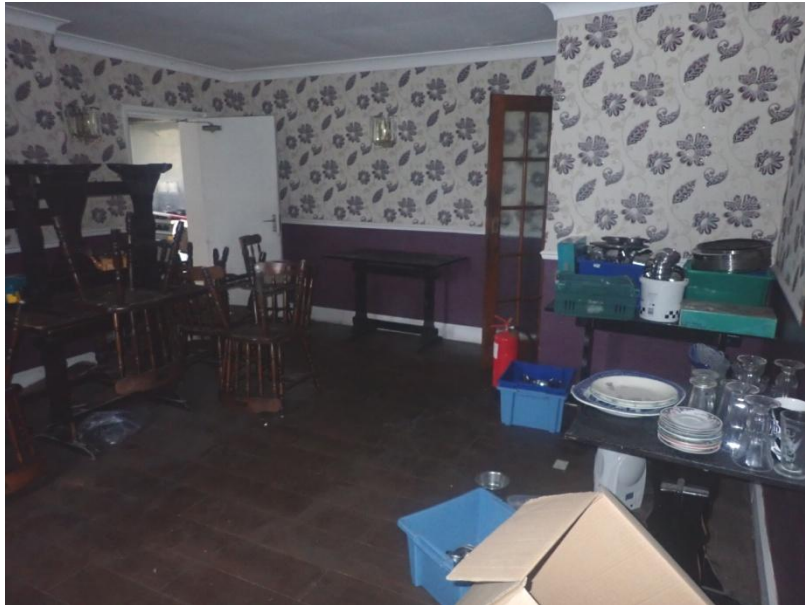
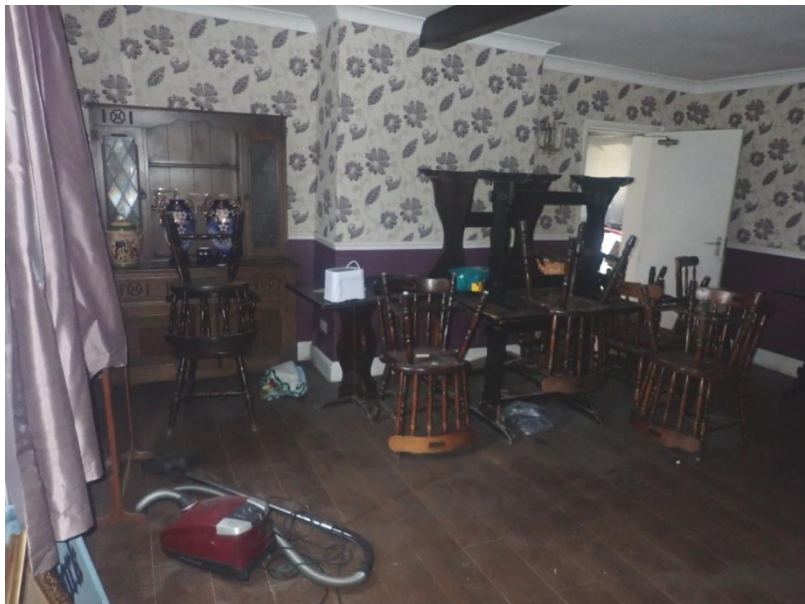
Plates 157 and 158 present several general views of the interior of **Cell 8** from differing positions.

Plate 157: General view of the interior of Cell 8, from the north-west

Plate 158: General view of the interior of Cell 8, from the north-west

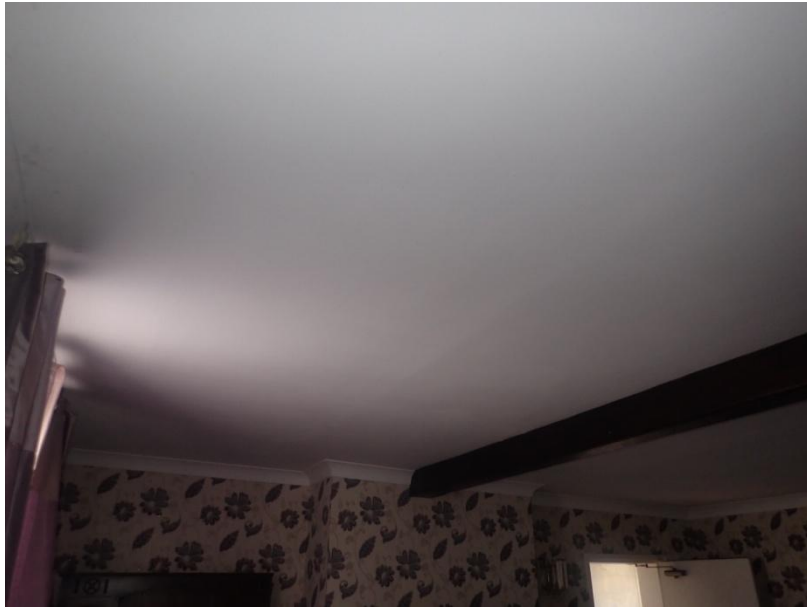
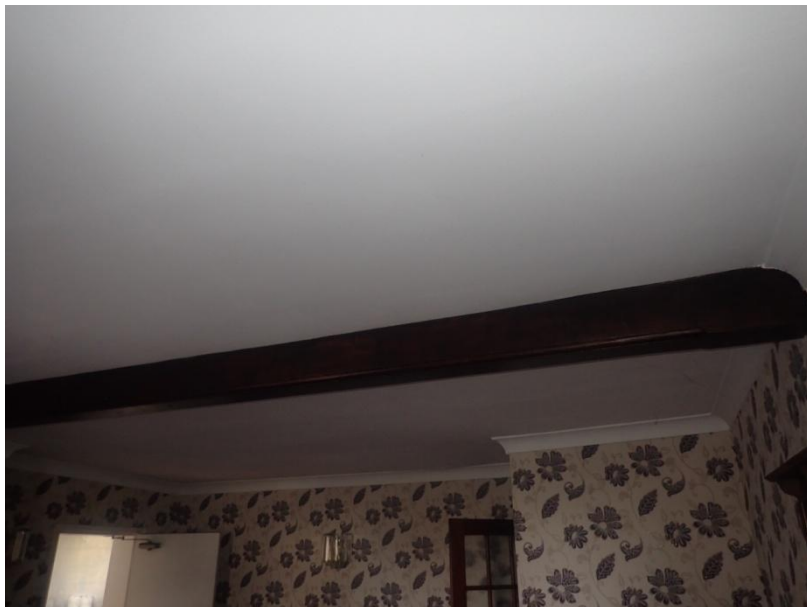
Plates 159 and 160 show the roof ceiling structure of **Cell 8**, which has been rendered over with modern plasterwork. Of particular note is the east-west orientated principal horizontal timber joist, which may be an original feature.

Plate 159: View of the ceiling of Cell 8, from the north-west

Plate 160: View of the ceiling of Cell 8, from the north

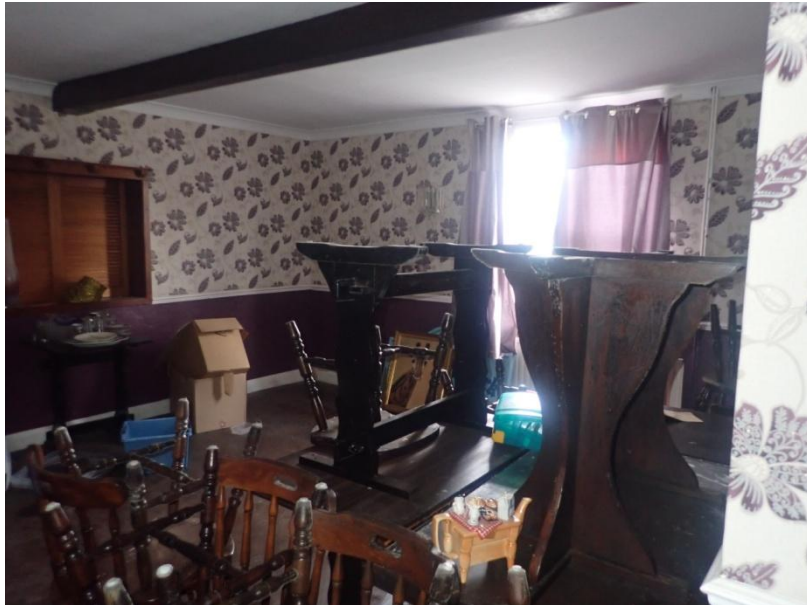
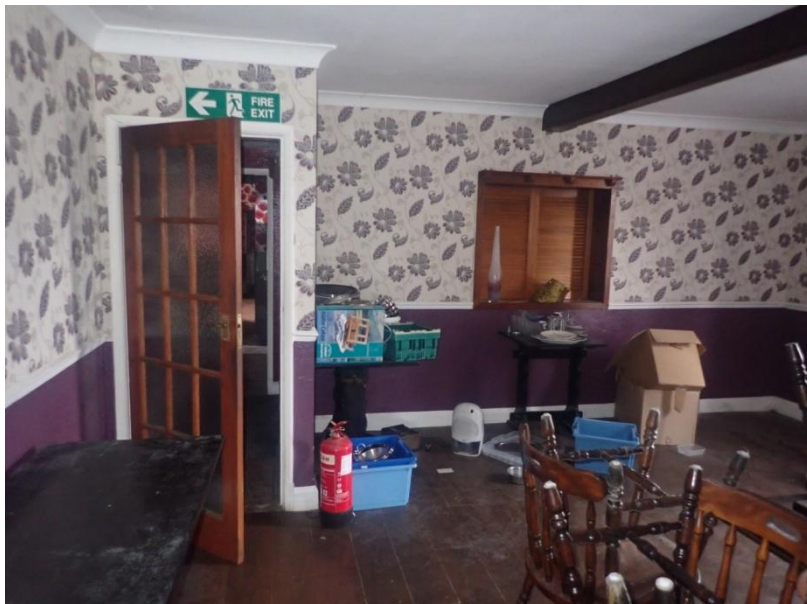
Plates 161 and 162 present several further general views of the interior of **Cell 8**.

Plate 161: General view of the interior of Cell 8, from the south-east

Plate 162: General view of the interior of Cell 8, from the north-east

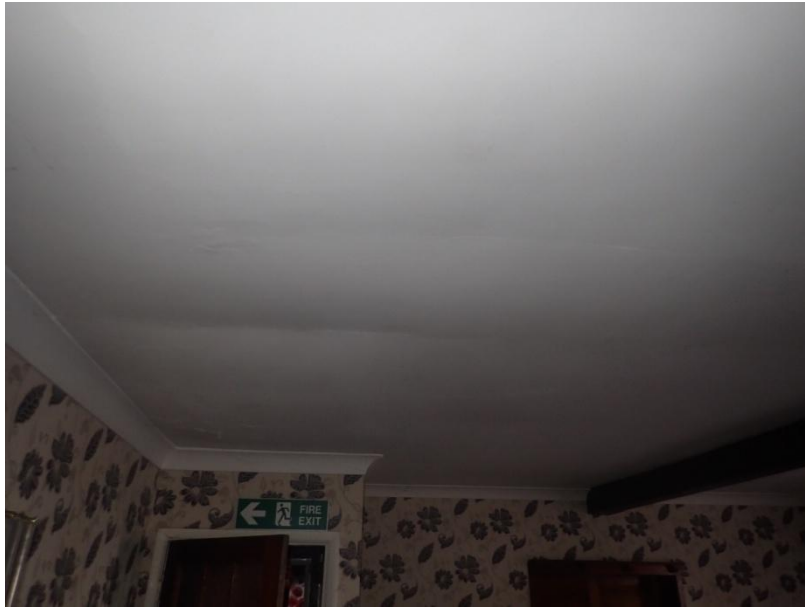
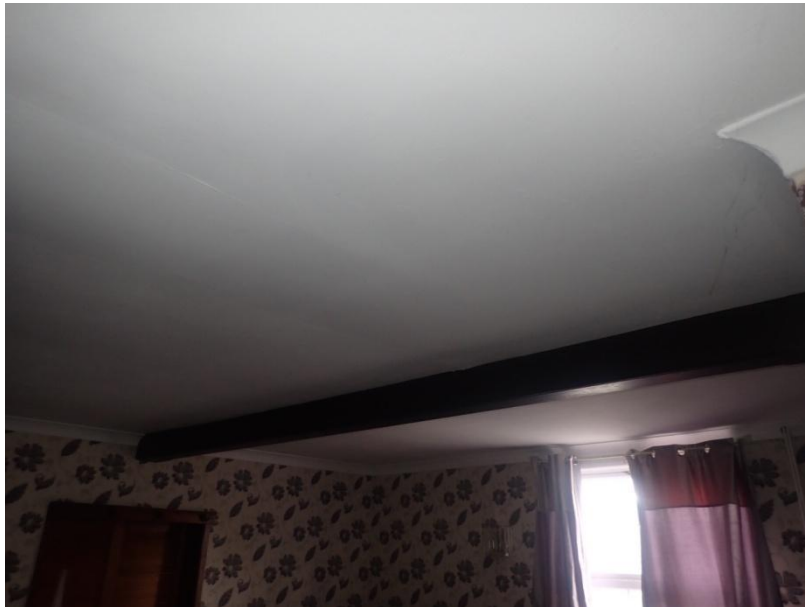
Plates 163 and 164 feature further views of the nature of the ceiling structure of **Cell 8**.

Plate 163: View of the ceiling of Cell 8, from the north-east

Plate 164: View of the ceiling of Cell 8, from the south-east

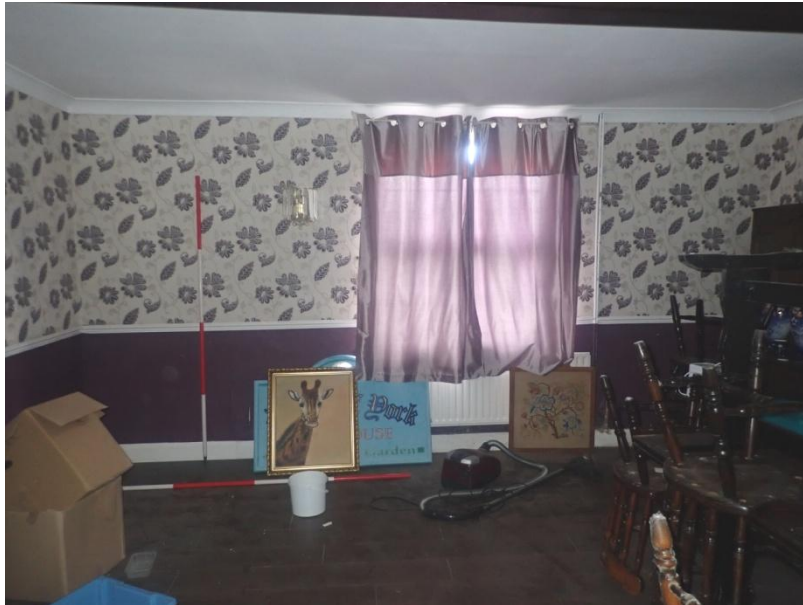
Plate 165 furnishes a detailed view of the north wall of **Cell 8** and of the inner face of the north facing ground floor window opening that was recorded externally at the North Elevation of this building. The wall has been covered over with wallpaper. Horizontal timber dado rails occur at its mid levels and horizontal timber skirting boards at its base. Plaster cornice work may be seen at its uppermost levels.

Plate 165: View of the north wall of Cell 8, from the south-east

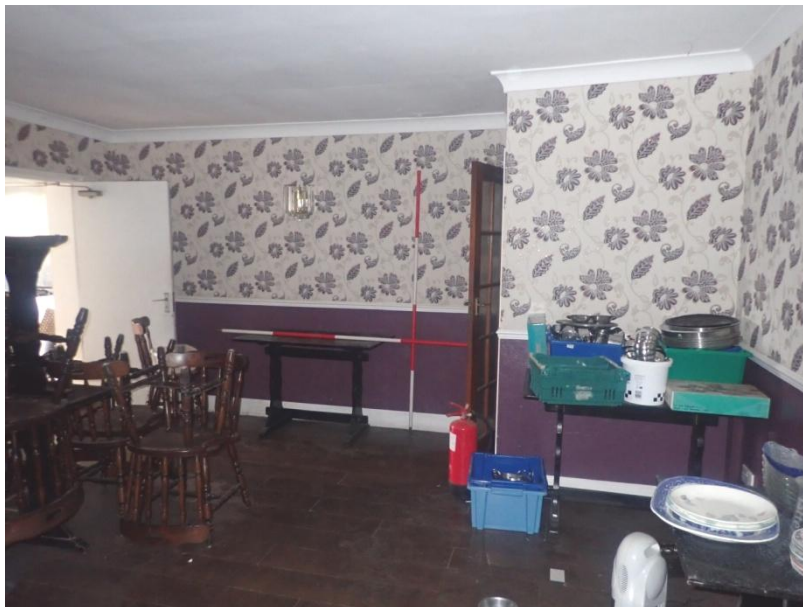
Plate 166: View of the south wall of Cell 8, from the north-west

Plate 166 shows the south wall of **Cell 8**, which is covered over with wallpaper. Horizontal timber dado rails occur at its mid levels and horizontal timber skirting boards at its base. Plaster cornice work may be seen at its uppermost levels.

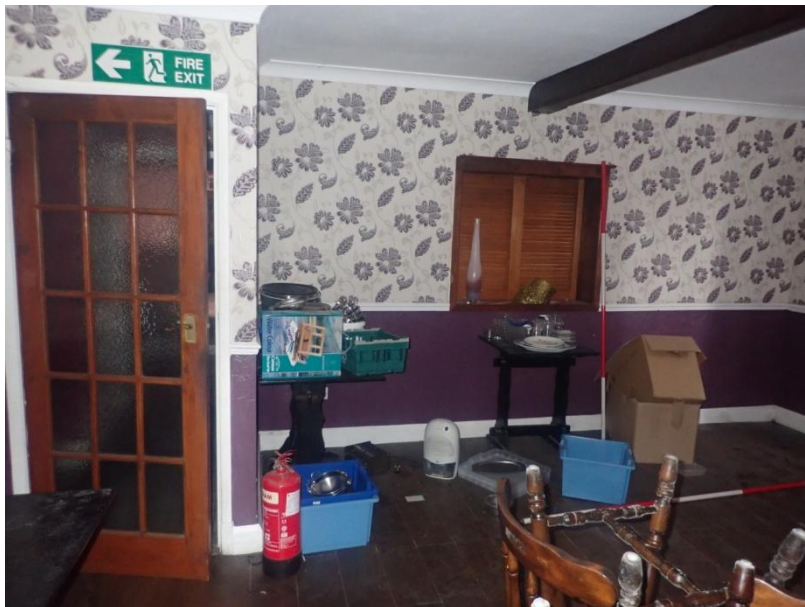
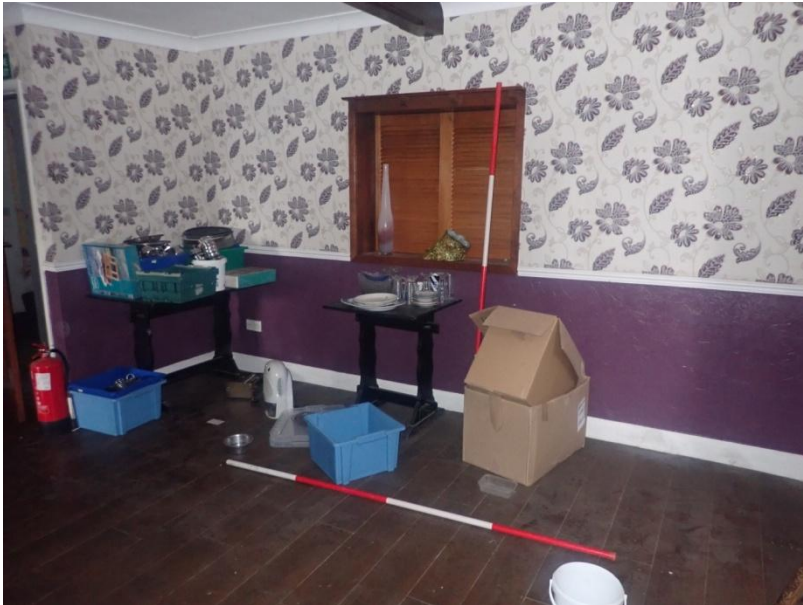
Plate 168: View of the west wall of Cell 8, from the north-east

Plates 168 and 169 feature the west wall of **Cell 8**, which is also the internal dividing wall with the adjoining **Cell 6** to the west. This west wall has also been covered over with wallpaper. Horizontal timber dado rails occur at its mid levels and horizontal timber skirting boards at its base. Plaster cornice work may be seen at its uppermost levels. Also shown is the modern timber servery hatch, which was also recorded within **Cell 6**. To the left (south), is the inner face of the ground floor west facing entrance opening that was also recorded within **Cell 7**. This opening is occupied by a timber frame of a head and surrounds and by the timber glazed panelled door and leads onto **Cell 7** to the west.

Plate 169: View of the west wall of Cell 8, from the north-east

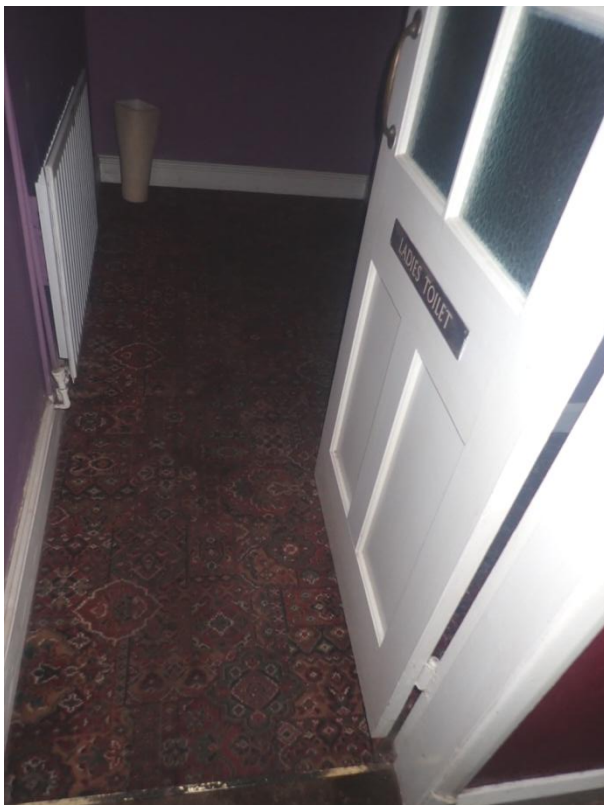
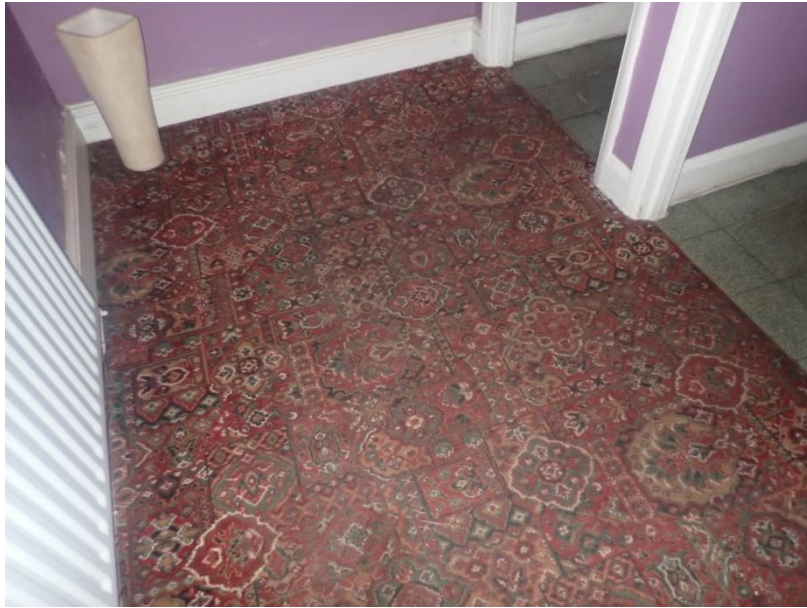
Plate 170: View of the flooring of Cell 9, from the south-west

Plates 170 and 171 show the carpeted flooring of **Cell 9**.

Plate 171: View of the flooring of Cell 9, from the south-west

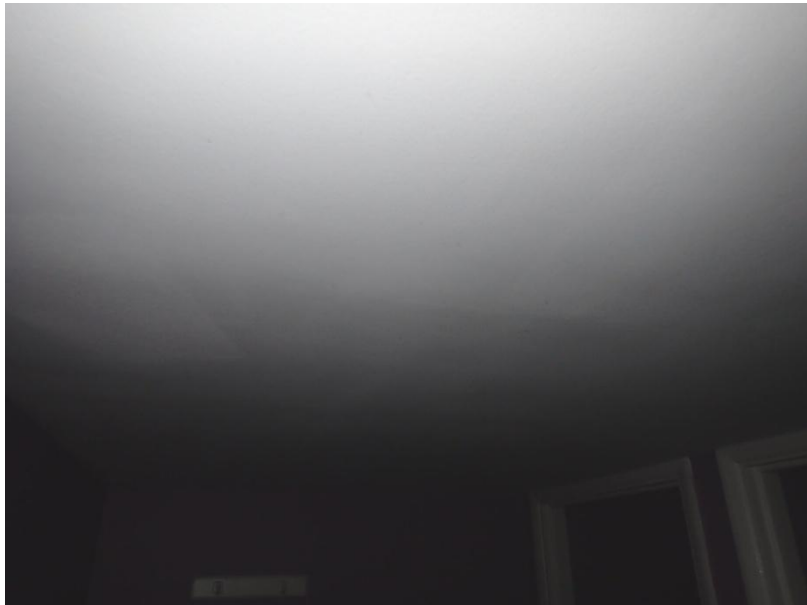
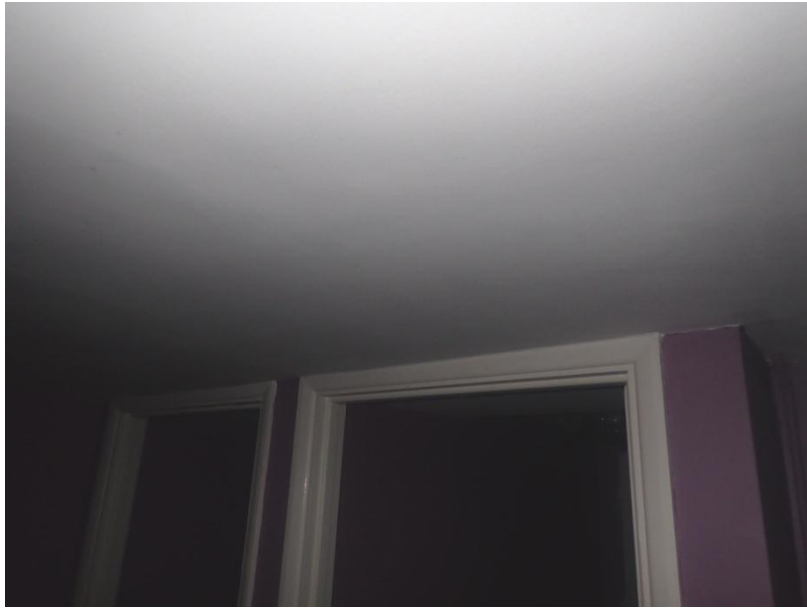
Plate 172: View of the ceiling of Cell 9, from the south-west

Plates 172 and 173 feature the nature of the ceiling of **Cell 9**, which has been rendered over with modern plasterwork.

Plate 173: View of the ceiling of Cell 9, from the north-west

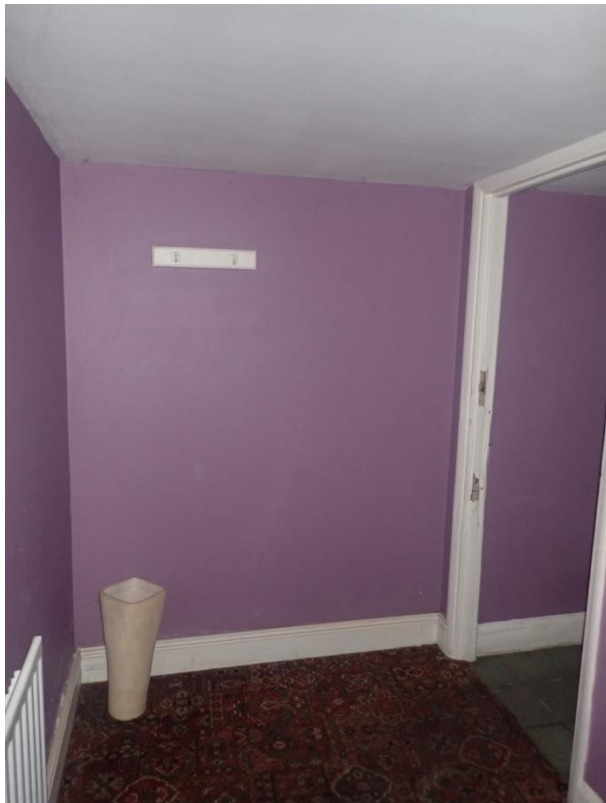
Plate 174: View of the east wall of Cell 9, from the south-west

Plate 174 presents a view of the east wall of **Cell 9**, which has been rendered over with modern plasterwork. Modern horizontal timber skirting boards occur at its base.

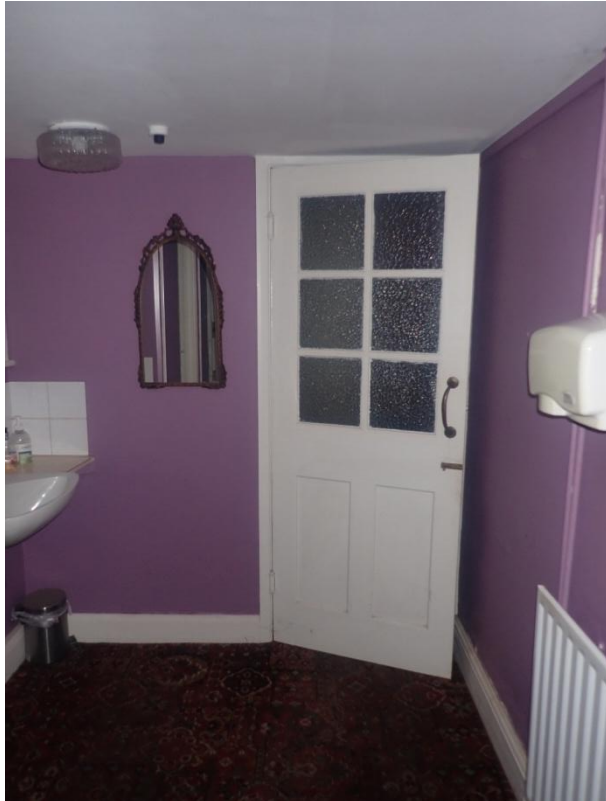
Plate 175: View of the west wall of Cell 9, from the north-east

Plate 175 features much of the west wall of **Cell 9**, which is also the internal dividing wall with the adjoining **Cell 7** to the west. This west wall has been rendered over with modern plasterwork. Modern horizontal timber skirting boards occur at its base. To the right (north), is the inner face of the west facing entrance opening that extends onto **Cell 7** to the west. This opening is occupied by a timber frame with a head and surrounds and by a modern timber door that is partially glazed and partially panelled.

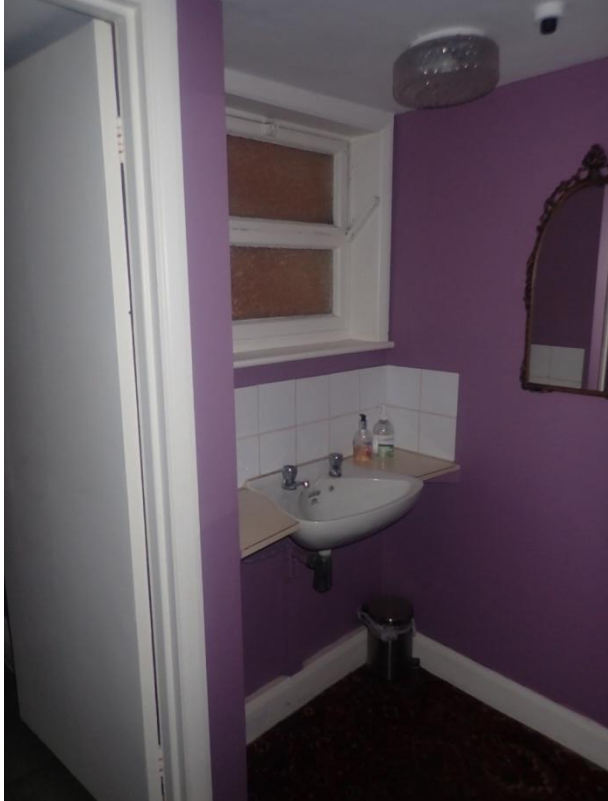
Plate 176 features the remainder of the west wall and also of the south wall of **Cell 9**. Here also, this south wall has been rendered over with modern plasterwork. Modern horizontal timber skirting boards occur at its base. The central feature of this south wall is the inner face of the south facing ground floor window opening that was recorded externally at the South Elevation of this building. This opening is occupied by a slightly recessed glazed modern Upvc casement window, which has been boarded over externally.

Plate 176: Views of the west wall and the south wall of Cell 9, from the north-east

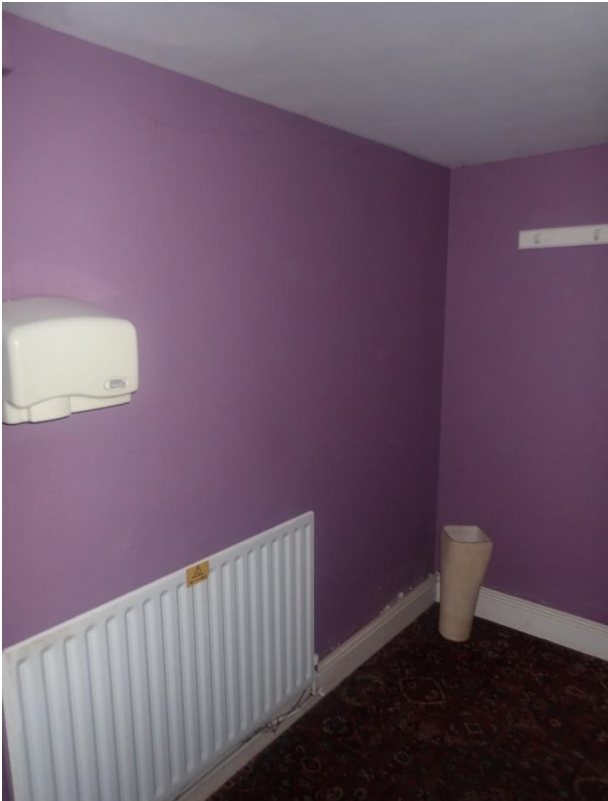
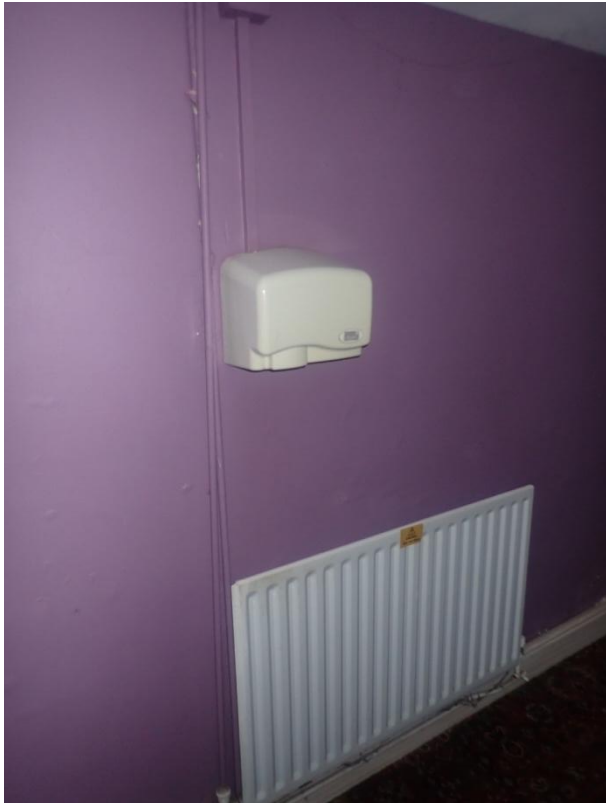
Plates 177 and 178 show the north wall of **Cell 9**. Here also, this north wall has been rendered over with modern plasterwork. Modern horizontal timber skirting boards occur at its base. This is also the internal dividing wall with the adjoining **Cell 8** to the north.

Plate 177: View of the north wall of Cell 9, from the south-west

Plate 178: View of the north wall of Cell 9, from the south-west

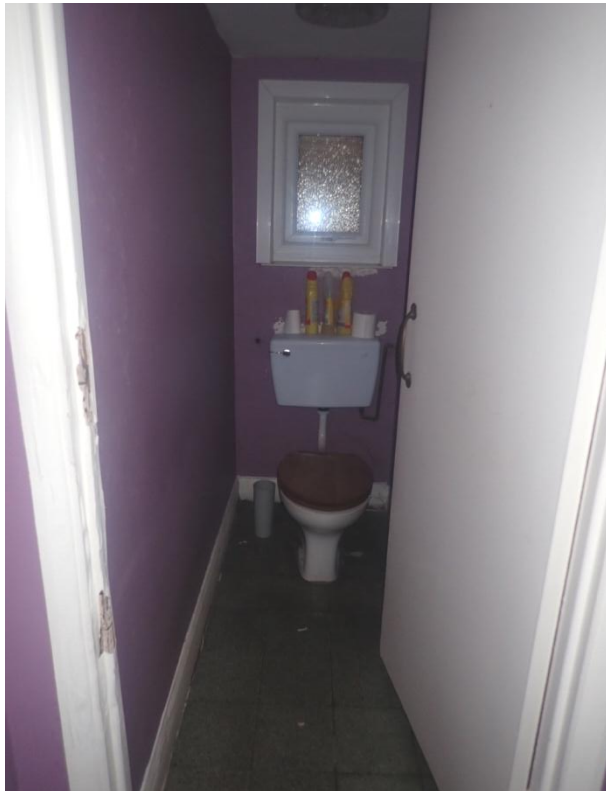
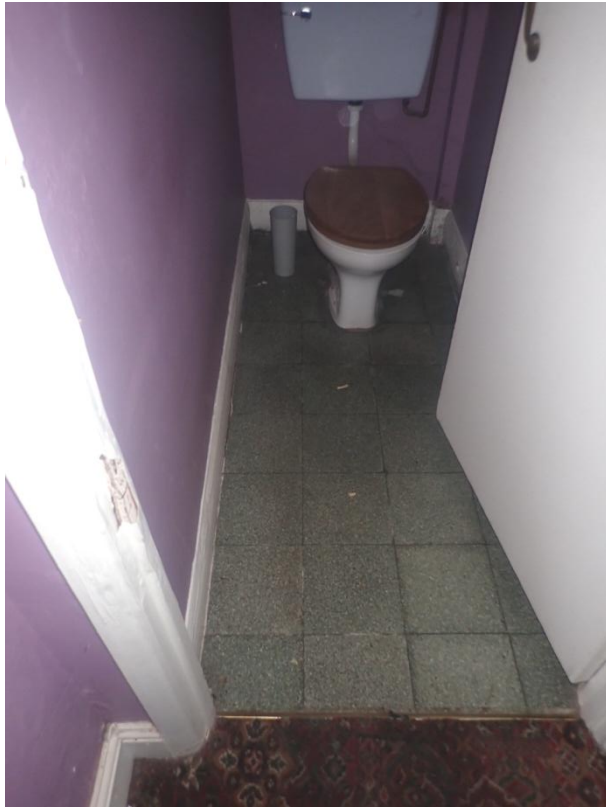
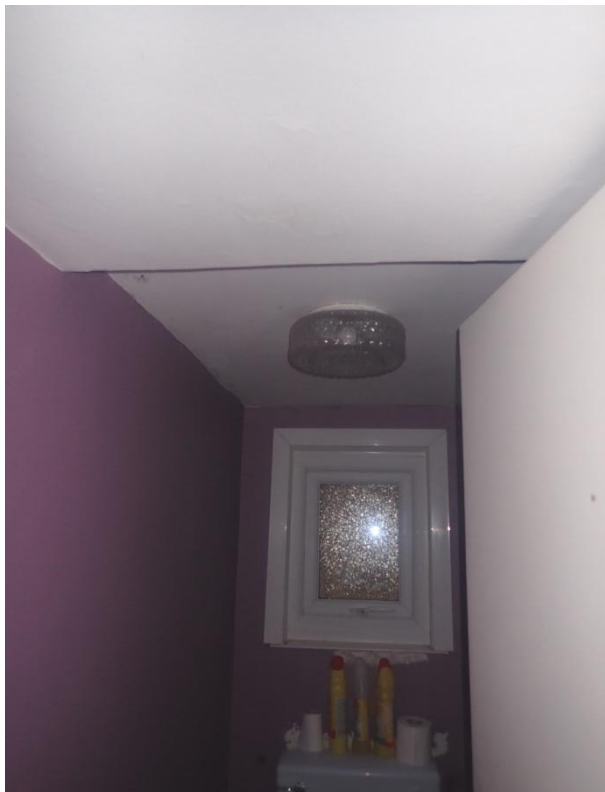
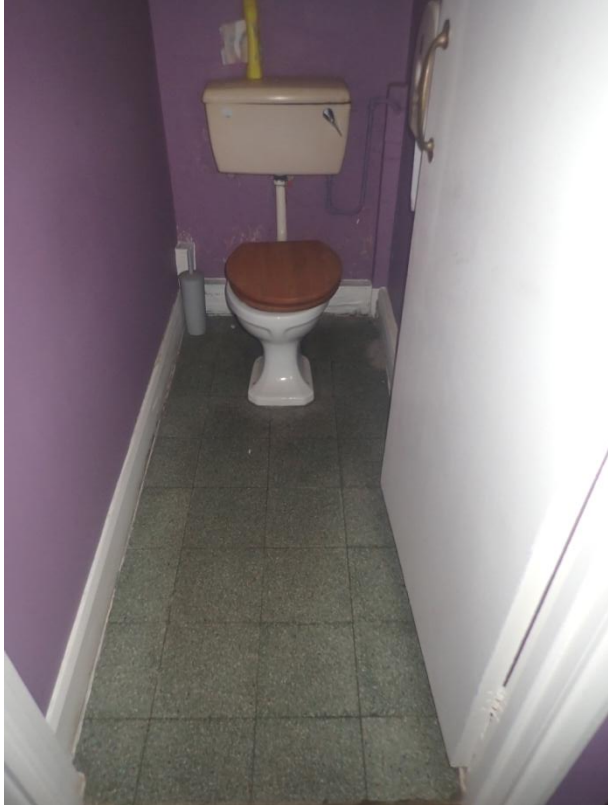
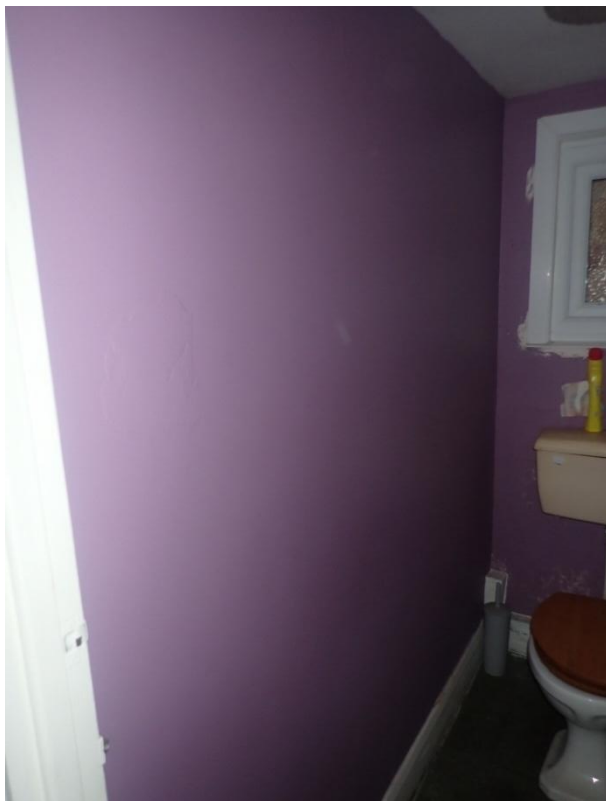
Plates 179-185 present views of the two toilets which are both within the interior of the single storey modern toilet extension. Both toilets have flooring of modern ceramic floor tiling and ceilings, which have been rendered over with modern plasterwork. All of the walls have also been rendered over with modern plasterwork and have horizontal skirting boards at their bases. At the back wall of each toilet are the inner faces of two small glazed Upvc windows, which were recorded externally at the South Elevation of this building.

Plate 179: View of the interior of the first toilet, from the north-west

Plate 180: View of the interior of the first toilet, from the north-west

Plate 181: View of the interior of the first toilet, from the north-west

Plate 182: View of the interior of the second toilet, from the north-east

Plate 185: View of the interior of the second toilet, from the north-east

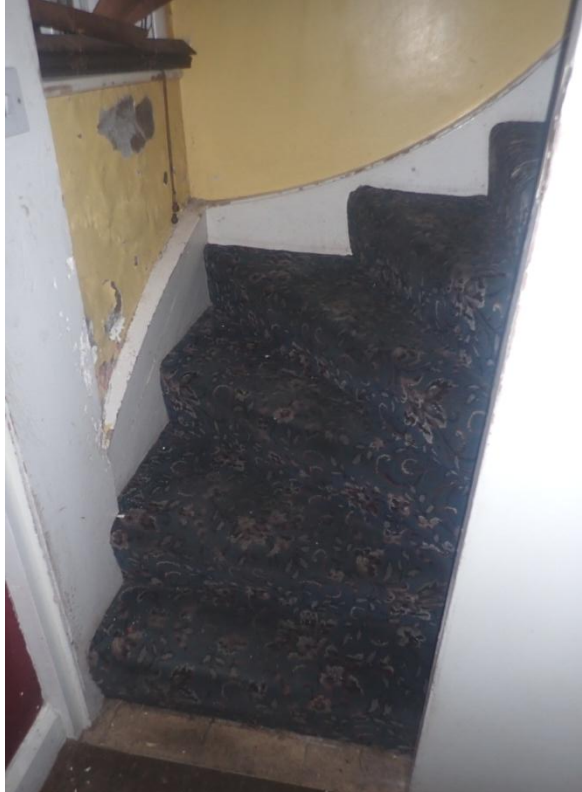
Plate 186: View of the lower levels of the stairwell of Cell 10, from the north-east

Plate 186 features the lower levels of the ground floor stairwell of **Cell 10** along with the lower levels of the south and west walls of **Cell 10**. The stairwell is covered with modern carpeting. The exposed walls are rendered over with plasterwork with timber skirting boards alongside the stairwell and at the lowermost levels of these walls.

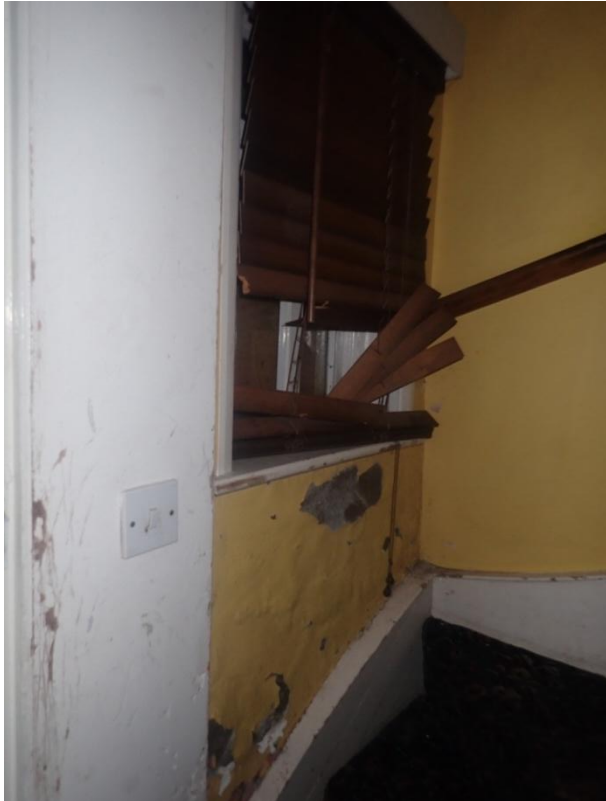
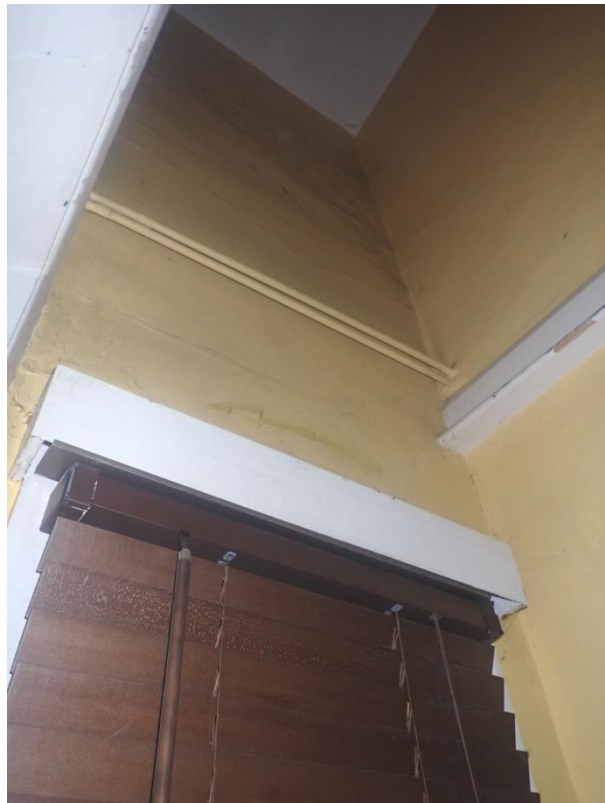
Plates 187 and 188 feature the south wall of **Cell 10**, which has been rendered over with plasterwork. Timber skirting boards occur at its base. The inner face of a ground floor south facing window opening is also featured. This was recorded externally at the South Elevation of this building. The opening is occupied by timber blinds.

Plate 187: View of the south wall of Cell 10, from the north-east

Plate 188: View of the south wall of Cell 10, from the north-east

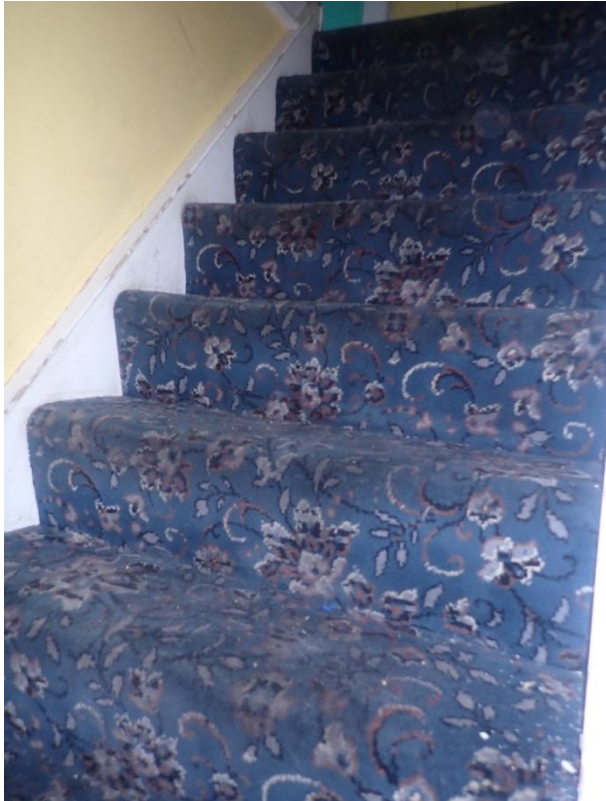
Plates 189 and 190 provide further views of the carpeted stairwell that extends up to the first floor landing. A timber handrail is shown attached to the west wall, whilst the north wall on the first floor landing is also featured. This has been rendered over with plasterwork.

Plate 189: View of the stairwell of Cell 10, from the south-east

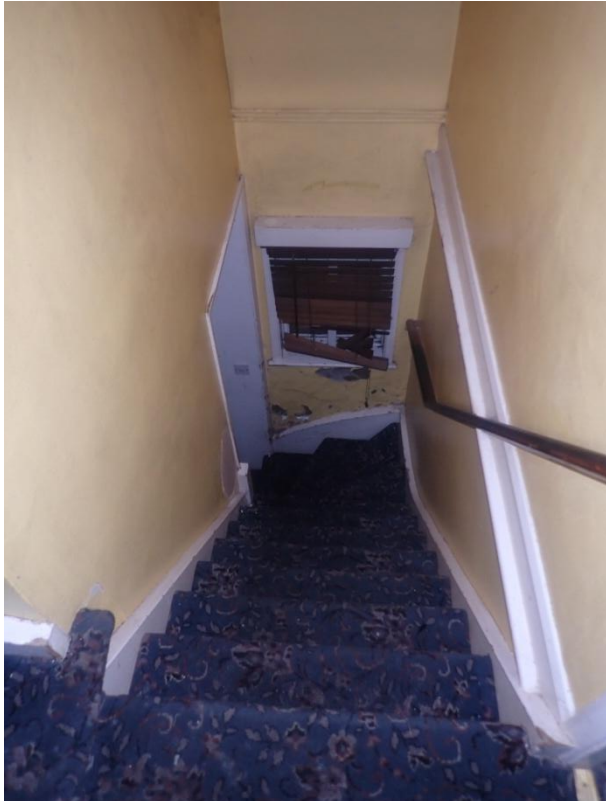
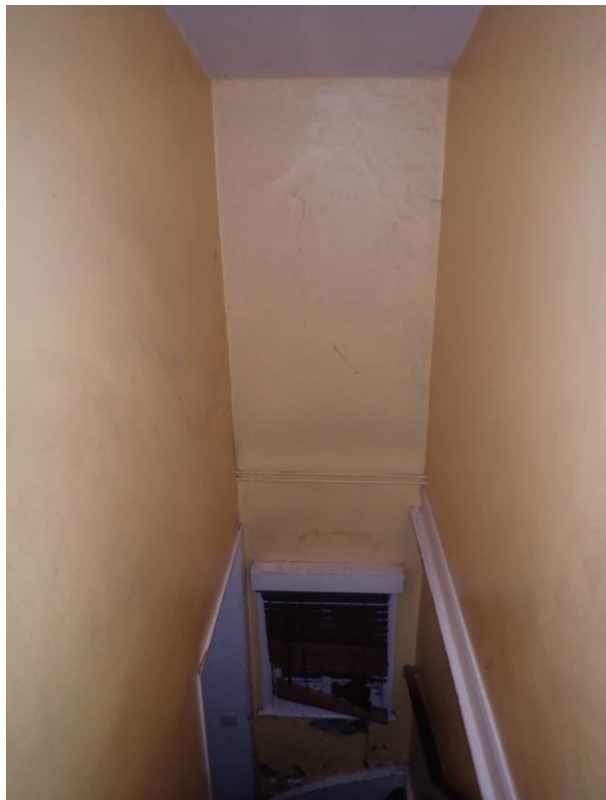
Plates 191 and 192 feature further views of the stairwell of **Cell 10** looking downwards from the first floor landing.

Plate 191: View of the stairwell of Cell 10, from the north-west

Plate 192: General view of the interior of the stairwell of Cell 10, from the north-west

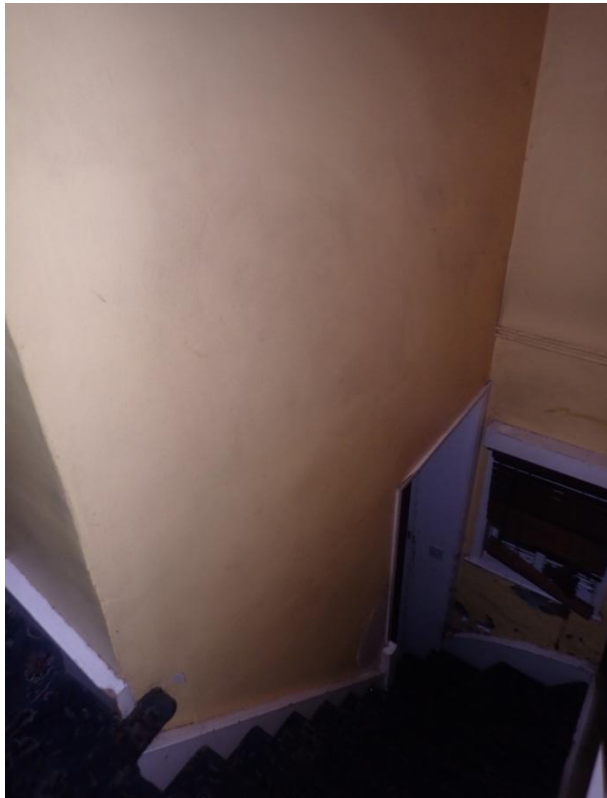
Plates 194 and 195 provide views of the east wall of **Cell 10**, which has been rendered over with plasterwork. At the base of the wall are timber skirting boards alongside the stairwell.

Plate 194: View of the east wall of Cell 10, from the north-west

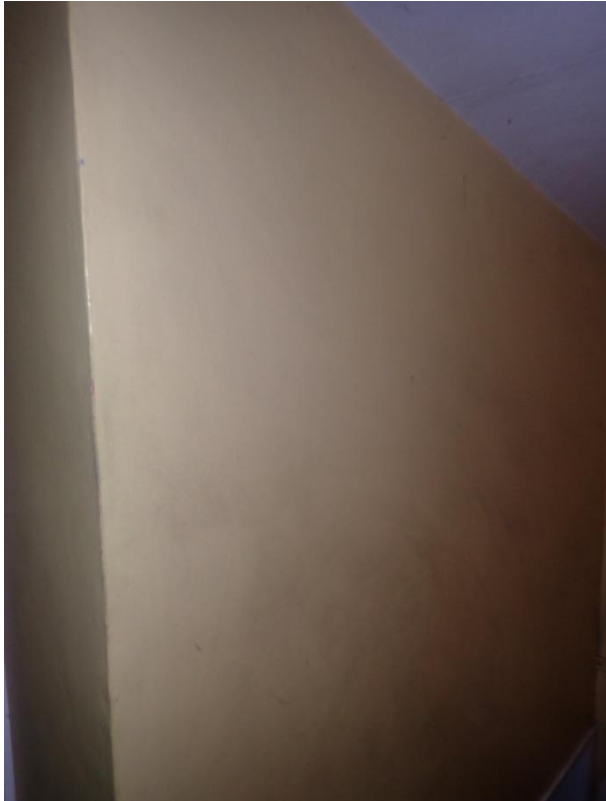
Plate 195: View of the east wall of Cell 10, from the north-west

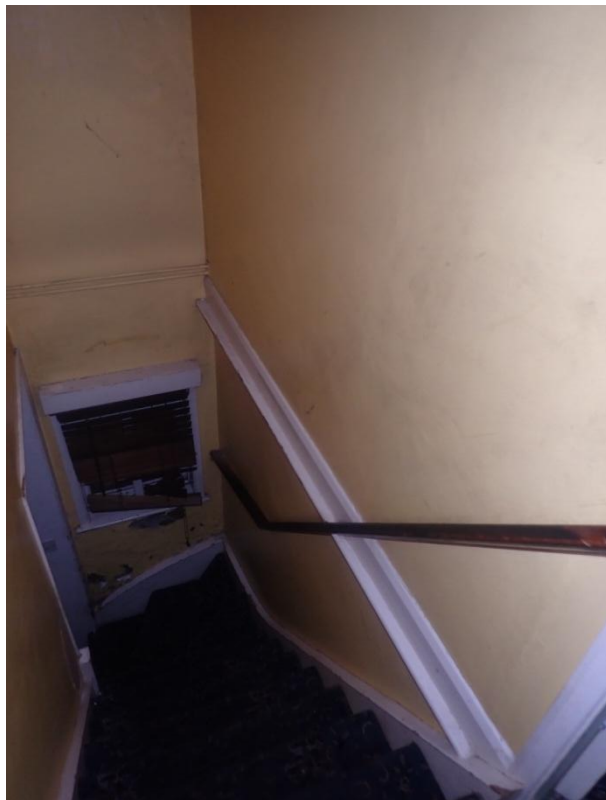
Plate 196: View of the west wall of Cell 10, from the north-west

Plates 196 and 197 present images of the west wall of **Cell 10** which has been rendered over with plasterwork. At the base of the wall are timber skirting boards alongside the stairwell.

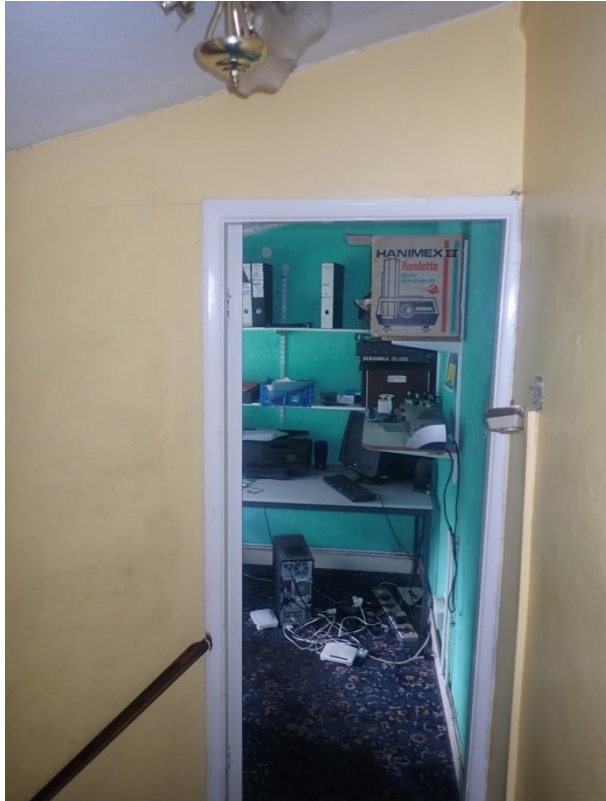
Plate 199: View of the west wall of Cell 10, from the north-east

Plate 199 shows the northern end of the west wall of **Cell 10**, which has also been rendered over with plasterwork. Also shown is the west facing entrance opening onto **Cell 11** to the west. This opening is occupied by a timber frame of a head and surrounds with a timber door.
