**NEVILLE HALL
FREELANCE ARCHAEOLOGIST & CONSULTANT**

HISTORIC BUILDING RECORDING AT THE
FORMER DUKE OF YORK PUBLIC HOUSE,
106, RISEGATE ROAD,
GOSBERTON RISEGATE, LINCOLNSHIRE

January 2023

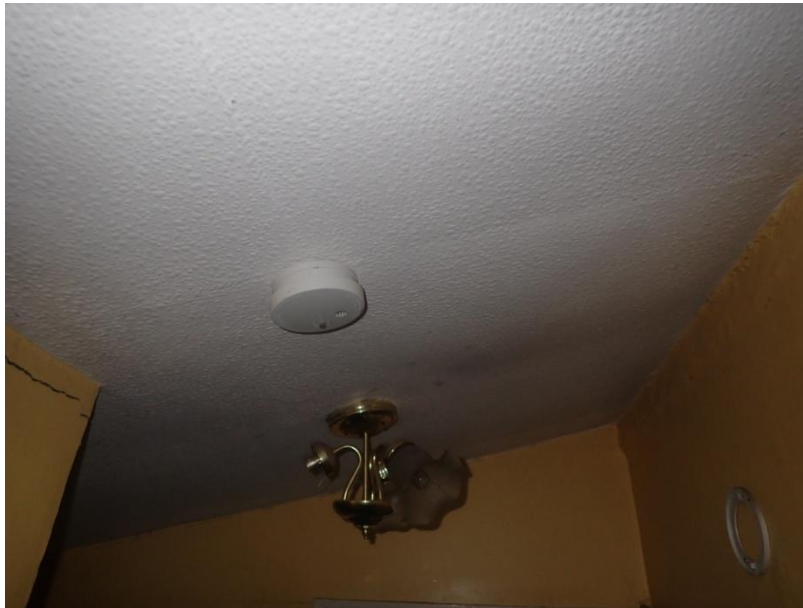
Plate 200: View of the ceiling of Cell 10, from the north-east

Plate 200 features a further view of the ceiling of **Cell 10**, which has been covered over with lining paper.
