ARCHAEOLOGICAL MONITORING
AT PLOT 2, MANOR FARM,
TOWN ROAD,
QUARRINGTON, SLEAFORD, LINCOLNSHIRE.

National Grid Reference: TF 0564 4442
Site Code: MFQA11
Accession No: LCNCC: 2011.86
Planning References: N/57/0219/10 & N/57/0342/10

July 2011

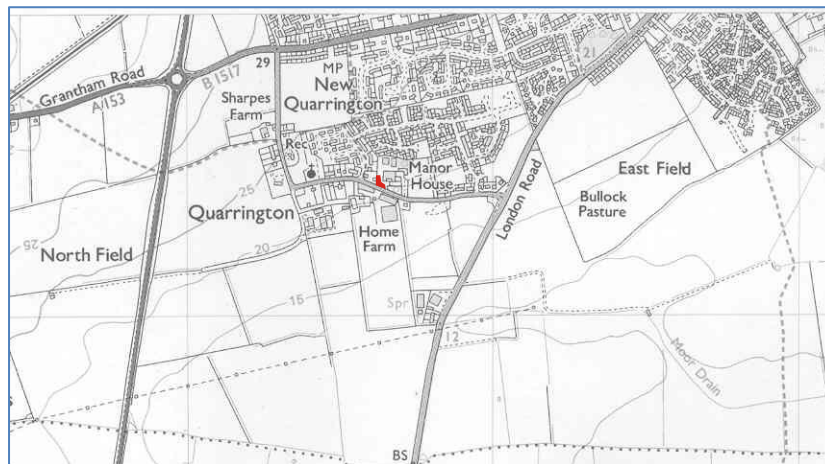
Figure 1: Site location at scale 1:25,000. The site is shown in red.
(O.S. copyright licence number 100048723)

The development site comprising Plot 2 is situated to the west of the Manor Farm complex, on the northern frontage of Town Road, within the historic core of the settlement of Quarrington, at National Grid Reference TF 0564 4442, and at a height of approximately 20m AOD. Quarrington is located approximately 16.5km to the south-east of Grantham and approximately 2km to the south-west of Sleaford, in the civil parish of Sleaford, within the administrative district of North Kesteven, county of Lincolnshire [Figures 1-2].

Copies of manuscript and Ordnance Survey (O.S.) maps were obtained from the Lincolnshire Archives. The enclosure award map for the Lordship of Quarrington of 1794 (Archive ref. Kesteven Award 67) shows the area of the development site as being located within an open field (plot no. 57) with the Manor House to the east in the adjoining plot no. 58 and a barn (now converted to a residential dwelling) on the boundary between these two plots. By the time of the Second Edition six inch to one mile scale O.S. map of 1905, plot no. 57 has been subdivided by the addition of a north-south orientated field boundary, though the development site is still situated within an open field. The manor house is shown to the east with the barn to the west of this. The modern O.S. map, which dates to 2006, shows modern residential development to the north and west of the development site with the Manor House complex to the east [**Figure 1**].

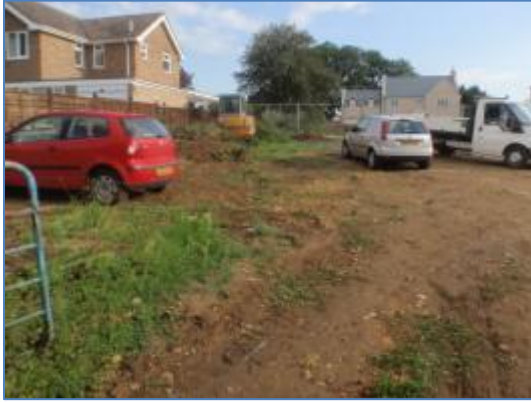
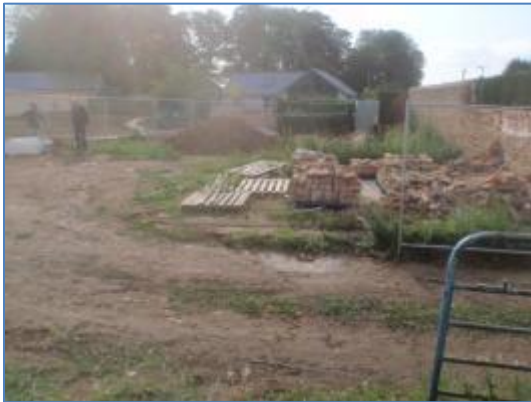
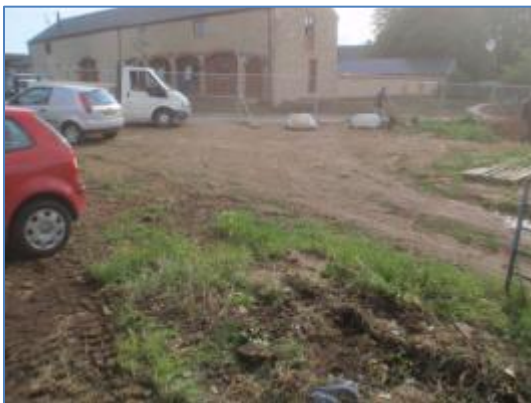
A former outbuilding that had been situated by the southern boundary of the site (adjacent to the northern Town Road frontage) had already been demolished and the area cleared prior to arrival [**Plates 1-3**].

Plate 1: Pre-groundworks, from the south

Plate 2: Pre-groundworks, from the west

Plate 3: Pre-groundworks, from the south-west

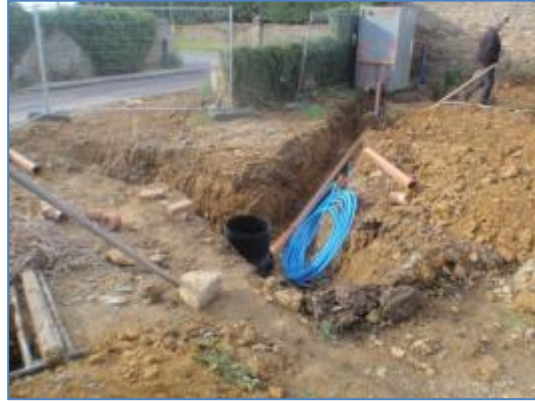
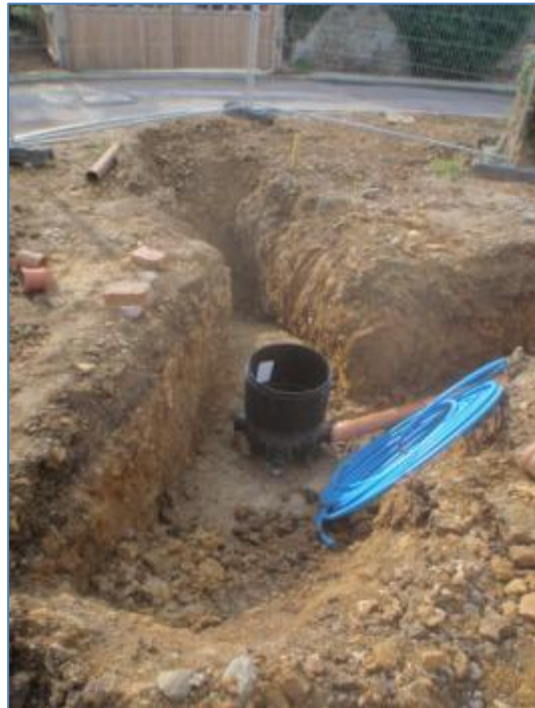
Three service trenches were excavated to the east of the house plot to connect to existing services. These were excavated to varying lengths, to an average width of 0.90m and to depths of 0.80m-1.0m below ground levels [**Plates 4-5**]. The deposit sequence in this area of the site comprised a thin topsoil (**001**), which overlay the natural horizon (**002**) of cornbrash. The deposit (**001**) included some modern demolition material within its make-up. This deposit sequence was recorded within the east facing **Representative Section 1** [**Plate 6**].

Plate 4: Service trenches, from the north

Plate 5: Service trenches, from the north-west

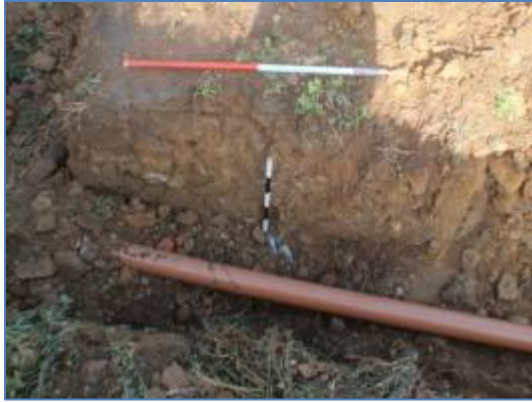
Plate 6: Representative Section 1, from the east

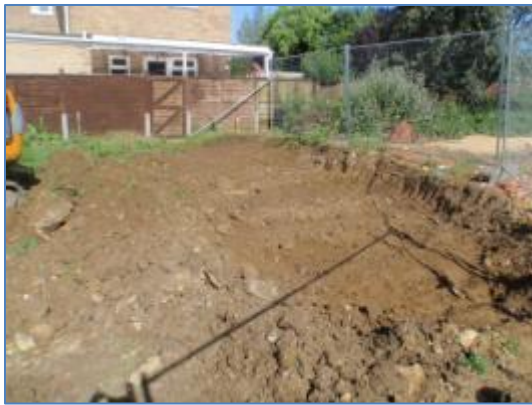
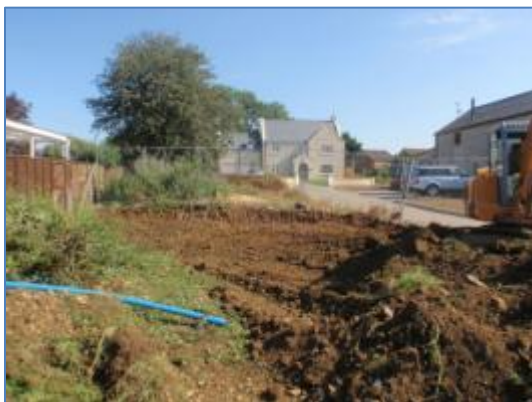
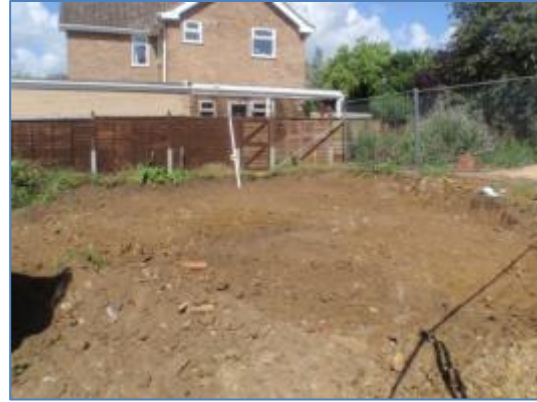
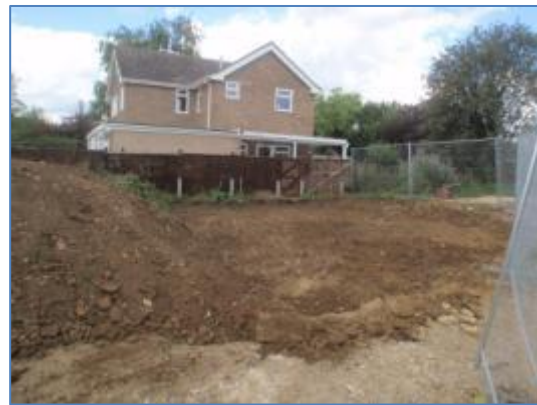
The first area of ground reduction took place at the northern end of the site and comprised an area that was slightly larger than the new build footprint for the detached garage. This area of ground reduction measured approximately 9.0m in length (from west-east) and up to 6.50m in width (from north-south). This area extended southwards from the northern boundary of the site, up to the site access road to the east and up to the site boundary to the west [**Plates 7-10**].

It was apparent that there was a natural downward slope that extended to the south. Consequently the depth of the strip was at its greatest to the north, where it extended to average depths of 0.40m below ground levels and correspondingly decreased to the south where it comprised a shallow surface scrape of up to 0.20m in depth. The ground reduction was undertaken in order to create a level building platform for the construction of the garage.

This ground reduction extended through a modern made ground deposit (**003**) and extended to a buried topsoil horizon (**001**) at the base of this reduction. The deposit (**003**) originated from the construction of the nearby access road, which included dumped site material from this construction in its make-up.

Plate 9: As Plate 7, from the east

Plate 7: Garage site, ground reduction, from the east

Plate 10: Completed ground reduction, garage site, from the east

Plate 8: As Plate 7, from the south

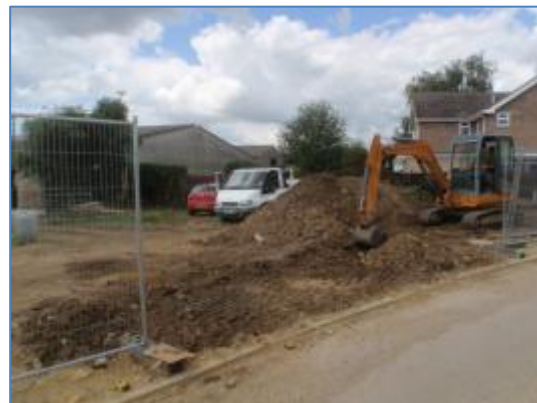
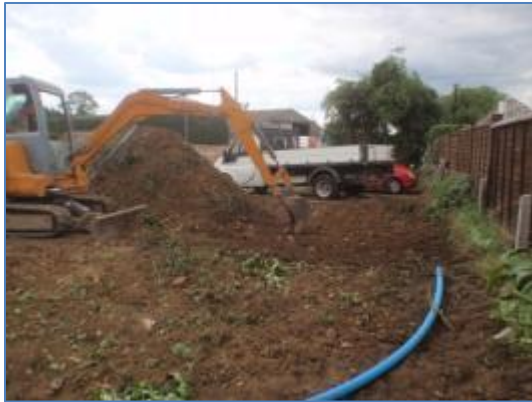
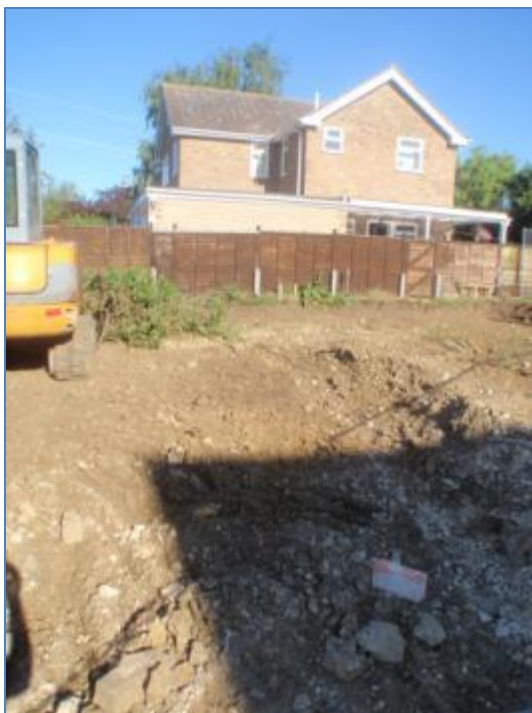
This was followed by a further phase of ground reduction of a driveway that extended westwards from the access road to the immediate south of the garage and thence connected to the first area of ground reduction [**Plates 11-13**]. This reduction removed the modern made ground deposit (**003**), which had originated from the construction of the nearby access road and consisted of

dumped site material from this construction. This made ground deposit was relatively shallow and in turn overlay the topsoil horizon (001), which was evident at the base of this excavation. This area of ground reduction was also relatively shallow at an average depth of up to 0.30m below ground levels. This second area of ground reduction measured approximately 18.0m in length (from east-west) and between 2.90m and 3.8m in width (from north-south).

Plate 11: Ground reduction, driveway, from the east

Plate 12: As Plate 11, from the north

Plate 13: Completed ground reduction, driveway, from the east

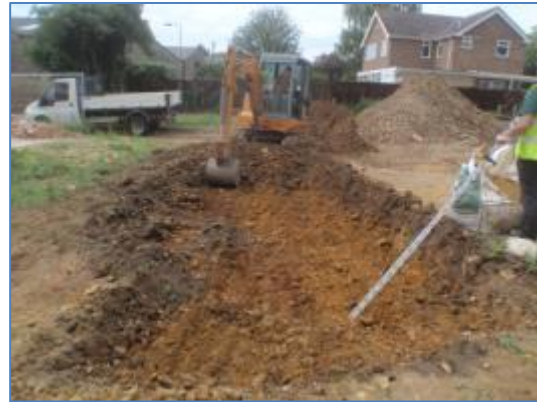
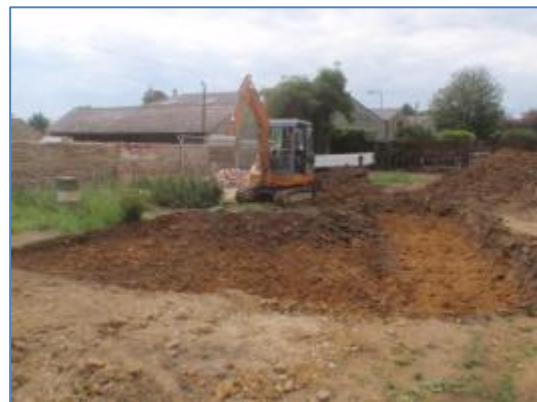
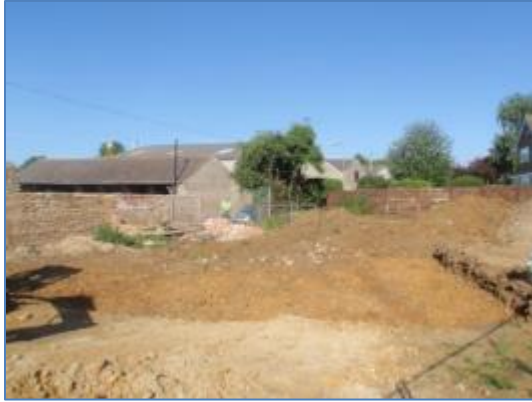
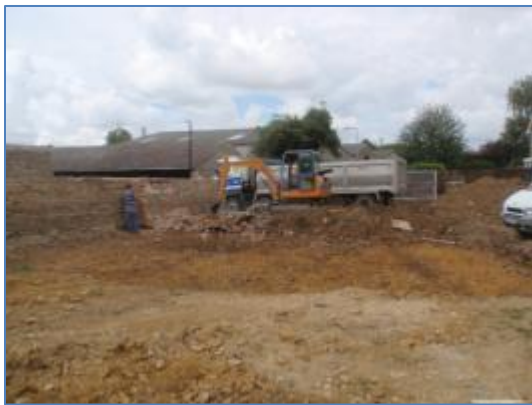
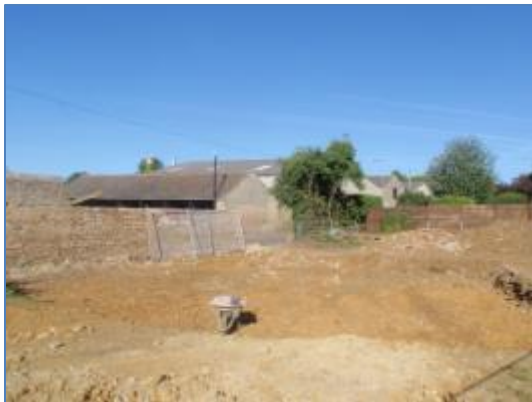
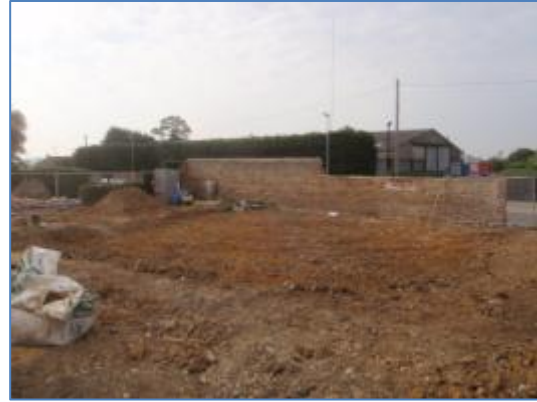
The topsoil (001) appeared to shallow out and decrease in depth southwards and towards the southern boundary of the site. During this ground reduction, the surviving floor surfaces of the demolished outbuilding were also removed which comprised a series of wooden railway sleepers with the remainder consisting of a concrete slab with hardcore. This had a combined depth of 0.20m. The depth of the railway sleepers was 0.25m. Both elements of the floor surface came down directly onto the underlying natural cornbrash horizon (002). This former outbuilding had been constructed on relatively shallow brick foundations in a stretcher bond and from the bricks could be dated to the 20th century.

Plate 14: Ground reduction, house plot, from the east

Plate 16: As Plate 14, from the east

Plate 17: As **Plate 14**, from the east

Plate 20: Completed ground reduction, house plot, from the north

Plate 18: As **Plate 14**, from the east

Plate 19: As **Plate 14**, from the east

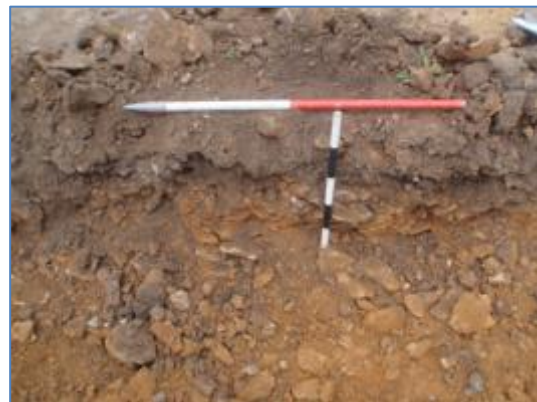
The final phase of monitored ground reduction comprised an area that was slightly larger than the new build footprint for the residential dwelling. This third area of ground reduction extended up to the southern boundary of the site and measured up to approximately 15.0m in length (from north-south) and approximately 13.0m in width (from east to west). This ground reduction reached depths of between 0.45m-0.50m below ground levels to the north and following the aforementioned natural downwards slope of the site to the south, correspondingly decreased in depth to a minimum of 0.15m below ground levels by the southern site boundary [Plates 14 and 16-20]. The deposit sequence in this area comprised the topsoil horizon (001), which came down directly onto the natural horizon of cornbrash (002), which extended to the base of this excavation. This deposit sequence was recorded in the south facing **Representative Section 2** [Plate 15].

Plate 15: Representative Section 2, from the south

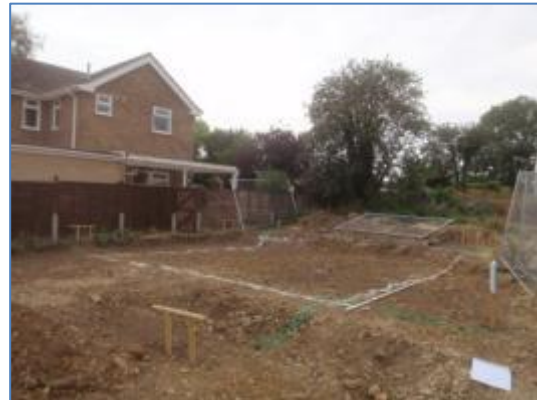
The foundations for the new detached garage had been set out prior to arrival [Plate 21]. Along the northern site boundary and within the northerly west-east orientated foundation trench, the archaeological monitoring of the mechanical excavation of the garage foundations identified a full deposit sequence [Plates 22 and 24]. The modern made ground deposit (003) overlay the topsoil horizon (001), which was in turn above a buried ploughsoil horizon (004). This was in turn above the natural horizon of cornbrash (002), which extended to the base of this excavation. This deposit sequence was recorded in the northern south facing section of this foundation trench within **Representative Section 3** [Plate 23].

Plate 21: Set out foundations for the garage, from the south-east

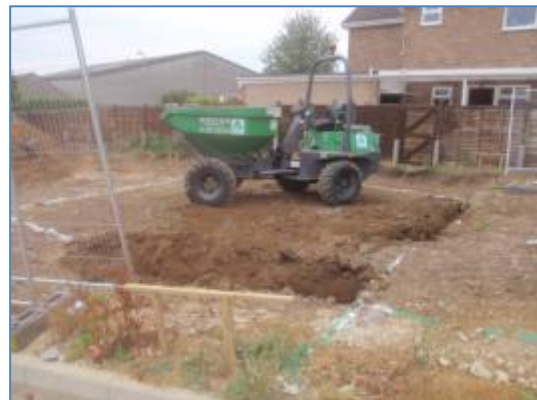
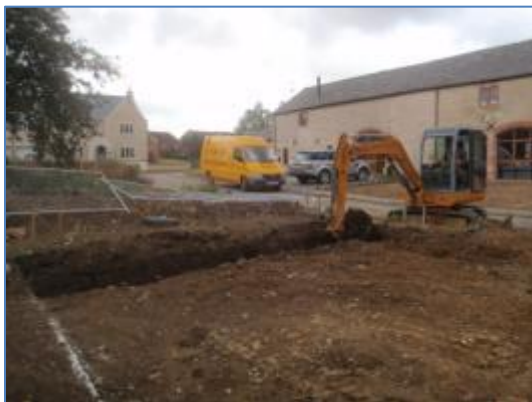
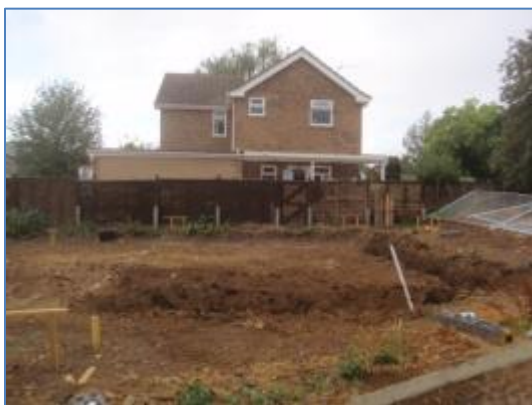
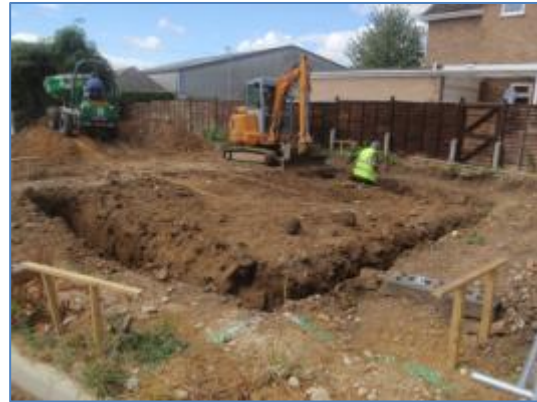
Elsewhere these foundations were excavated from the reduced ground levels [Plates 24-26]. The foundation trenches were excavated to varying lengths, to an average width of 0.80m and to depths of 1.40m along the northern site boundary decreasing to 1.0m in depth elsewhere and from these reduced levels. From these reduced levels and in the second easterly north-south orientated foundation trench, the observed deposit sequence consisted of the topsoil (001), the buried ploughsoil (004) and the natural horizon of cornbrash (002) at the base of this excavation.

Plate 22: Excavation of the garage foundations, from the east

Plate 26: As Plate 22, from the north-east

Plate 24: As Plate 22, from the south

Plate 25: As Plate 22, from the east

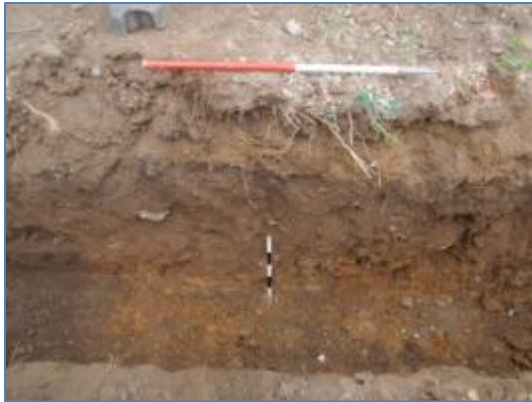
Plate 23: Representative Section 3, from the south

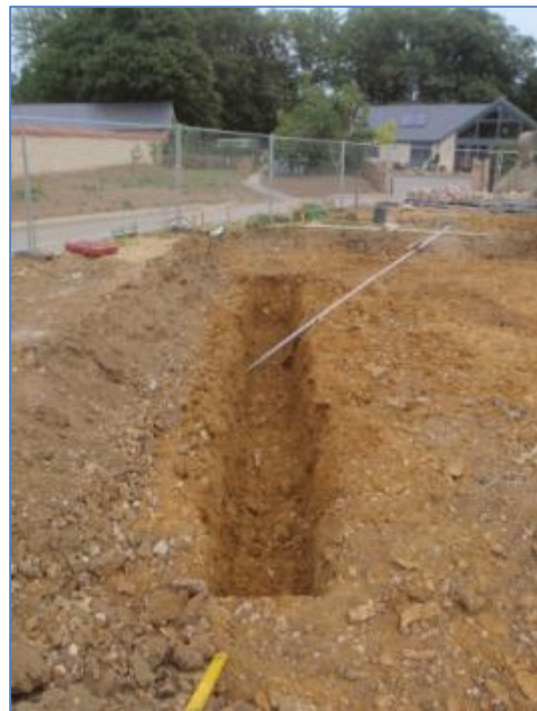
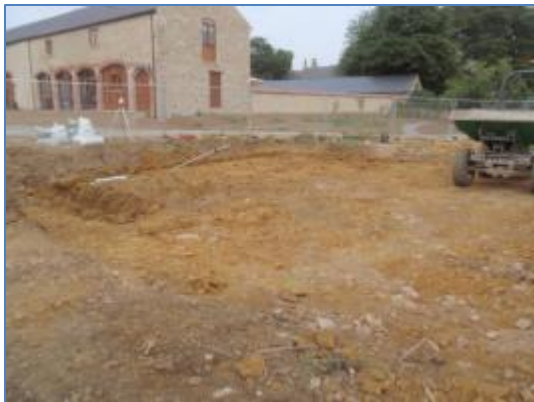
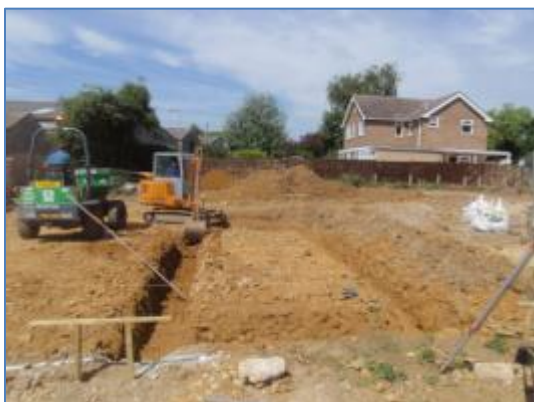
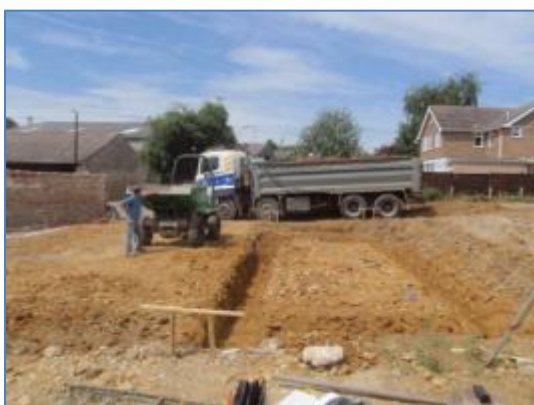
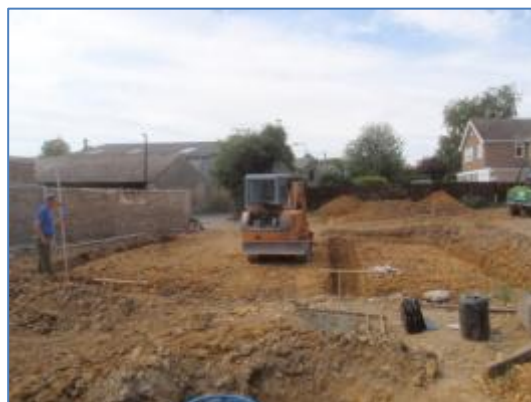
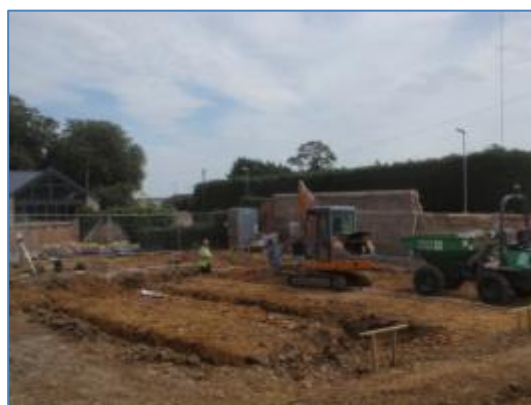
The initial ground reduction of the area of the house plot had exposed the natural horizon of cornbrash (002) over nearly all of this area, with the exception of a thin deposit of the topsoil (001) towards the southern site boundary. Consequently when the foundations were excavated from the reduced level, the natural horizon of cornbrash (002) was encountered throughout and to the base of the excavated foundation trenches. These foundation trenches were similarly excavated to varying lengths, to an average width of 0.80m and to depths of between 0.80m-0.90m below the reduced ground levels [Plates 27-30 and 32-35].

Plate 27: Excavation of the house foundations, from the west

Plate 28: As **Plate 27**, from the south-west

Plate 29: As **Plate 27**, from the east

Plate 32: As **Plate 27**, from the east

Plate 30: As **Plate 27**, from the east

Plate 33: As **Plate 27**, from the north-west

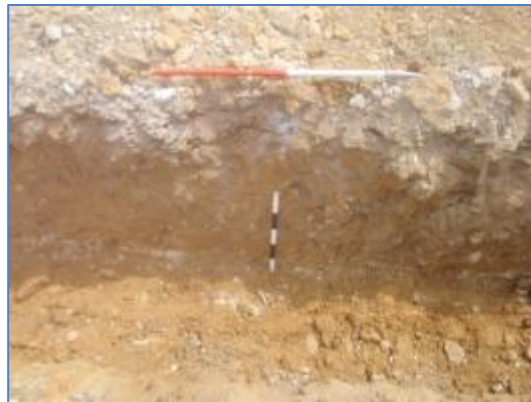
During the mechanical excavation of the easterly north-south orientated foundation trench of the house, an opportunity was provided to record a further section. Here the modern made ground deposit (003) directly overlay the cornbrash horizon (004). This was recorded within the final west facing **Representative Section 4** [Plate 31]. This also confirmed the absence of the undated buried ploughsoil horizon (004) in the south-eastern area of the site and that ground reduction had also taken place in this area.

Plate 31: Representative Section 4,
from the west

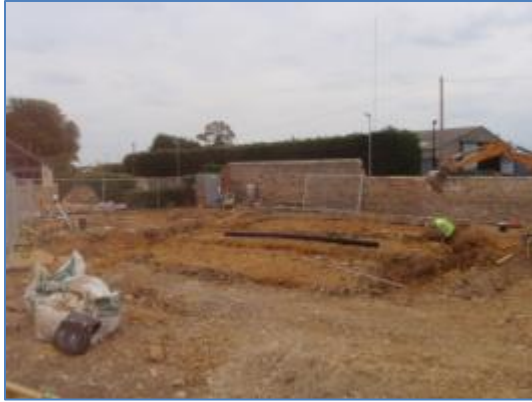
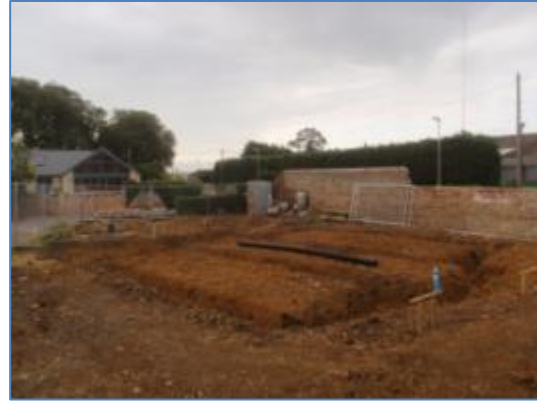
Plate 34: As **Plate 27**, from the north-west

Plate 35: Completed house foundation excavations, from the north-west
