AN ARCHAEOLOGICAL EVALUATION AT THE CART SHED, EASTHORPE MANOR, EASTHORPE ROAD, EASTHORPE, LEICESTERSHIRE

National Grid Reference: SK 8101 3859

April 2013

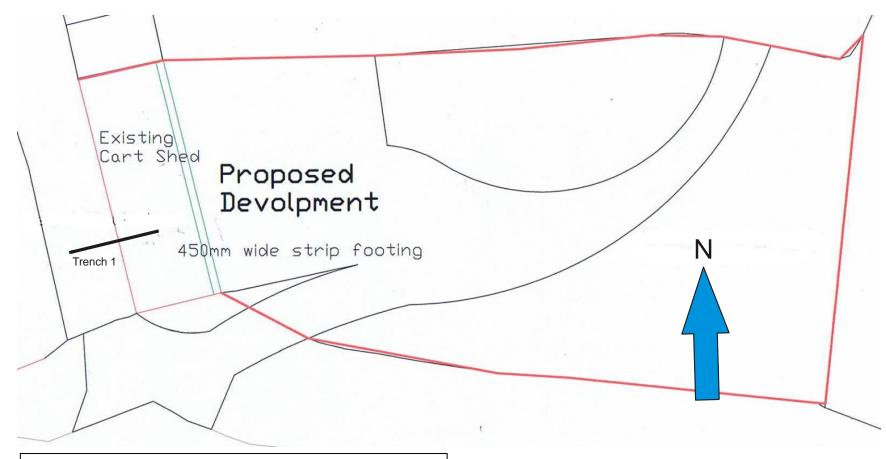
Figure 3: Plan of the proposed layout of **Trench 1**, at an original scale of 1:100 (not to scale), extract from Architects plan)

- 6.1 The archaeological evaluation was undertaken at the development site by Neville Hall MIFA on the 22nd of April 2013. This comprised the mechanical excavation under archaeological supervision of a single archaeological trial trench (designated **Trench 1**) along the line of a proposed new foul sewer which would extend from the west elevation of the Cart Shed, across an entrance trackway to the Easthorpe Manor complex, to connect to existing services according to the Specification for this project previously compiled by Neville Hall MIFA [**Figure 3**]. The trench was excavated by a three ton 360° mechanical excavator that was fitted with a 0.60m wide toothless bucket.

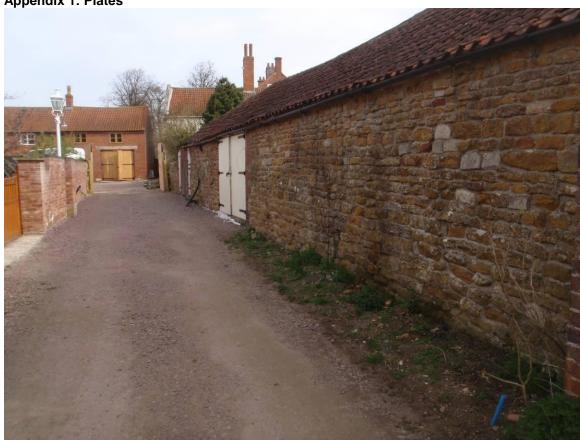
Plate 1: Pre-site works, from the south

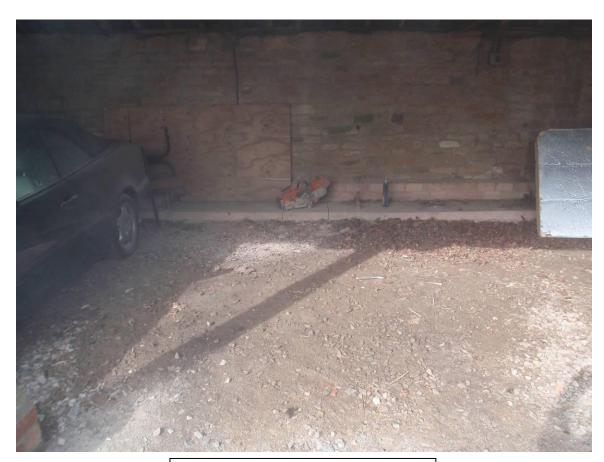
Plate 2: Pre-site works, from the east

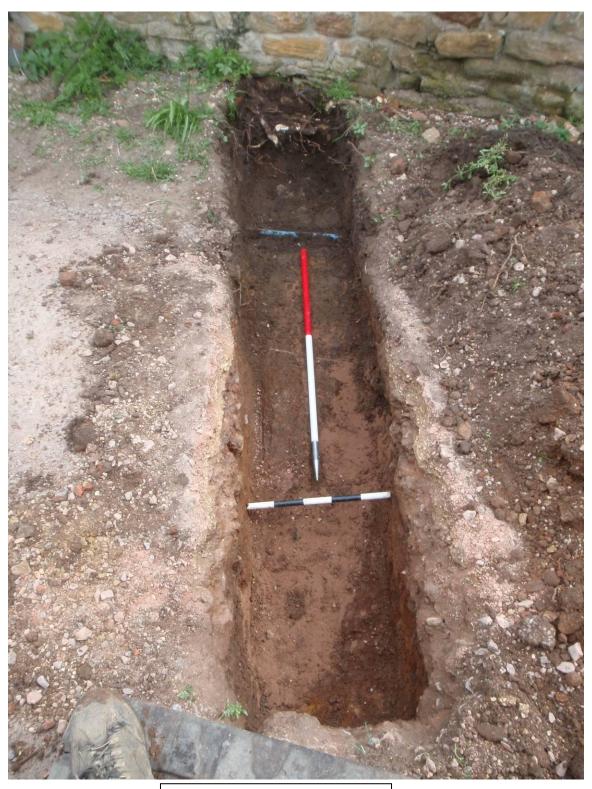
Plate 3: Trench 1, from the west

- 7.2 The single trial trench was excavated under archaeological supervision for a length of 3.0m and to a width of 0.50m as detailed in the agreed Written Scheme of investigation for this evaluation. The trench was excavated to depths of 0.48m and 0.52m below ground levels. The mechanical removal of the current tarmac surface of the trackway (001) revealed a second such and earlier trackway surface (002). Below this was a third such surface of possible post medieval date (003). This was a compacted surface composed of brick and tile fragments and probably earth. Below this was a fourth and final such trackway surface in this sequence (004). This was similarly composed of compacted earth with a much less frequent density of brick/tile fragments. This final surface lay on the top of the underlying natural horizon (005), which extended to the base of the trench excavations. This sequence was recorded within the south facing Section 1.

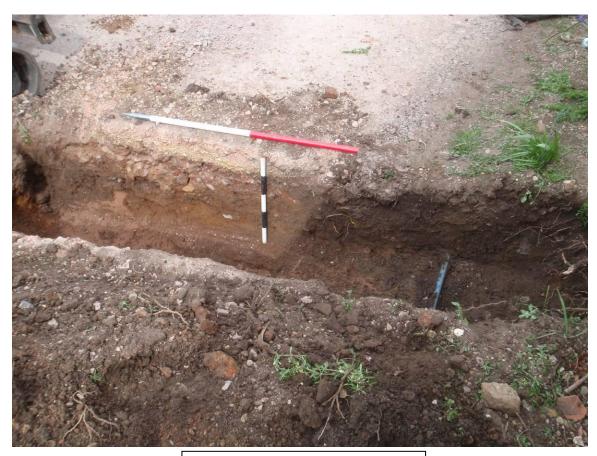
Plate 4: Section 1, from the south

- 7.3 This sequence of trackway surfaces and natural horizon occupied the central portion of the trench section. To the west, this sequence was truncated by a modern service trench which extended north-westwards and beyond the northern limit of excavation of the trench. This service trench had been sealed by the current tarmac surface (001), but had removed the earlier layers within this sequence (002), (003) and (004), thus establishing its recent origin. This service trench was found to extend to the south-east across the base of the trench and was cut into the natural horizon (005). One of the fills of this service trench comprised modern coarse sand.

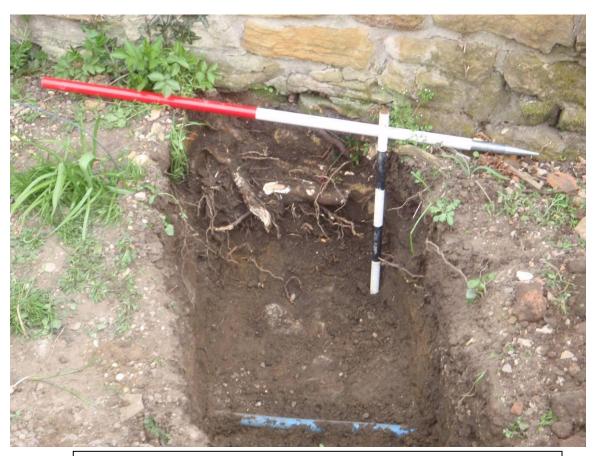
Plate 5: Exposed Foundations of the west wall of the Cart Shed, from the west

- 7.4 The foundations of the west wall of the Cart Shed were exposed at the eastern end of this trench. Below ground level were several courses of stone, which in turn rested upon a basal course or stone offset. Although the cut [006] for the construction trench was not discernible in this excavation, the backfill (007) of this trench was, and was also recorded within Section 1. The construction trench [006] was truncated by the line of a north-south orientated modern water pipe trench, which also in turn truncated the line of a further modern service trench on the same orientation and located to the immediate west. This second service trench also truncated in turn the sequence of trackway surfaces with the exception of the current tarmac surface (001). The water pipe service trench and the construction trench back fill (007) were in turn sealed by the modern topsoil horizon (008).
