AN ARCHAEOLOGICAL WATCHING BRIEF  
AT 18/20 MICHAELGATE,  
LINCOLN, LINCOLNSHIRE.

**National Grid Reference: SK 97616 71659**  
**Site Code: MGLI13**  
**Accession No: LCNCC: 2013.101**  
**Planning Reference: 2013/0024/F**

PREPARED FOR MR. STEVE EDWARDS

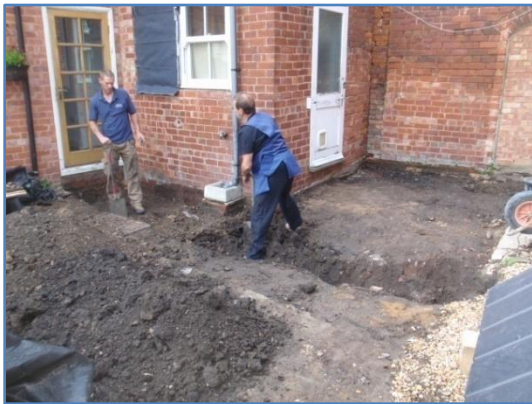
**Plate 2:** Work in progress, hand ground reduction, from the north

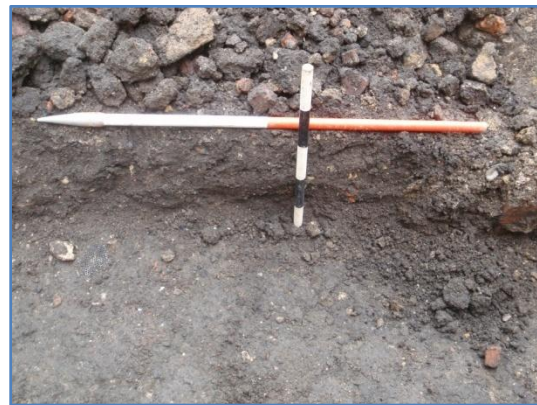
**Plate 5: Representative Section 1,** from the south

- 001** Modern made ground deposit incorporating a disturbed topsoil. Friable, dark grey brown sandy silt with small angular stones 5% & small-medium brick/tile fragments 1%. Recorded within **Representative Section 1**. Depth - >0.30m.

- 7.2 A modern made ground deposit (**001**) which incorporated a disturbed topsoil within its matrix was recorded and observed throughout the area of monitored ground reduction and extended to the base of these excavations. This deposit sequence was recorded within **Representative Section 1**. A small assemblage of 19<sup>th</sup> and 20<sup>th</sup> century pottery was recovered from the deposit (**001**), but was not retained.

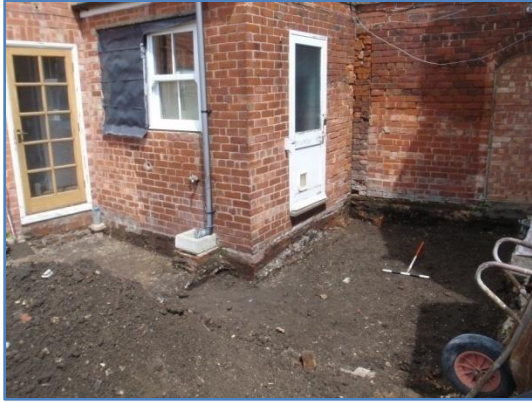
**Plate 7:** Completed hand ground reduction, from the north
