AN ARCHAEOLOGICAL WATCHING BRIEF AT  
ST. GENEWYS CHURCH, NORTHORPE ROAD,  
SCOTTON, LINCOLNSHIRE.

**National Grid Reference: SK 8902 9909**  
**Site Code: GCSC14**  
**Accession No: LCNCC: 2014.9**

PREPARED FOR MR. DAVID STERRY ON BEHALF OF HIS CLIENTS - THE VICAR &  
CHURCHWARDS OF ST. GENEWYS CHURCH

July 2014

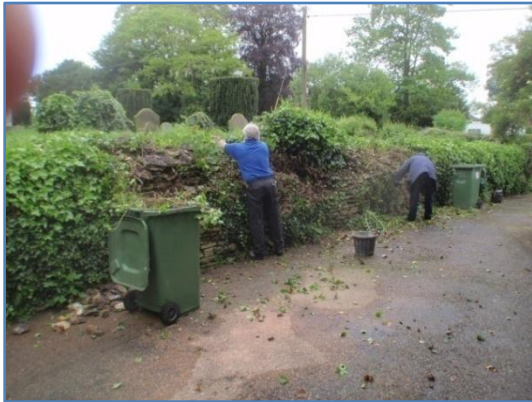
**Plate 1:** Removal of ivy overgrowth from the eastern churchyard boundary wall, from the south-east

- 7.1 The section of the eastern churchyard boundary wall, which was the subject of this archaeological watching brief measured 7.6m in length. Prior to the start of this watching brief, the churchyard wall was covered with a dense growth of ivy which was removed. This revealed a wall (**001**) constructed of coursed and unmortared angular limestone blocks (dry stone), of which twelve courses in height were visible. The limestone blocks had been roughly worked and faced. The bole and root systems of a large and mature sycamore tree had caused this section of the eastern churchyard boundary wall to bow outwards; hence the need for the replacement and repair of this section of the churchyard wall [**Plate 1**].

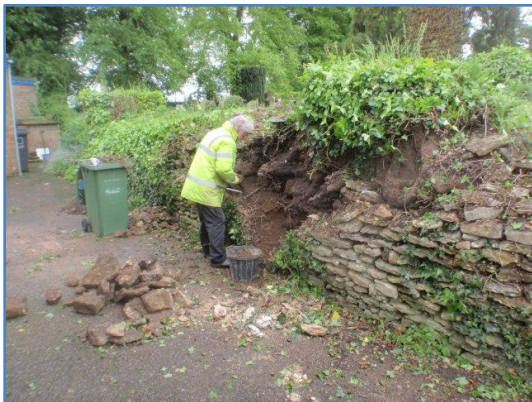
**Plate 2:** Removal of the existing dry stone wall from the eastern churchyard boundary wall, from the north-east

- 7.2 The relevant section of the eastern churchyard boundary wall was then dismantled by hand [**Plates 2-10, 12-19 and 23-24**]. This process began at the south-eastern end of this section. The hand removal of the outer face of this wall revealed an inner rubble core infill (**002**) of further loose angular limestone fragments within a matrix of redeposited natural. The hand removal of the inner face of this wall revealed a deposit sequence consisting of a graveyard soil (**003**) and an underlying natural horizon (**004**). This process also revealed that the width of this south-eastern section of wall was 0.75m. To the north-west, the width of the wall was revealed to be 0.60m [**Plates 20 and 22**]. The deposit sequence was recorded within two sections, designated as **Representative Sections 1 and 2** [**Plates 11 and 21**]. The boundary wall was removed down to ground levels with the wall foundations remaining intact.

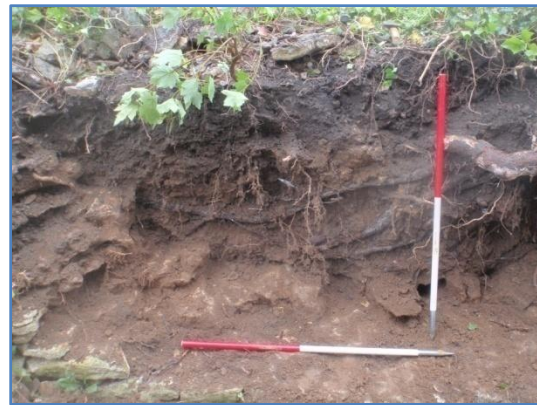
**Plate 11:** Representative Section 1, from the east

- 001** Eastern churchyard boundary wall of which some 7.60m in length was the subject of this archaeological watching brief. Constructed of coursed and unmortared angular limestone blocks, (dry stone walling) of which twelve courses in height were visible. The limestone blocks had been roughly worked and faced. Of probable later 19th century date with some evidence of modern 20th century repair. Recorded within **Representative Sections 1-2**. Height - 1.40m-1.45m. Width - 0.60m-0.75m.

- 002** Rubble infill core of the eastern churchyard boundary wall revealed by the removal of the outer face of the wall. Composed of a redeposited friable, light orange brown sandy silt matrix (natural) with small-medium angular limestone fragments 30%.

- 003** Graveyard soil revealed by the removal of the inner face of the wall. Friable, dark grey brown sandy silt. Above (**004**). Recorded within **Representative Sections 1-2**. Depth - 0.96m.

- 004** Natural horizon. Friable, light orange brown sandy silt. Below (**003**). Recorded within **Representative Sections 1-2**. Depth - >0.78m.

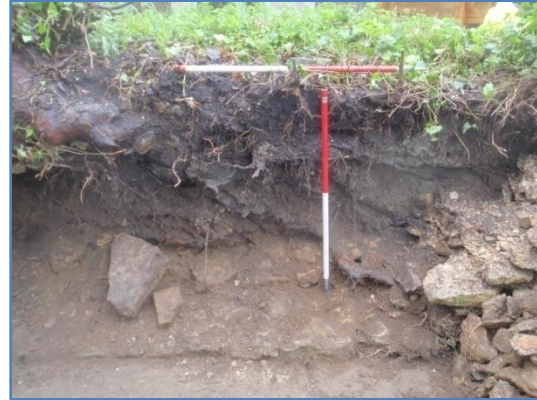
**Plate 21:** Representative **Section 2**, from the east

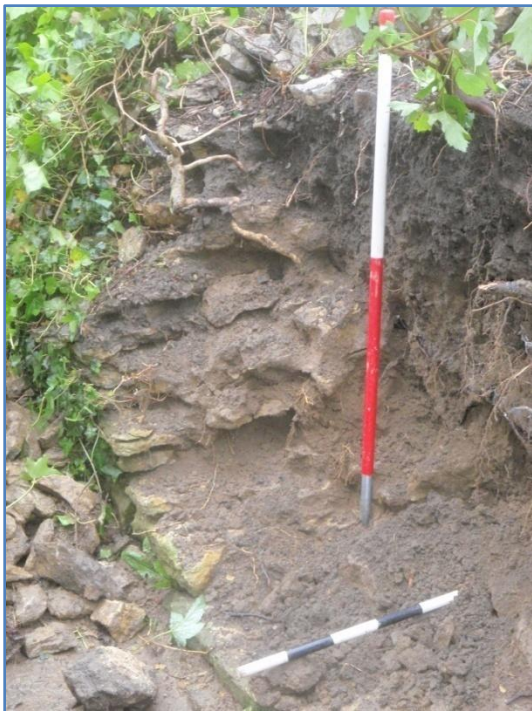
**Plate 20:** Exposed south-eastern end of the churchyard boundary wall section, from the north-east

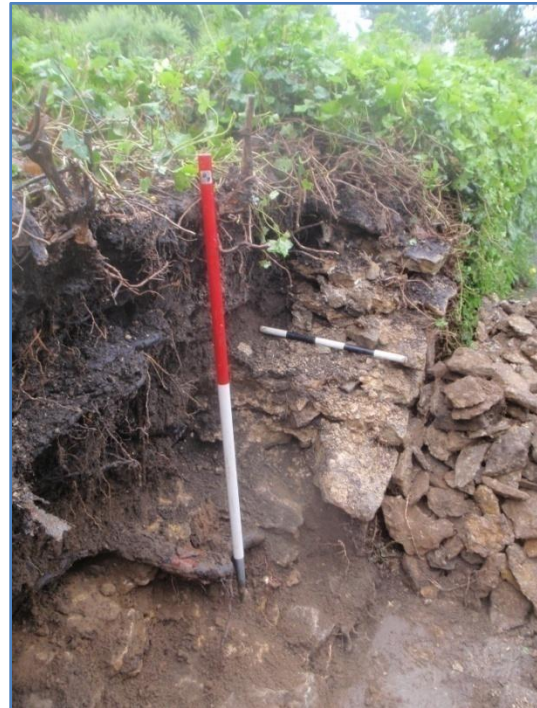
**Plate 22:** Exposed north-western end of the churchyard boundary wall section, from the south-east

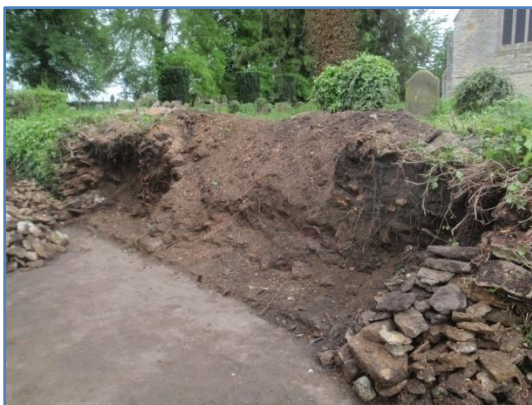
**Plate 25:** View of the removed tree bole & root systems & removal of the existing dry stone wall from the eastern churchyard boundary wall, from the north-east

- 7.3 The sycamore tree appears to have been planted in the 1860s and was probably part of the restoration works of 1866. This section of the eastern churchyard boundary wall appears to have probably post-dated this tree planting and so may be of late 19th century date. The hand removal of the stone walling also revealed the extent of the tree bole and the root systems, which were extensive. To the north-west, the hand removal of the stone walling also identified some modern 20th century repair work where the limestone blocks were bonded by a light buff sandy lime mortar.

- 7.4 The removal of the tree bole and the relatively shallow root systems were then removed to allow the final completion of the dismantling of this section of the churchyard boundary wall down to ground level [**Plates 25-29**]. During these final stages, two fragments of disarticulated human bone were recovered from the graveyard soil (**003**) and were collected for eventual reburial.

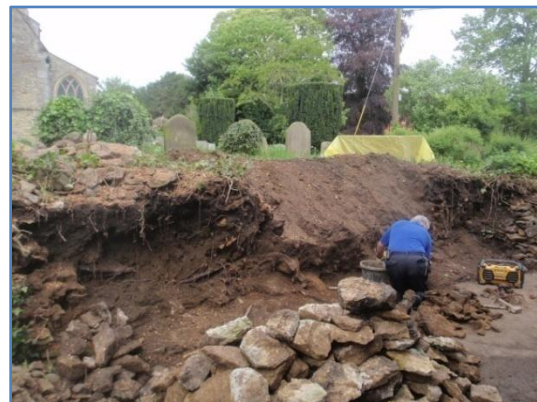
**Plate 28:** Completed removal of the dry stone wall of the eastern churchyard boundary wall, from the south-east
