ARCHAEOLOGICAL MONITORING & RECORDING
AT 30, HOLLAND ROAD,
SPALDING, LINCOLNSHIRE.

National Grid Reference: TF 2515 2252
Site Code: HRSP14
Accession No: LCNCC: 2014.60
Planning Reference: H16-1103-13

August 2014

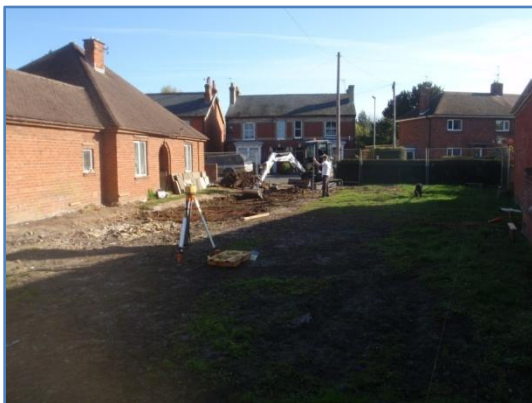
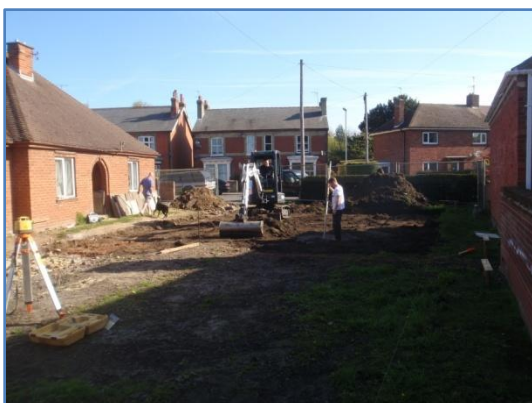
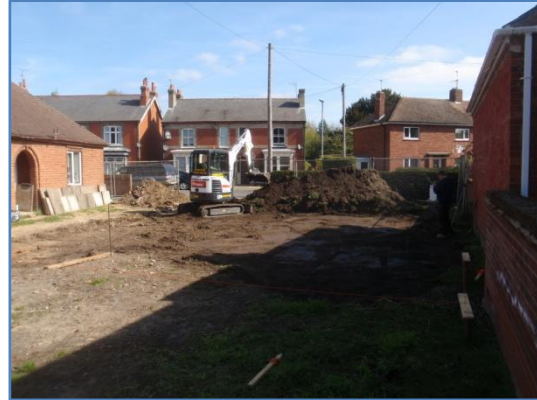
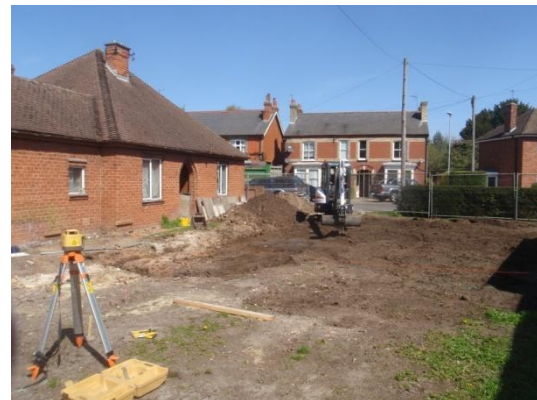
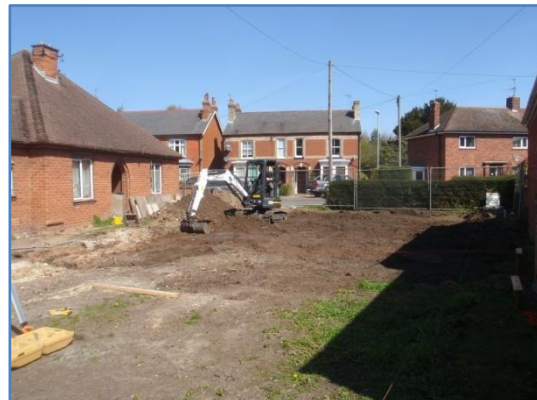
Plate 2: Ground reduction, from the south-west

Plate 3: Ground reduction, from the south-west

Plate 4: Ground reduction, from the south-west

Plate 5: Ground reduction, from the south-west

Plate 6: Ground reduction, from the south-west

- 7.1.1 The groundworks programme commenced with an initial mechanical ground reduction under archaeological supervision of an area which was slightly larger than the new build footprint [**Plates 2-6**]. The extent of this area of ground reduction is shown on **Figure 4**. The average depth of this ground reduction varied between 0.20m-0.30m below ground levels. This initial ground reduction extended through and into a topsoil horizon (**001**) over much of the monitored area. However, to the north and towards an existing dwelling on the site, this ground reduction entailed the removal of a concrete path and an area of modern made ground (**002**), which contained demolition material, which was associated with a former garage to this dwelling which had stood on this site and which had been demolished prior to arrival. All newly exposed surfaces were walked over and were rapidly scanned for any surface finds. Rare sherds of 20th pottery were noted, but were not retained.

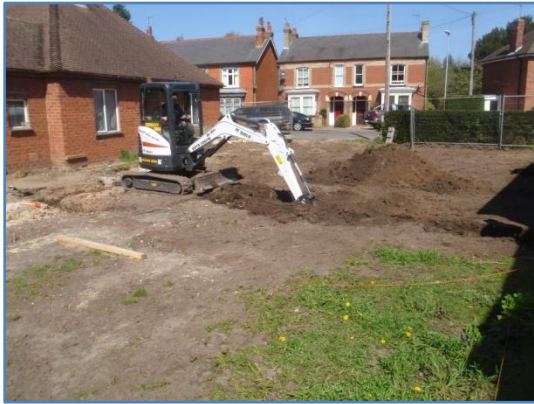
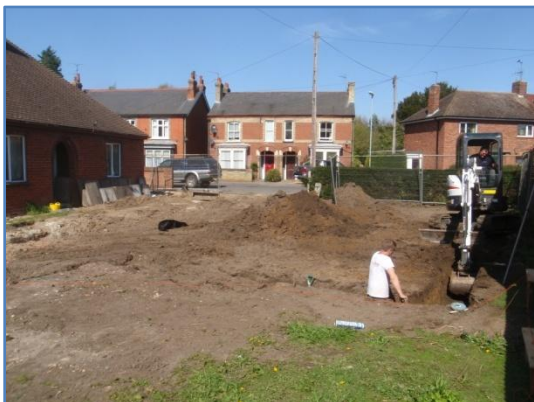
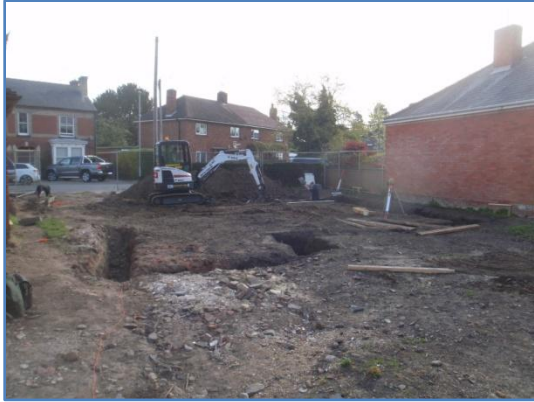
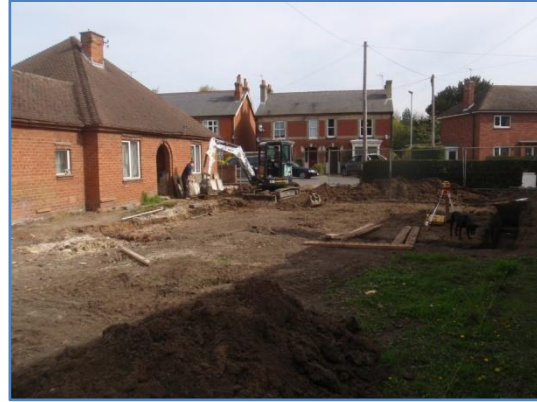
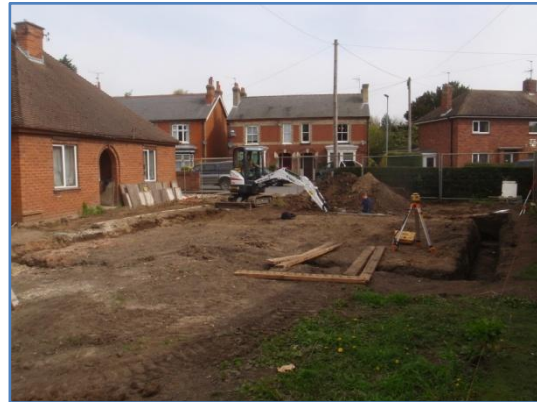
Plate 7: Excavation of the foundations, from the south-west

Plate 13: Excavation of the foundations,
from the south-west

Plate 17: Excavation of the foundations, from the south-west

Plate 20: Excavation of the foundations, from the south-west

Plate 21: Excavation of the foundations, from the south-west

- 7.2.1 The second phase of the groundworks programme consisted of the mechanical excavation under archaeological supervision of the foundation trenches from the reduced ground levels. These trenches were excavated to varying lengths, to a width of 0.70m and to depths of 0.80m-1.0m below the reduced levels. The extent of the foundation trenches excavated are shown in **Figure 4**. The excavation of these foundation trenches was simultaneously accompanied by further limited ground reduction within the interior of the new build area of a further 0.10m and within the topsoil horizon (**001**) [**Plates 7, 10, 13-17, 19-21 and 23-25**].
- 7.2.2 The foundation trench excavations commenced within the south-western area of the new build with the excavation of two short lengths of trench. Here the removal of the modern

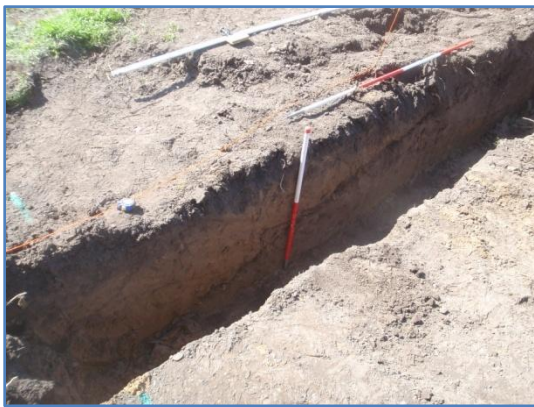
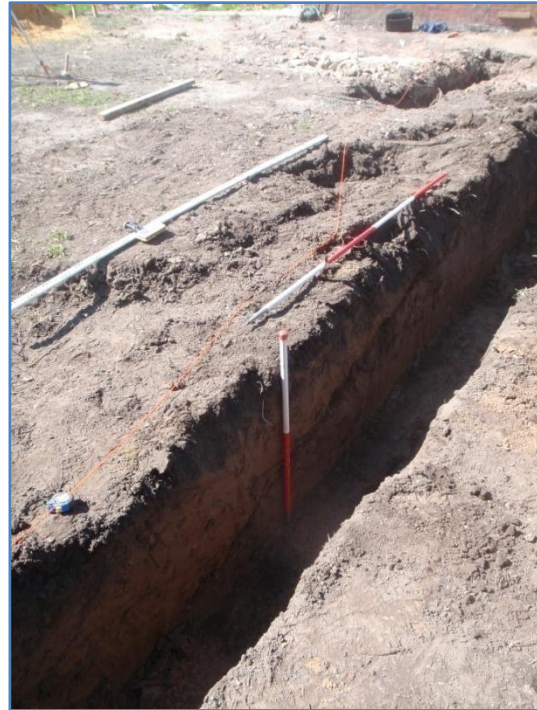
Plate 8: Representative Section 1, from the north-east

Plate 9: Representative Section 1, from the north-east

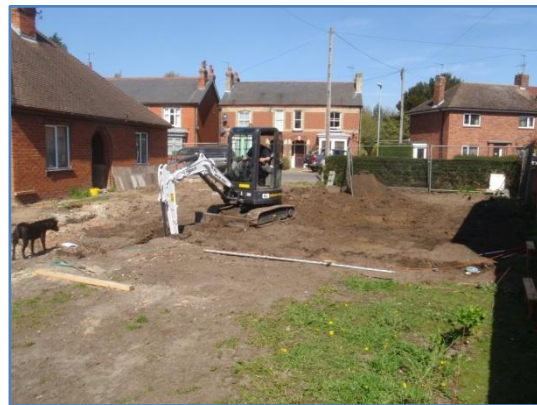
Plate 10: Excavation of the foundations, from the south-west

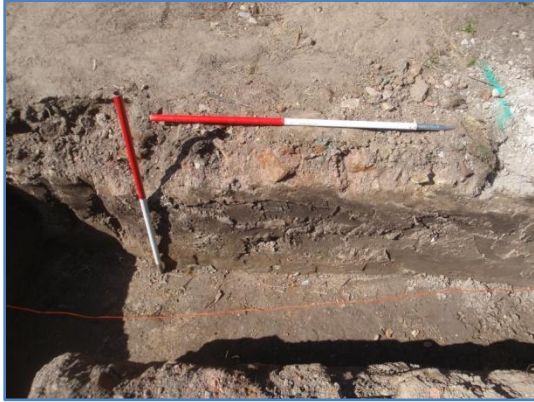
Plate 11: Representative Section 3,
from the south-east

made ground deposit (002) revealed the underlying topsoil horizon (001). Below the topsoil horizon were two alluvial flood deposits (003) and (004). The flood deposit (004) in turn overlay a natural horizon (005), which was encountered at the base of the foundation excavations. This deposit sequence was recorded within **Representative Section 3 [Plate 11]**.

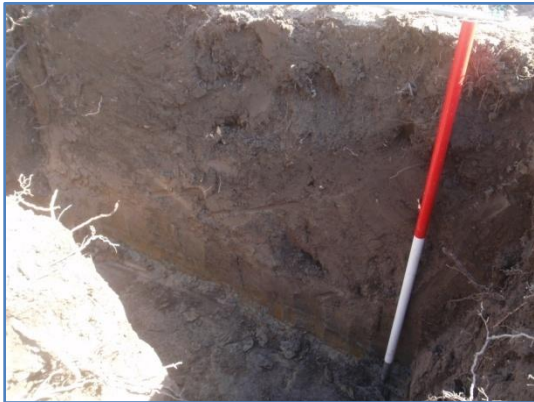
Plate 12: Representative Section 2,
from the north-west

- 7.2.3 To the south-east and beyond the extent of the made ground deposit (002), the foundation trench excavations identified a change to this deposit sequence, which was recorded within **Representative Section 2 [Plate 12]**. The removal of the topsoil horizon (001) revealed this to be overlying the alluvial flood deposit (003), which in turn overlay the natural horizon (005). The alluvial flood deposit (004) was observed to be absent in this area of the site.

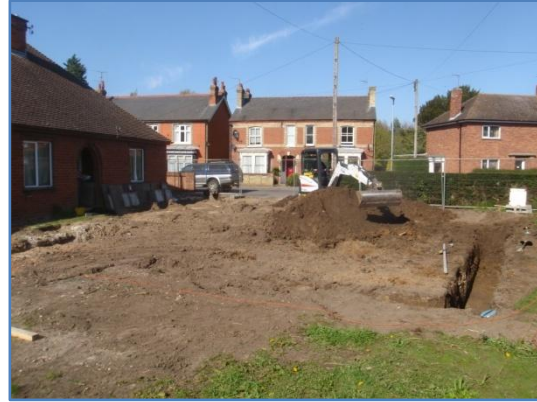
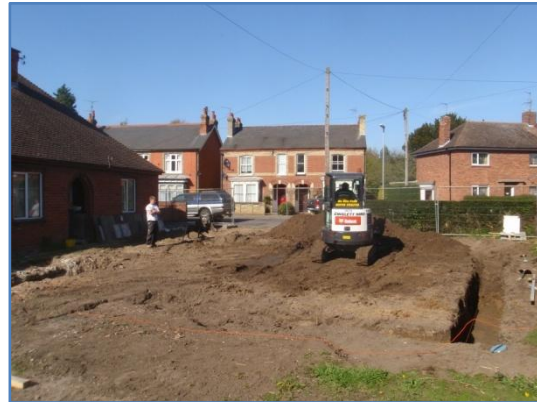
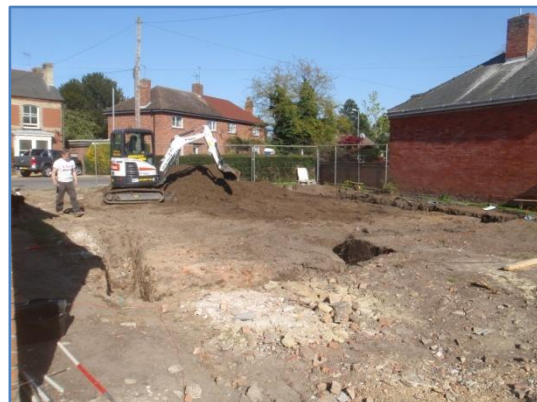
Plate 14: Ground reduction, from the
south-west

Plate 15: Ground reduction, from the
south-west

Plate 16: Ground reduction, from the
south

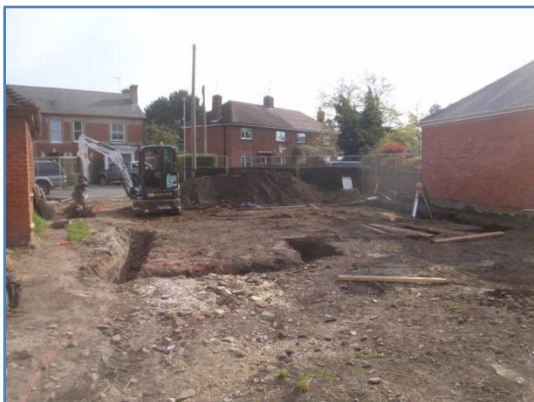
Plate 19: Excavation of the foundations, from the south-west

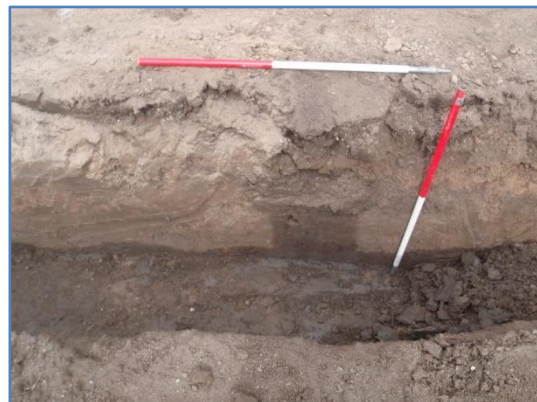
Plate 22: Representative Section 6, from the south-east

- 7.2.9 This was followed by the mechanical excavation under archaeological supervision of the remainder of the first foundation trench, which was adjacent to the existing residential dwelling on the site. This resumed excavation began at the south-western end of this trench where the deposit sequence comprised the modern made ground deposit (002), the topsoil deposit (001), the alluvial flood deposits (003) and (004), which in turn overlay the natural horizon (005)/(013), which extended to the base of the trench excavations. The deposit (004) occurred as a thin band of material, which eventually petered out to the east. With the disappearance of the deposit (004), the deposit sequence in the remainder of this foundation trench consisted of the modern made ground deposit (002), the topsoil horizon (001), the alluvial flood deposit (003) and the underlying natural horizon (005)/(013) at the base of the excavation. This deposit sequence was recorded within **Representative Section 6 [Plate 22]**.

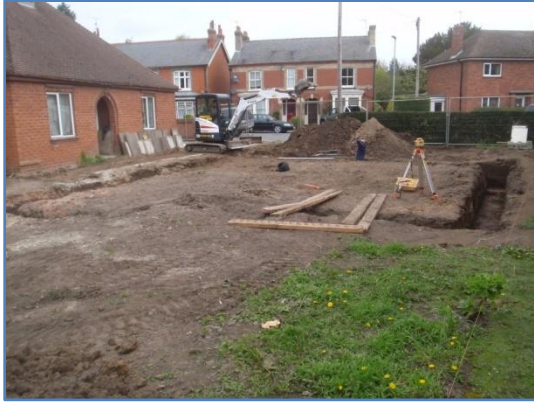
Plate 23: Excavation of the foundations, from the south-west

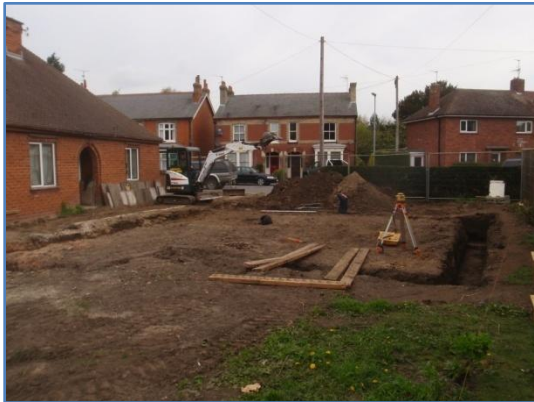
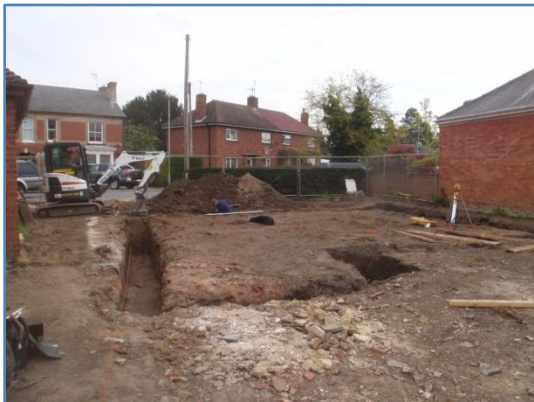
Plate 24: Completed foundation excavations, from the south-west

Plate 25: Completed foundation excavations, from the south-west

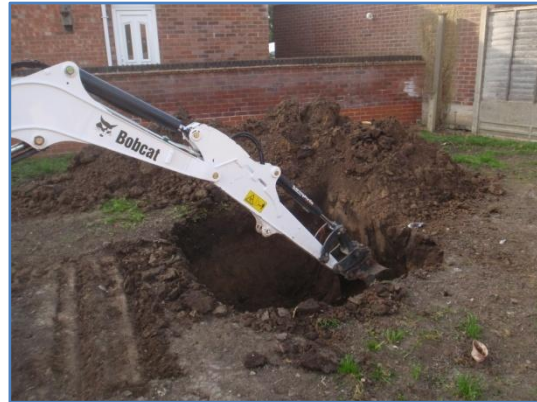
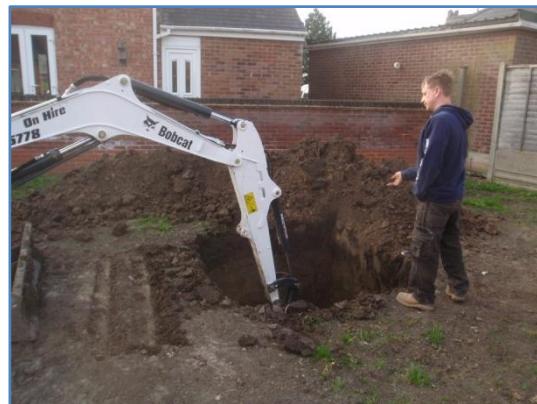
Plate 26: Excavation of the soakaway, from the north-west

Plate 27: Excavation of the soakaway, from the north-west

- 7.3.1 To the south-west of and at the rear of the new build area, a soakaway was mechanically excavated under archaeological supervision. This soakaway was excavated to a length of 1.80m, to a width of 1.50m and to depths of 1.20m below ground levels [**Plates 26-27 and 30**]. The removal of the topsoil (001) revealed an alluvial flood deposit (010), which in turn overlay a natural horizon (011), which extended to the base of this excavation. This deposit sequence was recorded within **Representative Section 4 [Plate 28]**.

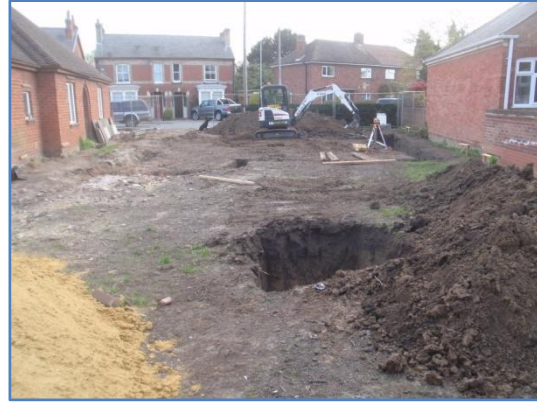
Plate 30: Location of the completed
soakaway in relation to the excavated
foundations from the south-west

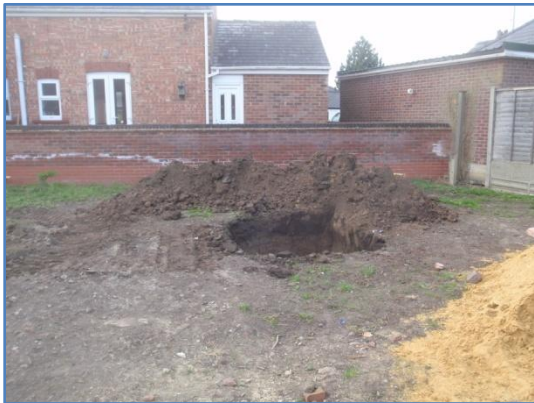
Plate 29: Completed excavation of the
soakaway, from the north-west
