ARCHAEOLOGICAL MONITORING & RECORDING
AT THE LOUTH POTATO COMPANY,
LIVESEY ROAD, LUDBOROUGH,
LINCOLNSHIRE.

National Grid Reference: TF 2956 9517
Site Code: LRLU14
Accession No: LCNCC: 2014.158
Planning Reference: N/107/02432/13

November 2014

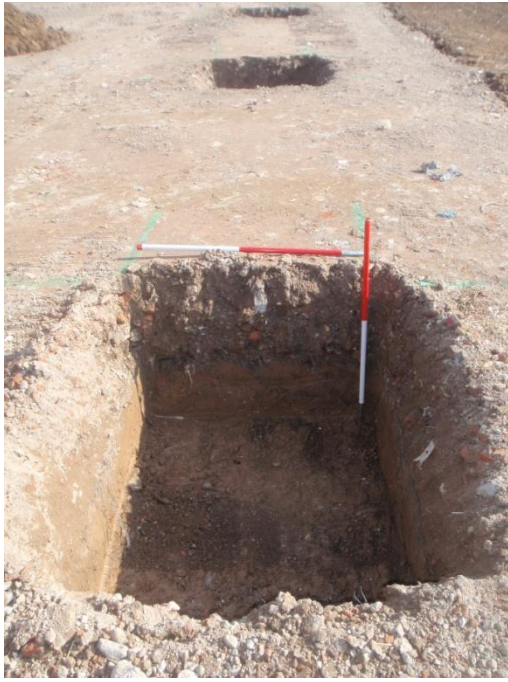
Plate 24: Stanchion Base 9, from the south-east

- 7.2.5 **SB9** was excavated to the south-west of **SB8** and along the south-eastern edge of the new build area. **SB9** was excavated to a length of 1.30m, to a width of 1.20m and to depths of 0.95m below the level of the redeposited hardcore [**Plate 24**]. Below the hardcore, the same deposit sequence noted earlier was also recorded here. **SB10** was excavated to the south-west of **SB9** and along the south-eastern edge of the new build area. **SB10** was excavated to a length of 1.40m, to a width of 1.30m and to depths of 0.85m below the level of the redeposited hardcore [**Plate 25**]. The hardcore layer was found to come down directly onto the underlying natural horizon (**002**), which extended to the base of this excavation.

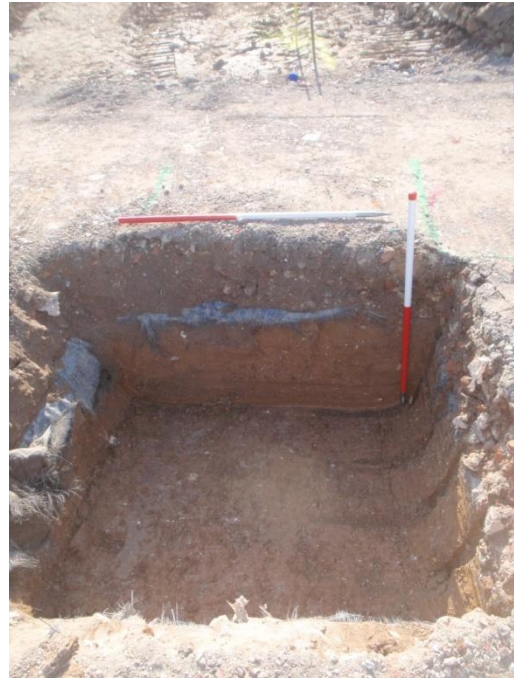
Plate 26: Stanchion Base 11, from the south-east

- 7.2.6 **SB11** was positioned at the southern corner of the new build area. **SB11** was excavated to the south-west of **SB10** to a length of 1.40m, to a width of 1.30m and to depths of 0.95m below the level of the redeposited hardcore [**Plate 26**]. The hardcore layer was found here to come down directly onto the underlying natural horizon (**002**), which extended to the base of this excavation.

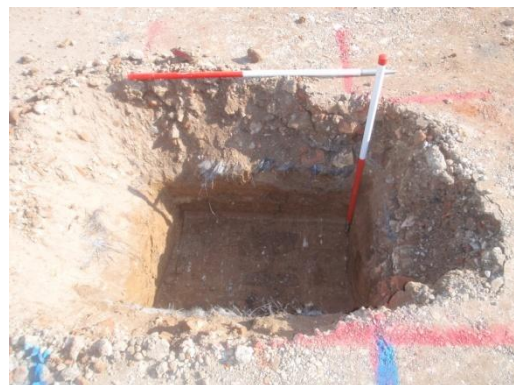
Plate 27: Stanchion Base 22, from the south-west

- 7.2.7 **SB22** was excavated to the north-west of **SB11** and along the south-western edge of the new build area. **SB22** was excavated to a length of 1.40m, to a width of 0.90m and to depths of 0.95m below the level of the redeposited hardcore [**Plate 27**]. The hardcore layer was found to come down directly onto the underlying natural horizon (**002**), which extended to the base of this excavation. **SB25** and **SB26** were positioned to the north-west of **SB22** and along the south-western edge of the new build area. Both stanchion bases were excavated as a single and combined base to a length of 2.20m, to a width of 0.90m and to depths of 1.0m below the level of the redeposited hardcore [**Plate 28**]. The hardcore layer was found to come down directly onto the underlying natural horizon (**002**), which extended to the base of this excavation.

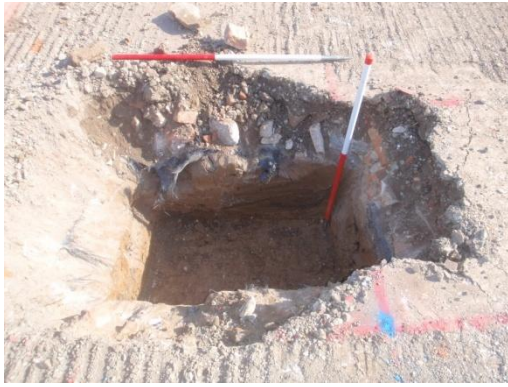
Plate 29: Stanchion Base 27, from the south-west

- 7.2.8 **SB27** was located to the north-west of **SB25/26** and along the south-western edge of the new build area. **SB27** was excavated to a length of 1.40m, to a width of 0.90m and to depths of 1.0m below the level of the redeposited hardcore [**Plate 29**]. The hardcore layer was found to come down directly onto the underlying natural horizon (**002**), which extended to the base of this excavation. **SB24** was situated to the north-west of **SB27** and along the south-western edge of the new build area. **SB24** was excavated to a length and to a width of 1.0m and to depths of 0.95m below the level of the redeposited hardcore. The deposit sequence in this excavation consisted of a thin band of topsoil/ploughsoil (**001**) underlying the hardcore and overlying the natural horizon (**002**), which extended to the base of this excavation. This deposit sequence was recorded within **Representative Section 4** [**Plate 30**].

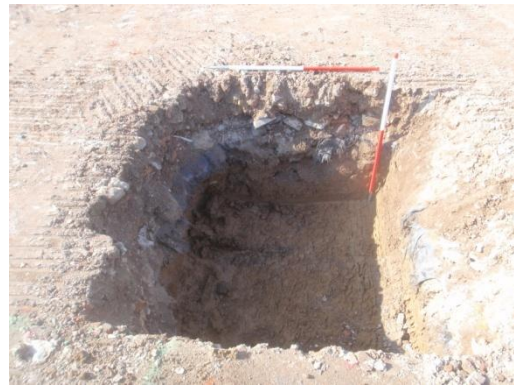
Plate 33: Stanchion Base 16, from the north-east

- 7.2.10 **SB16** was situated to the north-east of **SB17** and along the north-western edge of the new build area. **SB16** was excavated to a length of 1.40m, to a width of 1.30m and to depths of 1.0m below the level of the redeposited hardcore [**Plate 33**]. The deposit sequence in this excavation consisted of a thin band of topsoil/ploughsoil (**001**) underlying the hardcore and overlying the natural horizon (**002**), which extended to the base of this excavation. **SB15** was located to the north-east of **SB16** and along the north-western edge of the new build area. **SB16** was excavated to a length and a width of 1.30m and to a depth of 0.95m below the level of the redeposited hardcore. The deposit sequence in this excavation consisted of a thin band of topsoil/ploughsoil (**001**) underlying the hardcore and overlying the natural horizon (**002**), which extended to the base of this excavation. This deposit sequence was recorded within **Representative Section 3** [**Plate 34**].

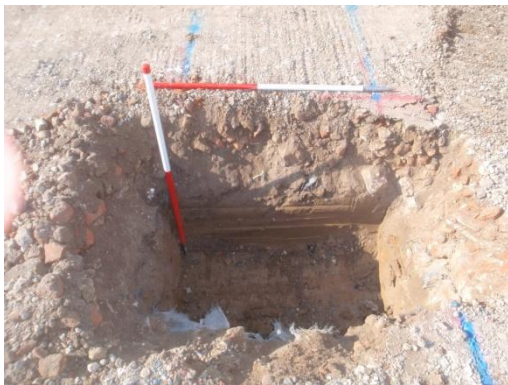
Plate 31: Stanchion Base 23, from the north-east

- 7.2.9 **SB23** was positioned to the north-west of **SB24** and along the south-western edge of the new build area. **SB23** was excavated to a length of 1.10m, to a width of 1.0m and to depths of 0.95m below the level of the redeposited hardcore [**Plate 31**]. The deposit sequence in this excavation consisted of a thin band of topsoil/ploughsoil (**001**) underlying the hardcore and overlying the natural horizon (**002**), which extended to the base of this excavation. **SB17** was situated at the western corner of the new build area and to the north-west of **SB23**. **SB17** was excavated to a length of 1.80m, to a width of 1.40m and to depths of 0.95m below the level of the redeposited hardcore [**Plate 32**]. The deposit sequence in this excavation consisted of a thin band of topsoil/ploughsoil (**001**) underlying the hardcore and overlying the natural horizon (**002**), which extended to the base of this excavation.

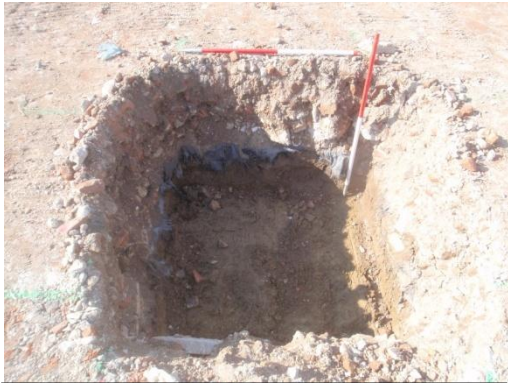
Plate 35: Stanchion Base 14, from the north-east

of 0.95m below the level of the redeposited hardcore [Plate 35]. The deposit sequence in this excavation consisted of the topsoil/ploughsoil (001) underlying the hardcore, which extended to the base of this excavation. **SB13** was located to the north-east of **SB14** and along the north-western edge of the new build area. **SB13** was excavated to a length and to a width of 1.40m, and to depths of 0.85m below the level of the redeposited hardcore [Plate 36]. The deposit sequence in this excavation consisted of a thin band of topsoil/ploughsoil (001) underlying the hardcore and overlying the natural horizon (002), which extended to the base of this excavation.

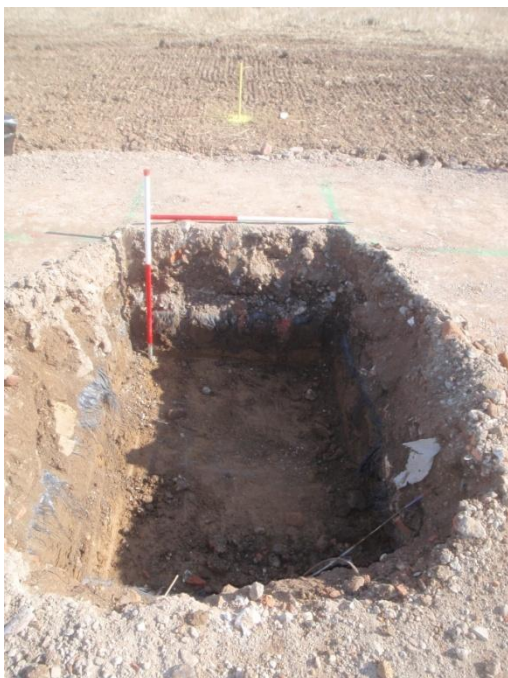
Plate 37: Stanchion Base 12, from the south-west

- 7.2.12 **SB12** was situated at the northern corner of the new build area and to the north-east of **SB13**. **SB12** was excavated to a length of 1.40m, to a width of 1.30m and to depths of 0.90m below the level of the redeposited hardcore [Plate 37]. The deposit sequence in this excavation consisted of a thin band of topsoil/ploughsoil (001) underlying the hardcore and overlying the natural horizon (002), which extended to the base of this excavation.

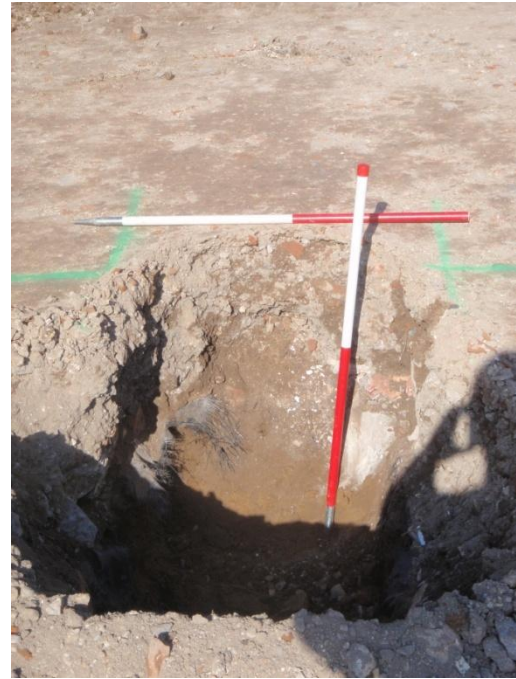
Plate 38: Stanchion Base 1, from the south-east

- 7.2.13 **SB1** was situated to the south-east of **SB12** and along the north-eastern side of the new build area. **SB1** was excavated to a length of 1.0m, to a width of 0.90m and to depths of 0.95m below the level of the redeposited hardcore [Plate 38]. The deposit sequence in this excavation consisted of a band of topsoil/ploughsoil (001) underlying the hardcore and overlying the natural horizon (002), which extended to the base of this excavation. **SB2** was positioned to the south-east of **SB1** and along the north-eastern side of the new build area. **SB2** was excavated to a length of 1.0m, to a width of 0.90m and to depths of 0.90m below the level of the redeposited hardcore. The deposit sequence in this excavation consisted of a band of topsoil/ploughsoil (001) underlying the hardcore and overlying the natural horizon (002), which extended to the base of this excavation. This deposit sequence was recorded within **Representative Section 2** [Plate 39].

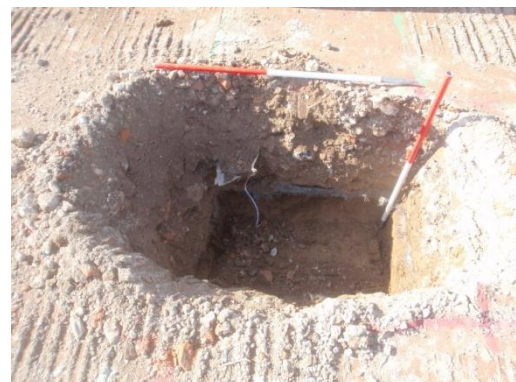
Plate 40: Stanchion Base 3, from the north-east

- 7.2.14 **SB3** was located to the south-east of **SB2** and along the north-eastern side of the new build area. **SB3** was excavated to a length and to a width of 0.90m and to depths of 0.95m below the level of the redeposited hardcore [Plate 40]. The deposit sequence in this excavation consisted of a thin band of topsoil/ploughsoil (001) underlying the hardcore and overlying the natural horizon (002), which extended to the base of this excavation. **SB4** was situated to the south-east of **SB3** and along the north-eastern side of the new build area. **SB4** was excavated to a length and to a width of 0.90m and to depths of 0.95m below the level of the redeposited hardcore [Plate 41]. The deposit sequence in this excavation consisted of a thin band of topsoil/ploughsoil (001) underlying the hardcore and overlying the natural horizon (002), which extended to the base of this excavation.

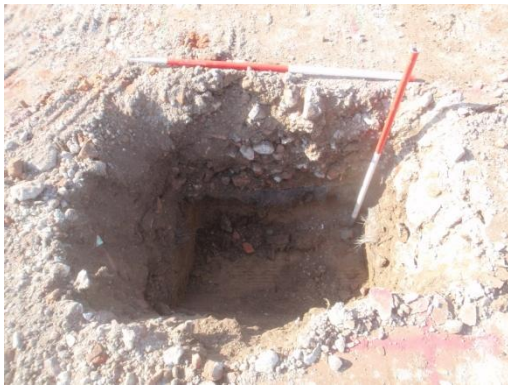
Plate 42: Stanchion Base 5, from the north-east

- 7.2.15 **SB5** was excavated to the south-east of **SB4** and along the north-eastern side of the new build area. **SB5** was excavated to a length of 1.0m, to a width of 0.90m and to depths of 0.95m below the level of the redeposited hardcore [Plate 42]. The deposit sequence in this excavation consisted of a band of topsoil/ploughsoil (001) underlying the hardcore and overlying the natural horizon (002), which extended to the base of this excavation.

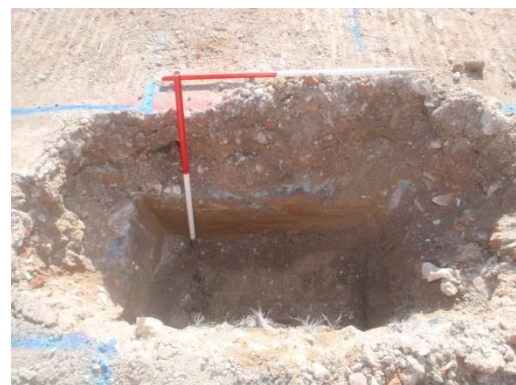
Plate 46: Stanchion Base 20, from the north-west

- 7.2.17 **SB20** was located to the south-west of **SB19** and was excavated to a length of 1.40m, to a width of 0.80m and to depths of 0.95m below the level of the redeposited hardcore [**Plate 46**]. The deposit sequence in this excavation consisted of hardcore overlying the natural horizon (**002**), which extended to the base of this excavation. **SB21** was situated to the south-west of **SB20** and to the north-east of **SB25/26**. **SB21** was excavated to a length of 1.40m to a width of 0.80m and to depths of 1.0m below the level of the redeposited hardcore [**Plate 47**]. The deposit sequence in this excavation consisted of hardcore overlying the natural horizon (**002**), which extended to the base of this excavation.
- 7.2.18 No archaeological activity or finds were identified throughout the monitoring of the excavation of these stanchion bases.

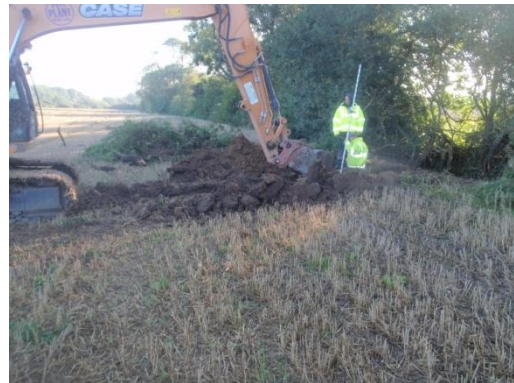
- 7.3.2.1 A second service trench was excavated from a dyke at the south-eastern field boundary north-westwards to the eastern corner of the area of the new build. This first section of this service trench was excavated to a length of 37.40m, to a width of 0.60m and to a depth of 0.90m below ground levels, which increased to a depth of 1.20m below ground levels at the eastern corner of the new build area [**Plates 61 and 63-65**].

Plate 61: Excavation of the Service Trench from the South-Eastern Dyke, from the south-west

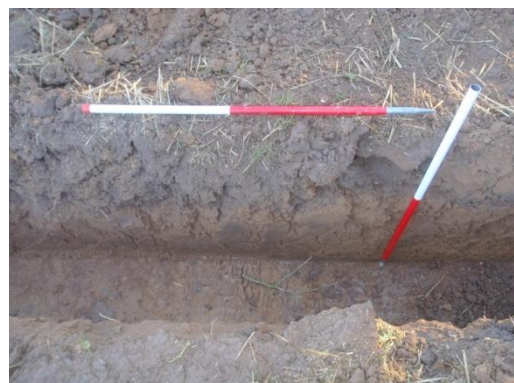
Plate 62: Representative Section 5, from the north-east

- 7.3.2.2 The deposit sequence encountered within this trench was the same and consistent with that observed within the area of the new build. This sequence comprised the topsoil/ploughsoil horizon (**001**) overlying the undisturbed natural subsoil horizon (**002**), which extended to the base of this excavation. This deposit sequence was recorded within **Representative Section 5** [**Plate 62**].

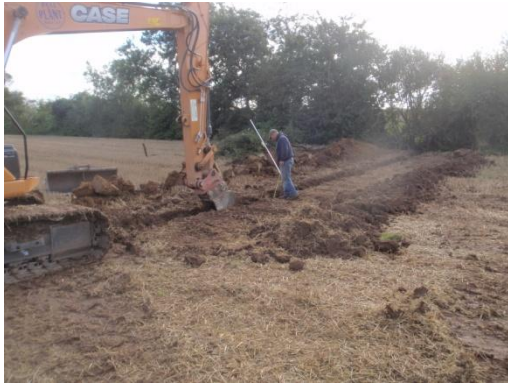
Plate 63: Excavation of the Service Trench from the South-Eastern Dyke, from the north-west

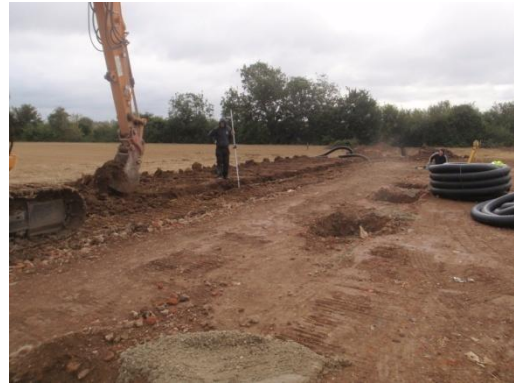
Plate 66: Excavation of the Service Trench from the South- Eastern Dyke & along the north-eastern side of the new build area, from the north-west

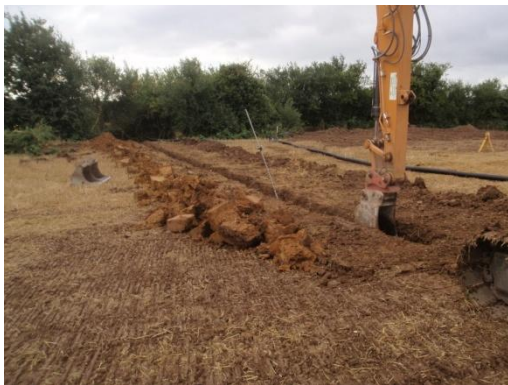
Plate 64: Excavation of the Service Trench from the South-Eastern Dyke, from the north-west

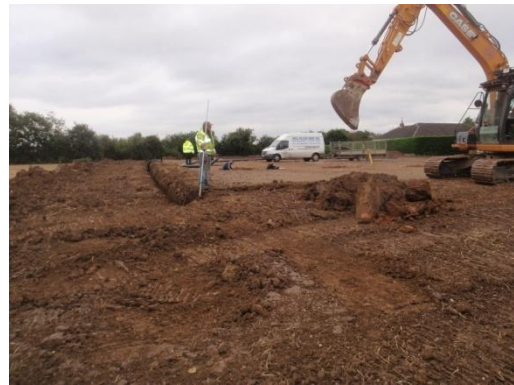
Plate 67: Excavation of the Service Trench along the north-eastern side of the new build area, from the north

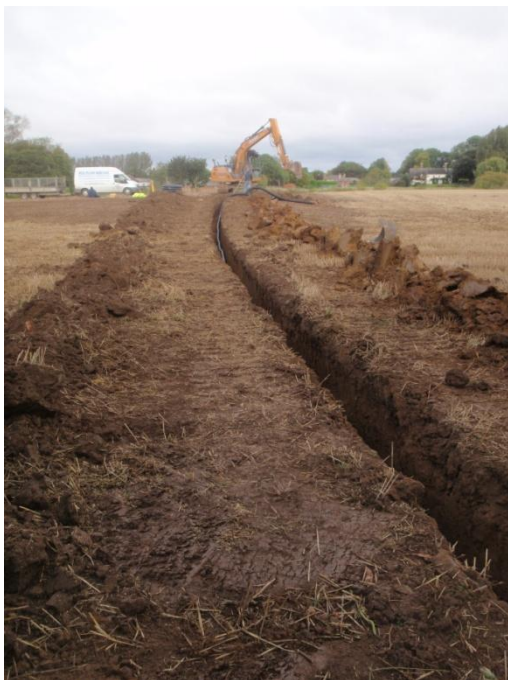
Plate 65: Excavation of the Service Trench from the South-Eastern Dyke, from the south-east

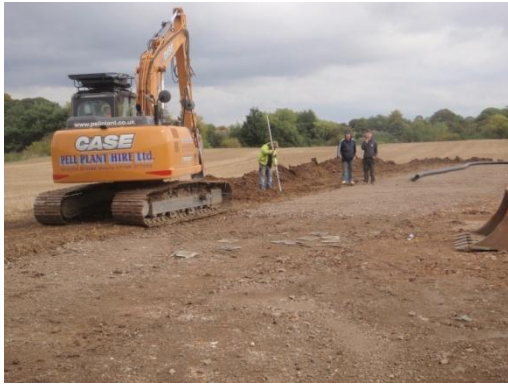
Plate 69: Excavation of the Service Trench along the north-western side of the new build area, from the south

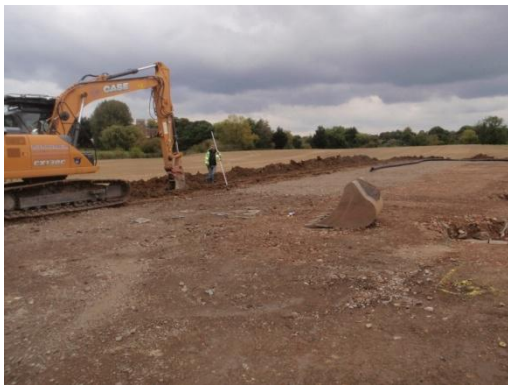
Plate 70: Excavation of the Service Trench along the north-western side of the new build area, from the south

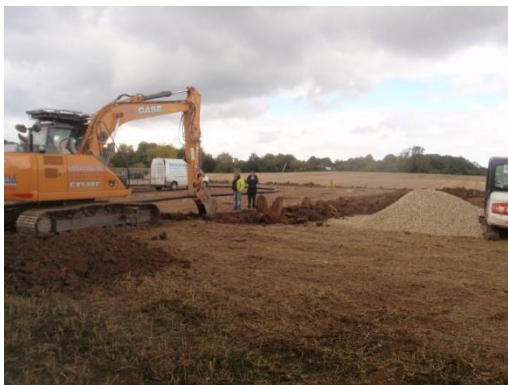
Plate 71: Excavation of the Service Trench along the south-eastern side of the new build area, from the south

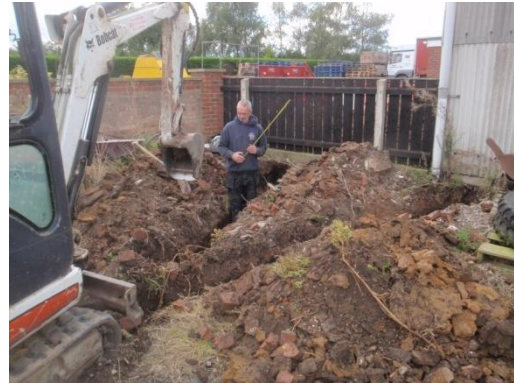
Plate 72: Excavation of the Service Trench, from the north

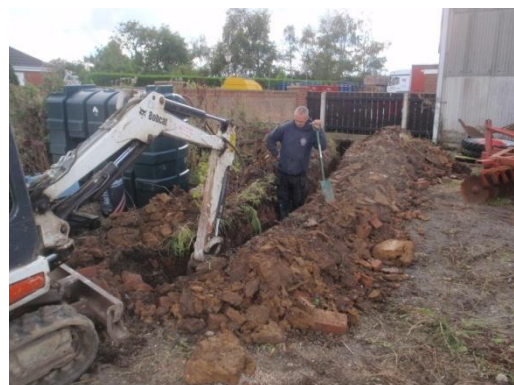
Plate 74: Excavation of the Service Trench, from the north

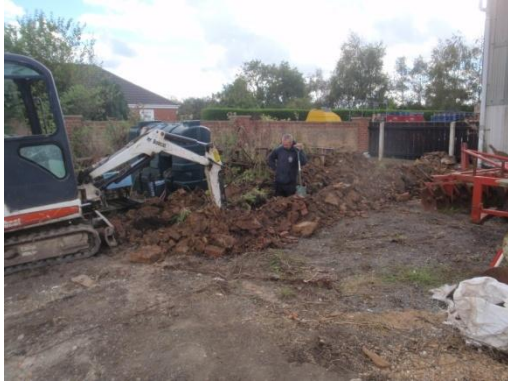
Plate 75: Excavation of the Service Trench, from the north

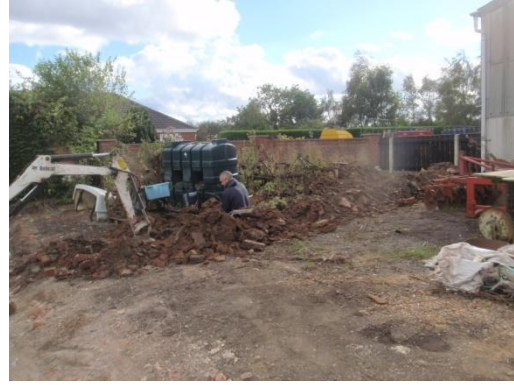
Plate 77: Excavation of the Service Trench, from the north

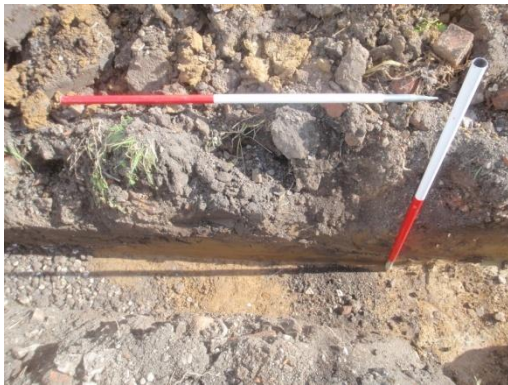
Representative Section 11 [Plate 76]. The natural horizon (002) extended to the base of these excavations.

Plate 76: Representative Section 11, from the north-west
